Consultant Support for Intelligent Compaction and Paver-Mounted Thermal Profiling Projects in 2020-2021

May 2022
Final Report

Project number TR202021
MoDOT Research Report number cmr 22-006

The Transtec Group, Inc.

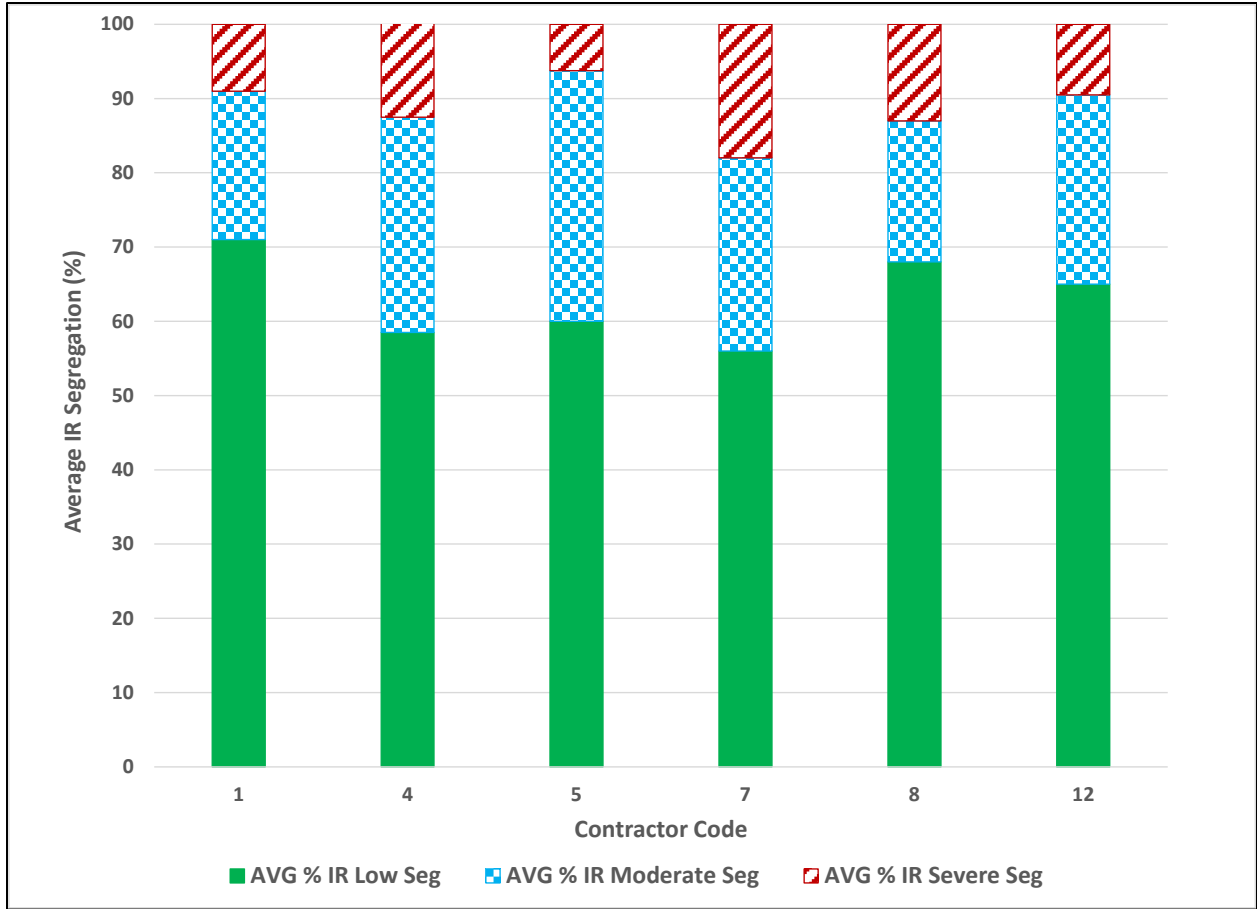
A summary of each contractor's overall average thermal segregation category (average of results for all 2021 projects completed by the contractor) is shown in Figure 30. All contractors had averaged 50 percent (half) low segregation and less than 20 percent severe segregation.

Figure 30. Chart. Average PMTP thermal segregation classification per contractor.

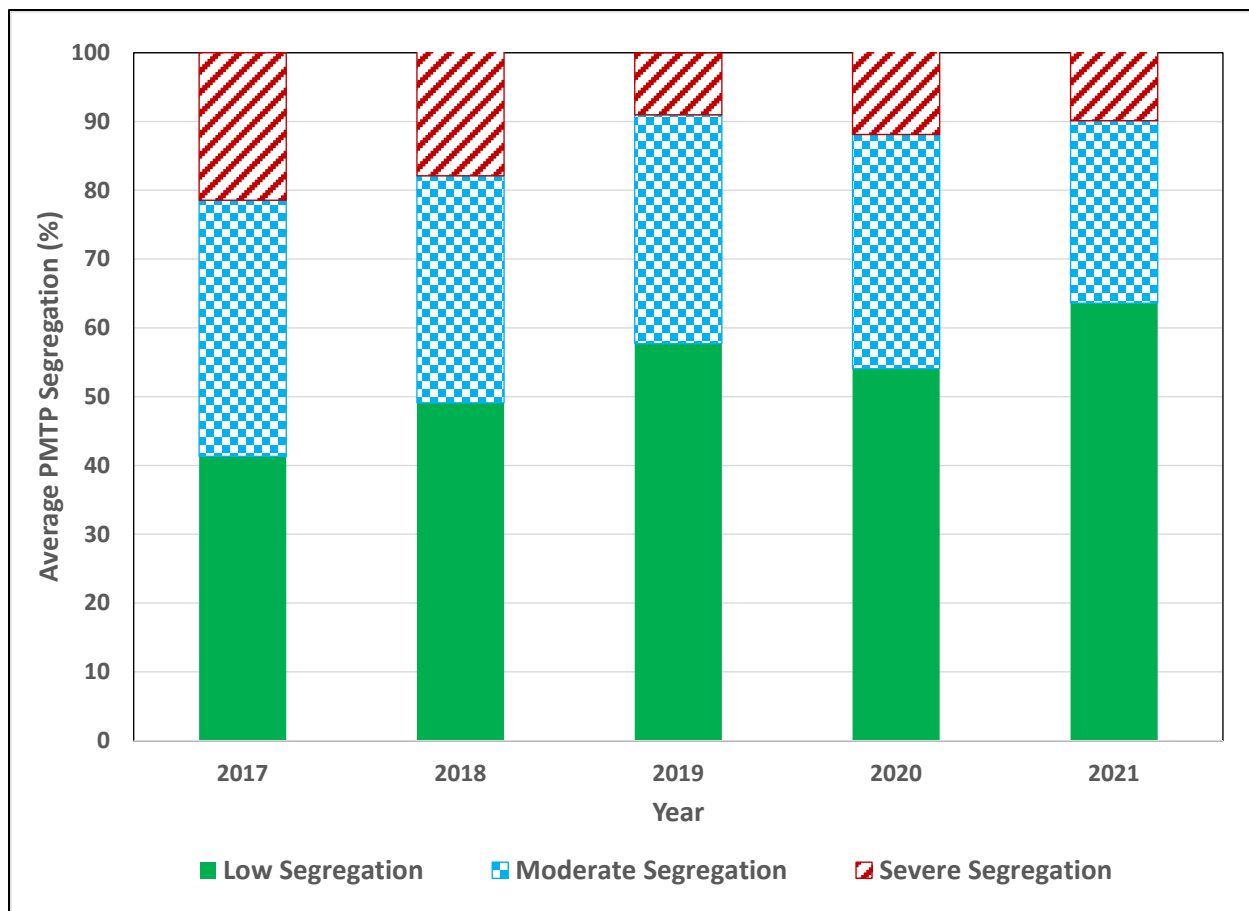
The average thermal segregation classifications were averaged across all projects during each construction season. The average PMTP segregation classifications are illustrated in Figure 31.

Figure 31. Chart. Average PMTP thermal segregation classification for all projects per construction season.

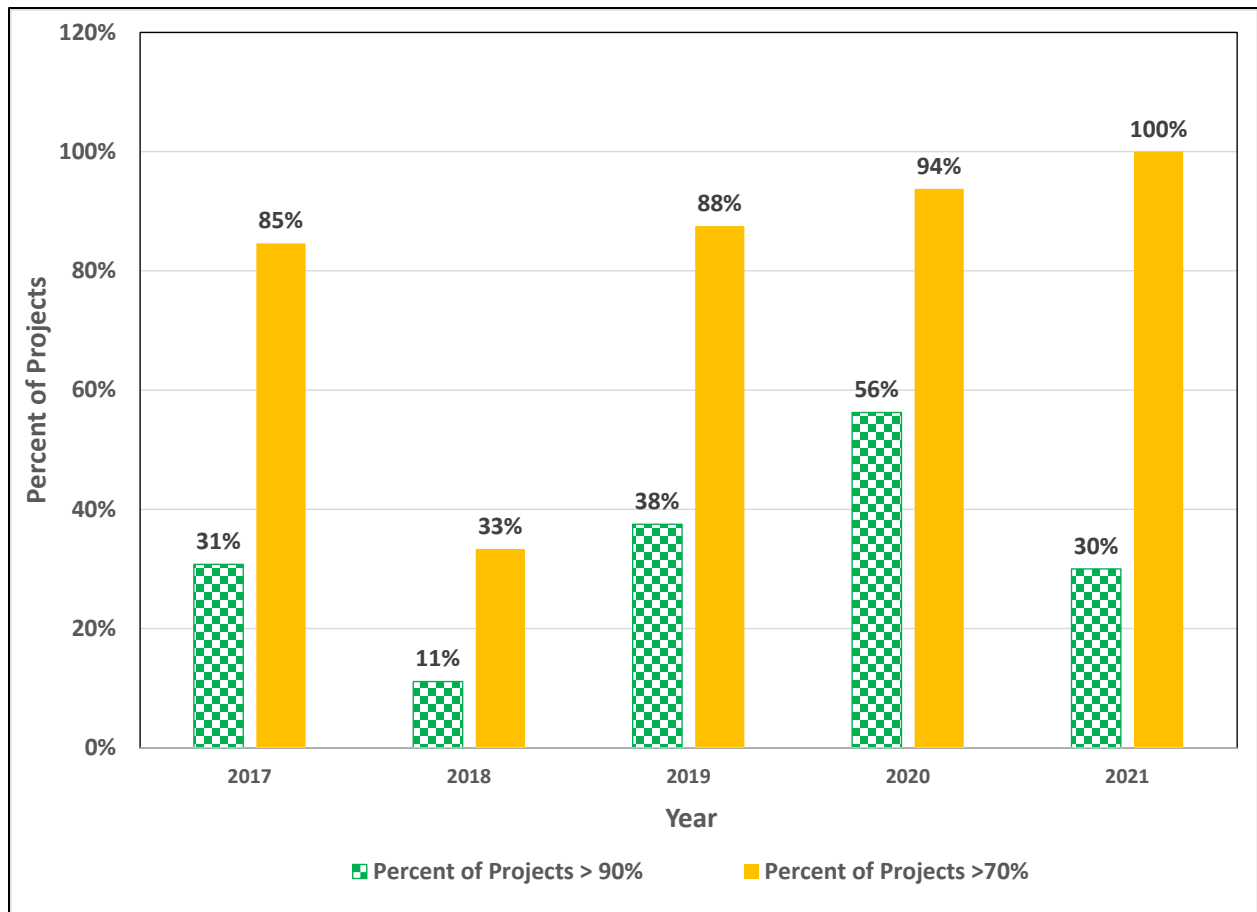
The same IC data were analyzed for the percent of projects that met the 70 percent threshold (moderate, no incentive, or disincentive) and the percent of projects that met the 90% threshold (passing, eligible for an incentive) illustrated in Figure 33.

Figure 33. Chart. Percent of projects that meet the 70 percent and 90 percent thresholds per construction season.
