# Best Practices for Road Weather Management

### Tennessee DOT Low Visibility Warning System

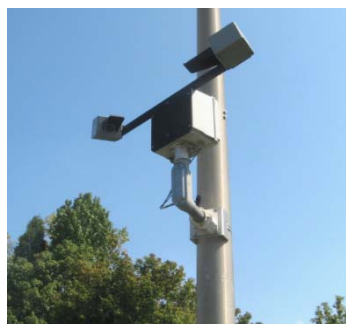
Figure TN-1. Fog detector.

*System Components:* The fog detection component of the system is comprised of nine (9) forward-scatter visibility sensors (Figure TN-1), fourteen microwave radar vehicle detectors, and 21 Closed Caption Television (CCTV) cameras (Figure TN-2). Data from these devices is transmitted by buried fiber optic cable to an on-site control center. Information from the on-site control center is relayed to a central computer located in the Highway Patrol office in Tiftonia, Tennessee, with the use of a leased point-to-point, T1 communication link. In addition to the electronic instrumentation, reflective roadside delineators are placed in the detection zone at 80-foot increments for visibility estimation in the field.

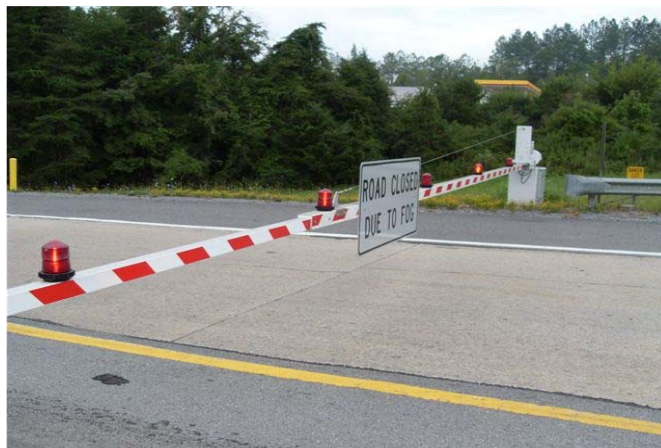
Figure TN-4. Swing gate.

The fog warning component of the system is made up of six (6) static warning signs with flashing beacons, ten Changeable Speed Limit Signs (CSLS) (Figure TN-3), ten overhead Dynamic Message Signs (DMS), and two Highway Advisory Radio (HAR) transmitters. These warning systems are connected to the on-site control center by buried fiber optic cable, and to the central computer on the leased T1 communication link. In addition to the warning systems, six remotely operated swing gates are located at interchange on-ramps to control access to the interstate in the most severe conditions (Figure TN-4).
