# Automation in Our Parks: Automated Shuttle Pilots at Yellowstone National Park and Wright Brothers National Memorial

June 2022

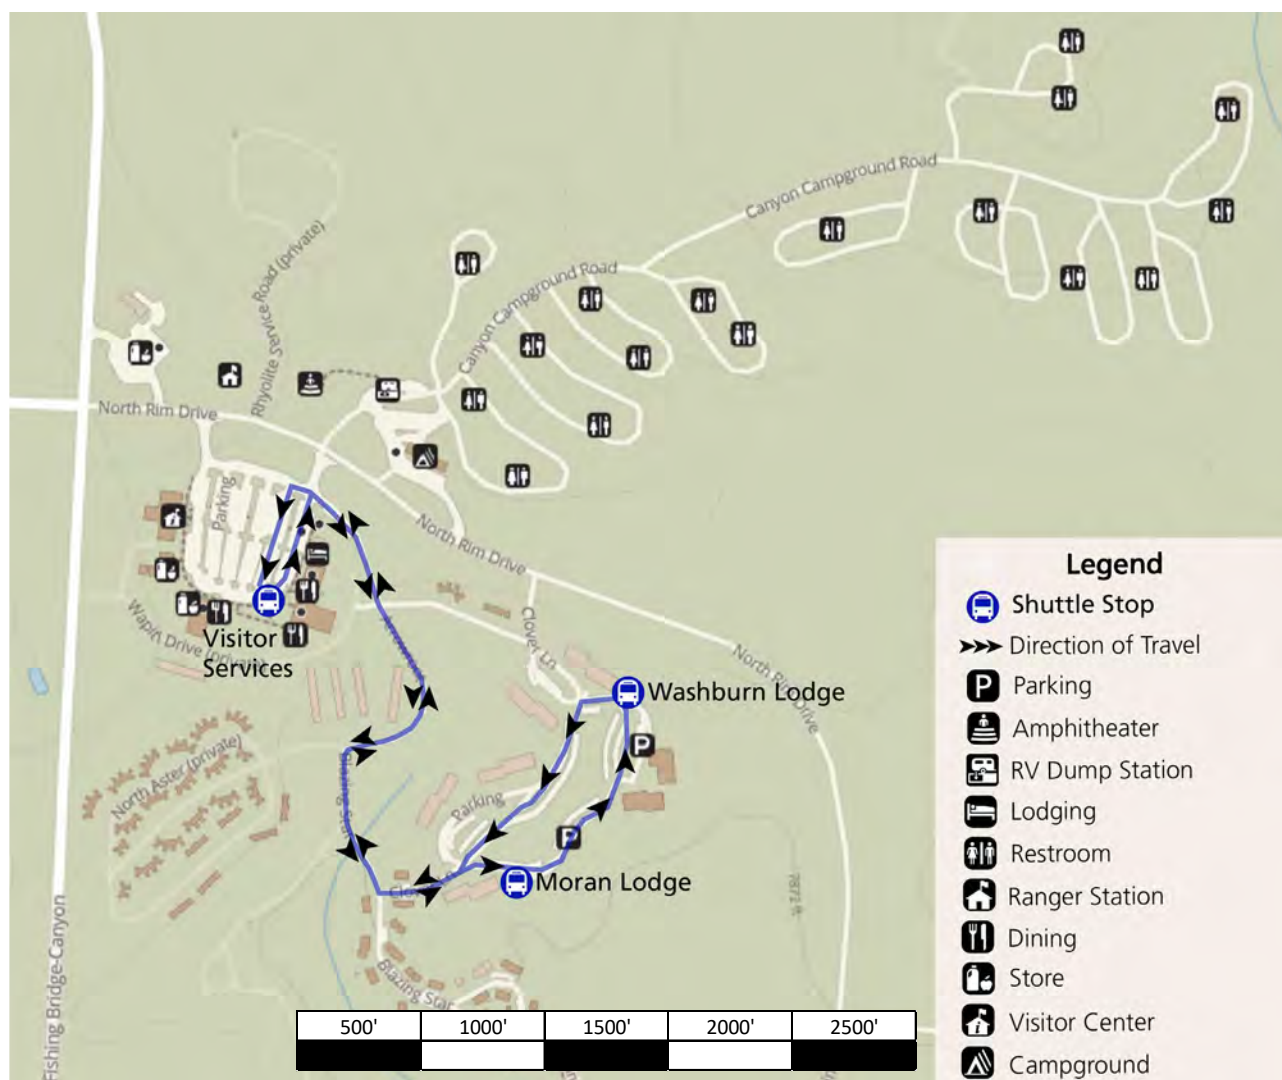
Figure 1: Map of First Automated Shuttle Route (Lodge Route)

The first route (Lodge Route) operated from June 9, 2021 to July 12, 2021 (shown in Figure 1). That route provided transportation between the Canyon Village Visitor Services area and the lodge area. It was roughly 1.5 miles long and had three stops (Visitor Services, Moran Lodge, and Washburn Lodge).

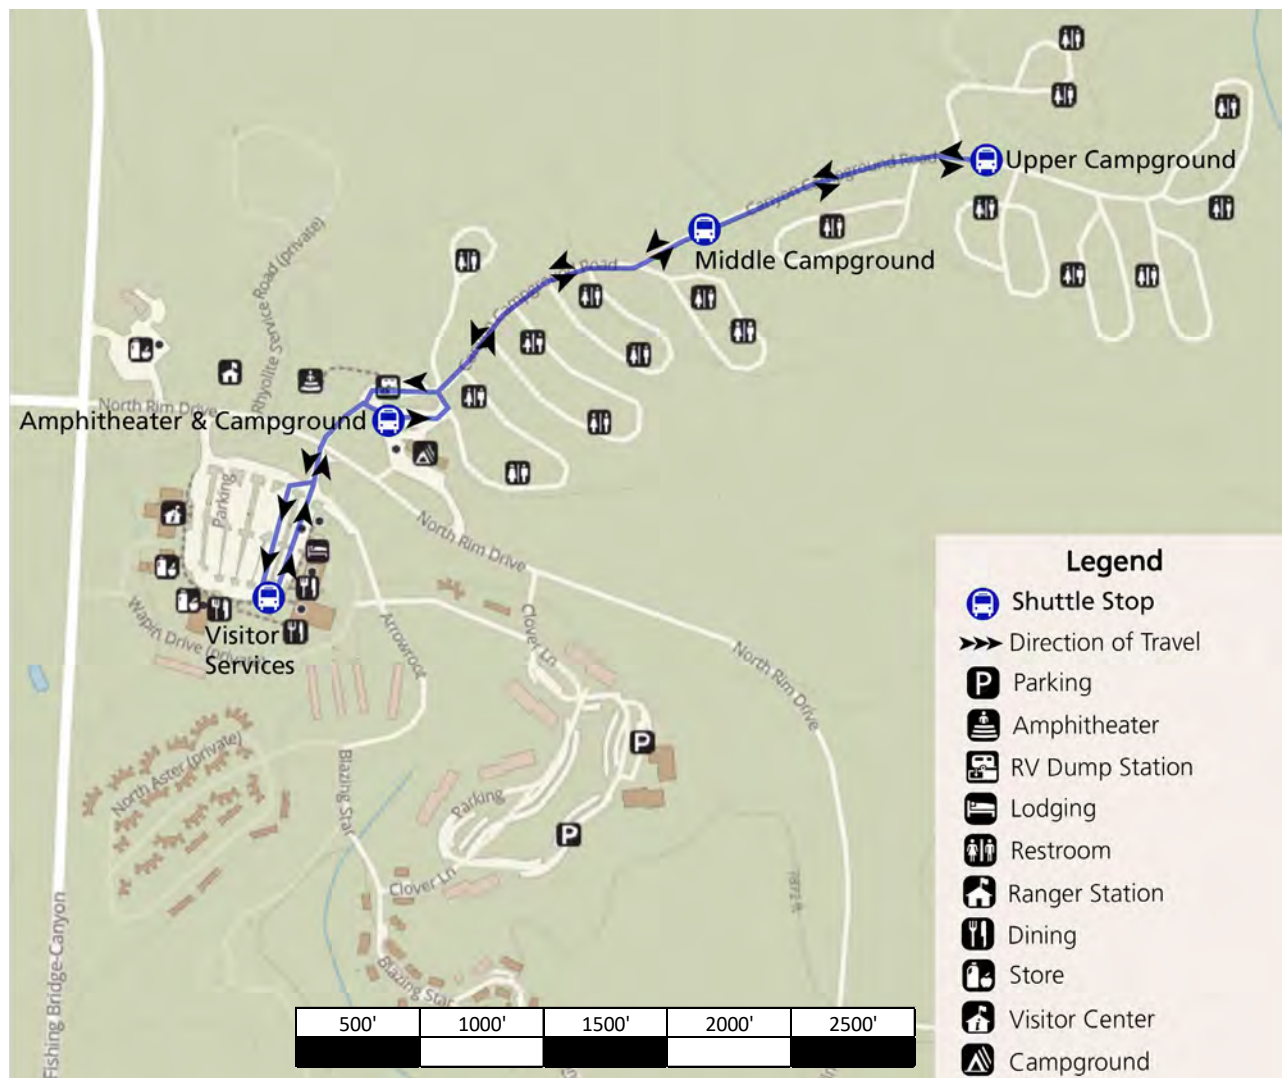
Figure 2: Map of Second Automated Shuttle Route (Campground Route)

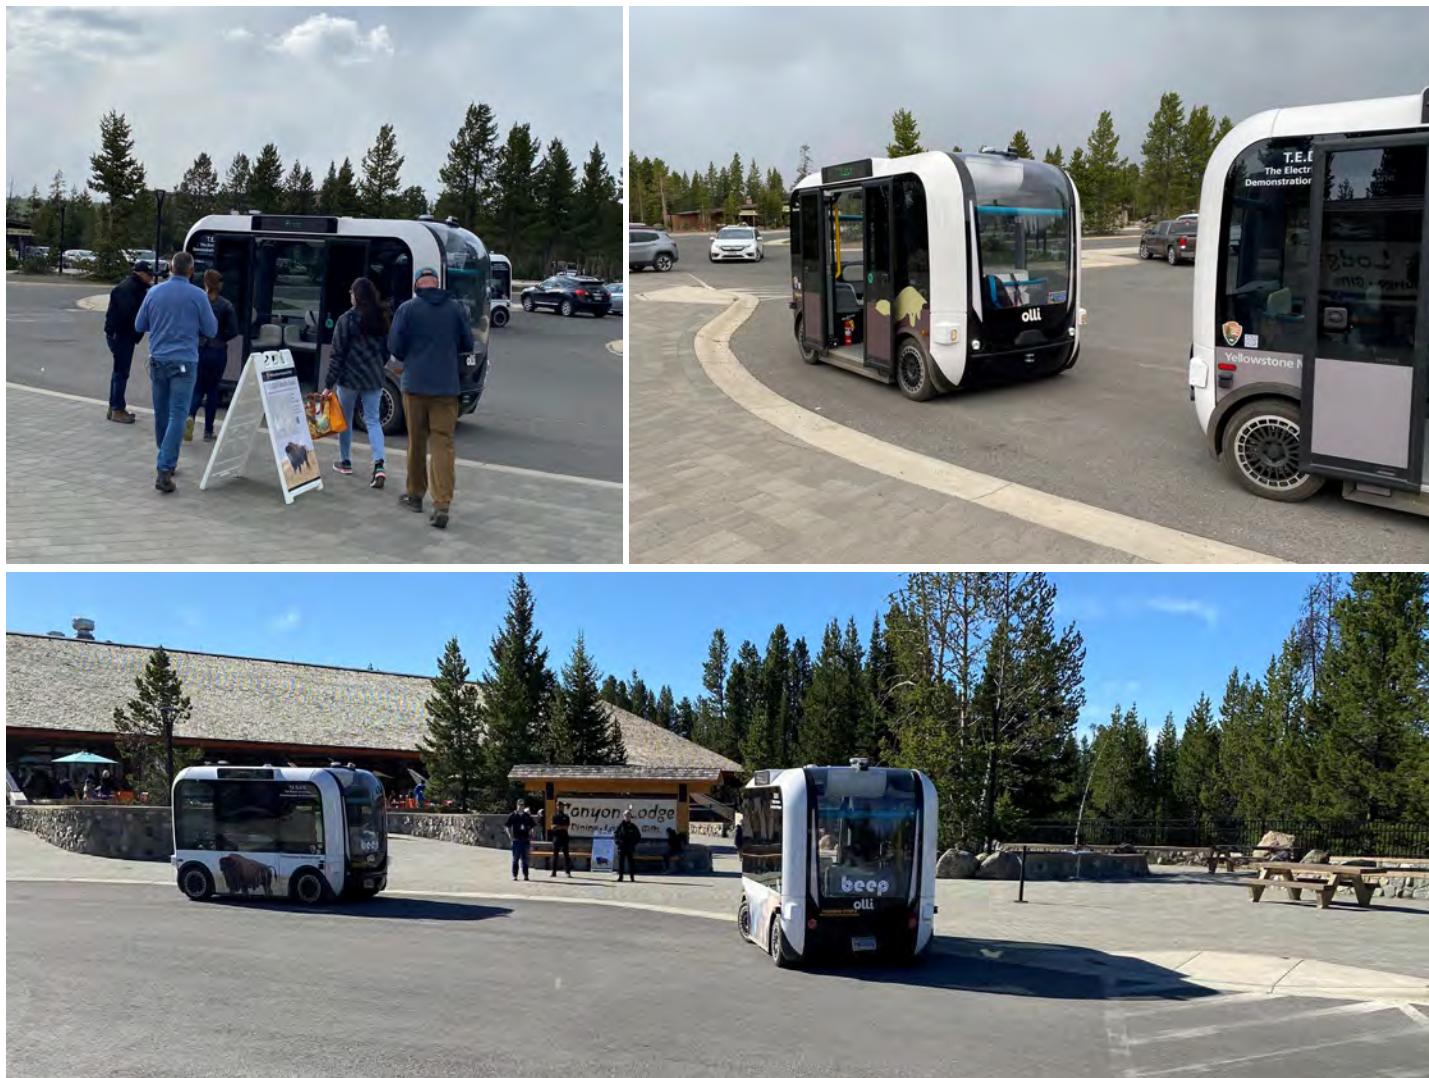
Figure 3: Automated Shuttles at the Visitor Services Stop

While the two routes provided service to different parts of the Canyon Village area, both shared a portion of the route in the horseshoe-shaped parking area and shared the same “Visitor Services” stop. Figure 3 shows the automated shuttles at the Visitor Services stop.

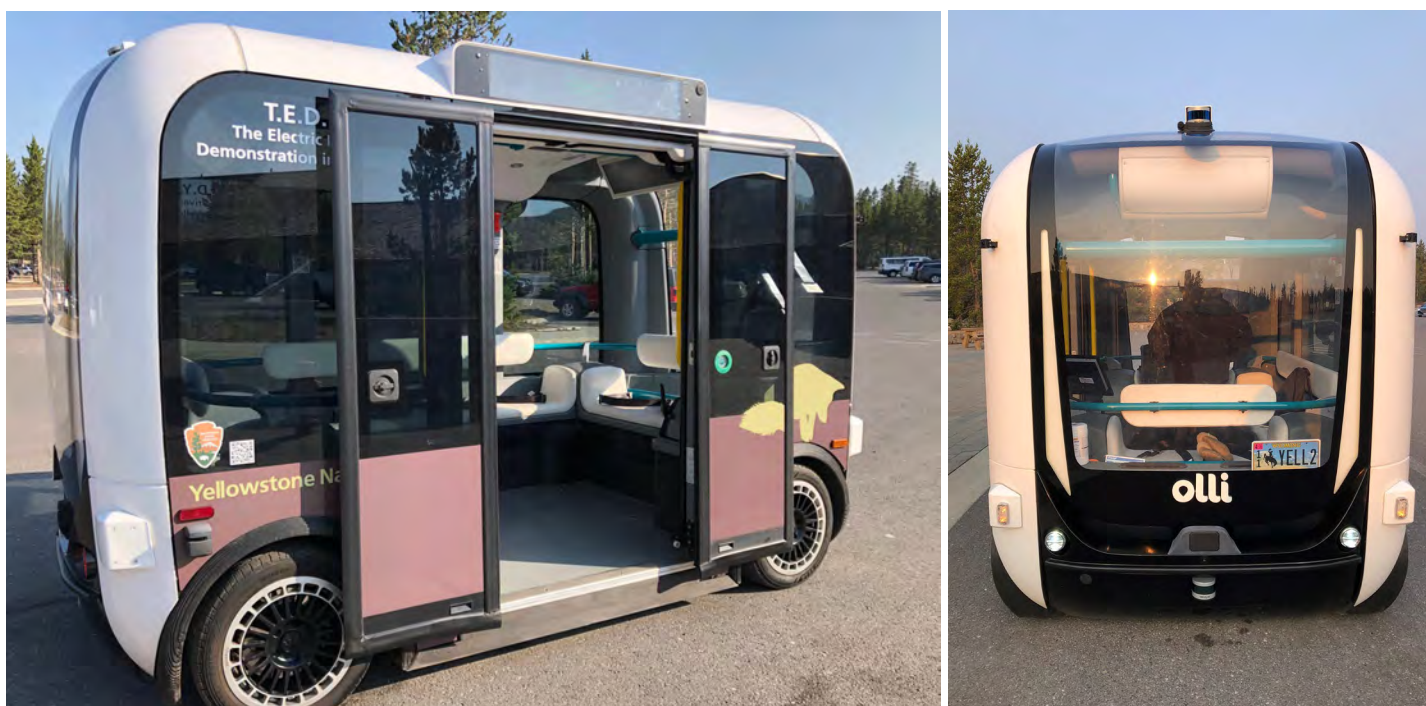
*Figure 4: Exterior of Local Motors Olli 1.0 Shuttle*

The maximum seated capacity of the Local Motors shuttle was eight passengers plus the operator, who stood while operating the vehicle. While the Local Motors Olli shuttle has a nominal maximum speed of up to 25 mph, actual operating speeds are typically much slower (for operating speed estimates in the TEDDY pilot, see the discussion in the Pilot Evaluation section).<sup>14</sup> The TEDDY service did not operate at reduced passenger capacity due to COVID-19 safety precautions.<sup>15</sup> Passengers were, however, required to wear masks while onboard.

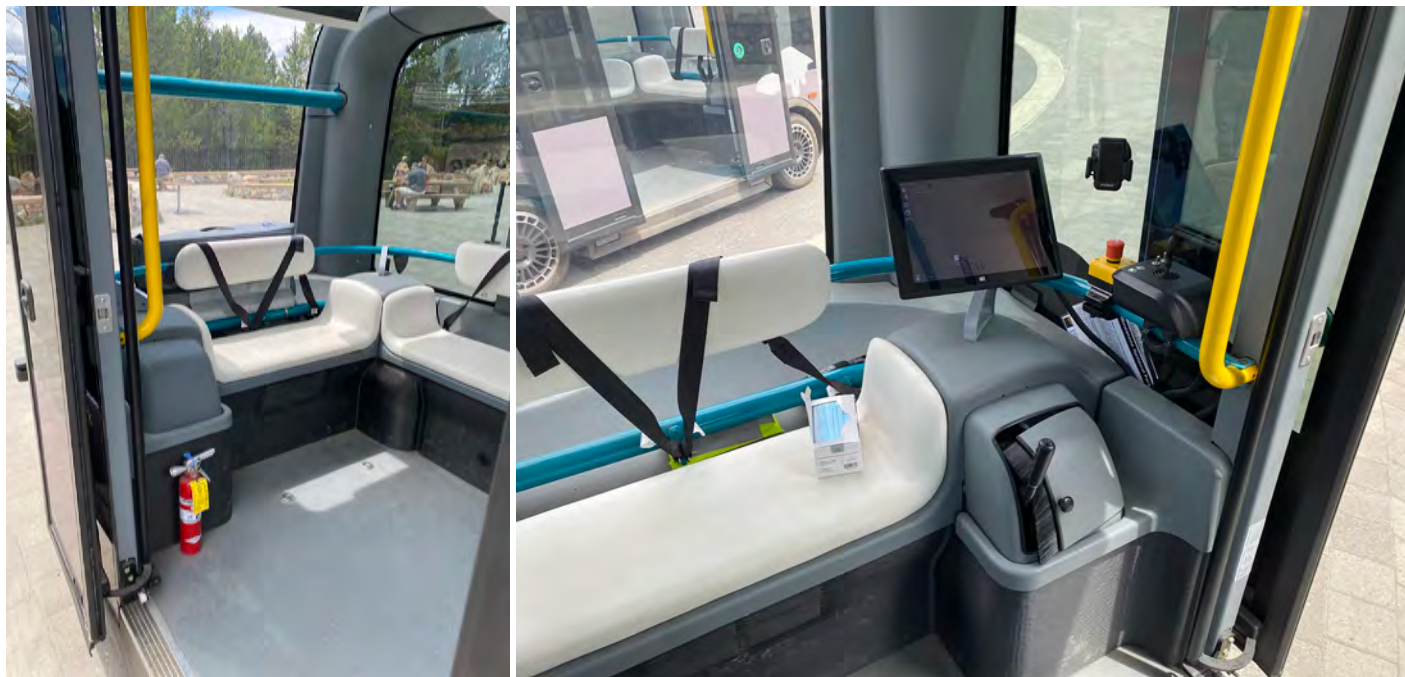
Figure 5: Interior of Local Motors Olli 1.0 Shuttle

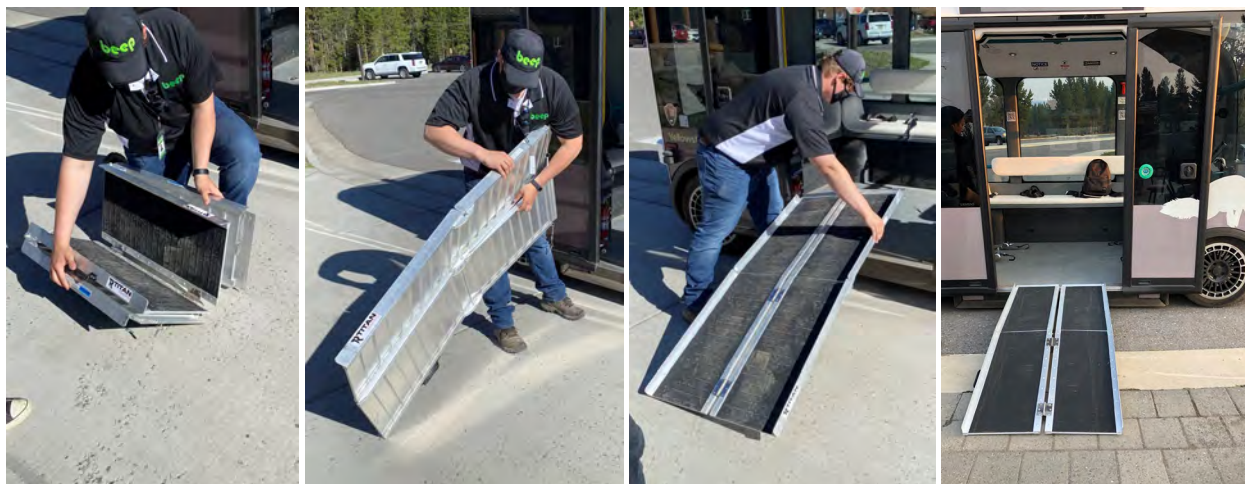
Figure 6: Deployment of Automated Shuttle Accessibility Ramp

The Local Motors Olli 1.0 shuttles did not have built-in accessibility ramps. Beep procured a portable folding accessibility ramp that the operator could deploy when necessary.<sup>16</sup> When deployed, the ramp would be placed at the door of the vehicle so that wheelchair users or other riders who could not step up into the vehicle could board and alight (Figure 6 shows the process of unfolding and placing the ramp at the entrance of a shuttle). During a site visit, the research team observed that it took approximately two minutes for two staff to set up the ramp, and a total estimated time of five to seven minutes for staff to set up the ramp, secure a wheelchair, and remove the ramp. Staff also reported that they would kneel the vehicle (i.e., lower the suspension of the vehicle to decrease the height of the vehicle floor) if they observed a passenger with mobility difficulties.

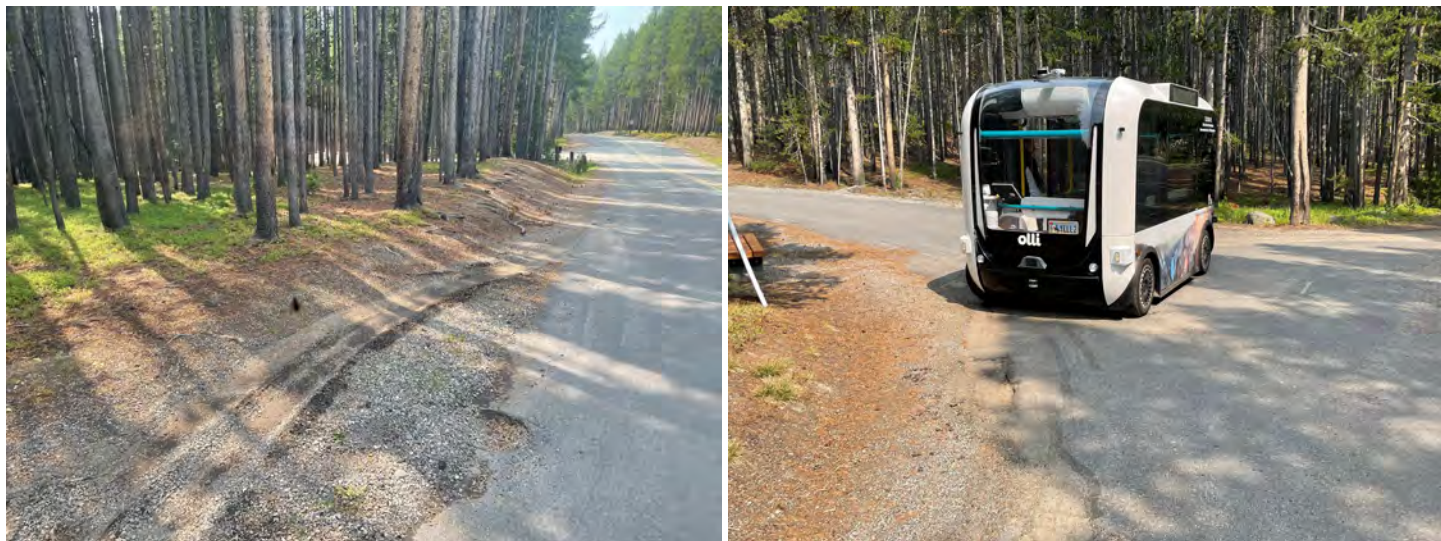
Figure 7: Road Damage Resulting from a Repeated Shuttle Turn

<sup>17</sup> Note that, during the site visit, research staff noted that running the shuttle repeatedly in the exact same route led to some rutting and roadway damage (spalling) at the edge of the roadway.

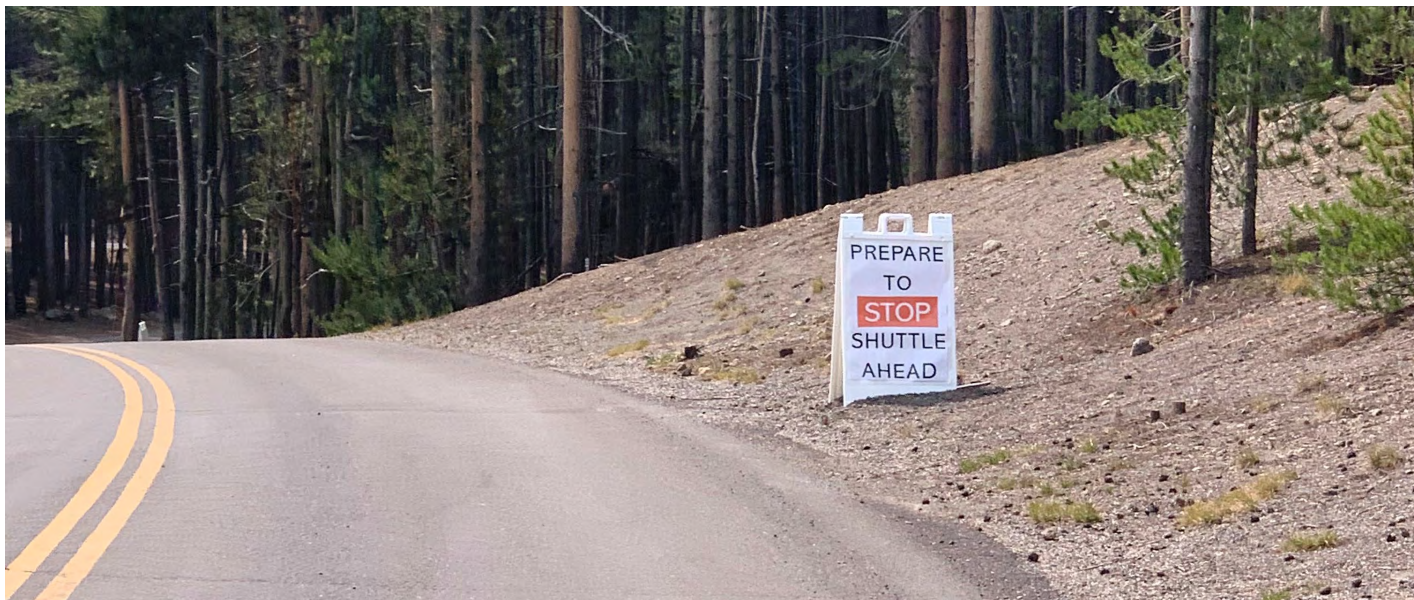
Figure 9: “Prepare To Stop Shuttle Ahead” Sandwich Board Sign on Second Route

In addition to the sandwich board signs, NPS and Xanterra added seven additional stop signs to the two routes in order to reduce speeds of other vehicles and help increase safety at intersections. They added four stop signs along the Lodge Route and three stop signs along the Campground Route. In addition, for one of the intersections on the Campground Route, they added a sign that read “Prepare To Stop-Shuttle Ahead” near the route, given that a shuttle stop was located near an intersection at the bottom of a hill, and the approach to the intersection had somewhat limited visibility (Figure 9).

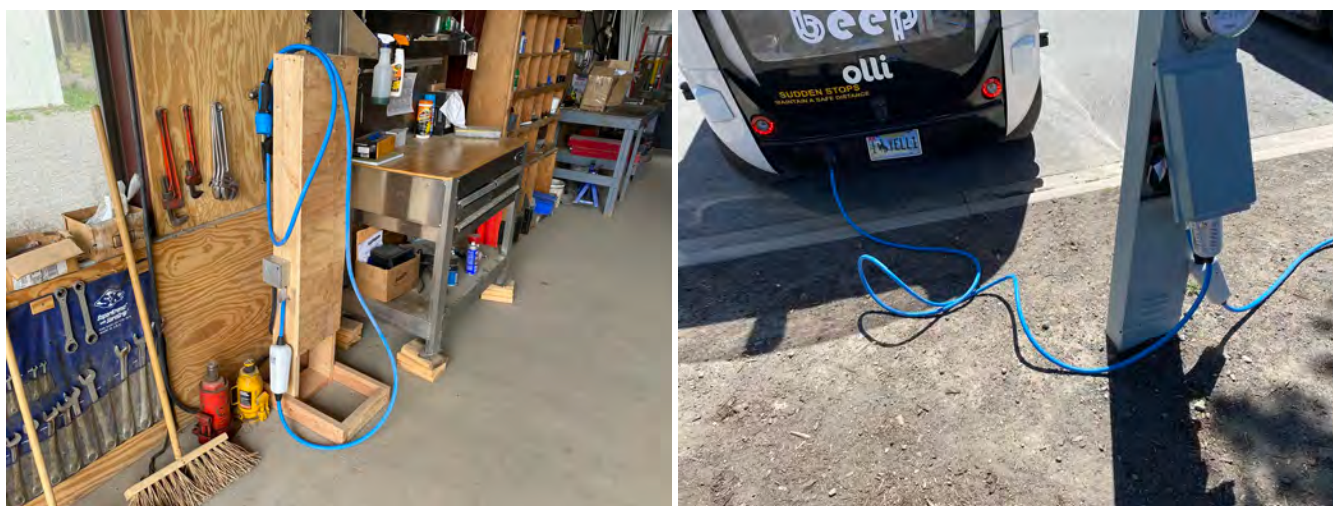
Figure 11: Charging Equipment at the Storage Garage (left) and at the Main Horseshoe-Shaped Parking Area (right)

In addition to the charging capabilities at the storage garage, additional charging capability was added in the main Canyon Village horseshoe-shaped parking area, which allowed for midday charging during breaks in service (Figure 11). Charging in the main parking area was neither in the original plans for the pilot nor in the contract that was signed by NPS and the vendor—the vendor response to the RFQ indicated that the shuttles could operate using only charging infrastructure available at the storage site. NPS staff noted that the flexibility on the part of NPS to support charging in the parking area enabled the pilot to be successful and reduced the amount of time that would have been required to bring the shuttle back to the storage garage.

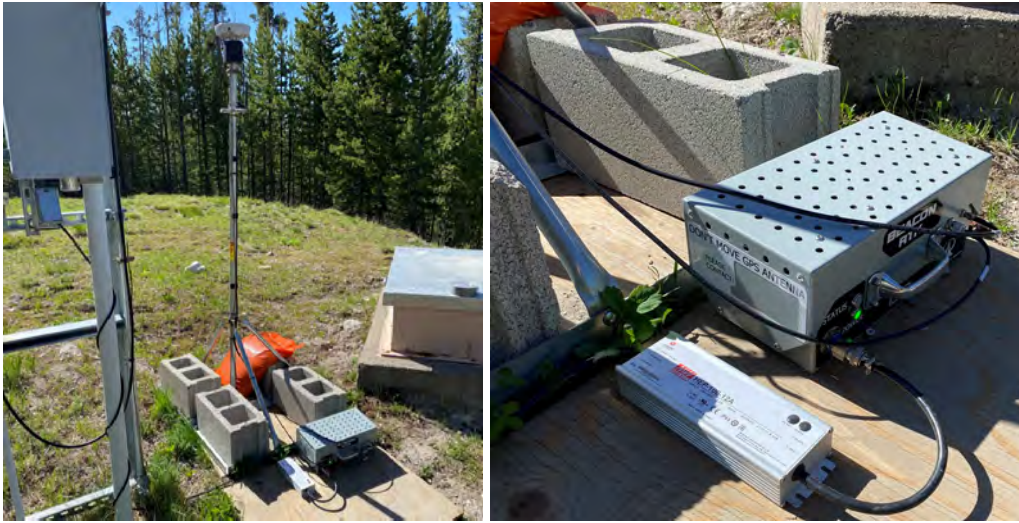
Figure 12: RTK Base Station in the Canyon Village Area

location. RTK can provide accuracy within a few centimeters, whereas standalone GPS without RTK typically provides accuracy within a few meters. For more information on how GPS works, see the educational resources section of the official U.S. government GPS website: U.S. Space Force. <https://www.gps.gov/students/>

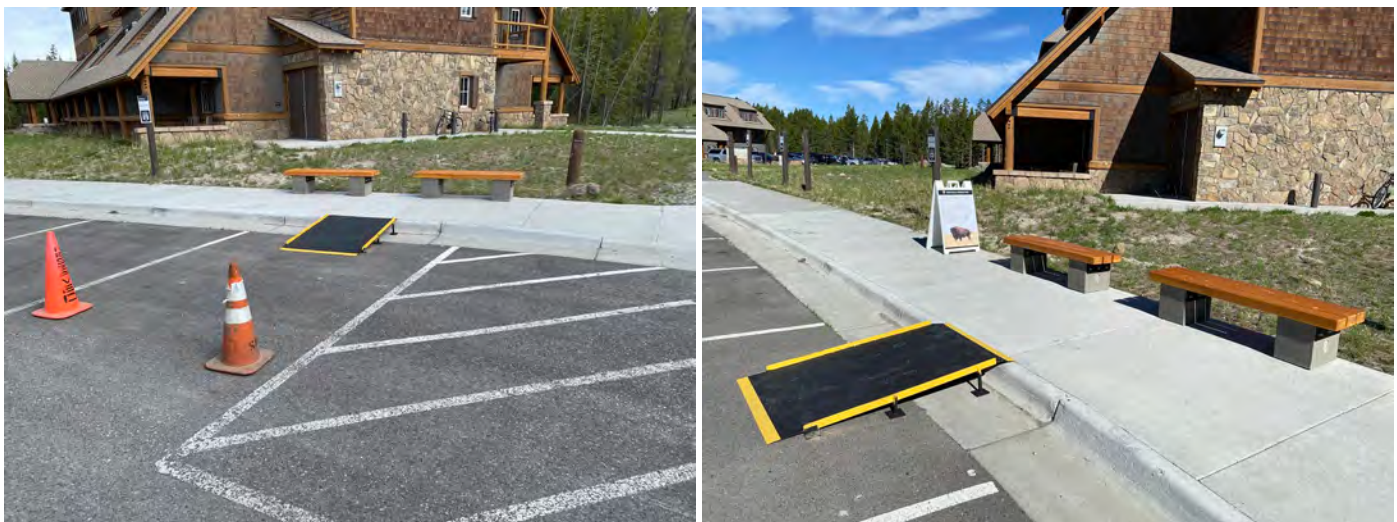
Figure 13: Ramp Installation at the Washburn Stop

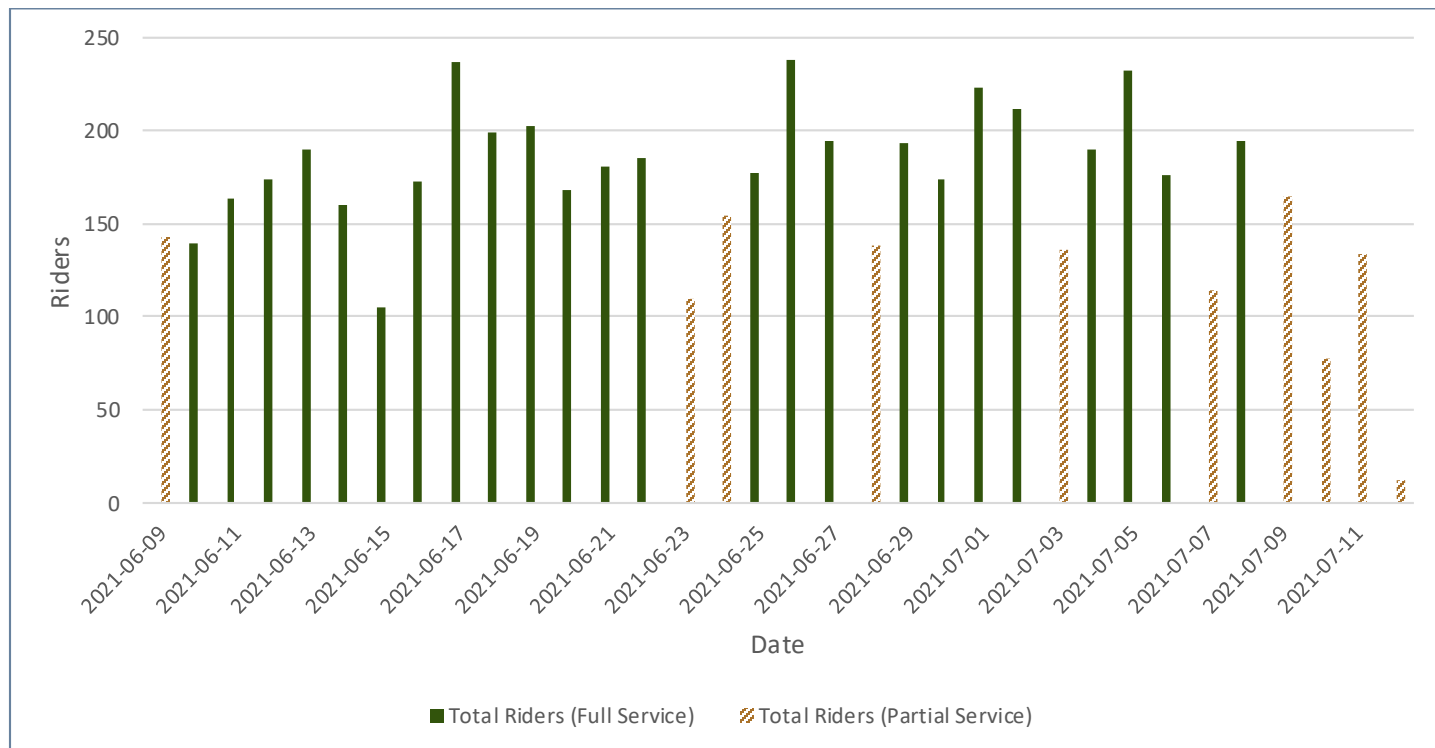
Figure 14: TEDDY Shuttles Riders per Day: Lodge Route, June–July 2021

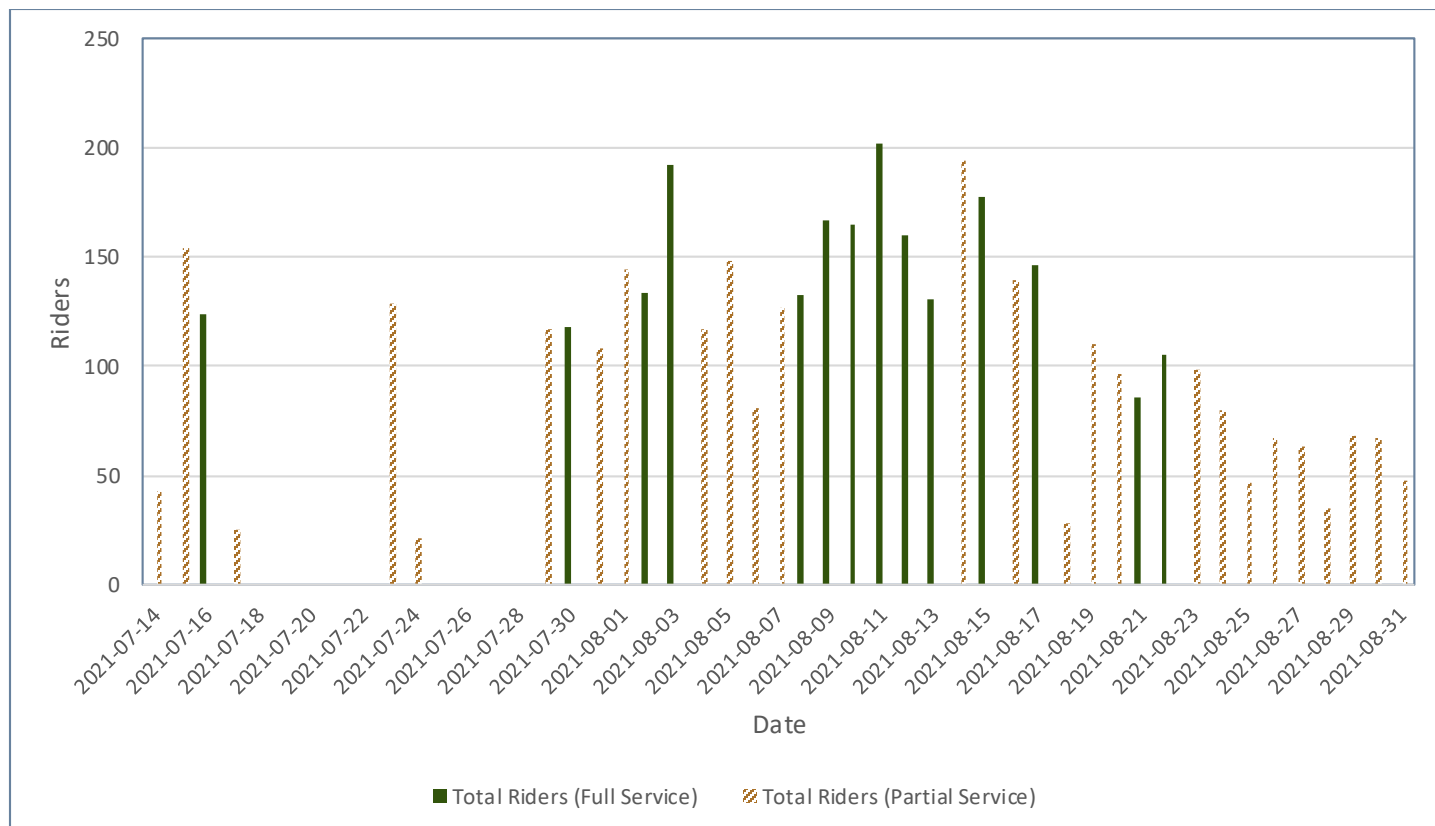
Figure 15: TEDDY Shuttles Riders per Day: Campground Route, July–August 2021

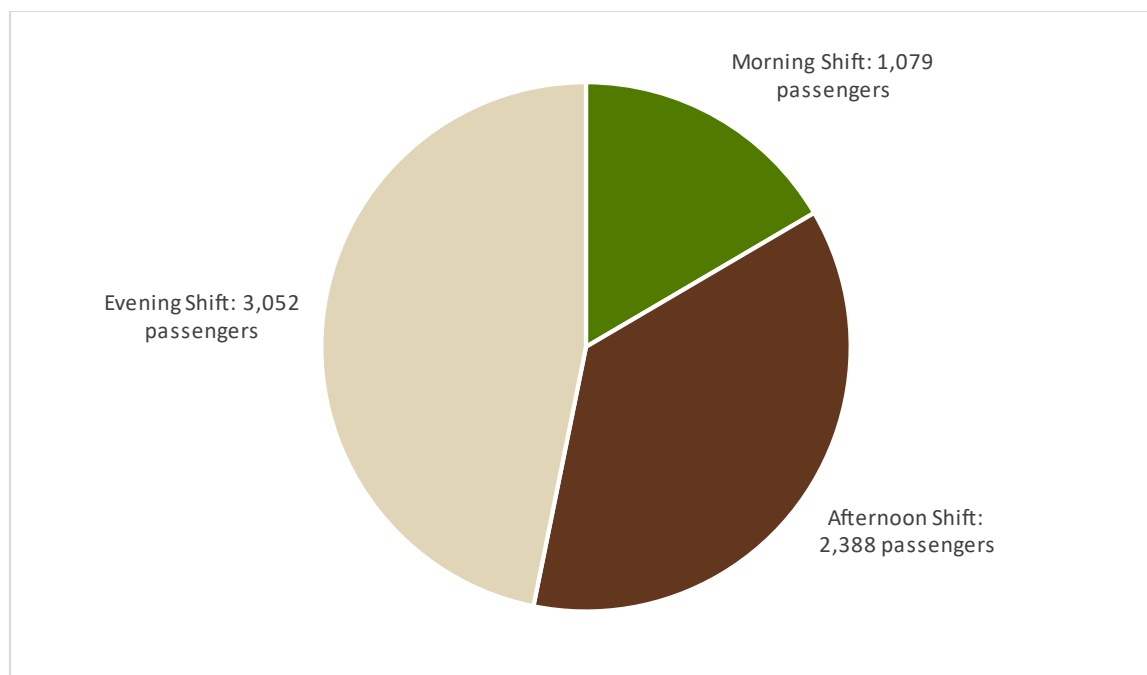
*Figure 16: TEDDY Shuttles Riders by Shift for Days of Full Service*

The number of trips and passengers varied by both day and shift, and the shift variation had a clear overall pattern. The morning shift had the fewest number of total trips and passengers and had the lowest passenger/trip ratio. On days for which both shuttles were in service for the entire day, the morning shift (7:00–10:00 am) averaged 2.7 passengers per trip, the afternoon shift (12:30–3:30 pm) averaged 4.5 passengers per trip, and the evening shift (6:00–9:00 pm) averaged 5.2 passengers per trip. The breakdown of total passengers between shifts can be seen in Figure 16.

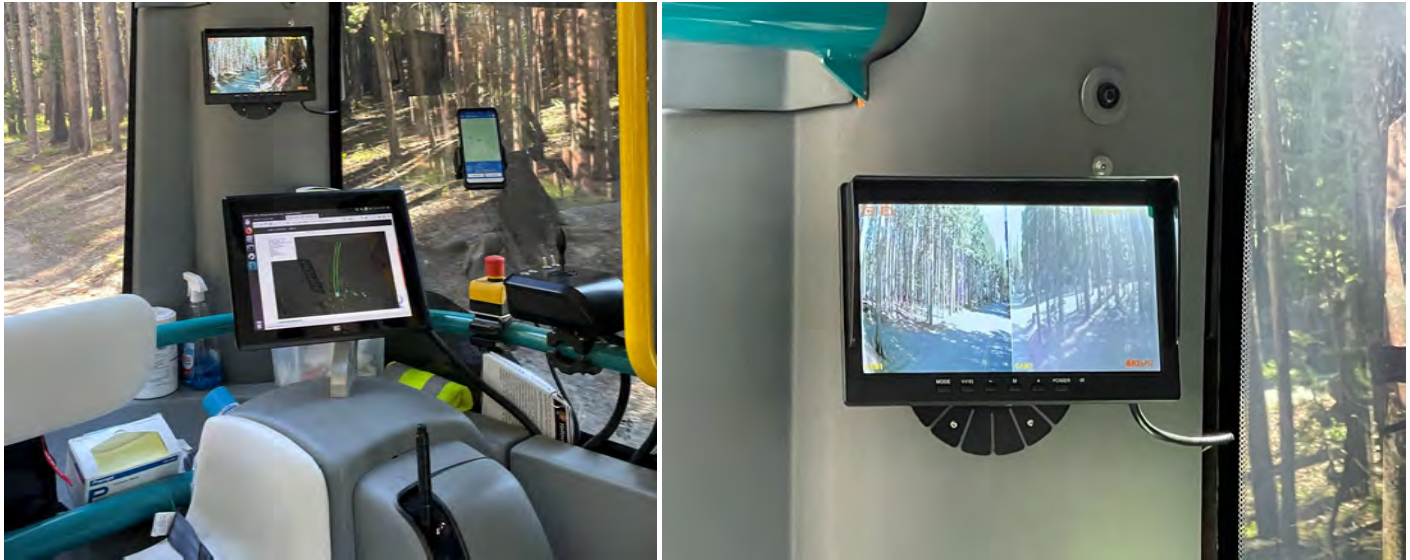
Figure 18: Additional Monitor Added to Address Blind Spots

For both incidents, the investigations showed that the shuttle and the shuttle operator were not at fault. The incidents both resulted from another vehicle backing out of a parking space, where the driver could not fully see the shuttle or assumed that the shuttle would stop more quickly than it did. The incident on August 23, 2021, while minor, did damage the shuttle enough for it to be taken out of service for the remainder of the pilot.

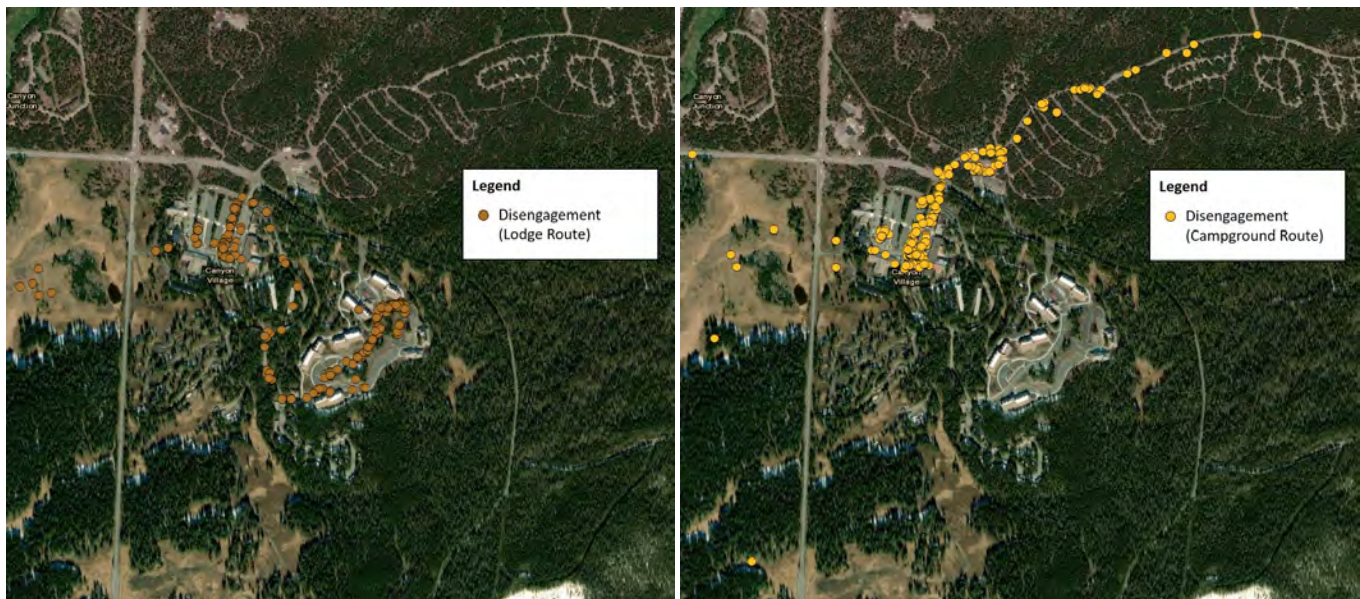
*Figure 19: Maps of TEDDY Shuttle Disengagements for the Lodge Route (left) and Campground Route (right)*

The disengagement data included information on the initiation of the disengagement (operator or ADS) and a description of the cause. Almost all disengagements were due to obstacle detection (90.0 percent), but there were also several disengagements due to a weak signal (9.0 percent),<sup>27</sup> as well as a few due to operator error (0.4 percent) and deviations from the path (0.6 percent).

As previously noted, several of the disengagements were due to a “weak signal error” (43 total disengagements, 9.0 percent of all disengagements). In those cases, a weak cellular signal from the RTK base station could cause the shuttle’s ADS to have difficulty with localization, causing it to disengage, and requiring the operator to take over manually until the signal strengthened. Communications in a remote, mountainous location like Yellowstone National Park are a known challenge, and challenges related to the communications were apparent throughout the pilot. To deploy automated shuttles as a longer-term service option, the automated driving system being used would need to be able to function in these types of environments where communications have historically been challenging.

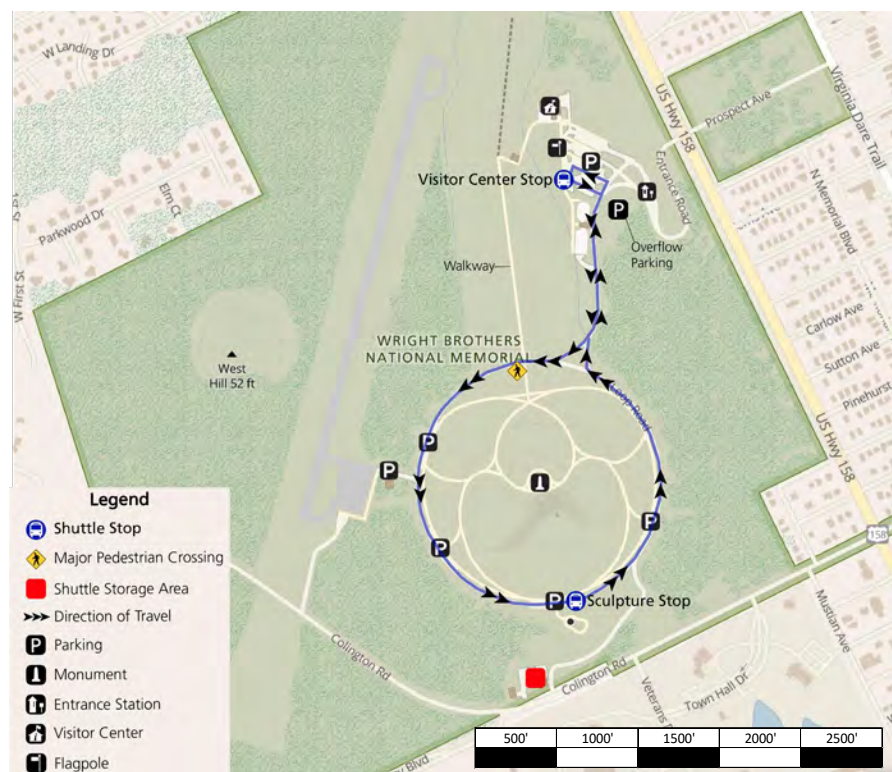
Figure 22: Map of Wright Brothers National Memorial CASSI Shuttle Route

Wright Brothers National Memorial is located in Kill Devil Hills, North Carolina. The Memorial, dedicated to the first powered airplane flights by Wilbur and Orville Wright in December 1903, received 482,192 visitors in 2021.<sup>31</sup> Visitors can park in the main parking area near the Visitor Center and walk to the monument or drive onto Wright Brothers Memorial Loop, where additional parking is available. The Wright Brothers Monument is located at the top of a hill surrounded by the Memorial Loop. Visitors can walk up the hill to the monument or see the Wright Brothers sculpture at the southern end of the Memorial (Figure 22).

Requirements for the shuttle storage included a secured location for overnight parking, availability of charging equipment, and a covered location not subject to temperatures below 40 or above 95 degrees Fahrenheit. The pilot occurred in a mild season in which these temperature limitations could be met, so no climate control equipment was required. NPS staff oversaw upgrades to an existing shed onsite to ensure that the shuttle could be safely stored (Figure 27). The operator manually navigated the shuttle from its service route to the storage shed before and after service hours ended, as well as any time when midday charging was required. The storage shed was located approximately 0.35 miles from the sculpture stop (see site map, Figure 22).

Most visitors walked through the Memorial by starting at the visitor center and continuing south down the walkway toward the Wright Brothers Monument. Pedestrians must cross a marked crosswalk across Memorial Loop to walk toward the Monument (see site map, Figure 22). Drivers attempted to pass the shuttle as the shuttle yielded to pedestrians in the crosswalk, creating an unsafe environment for the pedestrians and the shuttle operation. Park staff resolved this issue by placing orange cones, an MUTCD-compliant crosswalk sign, and a custom sign instructing drivers not to pass at crosswalks (Figure 41 and Figure 42).<sup>52</sup>

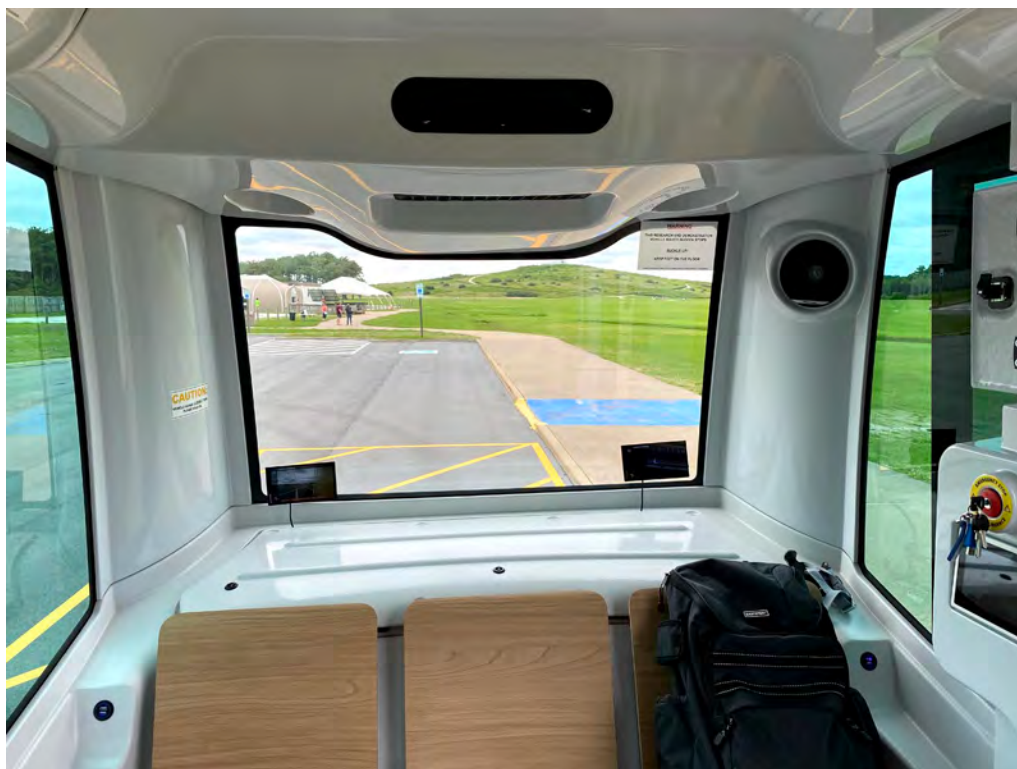
Figure 23: Interior View of the Shuttle

Figure 23 and Figure 24 show the interior and exterior of the shuttle. The shuttle was equipped with a built-in automated accessibility ramp that the safety operator could deploy when necessary (Figure 25). In addition, safety operators could lower the floor of the shuttle (kneeling the shuttle) to allow for easier boarding of visitors with limited mobility.

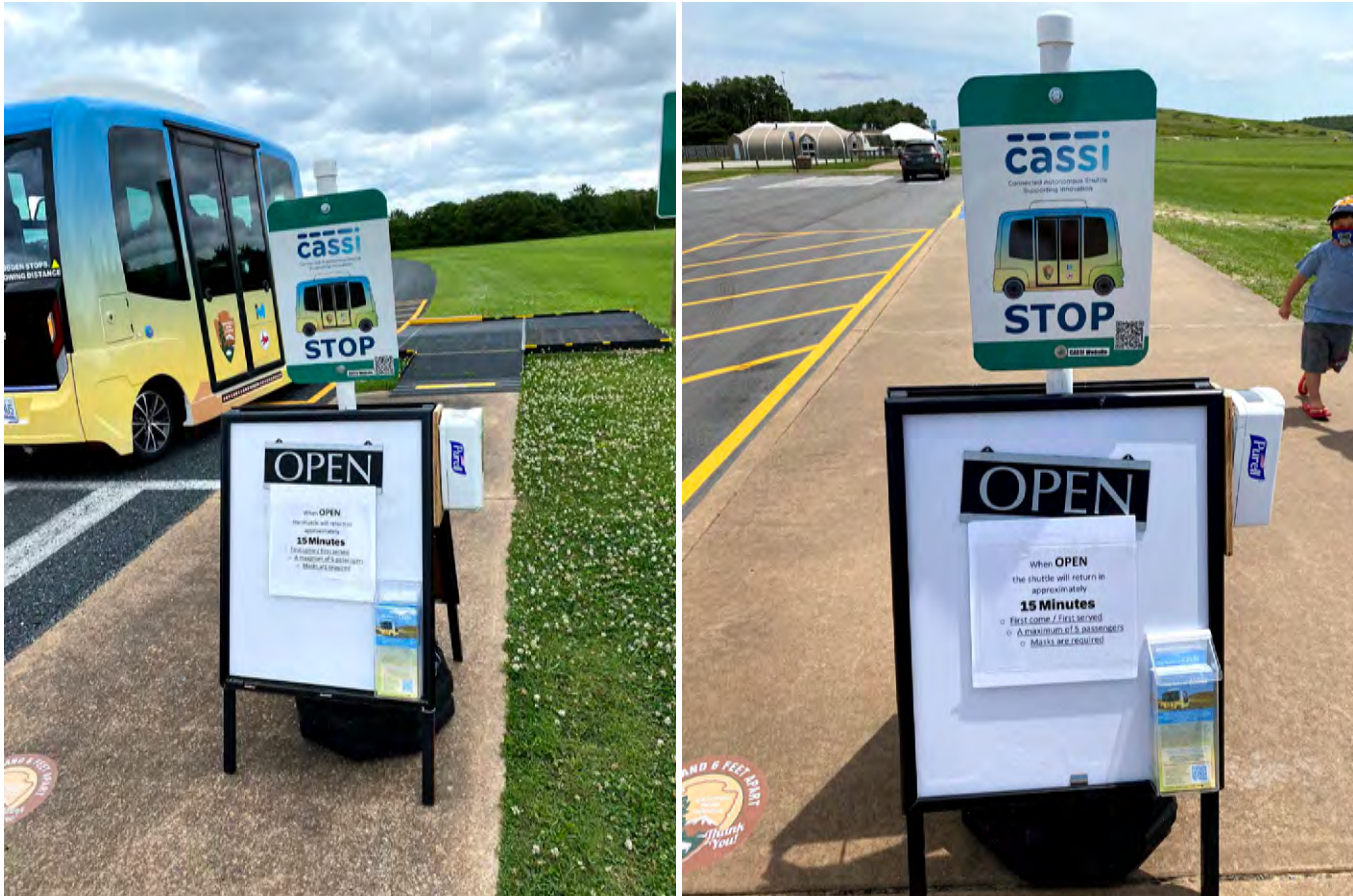
Figure 26: Signage at the Sculpture Stop (left) and at the Visitor Center Stop (right)

NPS staff placed sandwich board signs to indicate where shuttle stops were located and to provide guidelines and information about riding the shuttle (Figure 26). Signs included a reversible “open/closed” plaque to let visitors know if the shuttle was in service. The signage also notified visitors that:

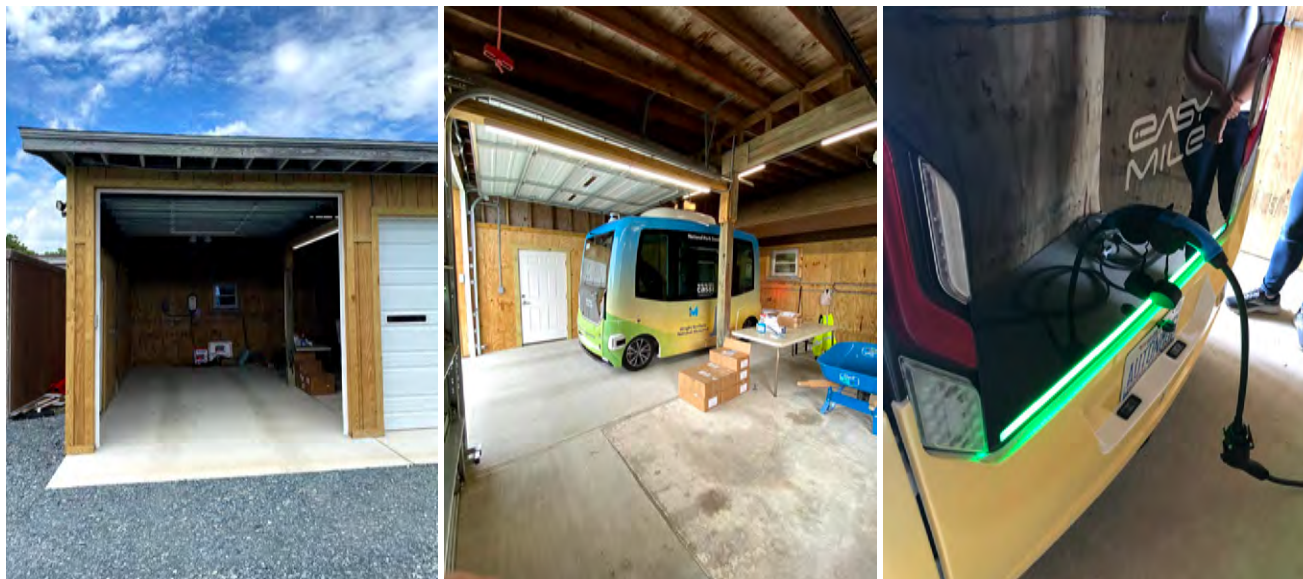
Figure 27: Shuttle Storage Garage Exterior (left), Interior (center), and Charging Equipment (right)

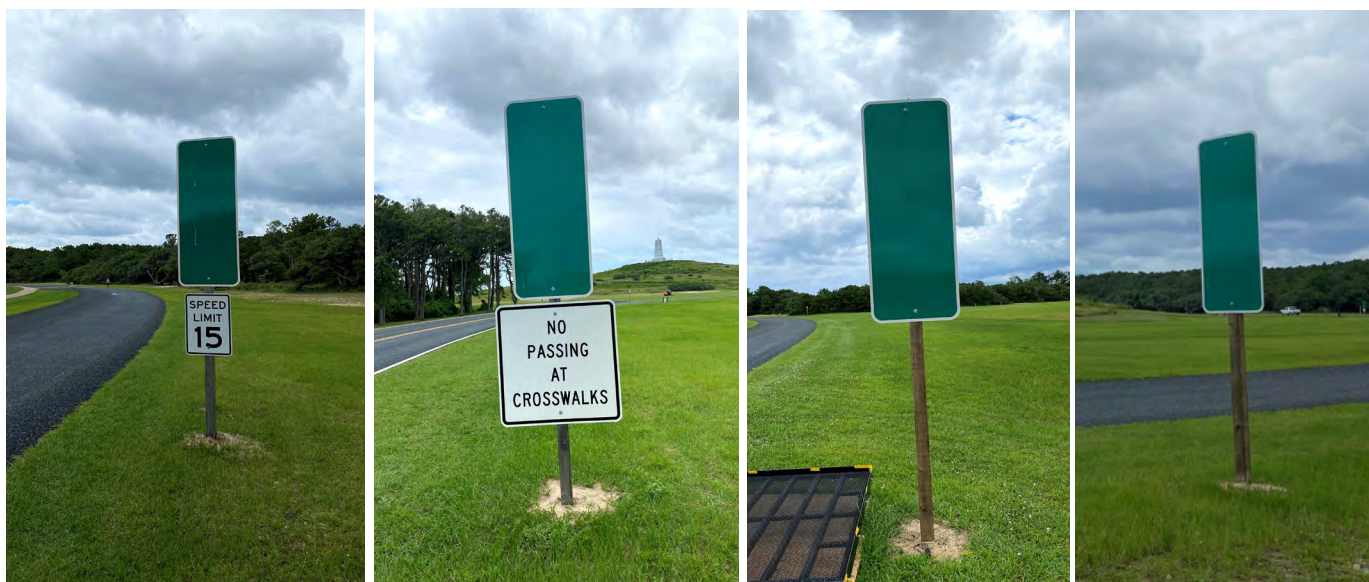
Figure 28: The Four Localization Signs Installed Along Shuttle’s Route

<sup>37</sup> The signs would appear as vertical elements in the shuttle’s lidar scans, and the ADS could measure the vehicle’s distance from the signs and compare it to its internal map as a way of improving localization.
