# Automation in Our Parks: Automated Shuttle Pilots at Yellowstone National Park and Wright Brothers National Memorial

June 2022

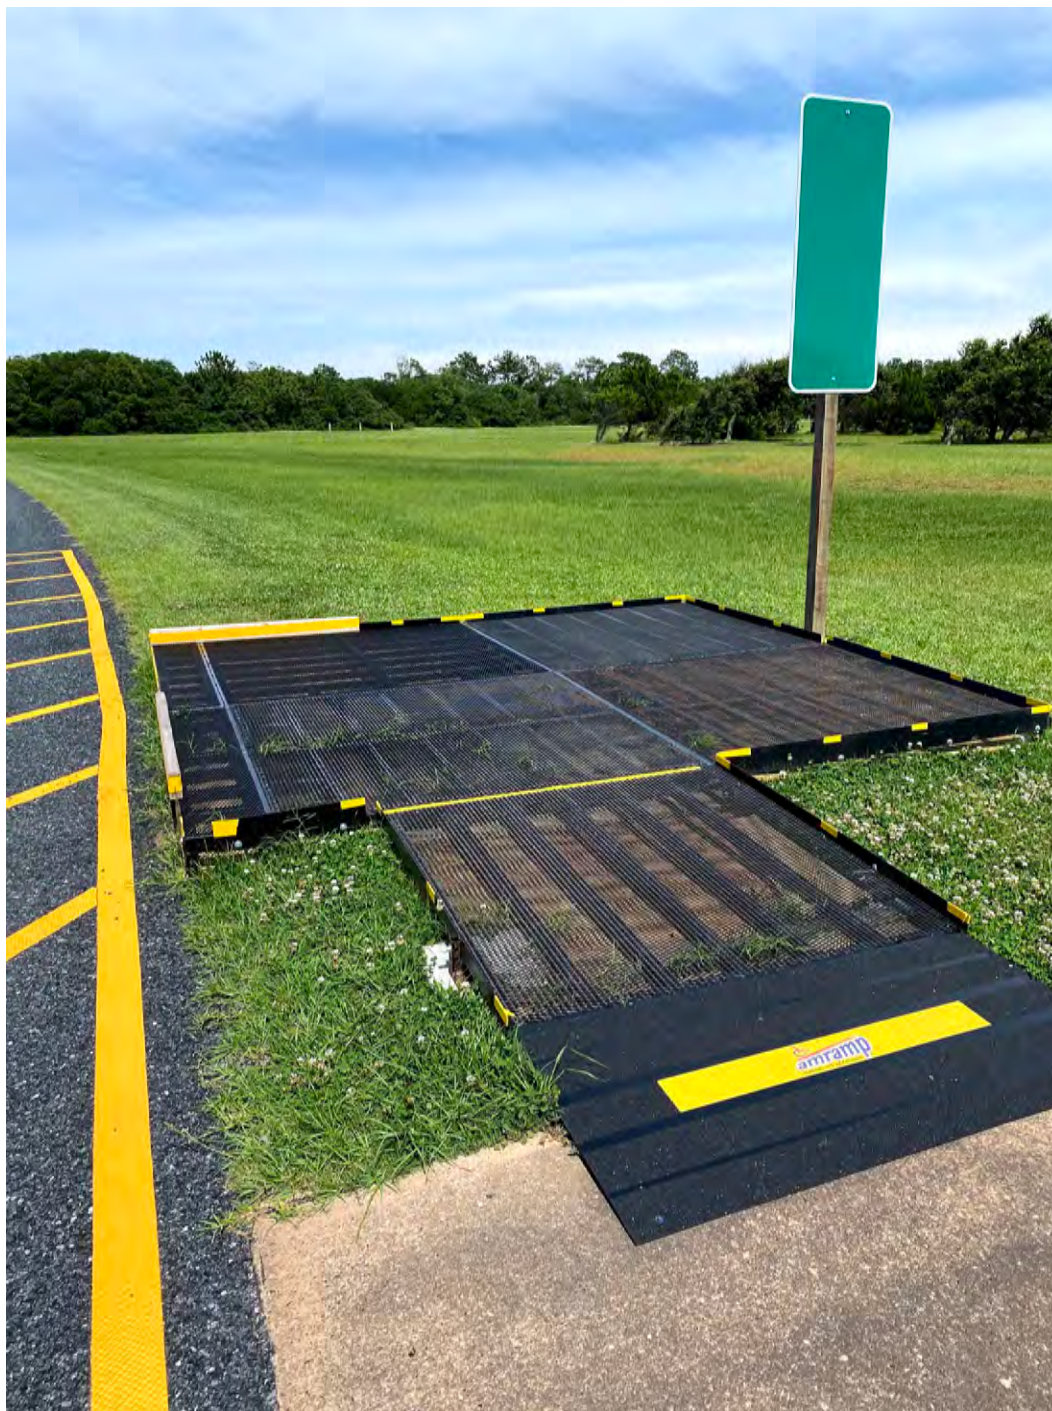
*Figure 29: Accesible Ramp and Platform Installed at Sculpture Stop*

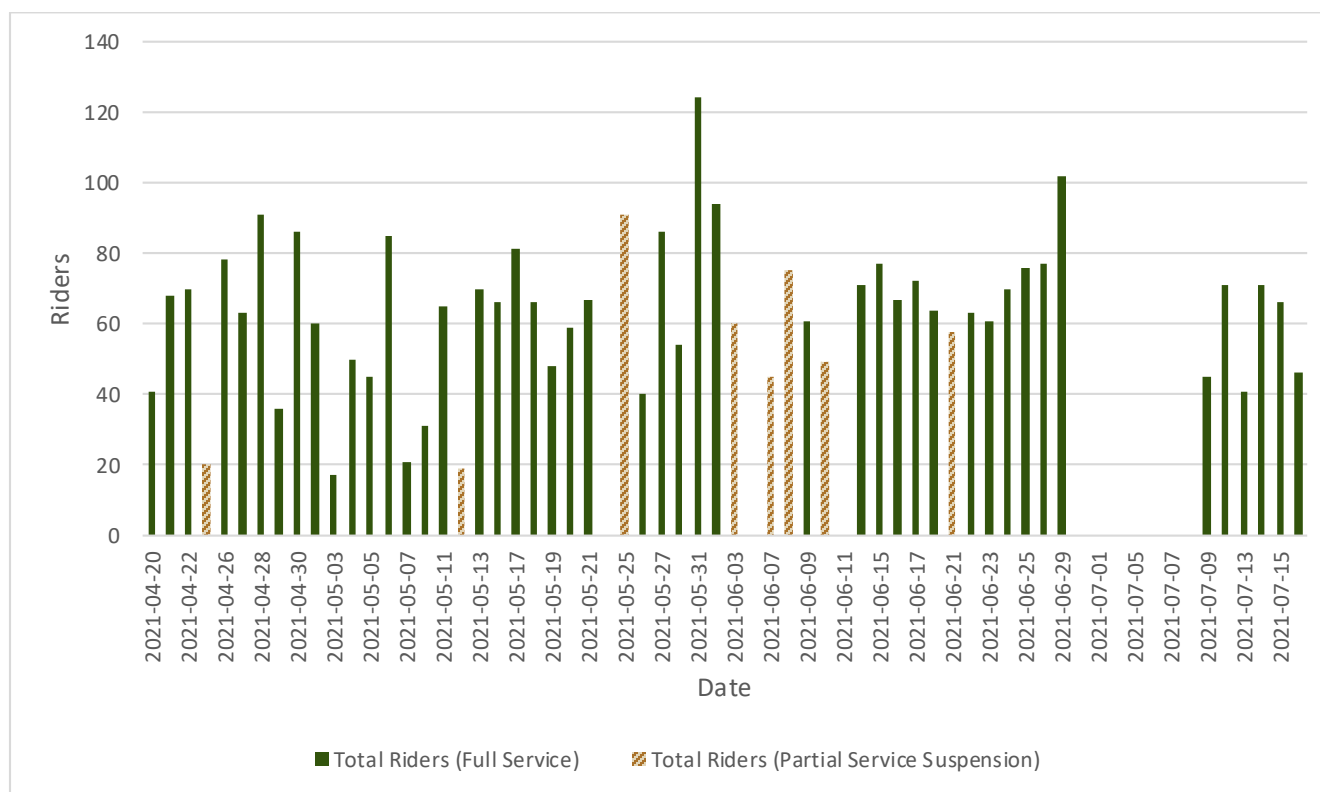
Figure 31: CASSI Shuttle Riders per Day April-June 2021

With 3,380 total passengers and 809 total trips throughout the pilot, the shuttle carried approximately 4.2 riders per roundtrip. There was almost no variation in the average riders per roundtrip between the morning and afternoon shifts, although the afternoon shifts saw more riders and trips overall, likely due to that shift being longer. Another possible

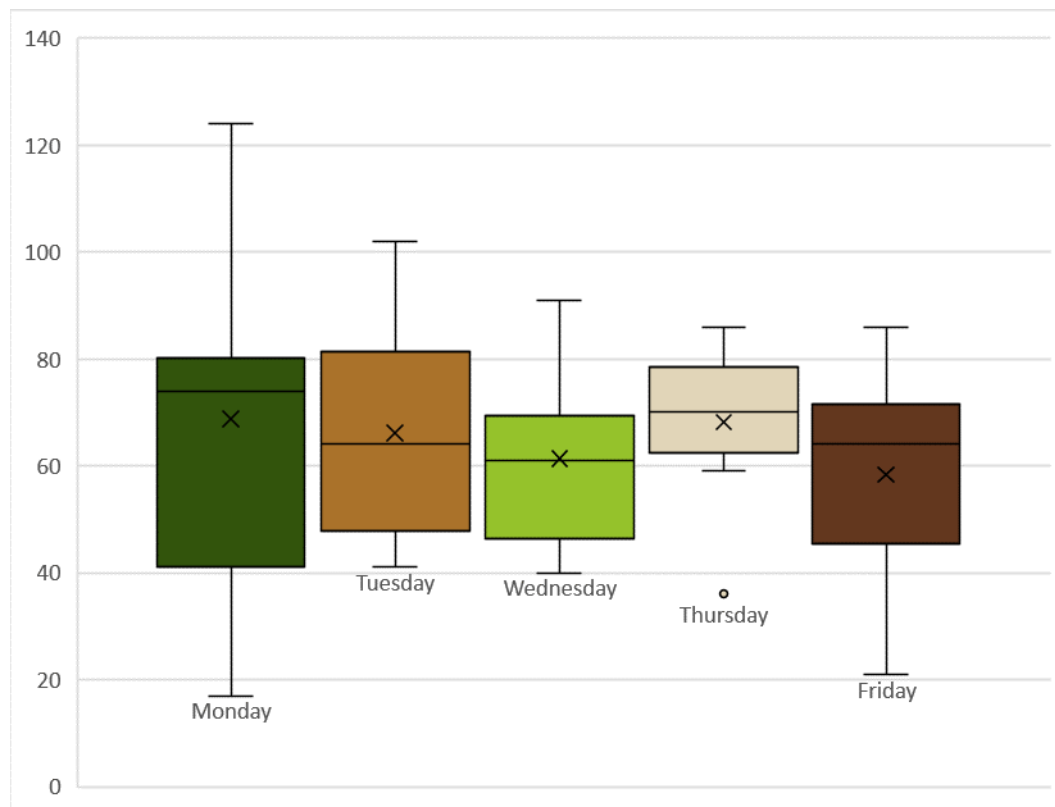
Figure 32: CASSI Shuttle Riders by Day of the Week, Full Service

explanation for the ridership variation across shifts could be different levels of park visitation throughout the day. There was some variation by day of the week, with Mondays having approximately 10 more riders than Fridays on average; however, it is unclear why this would be the case.<sup>43</sup> Figure 32 presents a box-and-whisker chart for the ridership data on each day of the week.<sup>44</sup>

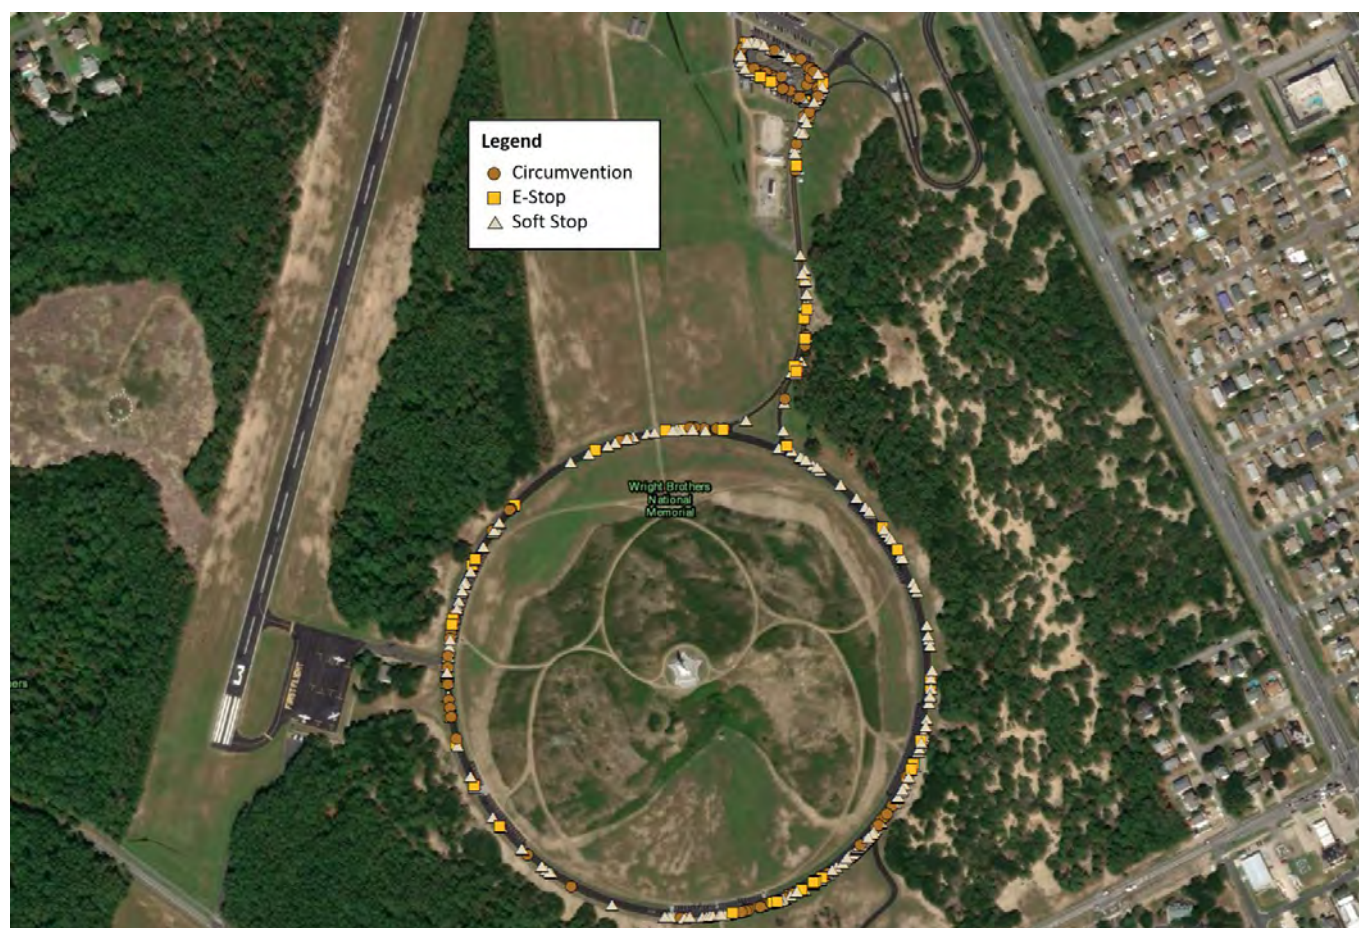
*Figure 34: Map of CASSI Shuttle Disengagements*

<sup>48</sup> An “e-stop” is a stop triggered either manually by the operator using the button inside the vehicle or automatically by the vehicle computers when an obstacle gets too close. A “soft stop” is triggered either manually by the operator on the operator panel or automatically by the vehicle computers when an obstacle is identified ahead in the shuttle’s future path; this stop is made more gradually than an e-stop. A “circumvention” occurs when the operator switches from automated mode to manual mode to manually drive around an obstacle.

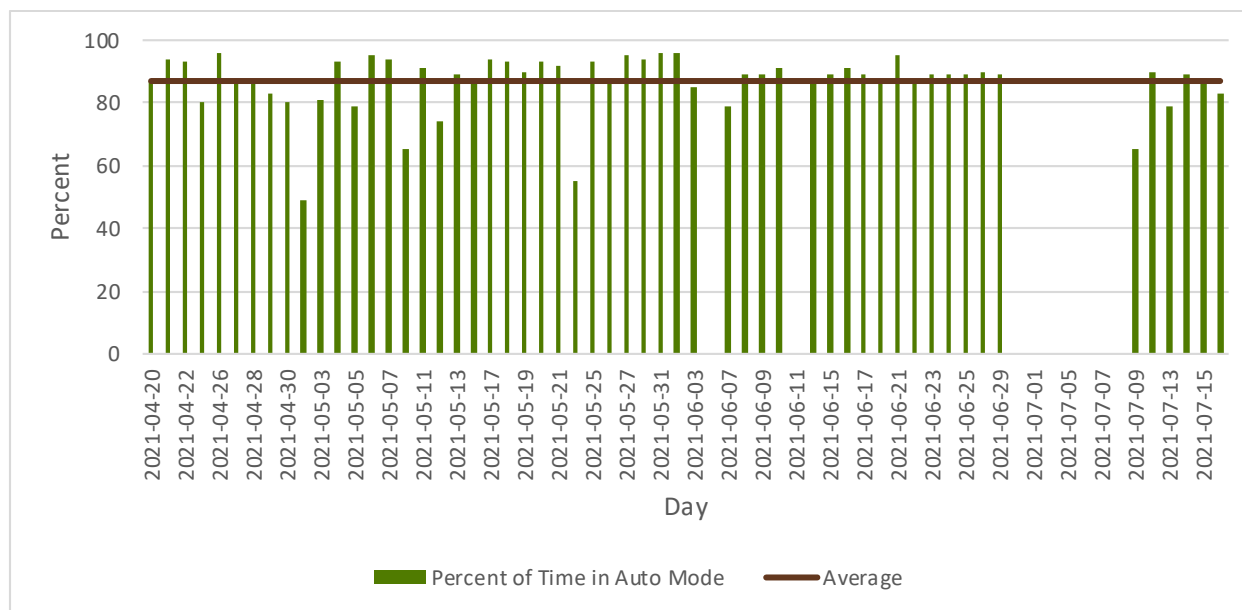
Figure 35: Time Spent in Automated Mode

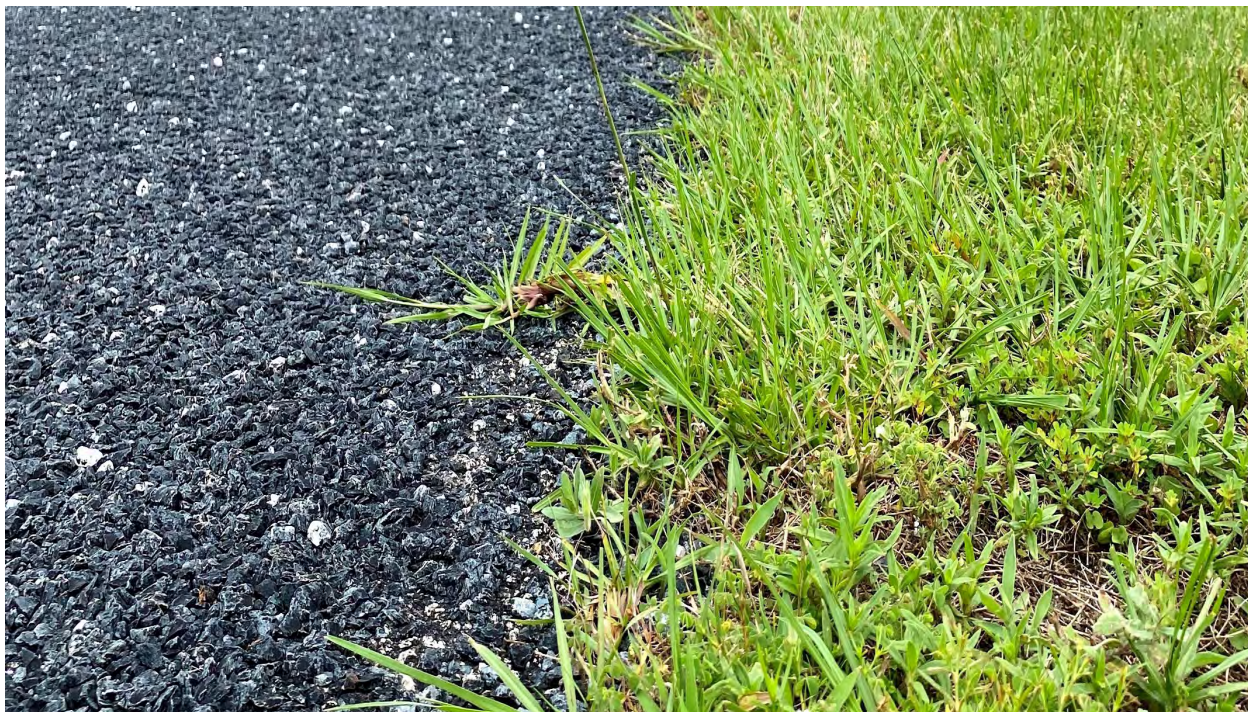
*Figure 36: Weeds Sticking Out into Roadway, Which Caused Shuttle Disengagements*

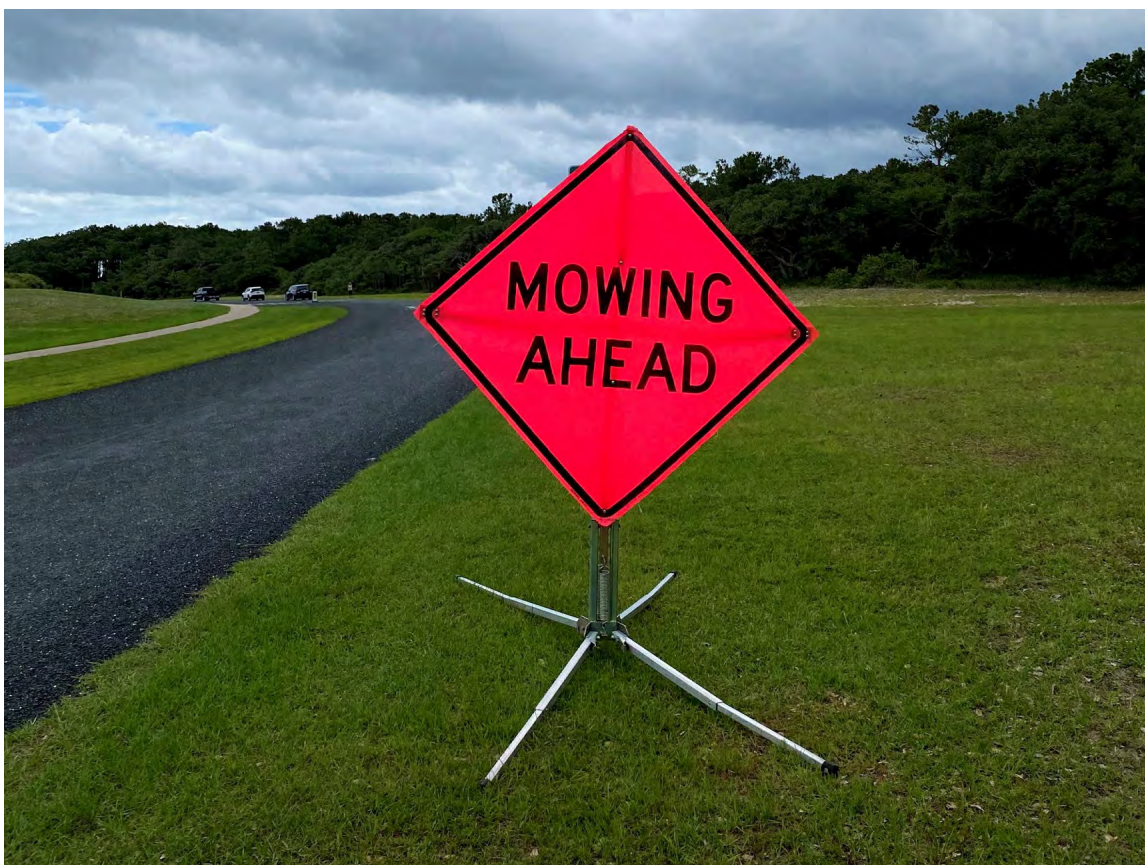
*Figure 37: Signage Warning Visitors That Lawn Mowing is in Progress*

During the pilot, it was discovered that weeds growing within 1.5 feet of the roadway interfered with the lidar sensors on board the shuttle, causing the shuttle to repeatedly slow, stop, or disengage at multiple points along its route. Park staff then mowed the grass as frequently as every three days to address the issue (Figure 36 and Figure 37). Park staff noted that this frequency of mowing is not sustainable in the long term. In addition, before the pilot began, several tree canopies were trimmed in the northwest area of the circle to not interfere during the pilot. These trees and related vegetation were monitored during the concurrent growing season.

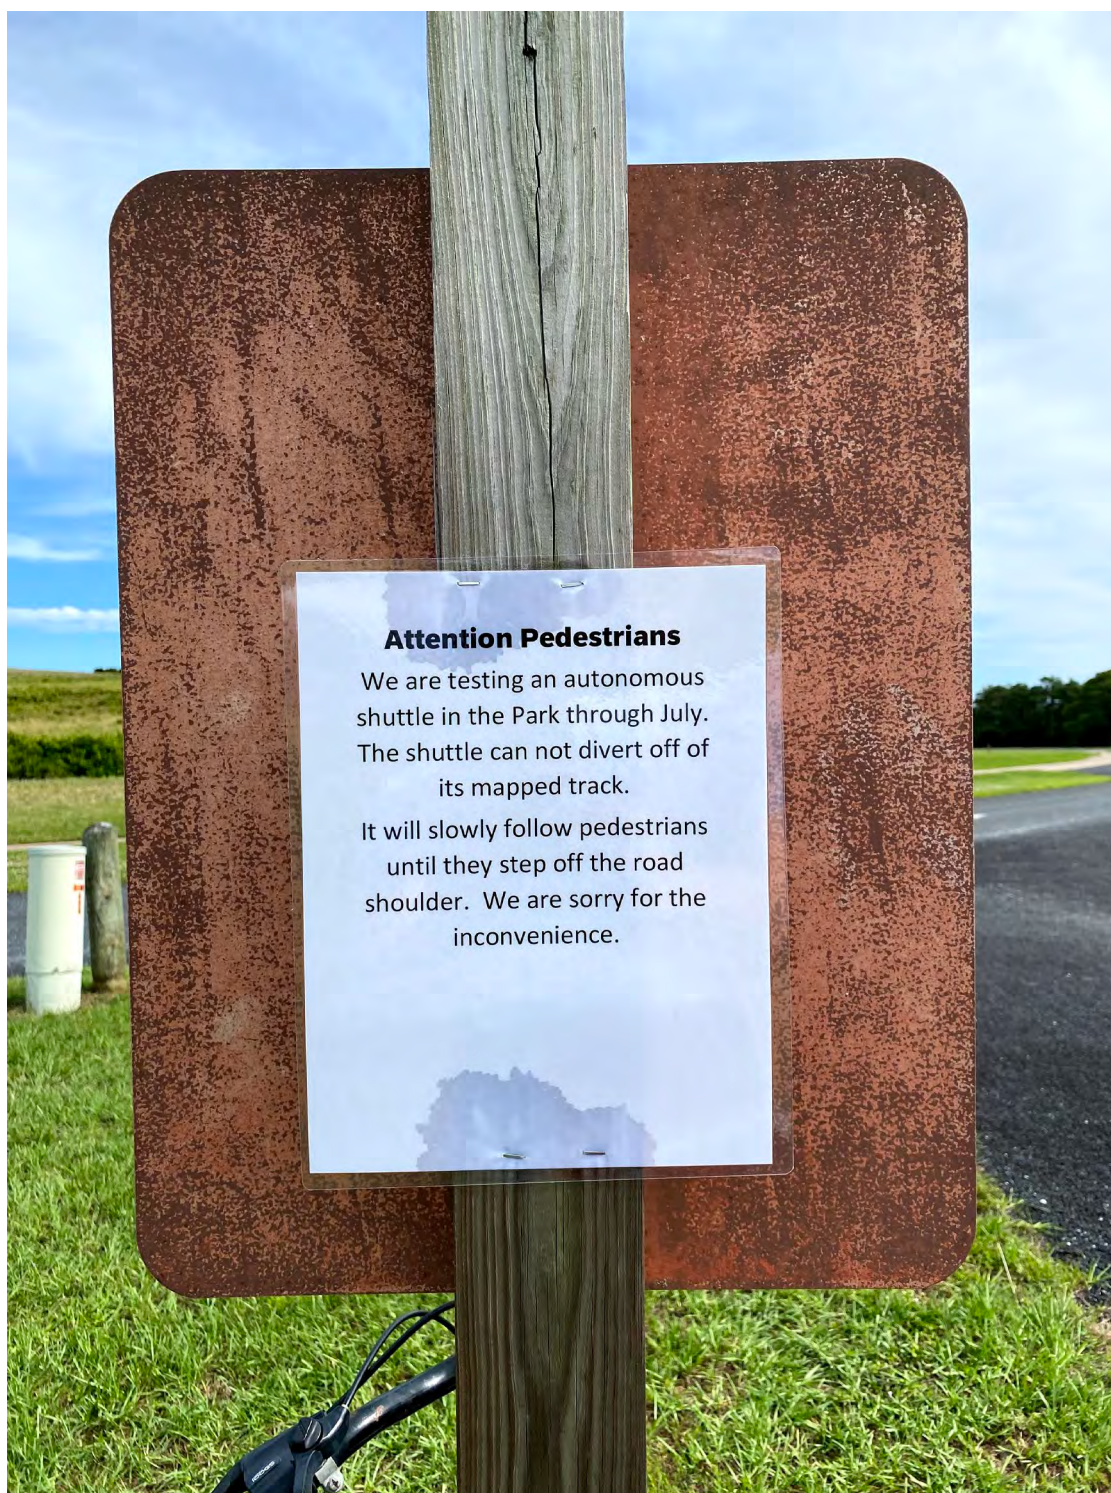
*Figure 40: Notification Sign to Pedestrians Indicating That the Shuttle Will Not Pass Them in the Roadway*

Road. NPS staff later installed a sign asking pedestrians walking in the roadway to step off the shoulder to allow the shuttle to pass (Figure 40).<sup>51</sup>

- **Be prepared to address visitor confusion, which may result from unexpected vehicle behaviors.** In the case of the CASSI pilot, the shuttle's safety protocols prevented it from passing pedestrians, forcing the shuttle to slowly follow them around the route. Ultimately, this issue was addressed by adding signage noting this behavior and asking pedestrians to exit the roadway to allow the shuttle to pass (refer to Figure 40).

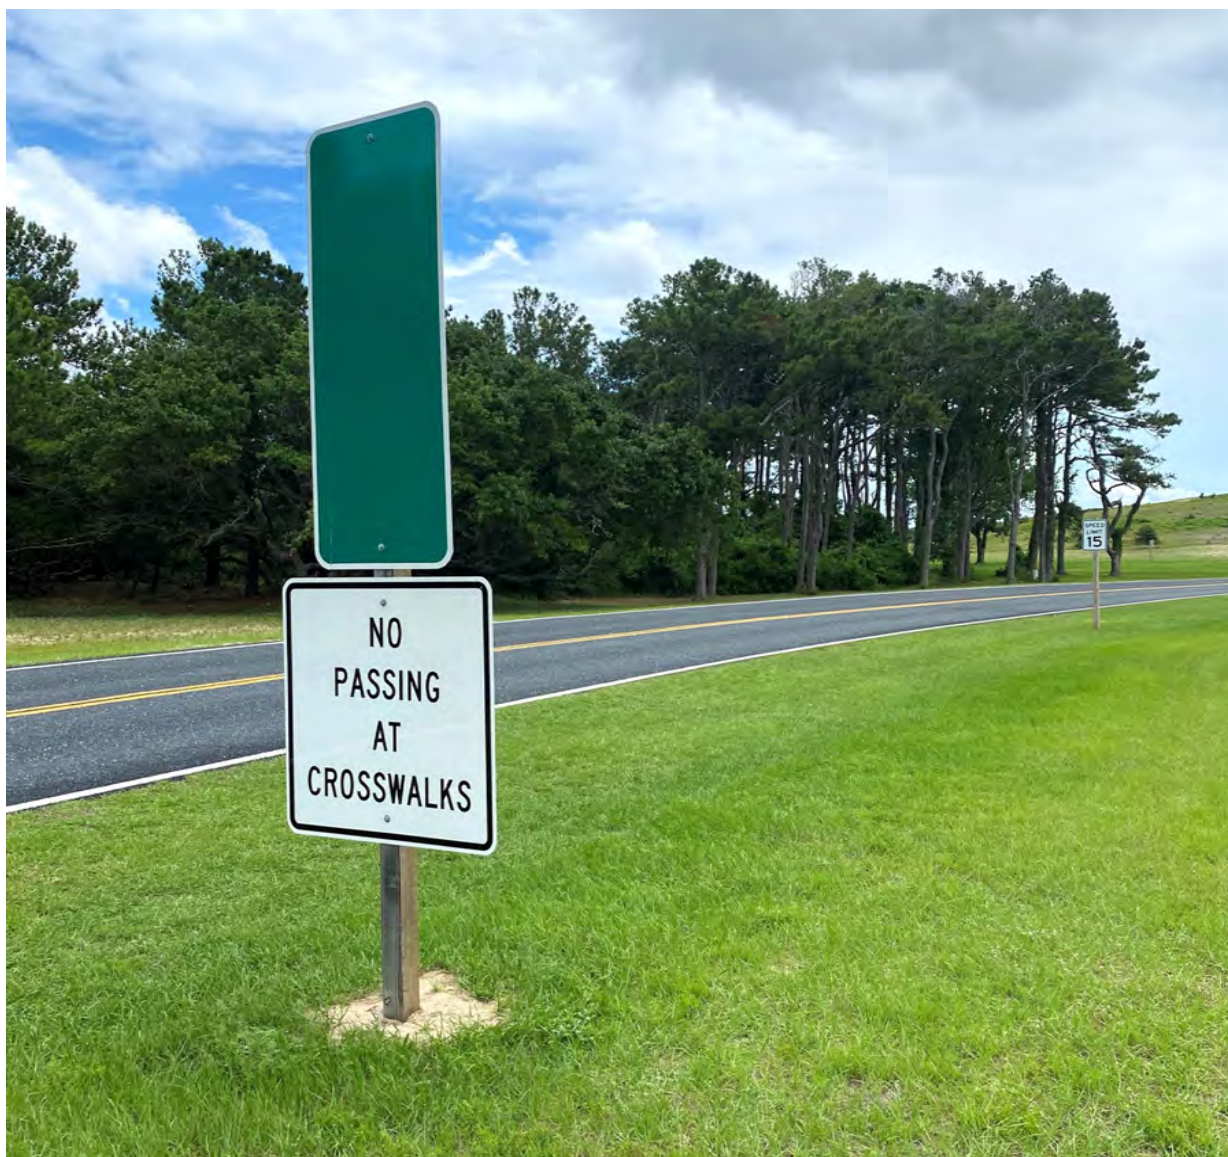
*Figure 41: Signage Instructing Drivers Not to Pass Shuttle at Crosswalks*

Most visitors walked through the Memorial by starting at the visitor center and continuing south down the walkway toward the Wright Brothers Monument. Pedestrians must cross a marked crosswalk across Memorial Loop to walk toward the Monument (see site map, Figure 22). Drivers attempted to pass the shuttle as the shuttle yielded to pedestrians in the crosswalk, creating an unsafe environment for the pedestrians and the shuttle operation. Park staff resolved this issue by placing orange cones, an MUTCD-compliant crosswalk sign, and a custom sign instructing drivers not to pass at crosswalks (Figure 41 and Figure 42).<sup>52</sup>

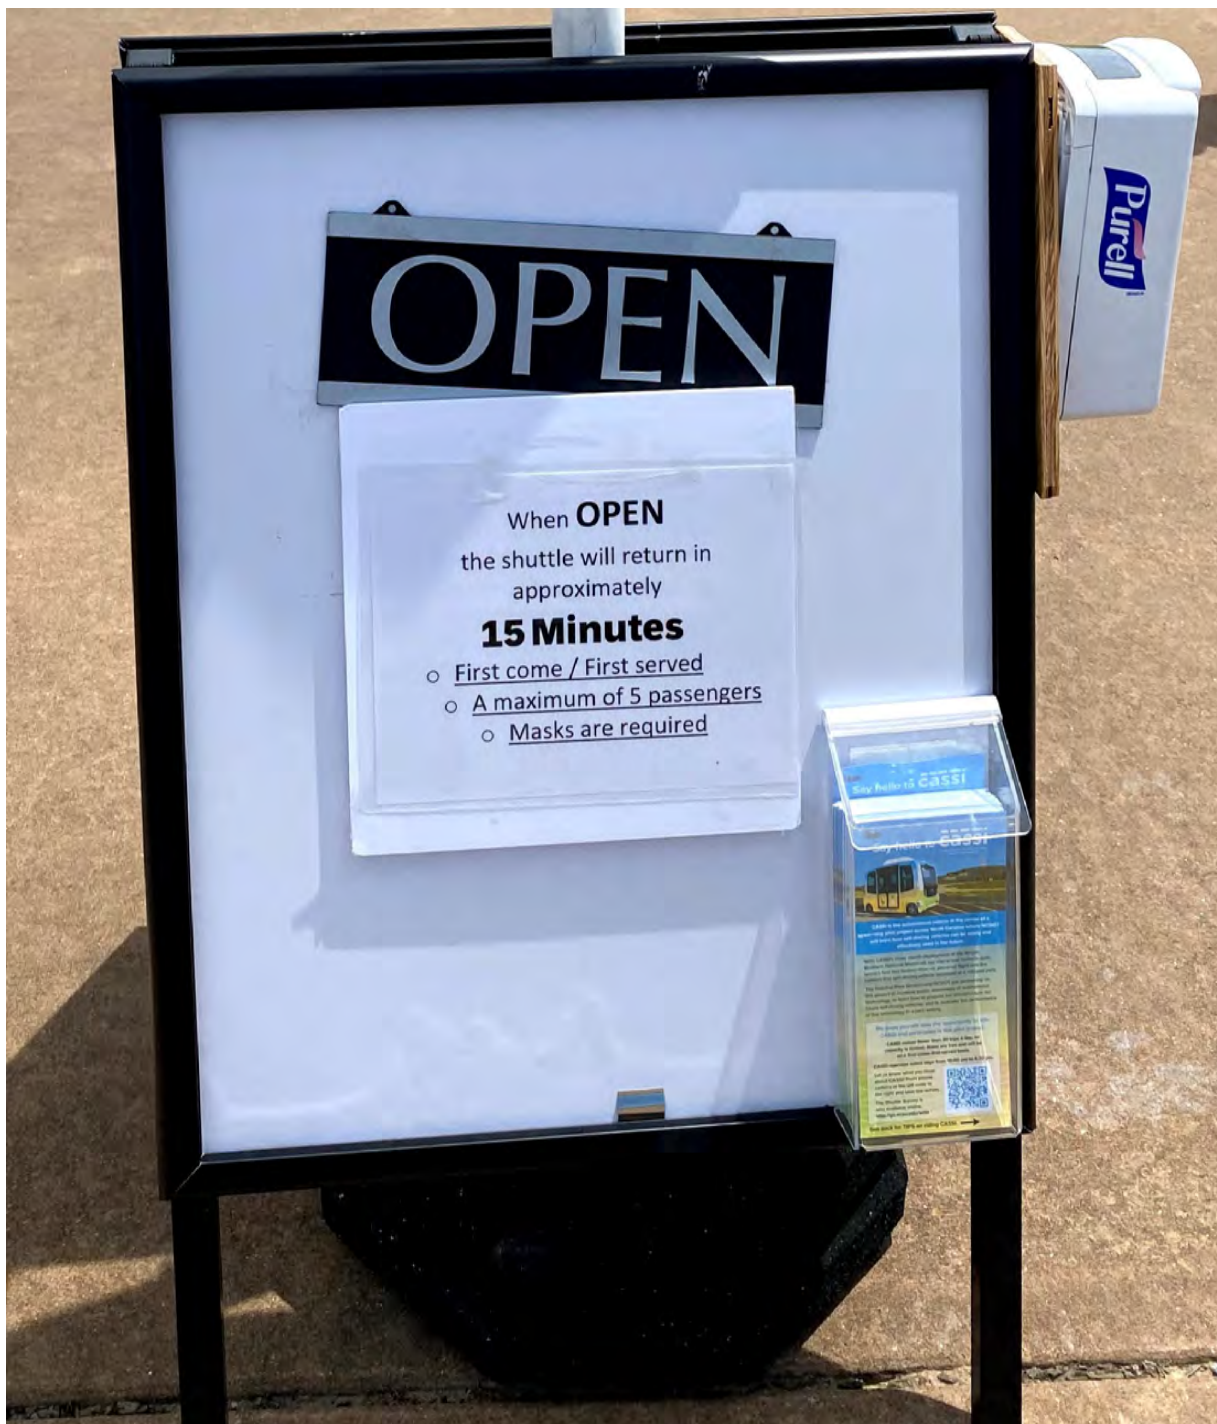
Figure 43: Signage at Visitor Center Stop Displaying an “Open” Status

Some issues related to signage at the shuttle stops were reported by park staff. Signage (Figure 43) was lacking some relevant information, which led to some visitor confusion about the CASSI's frequency, route, and rules. The following items were observed at the shuttle stops:
