# Assessment of Existing and Potential Volume Reduction for Post Construction Stormwater Management

*Prepared for:  
The Ohio Department of Transportation,  
Office of Statewide Planning & Research*

Project ID Number: 102133

*Final Report*

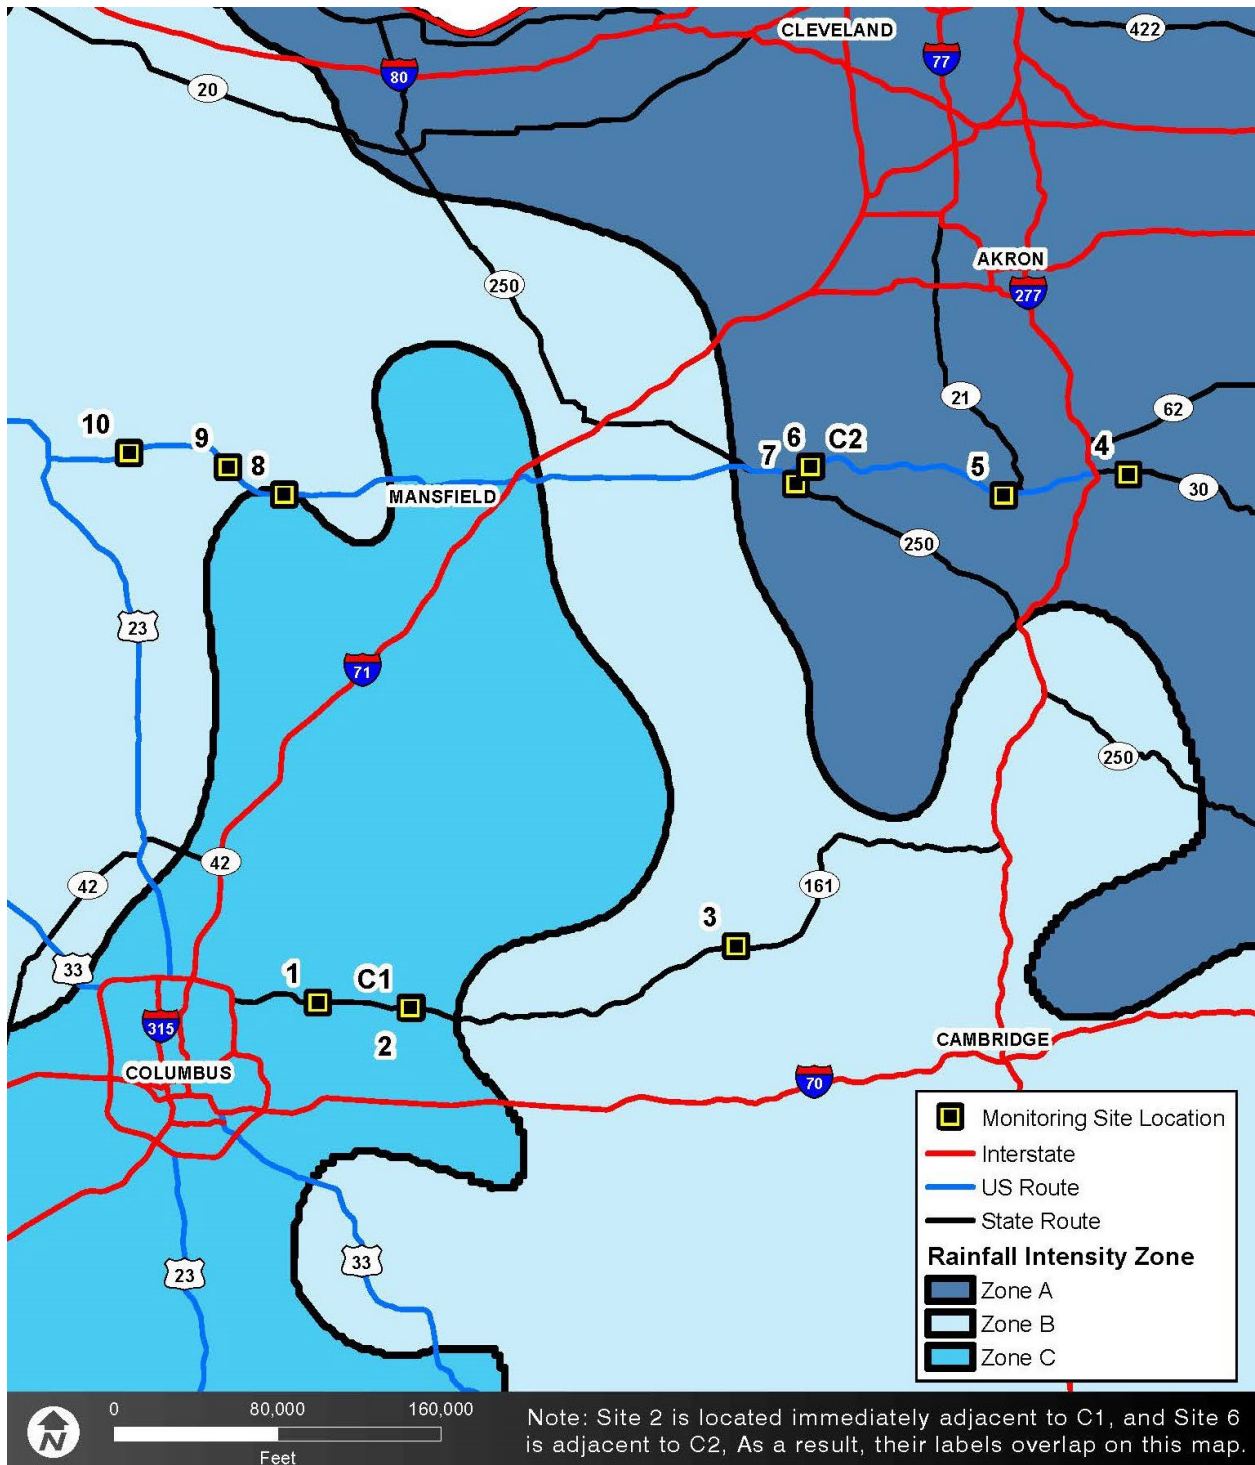
Figure 1: Monitoring Site Locations

After careful consideration and analysis, 12 sites were selected for this research effort. See Figure 1 for the location of the selected monitoring sites. Amendment sites are numbered one through ten, and control sites are denoted by "C".

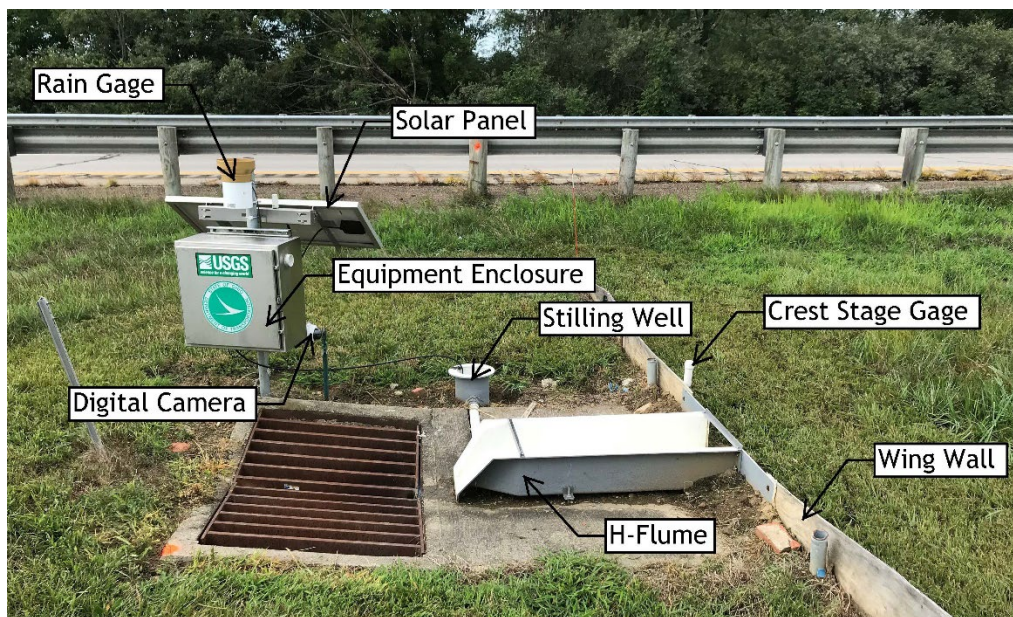
Figure 2: Installed Monitoring Equipment

The H-flumes were installed directly to the drainage basin concrete approach pad at each site. Holes corresponding to the holes in the feet of each H-flume were drilled into the approach pad. Concrete expansion anchors were inserted into the holes for attaching and leveling the H-flumes. Wing walls were attached to the H-flume approach section and anchored using fence posts. A detached stilling well was connected to the H-flume with PVC piping. The outdoor camera was installed near the approach section. A 2-inch pipe was driven into the ground to serve as a mast onto which the environmental enclosure, rain gage, solar panel, and modem antennae were attached. The mast was installed at a location close to the H-flume that provided an adequate level of safety for servicing personnel as well as traffic.

The monitoring equipment was installed during March of 2018 with the final installation completed on March 31, 2018. A few of the gages had some operational malfunctions due to instrumentation failures or insufficient wiring installations, but all gages were fully functioning by April 10, 2018. Figure 2 shows a typical site, with installed monitoring equipment.

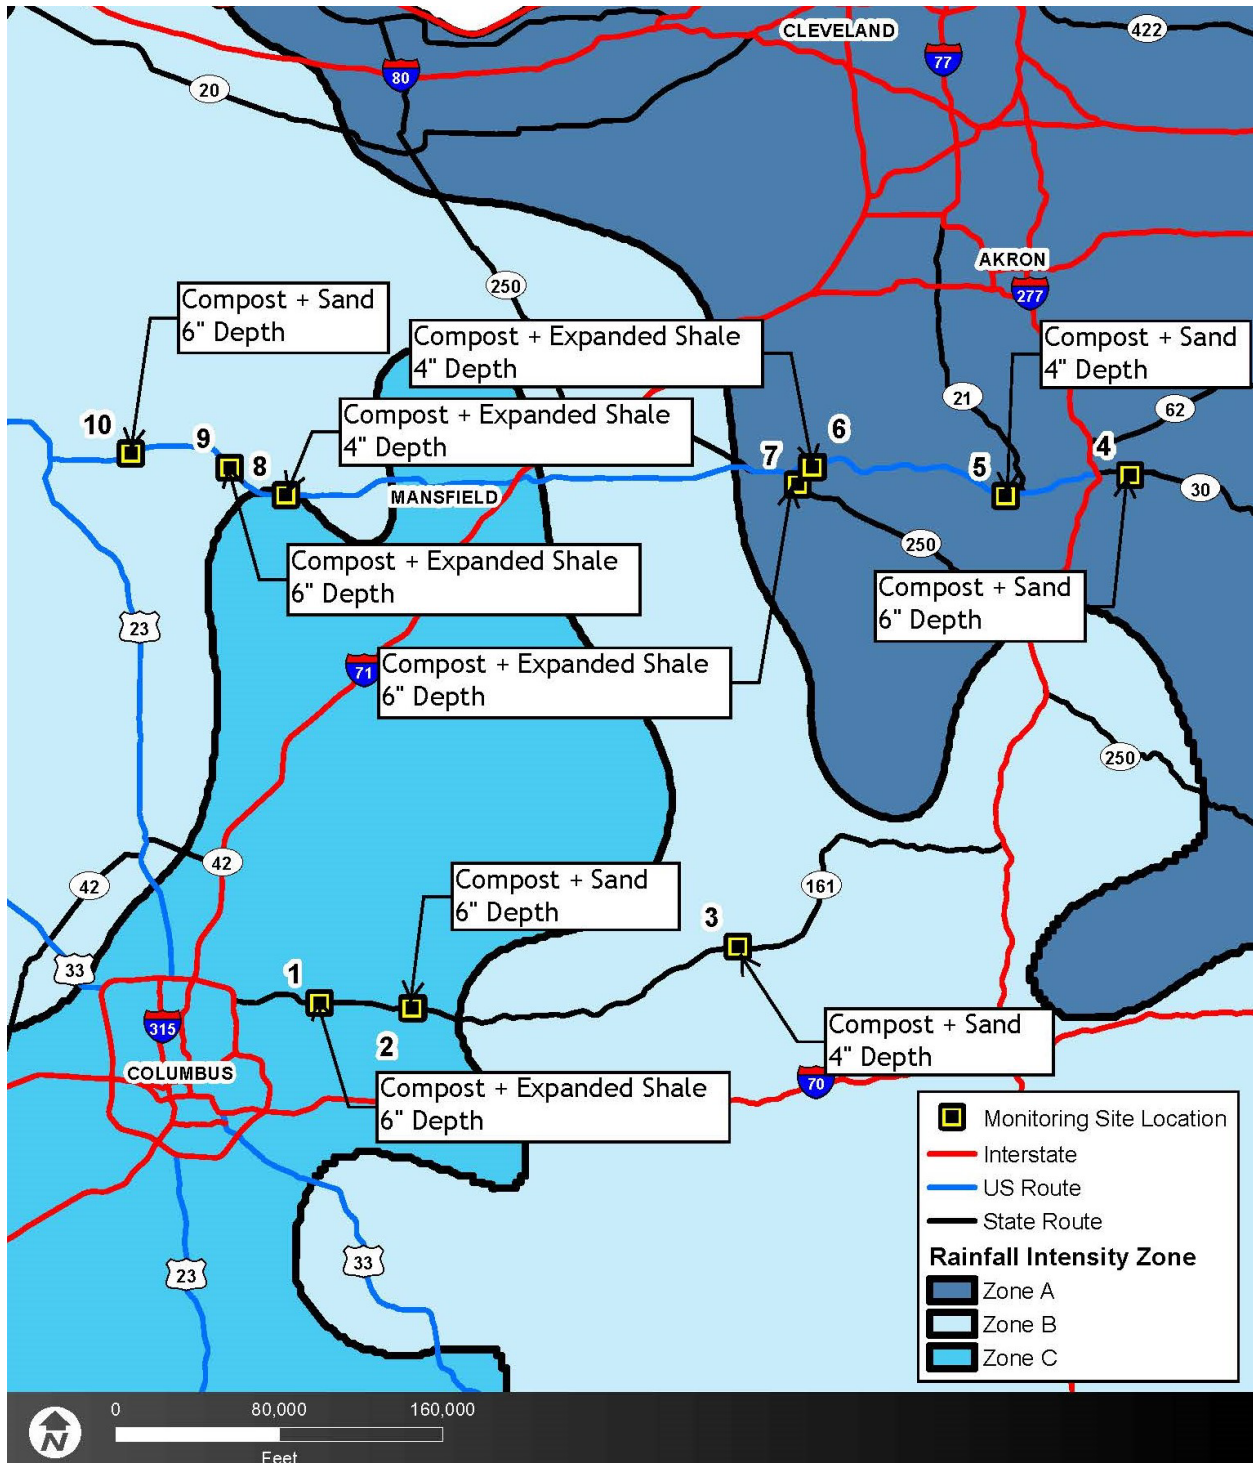
Figure 3: Soil Amendment Locations

When possible, different combinations of amendment mixes and depths were located near one another in order to provide opportunities for data comparison under similar rainfall conditions. The location of each amendment mix to be installed is shown in Figure 3.

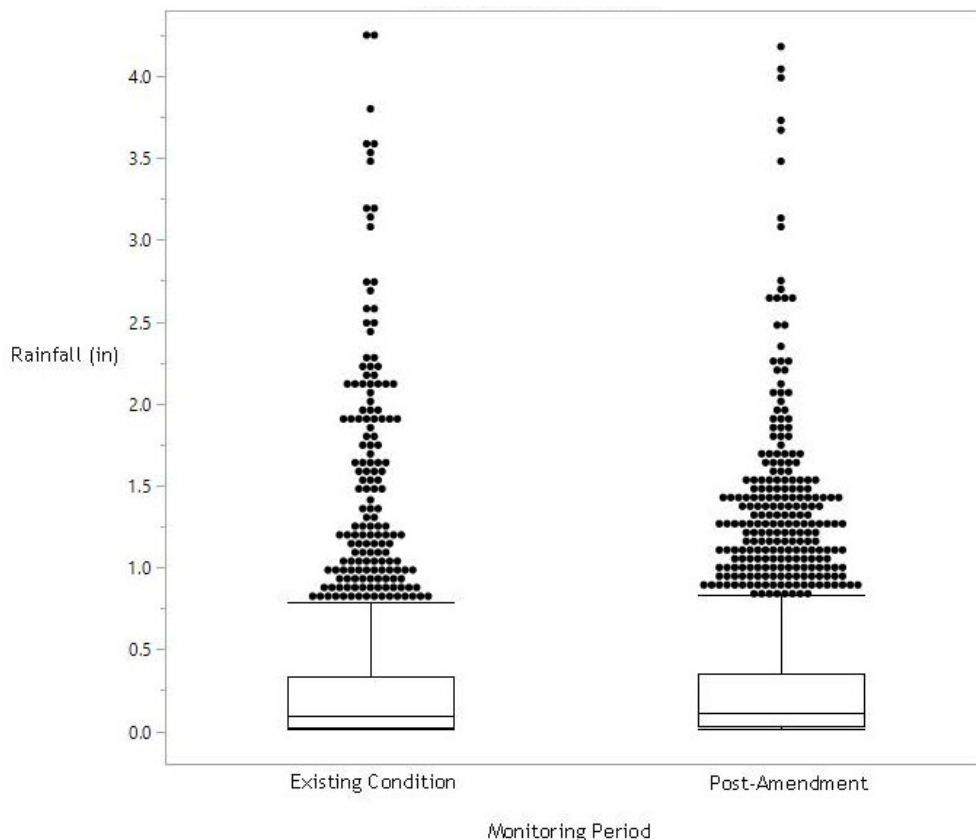
Figure 4: Rainfall Distribution Plot

The distribution of rainfall amounts associated with events was similar in the existing condition and post-amendment monitoring periods. The distribution of rainfall events observed over the course of the research project is shown in the boxplot, in Figure 4. This plot shows that rainfall events of similar magnitude occurred at a similar frequency during both the existing conditions monitoring period and the post-amendment monitoring period. Because the duration of the post-amendment monitoring period was greater than the existing condition monitoring period, there are more data points (rainfall events) in the post-amendment period.

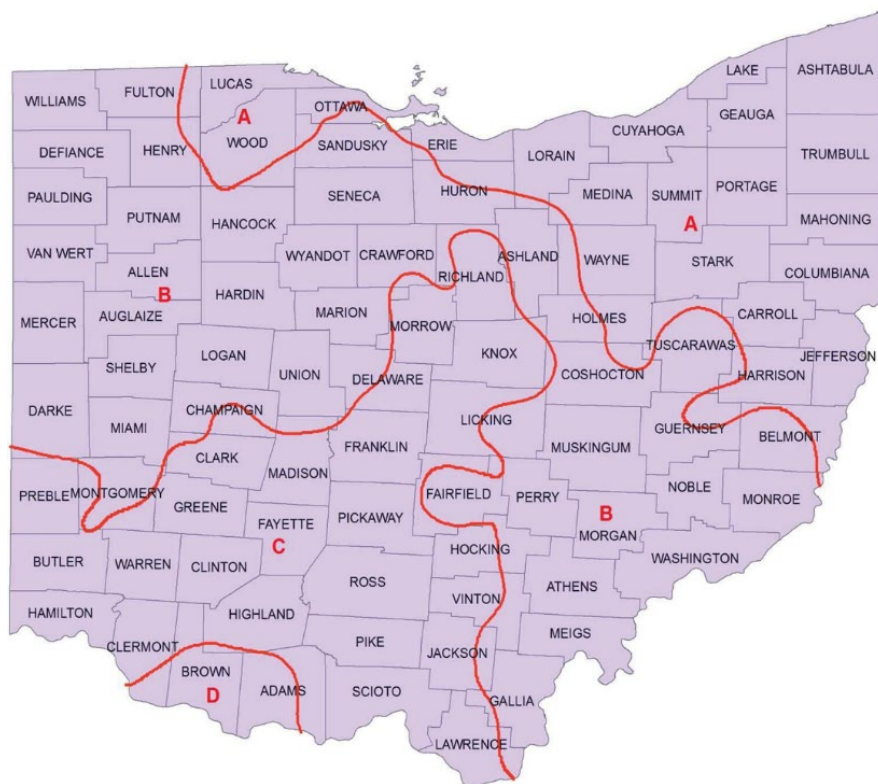
Figure B5: ODOT Rainfall Intensity Zone Map Throughout Ohio

The selected monitoring sites were evenly distributed among the various Ohio rainfall intensity zones, with the exception of Zone D. Zone D covers a small area and is not representative of the majority of the state, so it was excluded. Even distribution among the rainfall intensity zones is intended to insure that the proposed amended filter strip BMP will be functional and effective throughout the state, and under a wide variety of environmental settings and rainfall conditions. Distributing the monitoring locations will also help ensure that measurable rainfalls are recorded at all sites and minimizes the potential for localized rainfalls to skew the monitoring results. Figure B1, shows the Rainfall Intensity Zones for the state of Ohio, as illustrated in Figure 1101-3 of the ODOT Location and Design Manual, Volume 2.

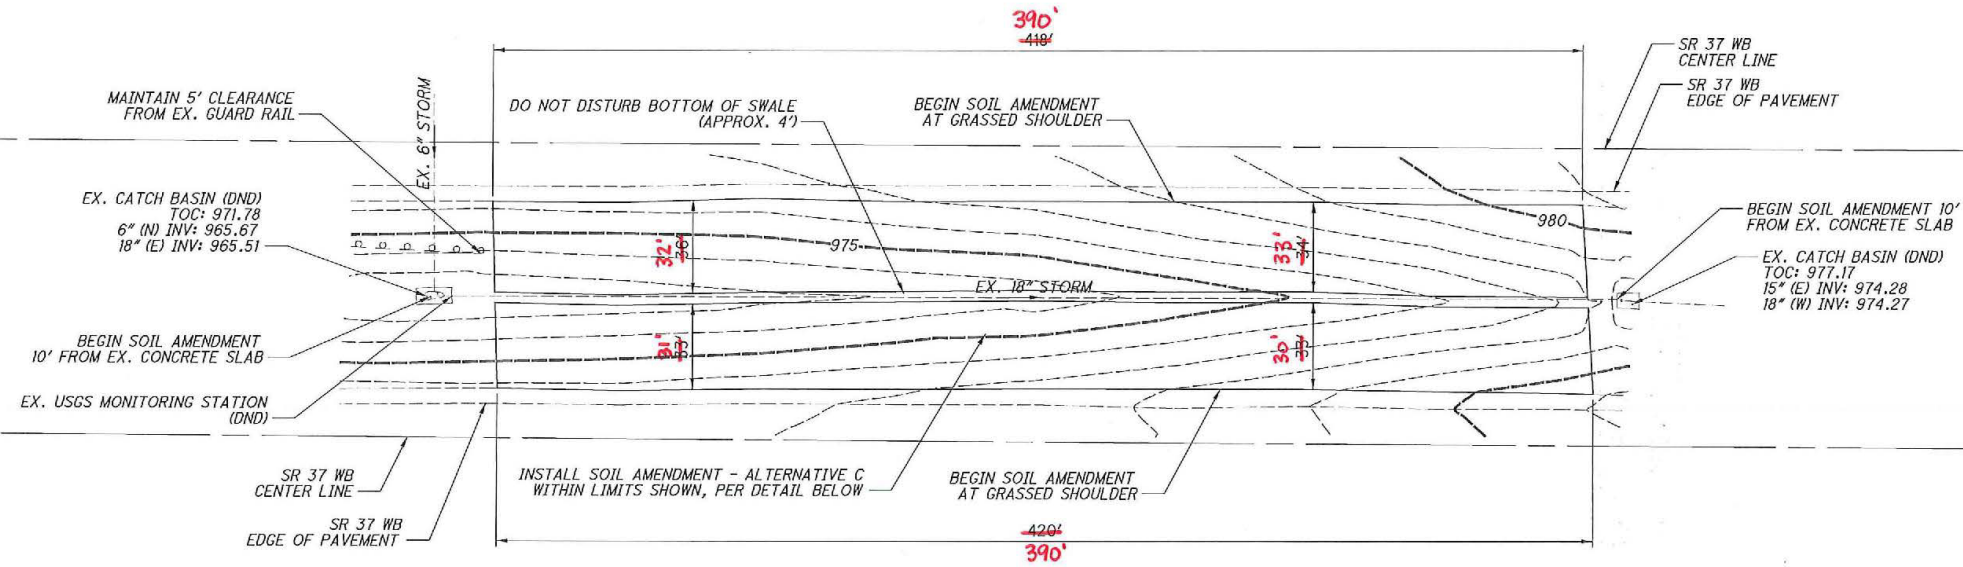
**ALTERNATE C**

6" AMENDMENT DEPTH USING COMPOST AND SAND AS AMENDMENTS  
NOT TO SCALE

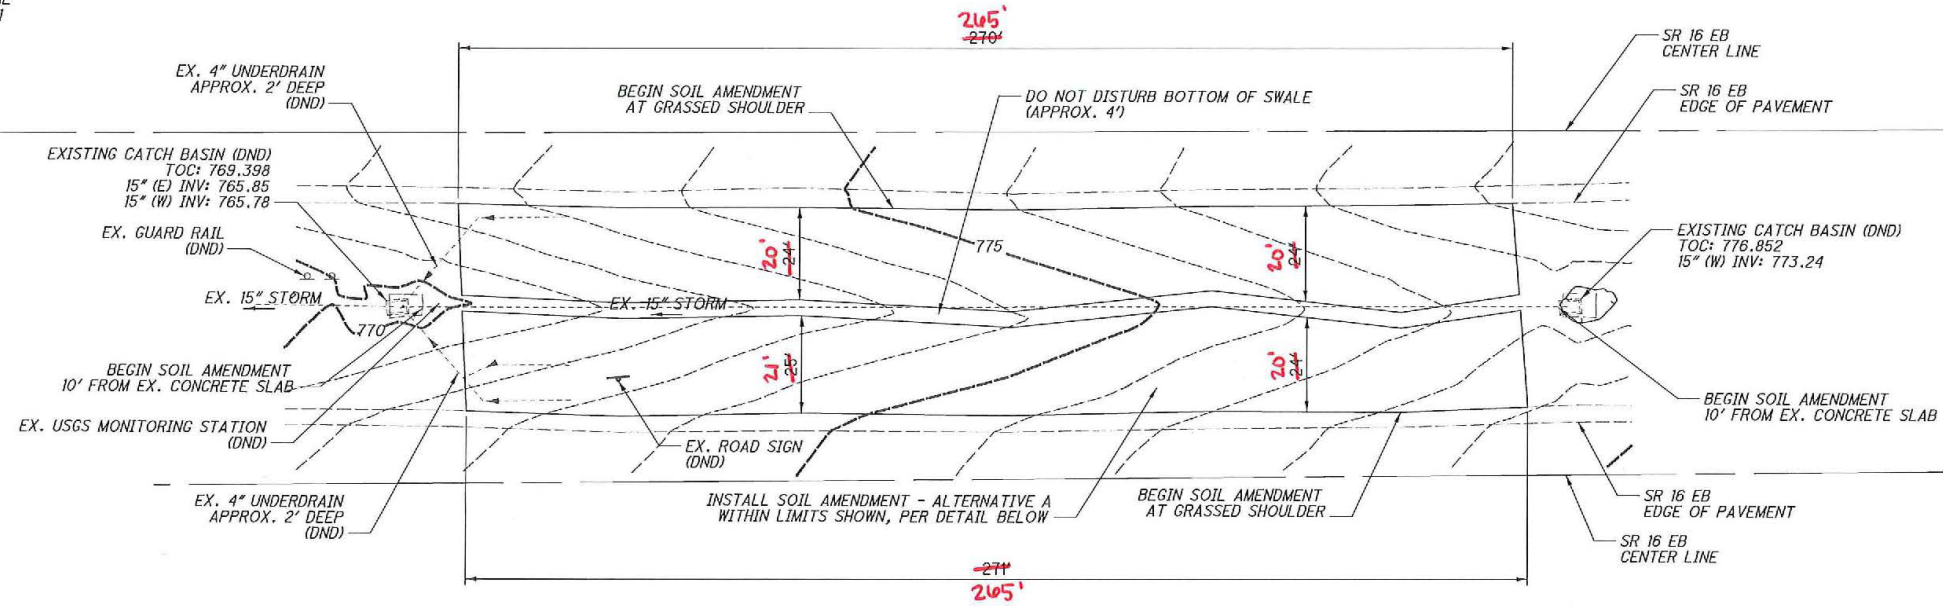
**ALTERNATE A**

4" AMENDMENT DEPTH USING COMPOST AND SAND AS AMENDMENTS  
NOT TO SCALE

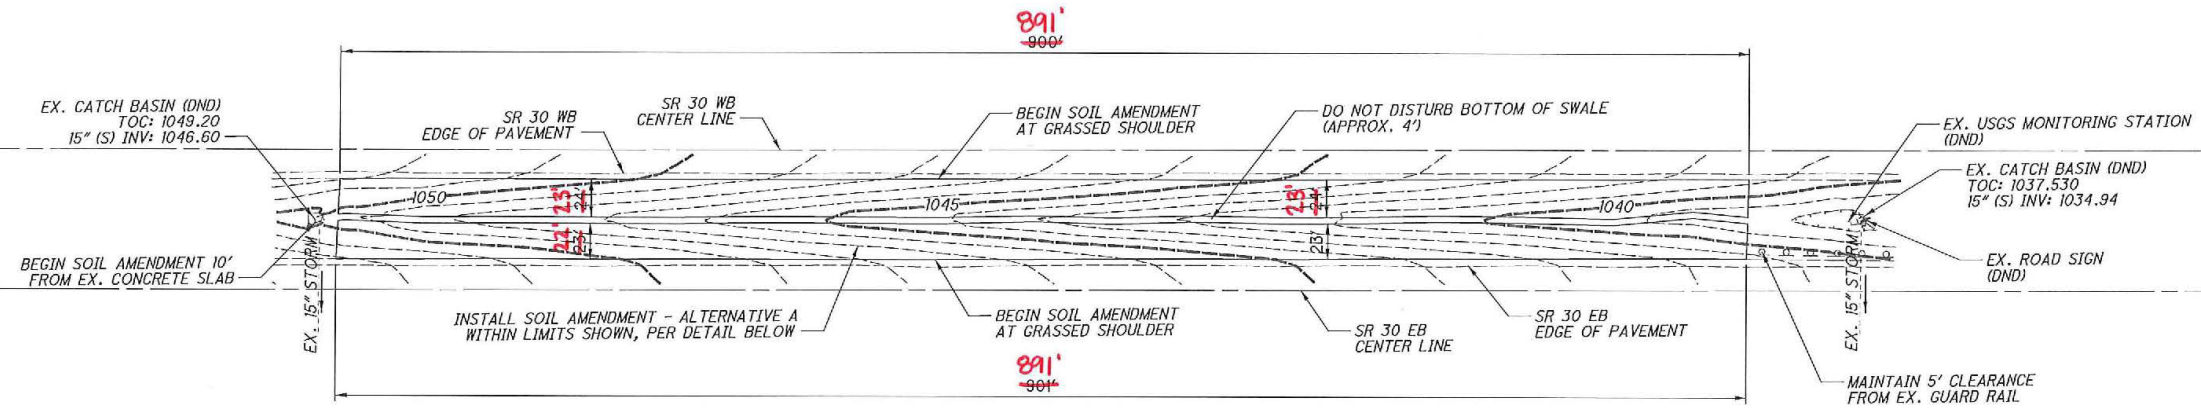
**ALTERNATE A**

4" AMENDMENT DEPTH USING COMPOST AND SAND AS AMENDMENTS  
NOT TO SCALE

**FINAL AMENDED SOIL COMPOSITION**  
(% BY VOLUME)  
COMPOST = 31%  
SAND = 19%  
NATIVE SOIL = 50%

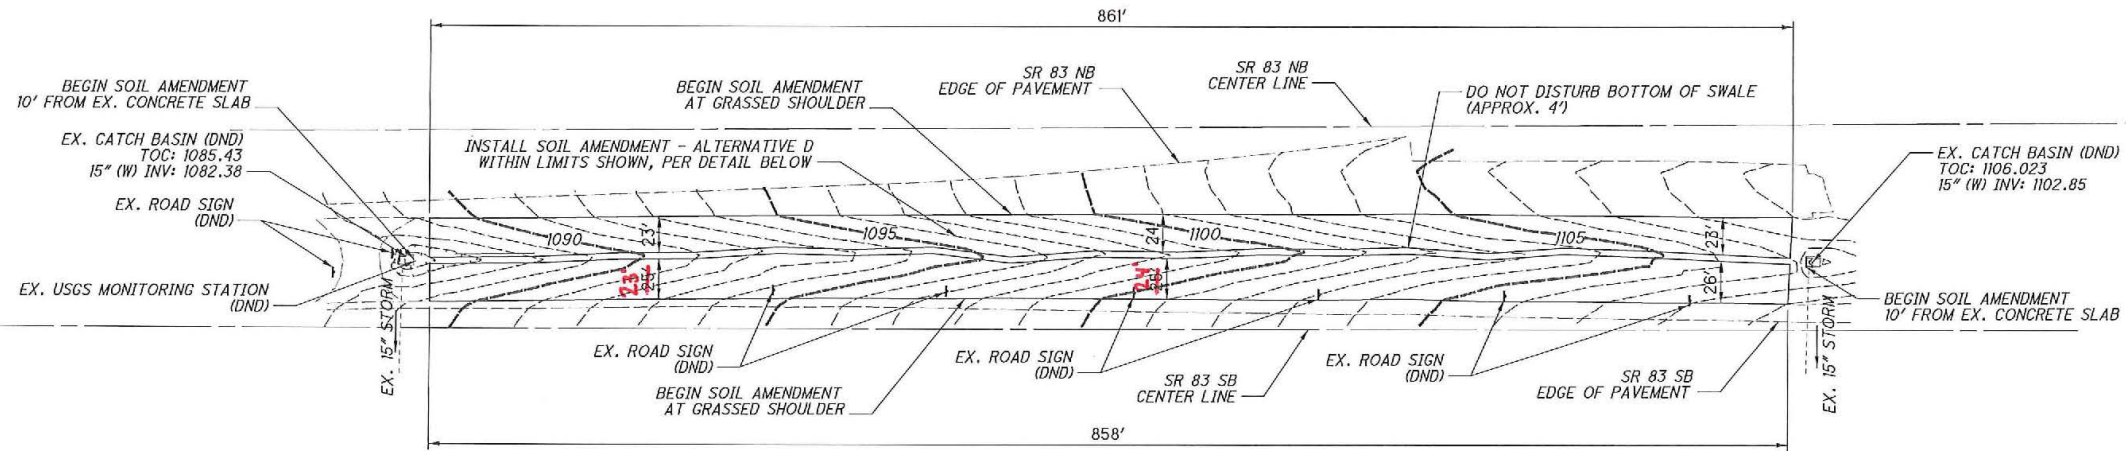
**ALTERNATE D**

6" AMENDMENT DEPTH USING COMPOST AND EXPANDED SHALE AS AMENDMENTS  
NOT TO SCALE

**FINAL AMENDED SOIL COMPOSITION**  
(% BY VOLUME)  
COMPOST = 28%  
EXPANDED SHALE = 17%  
NATIVE SOIL = 54%

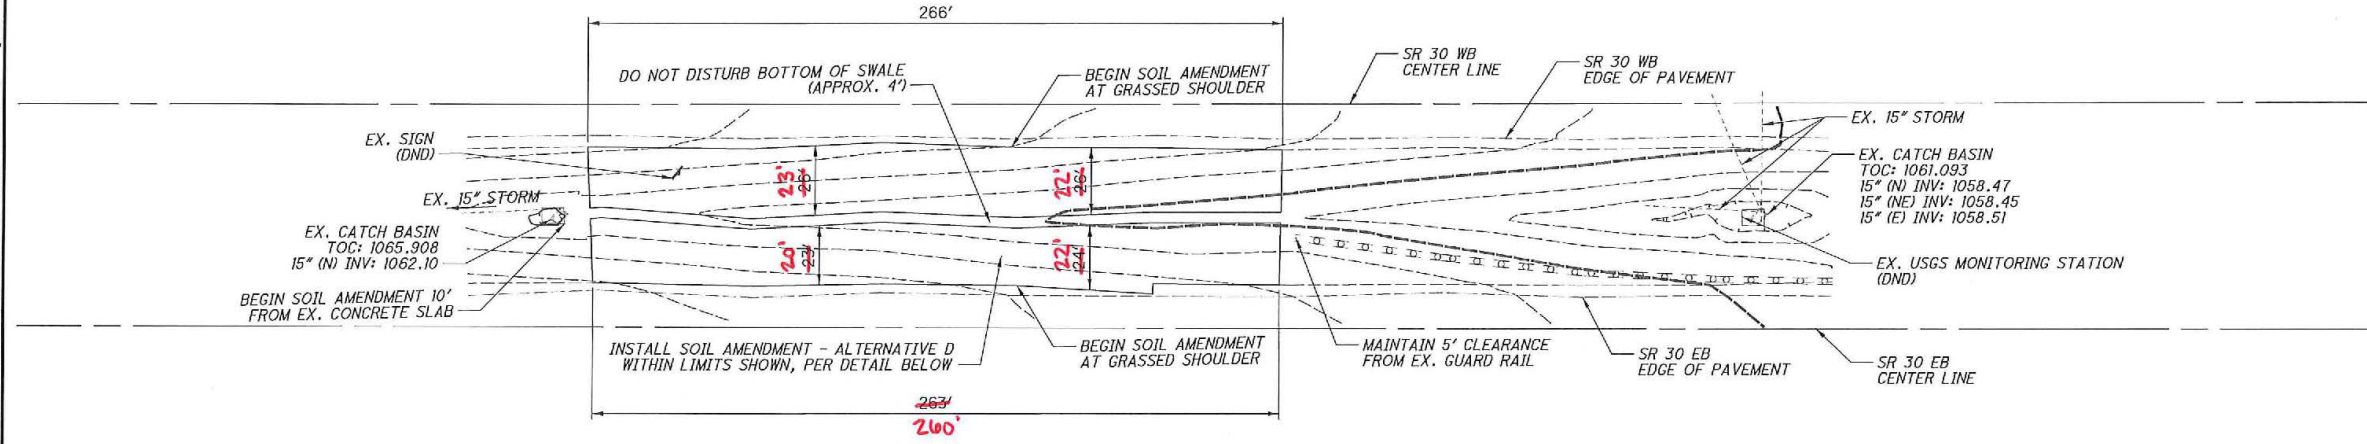
**ALTERNATE D**

6" AMENDMENT DEPTH USING COMPOST AND EXPANDED SHALE AS AMENDMENTS  
NOT TO SCALE

**FINAL AMENDED SOIL COMPOSITION**  
(% BY VOLUME)

COMPOST = 29%  
EXPANDED SHALE = 17%  
NATIVE SOIL = 54%

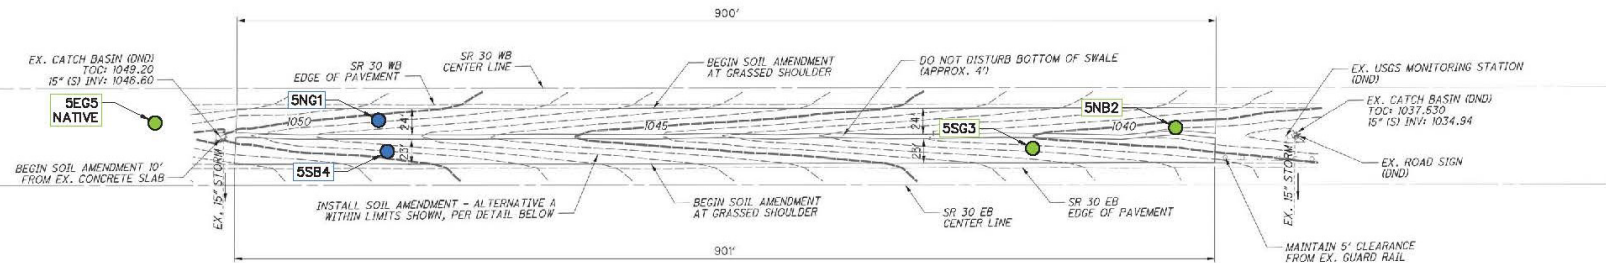
**ALTERNATE A**

1" AMENDMENT DEPTH USING COMPOST AND SAND AS AMENDMENTS  
 NOT TO SCALE

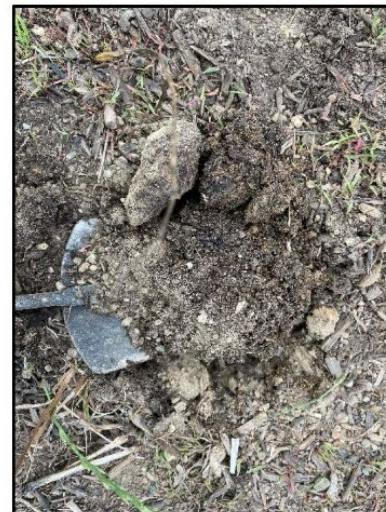
5NB2 Soil Revealed - Very loose structure

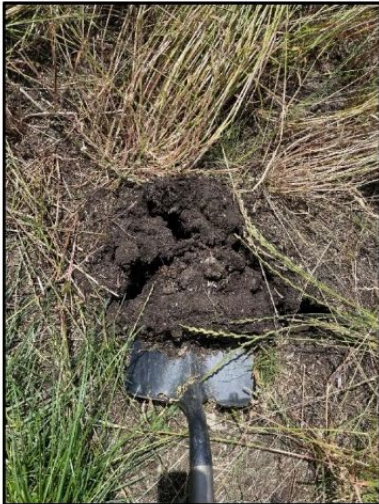
8SB4 Soil Revealed - mainly compost, little soil, very loose structure

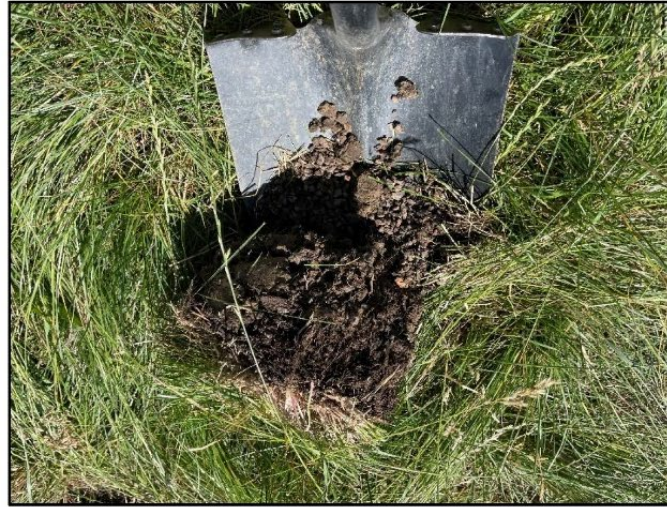
8SG3 Soil Revealed - lots of expanded shale

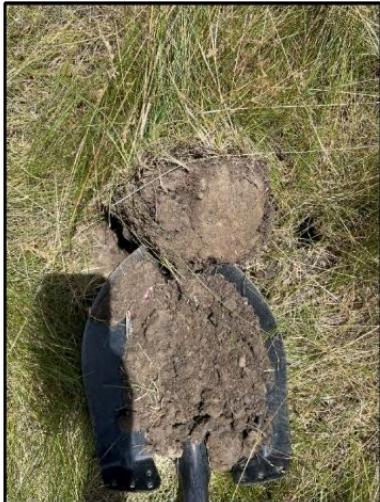
9EG5 Soil Revealed - very loose

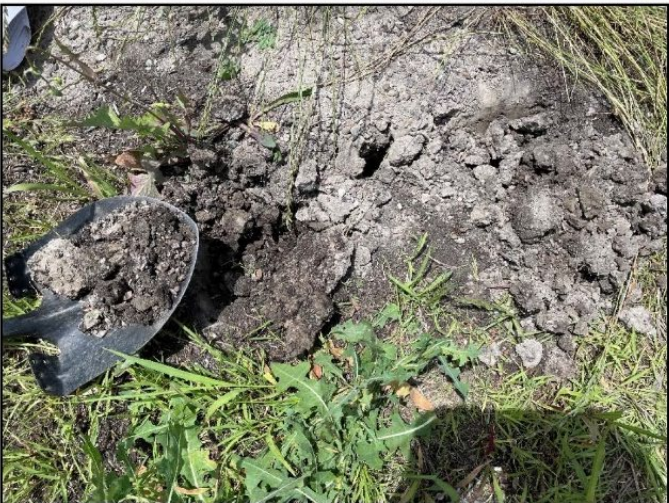
9NB2 Soil Revealed - very loose no structure

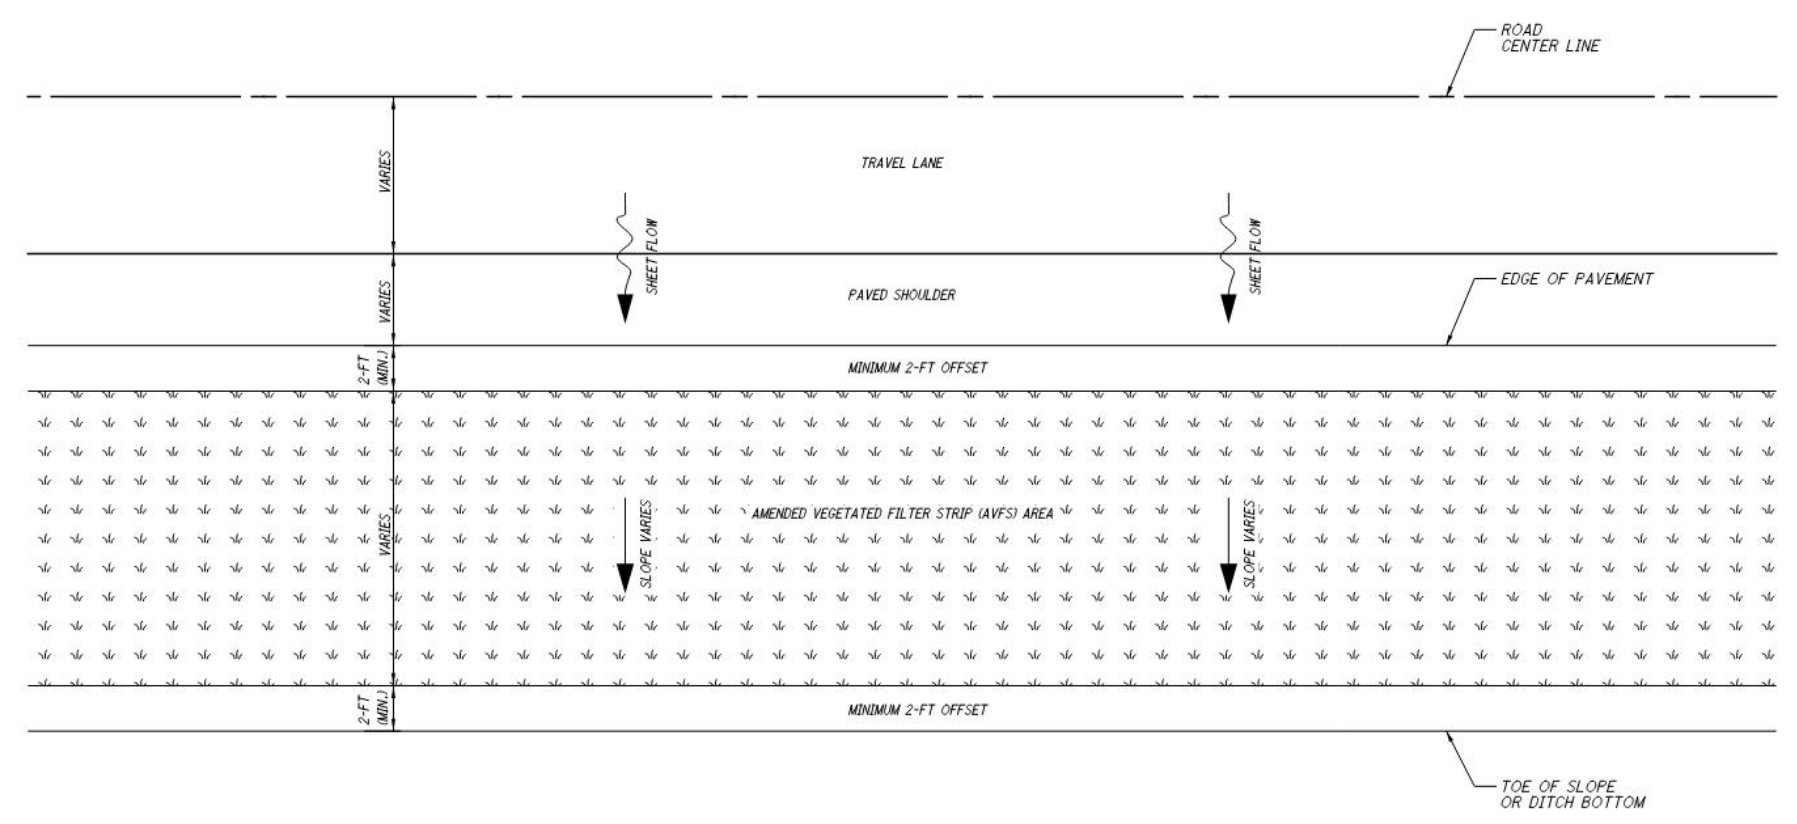
### AMENDED VEGETATED FILTER STRIP (AVFS)

NOT TO SCALE

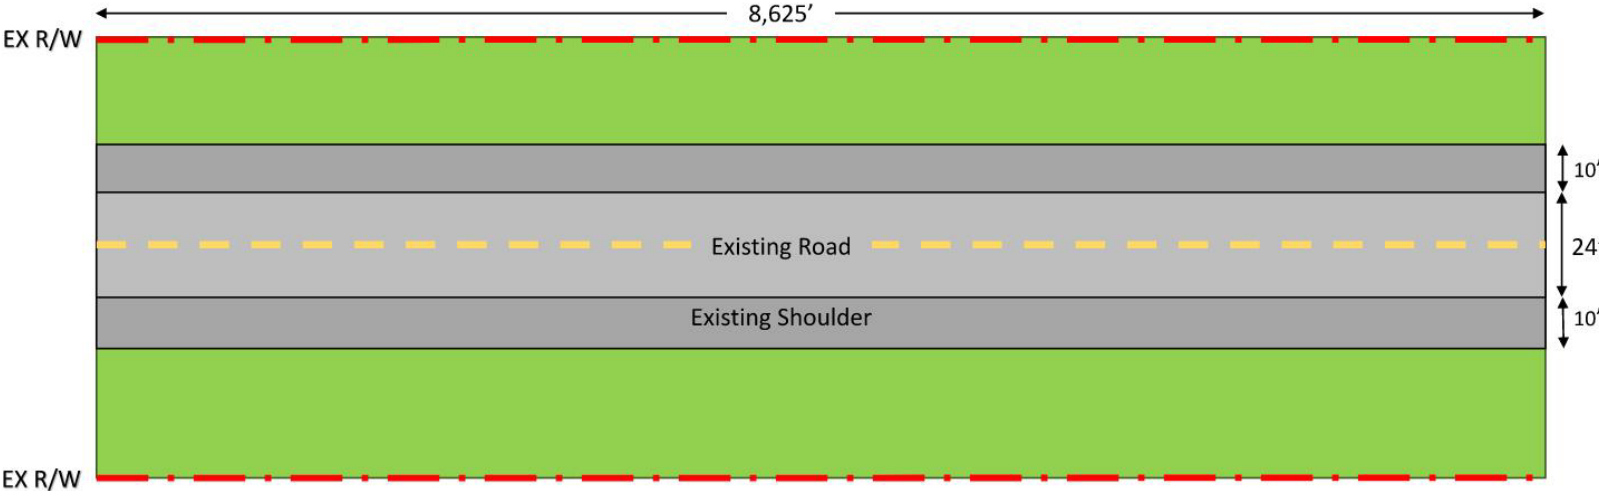
# Example 1 – 100% Redevelopment

- EDA = 10.00 acres      Aix = 10.00 acres      Ain = 0.00 acre
- $T\% = [(10.00 * 20) + (0.00 * 100)] / (10.00 + 0.00) = 20\%$
- Treatment Requirements = 10.00 acres \* 20% = 2.00 acres

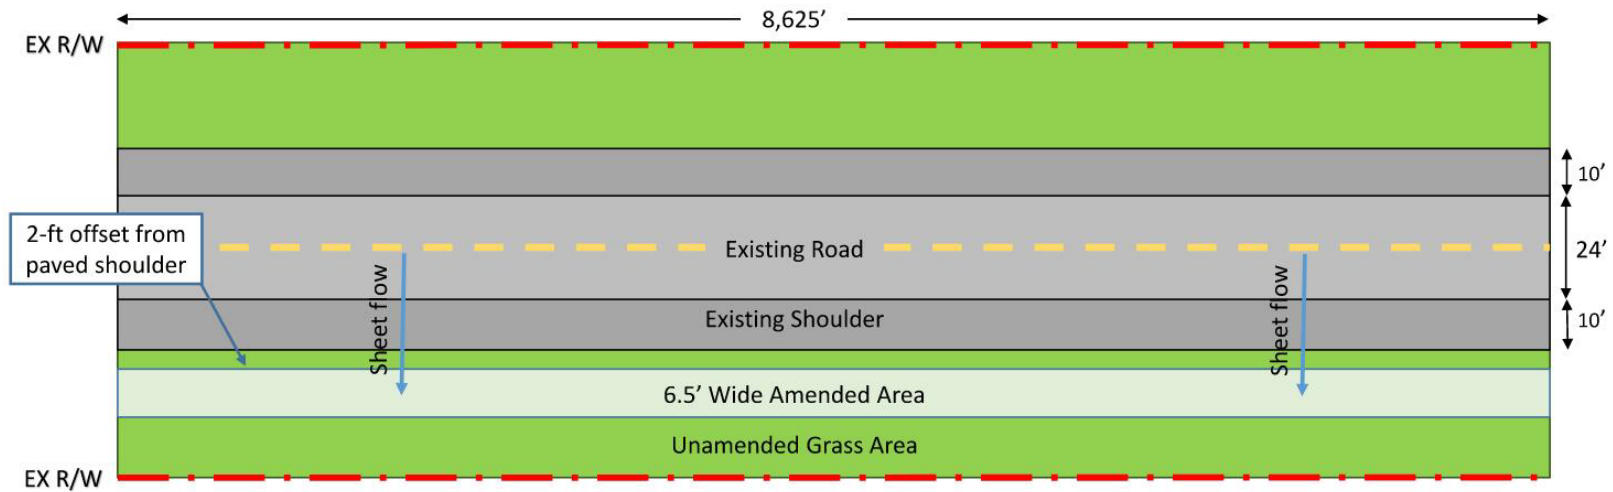
# Example 2 – New Turn Lane

- Credit for tributary area sheet flowing to amended filter strip:  $\frac{8,625' * 6.5'}{43,560} * 60\% = 0.77 \text{ acres}$
- Credit for amended filter strip area:  $\frac{8,625' * 6.5'}{43,560} * 100\% = 1.29 \text{ acres}$
- Total Credit for BMP: 2.06 acres      **Meets Requirement of 2.00 acres**

**NOTE:**  
While tributary area width is greater than amended area width, the maximum tributary width given credit is equal to the width of amended filter strip.

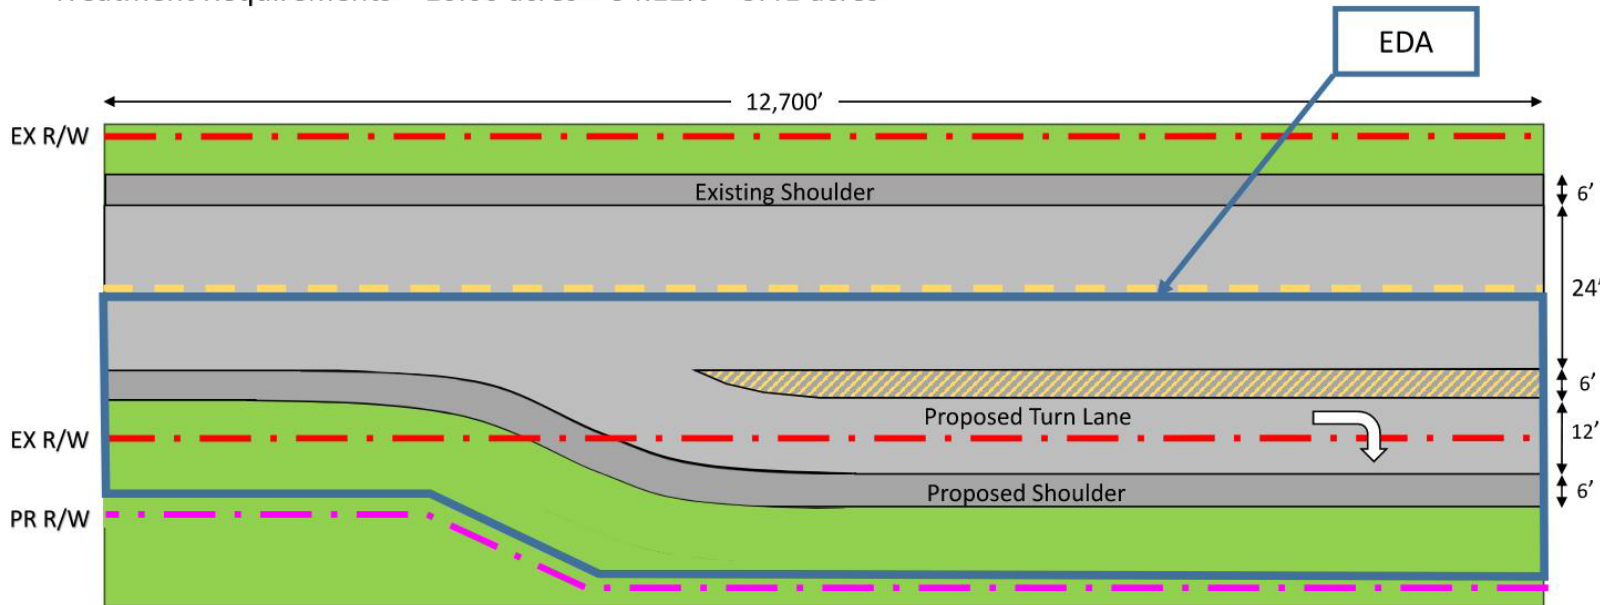
# Example 2 – New Turn Lane

- EDA = 10.00 acres      Aix = 7.00 acres      Ain = 1.50 acre
- $T\% = [(7.00 * 20) + (1.50 * 100)] / (7.00 + 1.50) = 34.12\%$
- Treatment Requirements = 10.00 acres \* 34.12% = 3.41 acres

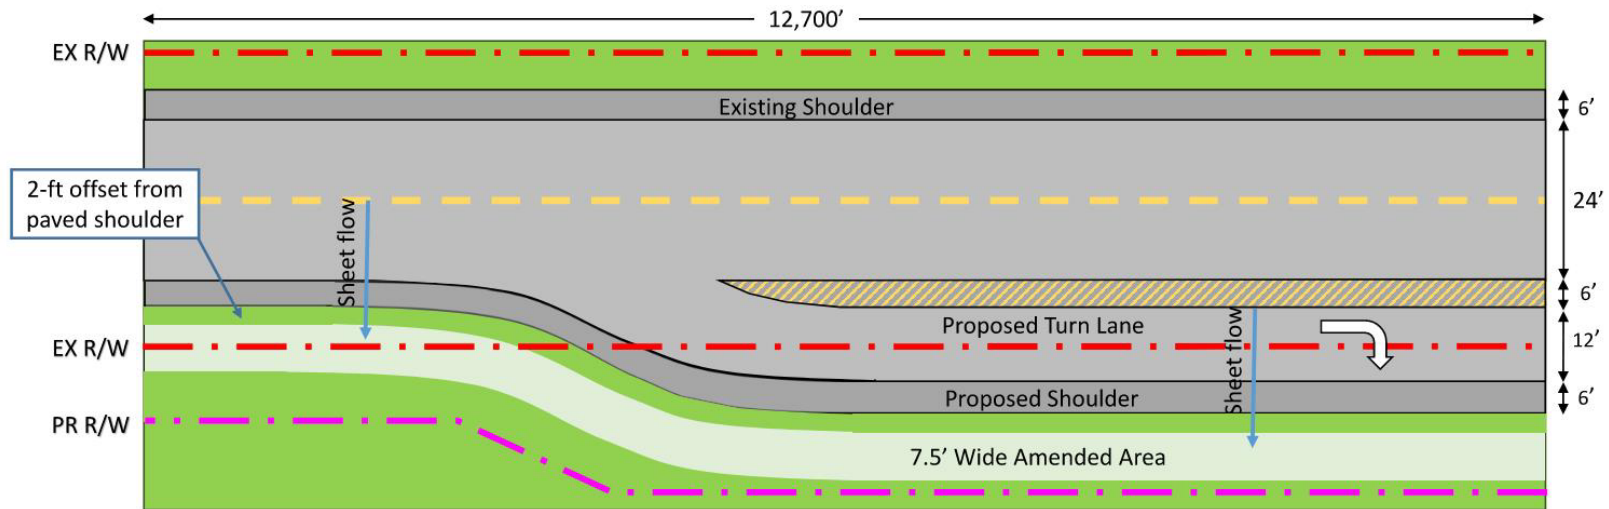
# Example 3 – Adding a lane

- Credit for tributary area sheet flowing to amended filter strip:  $\frac{12,700' \times 7.5'}{43,560} \times 60\% = 1.31 \text{ acres}$

**NOTE:**  
While tributary area width is greater than amended area width, the maximum tributary width given credit is equal to the width of amended filter strip.

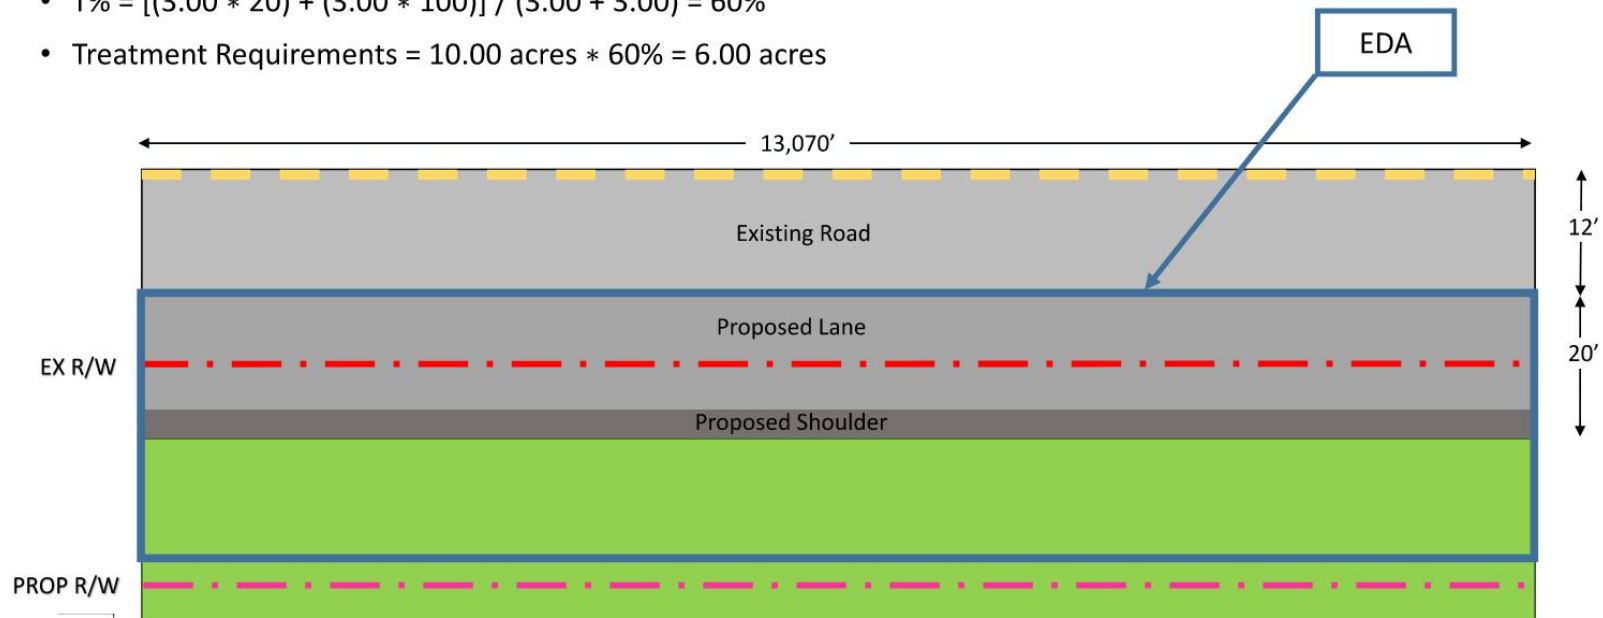
# Example 3 – Adding a lane

- EDA = 10.00 acres      Aix = 3.00 acres      Ain = 3.00 acre
- $T\% = [(3.00 * 20) + (3.00 * 100)] / (3.00 + 3.00) = 60\%$
- Treatment Requirements = 10.00 acres \* 60% = 6.00 acres

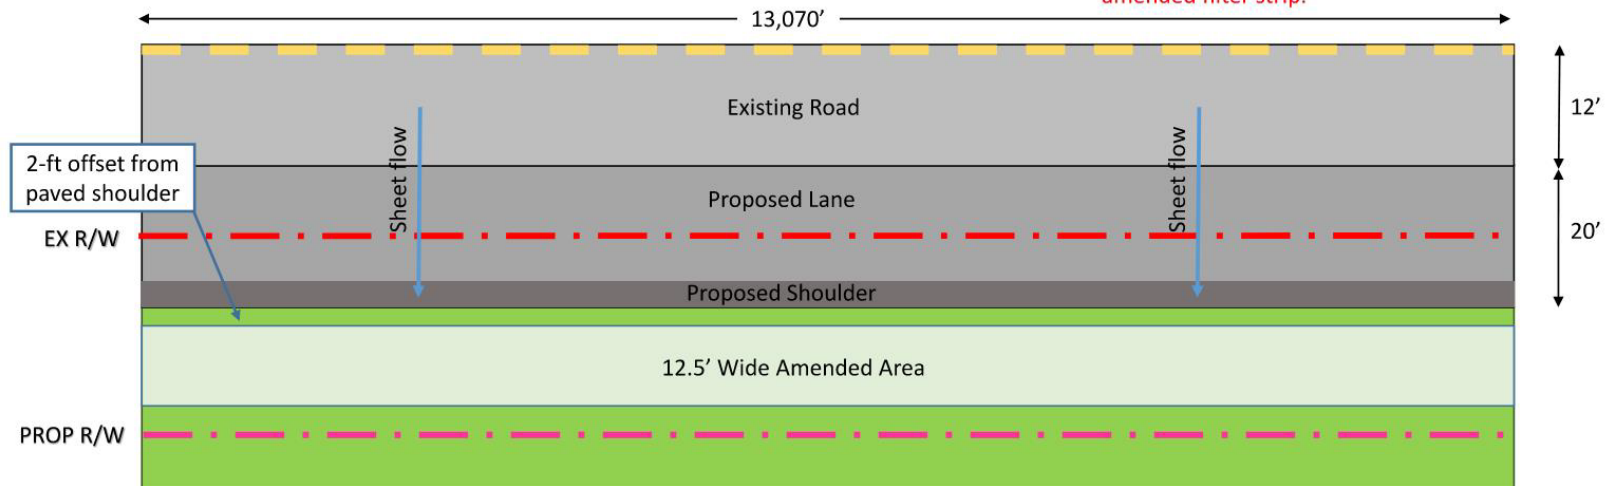
# Example 4 – Partial Length Amendment

Credit for tributary area sheet flowing to amended filter strip:  $\frac{13,070' * 12.5'}{43,560} * 60\% = 2.25 \text{ acres}$

**NOTE:**  
While tributary area width is greater than amended area width, the maximum tributary width given credit is equal to the width of amended filter strip.

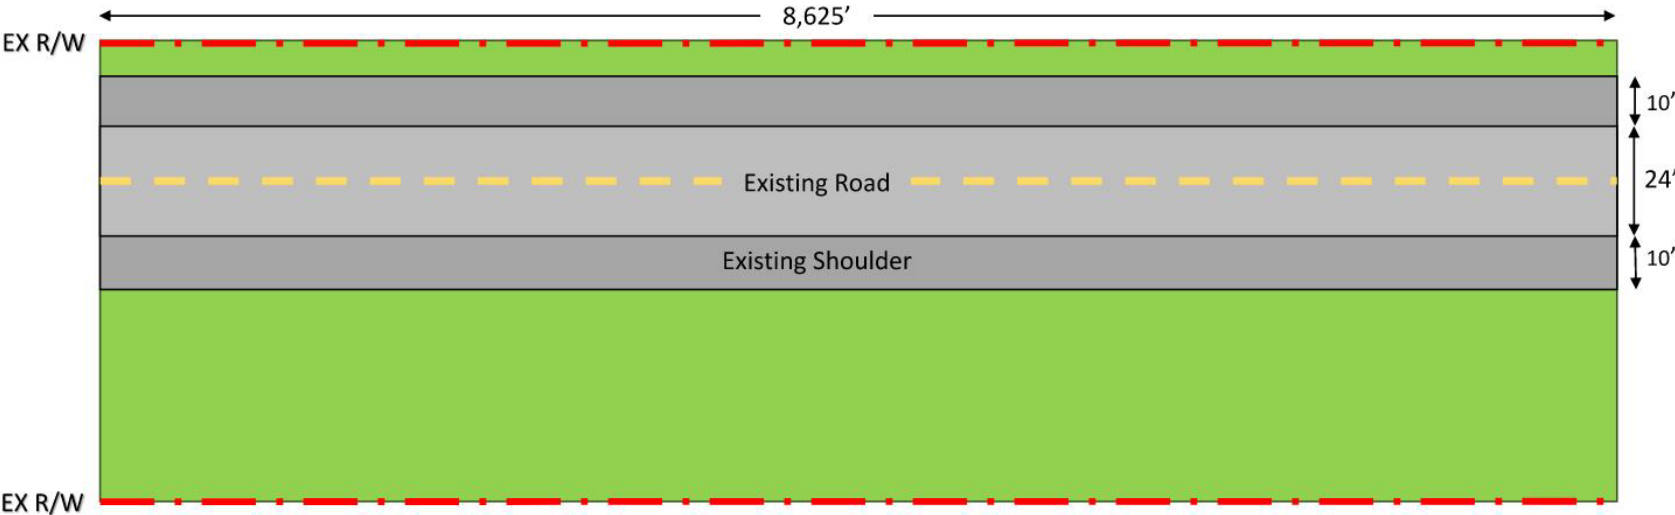
# Example 4 – Partial Length Amendment

- EDA = 10.00 acres      Aix = 10.00 acres      Ain = 0.00 acre
- $T\% = [(10.00 * 20) + (0.00 * 100)] / (10.00 + 0.00) = 20\%$
- Treatment Requirements = 10.00 acres \* 20% = 2.00 acres

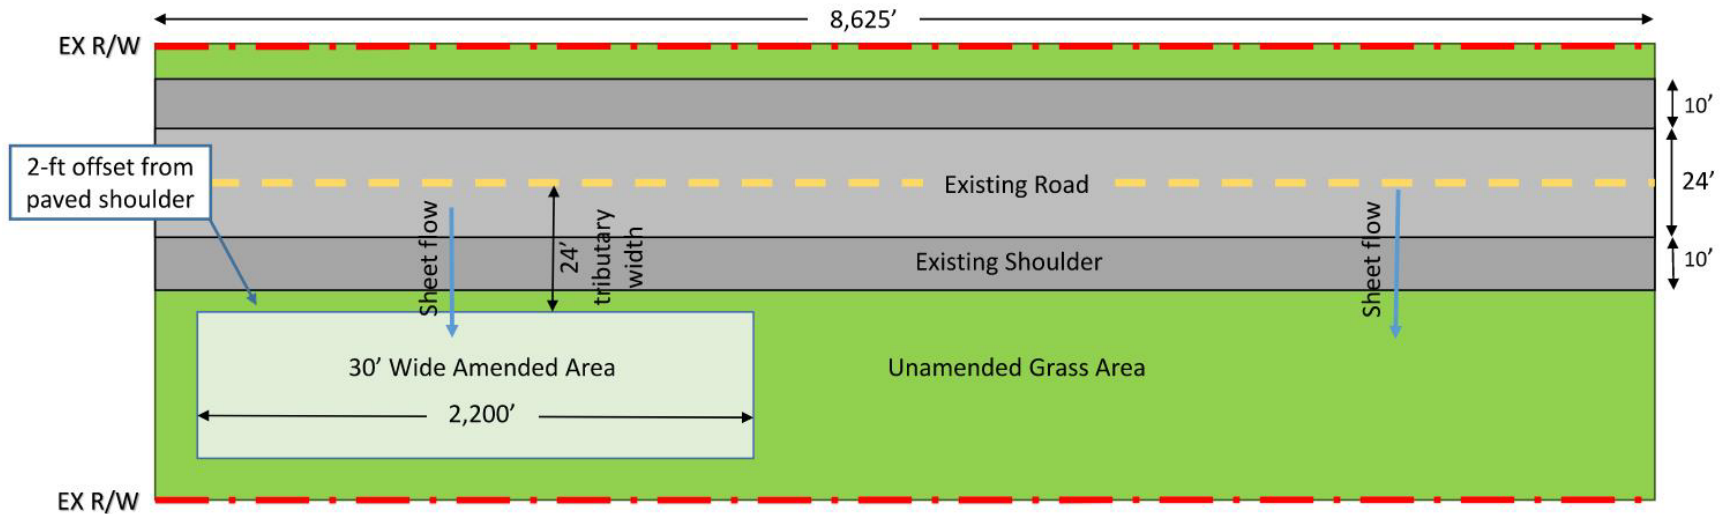
- Credit for tributary area sheet flowing to amended filter strip:  $\frac{2,200' \times 24'}{43,560} \times 60\% = 0.73 \text{ acres}$
- Credit for amended filter strip area:  $\frac{2,200' \times 30'}{43,560} \times 100\% = 1.52 \text{ acres}$
- Total Credit for BMP: **2.25 acres**      **Meets Requirement of 2.00 acres**

**NOTE:**  
Tributary area width is less than amended area width.
