Automated and Connected Vehicle (AV/CV) Test Bed to Improve Transit, Bicycle, and Pedestrian Safety— Phase III: Technical Report

Technical Report 0-6875-03-R1

TEXAS A&M TRANSPORTATION INSTITUTE
COLLEGE STATION, TEXAS

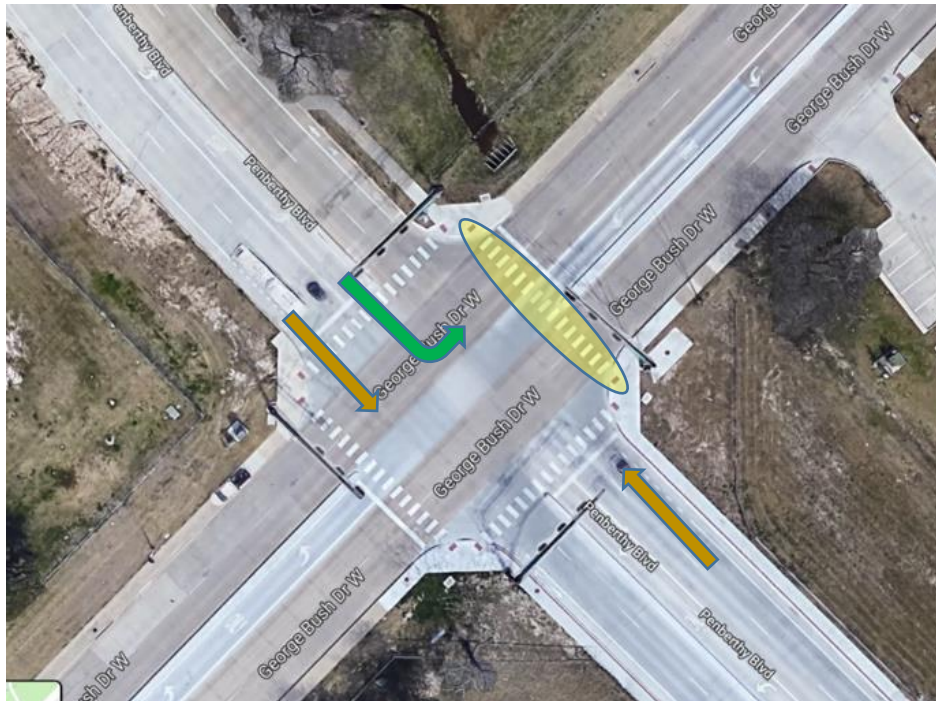
Figure 3. Crosswalk of Interest and Path of Left-Turning Buses.

This section describes the operation of the GBD/PB smart intersection. It includes a review of the system components and the process for alerting bicyclists and pedestrians that a bus is turning left at the intersection. Figure 1 shows the location of the GBD/PB intersection on the Texas A&M University campus. As illustrated in Figure 2, buses on Route 8 (named the Howdy Route by Texas A&M), which turn left from Penberthy Boulevard to George Bush Drive at the intersection, are the focus of this project. Buses on two other routes operate straight through the intersection on Penberthy Boulevard. These buses are not the focus of the project. The path of the turning buses and the crosswalk of interest are highlighted in Figure 3. Figure 4 illustrates a bus turning left at the intersection.

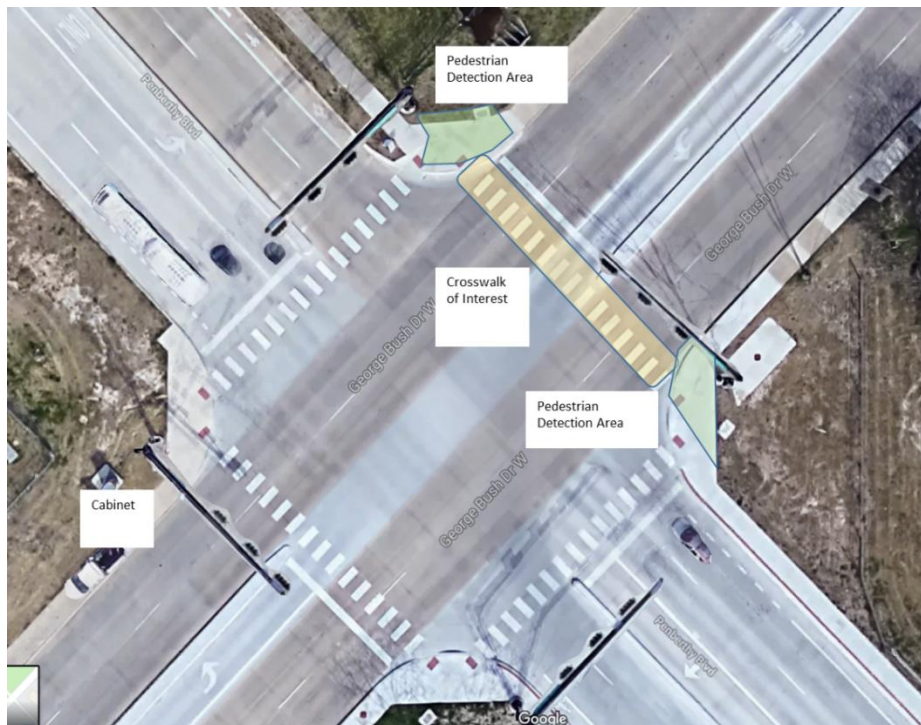
Figure 5. Pedestrian Detection Area at GBD/PB.

Figure 5 and Figure 6 show the location of the traffic signal cabinet, the traffic signal poles, the pedestrian detection areas, and the pedestrian push buttons. The following equipment was installed at the intersection for the smart intersection application.

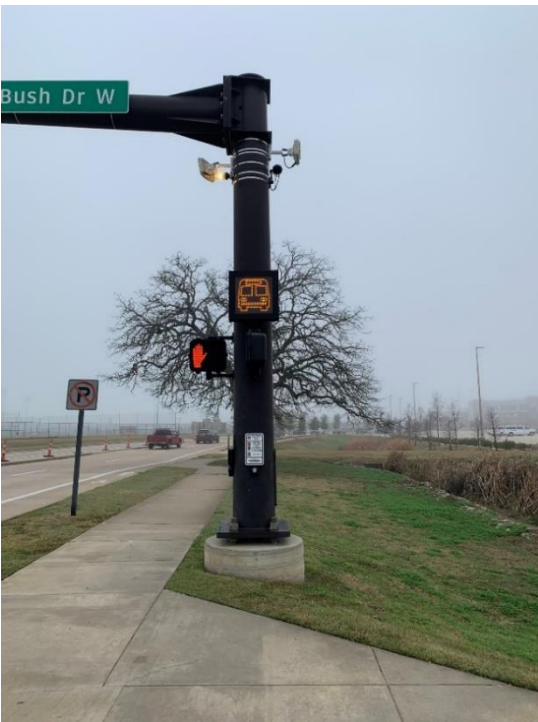
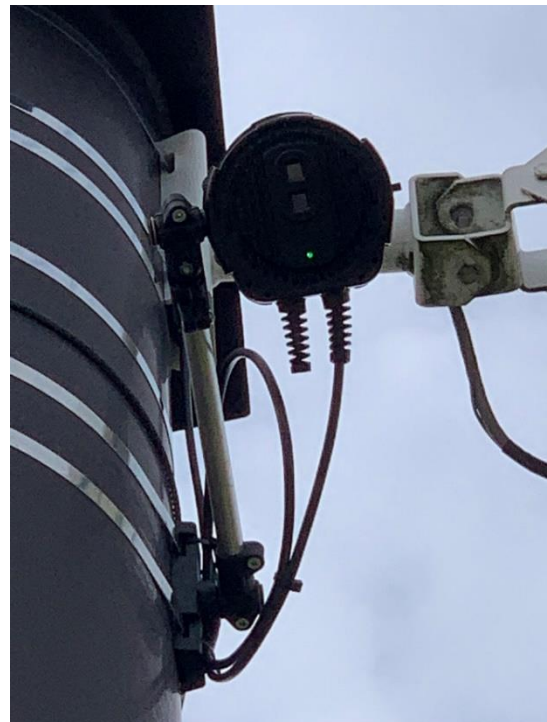
Figure 7. Location of FLIR Sensors on Traffic Pole.

- A Siemens M62 controller was installed in the City of College Station traffic signal cabinet. This controller allows the project to interface with the controller without connecting to the City of College Station network, ensuring the integrity of the security of the city communication network. The M62 controller does not influence the signal operations at the intersection. The existing M60 controller is still in the cabinet as a backup in case the M62 controller malfunctions.
- A field-hardened personal computer (PC) and a modem were installed in the traffic signal cabinet.
- FLIR[®] infrared sensors were installed on the signal poles at the northeast and southeast corners of the intersection. Figure 7 illustrates the location of the sensors, which detect

pedestrians and bicyclists on the sidewalk waiting to cross the intersection. The sensors were channelized into detector channel #49 using temporary wiring which can be removed at the end of the project. Channel #49 is not being used by the City of College Station, and the FLIR sensors do not have any impact on the operation of the signal system.

The FLIR sensors were adjusted in September 2020 to enhance the detection of pedestrians and bicyclists in the intersection waiting zones. The video tape of the zones and the log files were reviewed after this adjustment. The detection of pedestrians and bicyclists in the east side zone was enhanced with the adjustment.

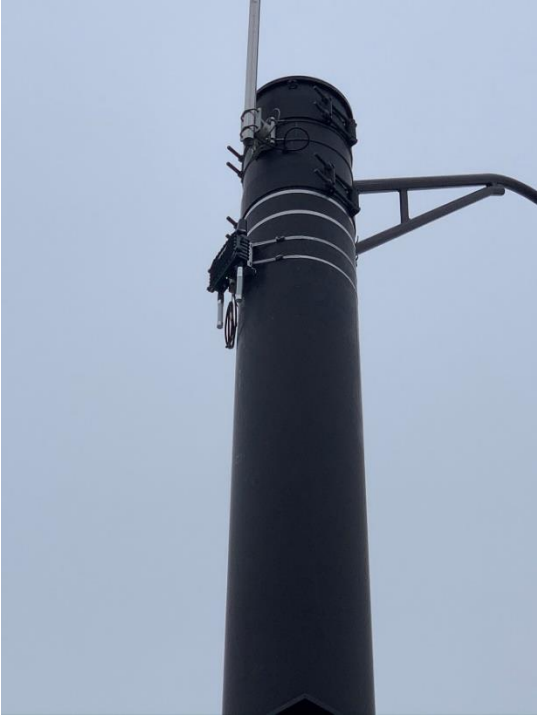
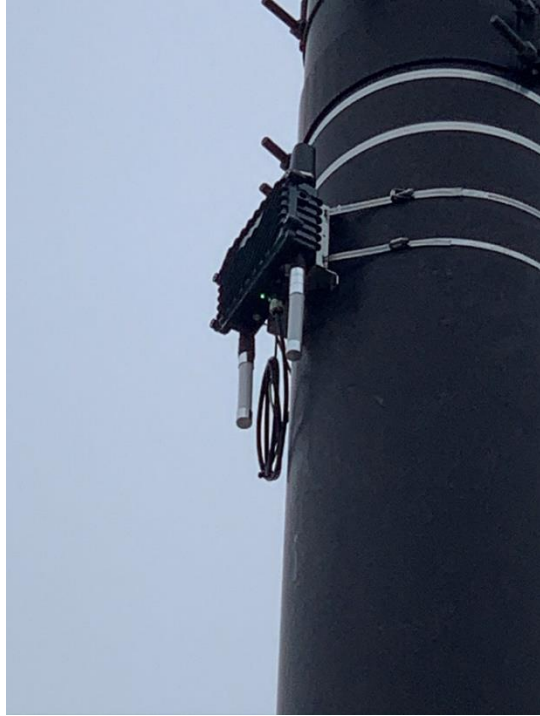
Figure 8. Location of Cohda DSRC Radio.

- A Cohda Wireless™ dedicated short range communication (DSRC) radio was installed on a pole at the northwest corner of the intersection. The location of the DSRC radio, which detects when a bus on Route 8 is arriving at the intersection, is shown in Figure 8.

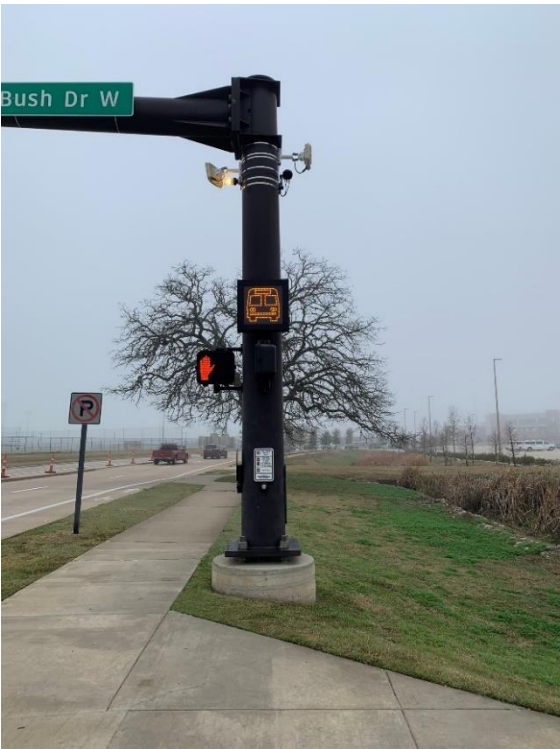
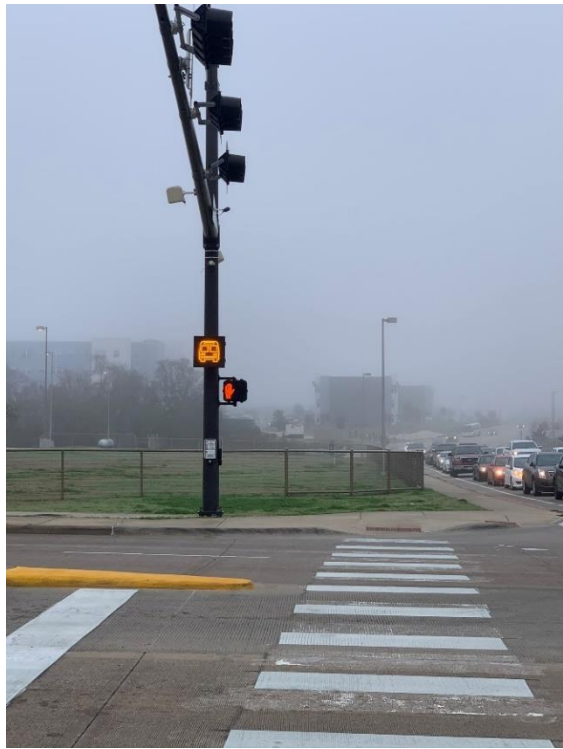
Figure 9. Fiber Optic Bus Signs.

- As illustrated in Figure 9, fiber optic supplemental bus signs were installed on the signal poles at the northeast and the southeast corners of the intersection. The bus signs are connected to Load Switch 1 Red in the signal cabinet and are illuminated when a Route 8 bus arrives at the intersection to turn by interfacing with the controller using Special Function 8. This special function was not being used by the City of College Station. The use of Special Function 8 does not have any impact on the function of the intersection.

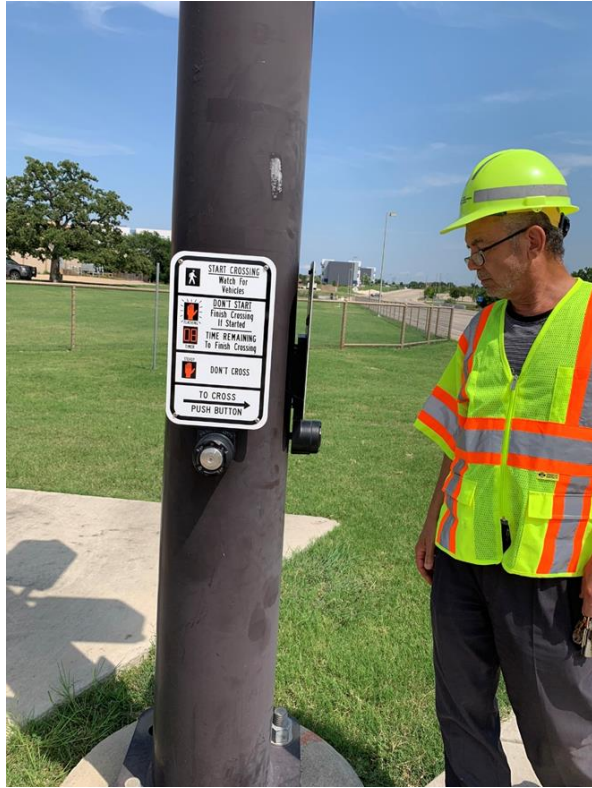
Figure 10. Polara Accessible Pedestrian System.

- Figure 10 shows the location of the Polara Accessible Pedestrian Systems (APSs), which were installed on the signal poles on the northeast and the southeast corners of the intersection. The Polara APSs provide an audio message (“Caution, Bus Turning” in English) when a Route 8 bus is turning at the intersection.

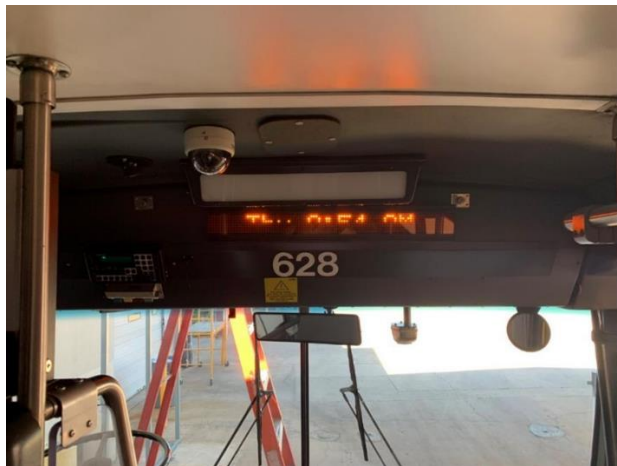
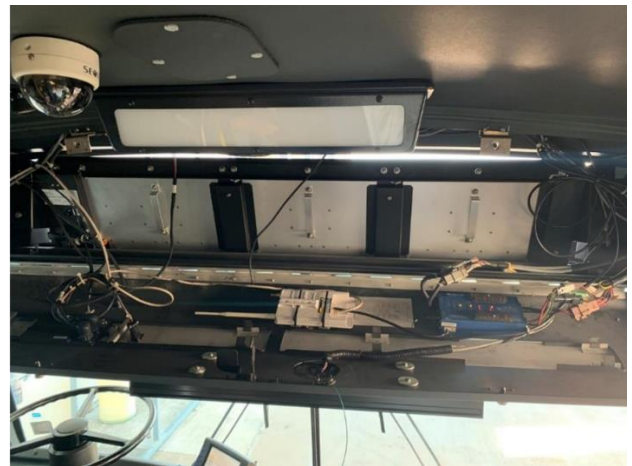
Figure 12. Location of DSRC Radios on Texas A&M Buses.

The radios were installed behind the destination sign panel above the windshield on the front of the buses, which is shown in Figure 12. The placement of the radios was selected to ensure no distraction to bus drivers or impact on bus operations. It was also selected due to ease of removing the panels for the initial installation and for ongoing maintenance and troubleshooting. Figure 13 illustrates the placement of the DSRC radio antennae on the roof of the bus. The installation took advantage of an existing opening in the bus roof. Texas A&M Transportation Services provided 12-volt power for the radios, with a switch connection so that the radio operates only when the bus engine is on.

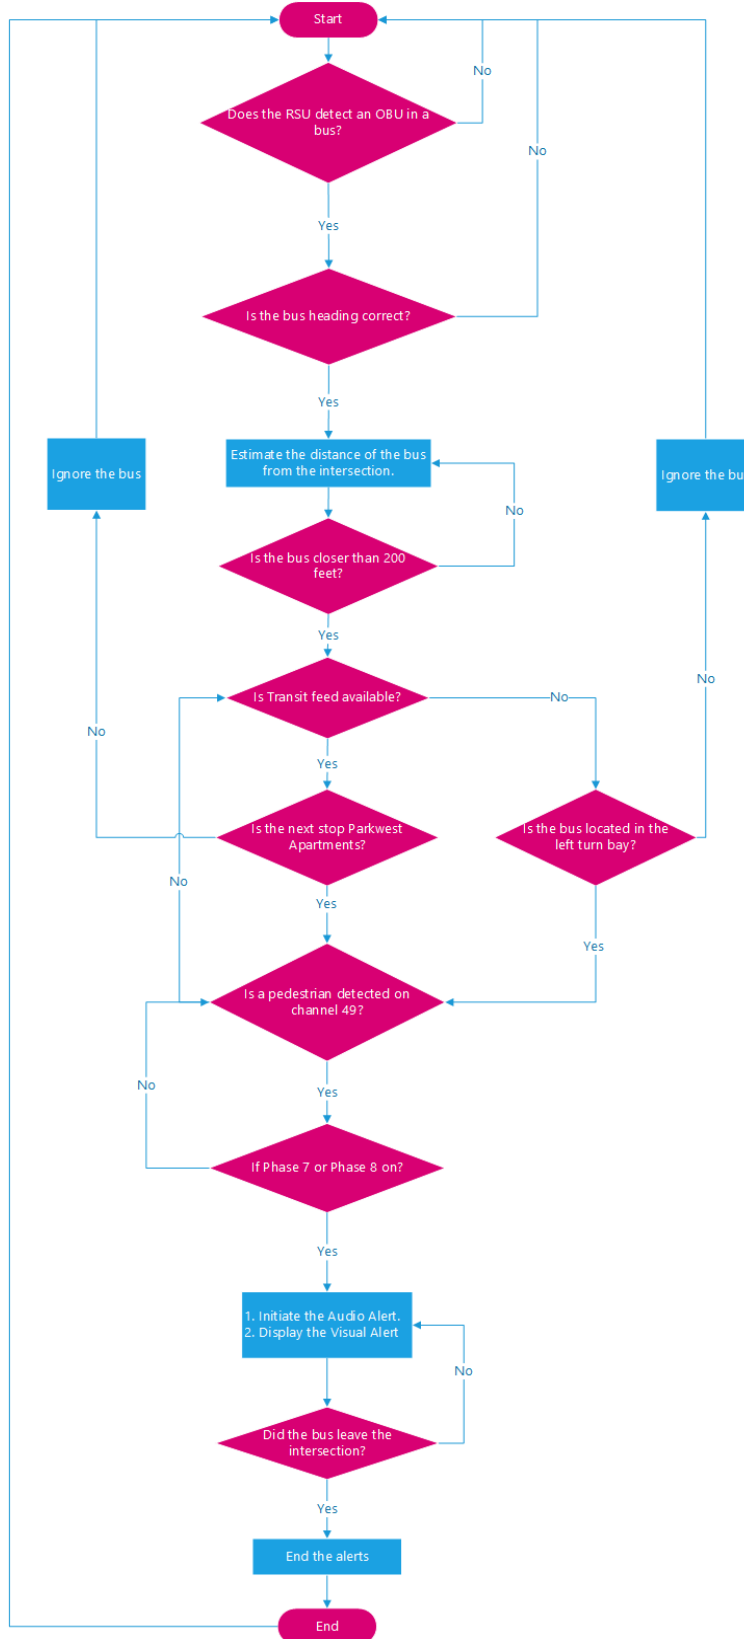
Figure 14. Flowchart of the System Architecture.

The system was configured as per the architecture illustrated in Figure 14. The system uses the various components in the following manner.

1. DSRC Roadside Unit (RSU) — Identify a bus with an onboard unit and obtain the coordinates and the heading of the bus along with a custom identification (ID).

- a. Coordinates are used to calculate the distance of the bus from the intersection.
 - b. Coordinates are used to determine if the bus is in the left-turn bay.

- c. Heading is used to determine if the bus is approaching the intersection from the correct direction.
2. Cellular modem — Monitor the live feed from Texas A&M Transportation Services to match the ID of the onboard unit (OBU) and determine the next stop of the instrumented bus.

3. FLIR detector — Detect a pedestrian on the sidewalk.
4. Traffic signal controller.
 - a. Monitor the presence of the pedestrian on detector channel # 49.

- b. Monitor if the signal phase is Phase 7 or Phase 8.
 - c. Call Special Function 8 to display the bus sign.
5. Polara APS — Initiate audio alert using a digital i/o card.

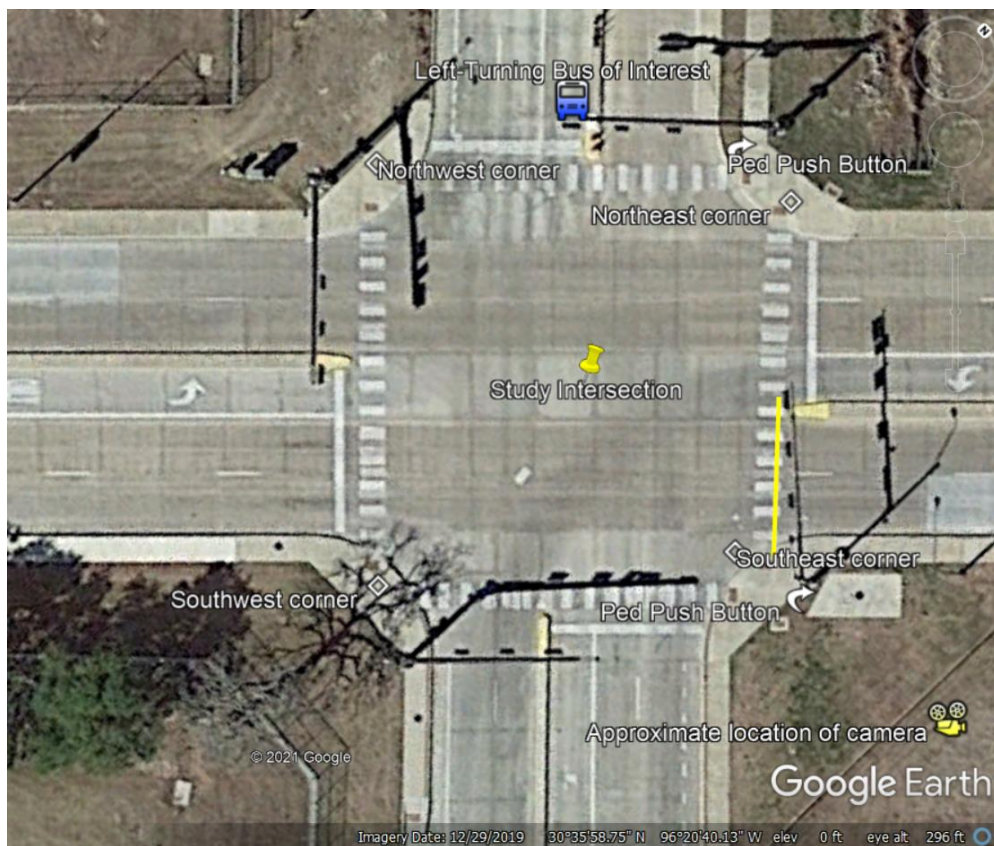
Figure 16. Aerial View of Intersection.

Figure 16 shows an aerial view of the intersection, with the pedestrian push buttons examined in the analysis highlighted. The northeast and southeast corners are the corners of interest along with the crosswalk that connects the two corners, in particular the area highlighted with a yellow line in Figure 16. Temporarily installed or city cameras were used to record the view of interest at the GBD/PB intersection. The characteristics of the crosswalk of interest are presented in Table 2. The posted speed limit for the east and west legs (George Bush Drive) is 50 mph, 40 mph for the south leg, and 30 mph for the north leg which is part of the Texas A&M campus. All legs at this intersection have four through lanes along with a left-turn lane.

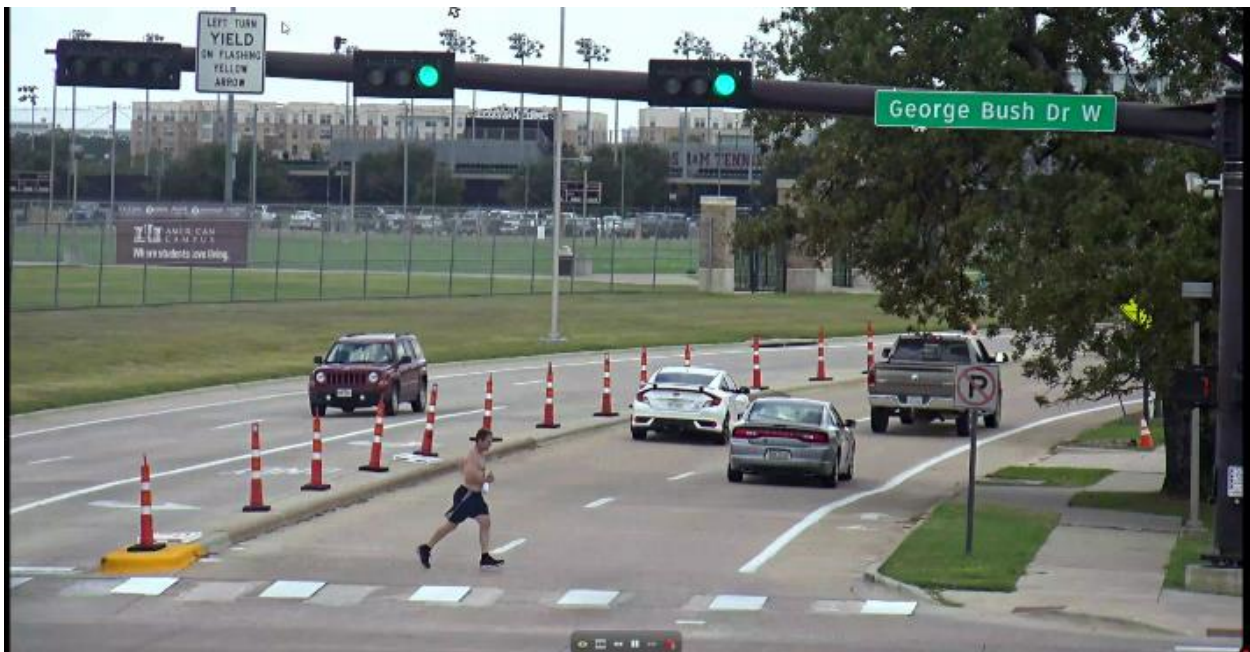
Figure 17. Street-Level View of the Intersection (Before).

Operation of the intersection was recorded in the before period from October 1 to October 22, 2019, with the assistance of Texas A&M University Transportation Services. A solar trailer was deployed with two cameras. The research team was able to position the cameras to provide both a street-level view (Figure 17) and a bird's-eye view (Figure 18) of the intersection. The two views allowed the research team to observe the following items:

- All vehicles and pedestrians passing through the crosswalk of interest.
- The waiting areas at both corners bounding the crosswalk of interest.
- The vehicular signal heads for the northbound intersection approach.
- The pedestrian signal head on the northeast corner for the crosswalk of interest.

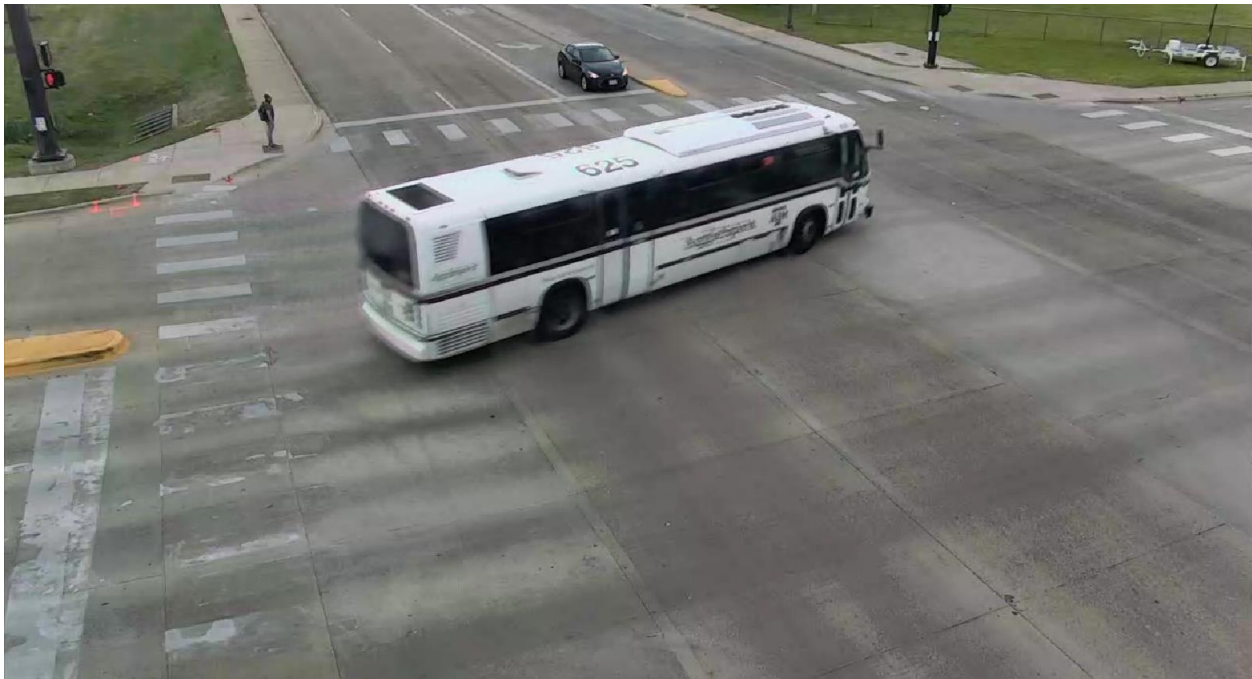
Figure 20. Bird's-Eye Camera View of the Intersection (After).

Operation of the intersection was again recorded in the after period from March 29, 2021, to April 12, 2021, with the assistance of Texas A&M University Transportation Services and the City of College Station. The research team used a different camera setup because the two-camera solar trailer from the before period was not available for the after period. The research team obtained street-level footage from a one-camera solar trailer provided by Transportation Services (see view in Figure 19) and bird's-eye footage from the permanently installed pan-tilt-zoom camera maintained by the city (see camera view in Figure 20). The activated bus warning sign is illustrated in Figure 19 and the presence of the solar trailer is shown in the upper-right corner of Figure 20.

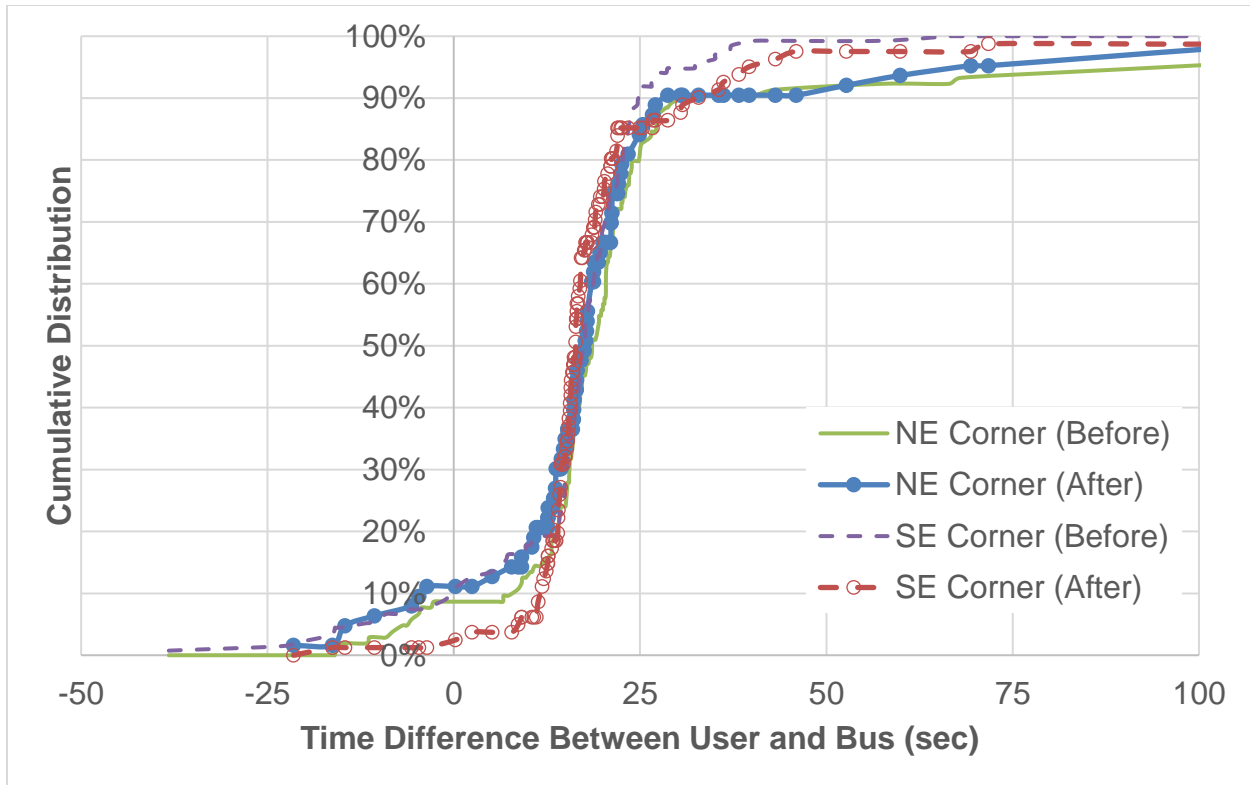
Figure 22. Cumulative Distribution of Time Difference Between User Entering the Intersection and Bus Starting Left Turn.

The timestamps were used to calculate the number of seconds between when the user entered the intersection and when the bus began the left turn. Figure 22 shows the cumulative distribution of the time difference between the crosswalk users entering the intersection and the bus starting the left turn. The graph separated the distribution for those starting from the northeast (NE) corner and those starting from the southeast (SE) corner, since people originating from the northeast corner can proceed halfway through the crossing before reaching the bus-ped/bike conflict zone, so an early start is less concerning for these people. Negative values (at the bottom portion of the graph) indicate that the pedestrian or bicyclist moved into the intersection before the bus began turning. In the before period, approximately 90 percent entered the intersection after the bus had initiated the left turn, with 10 percent entering the intersection before the bus turned. One notable change was observed in the after period. Specifically, only about 2 percent of the pedestrians originating from the southeast corner entered the intersection before the bus turned (see the red data series on the graph). Pedestrians originating from the southeast corner would be most likely to be exposed to a conflict with the left-turning bus, so it is desirable to reduce the number of early corner departures by these pedestrians.

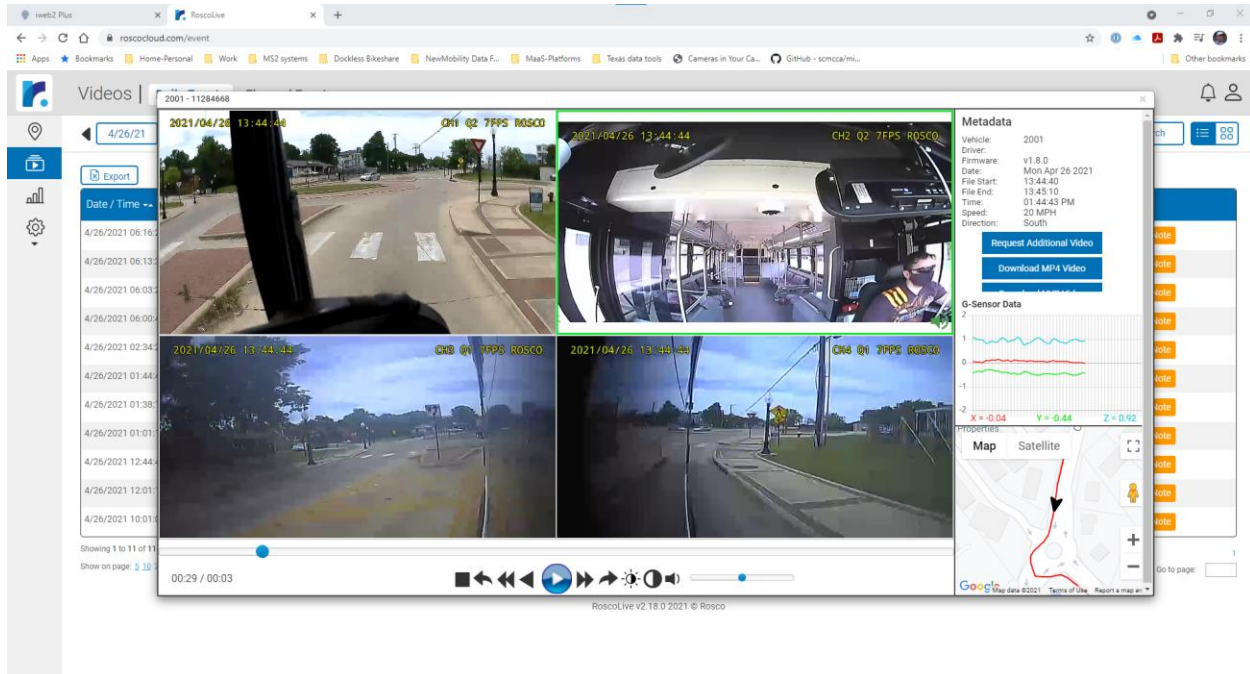
Figure 24. Screenshot of Video Review Subsystem Used to Verify Collision Alert Accuracy.

When reviewing red collision alerts, TTI used the following attributes from the Ituran telematics subsystem:

- Collision alert date and time
- Vehicle name: Bus 2001, Bus 2002
- Bus speed at time of collision alert
- Bus location and address at time of alert
- Specific sensor triggering the collision alert: Front, Left Rear, or Right Rear
