IMPACT OF SHOULDER CLEANING ON BALLAST DRAINAGE

SUMMARY

The Federal Railroad Administration (FRA) and the Association of American Railroads (AAR) jointly supported Transportation Technology Center, Inc., (TTCI) to investigate the influence of shoulder ballast cleaning (SBC) on the performance of fine-filled ballast. Repeated vehicle loadings degrade ballast particles over time and can eventually allow enough degraded ballast fines to accumulate around the tie ends to block drainage. This blocked drainage can then produce mud pumping and rapid track geometry degradation and can also accelerate track component degradation.

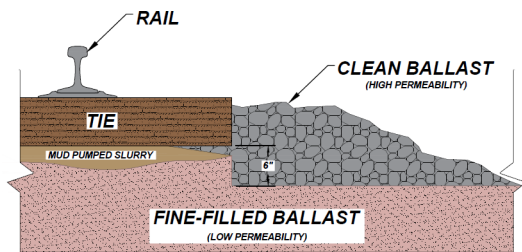
Figure 1. Diagram of the shoulder ballast cleaned section with scarifier

SBC is a ballast maintenance technique that focuses on opening the drainage paths around the tie ends by replacing degraded shoulder ballast with new, clean ballast (see [Figure 1](#)). Despite being commonly used to address fouled ballast locations (i.e., ballast defects), information on the ability of SBC to improve drainage is mostly anecdotal.

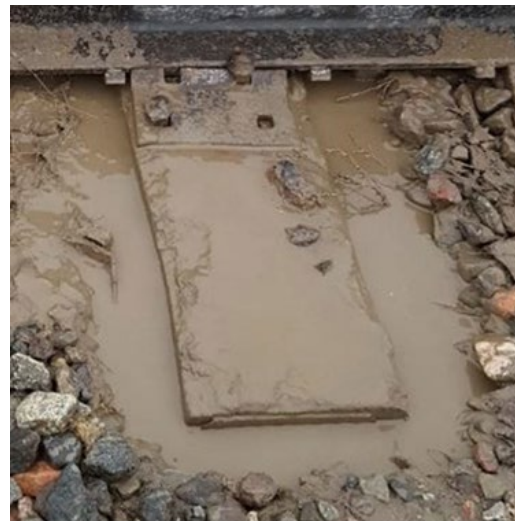
Figure 2. Photograph of mud pumping from no maintenance situation

The first performance indicator used was visual observation of surface mud pumping. Avoiding mud pumping is important because it is often a visual indicator of degraded ballast, can imply poor drainage, and is often used to justify ballast defects. Figure 2 shows surface mud pumping and water ponding from previous Phase I testing. However, no surface mud pumping was observed after each of the three Phase II tests. Figure 3 shows the section after Test 1. While the surface fines were moist, they did not result in the slurry formation that was commonly found in Phase I. The track was visually similar after Tests 2 and 3.

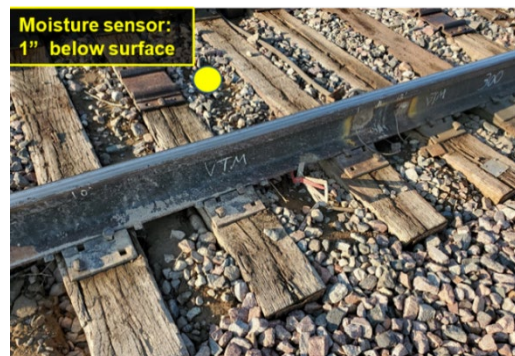
Figure 3. Photograph of SBC situation

rainfall should drain through and away from the track, ideally keeping the track drier. Drainage was calculated by monitoring moisture levels at the track center in the crib (Figure 3). Moisture sensors were installed 1 inch below the surface and measured water trapped in the track center. For this study, ballast with 10 percent moisture or less was considered “dry,” ballast with 15 percent moisture or more was considered “saturated,” and ballast with 10 to 15 percent moisture transitioned from dry to wet. To assess drainage, researchers used the metric of “days to reach below 15 percent.” This metric is simple and imperfect, but still represents complicated behavior well.

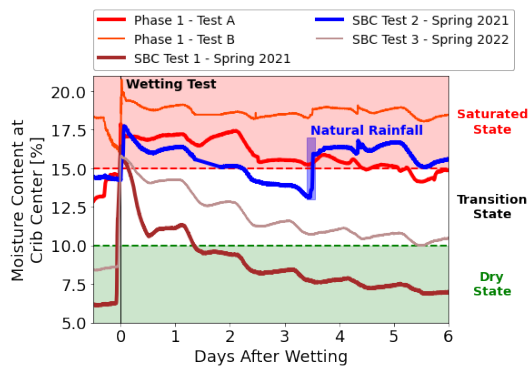
Figure 4 shows the drop in moisture levels after wetting for two previous Phase I tests (Tests A and B) in red, the two drier SBC tests (Tests 1

and 3) in brown, and the wetter SBC test (Test 2) in blue. The results show that in Phase I testing, it took upward of five days for moisture to drop below 15 percent. This result agrees with the visual observations of mud pumping and surface water ponding for days after wetting. In Phase II, Tests 1 and 3 showed the quickest drainage, taking about 3 to 6 hours. The pre-wetting moisture readings were dry at 6 and 8 percent, suggesting that although some moisture infiltrated the fines, much of the moisture drained through surface runoff. The location was also allowed to dry fully between rain events. Test 2 took longer to drain (~2 days), but the pre-wetting moisture reading was already at about 14.3 percent, and it took about two days for the ballast fines to return to their pre-wetting moisture levels. A natural rainfall event also occurred 3 days after the wetting test, causing the location to remain wet and suggesting that for Test 2, the high number of natural rainfall events along with artificial wetting caused the section to remain in a very wet state without drying in between rain events. The higher settlement rate in Test 2 also means that although the moisture did not form a slurry, it was likely able to penetrate deeper than in Tests 1 and 3.

Figure 4. Change in moisture content at crib center after wetting

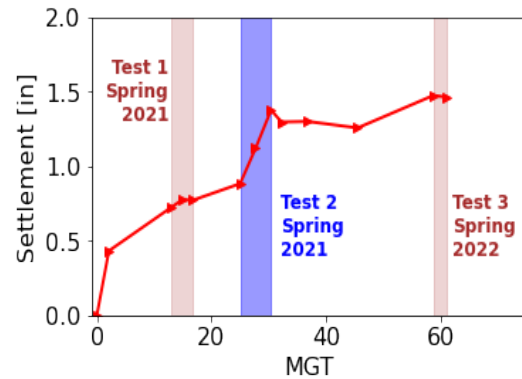
A third performance indicator assessed was settlement. Researchers used top-of-rail survey elevations (ToRE) to establish the track settlement, which indicates track deformation. When localized in a dip, as in this test, settlement has a strong relationship with surface profile roughness. Figure 5 shows the track settlement at the center of the dip after tamping,

which was done immediately after SBC. Ballast compaction, common after tamping, caused the initial 0.5 inch of settlement. The three shaded regions in Figure 5 show the wetting tests and the settlement rate within those shaded regions can be calculated. For reference, Phase I testing showed about 0.003 in/MGT when dry and 0.08 in/MGT when wet. Tests 1 and 3 again showed minimal settlement with rates at 0.012 in/MGT. These settlement rate values match well with the Phase I dry settlement (no wetting). Test 2 showed much greater settlement rates with about 0.091 in/MGT, like the wet settlement rate in Phase I.

Figure 5. Settlement during surfacing cycle from Spring 2021 to Spring 2022

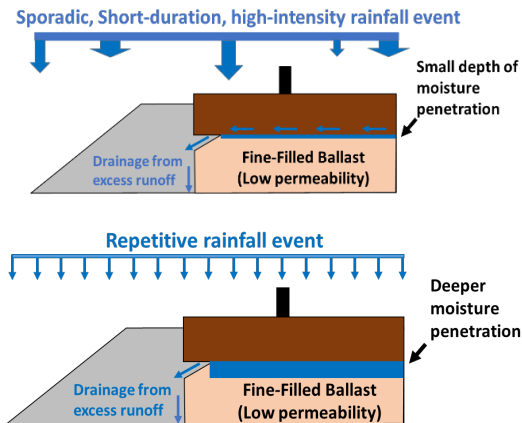
Figure 6. Diagrams of rainfall events and moisture penetration

Table 1 summarizes the qualitative performance of SBC by rainfall event. When no shoulder cleaning takes place, any moisture can become trapped underneath the tie and induce mud pumping. SBC did not produce mud pumping in areas where the shoulder ballast was cleaned. However, the SBC section did experience higher settlement rates after repetitive rainfall events because the fines underneath the tie were able to soften. Figure 6 shows a diagram of the two rainfall climates and the effect of drainage.

The settlement results suggest the effectiveness of SBC varies with climate. SBC will reduce track geometry degradation in arid environments that experience sporadic rainstorms, as excess water drains out of the shoulders instead of collecting underneath the tie and producing mud pumping. For wetter climates, locations may still experience greater settlement rates if the fines wet to a near-saturated state. However, the location will still drain more quickly with the clean shoulder, thereby preventing surface mud pumping.
