BDV29-977-26

# Florida Department of Transportation Research

## Susceptibility of Bridge Steel and Concrete Components to Microbiological Influenced Corrosion (MIC) and Microbiological Influenced Deterioration (MID) in Florida

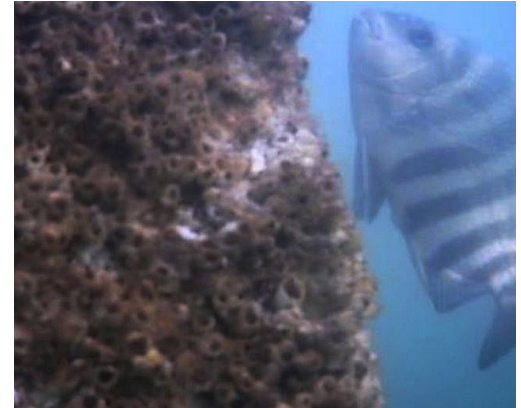
*Underwater structures are often colonized by barnacles and other marine life, which can host bacteria that are destructive to steel.*
