TOLERABLE MOVEMENT CRITERIA FOR HIGHWAY BRIDGES

**Federal Highway
Administration**

Report No.
FHWA/RD-85/107

Final Report
October 1985

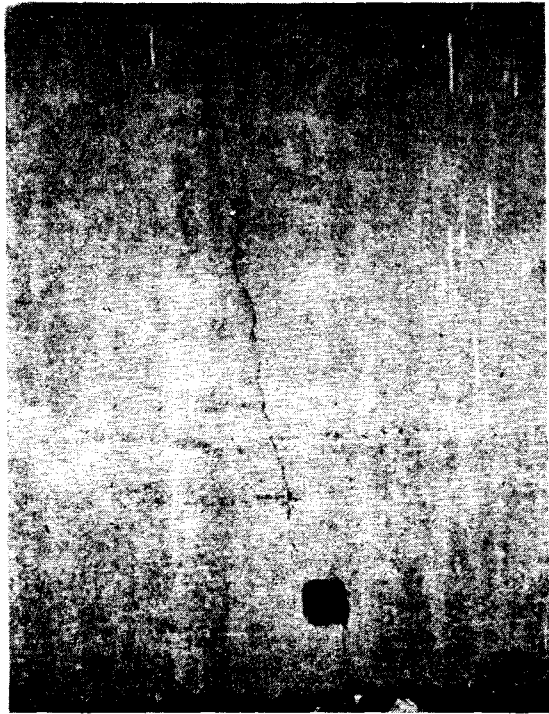
Figure 5. Minor cracking in abutment caused by differential settlement.

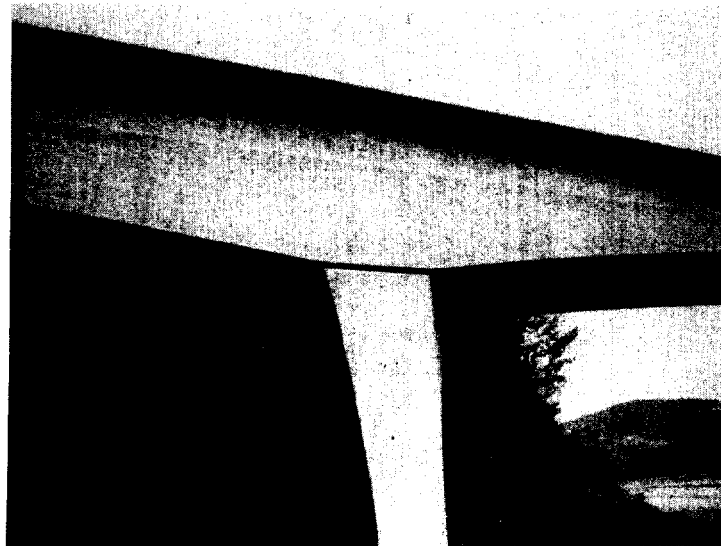
Figure 8. Closeup of bridge shown in figure 10
showing no signs of distress in spite
of differential settlement of abutment.

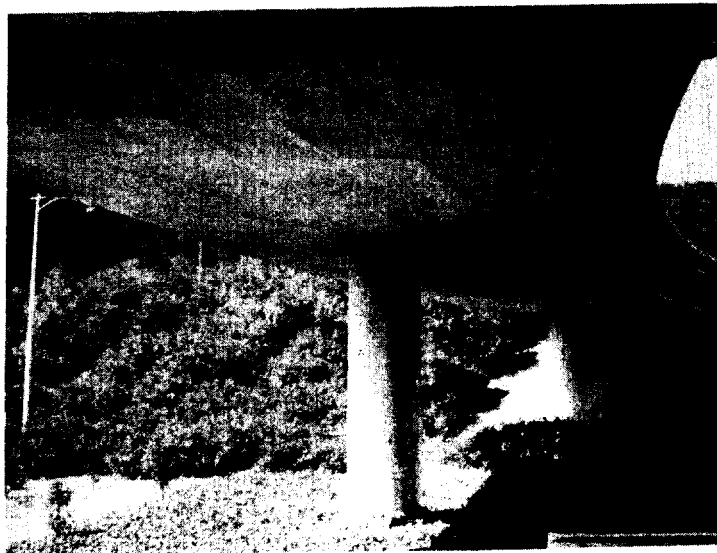
Figure 11. View of bottom of curved concrete box girder bridge shown in figures 12 and 13 showing no signs of distress in spite of the settlements that took place.

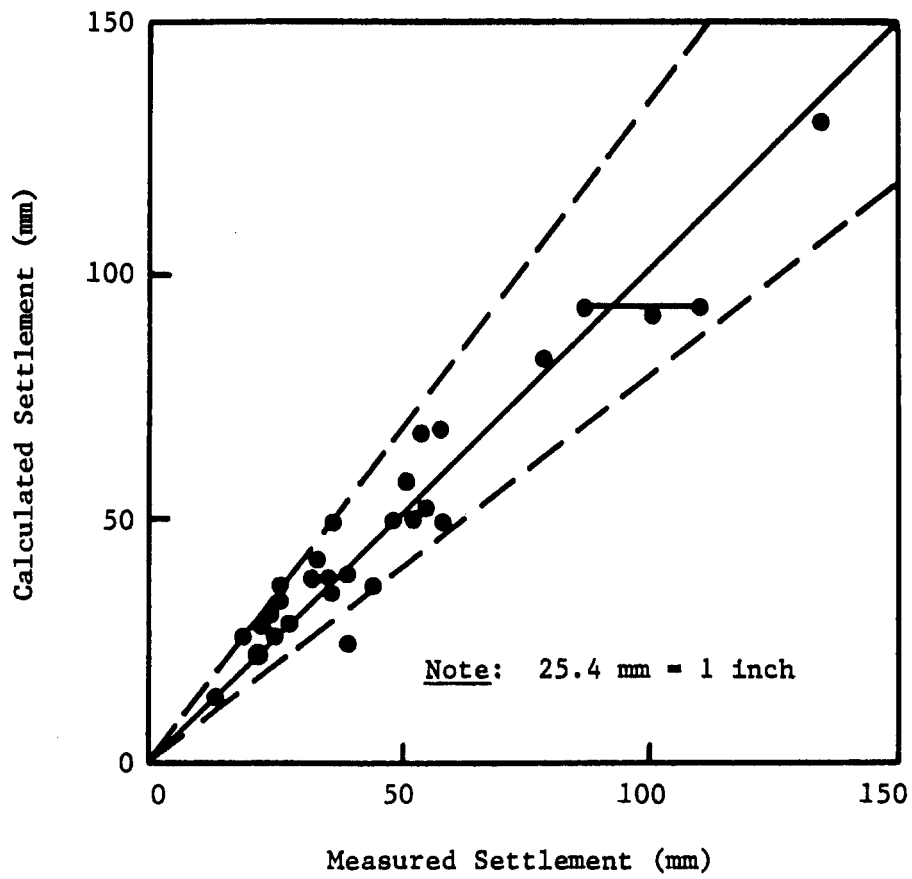
Figure 15. Comparison between calculated and measured settlements of overconsolidated clays, after Butler (50).

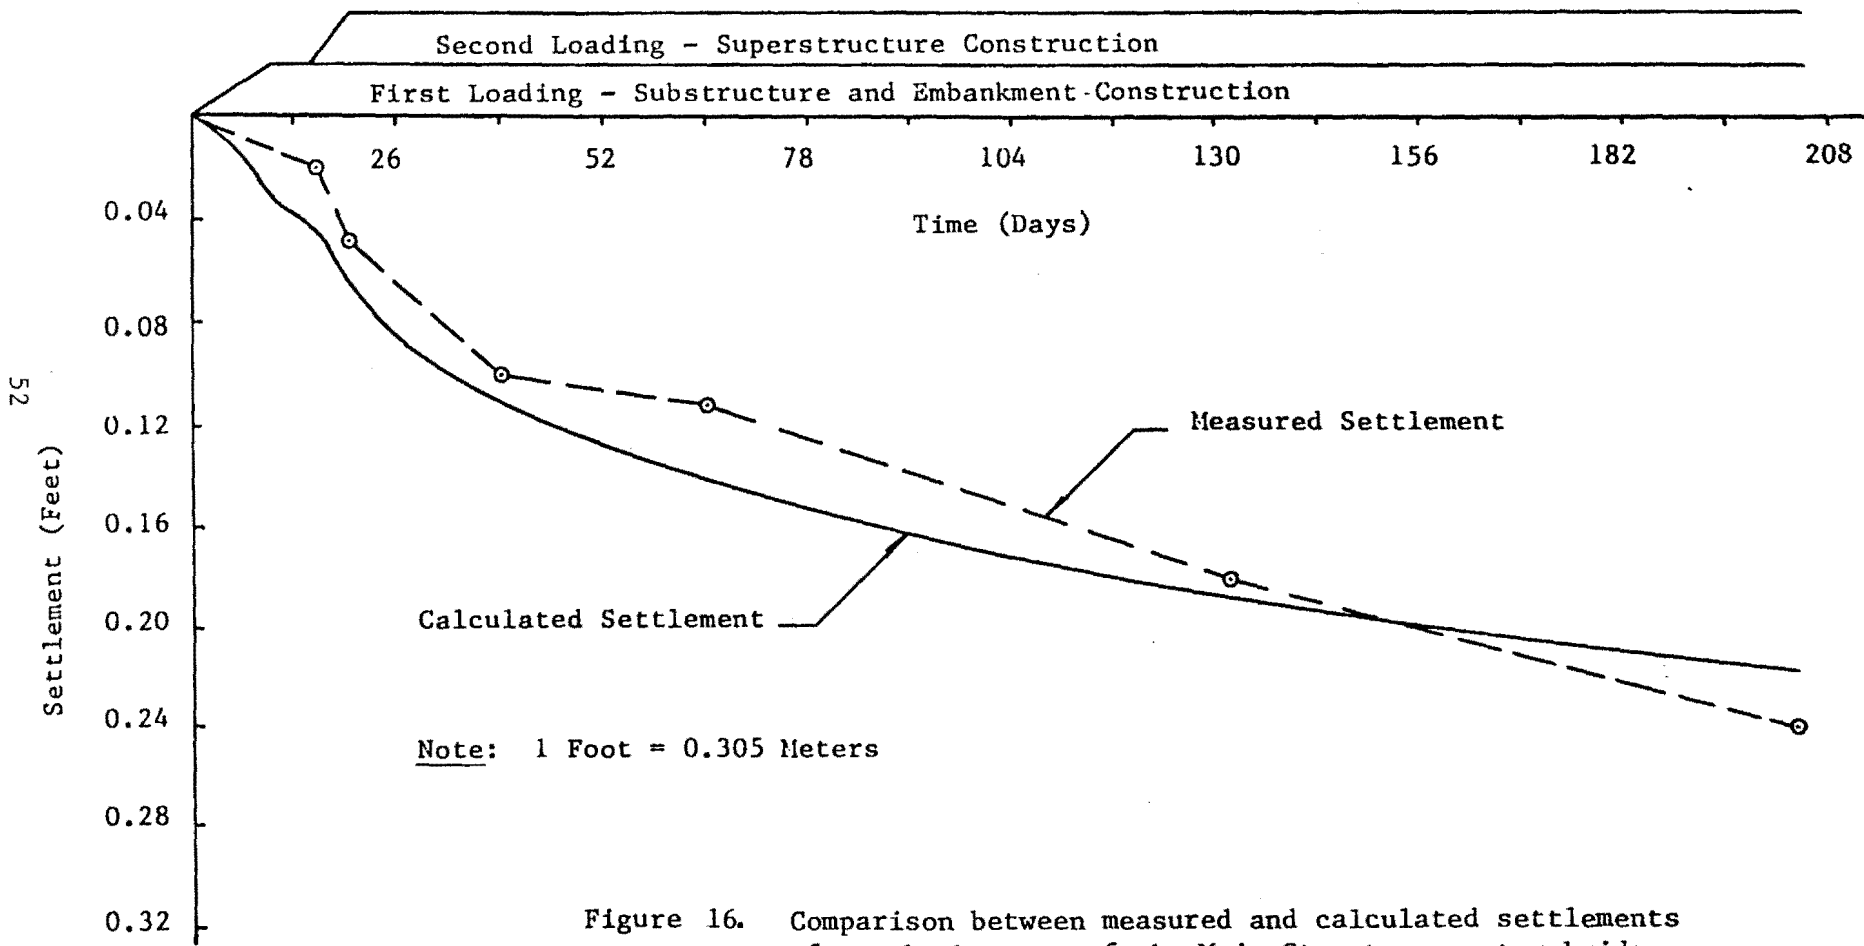
Figure 16. Comparison between measured and calculated settlements of north abutment of the Main Street connector bridge over Route 2 in East Hartford, Connecticut.

Overall, the results of the comparisons between predicted and measured settlements for cohesive soils showed that reasonably reliable predictions of the ultimate foundation settlement can be made, usually within 25 percent of the measured value, as shown in figures 13, 14 and 15, as long as good subsurface information and consolidation test data are available. However, in general, predictions of the time rate of settlement were less satisfactory than predictions of final settlement, as illustrated in figures 16 and 17.

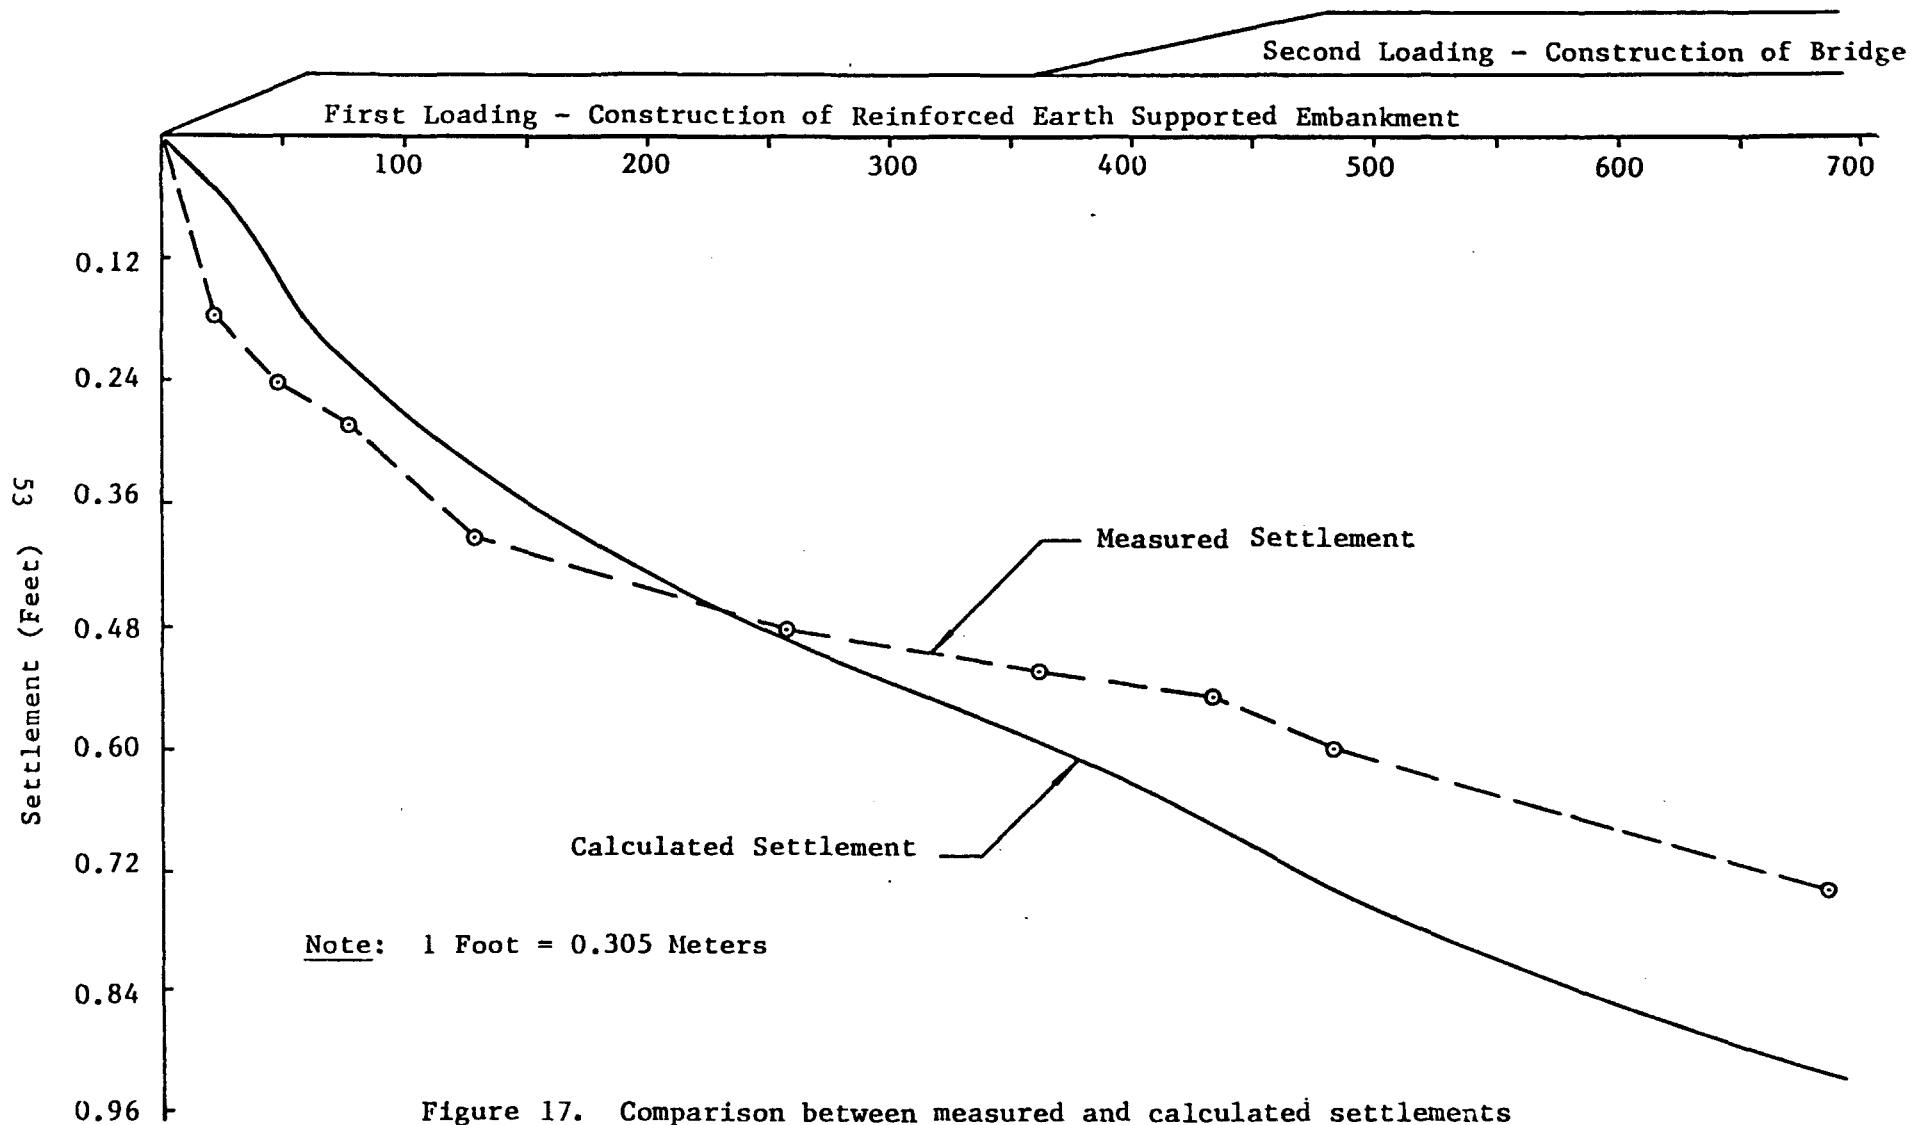
Figure 17. Comparison between measured and calculated settlements of north abutment of U.S. Route 1 Bridge over Boston and Maine Railroad at Wells, Maine.

Figure 17 shows the comparison between measured and calculated settlements beneath the center of the north abutment of the U.S. Route 1 bridge over the Boston and Maine Railroad at Wells, Maine, for the first 23 months following the start of construction. This bridge is a single span structure whose abutments are founded on approach embankments supported by reinforced earth, as shown in figure 18. The foundation soil consists of 30 feet (9.1 meters) of loose to medium dense sand overlying 50 feet (15.2 meters) of sensitive silty clay. The reinforced earth supported embankment was constructed first as a preload and was allowed to settle for about a year, as shown in figure 17, before the bridge was constructed. The final calculated settlement at the north abutment is 31.0 inches (78.8 cm). However, a comparison with the final measured settlement is not possible at this time because the settlement is incomplete.

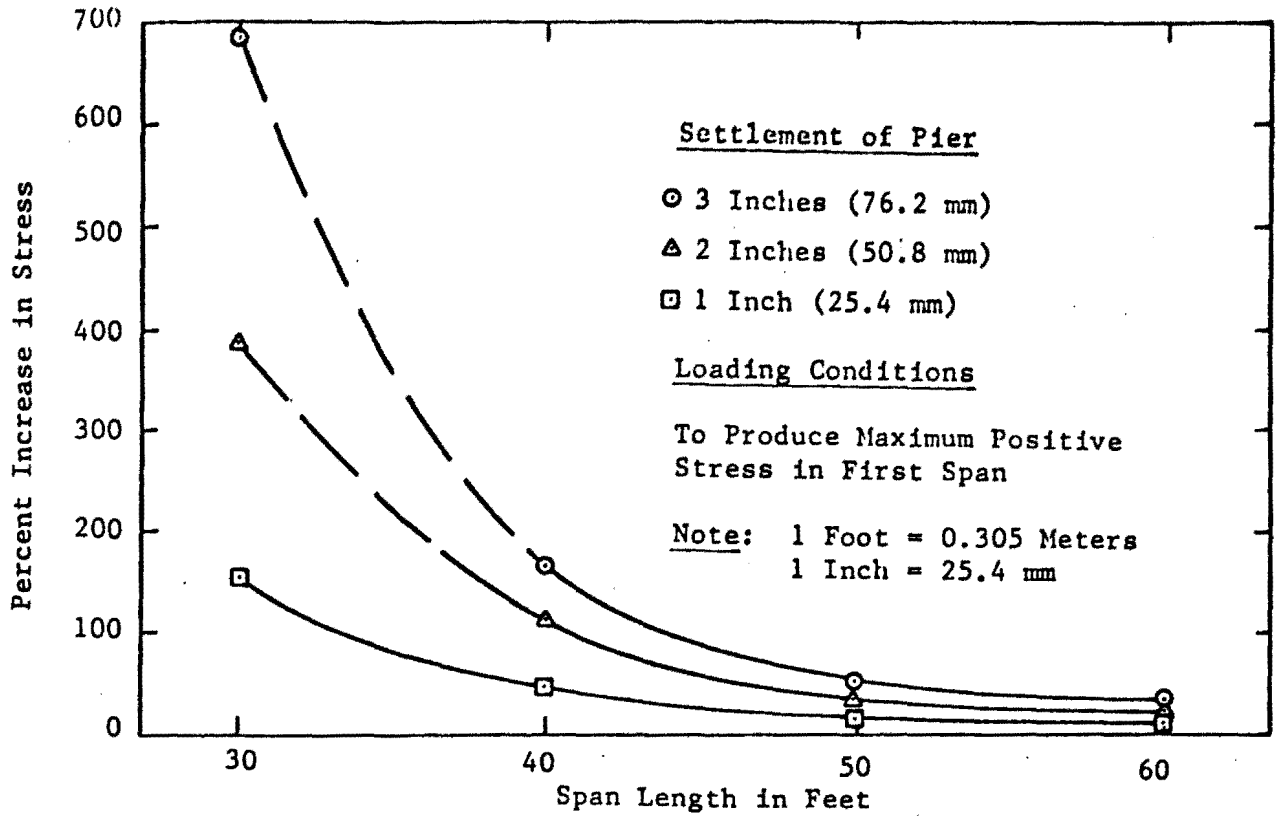
Figure 22. Theoretical percent increase in positive stress at mid-point of first span vs. span length for two-span continuous bridge (W36 composite).

systems, as illustrated in figures 22 through 25, were very informative with respect to the influence of support settlements on stress increases, they are not particularly useful from a design standpoint. In an effort to remedy this situation, a mathematical model for the behavior of multispan continuous steel bridges was developed, using the macro flexibility approach (52), as described in the Interim Report (8). The expressions that were produced were simplified for computational ease and put in a form that would permit relatively simple checks to be made on the maximum stress increase produced by the settlement of any bridge support (either abutment or piers). The resulting equations were then used to develop a series of six design aids that would permit the estimation of the maximum positive and negative stresses in steel bridges resulting from differential settlement of abutments or piers. These design aids, which are presented in figures 26 through 31, provide solutions for continuous steel bridges with up to five spans and with span lengths up to 250 feet (76.2 meters).

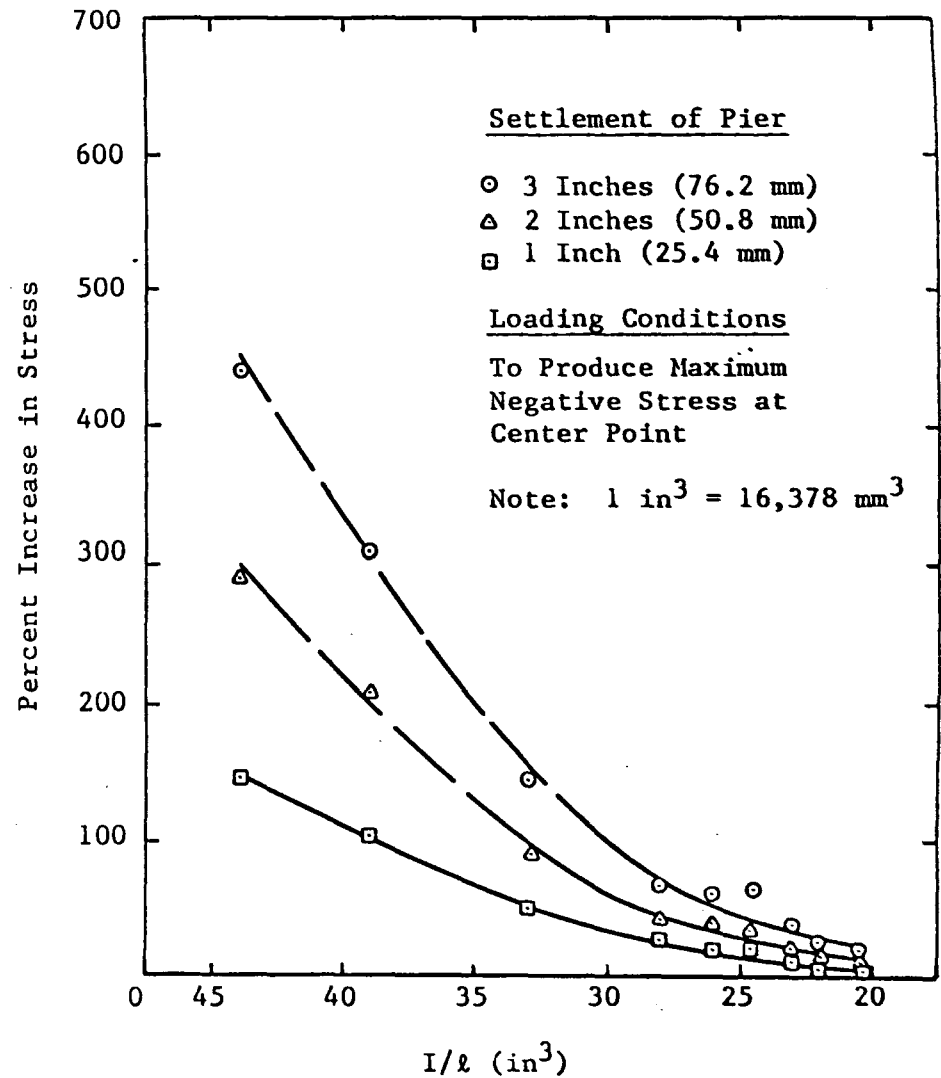
Figure 25. Theoretical percent increase in negative stress at center support vs. I/l for 2-span continuous bridges.

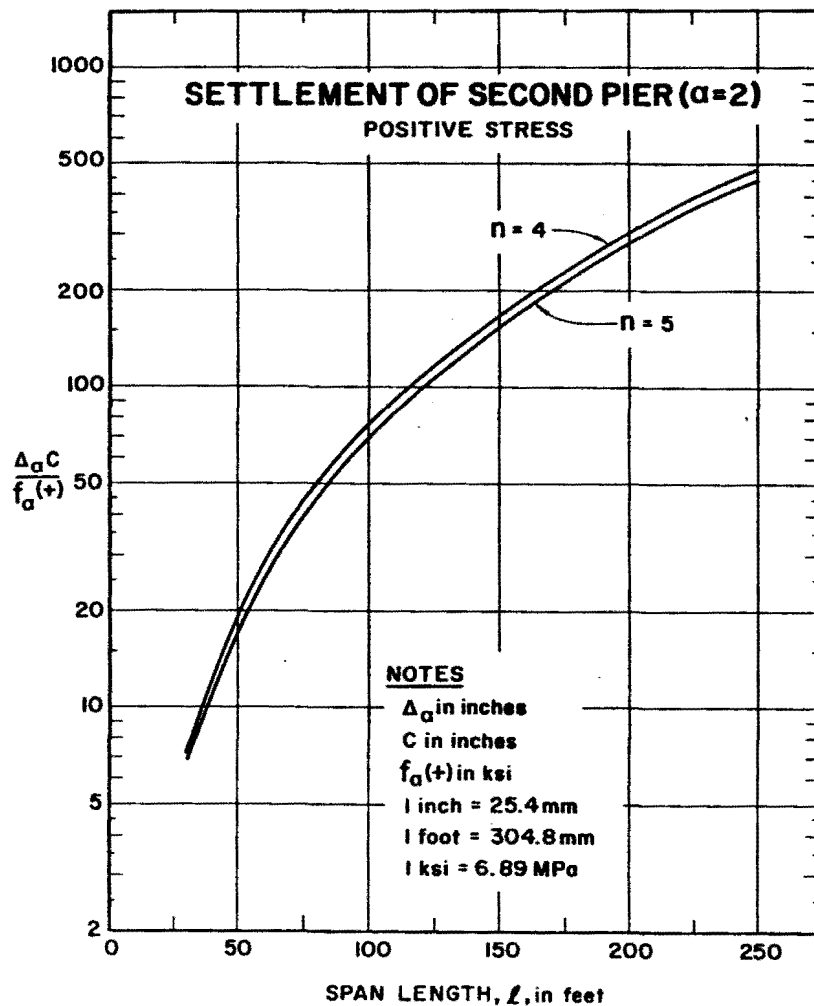
Figure 30. Design aid for determining the maximum positive stress increase caused by differential settlement of the second interior support.
