UNIVERSITY OF
TEXAS
ARLINGTON

TxDOT Report 0-6957-1

Synthesis on Rapid Repair Methods for Embankment Slope Failure: Final Report

Project Title: Synthesis on Rapid Repair Methods for Embankment Slope Failure

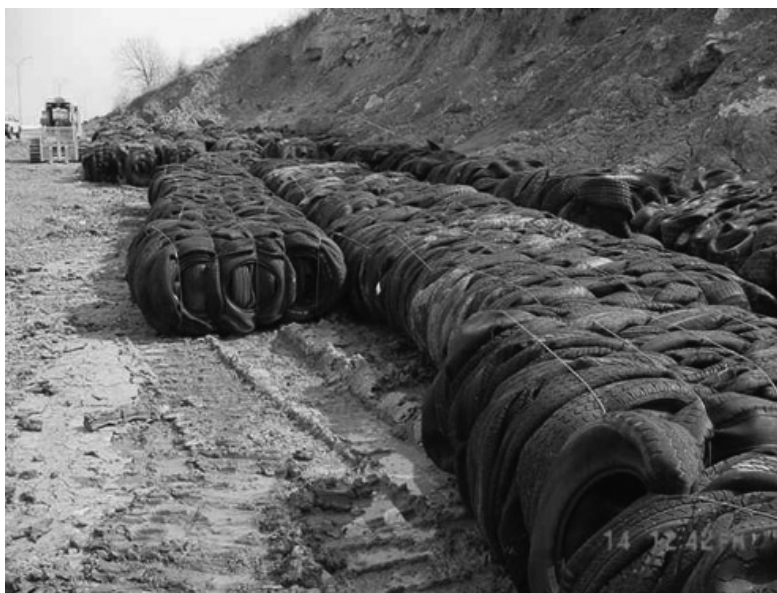
Figure 2-5 Tire bales in I-30 slope repair project, Tarrant County, Texas, 2002 (Prikryl et al. 2005)

Several states such as California, Colorado, New York, and New Mexico have used tire bales in embankment construction and rehabilitation. For instance, New Mexico successfully adopted this technique for at least five erosion control projects in the 1990s (Bandini et al. 2008). Moreover, TxDOT used this method for repairing several embankment failures, such as the failure in Interstate Highway 30 (I-30), West of Oakland Blvd, Fort Worth, in 2002. Initial assessment showed that this method improved the slope factor of safety by 2-3 times, compared to the original soil slope (Team Consultant Inc. 2003). Post-project observations indicated that the repaired slope had remained stable and porosity increased since the tire bales allow water to flow through the slope (Prikryl et al. 2005). Figure 2-5 shows the use of tire bales for the I-30 project.

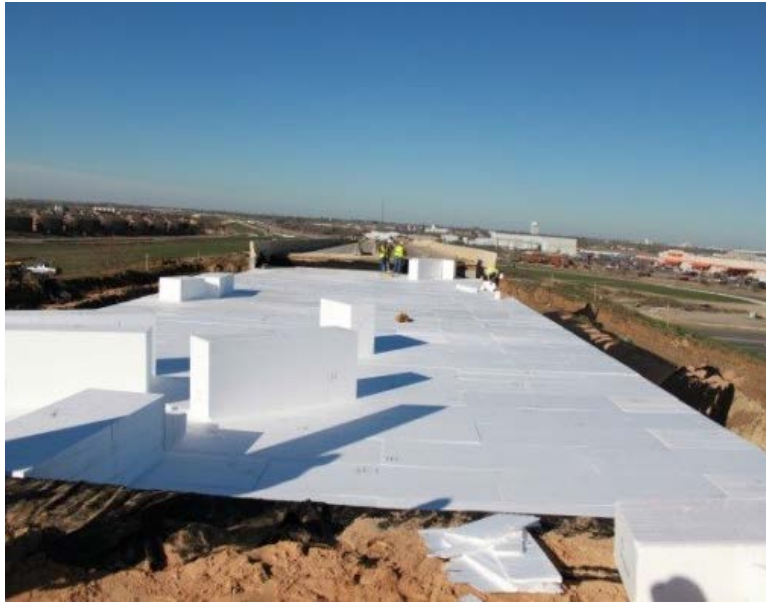
Figure 2-9 Application of gefoam in the US 67 bridge over SH 174 project (Ruttanaporamakul 2016)

In 2010, TxDOT used this method for embankment rehabilitation of the US 67 bridge over SH 174 in Johnson County, Cleburne, Texas (Ruttanaporamakul 2016). The results show a promising performance of this method. Figure 2-9 illustrates the application of gefoams in this project.

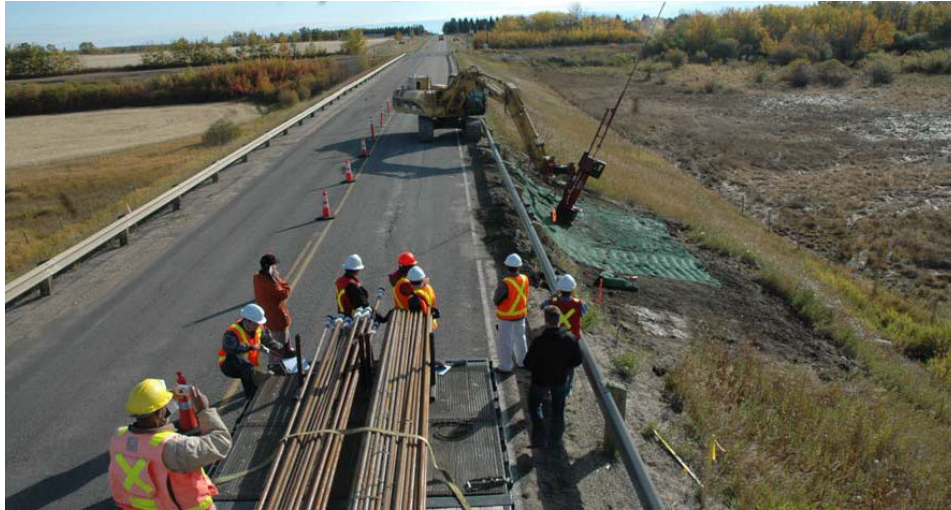
Figure 2-11 Use of SNL method in urban Access Road 172 Slope Repair Project (Smith et al. 2009)

Canadian dollar) per square meter. Compared to the alternative method (toe berm), the LSN method cost 70% less. No observable movement of slope components were reported from monitoring report on the slope six months after project completion (Smith et al. 2009).

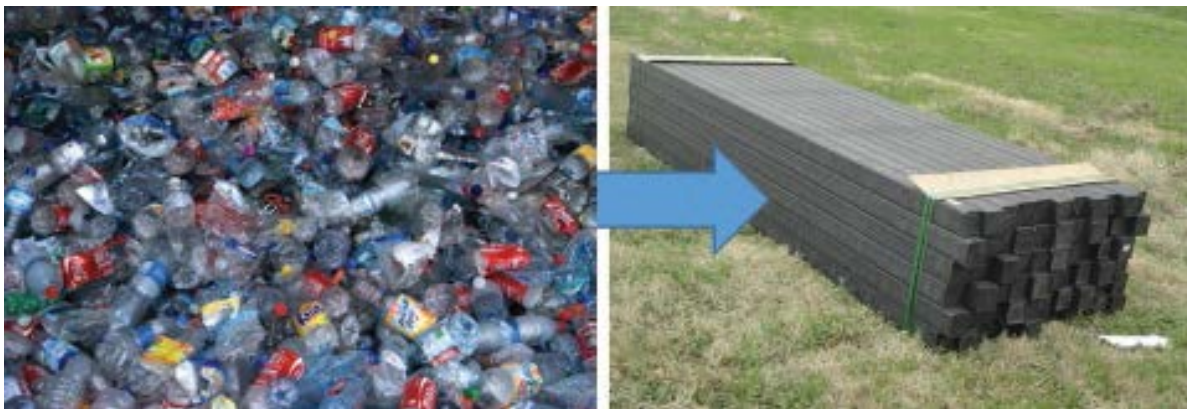
Figure 2-13 Recycled plastic pins (Hossain et al. 2017)

structures (Loehr and Bowders 2007; Khan et al. 2017). Typically, RPPs are fabricated from recycled plastics and waste materials (polymers, sawdust, and fly ash) (Chen et al. 2007). RPPs are lightweight and less susceptible to chemical and biological degradation than other reinforcement materials (Khan et al. 2017). RPPs are commercially available in different lengths, sizes, and shapes. In addition, RPPs are different in composition since they are manufactured by recycled plastics obtained from different sources (Loehr et al. 2000). Figure 2-13 shows a pile of plastic pins manufactured from recycled plastic bottles. To use RPPs for repairing slope failures, an engineering design is required (the design could be conducted using simple charts). Based on the design and calculations, proper RPPs are installed using a crawler-type drilling rig, having a mast-mounted vibrator hammer (Bowders et al. 2003). RPPs increase the factor of safety by providing an additional resistance along the slope failure plane (Hossain et al. 2017). RPPs could provide a sustainable and cost-effective solution to shallow slope failures. Since RPPs are commercially available and can be installed within a few days, they are an attractive option for emergency slope failure management (Khan et al. 2017).

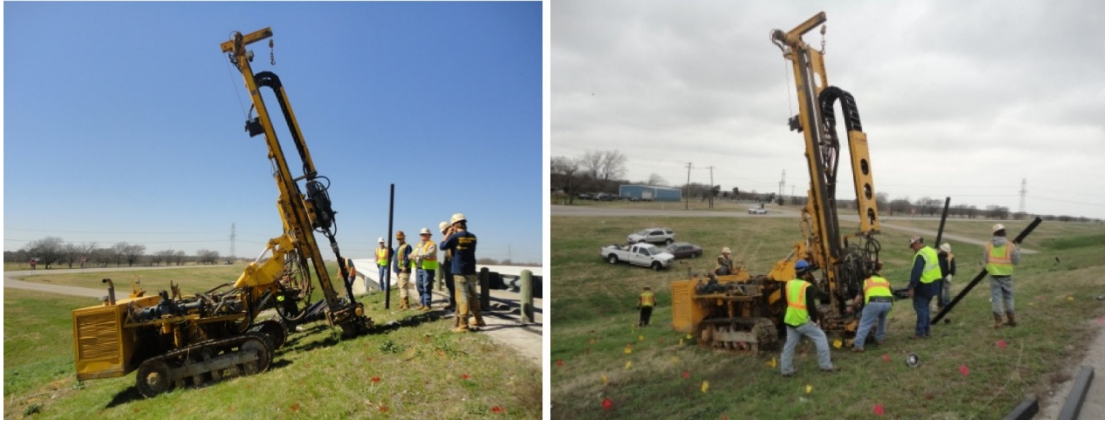
Figure 2-14 Installation of recycled plastic pins on U.S. Highway 287 near the St. Paul overpass in Midlothian, Texas (Khan et al. 2017)

RPPs were first utilized in the state of Missouri and Iowa, as a sustainable option to stabilize highway slopes where few field studies were conducted (Khan et al. 2017). Observations after slope repair with RPPs showed no further slope failure for this project (Loehr and Bowders 2007). In 2011, TxDOT conducted a slope stabilization project using RPPs on the southbound side of U.S. Highway 287 near the St. Paul overpass in Midlothian, Texas (Figure 2-14). Five years of monitoring the repaired slope showed minimal settlements proving the successful utilization of RPPs for this project (Khan et al. 2017). Studies showed a cost savings of 50 to 80 percent for this method compared to conventional methods, such as retaining structures (Hossain et al. 2017).

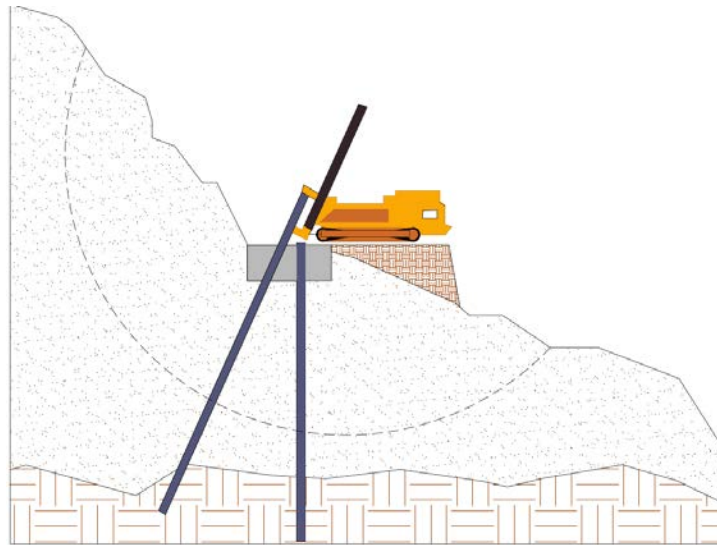
Figure 2-17 Installation of pin piles at different angles
(Adopted from Hayward Baker Inc. (2017))

Pin piles are small-diameter, high-capacity drilled or grouted piles (Richards and Rothbauer 2004). Their applications have been increased in recent years due to their flexible applications. Pin piles are ideal for foundations stabilization (Pearlman 2000; Richards and Rothbauer 2004). However, they are a suitable option for slope stabilization projects addressing deep-seated slope failures (Fay et al. 2012). Pin piles can be installed at different angles to stabilize loose soil mass on slopes. Figure 2-17 illustrates the installation of pin piles into a slope face at different angles.

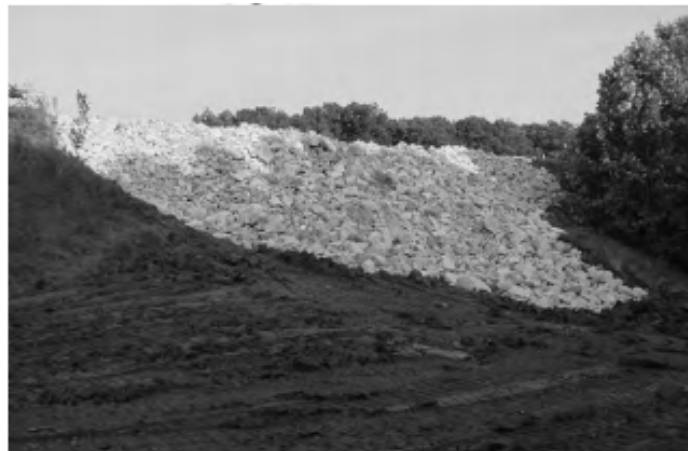
Figure 2-27 Typical soil substitution method (Reprinted from “Slope Maintenance and Slide Restoration Reference Manual” by Collin et al., by permission of James Collin, Year of first publication: 2008)

Soil substitution is the replacement of the failed soil mass with a more suitable material, such as silt or clay of low plasticity and cohesionless sands and gravels (Duncan et al. 2014). This method is effective especially for shallow slope failures (Collin et al. 2008). Replacement of failed soil mass with suitable material increases the stability of the slope by improving slope shear strength, drainage characteristics, and passive resistance forces (by weight) (Abrams and Wright 1972). This method also reduces the driving forces when using lightweight fill materials (Abramson et al. 2002). Figure 2-27 illustrates a project using this method for slope repair. A proper implementation of this technique will be achieved by excavating the original slope beyond the existing sliding surface (Collin et al. 2008). This method involves procurement of proper substitute material, which makes it cost-effective where a convenient source of fill material is located near the site (Nelson et al. 2017).

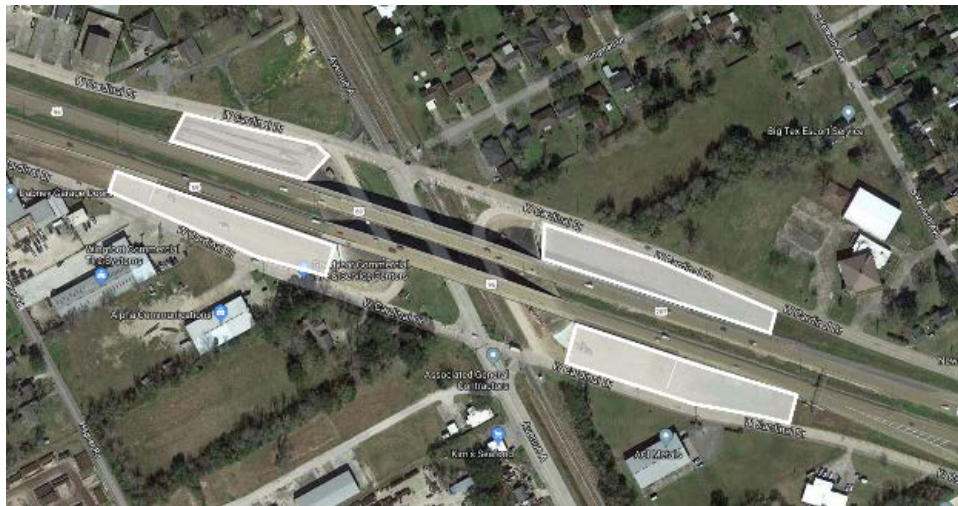
Figure 5-1 Slope failures in Jefferson County on US 69 at TX-93 Spur

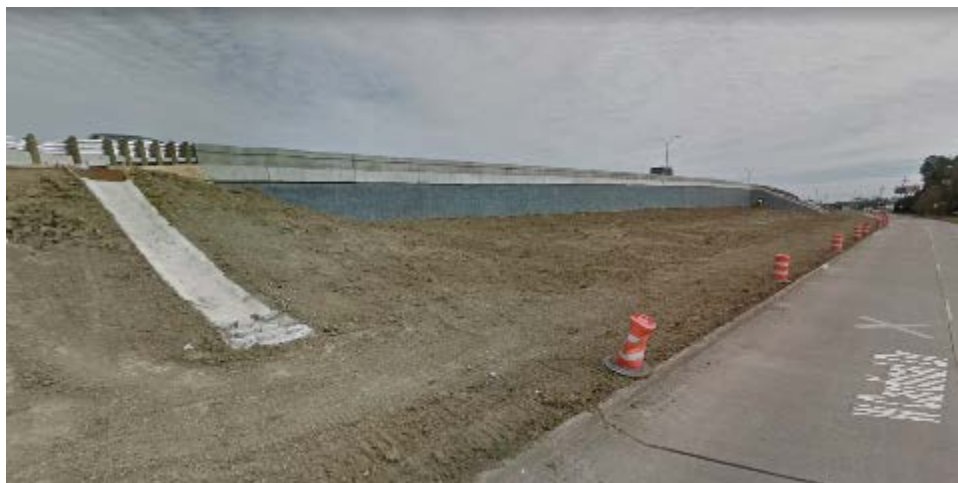
Figure 5-3 Reconstructed slope on North US 69 at TX-93 Spur

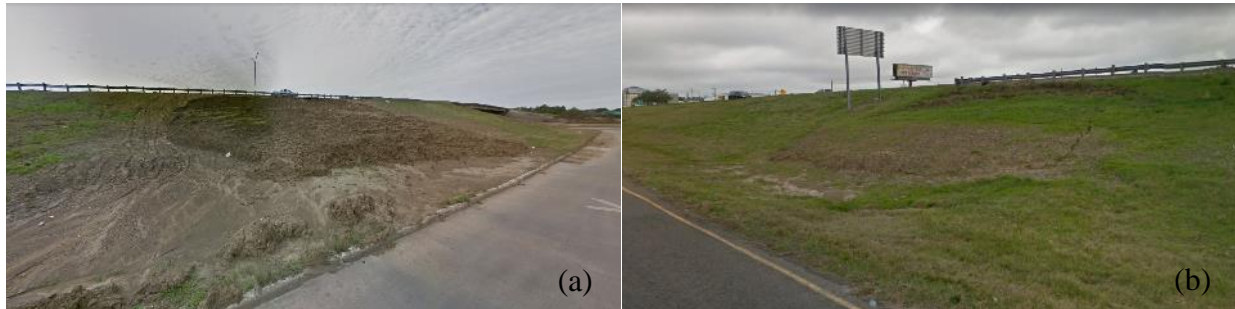
Figure 5-4 Slope failures in Beaumont, TX, after Hurricane Harvey: (a) North US 69 at Fannet Road Junction and (b) South US 69 at Lower Neches Valley Authority

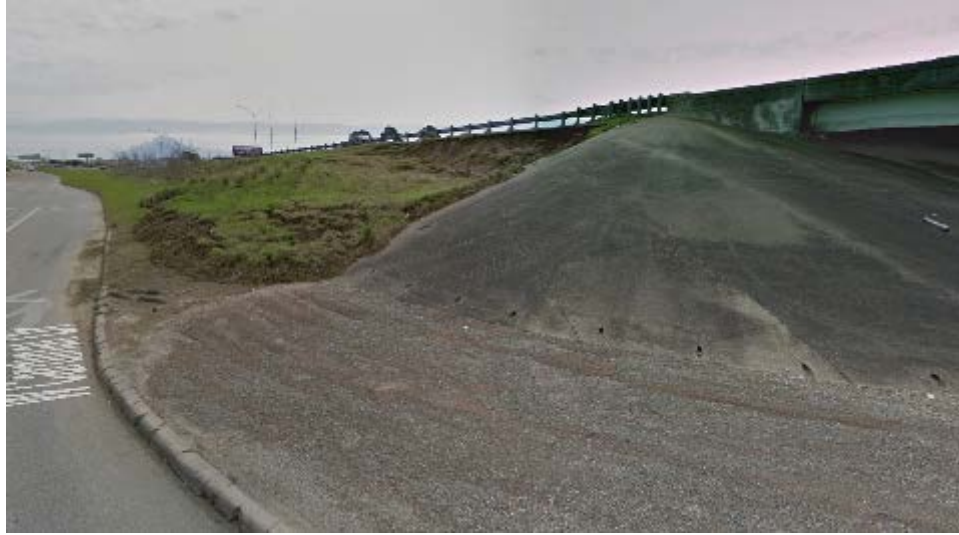
Figure 5-6 Slope failure on North US 69 at TX-93 Spur

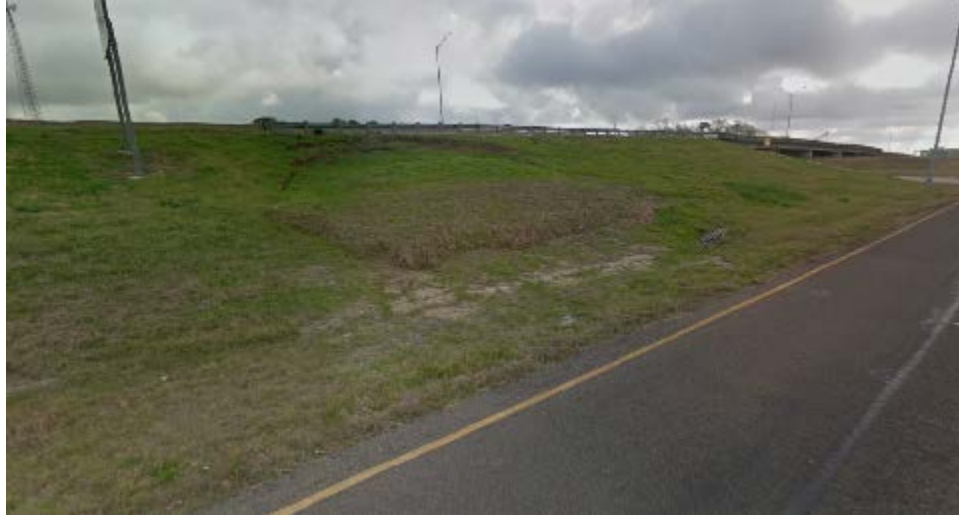
Figure 5-9 Slope failure on South US 69 at Chinn Lane

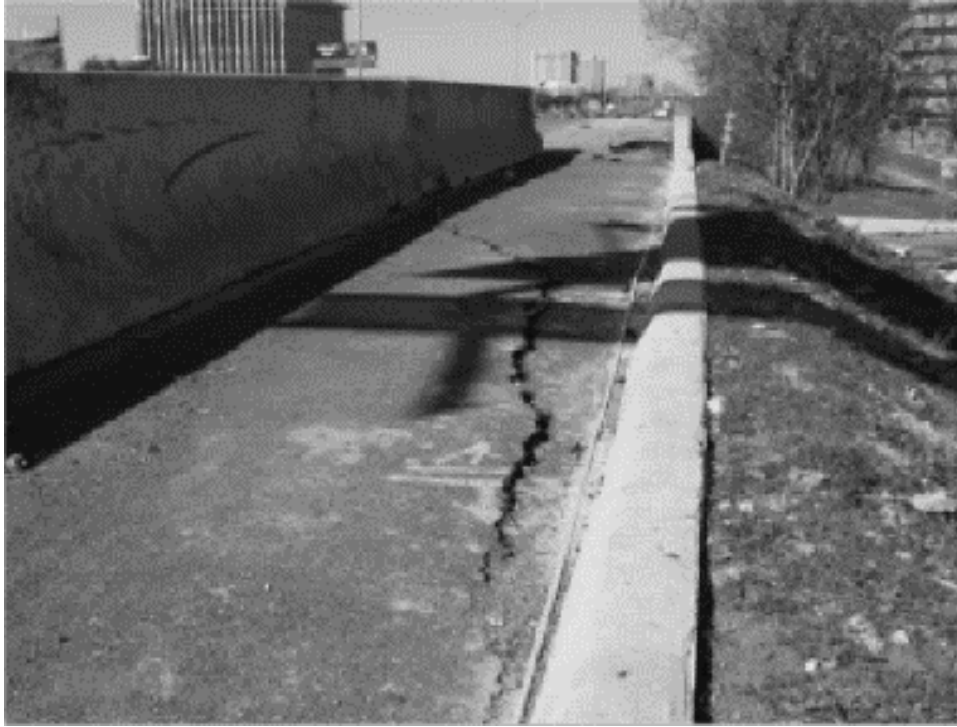
Figure 5-12 Crack and surficial movement of the slope (Hossain et al. 2017)

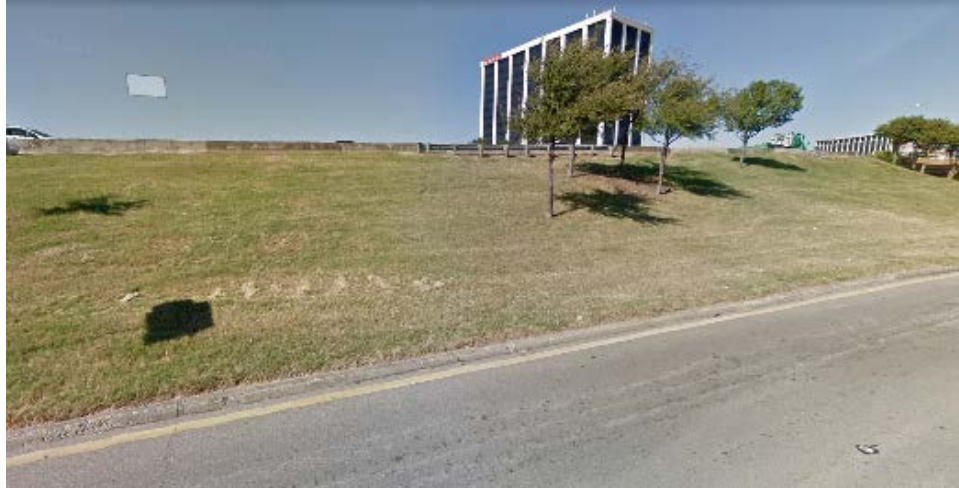
Figure 5-16 Mockingbird slope three years after stabilization with recycled plastic pins

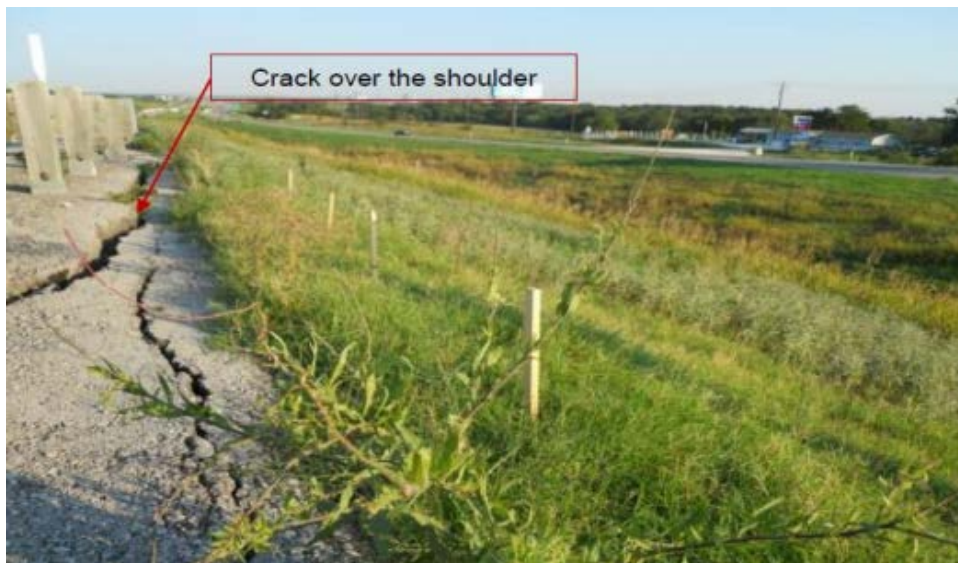
Figure 5-17 Crack and surficial movement of slope (Tamrakar 2015)

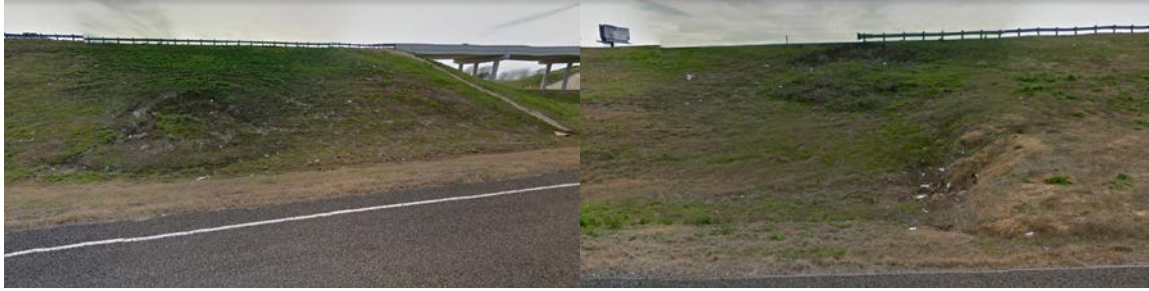
Figure 5-18 Failure of fill slope on US Highway 287 North near the St. Paul overpass in Midlothian

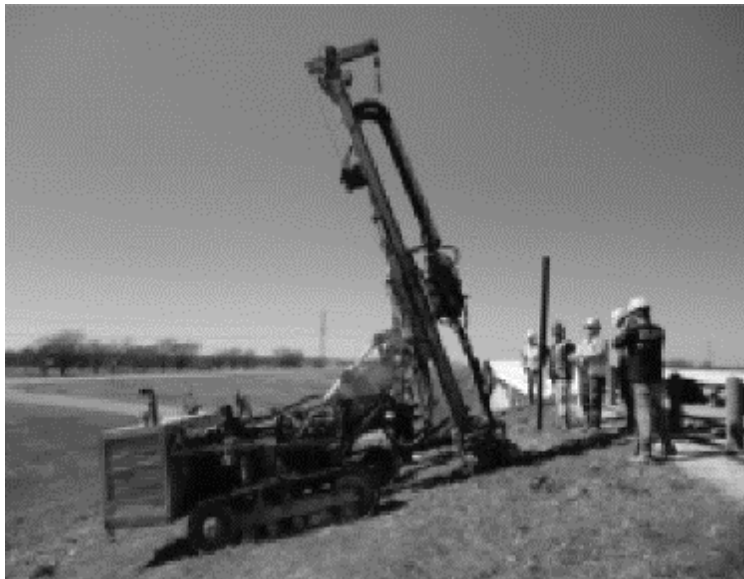
Figure 5-20 Installation of recycled plastic pins (Khan et al., 2016)

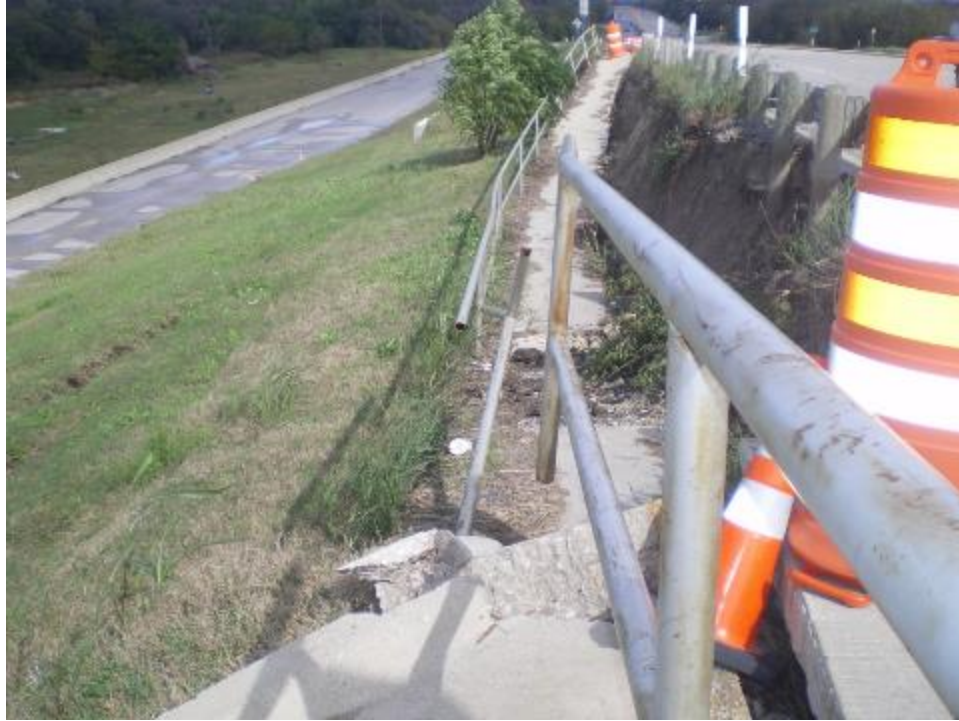
Figure 5-21 Slope failure on the West Texas Loop 12 (photo courtesy of Nicasio Lozano)

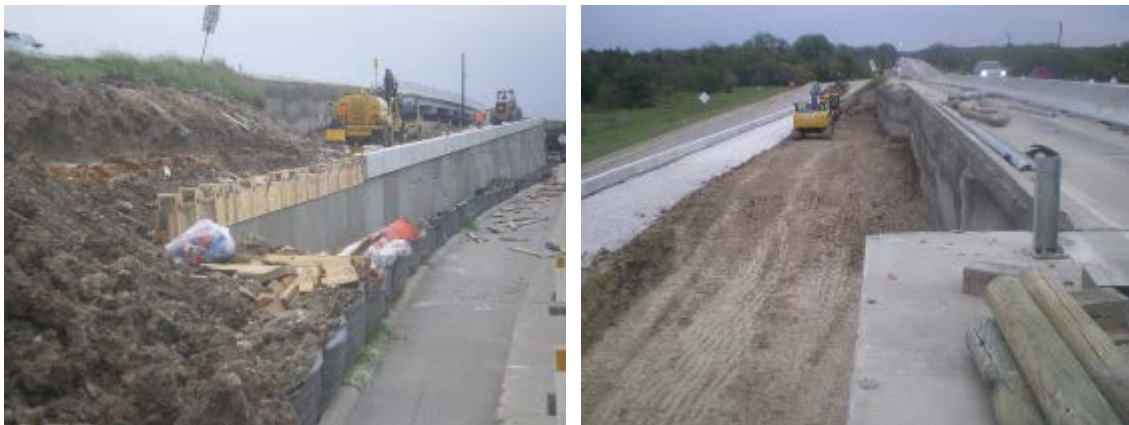
Figure 5-24 Installation of concrete retaining wall, backfilling and compaction (photo courtesy of Nicasio Lozano)
