Evaluation of Different Paint Systems for Over-Coating Existing Structural Steel

Final Report
August 2018

Center for Advanced Infrastructure and Transportation (CAIT)
Rutgers, the State University of New Jersey
100 Brett Road
Piscataway, NJ 08854

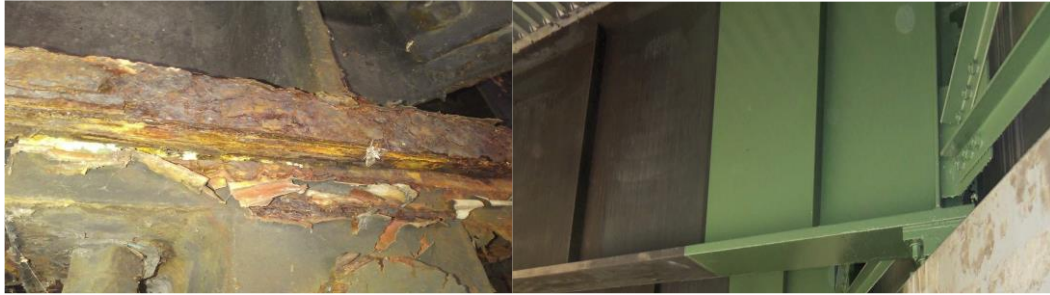
Figure 1. An Over-coated beam: US Route 202 over NJ Route 29 before and after Over-coating

A common practice for maintaining and repairing existing structural steel is to apply an epoxy mastic urethane overcoating. NJDOT has an active over-coating program, a typical application example is shown in Figure 1.

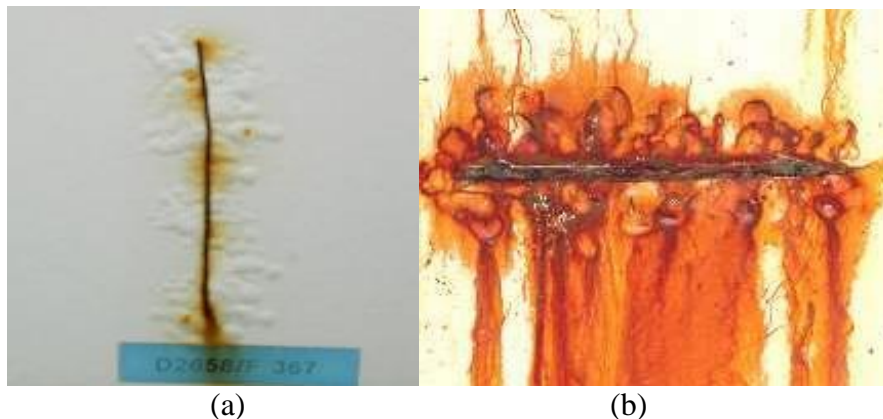
Figure 4. Creep growth at scribe: (a) without deep freeze cycles and; (b) with deep freeze cycles ⁽³⁰⁾

Research done by the automobile industry identified a method to further accelerate the creep growth⁽³⁰⁾. In this test, the researchers found that deep-freezing and thawing cycles could increase the creep growth by an order of magnitude, Figure 4. Difference in coefficient of thermal expansion of coating formulations and the metal are found to be primary cause for this accelerated creep growth.

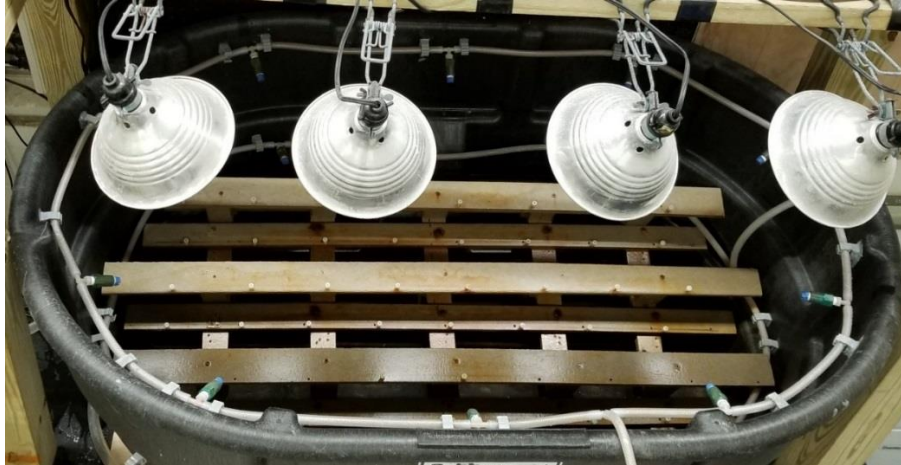
The chamber used for accelerated corrosion consisted of a plastic tank that does not corrode. Metal tanks that do not corrode can also be used instead of plastic tank. A holding rack for placing specimens was built inside the tank using the guidelines of ASTM D5894-16 ⁽⁷⁾ and ASTM B117-16 ⁽⁴⁾. The holding rack built using a non-

corrosive/conductive material, supports specimens at an angle between 15° and 30° from the vertical axis. These racks were placed parallel to the principal direction of the salt spray in the chamber.

Figure 5. Chamber for Accelerate Testing: Salt Sprayers and Holding Rack

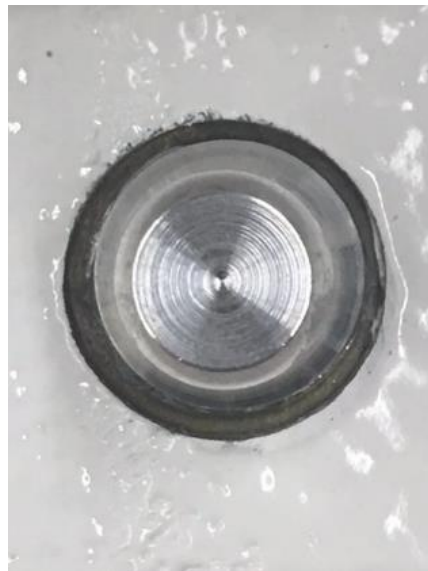
Figure 6. Pull Off Dolly (20 millimeter): Epoxied to Over Coated Steel Specimen

strength of the 20 mm diameter coatings isolated by the scribe, Figure 6, were measured at various stages of corrosion. The first set of adhesion strengths were obtained after proper curing of the coatings. For these tests, a minimum of three 20 millimeter pull off dollies were adhered to the circular painted areas within the scribe using a two-part manufacturer supplied epoxy, Figure 6. The epoxy was cured for a minimum of 24 hours. The pull off tester used was PosiTest® AT-M Manual Adhesion Tester, Figure 7 and 8. The tensile load was applied at a constant rate of 150 psi/s (1 MPa/s). This rate of loading was chosen to satisfy the requirement that the test has to be completed within 100 seconds. After each test, the maximum tensile stress and failure mode were recorded. The pull off dollies were then labeled and kept for comparative evaluation at various stages of corrosion. Once testing was completed, the specimens were placed in the test-chamber for accelerated testing. Pull-off tests were conducted for virgin samples and at intervals of 14 master cycles. Final tests were conducted after 100 master cycles of exposure.

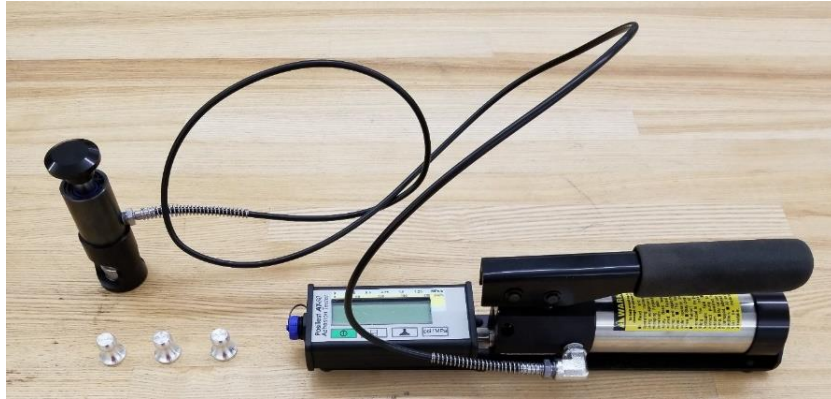
Figure 7. Pull Off Tester and 20 millimeter Pull Off Dollies

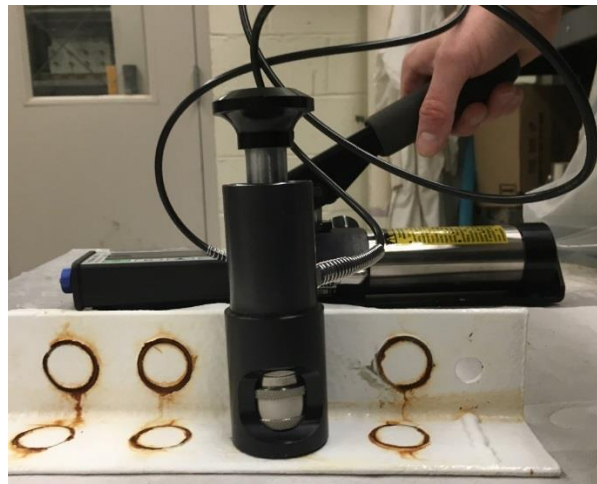
Figure 8. Pull-off test in progress

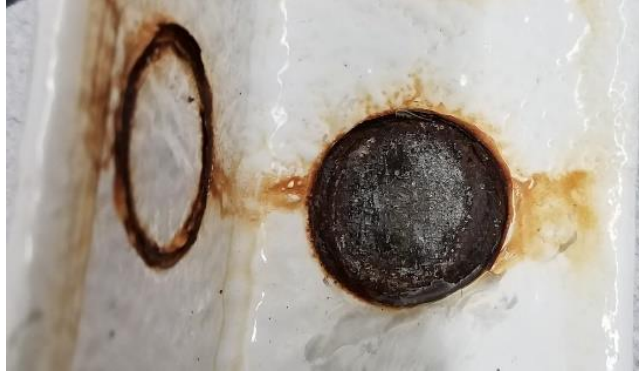
Figure 9. Images of circular coating: Before and after pull off test

After each 14 master cycles of exposure in the accelerated corrosion chamber, the specimens were taken out, rinsed with clean water to remove any debris or residue and dried with low-pressure compressed air. After cleaning, three 20-mm pull off dollies were adhered to the circular painted areas within the scribe using a two-part manufacturer supplied epoxy and cured for the required minimum of 24 hours. After the epoxy was cured, adhesion strengths were measured. The test in progress and the sample before and after pull-off are presented in Figures 8 and 9, respectively. Images of corrosion growth for the best and worst coating system evaluated in the current investigation are presented in Figures 10 and 11. These images were taken after the 20 mm diameter circular coating was pulled-off during the pull-off tests.

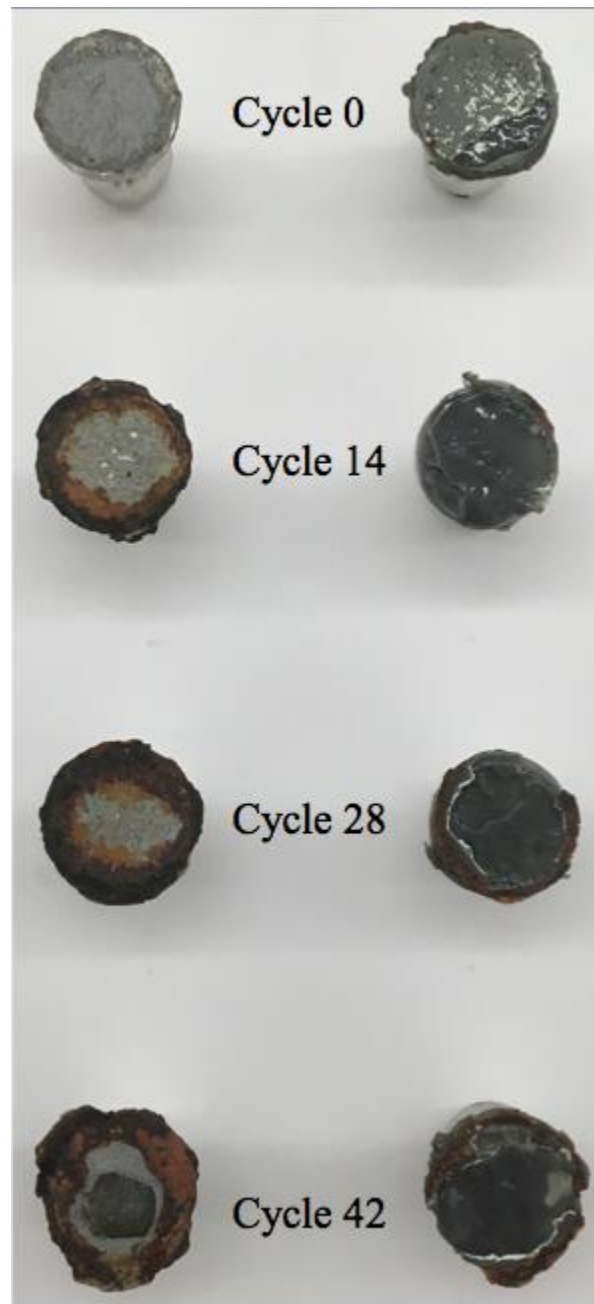
Figure 10. Worst and Best Performing Coating System: Images of corrosion growth after circular coatings were pulled-off, Cycle 0 to 42

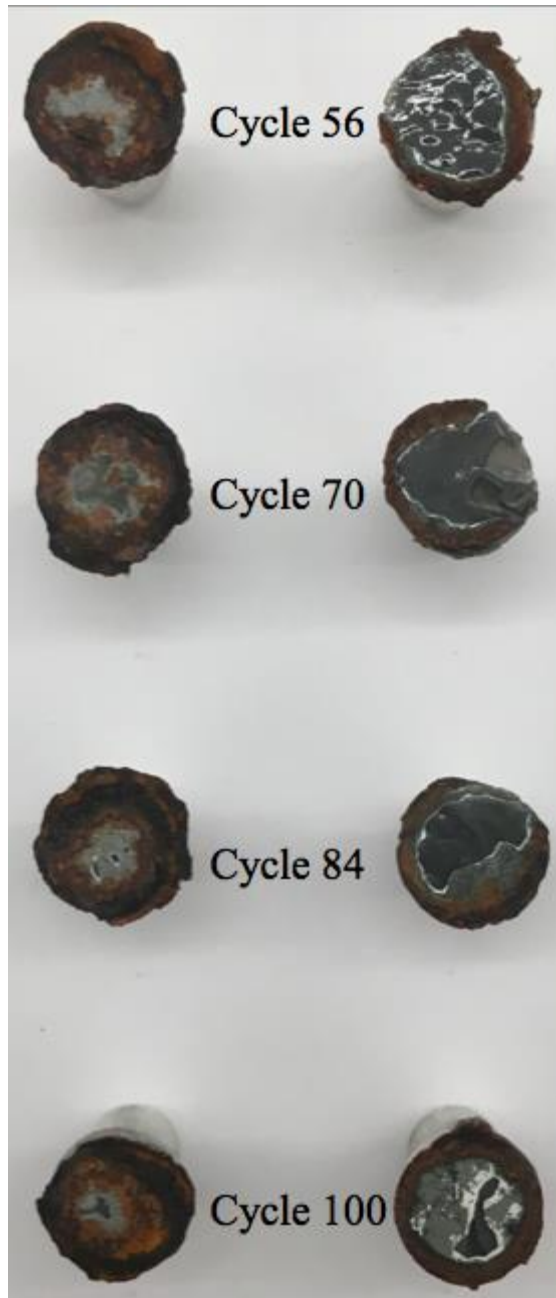
Figure 11. Worst and Best Performing Coating System: Images of corrosion growth after circular coatings were pulled-off, Cycle 56 to 100

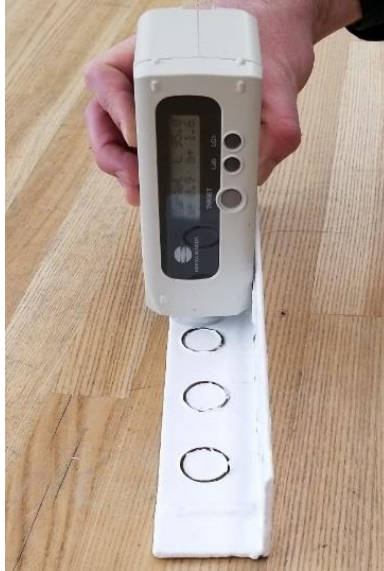
Figure 12. Konica Minolta CR-10 Plus Color Reader

Visual inspection along with a device called Colormeter, Figure 12, were employed to monitor the color change of the coatings during the testing. The Colormeter provides three readings designated as a*, b*, and L* coordinates. These coordinate numbers change with the change in the color of the coatings and provide a quantitative measure of the color changes. Since the color change is gradual and not significant, the measurements were made only at the beginning and the end of the exposure period, representing 0 and 100 cycles. Readings were taken at 9 random locations and the average was obtained. For the samples exposed to weathering, the surface was cleaned to remove the rust spots before taking the Colormeter readings.

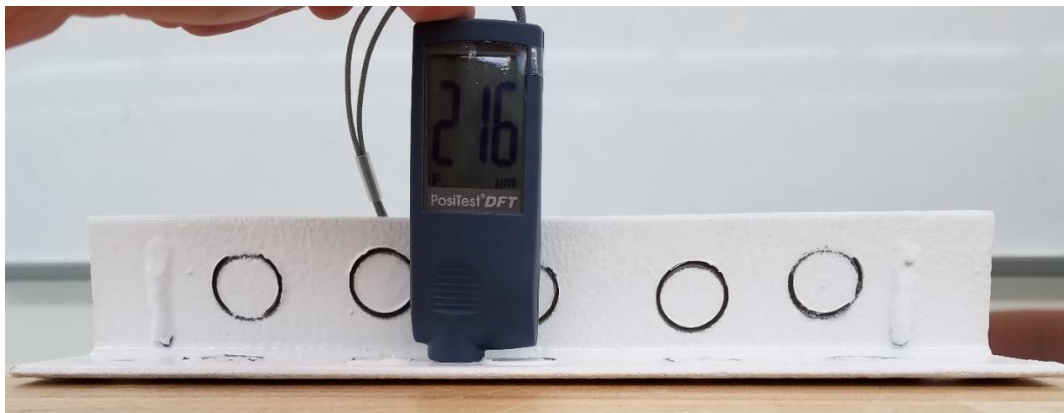
Figure 13. Thickness gage used for measuring the thickness of paint layers

Change in thicknesses of the coatings during the weathering cycle exposure were monitored using a thickness measuring gage, Figure 13. A minimum of three readings were taken to obtain an average thickness. Again, as the change in thickness was not significant, measurements were made only at 0 and 100 cycles. As in the case of color change measurement, readings were taken at 9 random locations and the average was obtained.

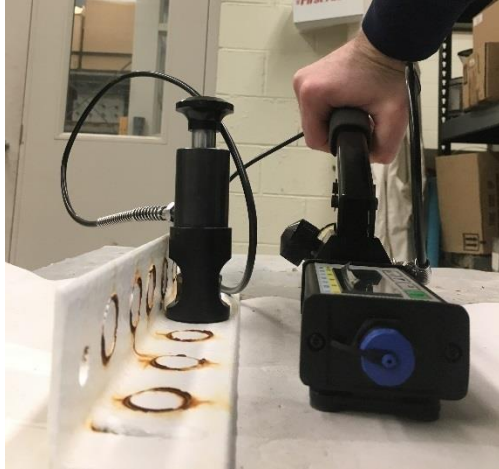
Figure 14. Typical Pull Test

Tests were conducted using a minimum of 3 samples for each coating system. In addition, the entire test was repeated for one of the coating system to verify the repeatability of the test. The procedure outlined in the aforementioned sections were followed for all the tests. Pictures of test sample and use of measuring equipment for adhesion strength are shown in Figures 14 to 16. The typical pull-off test for a corroded sample is shown in Figure 14, in which the corrosion progress around the circular perimeter can be seen. Elevation and plan views of a typical dolly attached to the coating using epoxy are shown in Figures 15 and 16, respectively.

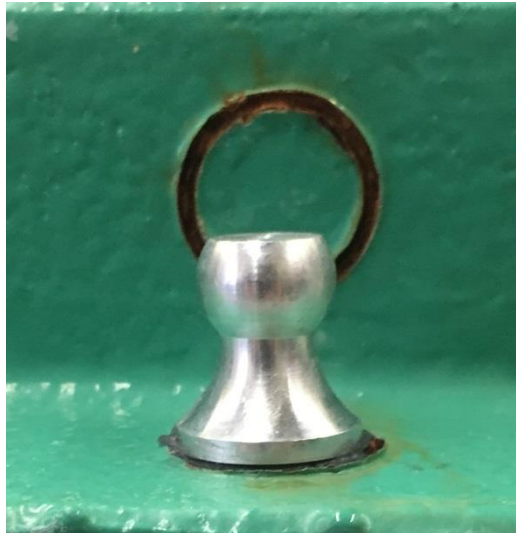
Figure 15. Pull Off Dolly (20 Millimeter): Epoxied to Inorganic Zinc Over Coated Steel Specimen

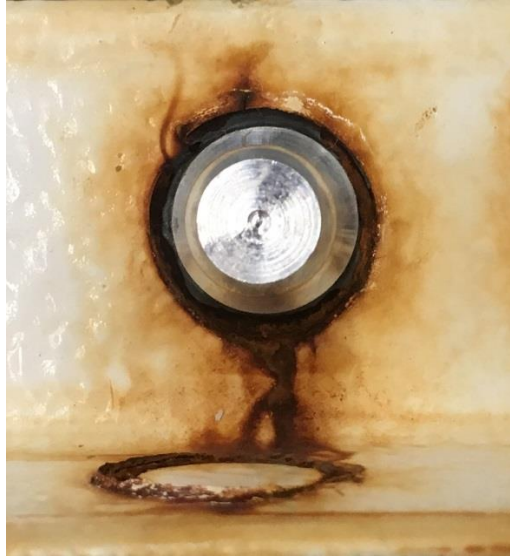
Figure 16. Pull Off Dolly (20 Millimeter): Epoxied to Epoxy Mastic Over Coated Steel Specimen

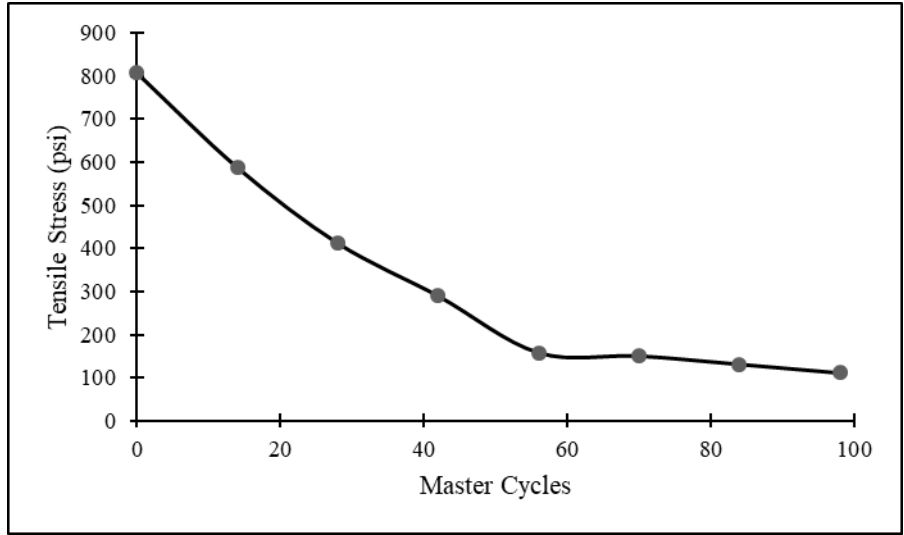
Figure 17. Direct Tensile Stress versus Number of Cycles: Coating 1

The results of the pull off tests are presented in Figures 17 to 22. Direct pull-off strength versus master cycles are presented for five coating systems and the replicate test of Coating 1. Note that 1 master cycle consist of: 8 cycles of wetting, 8 cycles of drying, 8 hours of UV exposure during the drying cycles and 8 hours of deep-freezing.

Based on the test results presented in Figures 17 to 22, the following observations can be made:

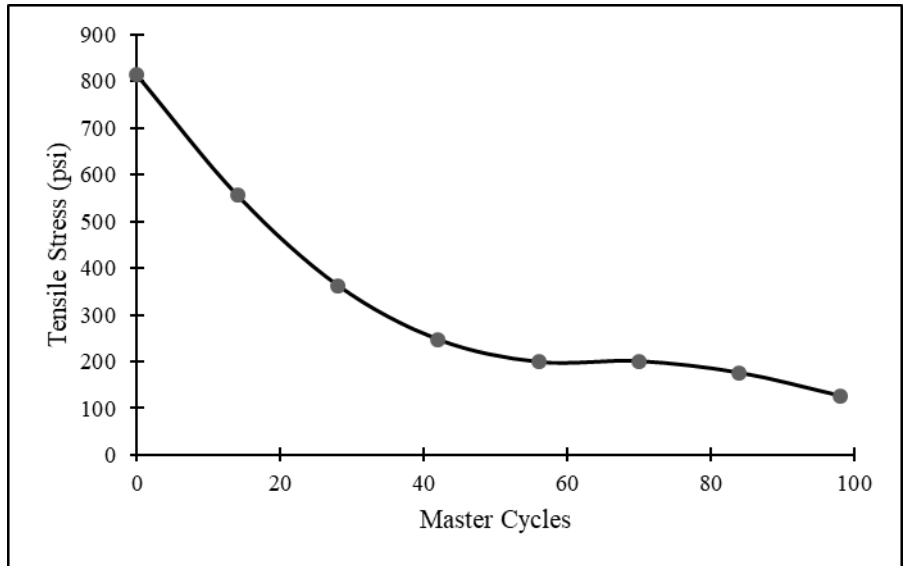
Figure 18. Direct Tensile Stress versus Number of Cycles: Coating 2

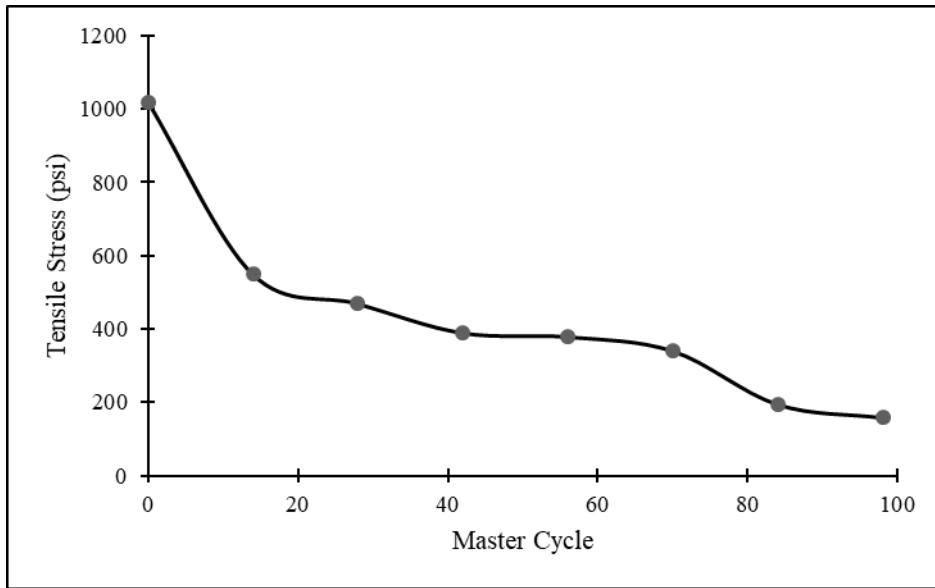
Figure 19. Direct Tensile Stress versus Number of Cycles: Coating 3

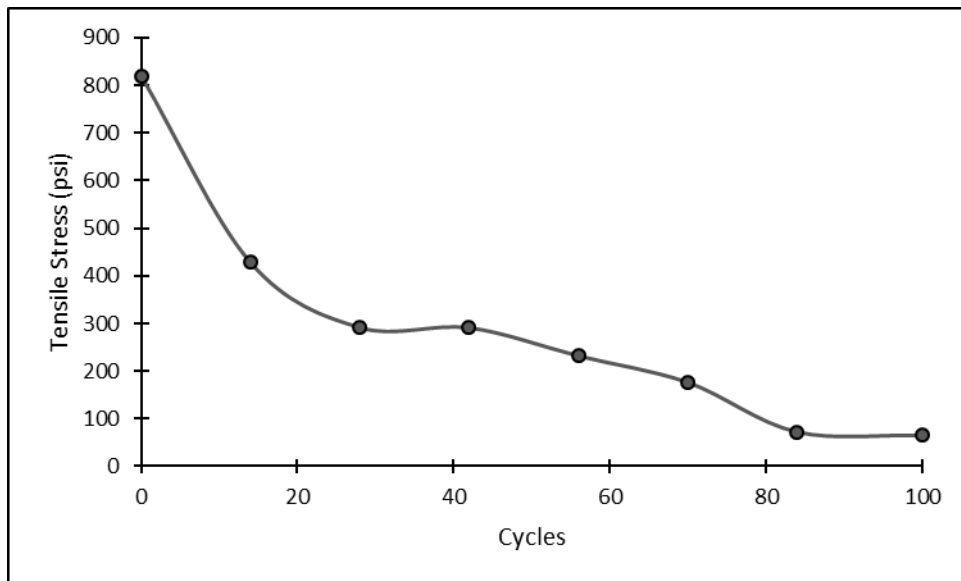
Figure 20. Direct Tensile Stress versus Number of Cycles: Coating 4

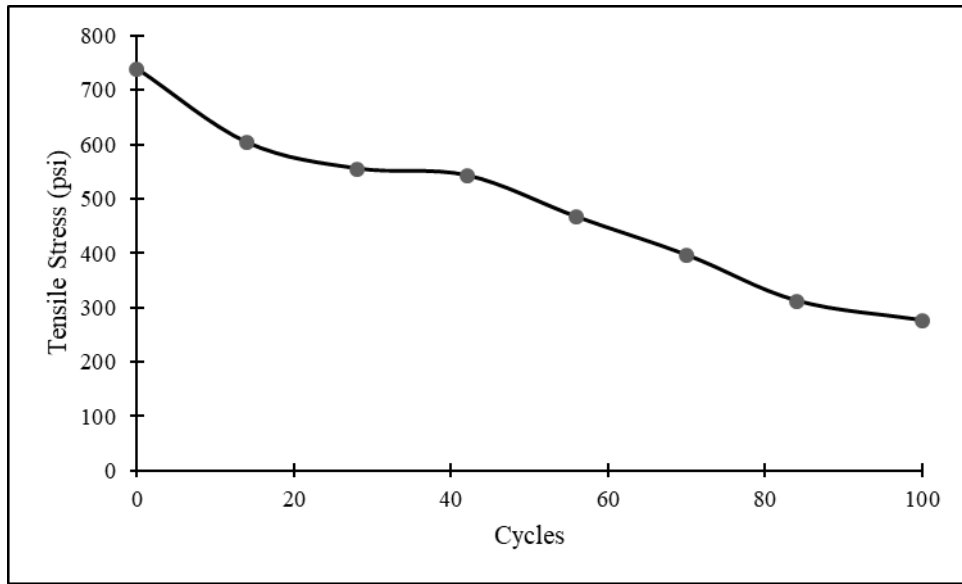
Figure 21. Direct Tensile Stress versus Number of Cycles: Coating 5

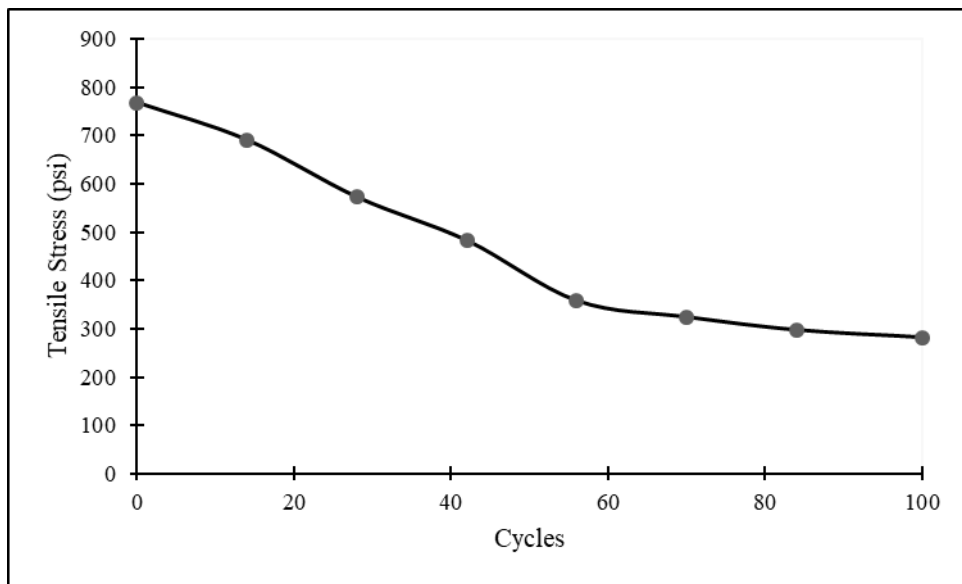
Figure 22. Direct Tensile Stress versus Number of Cycles: Coating 6

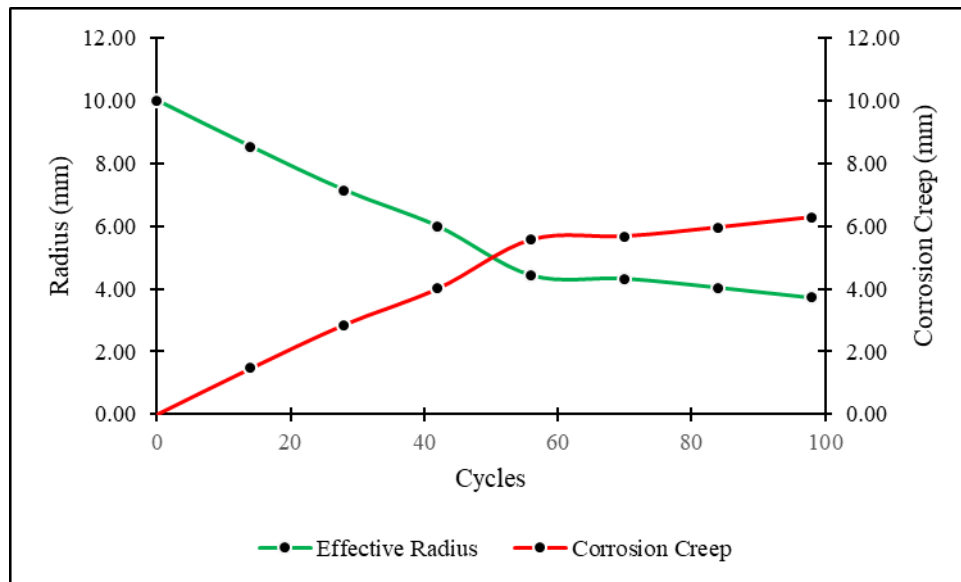
Figure 23. Effective Radius and Corrosion Creep Growth versus Number of Cycles: Coating 1

The adhesion strength results were used to estimate average creep growth using the procedure presented in section “*Interpretation in Pull-off Tests*”. The variation of reduction in radius and average corrosion creep growth are presented in Figures 23 to 28 for the 6 coating systems.

Since these results provide a different representation of the adhesion strength, the trends are the same. These graphs provide easier visualization for understanding the progress of deterioration and reinforces the observations made in earlier sections. Coatings 1 and 2 deteriorate rapidly under accelerated corrosion. Average creep growth at 14 cycles for these coatings were 1.6 mm. At 100 cycles of exposure, the corrosion creep increased to 6mm. Note that these coatings were judged to be weakest among the approved coatings of NJDOT. These numbers were 0.7 at 14 cycles and less than 4mm at 100 cycles for Coatings 4 and 5, that provided the best performance. The results of the current study concur with the generally accepted perception that zinc-based primers provide the best protection against corrosion. The results also correlate well with a 20-year field-performance study carried out by New Jersey Department of Transportation.

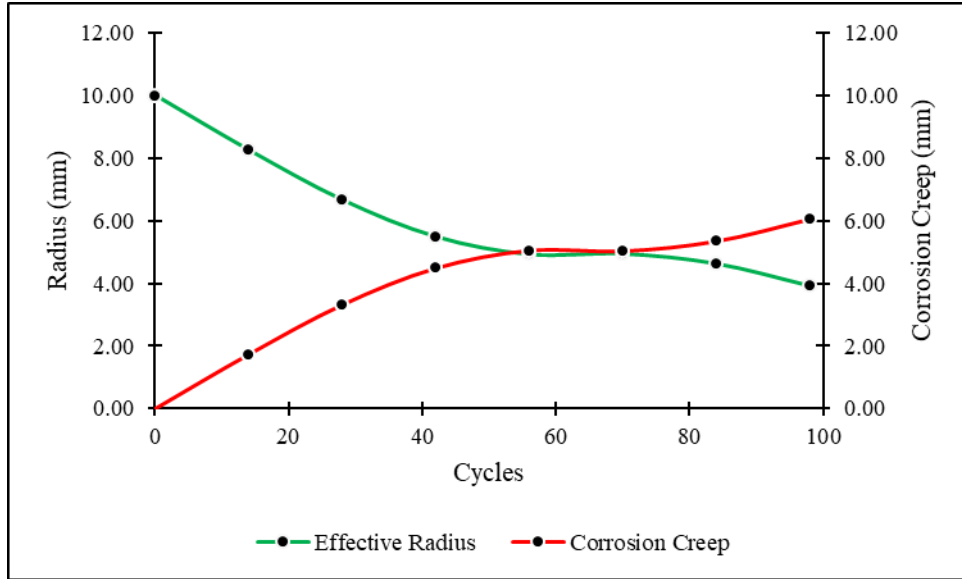
Figure 24. Effective Radius and Corrosion Creep Growth versus Number of Cycles: Coating 2

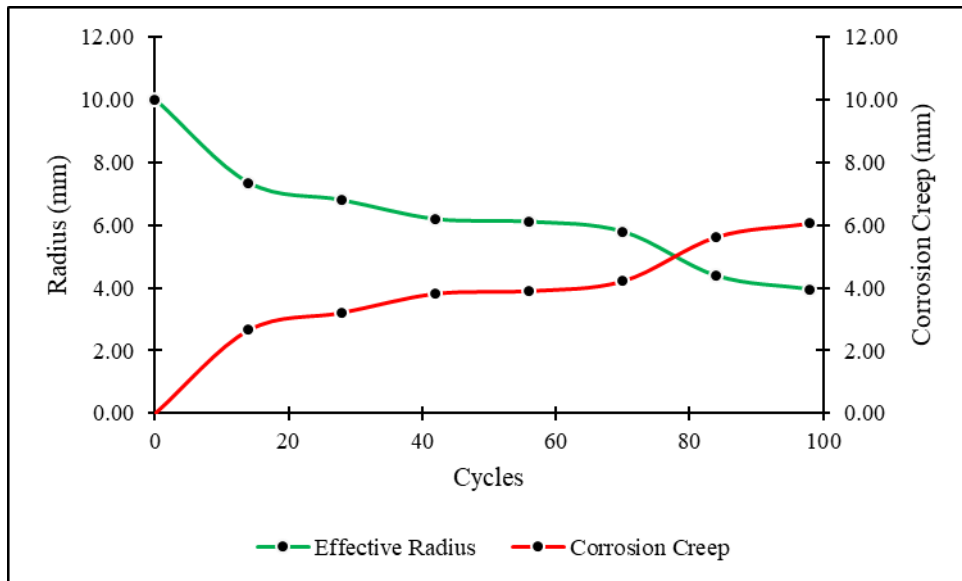
Figure 25. Effective Radius and Corrosion Creep Growth versus Number of Cycles: Coating 3

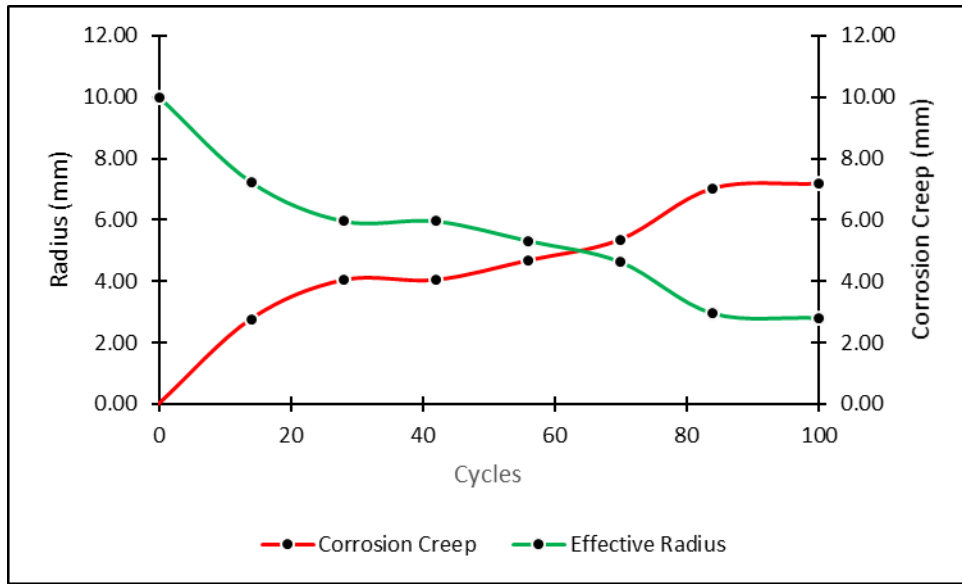
Figure 26. Effective Radius and Corrosion Creep Growth versus Number of Cycles: Coating 4

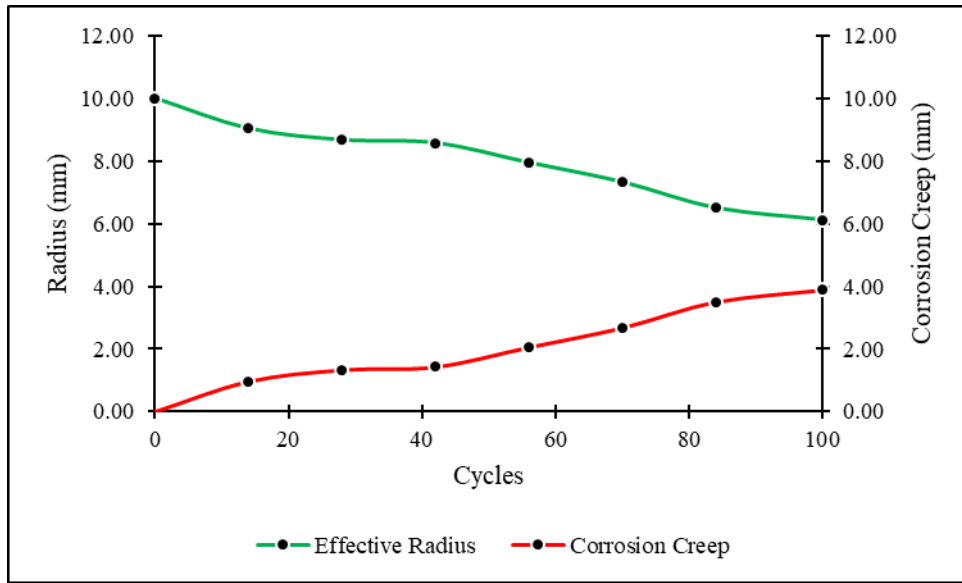
Figure 27. Effective Radius and Corrosion Creep Growth versus Number of Cycles: Coating 5

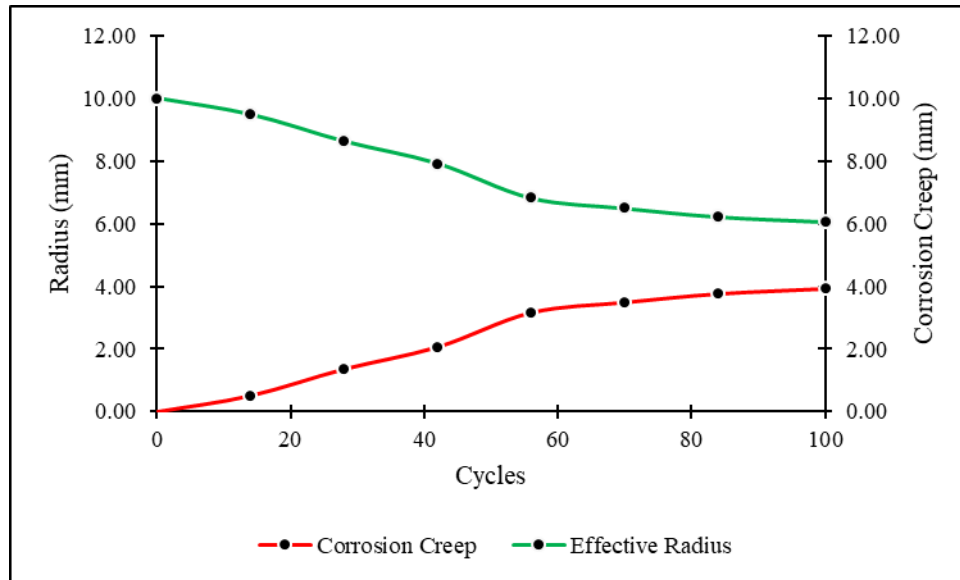
Figure 28. Effective Radius and Corrosion Creep Growth versus Number of Cycles: Coating 6

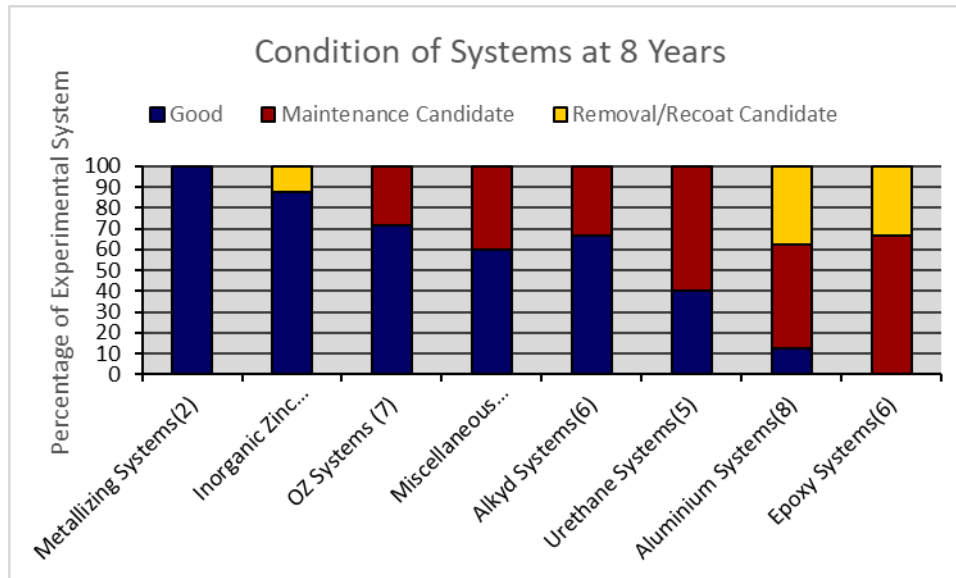
Figure 29. Condition of Systems at 8 Years from Mathis Bridge Study

The comparative performance of the 8 groups of coatings after 8 and 20 years of exposure are presented in Figures 29 and 30. In these figures the percentage of coatings within a chosen category that performed extremely well (Excellent, rating 7 or higher), reasonably well (Good, rating 4 to 7) and poorly (Poor, rating 4 to 0) are shown in the Y axis. For example, there were 8 coatings in Inorganic Zinc group. After 8 years of exposure, 7 out of 8 or about 90% provided excellent performance and after 20 years of exposure the percentage of coatings that provided excellent performance dropped to 25%. But even after 20 years of exposure only one coating system failed.

A careful review of the results presented in Table 11 and Figures 29 and 30 and the information obtained after only 1 year, lead to the following observations:

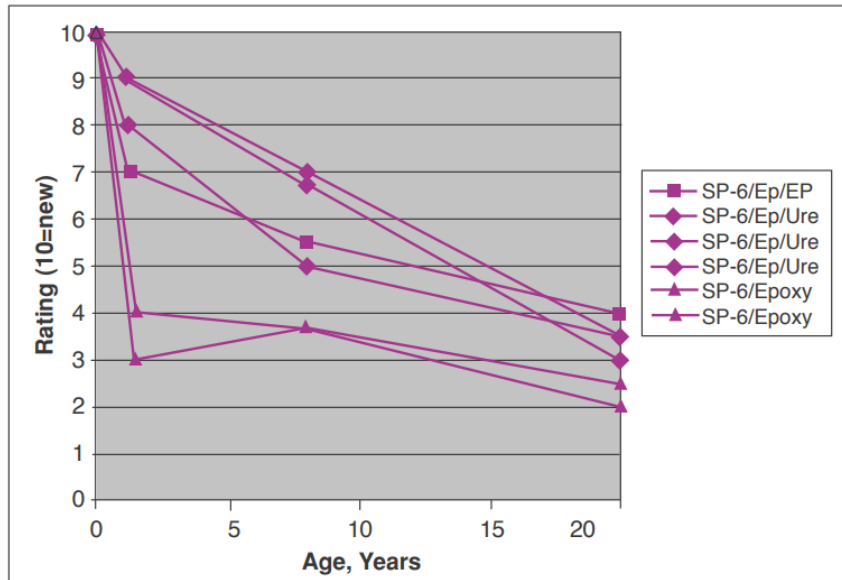
Figure 31. 20-Year Performance of Epoxy Systems from Mathis Bridge Study ⁽³⁴⁾

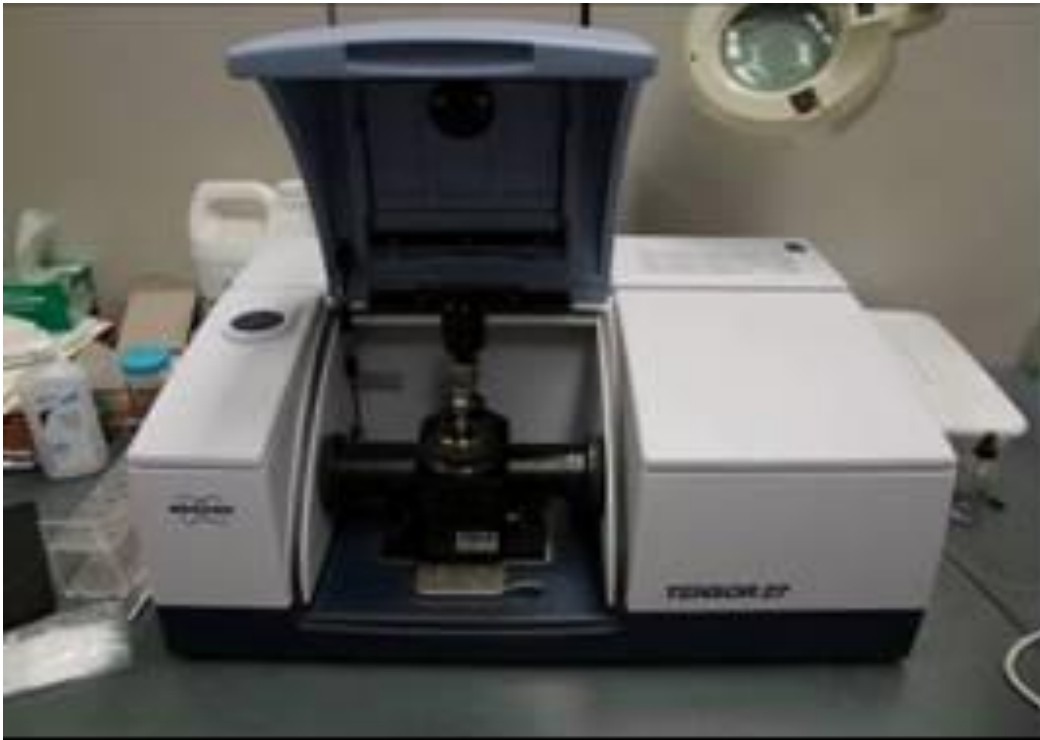
Figure 32. The Perkin-Elmer Infrared Spectrometer.

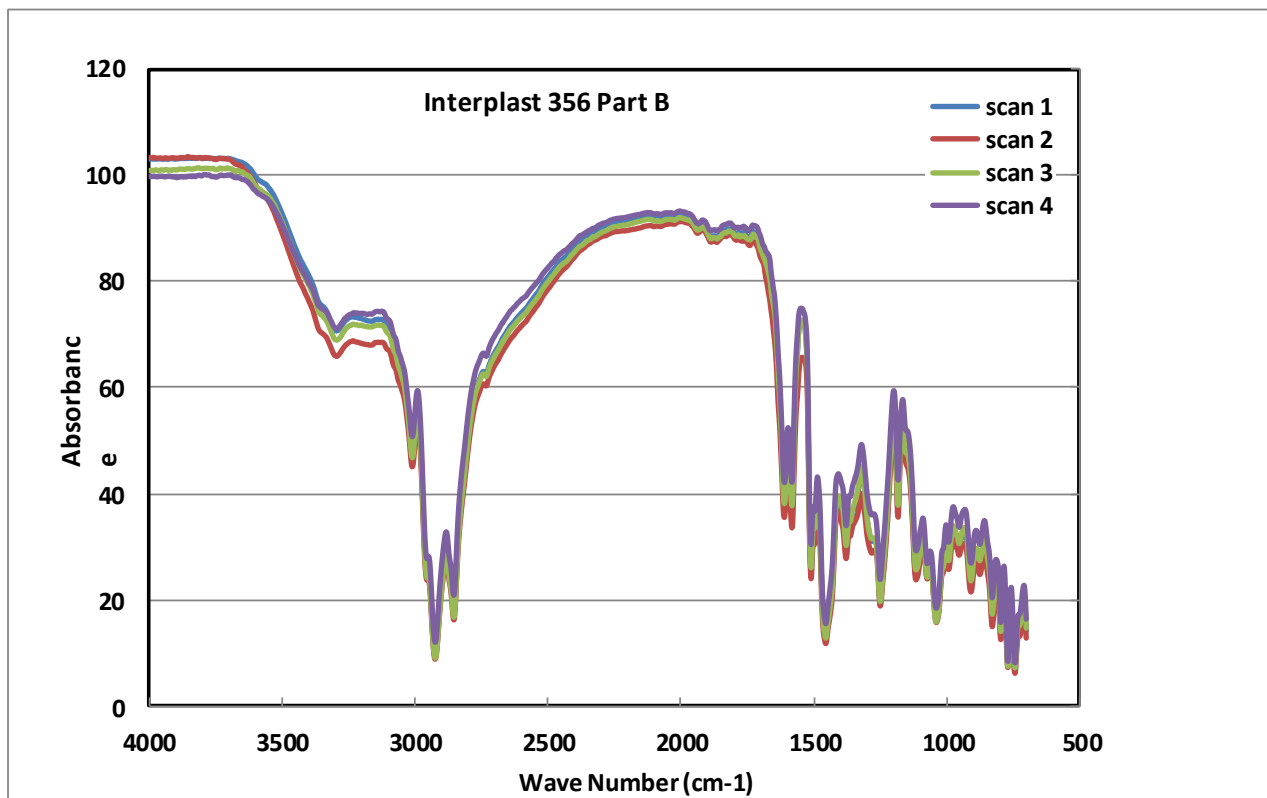
Figure 33. Plot of four (4) IR scans of Interplast 356 Part B from two batches

The IR scan of structural steels was relatively simple. The procedure included several simple steps as explained earlier that resulted in two scans from each batch. Two IR scans from each batch of steel paints were performed (scan 1 and scan 2). This resulted in a total of four scans from the two batches. For each scan the absorption versus the wave number was recorded and tabulated in an Excel spreadsheet. Typical IR scans for steel paints for INTERPLAST 356 PART B are shown in Figure 33. The figure shows consistent peaks and valleys of the IR scan from all three batches. Similar IR scans were observed for structural steel paints.
