## JOINT TRANSPORTATION RESEARCH PROGRAM

SPR-4119 2019

# Assessment of Bridges Subjected to Vehicular Collision

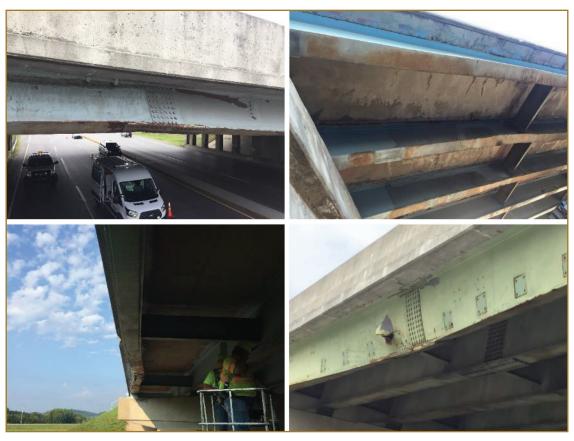
Examples of damage
