## TECHNICAL SUMMARY

# Enhancing Pedestrian Experiences at Roundabouts

*This Technical Summary pertains to Report 2023-01, “Pedestrian User Experience at Roundabouts,” published August 2022. More information is available at [mndot.gov/research](http://mndot.gov/research).*

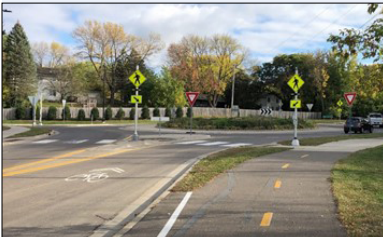
Pedestrians are generally more visible to drivers who are entering a roundabout than those exiting.

The case studies highlighted several conclusions about when drivers yield to pedestrians waiting or attempting to cross the street. Roundabouts with single-lane approaches had the highest rates of vehicles yielding to pedestrians, likely due to their simplicity and absence of driver distractions. Vehicles exiting roundabouts, however, had lower rates of yielding than drivers entering.

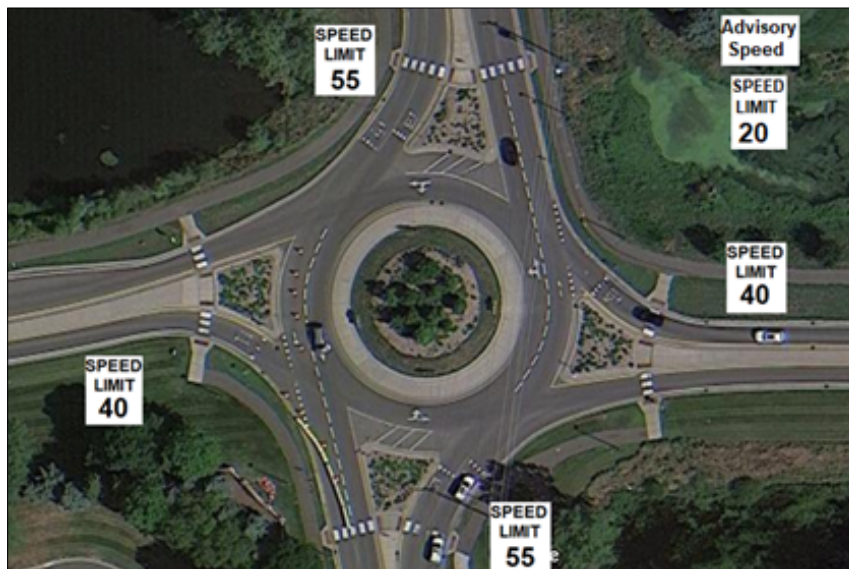
Vehicle speeds for entering and traveling through a roundabout are an important safety design consideration. Unsurprisingly, lower driving speeds in this study contributed to higher rates of yielding to pedestrians.
