Optimizing Maintenance Activities
Tenth Report

**REPAIR OF CONCRETE
PAVEMENT JOINTS**

*Combined State Studies
Of Selected Maintenance Activities
A Cooperative Analysis By Teams From
Iowa, Kansas, Nebraska, South Dakota*

**VALUE ENGINEERING STUDY OF
PAVEMENT JOINT REPAIR**

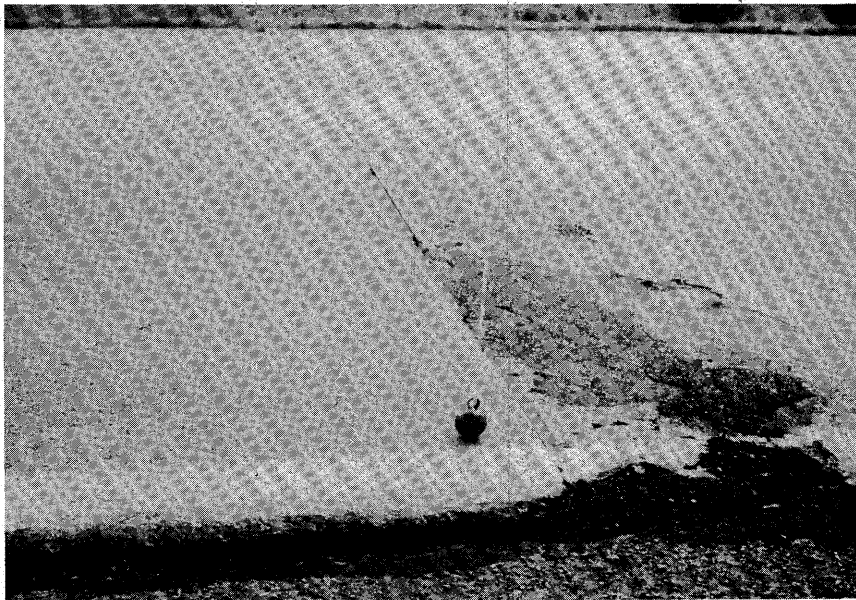
FIGURE 1 — LOCATE JOINT

Combine visual inspection and sounding to check condition of joint area concrete.

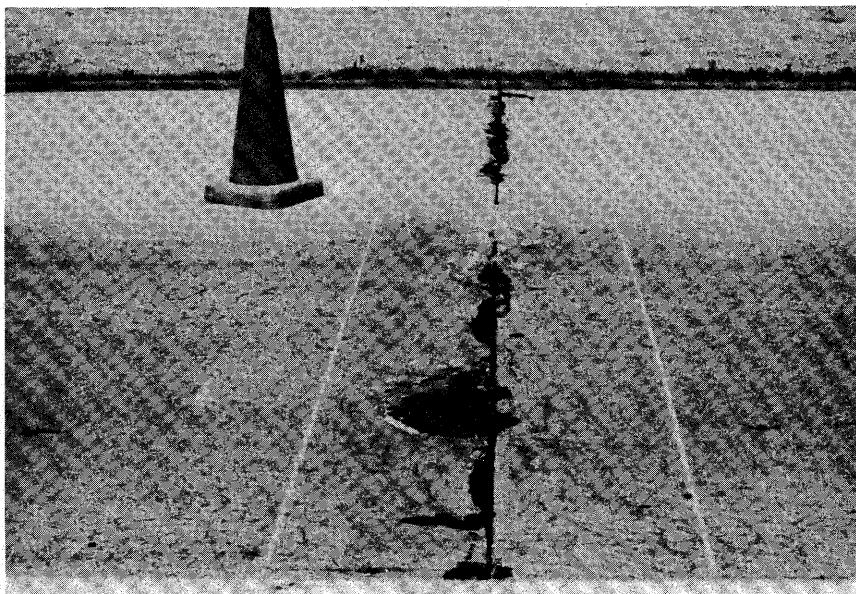
FIGURE 2 — MARK AREA

Use minimal marking or none at all on initial surveys to determine joint condition. Reserve extensive use of marking only where required to delineate damaged areas during construction of the joint repairs.

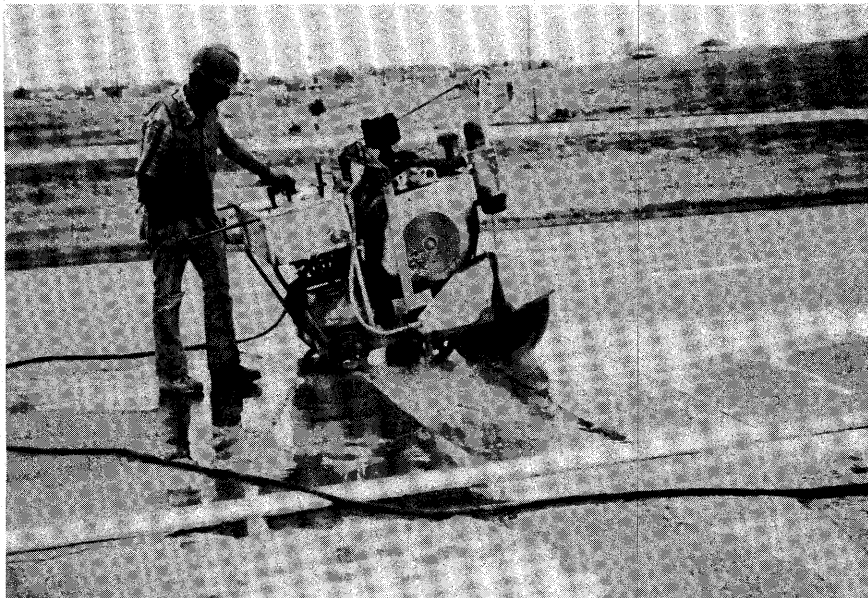
FIGURE 3 – SAW AREA
Diamond-blade saw in operation on partial-depth joint repair.

Partial-depth diamond blade sawing (2 - 3 inches deep) is recommended around the boundaries of partial-depth repairs where the concrete is to be removed by jackhammering. One state with extremely hard coarse aggregate and only physical damage at the joints has obtained satisfactory results by diamond blade sawing the perimeter of the partial depth repairs to a minimum depth of one inch. The depth of repair required in these cases is minimal compared to that required for joint distress associated with D-cracking and cement-aggregate reactions. The clean, straight line cuts facilitate removal of the old concrete, aid in edge finishing of the new concrete, minimize the possibility of spalling and provide for a smoother ride.

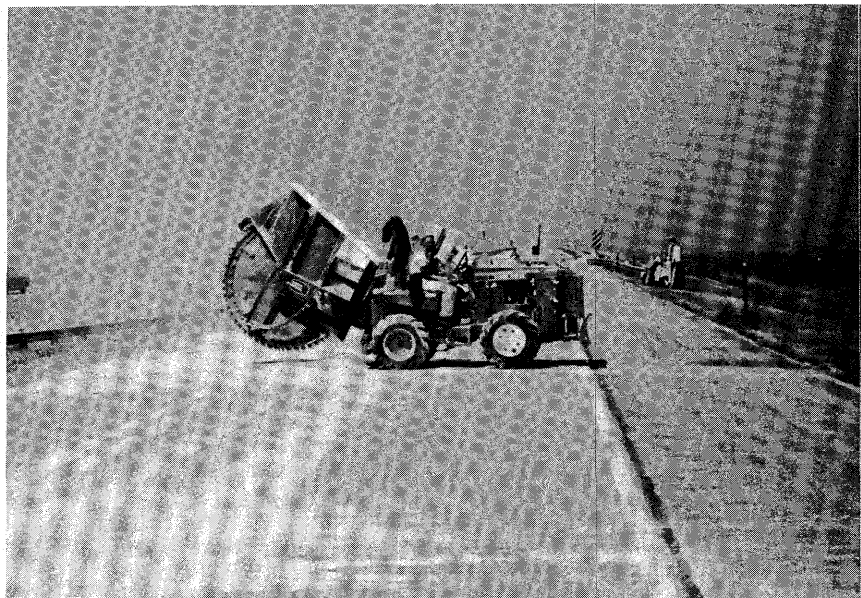
FIGURE 4 – ROCK SAW (WHEEL CUTTER)
Rock saw (wheel cutter) completed full-depth lane width cut.

- (b) The width of cut produced by the rock saw is capable of relieving compressive pressures adjacent to the cut in the pavement slab. Also, the width of cut, approximately four inches, is great enough to permit access to the under side of the slab sections with special lifting devices to remove the deteriorated concrete in one piece.

- (c) The rock saw tends to tear and spall the concrete at the top edges of the cut. The degree of tearing and spalling is somewhat dependent upon the quality of concrete and the type of coarse aggregate involved. These irregular edges may not be acceptable as the finished edge around the perimeter of the repair to some agencies. Partial-depth diamond-blade saw cuts in the pavement surface adjacent to the rock saw cuts can be used to provide a sharply defined edge and to produce a joint with less tire slap and a smoother ride. Due to the shelf that is produced by the diamond-blade saw cut it will be necessary to prepare the faces of the old concrete to a near vertical plane using 15 pound chipping hammers or similar equipment.

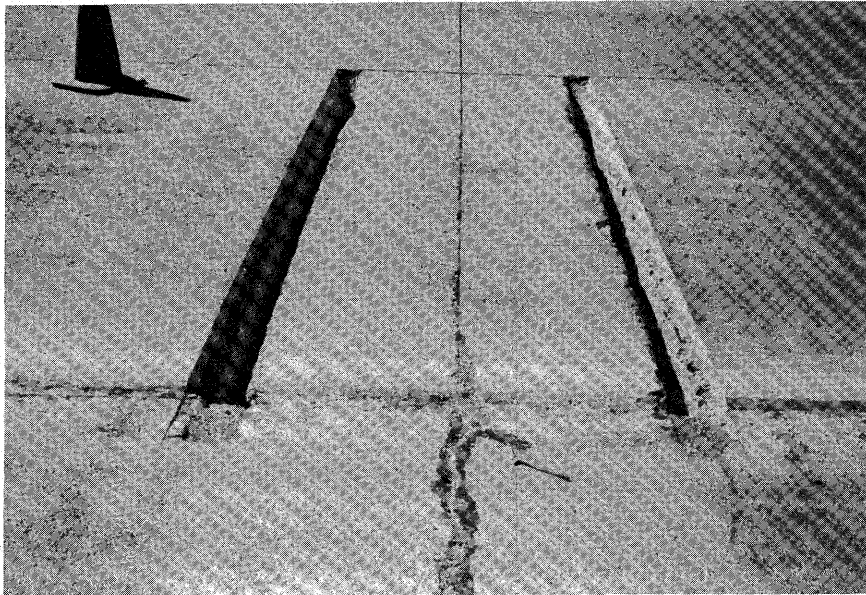
FIGURE 5 – COMBINATION SAW CUT

Full-depth rock saw cut with partial-depth diamond blade saw cut adjacent to it.

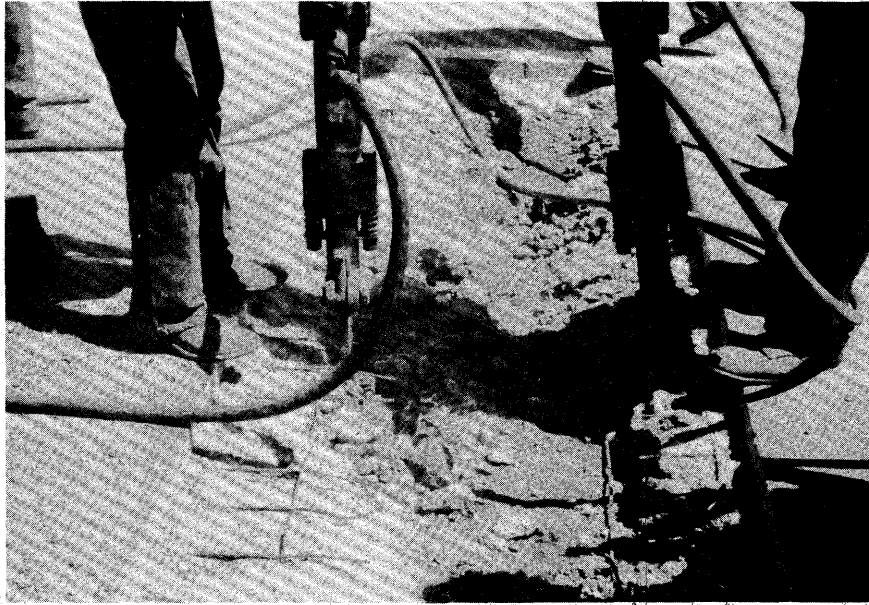
FIGURE 6 – BREAK CONCRETE
Breaking concrete with jackhammers.

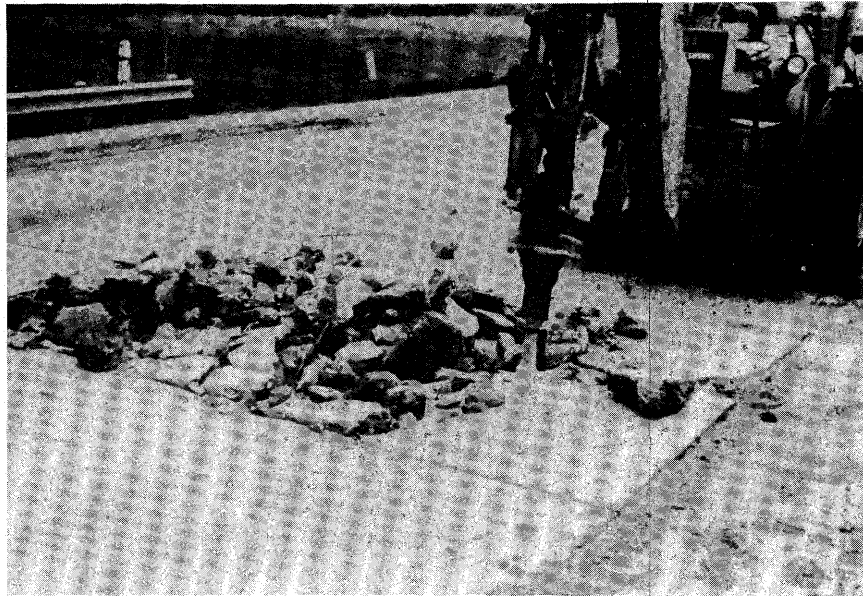
FIGURE 7 – BREAK CONCRETE
Breaking concrete with pavement breaker.

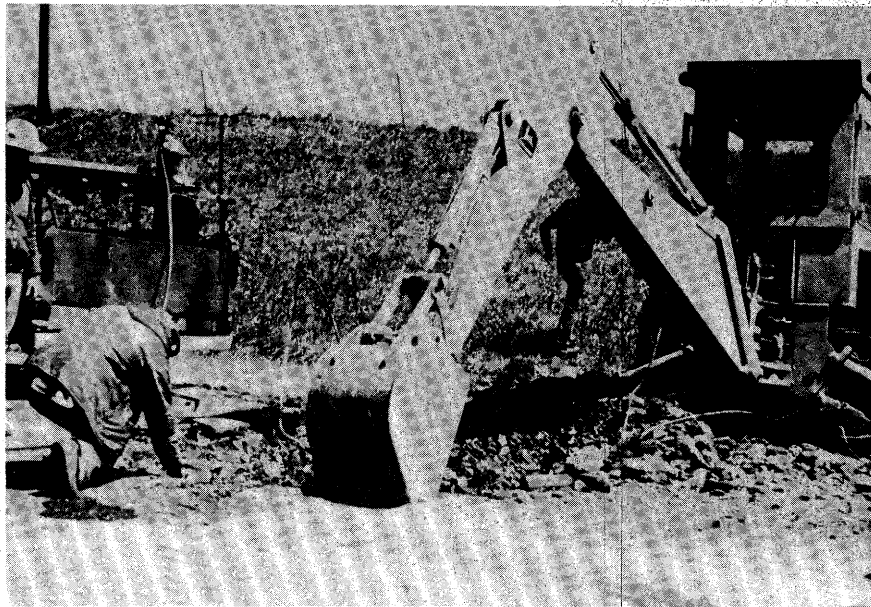
FIGURE 8 – REMOVE CONCRETE

The backhoe is favored by some states for the removal of broken concrete.

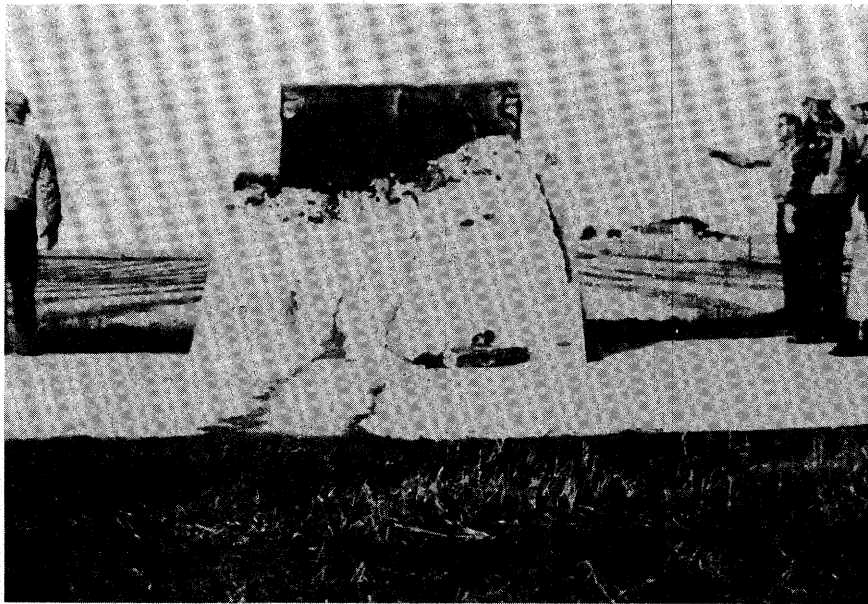
FIGURE 9 – REMOVE CONCRETE

A front-end loader removes concrete from a full-depth joint repair section.

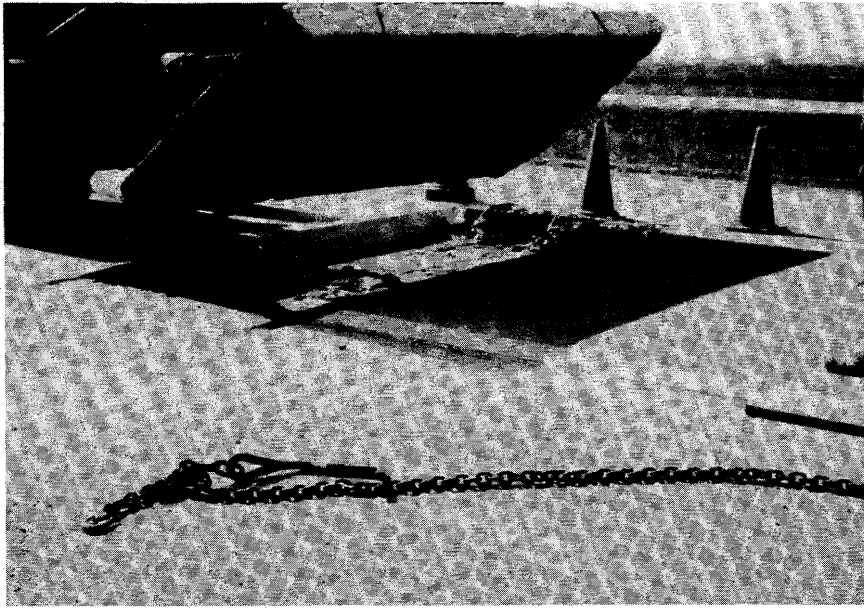
FIGURE 10 – REMOVE CONCRETE

Using a front-end loader with slings to remove full-depth joint repair section disturbs base very little.

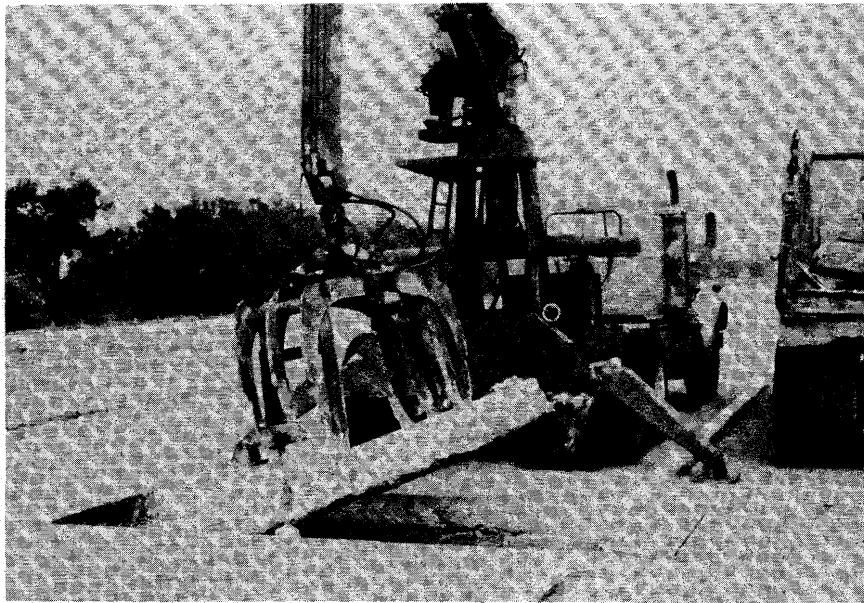
FIGURE 11 – REMOVE CONCRETE

Specialized equipment removes full-depth joint repair section with minimum disturbance of base.

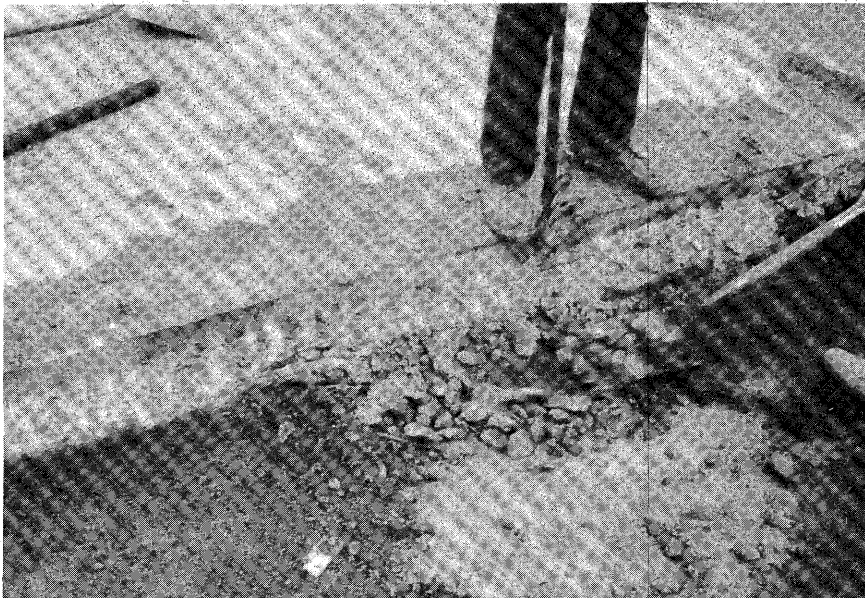
FIGURE 12 – CLEANING REPAIR AREA

Full-depth repair section prepared with a rock saw and a diamond-blade saw. The face of the cut has been prepared to a near vertical face. Projecting wire mesh is being clipped off. A small amount of old broken concrete is being removed with a shovel.

The cleanup phase includes the cutting off of all projecting mesh and tie bars flush with the joint repair faces. This will free the concrete patch to function independently of the adjacent lane slab and eliminate the transverse joint from forming a crack in the full-depth patch concrete. Under some conditions, it will be necessary to establish the longitudinal joint with some type of bond breaker.

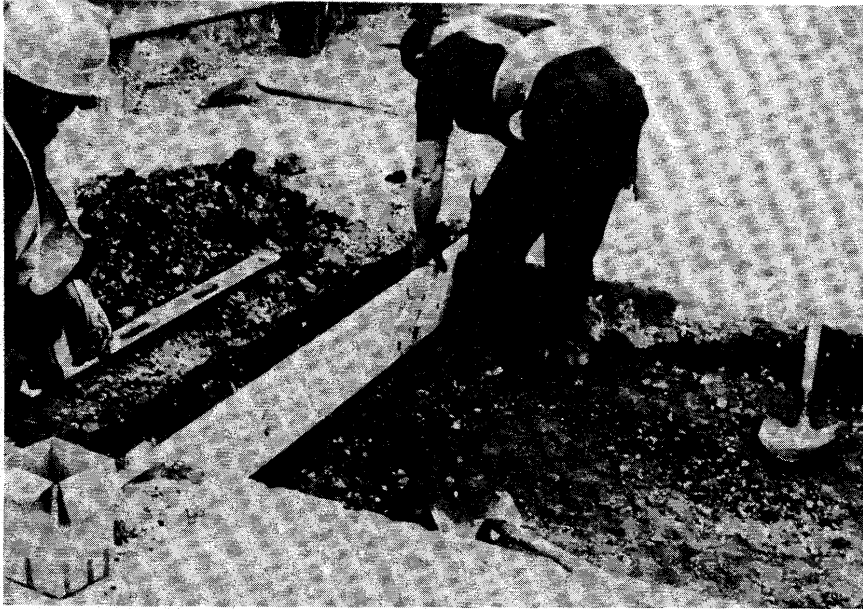
FIGURE 13 – PLACE FORM
A removable wood form is being installed.

Some states have used wood forms adjacent to the shoulder to form the edge of the patch. Heavy wood forms are reused while lightweight wood forms are often left in place.

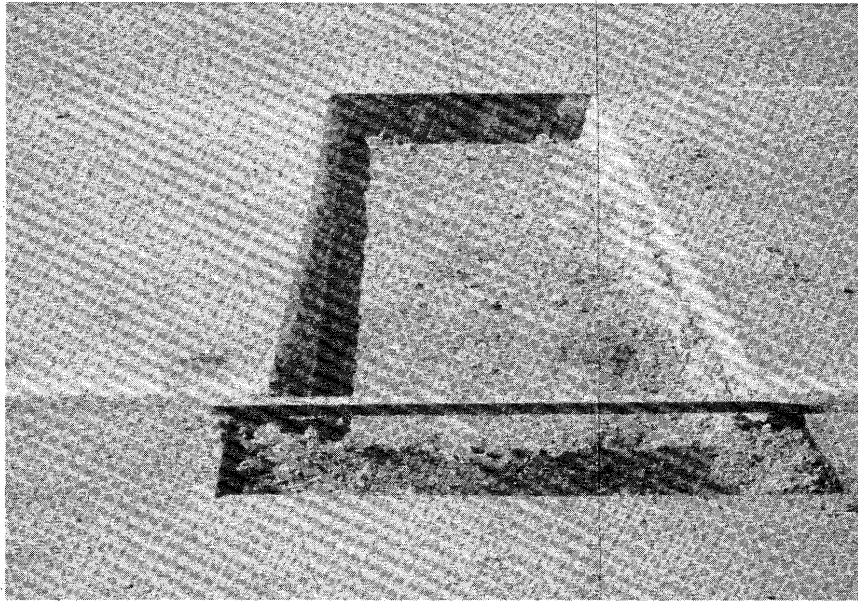
FIGURE 14 – PLACE FORM
An angle iron edge form in place.

The states in this study were in general agreement that the use of an angle iron (1" by 3" or 2" by 3") of sufficient length would be adequate for forming the patch edge. The angle iron is easily installed and removed to be reused on subsequent patches.

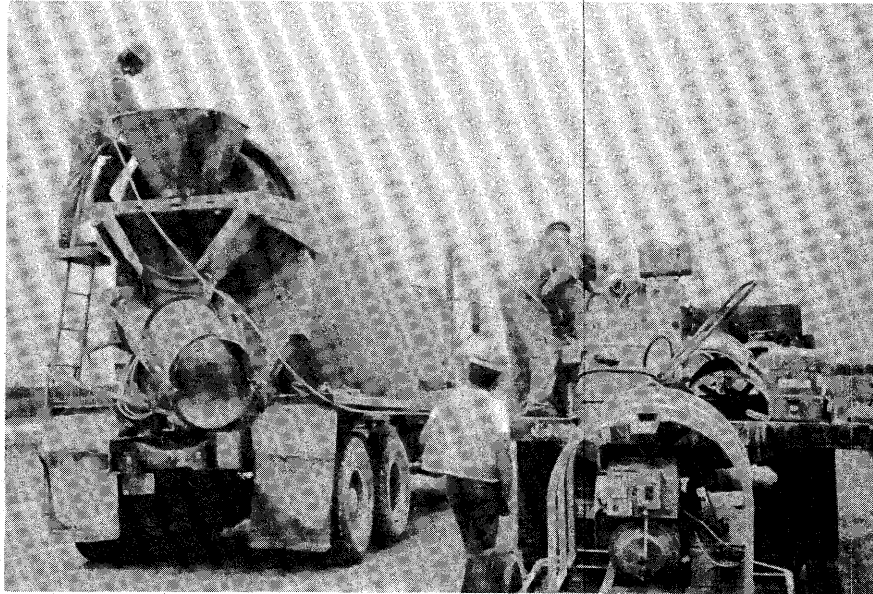
FIGURE 15 – MIX CONCRETE
Adding premixed calcium chloride to ready-mixed concrete prior to concrete placement.

When calcium chloride is to be added to accelerate the set of the concrete, it is recommended that the admixture be premixed with water off of the project prior to beginning repair operations. This eliminates the need to carry scales, bulk bags of material, water and large mixing containers to the field. It also reduces manpower activity in the field at the time of concrete placement. The premixed calcium chloride solution is dispensed by volume into the concrete mix just prior to placement at the repair site. Successful use of such a procedure requires planning for rapid discharge of the concrete into the repair work.

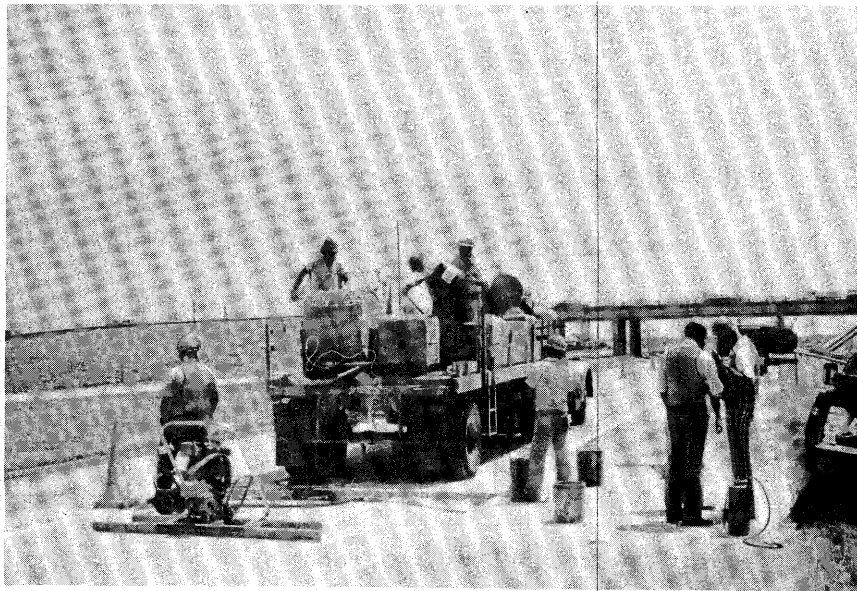
FIGURE 16 – MIX CONCRETE
Truck equipped with materials and small mixer for small volume maintenance work.

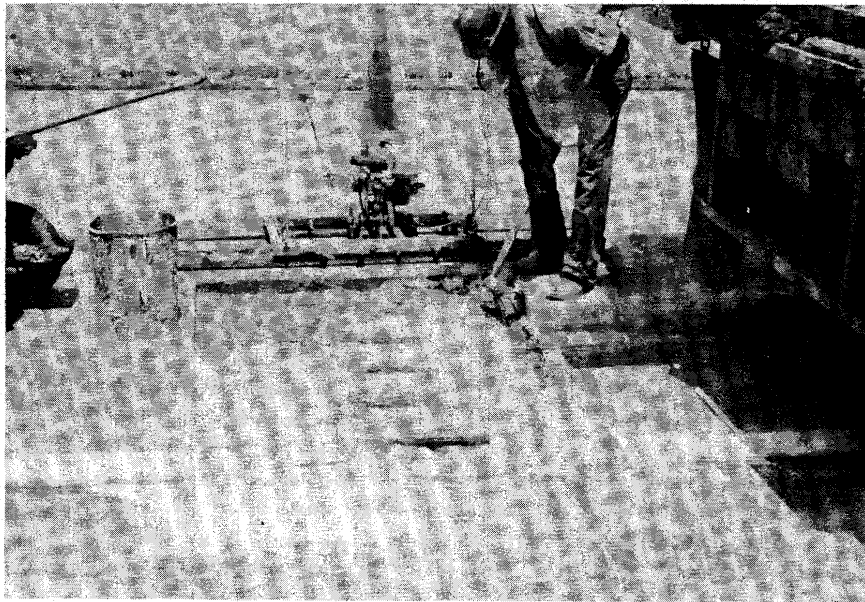
FIGURE 17 – GROUT AREA
Placing grout in partial-depth joint repair.

The grout should be brushed on the surfaces of the old concrete just prior to placement of the new concrete. Allowing the grout to become dry before the new concrete is placed in a partial-depth patch will almost always assure the failure of the patch. Allowing the grout to dry on the old surfaces of a full-depth patch before the new concrete is added will nullify the reason for grouting in the first place.

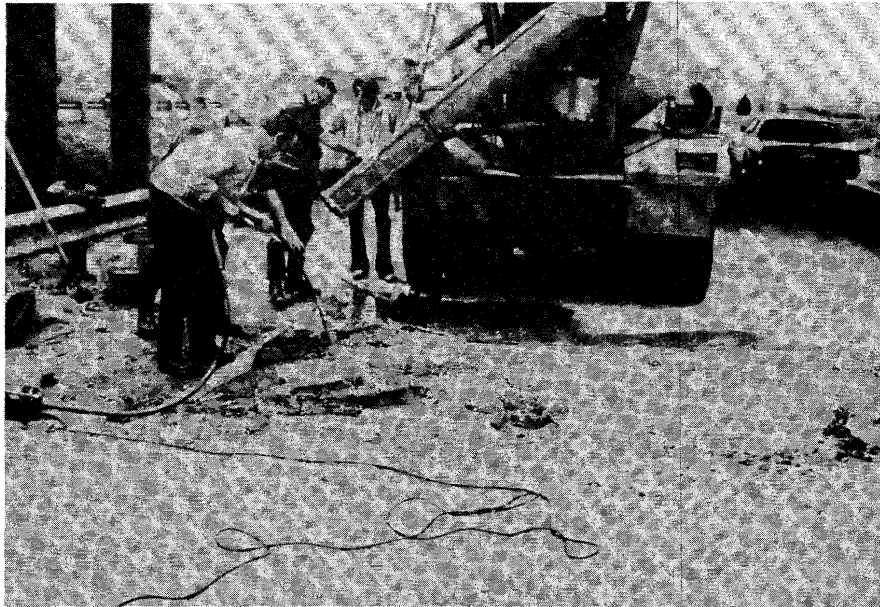
FIGURE 18 – PLACE CONCRETE AND STRIKE OFF
Internal vibration.

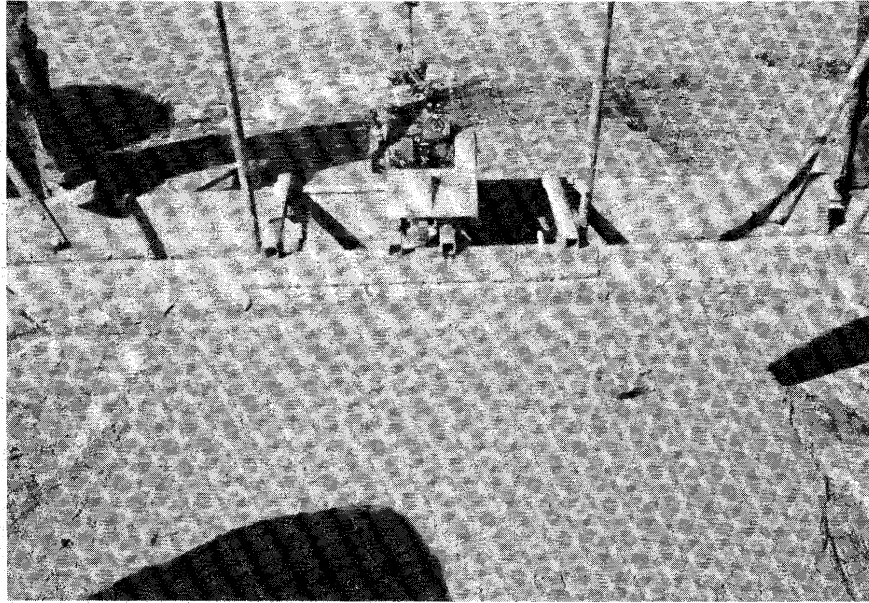
FIGURE 19 – PLACE CONCRETE AND STRIKE OFF
Vibrating screed used to strike off concrete.

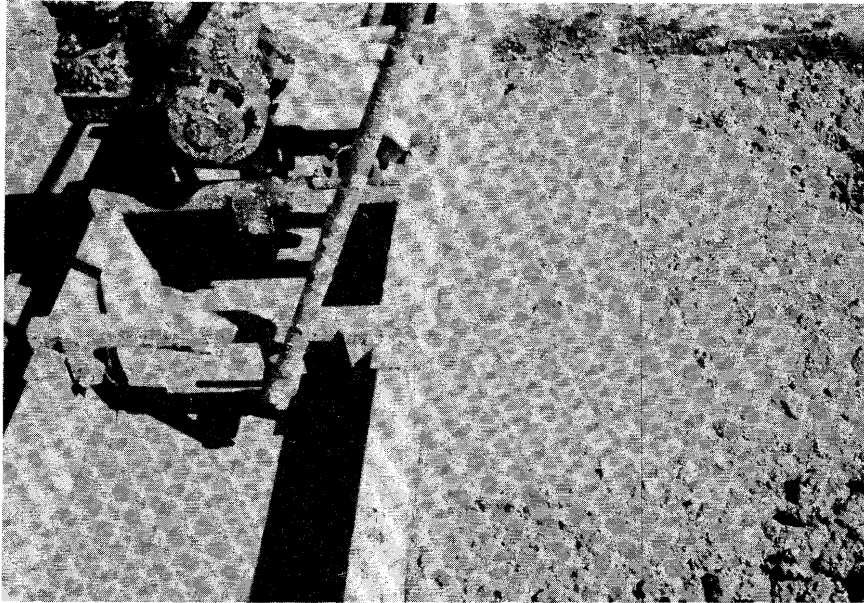
FIGURE 20 – FINISH CONCRETE
The vibrating screed will generally leave an adequate surface finish.

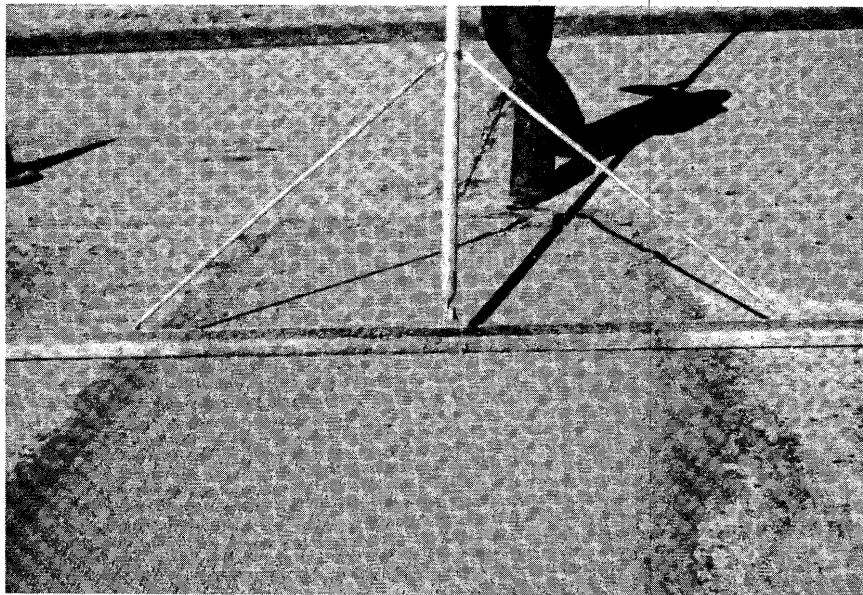
FIGURE 21 – FINISH CONCRETE
Occasionally, additional floating is required to provide a level patch.

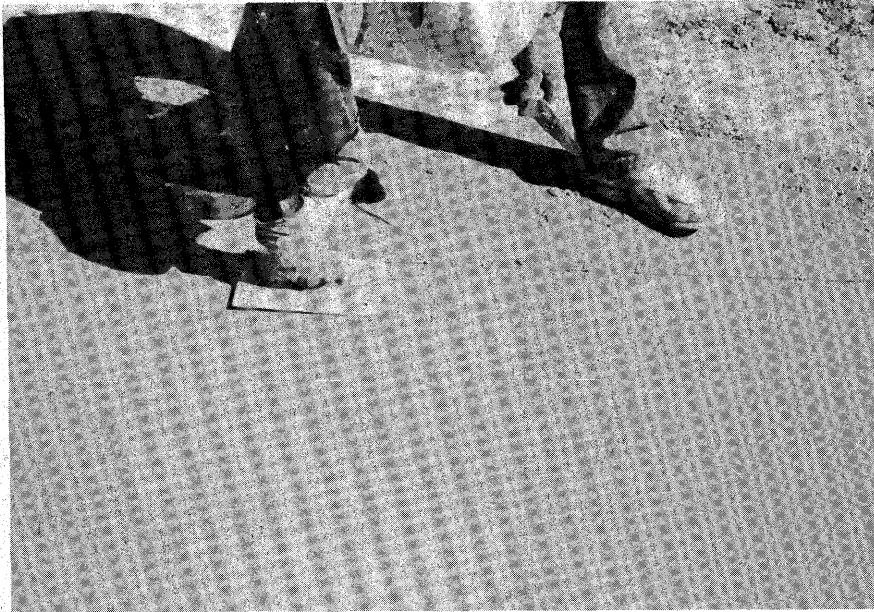
FIGURE 22 – FINISH CONCRETE
Edge finishing a full-depth patch.

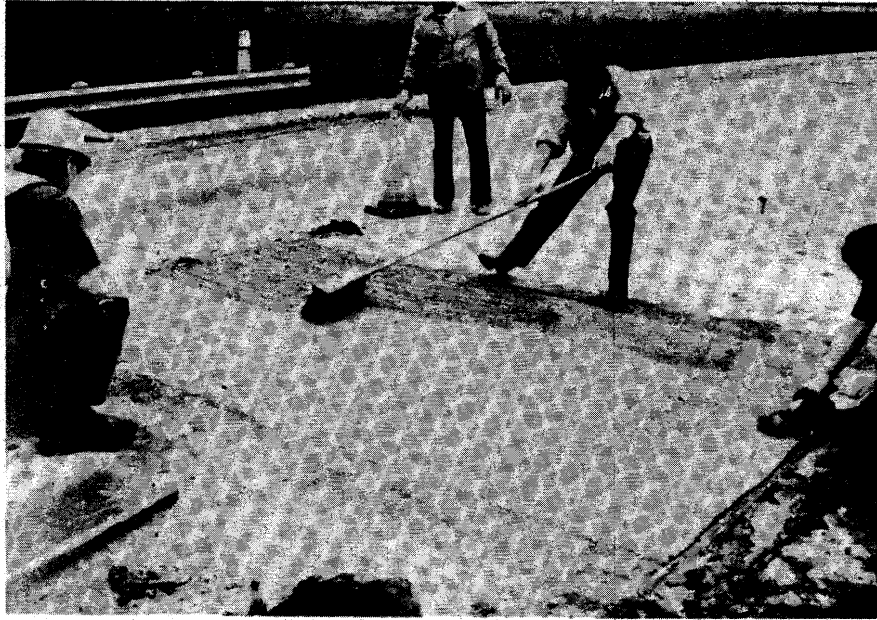
FIGURE 23 – TEXTURE CONCRETE
Broom texturing patch.

Texture imparted to the joint repair concrete surface should match as closely as possible the texture of the adjoining old pavement surfaces. Where the texture left by the vibrating strike off screed is reasonably similar to the texture of the adjoining old pavement, no further adjustments are needed. Where changes in texture are considered necessary, a burlap drag can be used to effect such changes. Tining or brooming textures are not necessary in most cases.

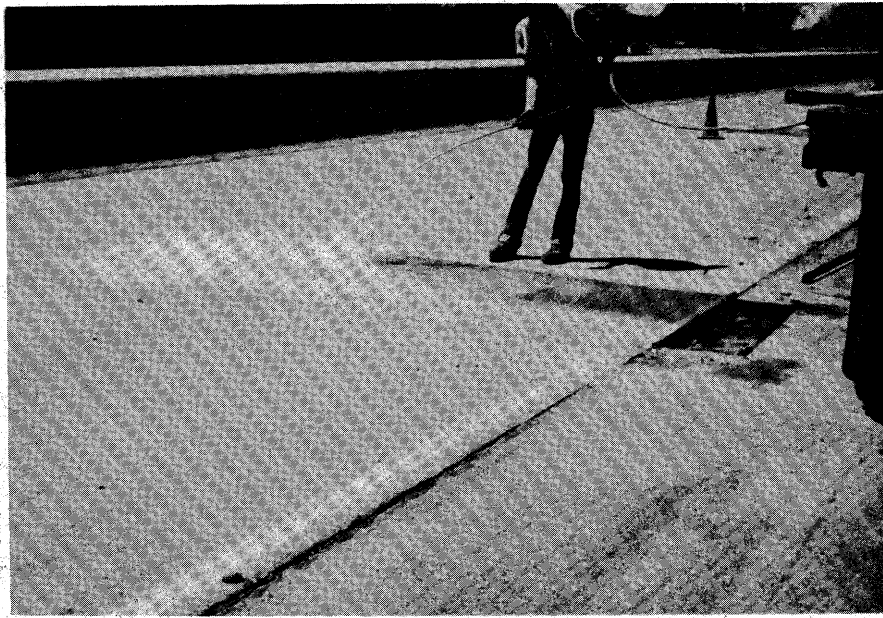
FIGURE 24 – CURE CONCRETE
Curing patch with white pigmented liquid membrane-forming compound.

Spraying a membrane curing compound on the repair concrete to effect cure is both practical and effective. The simplicity and advantages of this method have made it standard for curing concrete of the repair sections. Several states are considering eliminating the curing operation if studies underway indicate that the concrete does not appear to suffer any noticeable damage. One state, when using an accelerated set concrete, places a polyethylene film over the membrane cure followed by insulation board to retain the heat of hydration and moisture to further accelerate the strength gain of the concrete. It is believed that this procedure is necessary when the repair patch is to be opened to traffic in four hours. However, it was suggested that it is worth further study to determine the real need for curing concrete that gains strength so quickly.

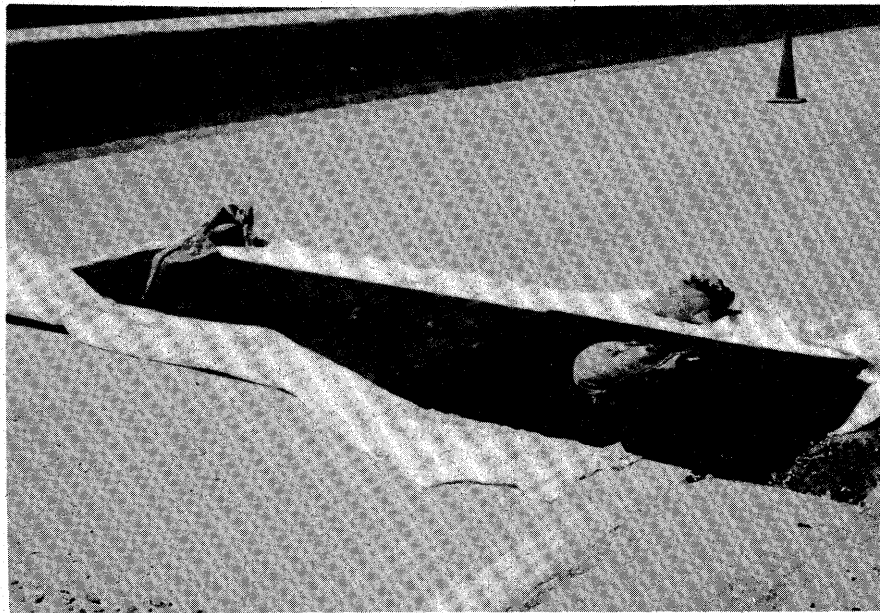
FIGURE 25 – CURE CONCRETE
An accelerated set concrete patch with curing compound, covered with polyethylene film and insulation board.

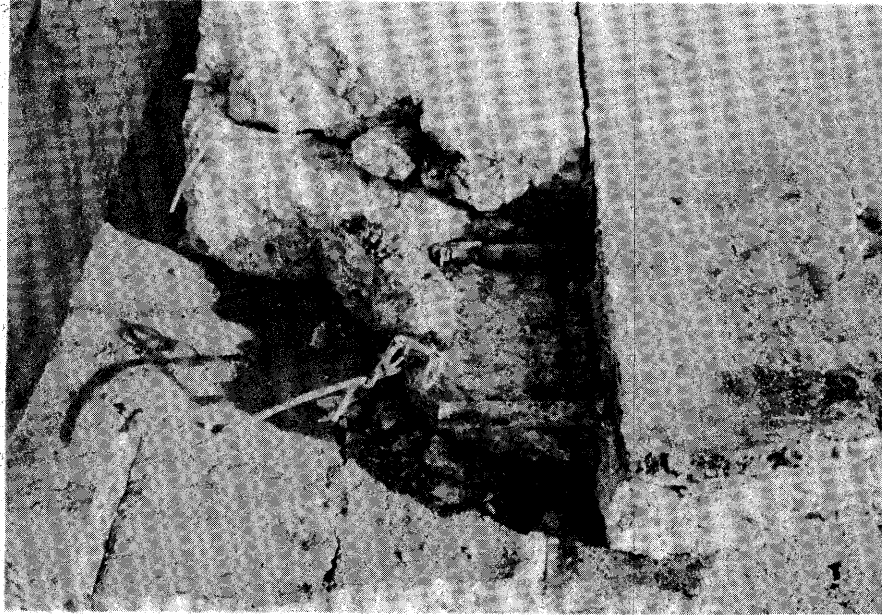
FIGURE 26 – DELAMINATION AT DOWEL BAR LEVEL

A questioning attitude was indicated among some participants of the study concerning the role of dowel bars in the functioning of transverse pavement joints. Where joint problems have developed on pavements undergoing cement aggregate reactions or "D" cracking, the adverse effects from the presence of dowel bars are particularly evident on the old full depth sections of concrete removed during joint repair operations. Delamination of the concrete at the dowel bar level is frequently observed in these sections upon removal. It is speculated in these cases, that differential vertical motion of the concrete on either side of the joint causes the dowel bars to act as levers to pry the structurally weakened concrete apart. The onset of such delaminations is usually the forerunner to breakup of the surface concrete directly over the delamination zones. A delaminated

condition is frequently found at pavement joints which appear structurally intact at the surface. Subsequent breakup of the surface area concrete then occurs, as the pavement is subjected to the continued effects of traffic and weather.

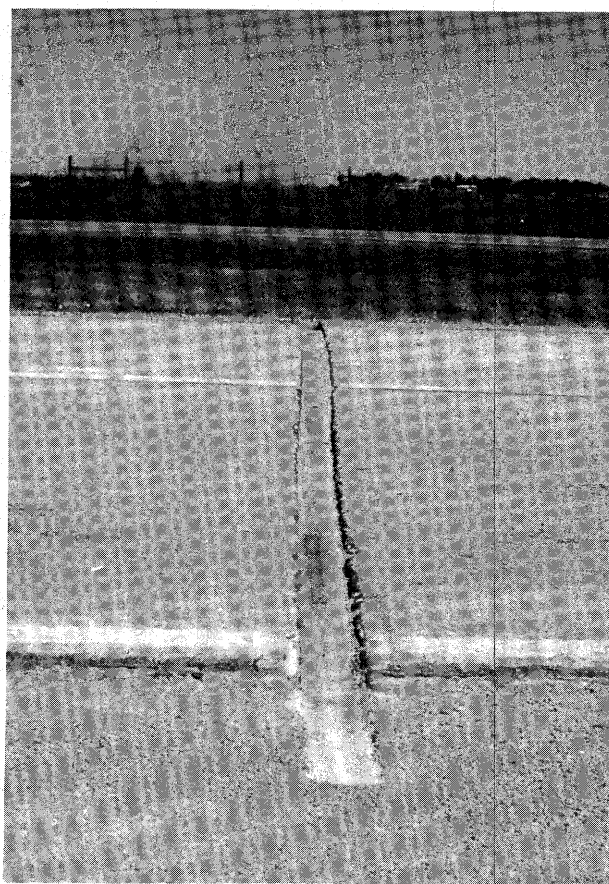
FIGURE 27 – COMPLETED PRESSURE RELIEF JOINT

It is desirable to saw pressure relief joints when temperatures are lower and the effects of thermal expansion are minimal. Spring and fall are better times from a seasonal standpoint while early morning and nighttime would be preferred on a daily basis.
