# **VOLUME III: SOURCES AND MIGRATION OF HIGHWAY RUNOFF POLLUTANTS - RESEARCH REPORT (FINAL REPORT)**

REXNORD, INC. MILWAUKEE, WI

**MAY 84**

Report No. FHWA/RD-84/059

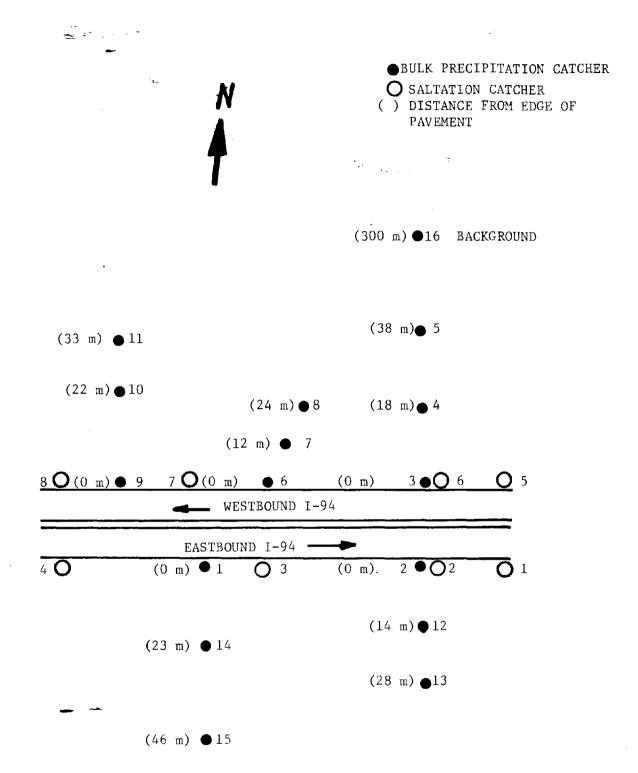
Figure 1. Bulk precipitation and saltation catcher installations - Milwaukee I-94 site, 1978.

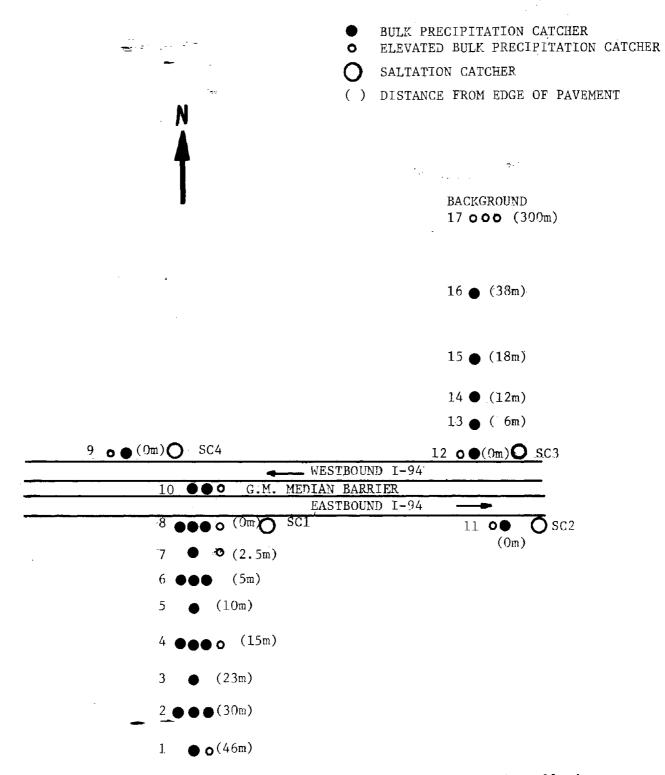
Figure 2. Bulk precipitation and saltation catcher installations - Milwaukee I-94 site, 1979.

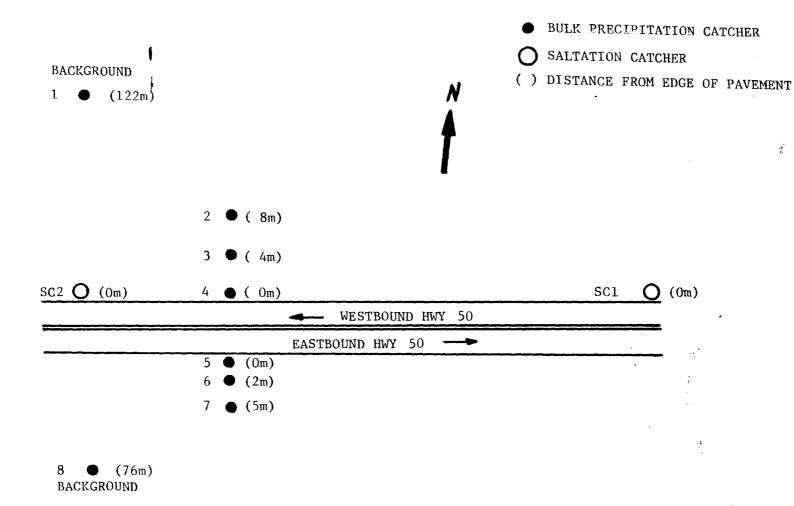
Figure 3. Bulk precipitation and saltation catcher installations - Sacramento Hwy 50 site.

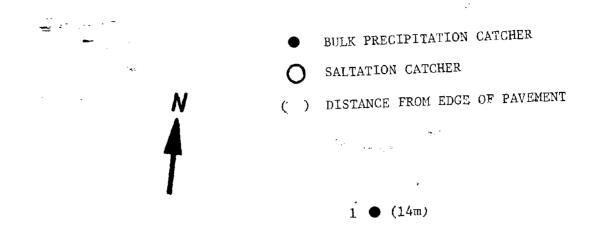
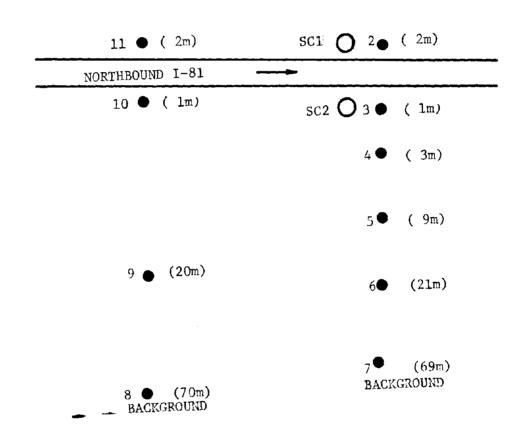
Figure 4. Bulk precipitation and saltation catcher installations - Harrisburg I-81.

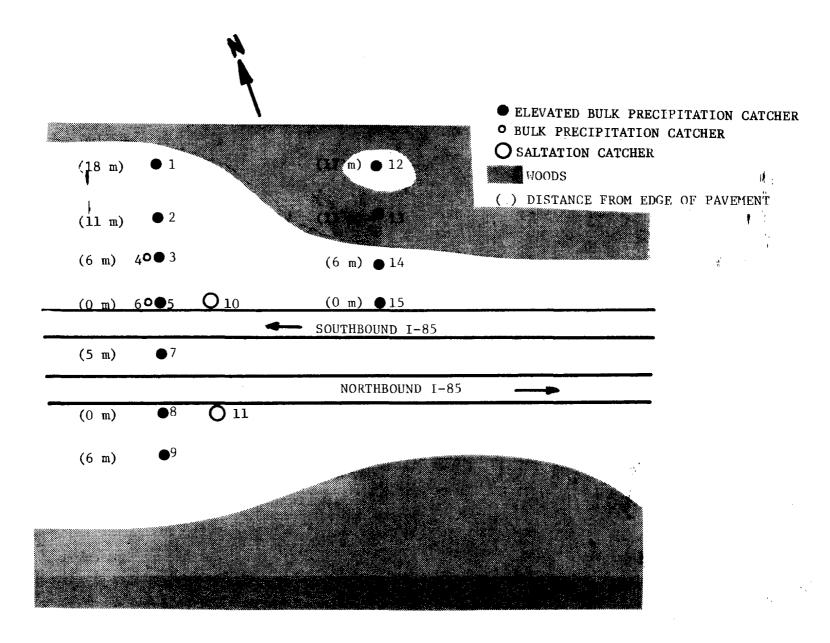
Figure 5. Bulk precipitation and saltation catcher installations - Efland I-85.

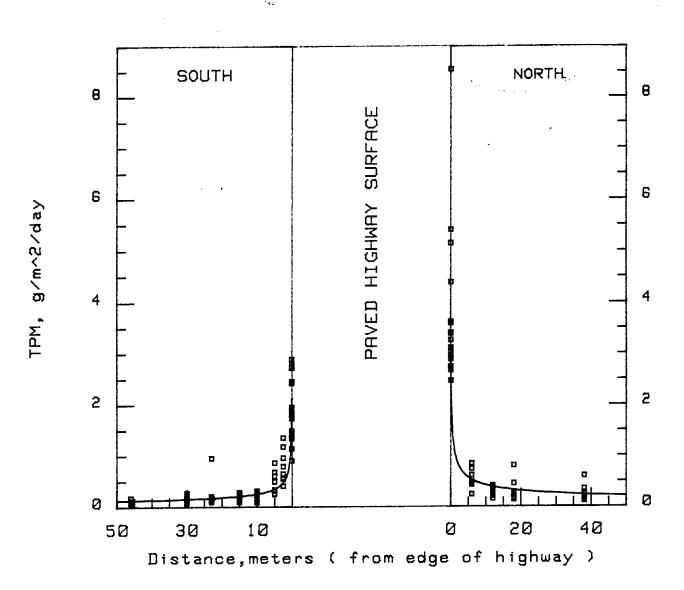
Figure 6. TPM deposition on areas adjacent to the paved highway surface - Milwaukee I-94.

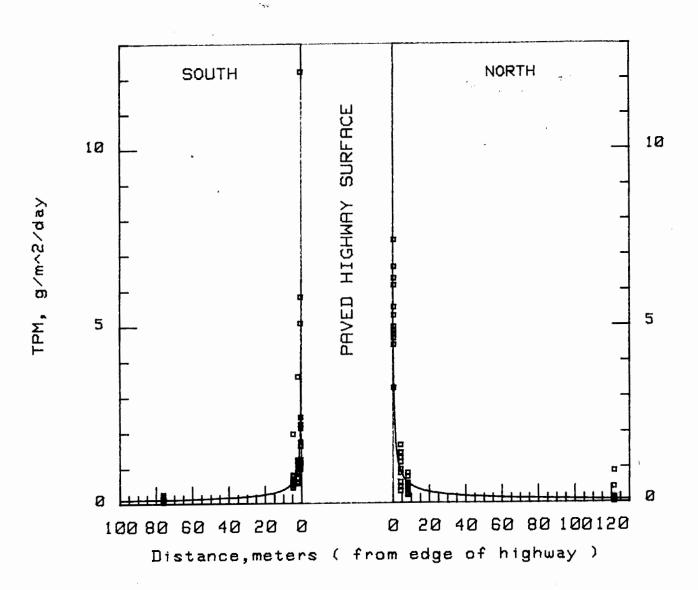
Figure 7. TPM deposition on areas adjacent to the paved highway surface - Sacramento Hwy 50.

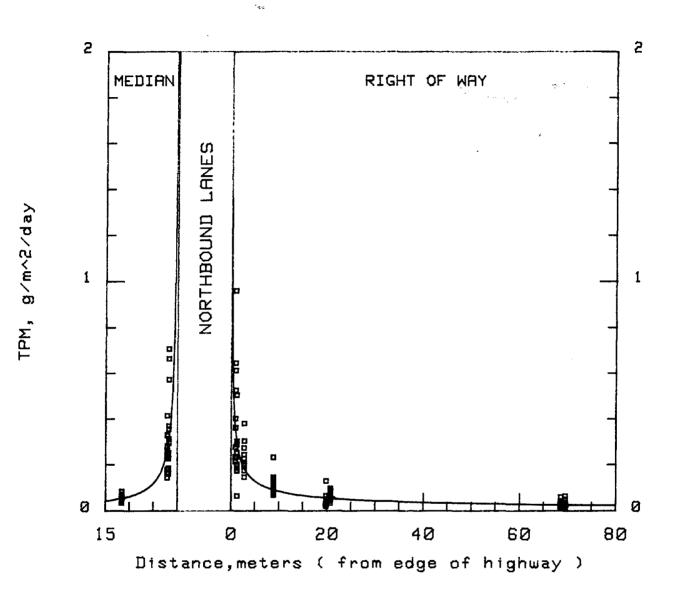
Figure 8. TPM deposition on areas adjacent to the paved highway surface - Harrisburg I-81.

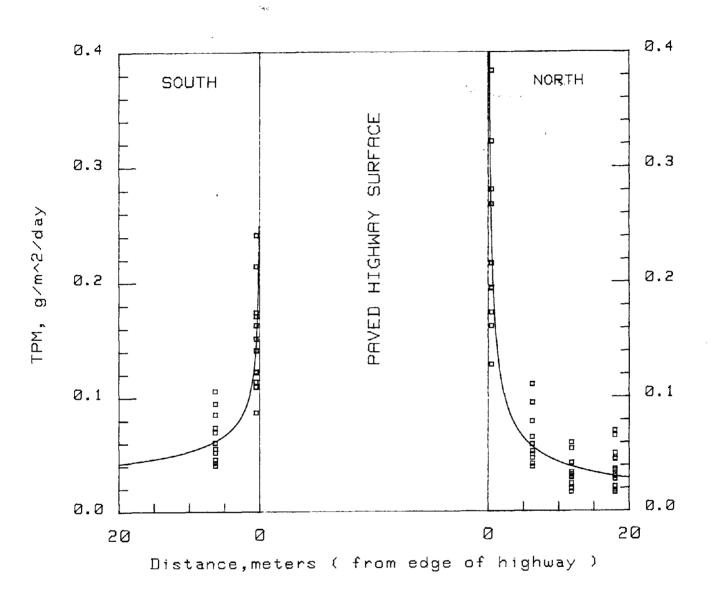
Figure 9. TPM deposition on areas adjacent to the paved highway surface - Efland I-85.

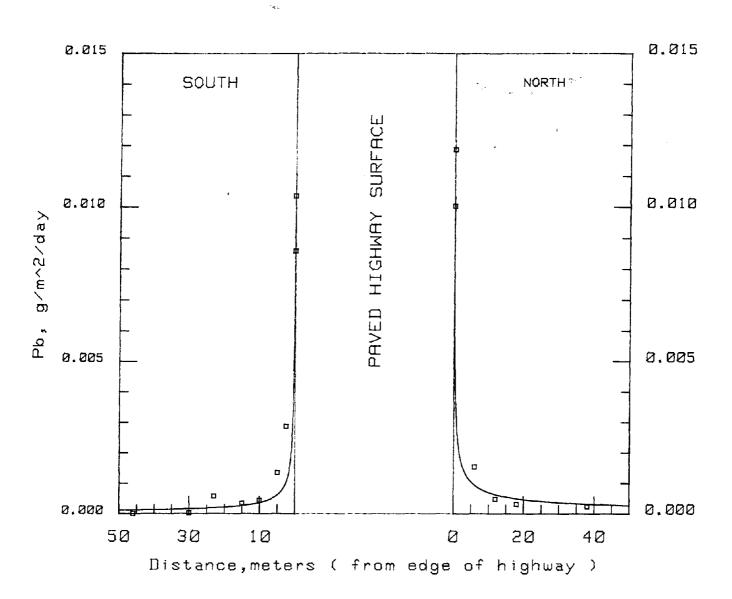
Figure 10. Lead deposition on areas adjacent to the paved highway surface, July 1979 - Milwaukee I-94.

Metals associated with bulk precipitation follow the same general pattern observed for TPM deposition in areas adjacent to the highway at the four sites monitored. As an example, graphs for lead deposition at the four sites for selected months are presented in Figures 10 through 13. Figure 10 shows that

at Milwaukee lead drops sharply within the first 10 m from edge of pavement, and approaches background levels at approximately 30 to 40 m from edge of pavement. At Sacramento, lead drops sharply within the first 10 m from edge of pavement, and approaches background levels at 50 to 60 m from edge of pavement (Figure 11). At Harrisburg (Figure 12), lead approaches background at 15 to 25 m from the edge of pavement, and at 10 to 20 m at Efland (Figure 13).

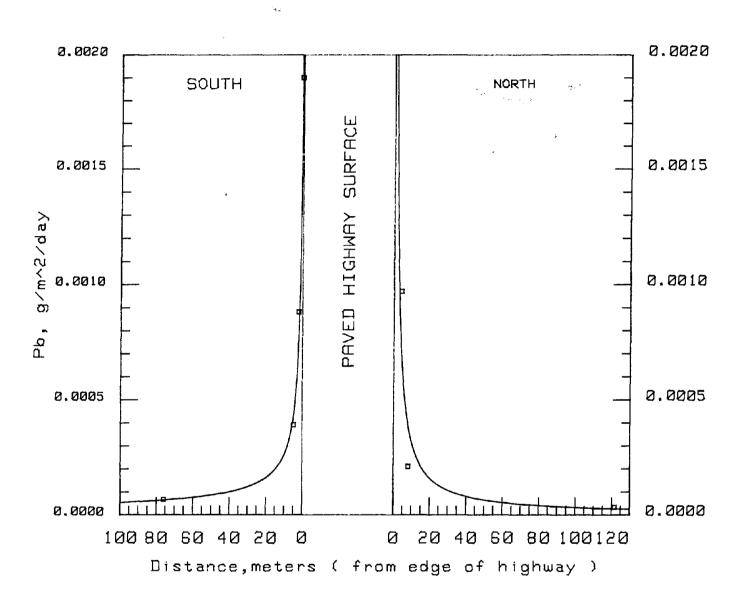
Figure 11. Lead deposition on areas adjacent to the paved highway surface, June 1980 - Sacramento Hwy 50.

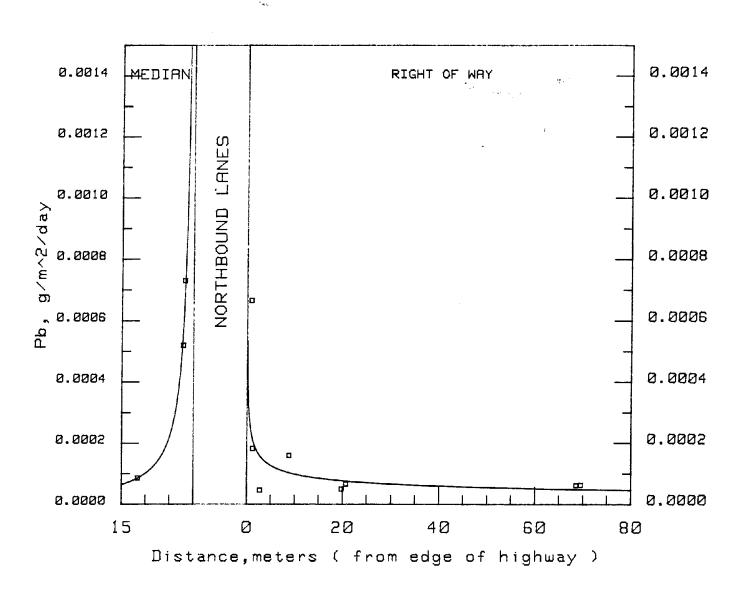
Figure 12. Lead deposition on areas adjacent to the paved highway surface, February 1980 - Harrisburg I-81.

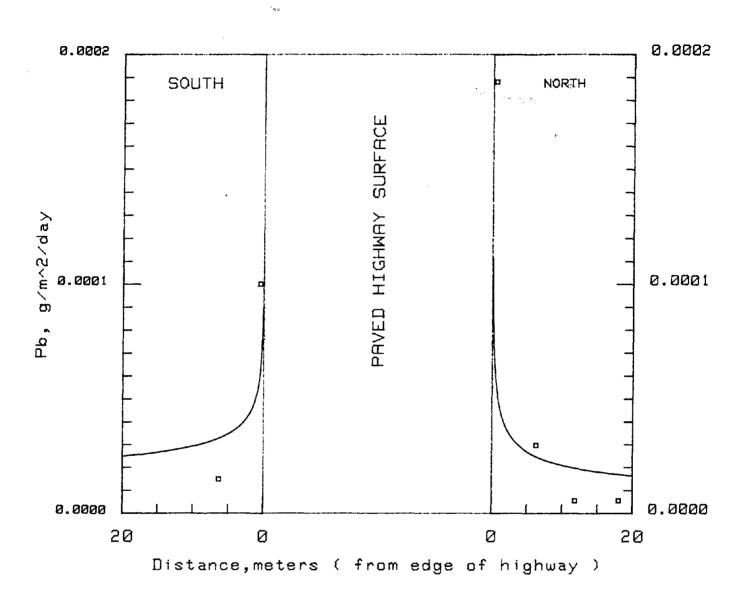
Figure 13. Lead deposition on areas adjacent to the paved highway surface, April 1982 - Efland I-85.

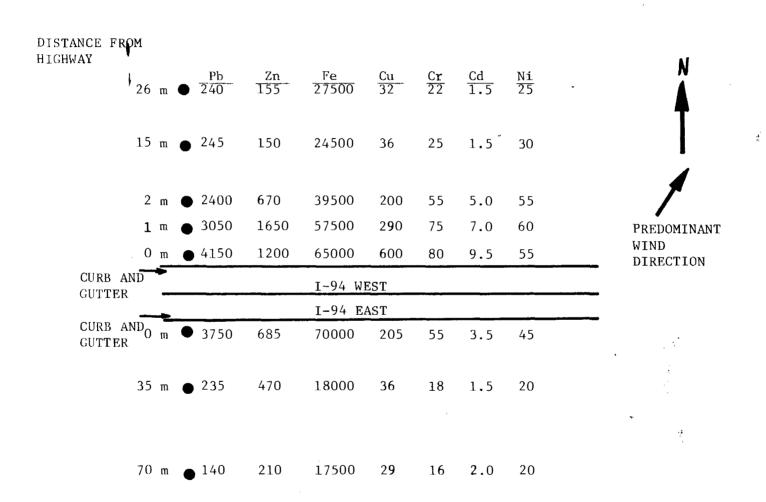
Figure 14. Distribution of selected metals (mg/kg) within the top 1 cm of soil at the Milwaukee I-94 monitoring site - July 17, 1979.

In general, the Milwaukee data show that metal concentrations in the top centimeter of soil are highest near the highway and that these concentrations decrease rapidly within the first 9 m and reach background levels at approximately 35 m from the paved surface. This pattern is similar to that observed for TPM deposition (Figure 6). The Milwaukee data (Figures 14, 15 and 16) also show that the concentrations of zinc, copper, chromium, cadmium and nickel are generally much higher for the northern near-highway soil samples than for the southern near-highway soil samples which indicates that the predominant wind direction may be an important factor in the distribution of these metals within the Milwaukee I-94 ROW. The Milwaukee I-94 data (Figures 15, 16 and 17) also suggest that the Menomonee Industrial Valley which lies just south of the study area may be a source of zinc contamination. Zinc concentrations at 35 and 70 m south of I-94 consistently exceed background levels and are higher than at the 26 m sampling point north of I-94. Again, this may be a function of the prevailing winds which carry the zinc out of the Menomonee Industrial Valley and deposit it in the southern right-of-way.

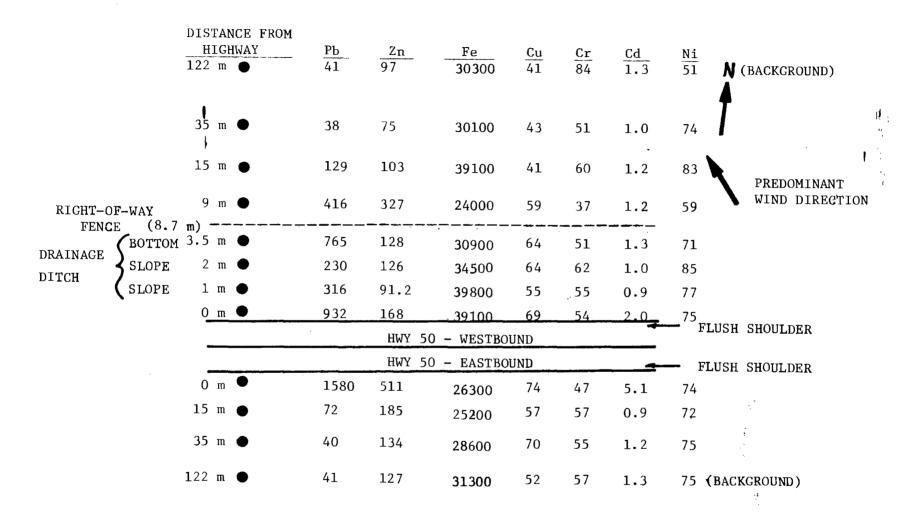
Figure 17. Distribution of selected metals (mg/kg) within the top 1 cm of soil at the Sacramento, Hwy 50 monitoring site - March 26, 1980.

On March 26, 1980, the top centimeter of soil was sampled along a transect crossing the Sacramento Hwy 50 right-of-way including the unpaved areas north and south of the highway (Figure 17). Similar to the Milwaukee data, the Sacramento data show that the metal concentrations in the top centimeter of soil are generally highest near the highway and that these concentrations decrease rapidly within the first 9 to 15 m, reaching background at approximately 35 m from the paved surface. This pattern is similar to that observed for TPM deposition (Figure 7). The data also indicate a buildup of lead in the bottom of the drainage ditch (3.5 m) and a corresponding decrease in the lead concentrations on the side slope of the drainage ditch (1 and 2 m). Apparently, lead concentrations in the bottom and side slopes of the drainage ditch are a function of both dustfall and runoff.

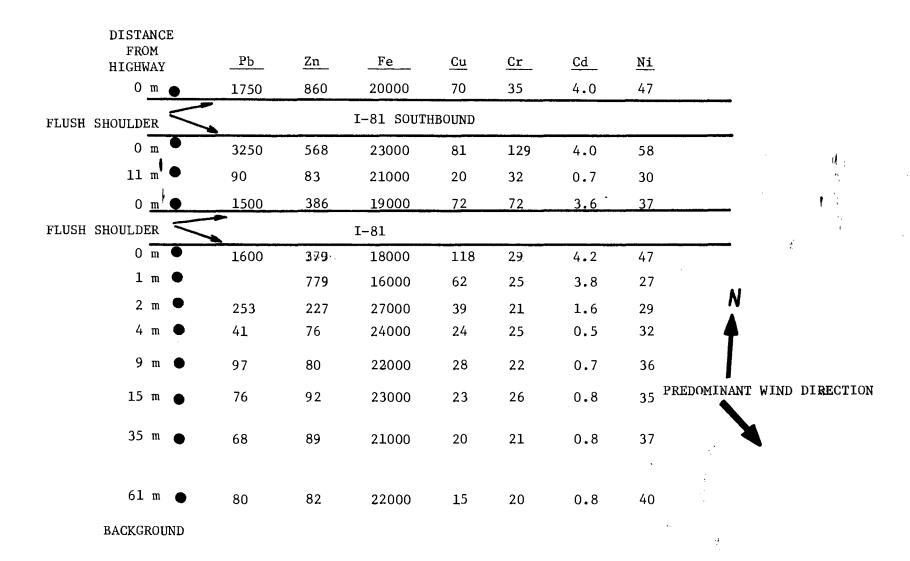
Figure 18. Distribution of selected metals (mg/kg) within the top 1 cm of soil at the Harrisburg I-81 monitoring site - September 9, 1980.

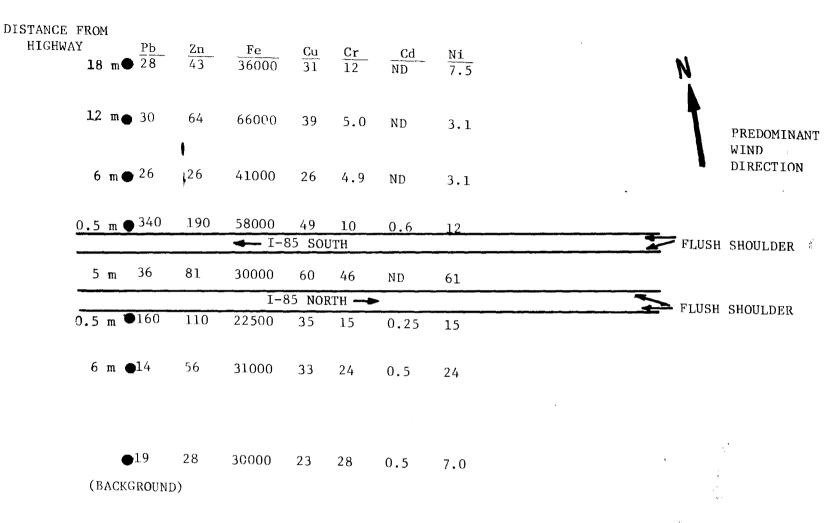
Figure 19. Distribution of selected metals (mg/kg) within the top 1 cm of soil at the Efland I-85 monitoring site - December 6, 1981.

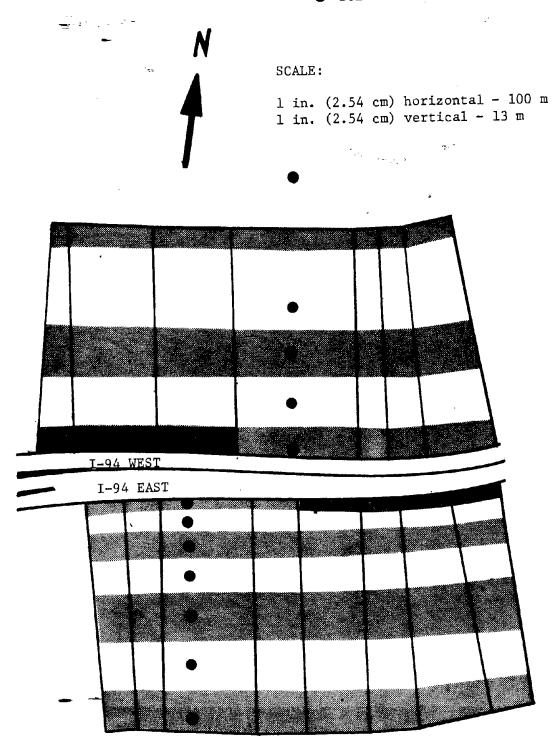
Figure 20. Bulk precipitation monitoring scheme for the period 4/16 to 11/21/79 and associated impact areas, Milwaukee I-94.

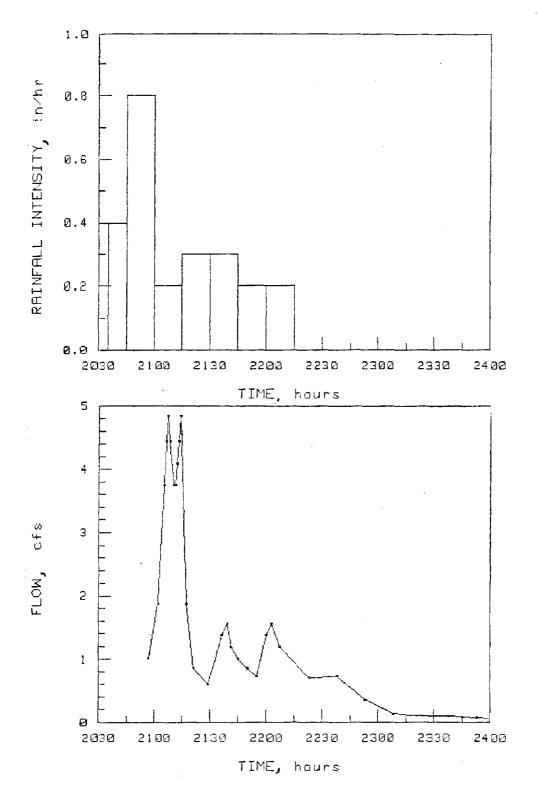
Figure 21. Rain and flow pattern, Milwaukee I-94, June 28-29, 1979.

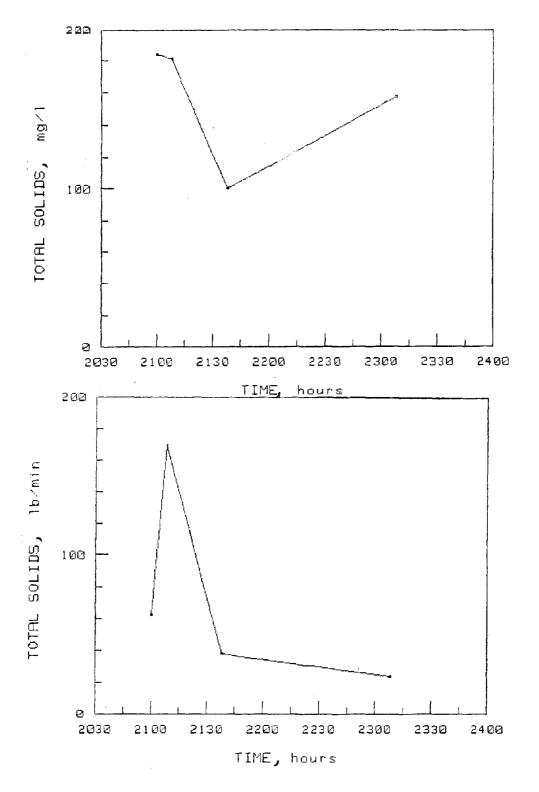
Figure 22. Total solids discharge pattern, Milwaukee I-94, June 28-29, 1979.

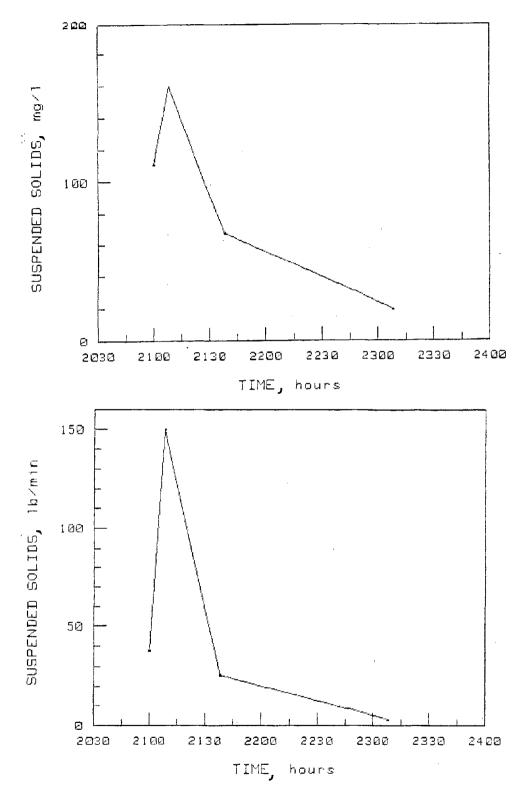
Figure 23. Suspended solids discharge pattern, Milwaukee I-94, June 28-29, 1979.

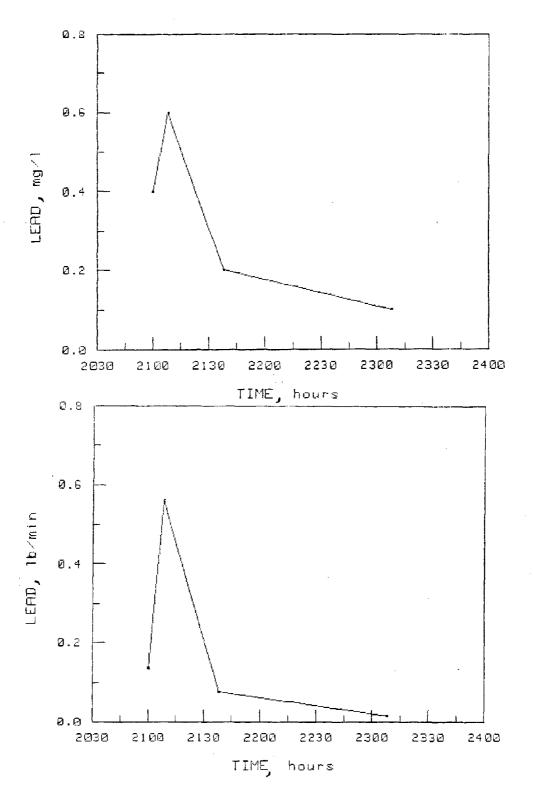
Figure 24. Lead discharge pattern, Milwaukee I-94, June 28-29, 1979.

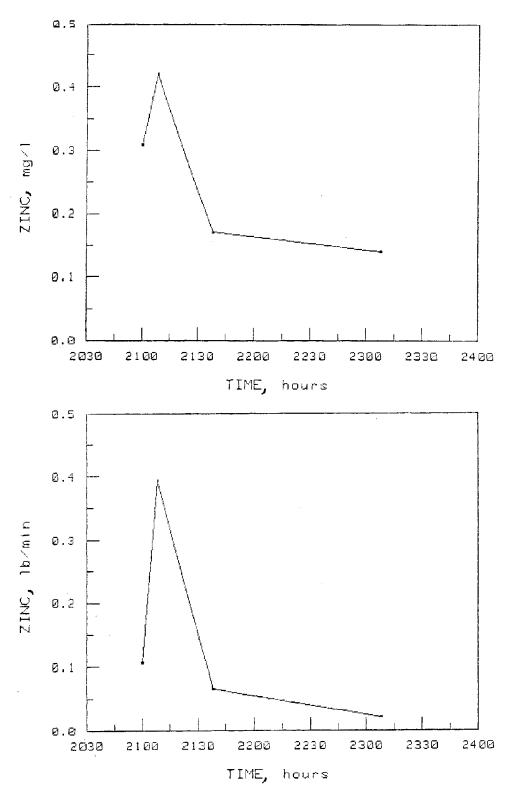
Figure 25. Zinc discharge pattern, Milwaukee I-94, June 28-29, 1979.

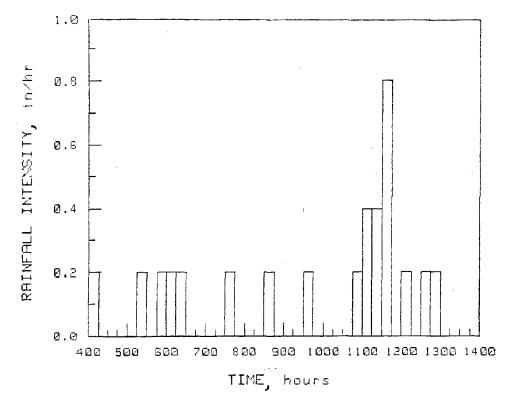
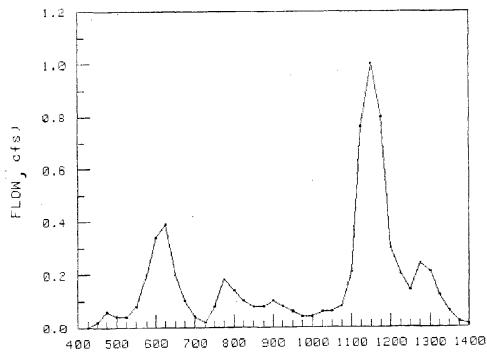
Figure 26. Rain and flow pattern, Sacramento Hwy 50, January 17, 1980.

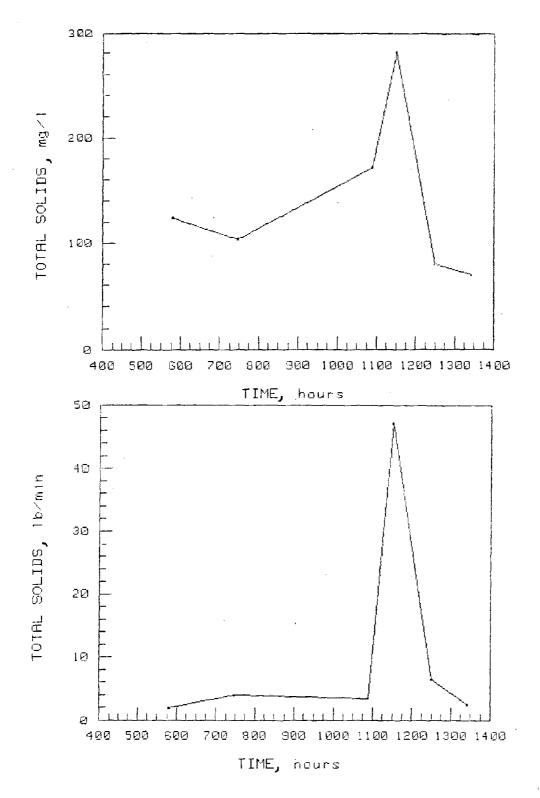
Figure 27. Total solids discharge pattern,
Sacramento Hwy 50, January 17, 1980.

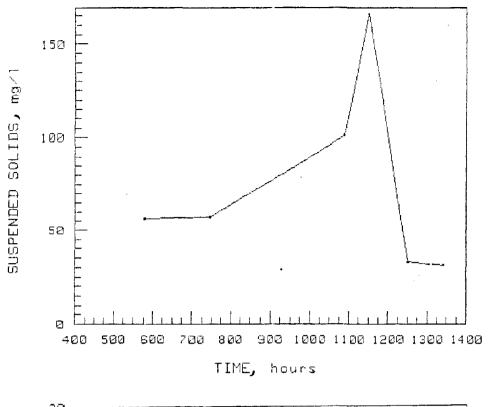
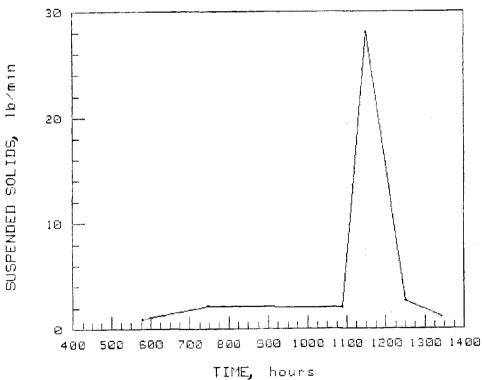
Figure 28. Suspended solids discharge pattern, Sacramento Hwy 50, January 17, 1980.

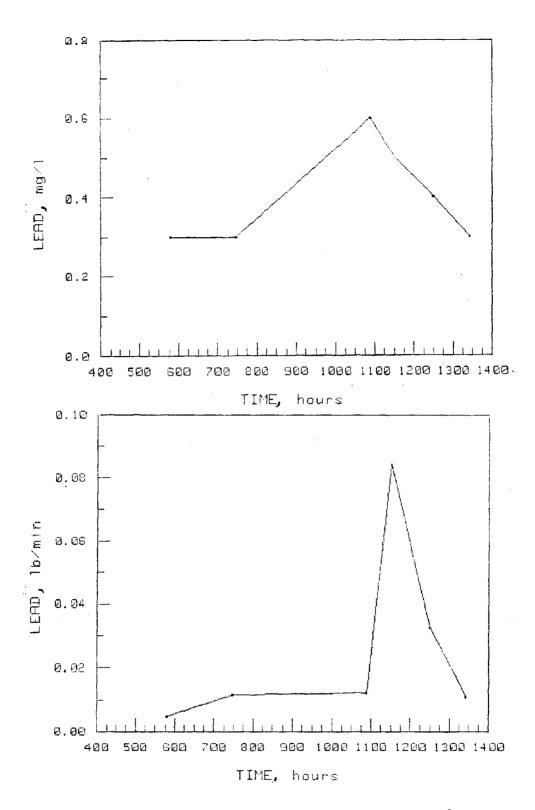
Figure 29. Lead discharge pattern, Sacramento Hwy 50, January 17, 1980.

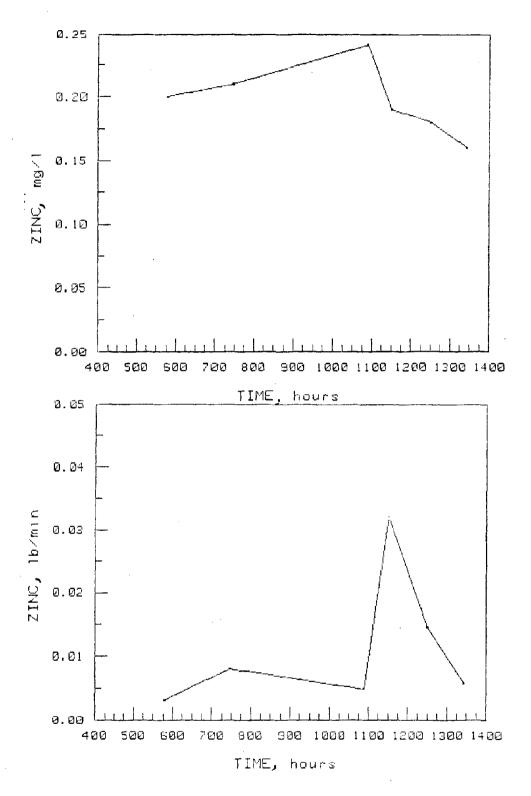
Metric units: To convert 1b to kg multiply by 0.4536. Figure 30. Zinc discharge pattern, Sacramento Hwy 50, January 17, 1980.

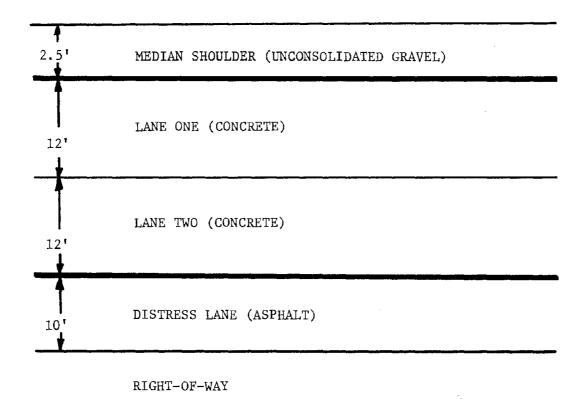
Figure 33. Schematic of test area for sweeping/flushing studies at the Harrisburg I-81 site - northbound lanes.

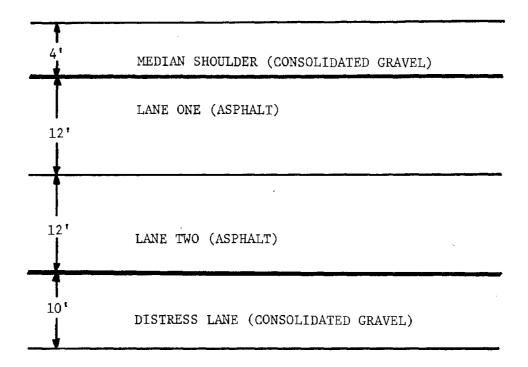
Figure  $^{34}$ . Schematic of test area for sweeping/flushing studies at the Efland I-85 site - northbound lanes.

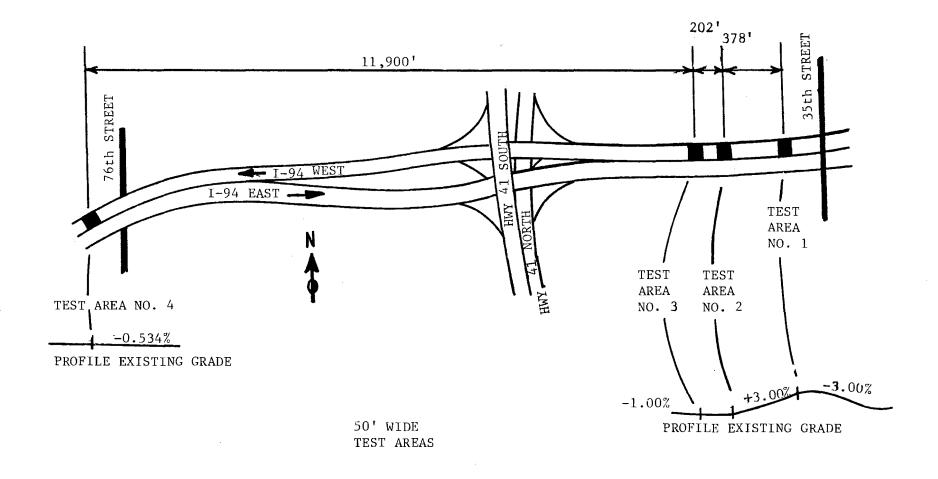
Figure 35. Lateral sweeping/flushing test area locations with profile grade - Milwaukee I-94.

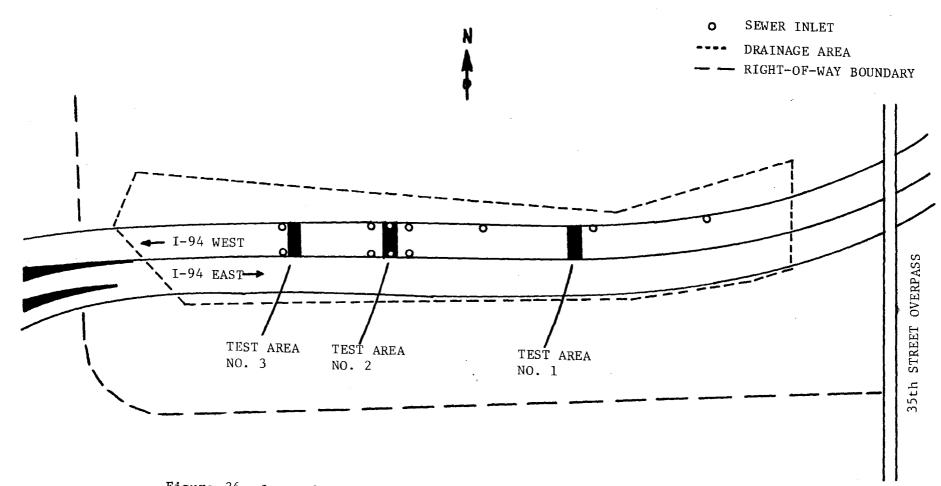
Figure 36. Lateral sweeping/flushing test areas relative to sewer inlets - Milwaukee I-94.

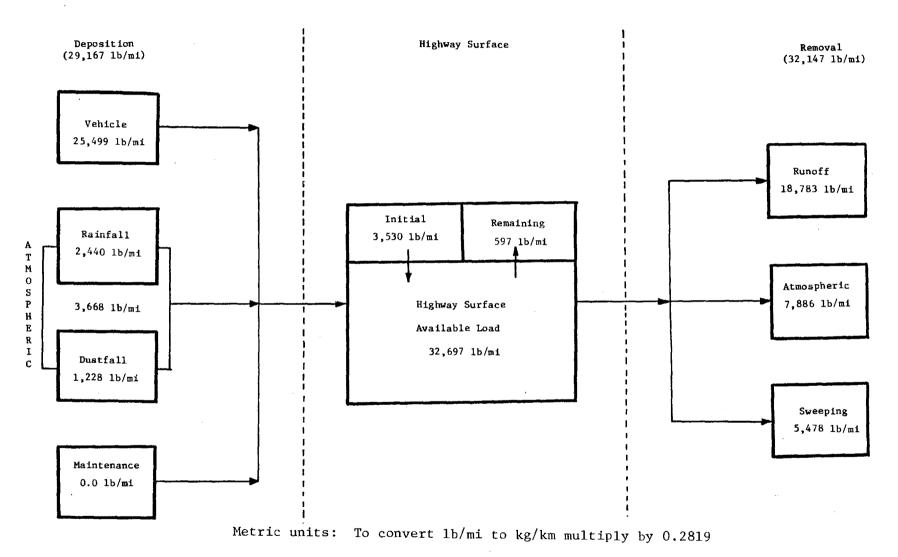
Figure 38.  ${\rm TS}_{250}$  mass balance for the Milwaukee I-94 site - April 17 through October 31, 1979.

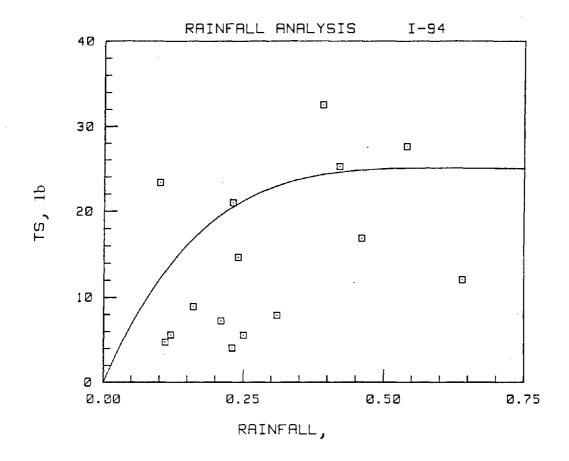
Figure 39. Scatterplot of rainfall volume and total solids loading with developed regression line.

Figure 39 shows the monitored rainfall quality data points and the developed regression line. This plot indicates that as rainfall volume increases, TS  $_{250}$  loadings increase asymtotically to 0.47 in. (1.19 cm) of rainfall to a maximum TS  $_{250}$  loading of approximately 25 lb/site area (11 kg/site area). Therefore, the maximum estimated loading for any unmonitored event was 25 lb/site area (11 kg/site area). Using the monitored TS  $_{250}$  loadings and those values estimated from the polynomial equation, the TS  $_{250}$  loading for the period April 17 through October 31, 1979, was calculated to be 3075 lb/mi (867 kg/km). However, comparison of monitored values to predicted values indicated an overestimate of 34 percent.

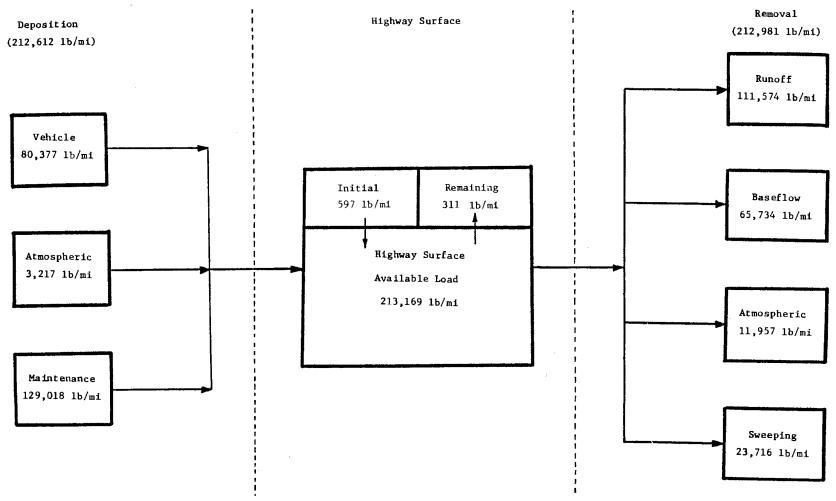
Figure 41. TS<sub>250</sub> mass balance for the Milwaukee I-94 site, November 1, 1979, through May 21, 1980.

The data (Figure 41) also indicate that the second largest source of  $TS_{250}$  to the highway surface during the winter period was vehicle related, 80,377 lb/mi (22,658 kg/km). The average daily traffic (ADT) monitored during the

period November 1, 1979, through May 21, 1980, was 114,389 vehicles per day. Using this ADT, the average winter vehicular deposition rate was calculated to be  $0.035~\rm lb/mi/vehicle$  (9.93 g/km/vehicle). The winter vehicular deposition rate was higher than the summer vehicular deposition rate of  $0.0011~\rm lb/mi/vehicle$  (0.31 g/km/vehicle). The higher winter vehicular deposition rate is probably due to increased exhaust emissions from stop-and-go driving during hazardous driving conditions, increased autobody rusting from caustic deicing agents, and "carry on" deposition.

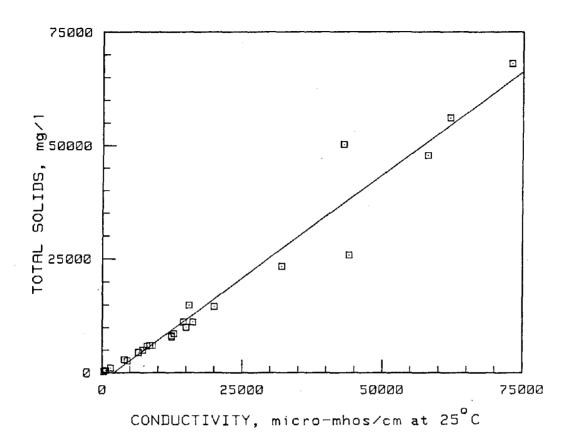
Figure 42. Scatterplot of winter baseflow total solids and conductivity data at the Milwaukee I-94 site.

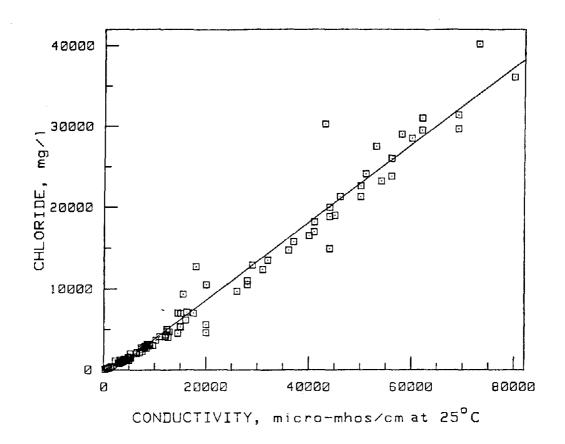
Figure 43. Scatterplot of winter baseflow chloride and conductivity data at the Milwaukee I-94 site.

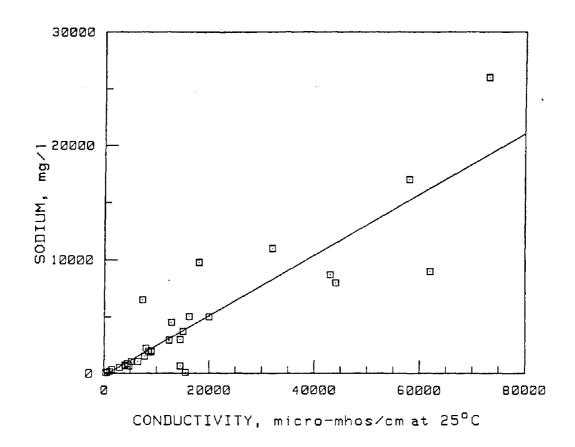
Figure 44. Scatterplot of winter baseflow sodium and conducivity data at the Milwaukee I-94 site.

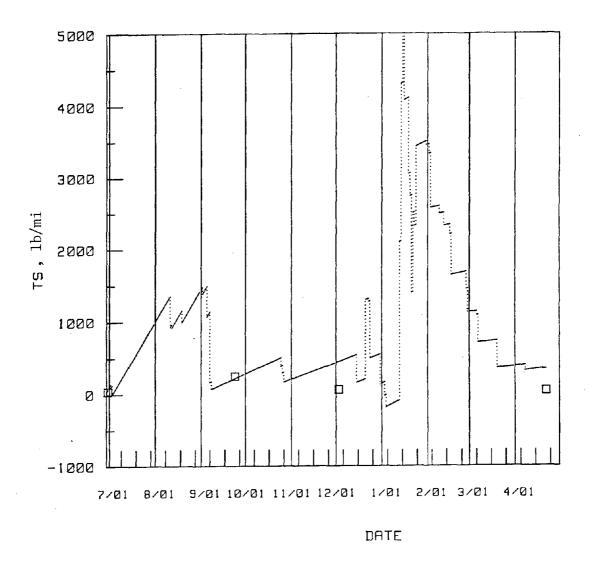
footnotemark Monitored  $TS_{250}$  highway surface load

The mass balance model graphically displayed in Figure 45 incorporates all atmospheric, runoff, surface load, and maintenance  $TS_{250}$  data during the period June 30, 1981, through April 22, 1982, at the Efland I-85 site. The graph shows that the last two surface monitored loads are low, but that overall the individually monitored components fit well into the mass balance. The mass balance indicates that the summer surface load peaked on September 4, 1981 [1506 lb/mi (425 kg/km)], and the winter surface load peaked on January 15, 1982 [5459 lb/mi (1540 kg/km)]. Milwaukee's peak summer surface load was 4,188 lb/mi (1,180 kg/km), and the peak winter surface load was 58,068 lb/mi (16,370 kg/km). The difference in peak surface load is probably due largely to differences in ADT and drainage design.

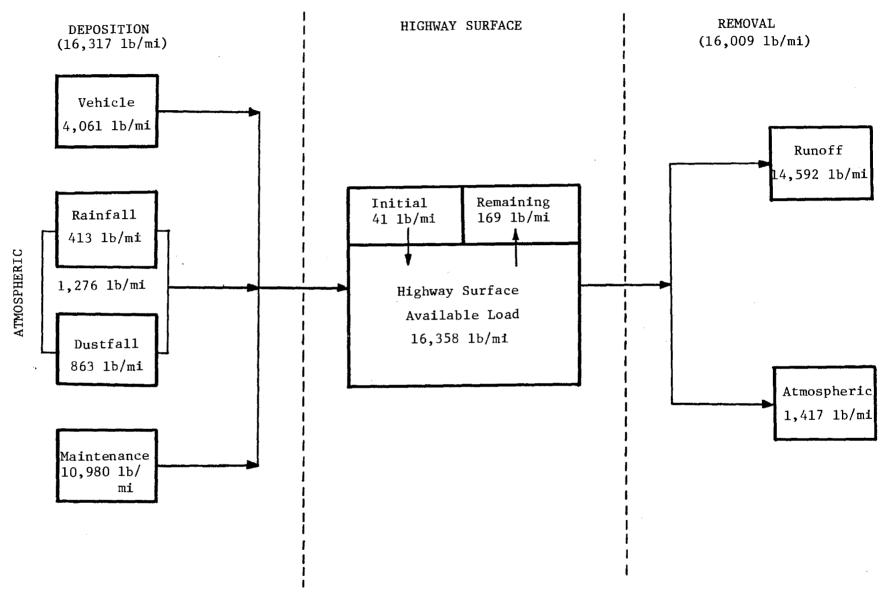
Figure 46. TS<sub>250</sub> mass balance for the Efland I-85 site - June 30, 1981, through April 22, 1982.

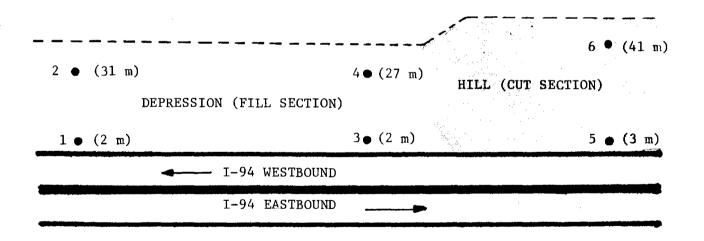
Figure 47. Soil and vegetation sampling scheme for the Milwaukee I-94 site.

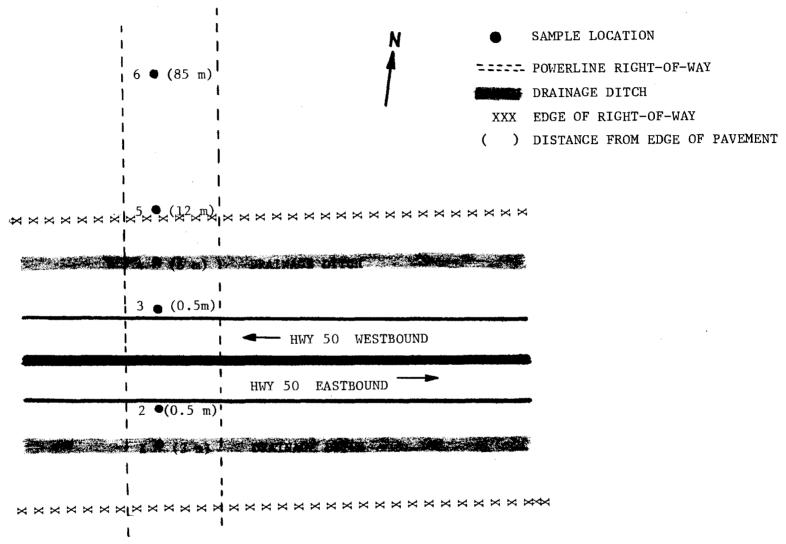
Figure 48. Soil and vegetation sampling scheme at the Sacramento Hwy 50 site.

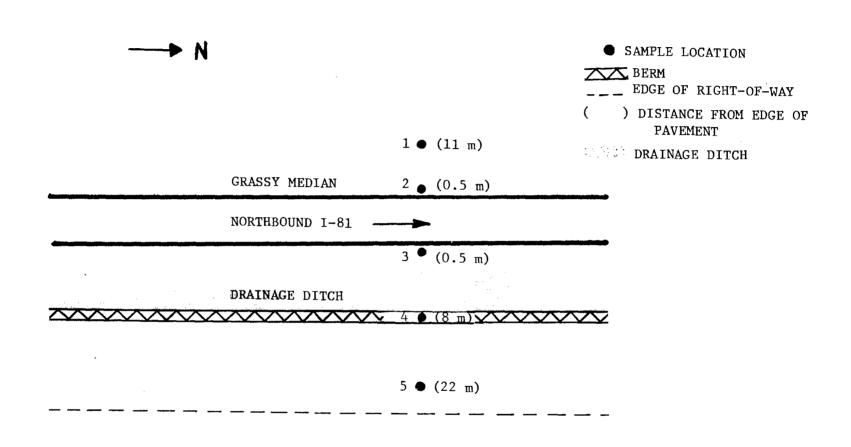
Figure 49. Soil and vegetation sampling scheme at the Harrisburg I-81 site.

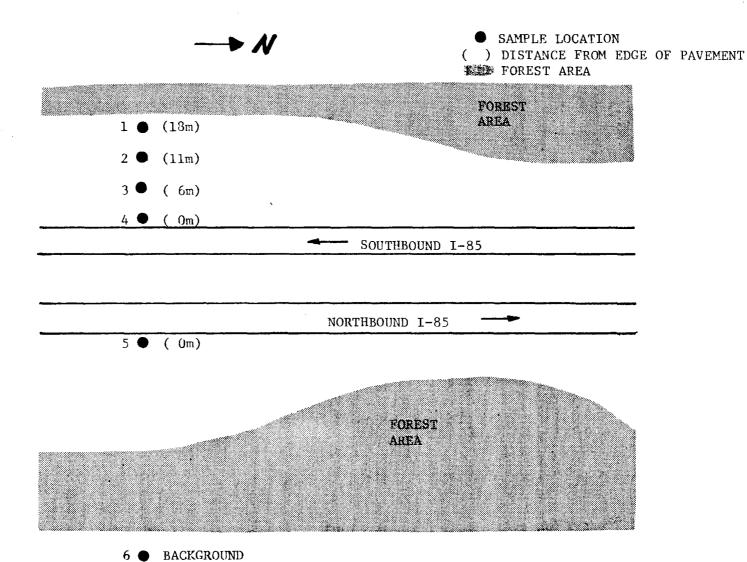
Figure 50. Soil and vegetation sampling scheme at the Efland I-85 site.

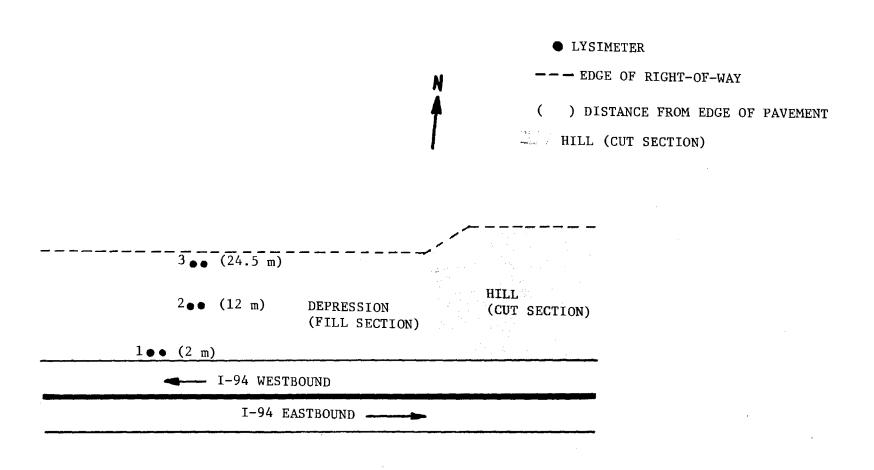
Figure 51. Lysimeter locations at the Milwaukee I-94 site.

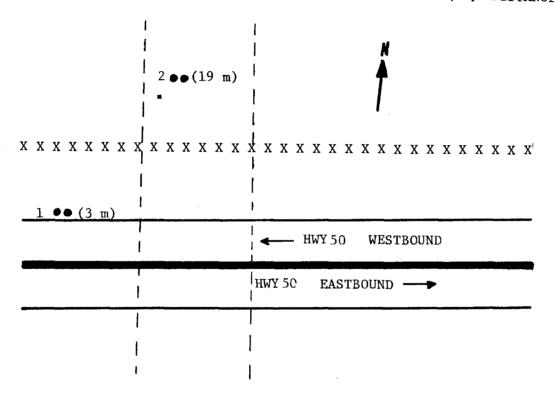
Figure 52. Lysimeter locations at the Sacramento Hwy 50 site.

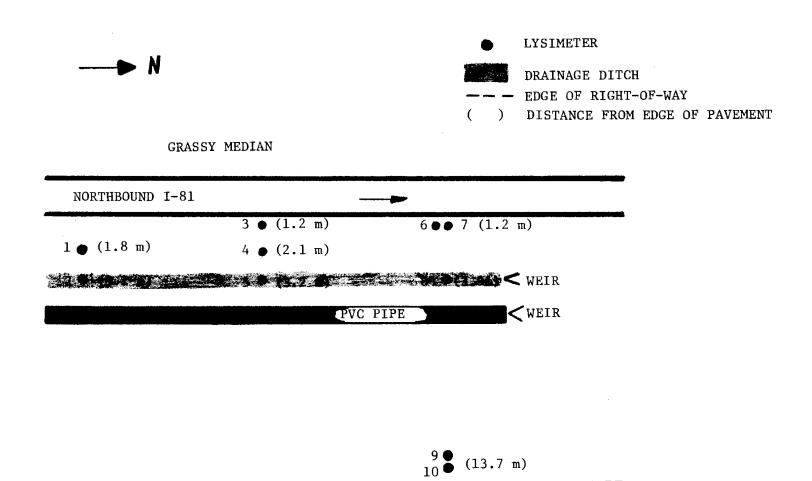
Figure 53. Lysimeter locations at the Harrisburg I-81 site.

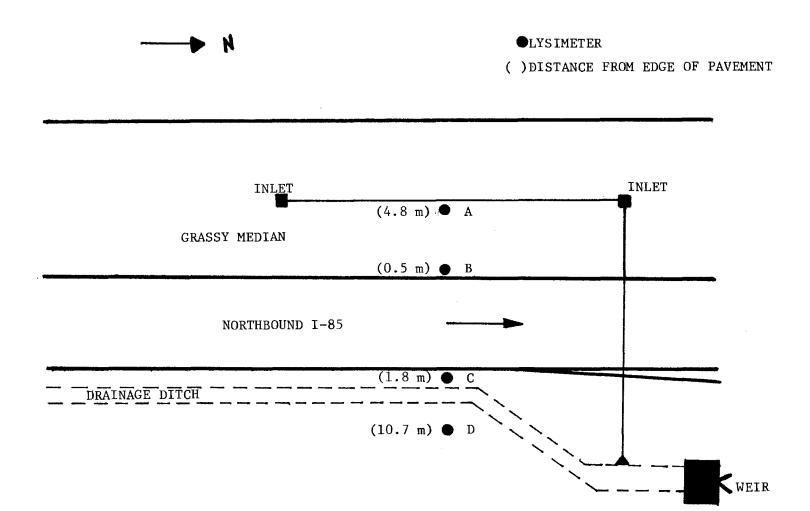
Figure 54. Lysimeter locations at the Efland I-85 site.
