**Project ID: 2020-SDSU-01**

**Post-Earthquake Serviceability Assessment of  
RC Bridge Columns Using Computer Vision**

**Final Report**

Departments of Civil and Environmental Engineering<sup>(a)</sup> and Computer Science<sup>(b)</sup>  
South Dakota State University  
Brookings, South Dakota

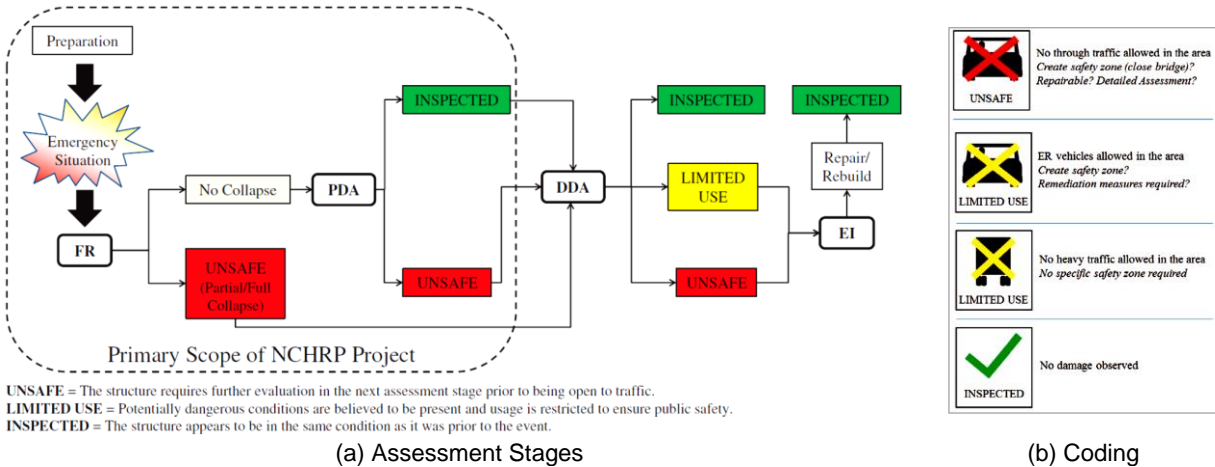
**Figure ES.2 – Transportation Infrastructure Assessment Stages and Coding (NCHRP 833)**

**Figure ES.2** graphically shows the assessment stages and coding after an event based on NCHRP 833. When the structure is not obviously collapsed as determined in the Fast Reconnaissance (FR), onsite assessment is needed by trained emergency responders and engineers to tag the affected structures. Such assessment may require closure of the structures for hours and days after an event, which are the most critical hours for rescue operations.

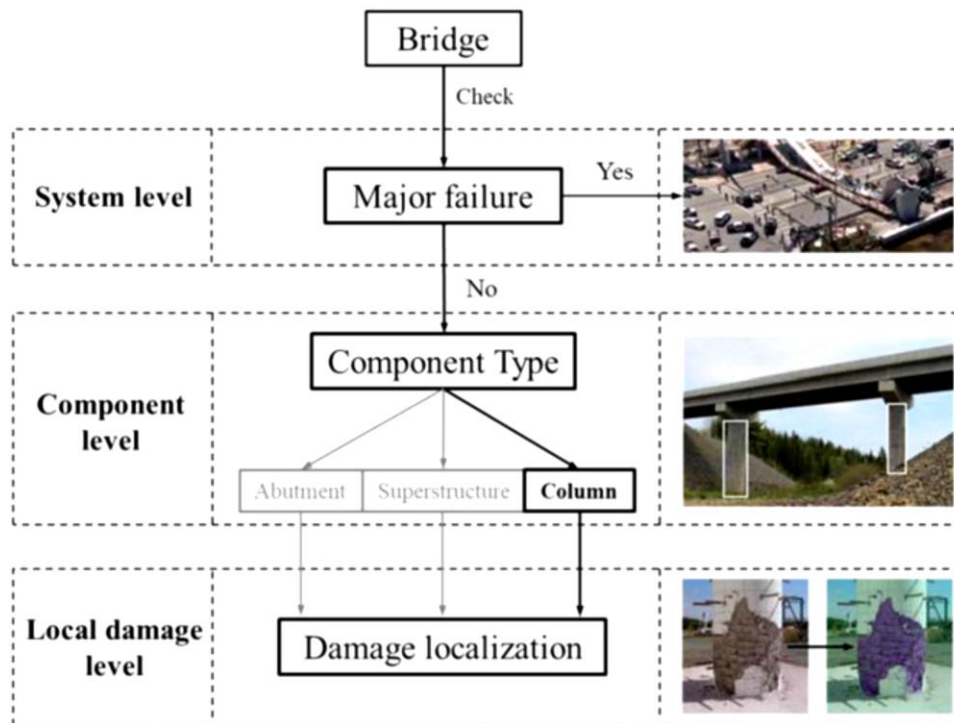
**Figure ES.4 – Automated Image-Based Bridge Inspection Method (Liang, 2019)**

Liang (2019) proposed a three-level image-based post-event inspection approach in which bridge failure, bridge columns, and column damages (cracking, spalling, and exposed rebar) can automatically be detected (**Fig. ES.4**). An image database including 1,154 photographs was formed, of which 80% was used for the labeling and network training and 20% was used for testing (evaluation). Bayesian optimization was used to enhance training with low number of images. The accuracy of the proposed method for the bridge failure detection was 98%, for the column detection was more than 80%, and for the column damage detection was 93%.

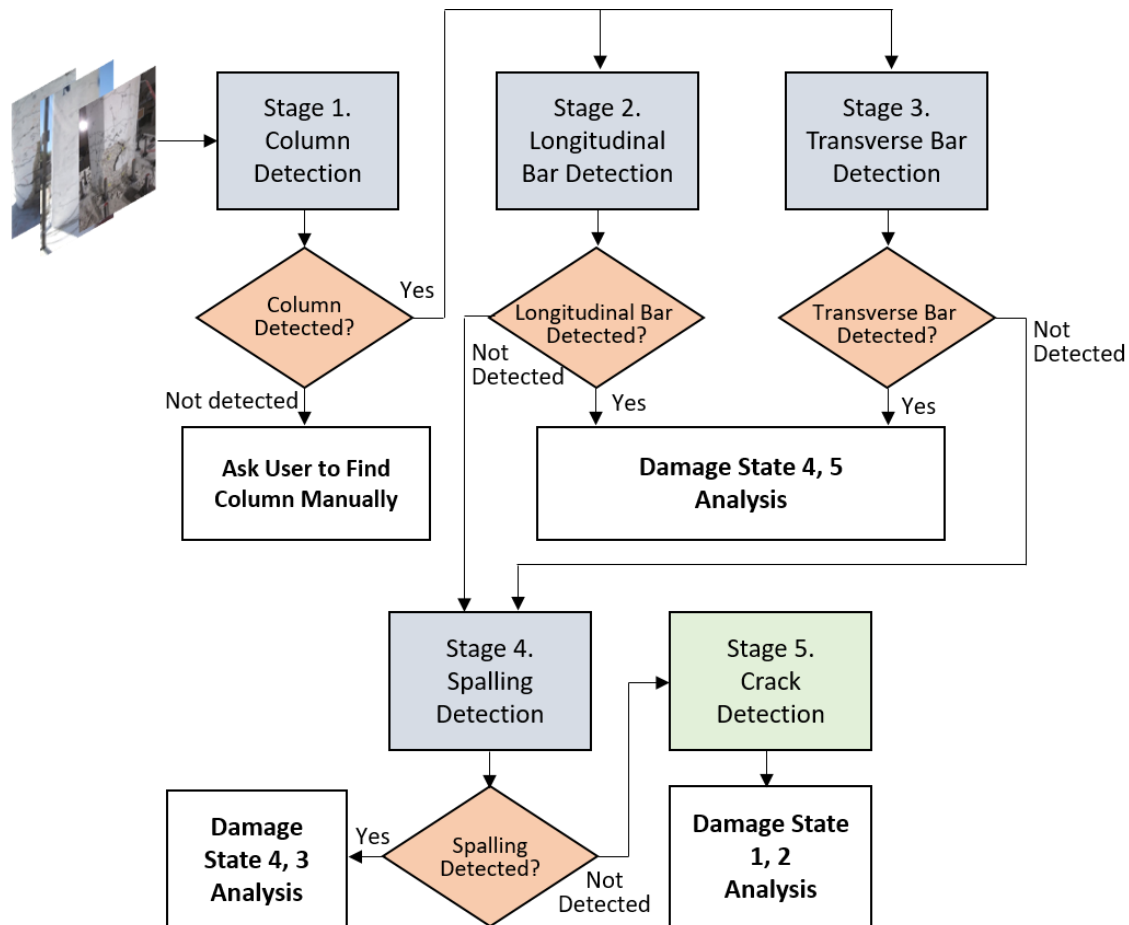
Figure ES.10 – AI-based Damage State Decision Flowchart

In this project, a deep learning technique was used to detect damages and quantify their properties for the subsequent detailed damage assessment step. An instance segmentation technique (e.g., Mask R-CNN by He et al., 2017) was used to detect damages. The segmented regions were used to extract useful properties, such as length, orientation, and the number of instances within a specific region (Yein et al., 2018). A cascade approach was developed by using deep neural networks (DNNs) designed for classification (e.g., MobileNet by Sandler et al., 2018) and instance segmentation (e.g., Mask R-CNN) tasks. MobileNet V2, a CNN architecture for classification, was used for detecting cracks by classifying small image patches. Mask R-CNN was used to detect and segment the target column, spalling, and exposed vertical/horizontal bars in the image. The outputs of the DNNs were processed to extract the parameters used in defining the column damage state.

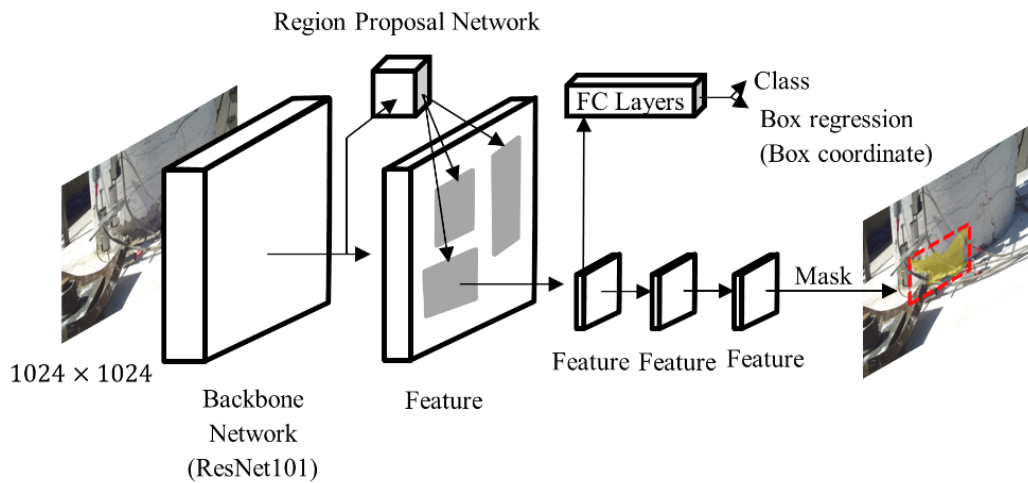
**Figure ES.11 – Mask R-CNN Overall Network Architecture**

Mask R-CNN (**Fig. ES.11**) was used for the initial detection of the damaged regions. ResNet101 (He et al., 2016) architecture was used as the backbone network, which is responsible for hierarchical spatial feature extraction. The Region Proposal Network (RPN) in the Mask R-CNN architecture generates anchors (rectangular areas of various scales and aspect ratios) over the image and scores the probability of the existence of objects at each location and bounding box. Bounding boxes with high probability were selected and downsized to a unit scale for the subsequent classification layers and mask generation layers. The classification subnetwork was fully connected layers with categorical output. The mask generation was done by predicting the binary value of each pixel in the mask. The size and location of the results of these subnetworks were recovered with respect to the input image. The backbone network is typically trained on a very large image dataset, such as ImageNet (Krizhevsky et al., 2012). However, the other components of Mask R-CNN must be retrained on the target problem and dataset.

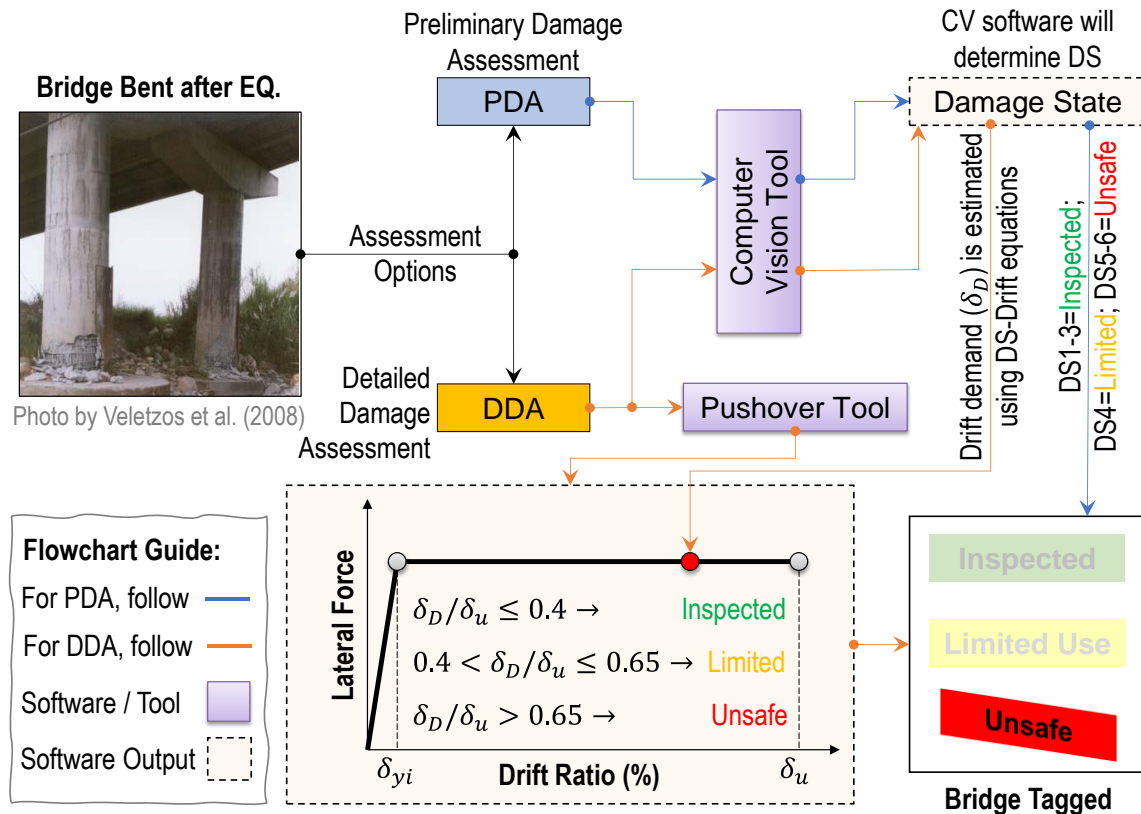
Figure ES.13 – Proposed Post-Earthquake RC Bridge Column Evaluation Using Computer Vision

In PDA, the user (who may not necessarily be a trained inspector or bridge engineer, but an authorized local personnel) will upload the bridge column damage photograph(s) to the computer vision tool (CVT). The photographs can be taken by a camera, cellphone, tablet, or drone. Per each photo of the column, this tool counts the exposed longitudinal and transverse bars, if any, measures the maximum spalled region length, if any, and counts the number of horizontal and vertical cracks. Subsequently, the column damage state (DS) is determined, and its serviceability is evaluated based on the proposed DS definitions (**Table ES.2**). For example, if DS4 is reported by CVT, the bridge is “yellow” tagged meaning that it should be open only to light traffics and first responders.

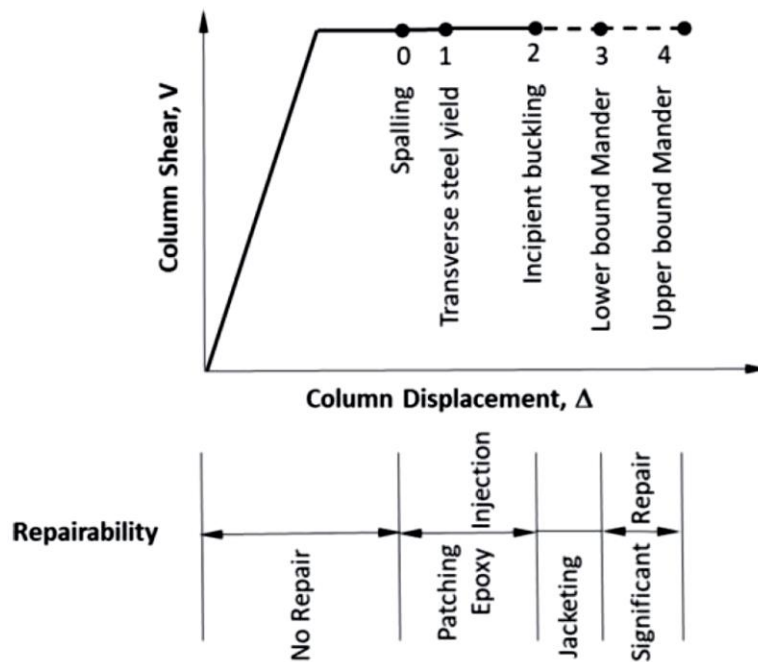
**Figure 2.15 – Various Limit States for RC Bridge Columns (NCHRP 949)**

NCHRP 949 (Murphy et al., 2020) recently proposed a three-level performance assessment for RC bridge columns using a pushover analysis based on steel bar and/or concrete strain limits (**Table 2.14**). **Figure 2.15** illustrates five points on a pushover curve that was used to impose limitations per performance level. It should be noted that the proposed strain-based assessment is best suited for a new design or in-depth analytical studies of damaged columns since structural analyses are needed to obtain the strain-displacement response of the column/bent.

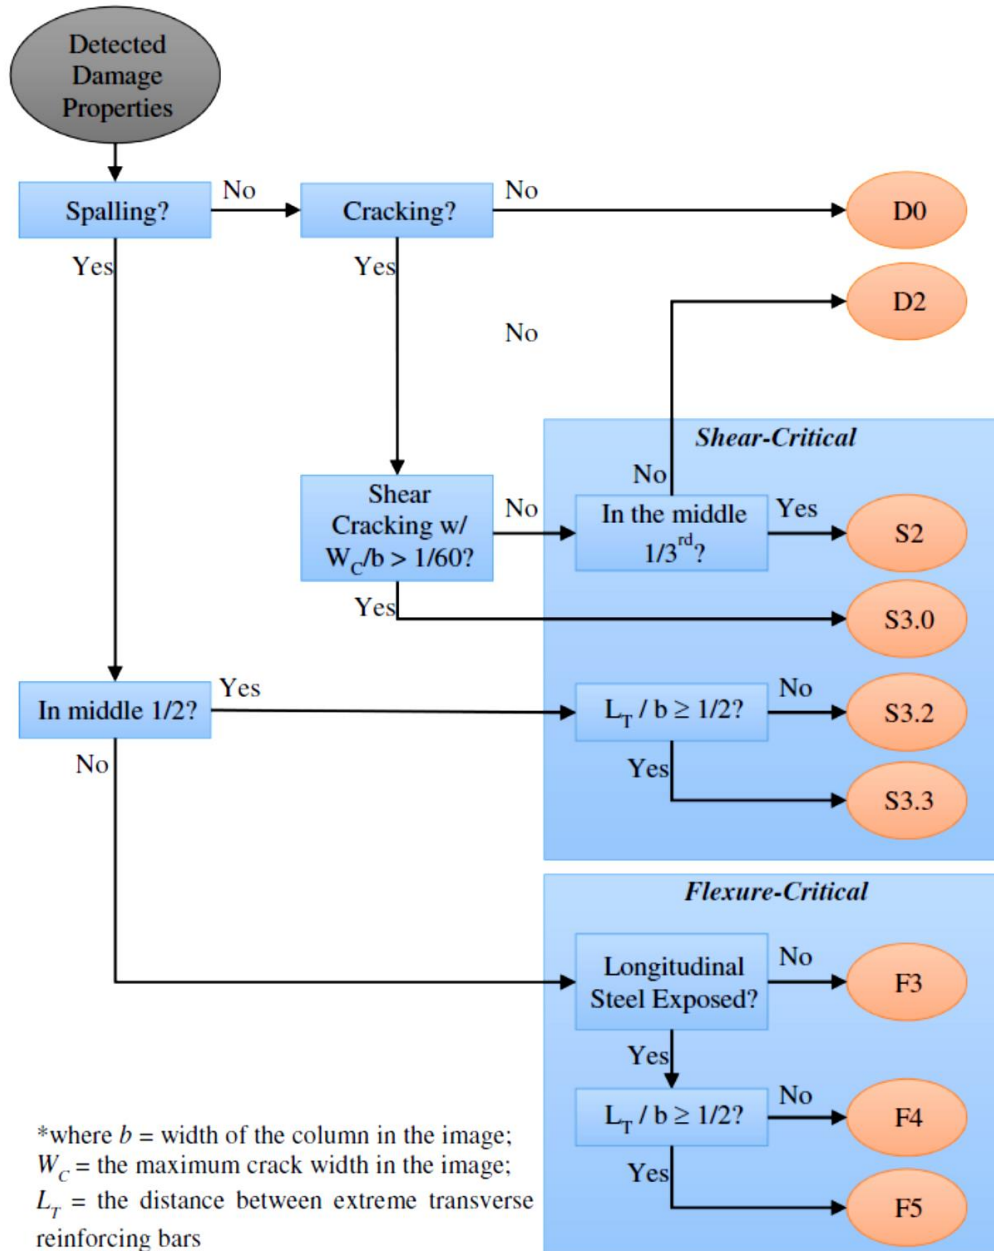
**Figure 2.24 – Automated RC Building Column Damage State Estimation (Paal et al, 2015)**

Computer vision may be incorporated to expediate post-event structural inspection and document damages automatically. German et al. (2013) and later Paal et al. (2015) developed a framework to automatically detect RC building columns and their earthquake-caused damages, and to estimate the column damage state then the corresponding drift demand. **Figure 2.24** shows a flowchart on how to determine the RC column damage state, which then will be used to estimate the drift demands using a statistical analysis of column test data (e.g., **Table 2.19**). For 50 column images, the overall accuracy for the damage state estimation was 88.5%. This might be the most advanced work that has been done in this topic on buildings. Such methods yet to be developed and implemented for bridges.
