AC NO: 20-76

# ADVISORY CIRCULAR

**SUBJECT:** MAINTENANCE INSPECTION NOTES FOR BOEING B 707/720 SERIES AIRCRAFT

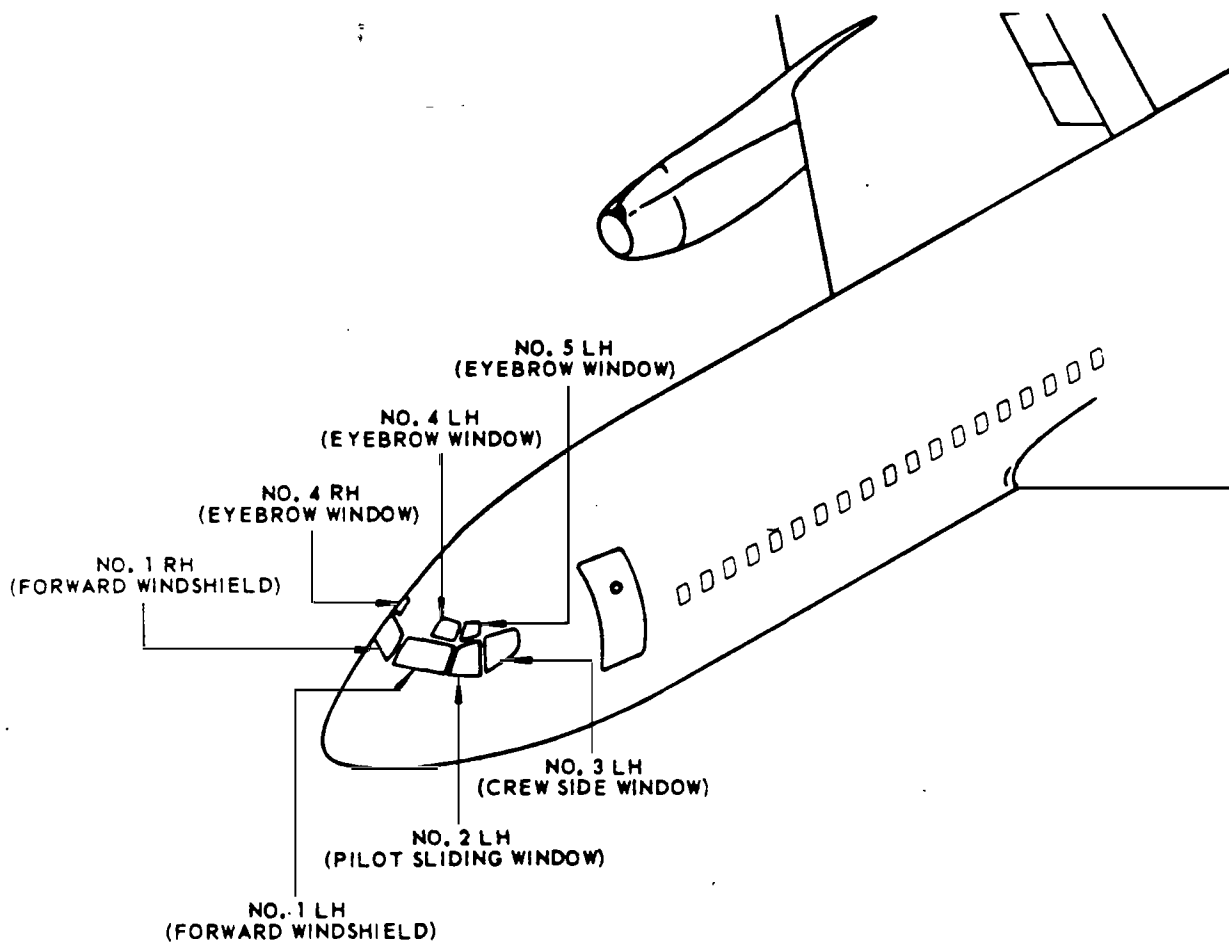
FIGURE 1. CONTROL CABIN WINDOW LOCATIONS

- (1) Inspection. Examine each window for:
- (a) Scratches, cracks, delaminations, discoloration of panes, and chipping.
  - (b) Binding of sliding windows, positive locking and locking mechanism release, seal deterioration, wear of bushings and guides.

- (c) Loose or missing window frame fasteners.
  - (d) Rain repellency of windows.
- (2) Scratched Windows.
- (a) Inner pane scratched. Inner pane scratches may contribute to a window failure under cabin pressure and heat.

- (b) Outer pane scratched. Scratches on the outer pane reduces pane strength under normal cabin pressurization conditions. Any scratch causes stress concentration.

- (3) Cracked panes. Any window with a cracked pane should be replaced.
  - (a) Inner pane cracked. This pane takes pressurization load and the airplane should not be pressurized if this pane is cracked.

- (b) Outer pane cracked. Cracks that extend toward the center of the pane or span the pane usually become progressively worse and the pane should be replaced at the first opportunity.

- (c) Cracking of vinyl usually occurs in the upper aft corner of the No. 1 windshields. It is a fail-safe, bird-proof core. The window should be replaced at the first opportunity.

- (4) Delamination. A delamination is the separation of either pane of glass from the vinyl core. When minor delamination occurs between the inner or outer pane and the vinyl core, the airplane could be flown pressurized. An electrically heated window need not be replaced due to delaminations unless the visibility is restricted or lack of window heating, or the pane is scorched.

- (5) Chipping. Chips on the laminated surface of the glass are layers or flakes of glass broken from a surface by excessive stresses. Presence of glass chips on laminated surface should be reason enough for window replacement if airplane is to be pressurized.

- (6) Arcing. Arcing will produce hot spots with possible eventual result of a cracked pane.
- b. Passenger Cabin Windows. These windows are located between the fuselage frames in the areas where passenger seating is provided. Passenger cabin windows consist of outer, center, and inner panes. The outer and inner panes are each capable of taking the full cabin pressurization load. The inner pane is nonstructural. All three panes are acrylic. The emergency exit hatch passenger window installations are very similar to those for the outer and center panes of the other passenger windows. (See Figure 2).

- (b) Scratches are easily detected by visual examination and are critical if they exceed certain limits. Manufacturer's maintenance manuals provide recommended limits on scratch, depth and length and should be consulted. (Figures 1 & 2)

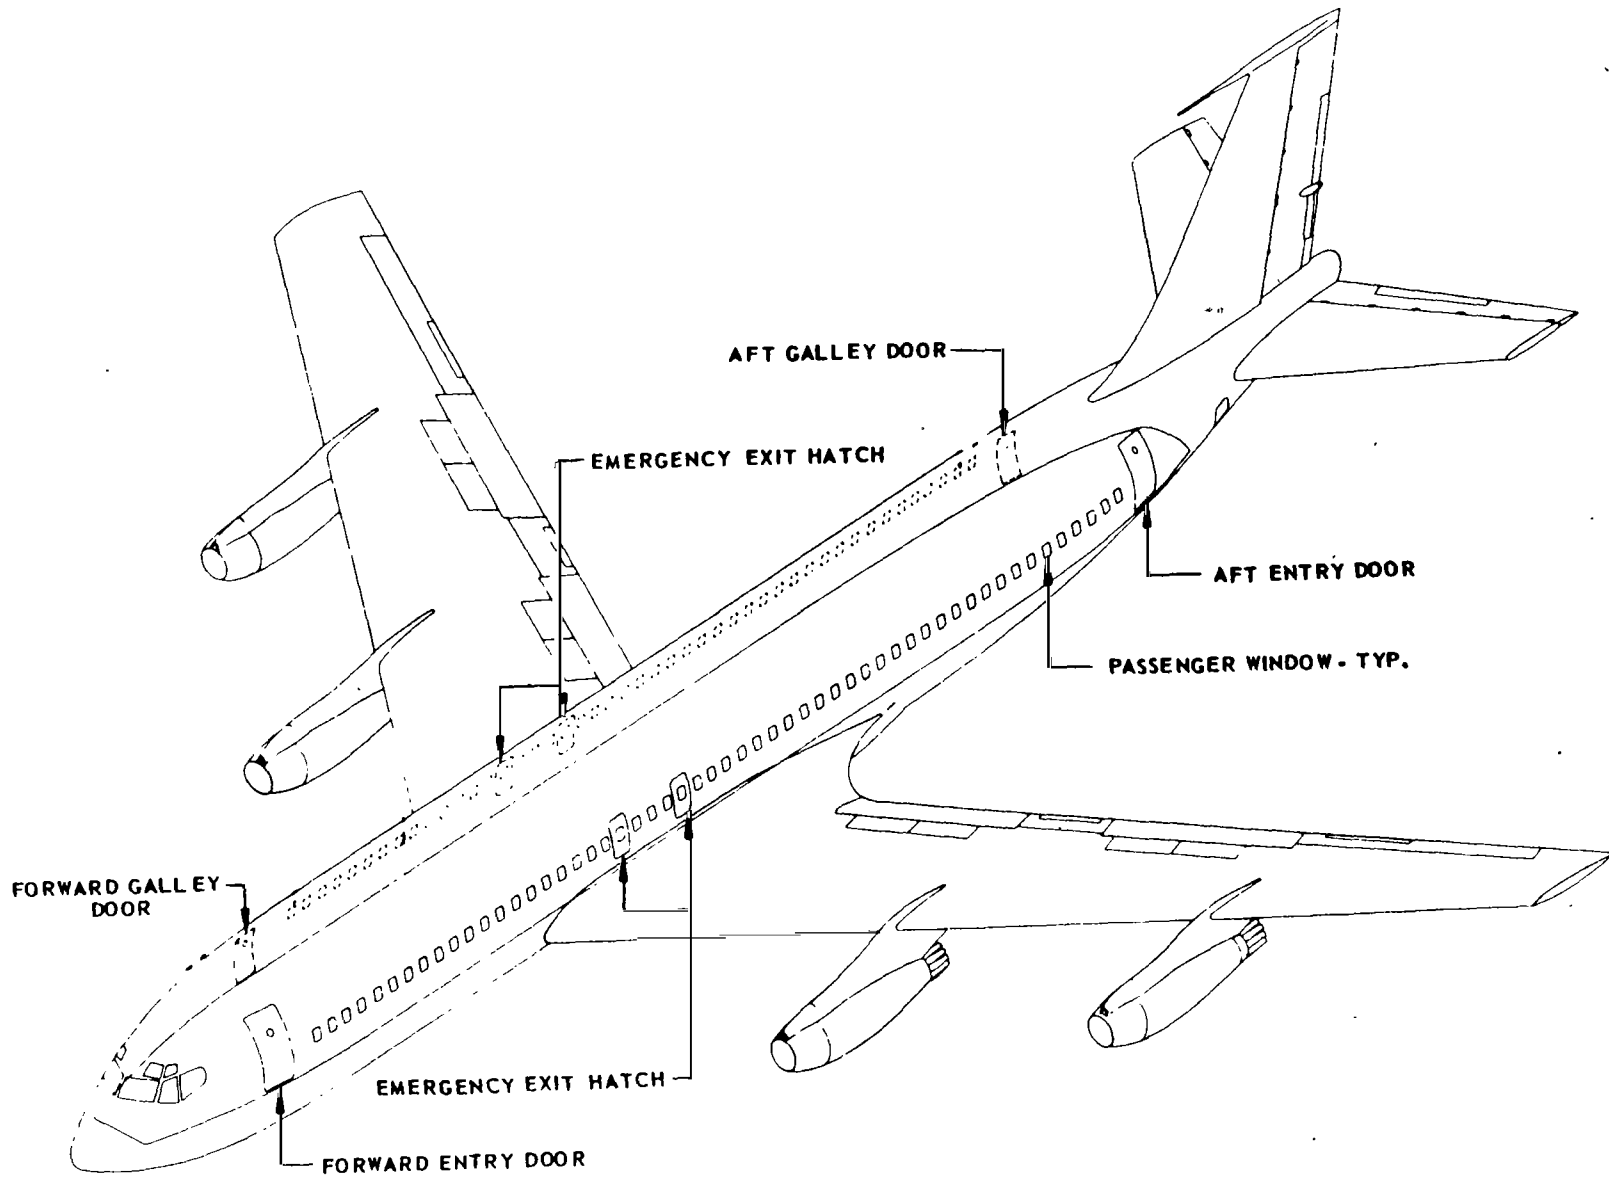
FIGURE 2 PASSENGER CABIN WINDOW LOCATIONS

- (1) Inspection/checks of passenger cabin windows. Examine the window for:
    - (a) Scratches, cracks, and crazing of acrylic panes.
    - (b) Deterioration of seals.

- (c) Marks, Scratches, and dents.
    - (d) Loose or missing fasteners at window retaining brackets.

- (1) Optical and visibility criterion should be established by the operator.
  - (2) A crack is a fissure perpendicular to the surface which extends completely through the pane. Airplane should not be pressurized with a cracked pane.

- (3) Crazing is a series of small fissures perpendicular to the surface but not extending through pane. Crazing can be caused by improper pane installation or exposure to certain liquids.

- (a) Surface crazing is permissible within certain limits if not a routed edge.
    - (b) Routed radius crazing of a pane is more serious than in the overall surface. Since routed crazing requires pane removal to monitor the extent of crazing, the pane may as well be replaced.

- (4) Delamination is a separation of adjacent layers of laminate parallel to pane surface. Manufacturer's maintenance manuals provide recommended delamination limits and should be consulted.

- (5) Scratches in routed radius will be impossible to see, unless window pane is removed.
    - (a) Scratches are most likely found on the exterior surface of the pane which is exposed to weather and washing and accompanying foreign bodies which inevitably get on that surface.
