# Emergency Relief Program Resilience Case Study – Colorado

## Reducing Risk through Rockfall Mitigation

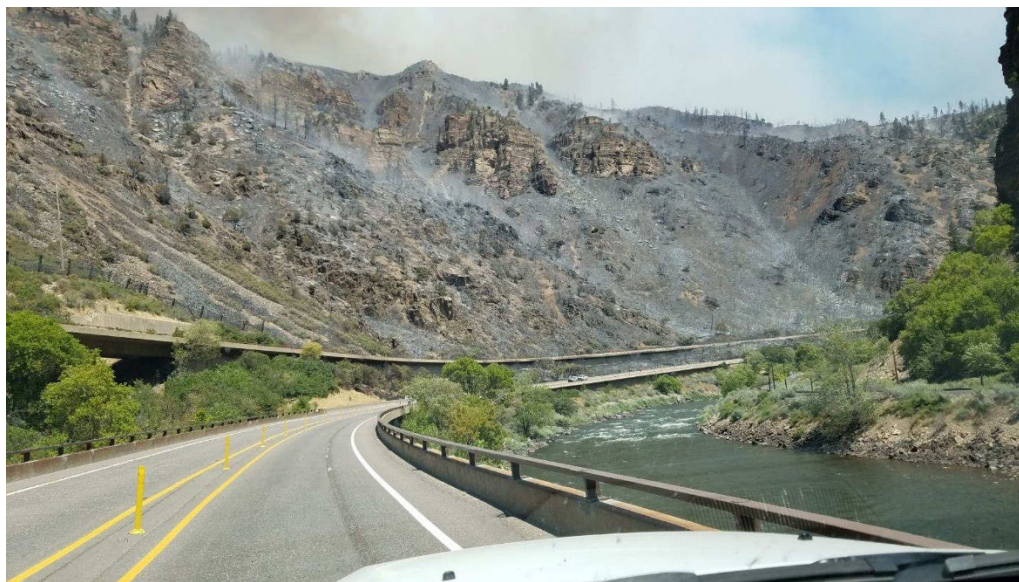
*The Grizzly Creek fire left burn scars along I-70 in Glenwood Canyon. Source: FHWA*

Immediately following the Grizzly Creek fire event, CDOT began conducting emergency repairs to allow emergency vehicles to access the area and repair the damaged portion of I-70. CDOT also began assessing the need for permanent repairs to restore and replace the rockfall fences damaged by the fire. Because the section of I-70 through Glenwood Canyon had experienced numerous rockfall events since it was first constructed, CDOT analyzed options to improve the long-term resilience of the roadway.

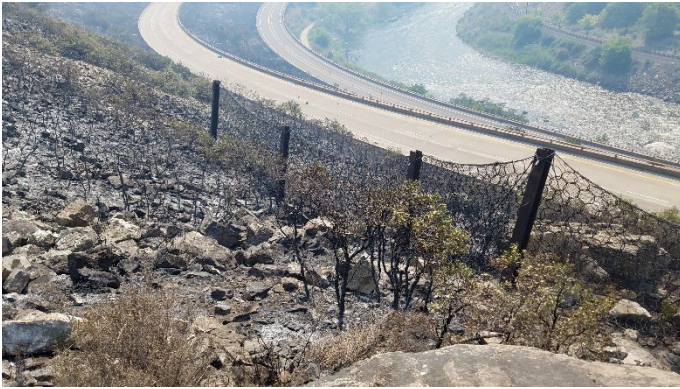
Rockfall fencing. Source: FHWA

In Spring 2021, CDOT installed a temporary 7-foot-tall barrier rockfall fence, which will be removed once vegetation is re-established on the burn scar (in approximately 5 years). The agency also installed two new rockfall fences—a 1-kj fence at milepost 121 and a 3-kj fence at milepost 123—to reduce the risk of damage from future small and medium rockfall events. The rock wall fencing substantially decreased the number of closures of the roadway due to minor rockfall events and minimized disruption to the traveling public overall. In July 2021, shortly after the fences were installed, intense rainfall events caused flooding in the area. The resulting mudslides and extensive debris flow, which was a greater magnitude than the fencing was designed to absorb, destroyed some of the newly installed fencing. While it is difficult to mitigate for such low-probability extreme events, CDOT is planning to repair the fencing to minimize damage caused by more commonly experienced small and medium rockfall events.

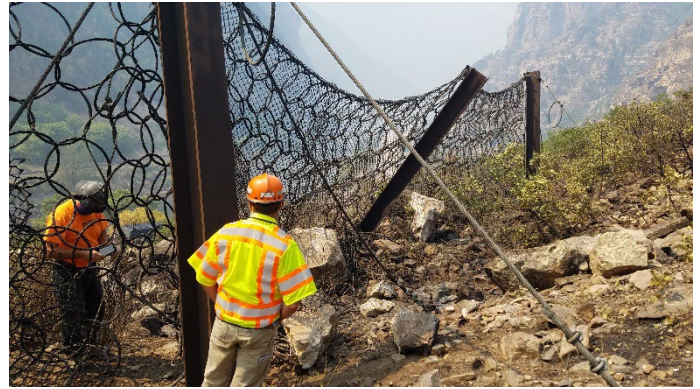
Section of rockfall fencing damaged by a debris flow. Source: FHWA
