ALTERNATIVE APPROACHES TO INSPECTIONS FOR FEDERAL LAND MANAGEMENT AGENCY ROADS

*Using Uncrewed Aircraft Systems to Support the Road Inventory
Program*

December 2023

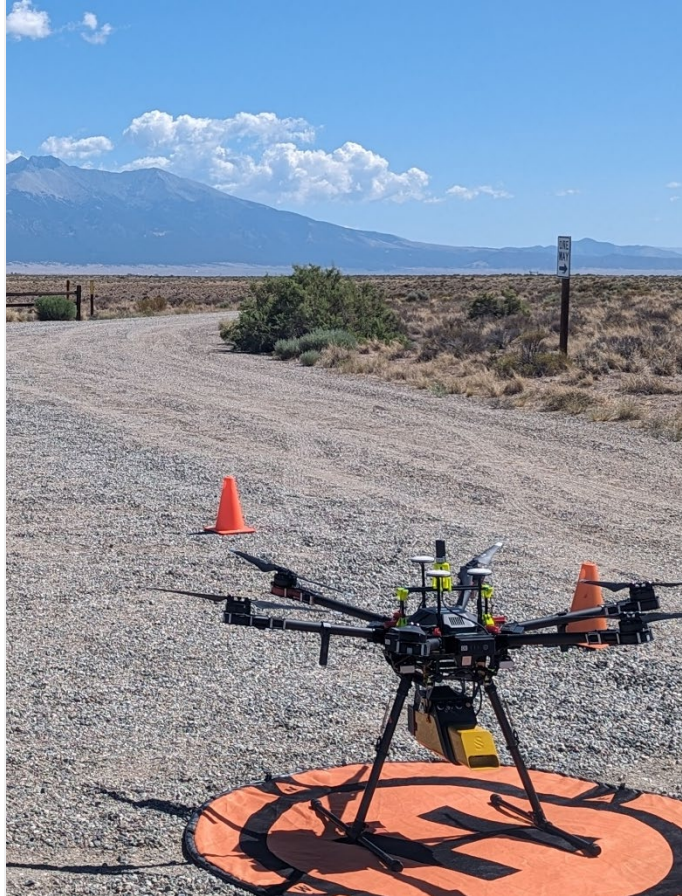
Figure 3. DJI Matrice 600 Pro with YellowScan VX20-100 lidar

After a safety briefing, USGS and FLH conducted a series of UAS flights in accordance with the Project Aviation Safety Plan. The mission entailed a total of eight UAS flights—four to acquire lidar data and four to acquire imagery using a Firefly Alta X. Each flight was between 8 to 10 minutes long following two parallel transect passes along either side of the road of interest for a total of approximately 60 to 80 minutes of flight time. Total flight distance was approximately 6.5 miles (cumulative out and back distance for all roads of interest). Launch points for the lidar flights and imagery flights were slightly different from one another due to staging considerations and, for the last imagery flight of the demonstration, remaining battery life. All but one flight was flown at 200 feet (61m) AGL; one lidar flight was flown at a lower altitude for the sake of comparison.²⁷ Only lidar-acquisition flights were flown on the first day of the demonstration. Strong winds in the afternoon prevented any additional UAS flights, including any for imagery acquisition.²⁸ With nondisruptive weather on the demonstration's second day, the team coordinated lidar and imagery flights to alternate in time and space in order to streamline safe operations while sharing the GPS base station and GCPs; there was no occasion where more than one UAS was operating coincidentally.

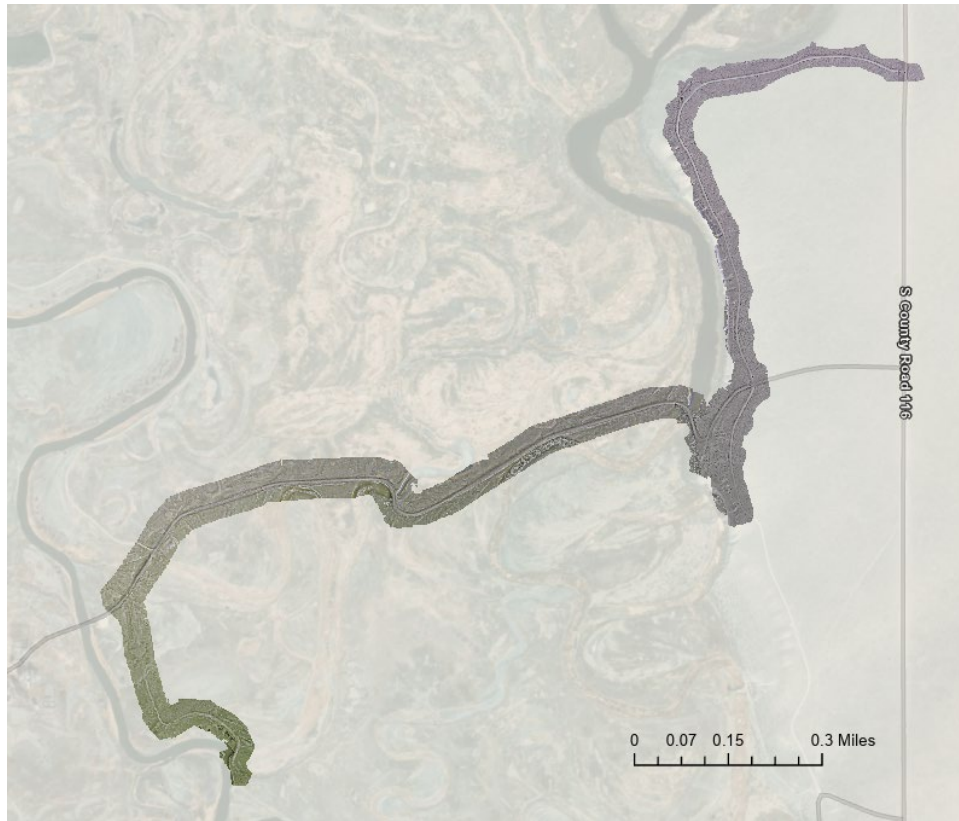
Figure 4. Orthomosaic of Unpaved Road at Alamosa NWR

The project team created a photogrammetrically corrected orthomosaic image using ArcGIS Pro’s Ortho Mapping Product generation tools (Figure 4). Imagery data were loaded into the workspace to create an image collection. During this step, seven images that had not rendered a geolocation (Lat (X), Long (Y), and elevation (Z) values) were removed from the collection. ArcGIS Pro automatically detected the spatial reference (WGS_1984_UTM_Zone_13N), camera model, and additional camera parameters. Default settings were used for all other parameters. Once the images were combined to make an image collection, the project team geometrically and color corrected it using the “Block Adjustment” and “Tie

Point Matching” geoprocessing tools with default settings. All settings were left at their default to create an orthomosaic image, except the output format, which was changed from a CRF file format to a TIF.

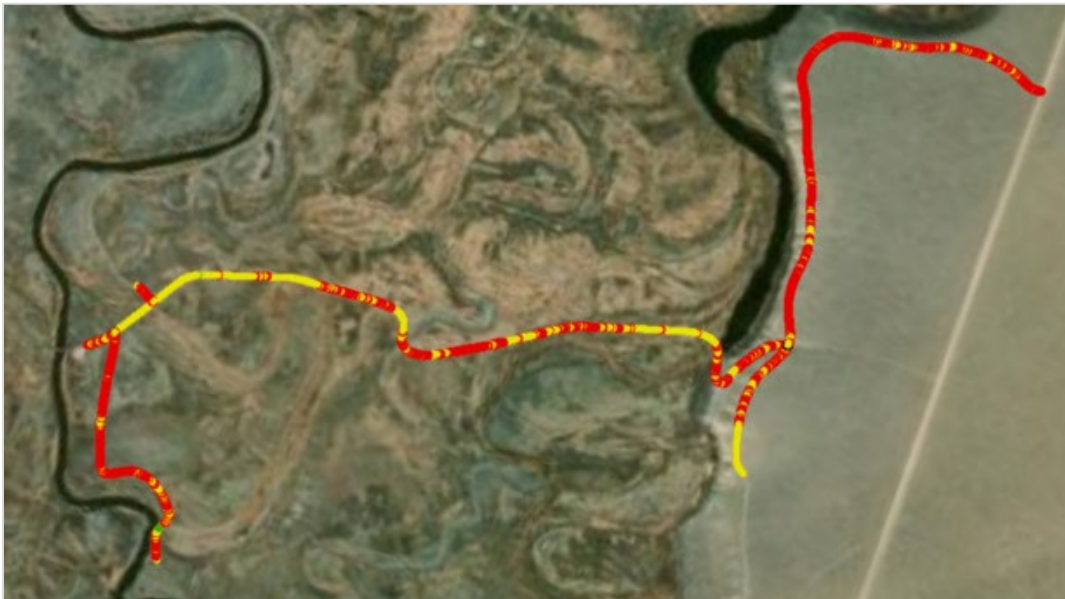
Figure 8. Drainage Ratings at One-Foot Intervals

However, considering the level of detail metric on a distress-by-distress basis offers additional nuance. Namely, the crown and drainage scores derived from the GIS analysis are currently believed to have a higher degree of reliability than the scores for the other distresses given the scale currently used in the rating criteria. Crown and drainage measurements were able to quickly be taken every one foot (Figure

8), revealing that the roads of interest were relatively flat or bowled. It is notable that this consequently made the final road ratings appear more severe than the ratings from the current RIP approach, failing to consider the local context (e.g., the arid environment; some roads being on a high bluff; etc.).

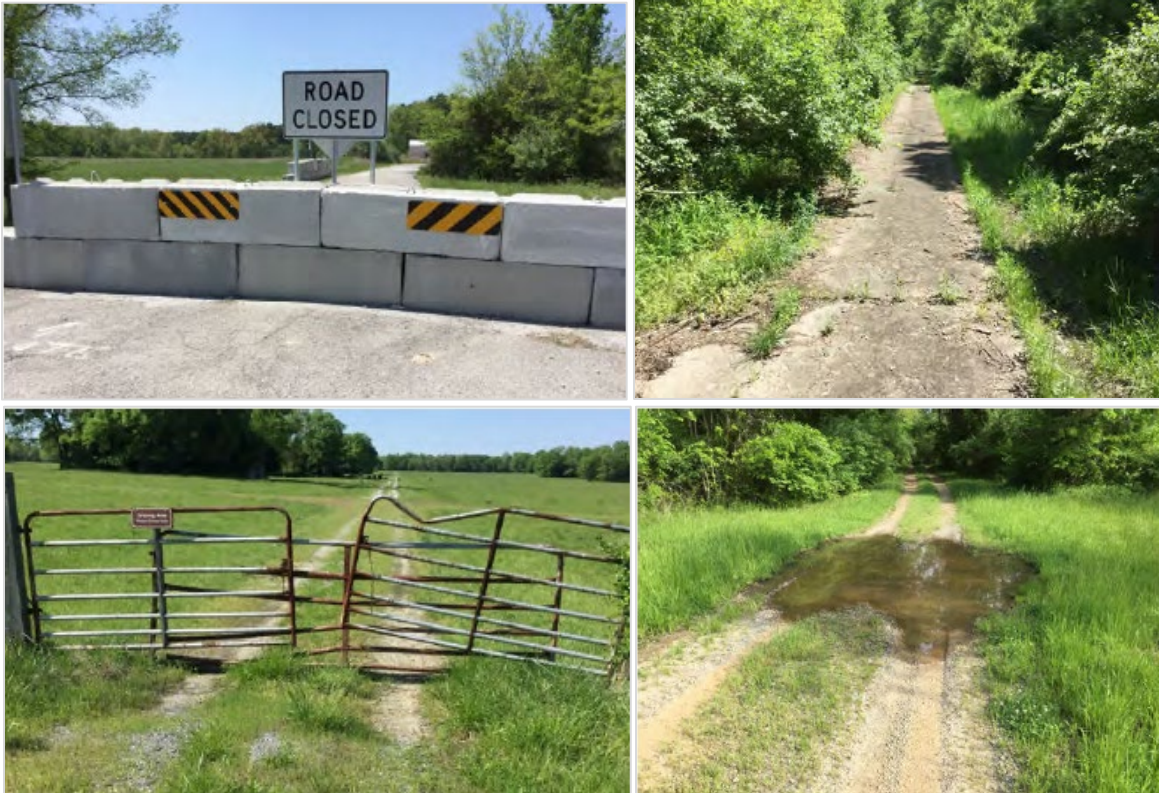
Figure 9. Example Obstructions Limiting Road Data Collection. Images clockwise from top left: concrete blocks marking closed road, overgrown vegetation, closed gate blocking travel, and soft roadbeds. Source: FWS

⁴⁰ The project team reviewed final RIP Road Condition Inventory Reports for geographically diverse FWS stations to better understand to what extent obstructions might hamper collections. Reasons for unpaved road mileage *not* being collected included the presence of concrete blocks, severe erosion, overgrown or fallen vegetation, closed gates, inundated and soft roadbeds, construction, and access restrictions due the presence of a military base.

approaches do not. They also can help minimize danger to teams because the pilot and team can choose the location(s) of UAS operations thus reducing their exposure to potentially unsafe conditions. This benefit was observed during the demonstration on Route 301 where the road eventually became impassable to vehicles. The UAS could have safely continued the data collection beyond the point at which the road could be driven.
