**TR-788: MITIGATION OF
CHLORIDE-INDUCED
CORROSION THROUGH
CHEMISORPTION**

**FINAL REPORT
IHRB PROJECT TR-788**

JULY 2023

**SPONSORED BY
THE IOWA HIGHWAY
RESEARCH BOARD**

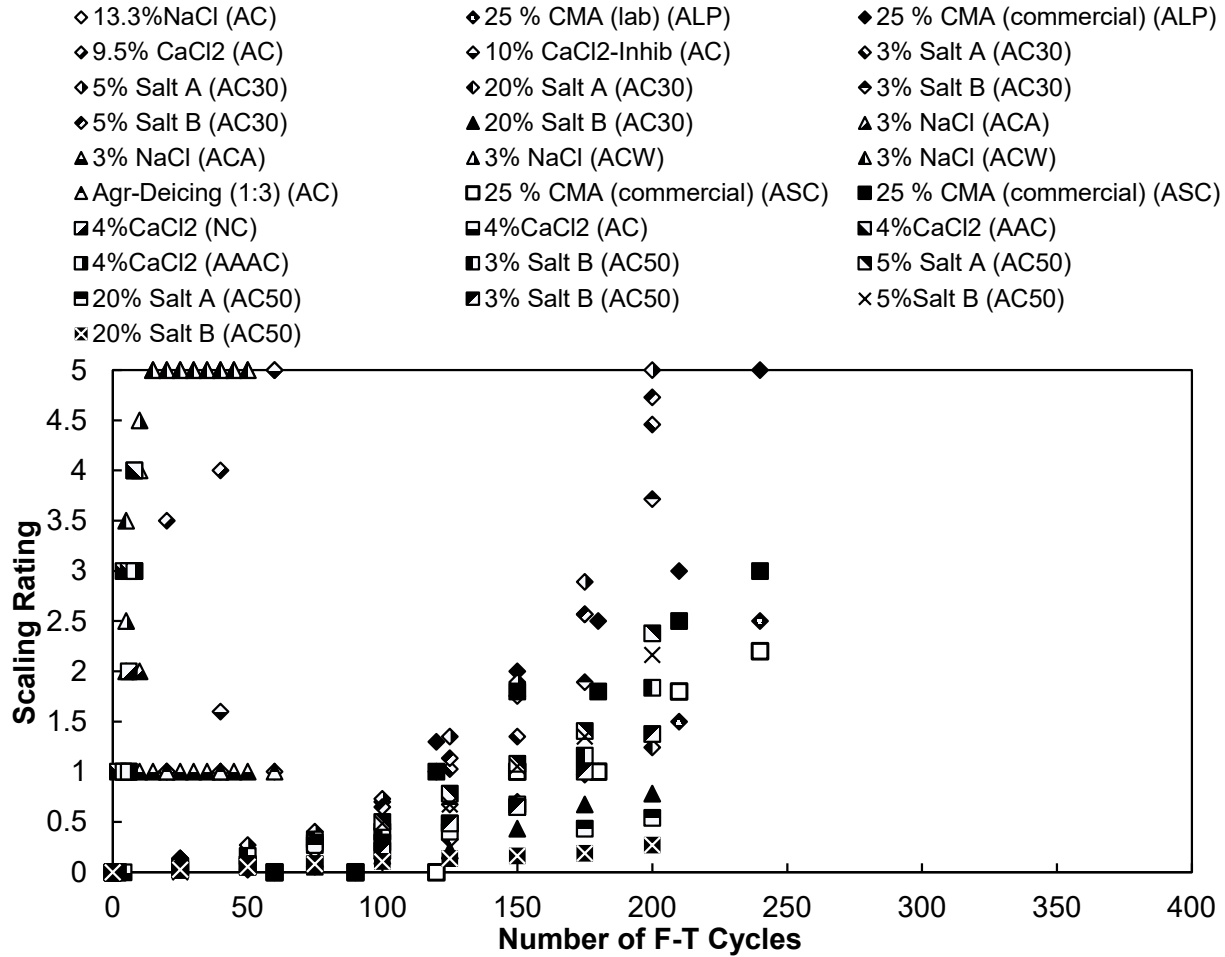
Figure 2-2: The variation of scaling rating with the number of F-T cycles for different studies [37, 38, 53, 72, 91, 92, 109].

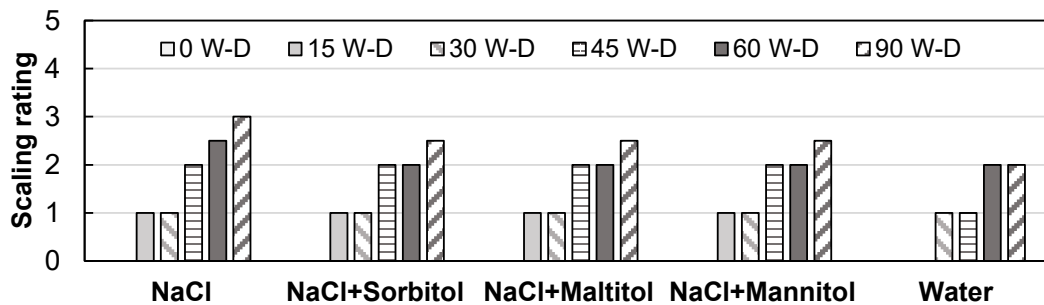
Figure 3-4: Visual observation-based scaling rating assigned to the OPC mortar specimens after exposure to W-D cycles of NaCl salt brine deicer with and without polyol corrosion inhibitors.

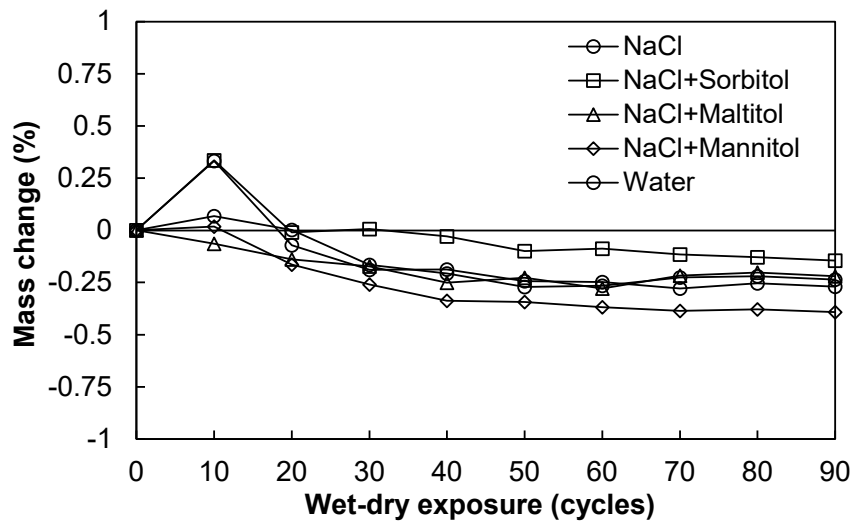
Figure 3-5: Mass change observed in the cement mortar specimens with respect to the number of W-D cycles of NaCl salt brine deicer with and without polyol corrosion inhibitors (note: negative mass change means mass gain).

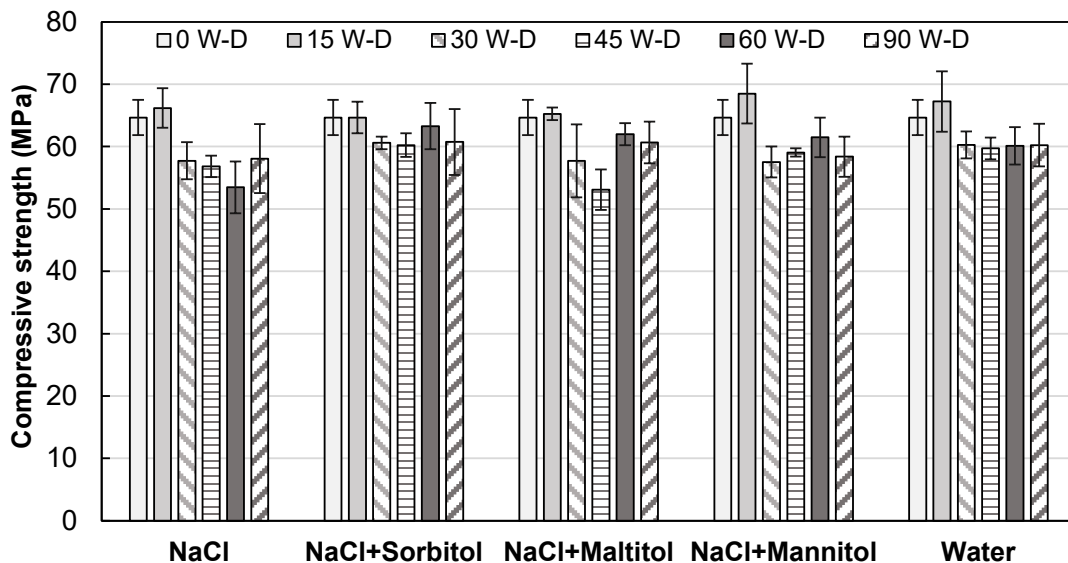
Figure 3-6: Compressive strength of cement mortar after exposure to W-D exposure cycles of NaCl salt brine deicer with and without polyol corrosion inhibitors.

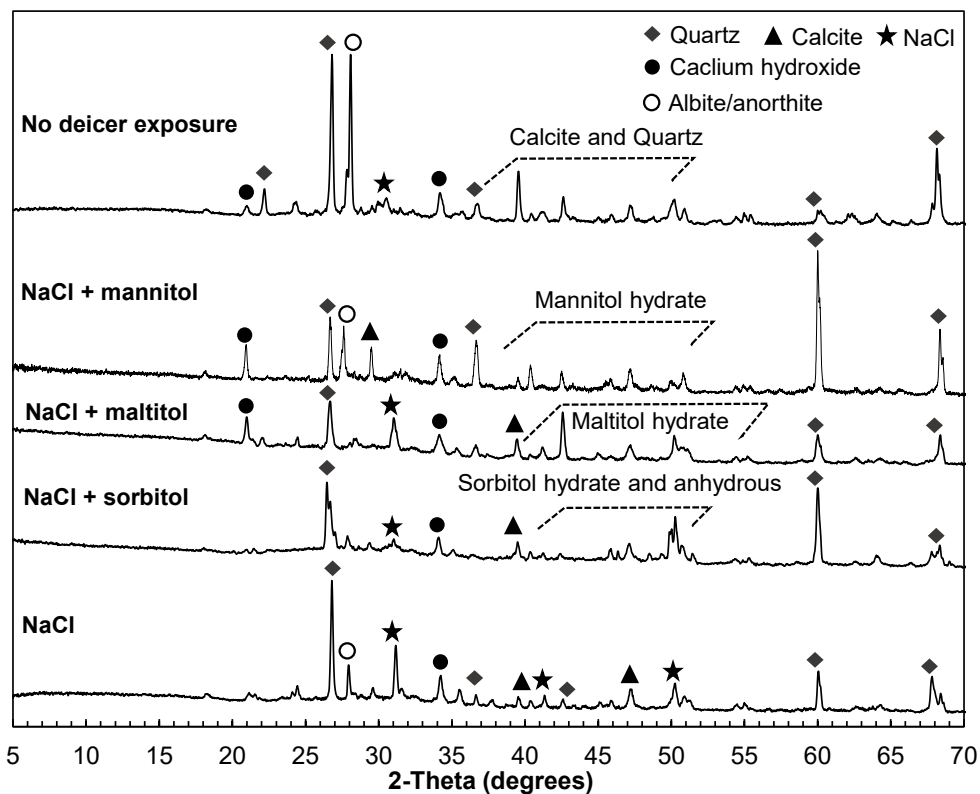
Figure 3-7: XRD spectra of cement mortar specimens after exposure to 60 W-D cycles of NaCl deicing solution in the absence and presence of polyol corrosion inhibitors.

exposure cycles for both cement mortar specimens corresponding to both reference and polyol-based deicing solutions. The XRD spectra of cement mortar specimens are provided in Figure 3-7. As observed in Figure 3-7, the XRD spectra of test specimens show the presence of quartz, calcite, and hydration products such as calcium hydroxide and C-S-H that are typically observed in the OPC mortar that is exposed to NaCl-based deicing solution [37, 84, 119–121]. In all the spectra, the intensity of quartz dominated the other compounds which can be linked with the relatively low penetration of NaCl deicer [37]. The presence of NaCl in cement mortar specimens can be attributed to the precipitation of the deicing solution in the voids. In the case of a polyol-based deicing solution, hydrated forms of sorbitol, mannitol, or maltitol are observed in the corresponding solutions in addition to the products that are observed in the reference NaCl only deicing solution. However, no new product formation or leaching of calcium is observed in the spectra, which suggests that the lack of chemical interaction between the polyol hydrates and cement hydration products, and hence they do not have a negative impact on cement paste. Consequently, on slight to moderate scaling damage and relatively lesser deterioration in the compressive strength in the cement mortar specimens that are subjected to polyol-based deicers.

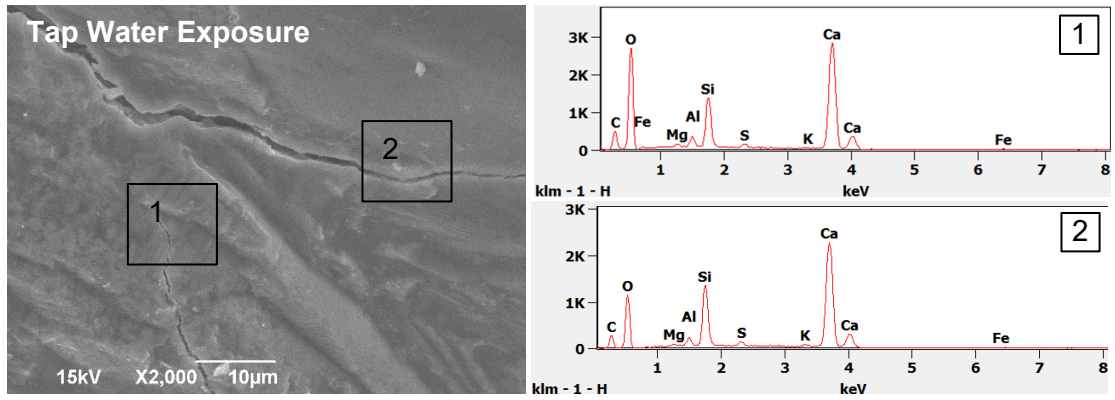
Figure 3-9: SEM micrograph and EDX spectra of cement mortar specimens after exposure to 60 W-D cycles of tap water.

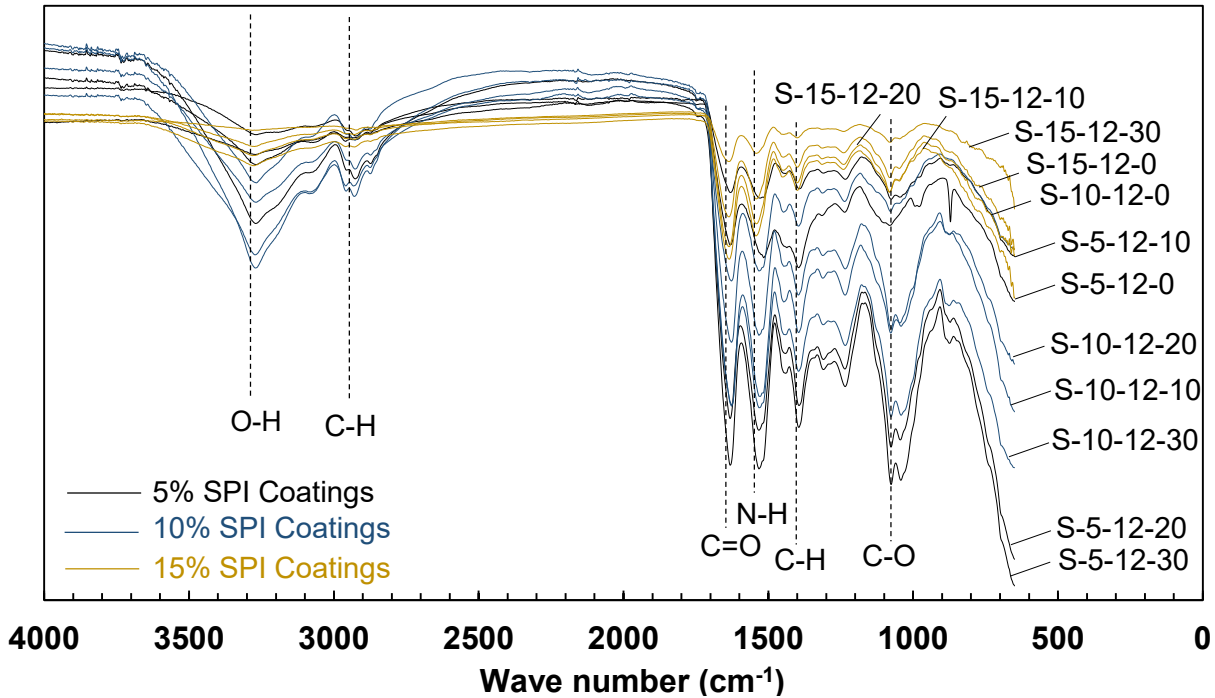
Figure 4-10: FTIR spectra of soy protein coatings with different concentrations of sorbitol.

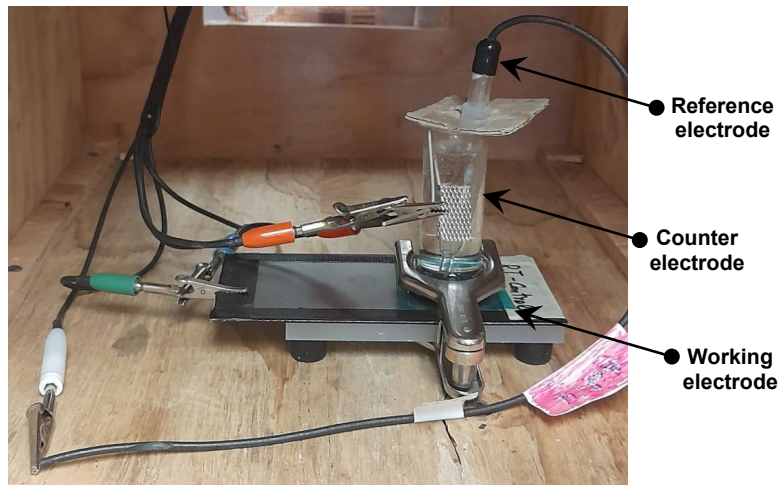
Figure 5-9: Potentiodynamic polarization test set-up for measuring corrosion current densities for MSP coatings.

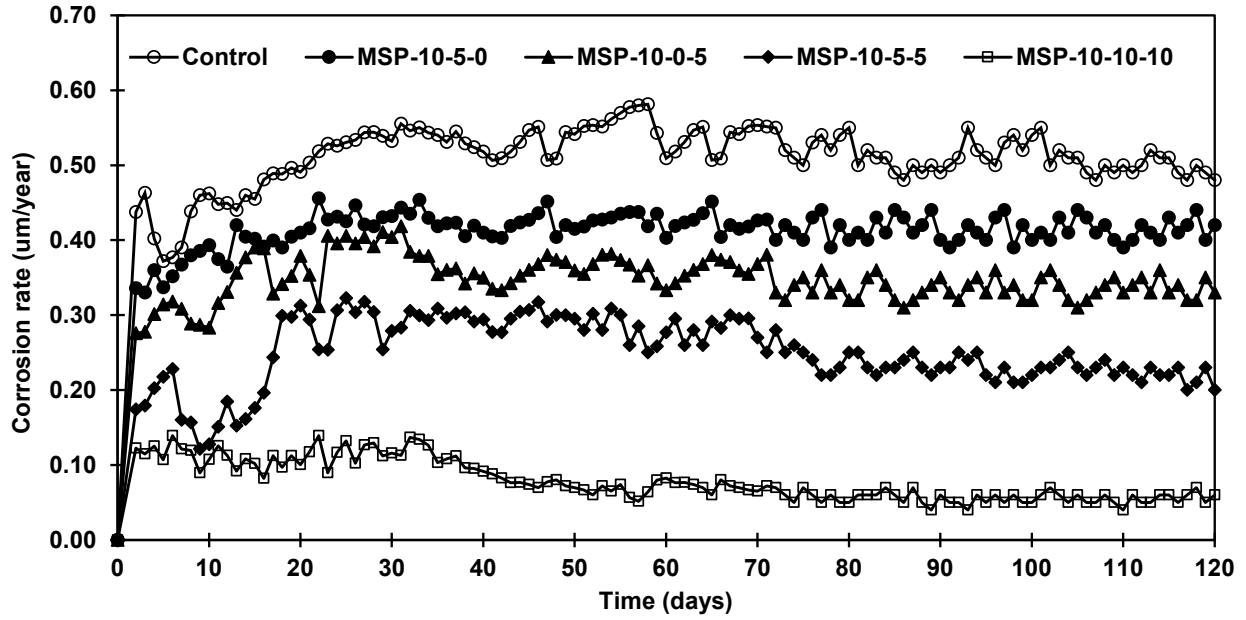
Figure 5-21: Corrosion rate of MSP coated rebars in simulated concrete pore solution over a period of 120 days.
