Crashes Related to Type and Location of Driveway Access

Final Report

Project Number
FDOT BDV25-977-76

Prepared By
USF Center for Urban Transportation Research

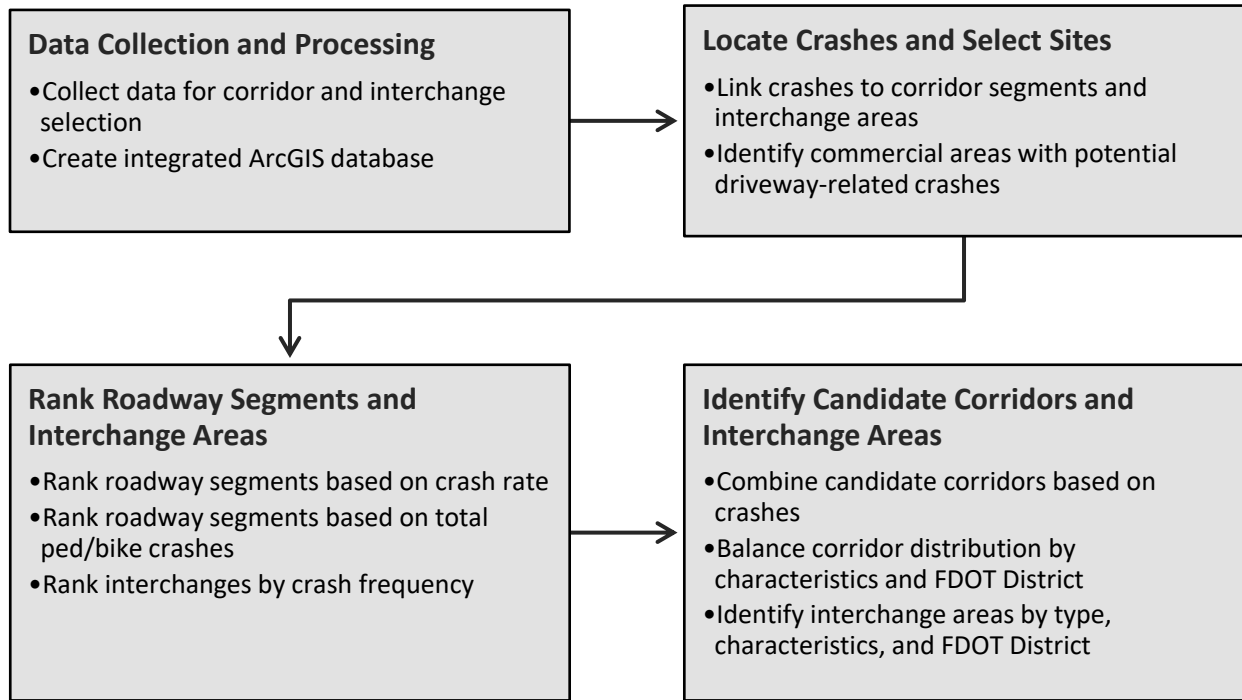
Candidate driveway sites for further data collection and analysis were selected through a screening process shown in Figure E-1. The final sample for analysis included: a) 192 roadway segments with 9,889 driveways and 10,596 commercial driveway-related crashes for corridors; and b) 69 interchange sites with 832 driveways and 853 crashes in the vicinity of the interchanges for interchange areas.

Figure E-1. Conceptual process for site screening and identification.

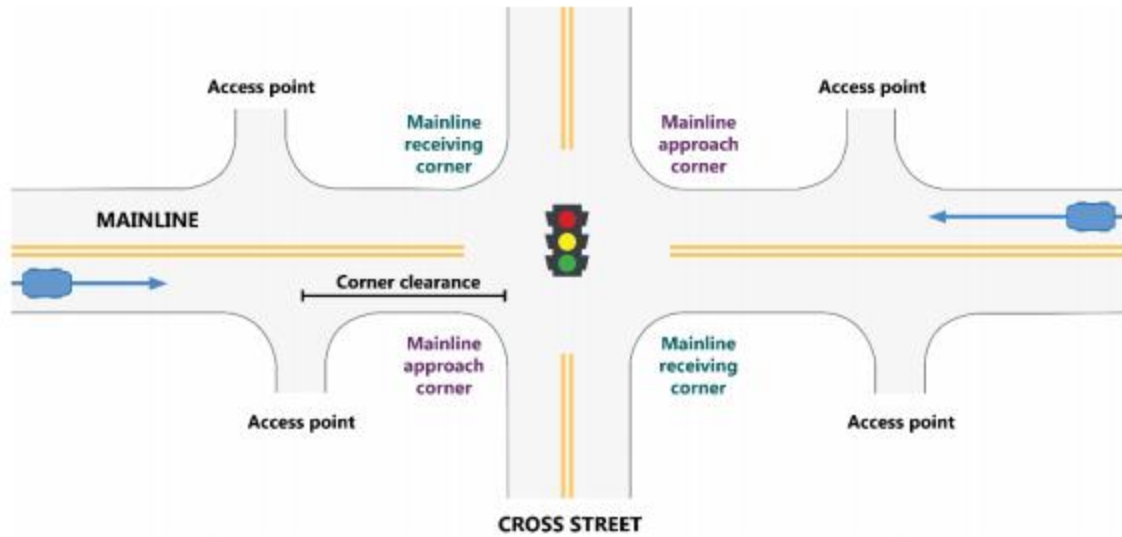
Inadequate separation of commercial driveways from intersections, interchange ramps (see Interchange Functional Area), and other access points has been shown to create unsafe roadway conditions (Dixon et al., 2022; Williams et al., 2014; FHWA, 2010; Gluck et al., 1990). Kwigizile et al. (2014) found that compared to other geometric features, corner clearance design had a significant impact on safety – increased length of corner clearance decreased crash frequency. Factors that contributed to crash frequency near intersections were commercial land use, traffic volume on the minor street close to that of the major street, higher traffic on the minor approach, increase in number of left-turn lanes and through lanes (with the number of through lanes having the highest impact on the number of crashes) and the number of corner clearances (Kwigizile et al., 2014). Amjadi (2018) found statistically significant (90% level) increases in all crash types on receiving corners with driveways within 50 ft of signalized intersections (see Figure 1); however, approach corners with limited corner clearances appeared to have statistically significant reductions in total, fatal and injury, and rear-end crashes.

Figure 1. Schematic of corner clearance study sites.

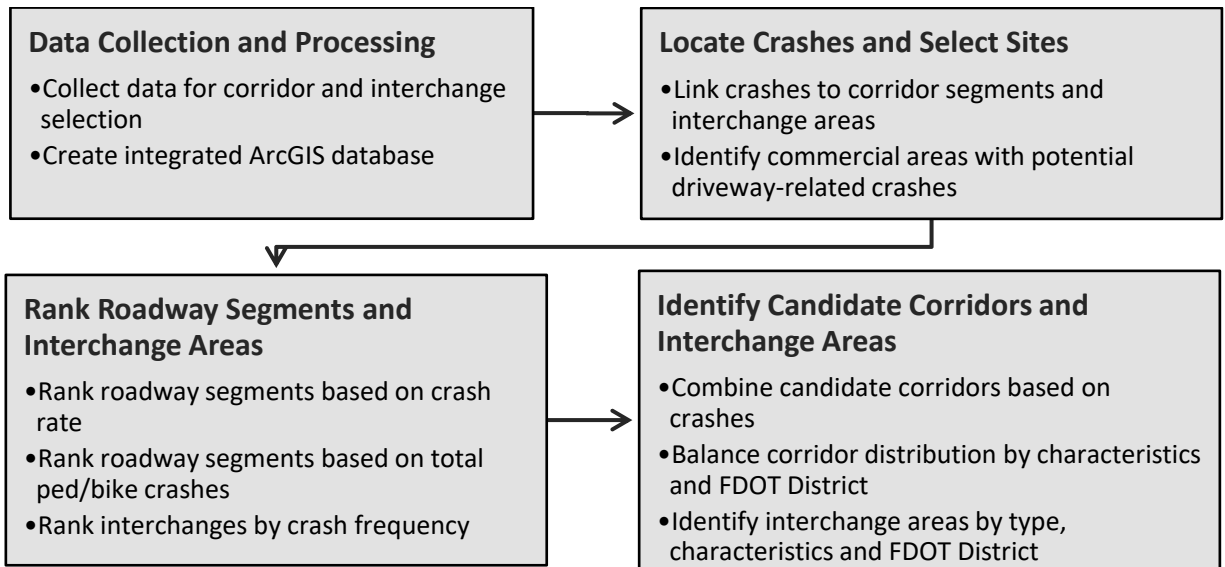
Candidate driveway sites for further data collection and analysis were selected through a screening process shown in Figure 13 and discussed in this section. Methods used to select case study sites are discussed in Section 4.3.

Figure 13. Conceptual process for site screening and identification.

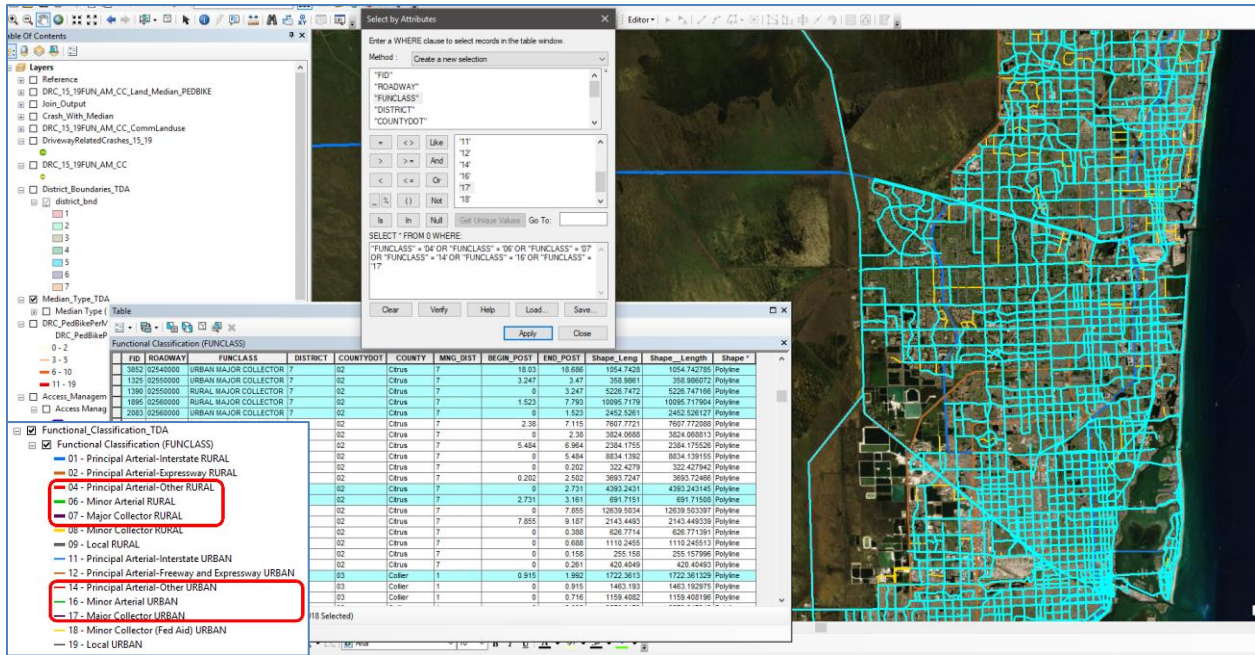
All the crashes were mapped on the corresponding roadway segments based on the FDOT Roadway ID – a unique eight-character identification number assigned to a roadway or section of a roadway either on or off the State Highway System for which information is maintained in the FDOT Roadway Characteristics Inventory (RCI). The first two characters of the eight-character ID are the county code, the next three are the section code, and the final three are the subsection code. Six functional classes representative of major corridors in Florida were considered for the study: Principal Arterial-Other Rural, Minor Arterial Rural, Major Collector Rural, Principal Arterial-Other Urban, Minor Arterial Urban, and Major Collector Urban. Using these functional classes, a total of 7,711 eligible roadway segments across Florida were selected for further processing (Figure 15). Driveway-related crash records were then linked to these roadway segments based on the eight-digit Roadway ID.

Figure 15. Eligible roadway segments based on functional class.

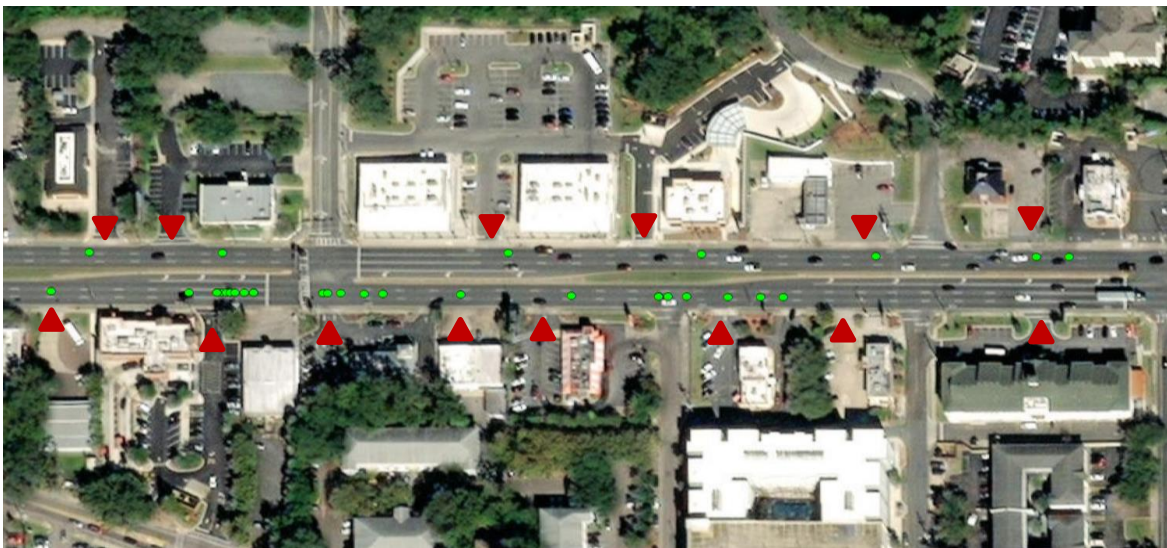
Next, the commercial driveways were manually identified along each of the candidate corridors, as shown in Figure 20. The centerline of the driveways was manually geolocated and its latitude and longitude were recorded and incorporated into the driveway characteristics review process. A similar process was used to review commercial driveways in the vicinity of interchanges, as shown in Figure 21.

Figure 20. Identification of commercial driveways and crash clusters along a major corridor. (Segment of SR-10/W Tennessee St, Tallahassee, FL)

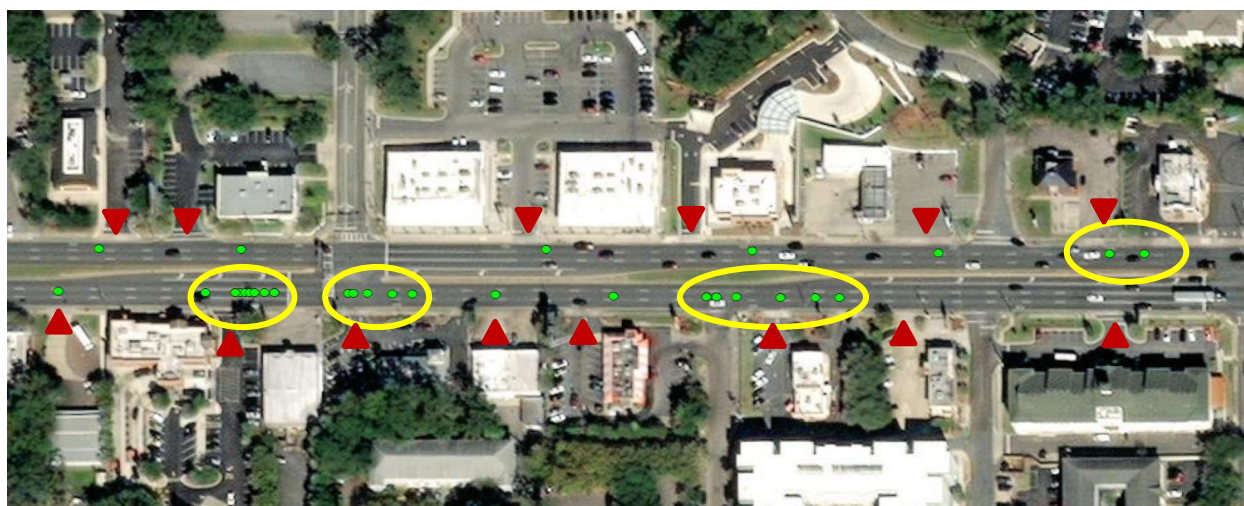
- Third, each driveway-related crash record was examined to determine if it fell into the influence areas of driveways before it was associated with the closest driveways as shown in Figure 22. The driveway influence area defined by the Florida Design Manual (FDOT, 2020) is 250 ft upstream and downstream from the driveway location. Therefore, crashes located farther than 250 ft from a commercial driveway were excluded from the analysis. Due to the large number of driveways along urban corridors, the influence areas of multiple driveways may overlap. Therefore, the influence areas under such scenarios were divided into segments based on the distance between adjacent driveways, using the method applied by Williamson and Zhou (2014).

Figure 22. Example of crash clusters and crash assignment to corridor driveways.

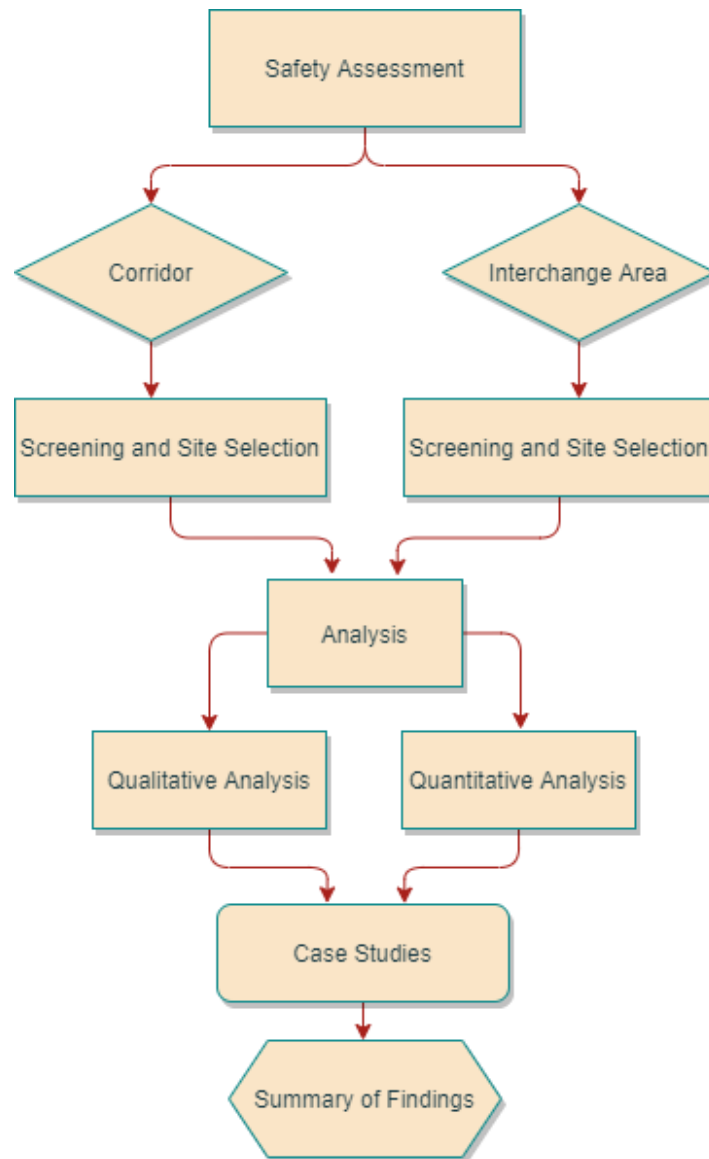
Figure 27 presents the overall methodology for the safety assessment of commercial driveways focusing on two aspects – corridors and interchange areas. The methodology for both the qualitative and quantitative analysis is discussed below. Interchange areas were examined separately due to their operational and design differences, such as higher speeds and traffic volumes, interchange types, weaving activity, and tendency for higher commercial development intensity that increases the potential for traffic conflicts. The screening and site selection processes for these two aspects are based on their respective criteria and supporting datasets for the analysis.

Figure 27. Conceptual methodology for driveway safety assessment.

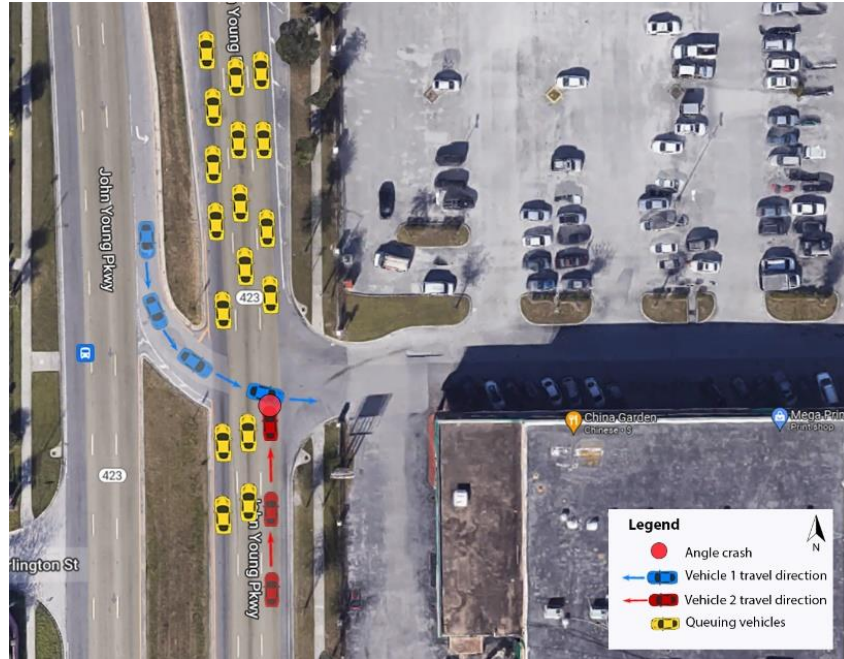
out of the driveway into the far left-turn lane (see Figure 32 and Figure 33). Two of the angle crashes were reported as front to rear passenger side. A review of the crash reports indicates that most of the crashes occurred in daylight, during peak hour traffic, and did not involve serious injuries, suggesting relatively low speeds at the time of the crash.

Figure 32. Typical left-turn-in crash scenario at the John Young Parkway location.

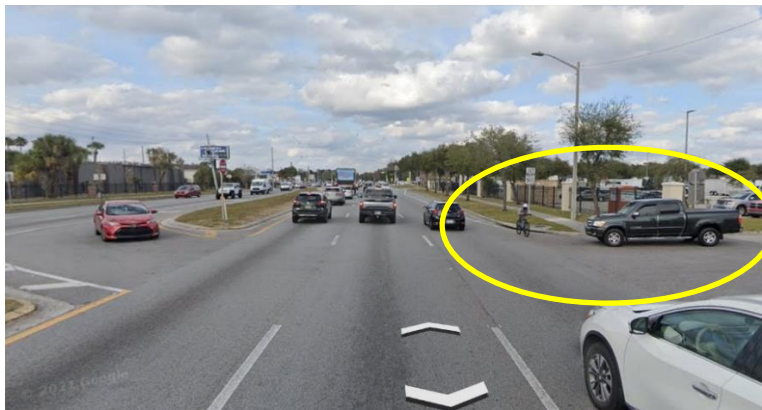
No bicycle- and pedestrian-related crashes were recorded along this segment during this period. However, examination of the Google images reveals bicycle and pedestrian activity on this corridor and the driveways pose clear safety concerns. Among these is that drivers looking left to exit these driveways may not notice southbound cyclists and pedestrians on the sidewalk beginning to cross the driveway. Vehicles inch out as they exit, thereby blocking the sidewalk and disrupting these bicycle and pedestrian movements, causing them to enter the paved right-of-way to pass the driveways (Figure 34). Fencing and landscaping at the driveway entrance further obscures visibility increasing the potential for bicycle/pedestrian crashes (Figure 35).

Figure 34. Vehicle blocking sidewalk to exit causes cyclist to enter through lane.

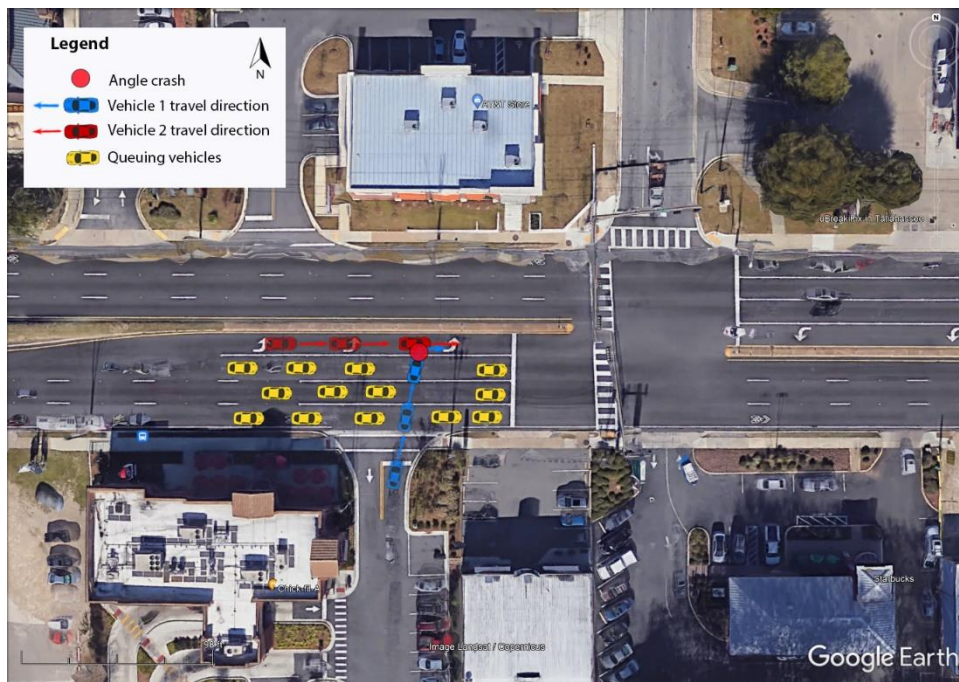
Figure 47. Angle crash on W. Tennessee Street.

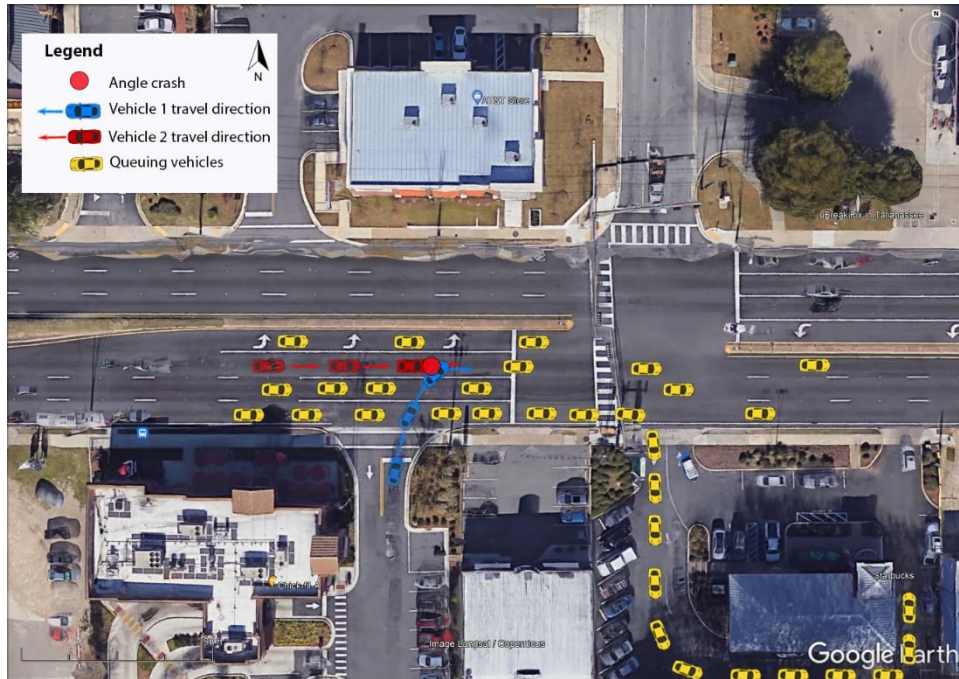
Figure 50. Angle crash on W. Tennessee Street.

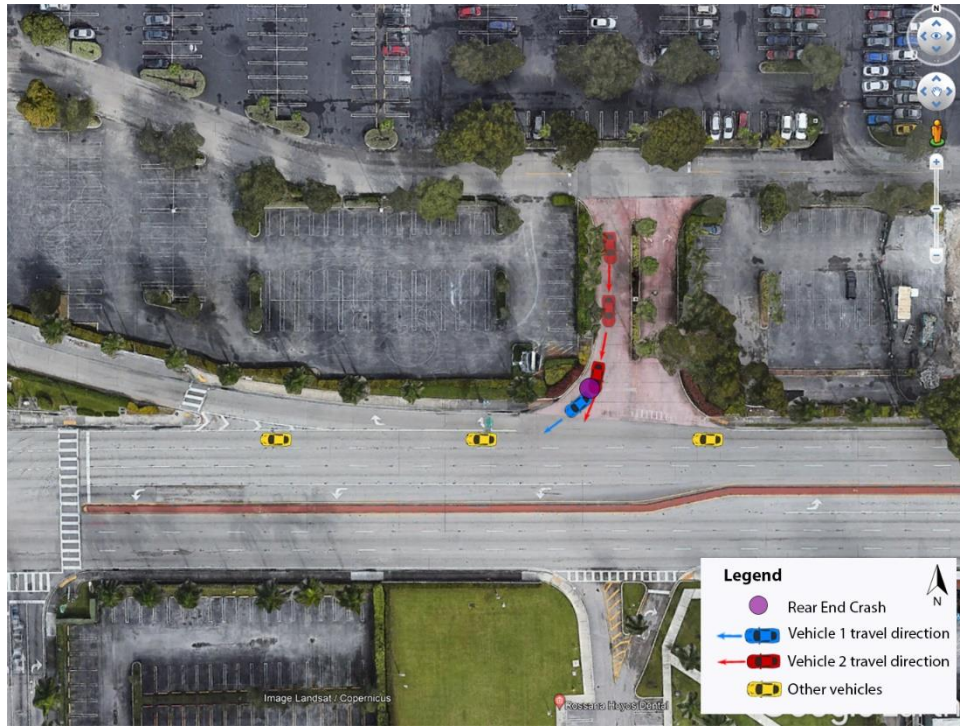
Figure 55. Rear-end crash on W. 49th Street.

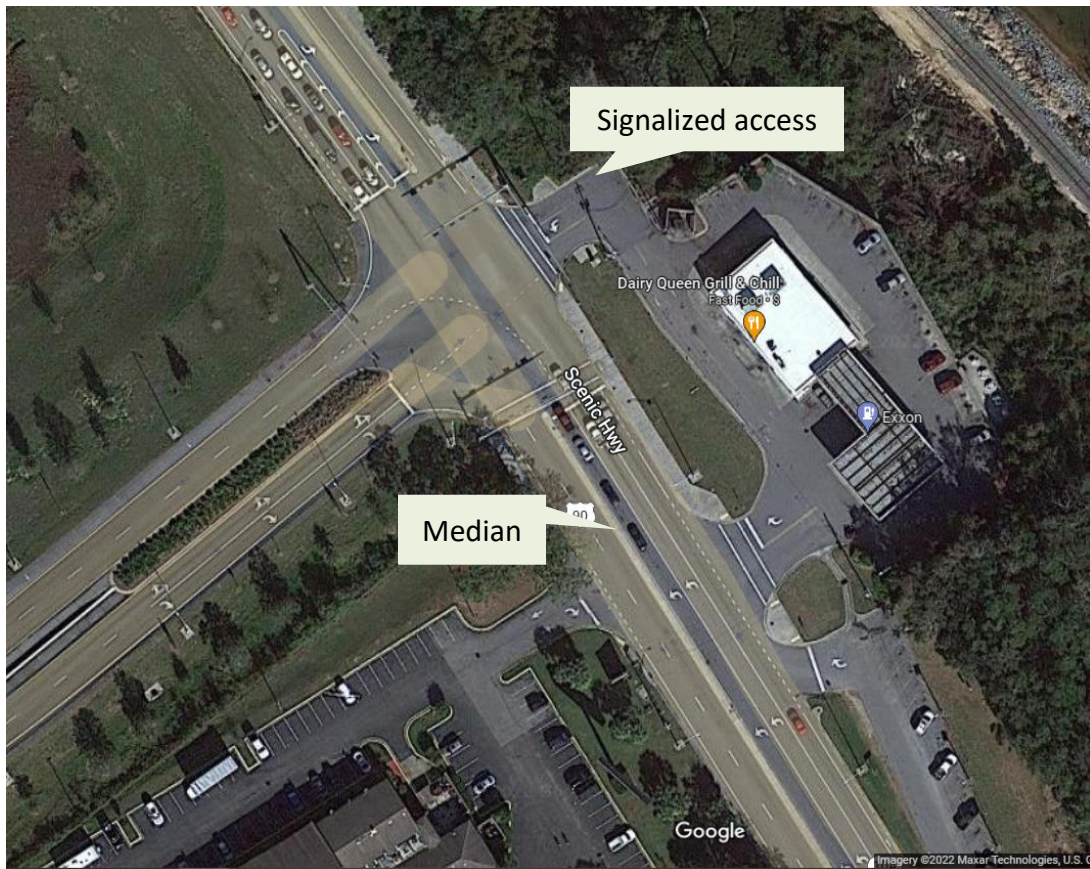
Figure 72. Driveway access as reconstructed in 2016.

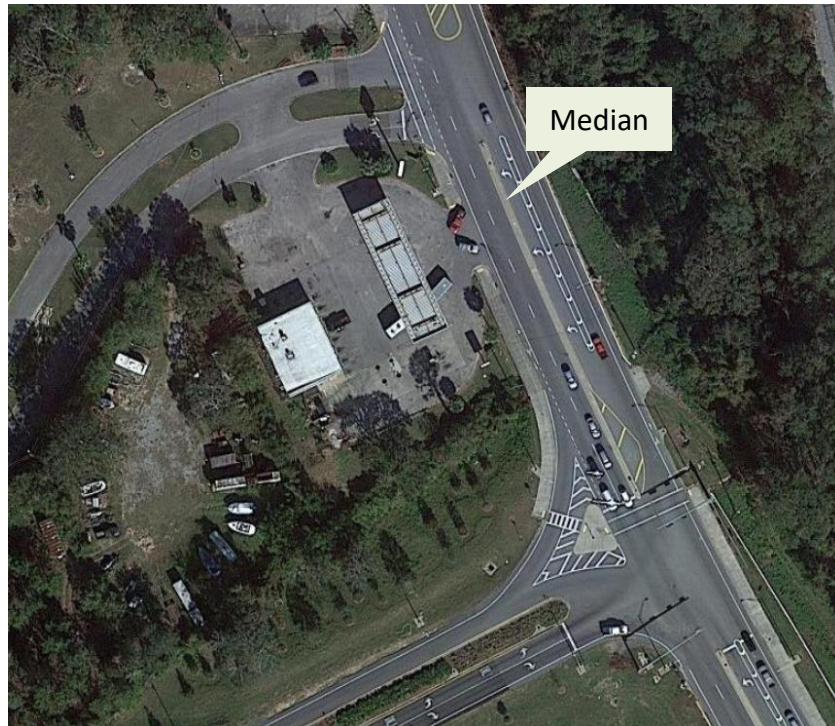
Figure 73. Commercial access and on-ramp design north of interchange following reconstruction.

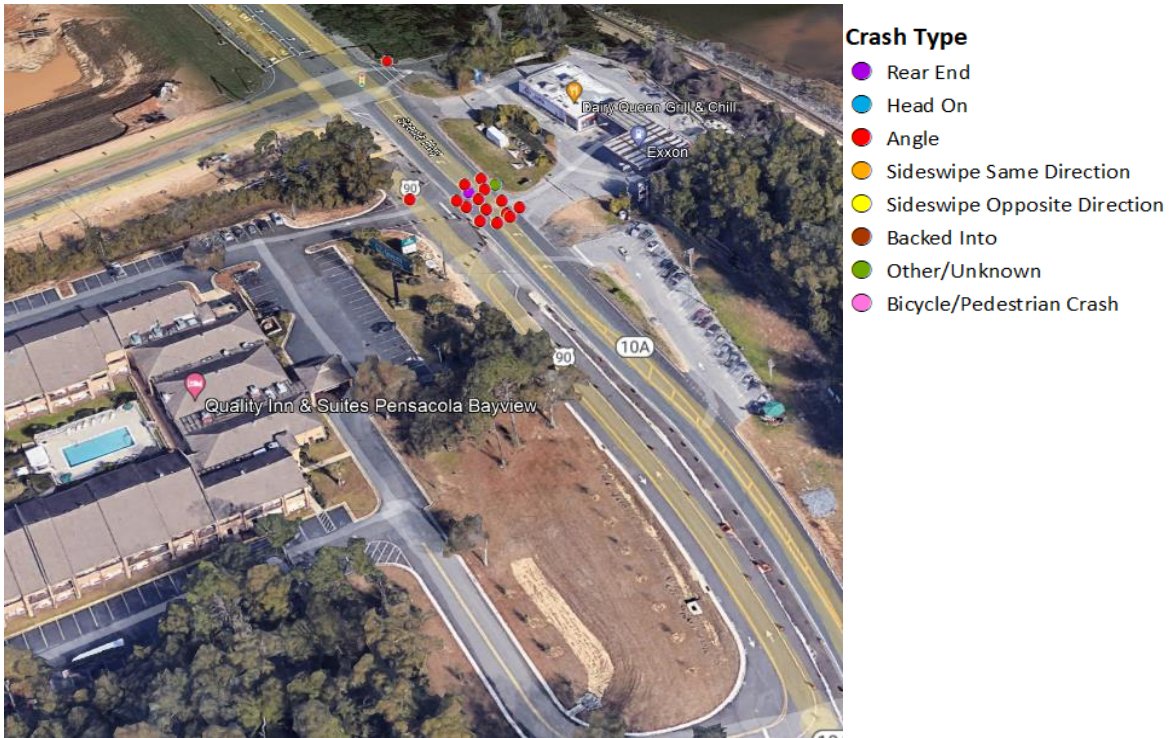
Figure 74. Configuration of access and crashes south of the Scenic Highway at I-10 interchange.

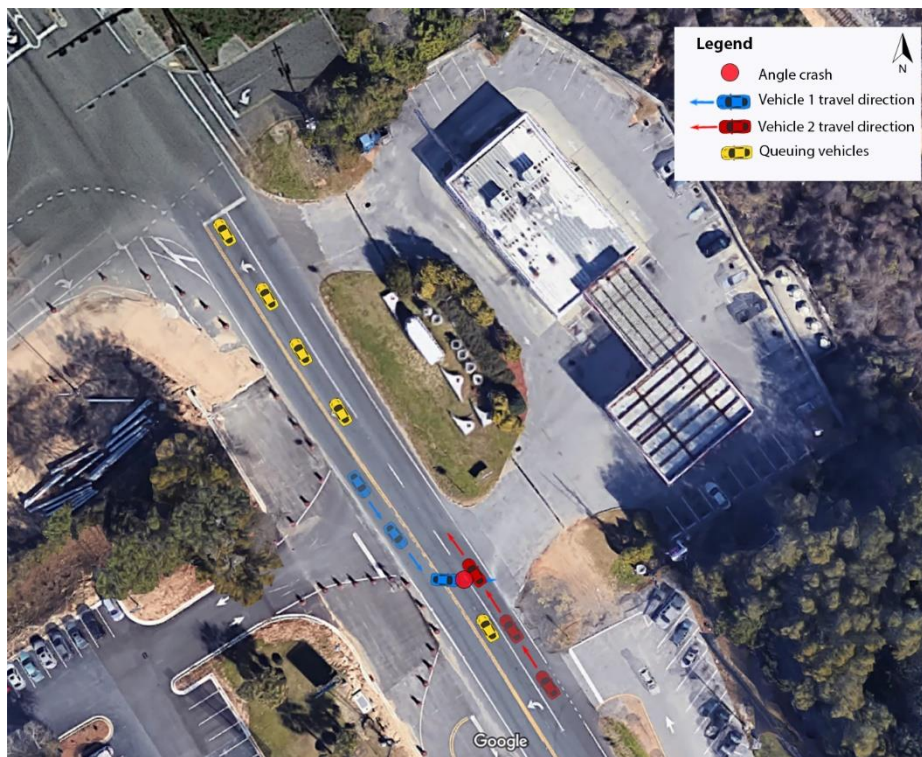
Figure 75. Left-turn in crashes at Scenic Highway at I-10 Interchange commercial plaza prior to median.

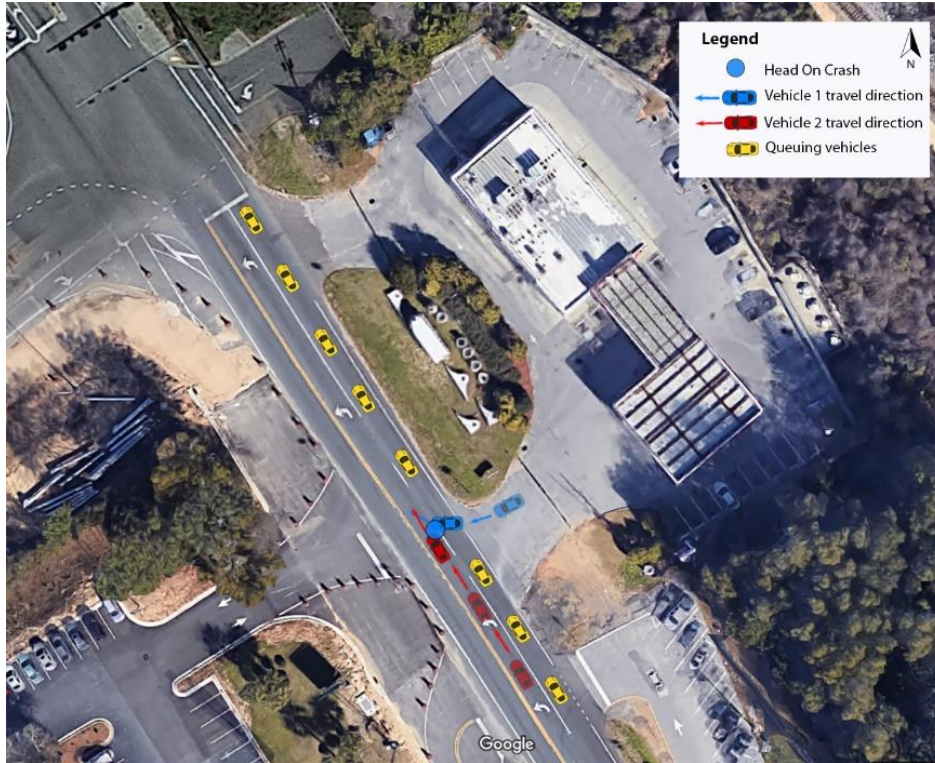
Figure 76. Right-turn out crashes at Scenic Highway at I-10 Interchange commercial plaza.

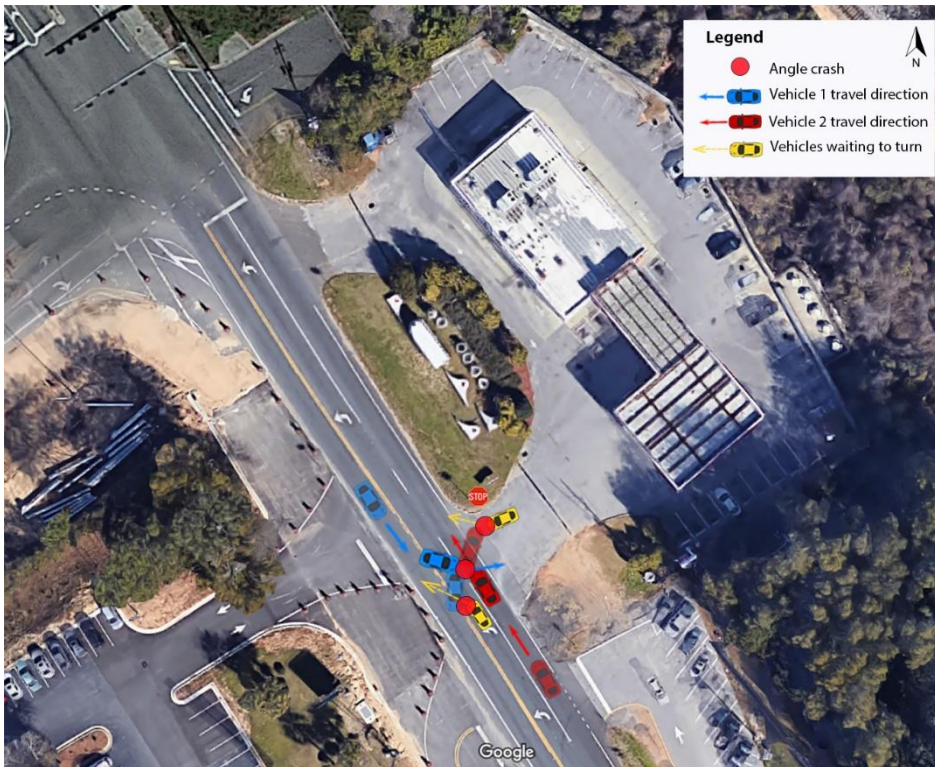
Figure 77. Crash involving multiple vehicles at plaza and hotel intersection with Scenic Highway.

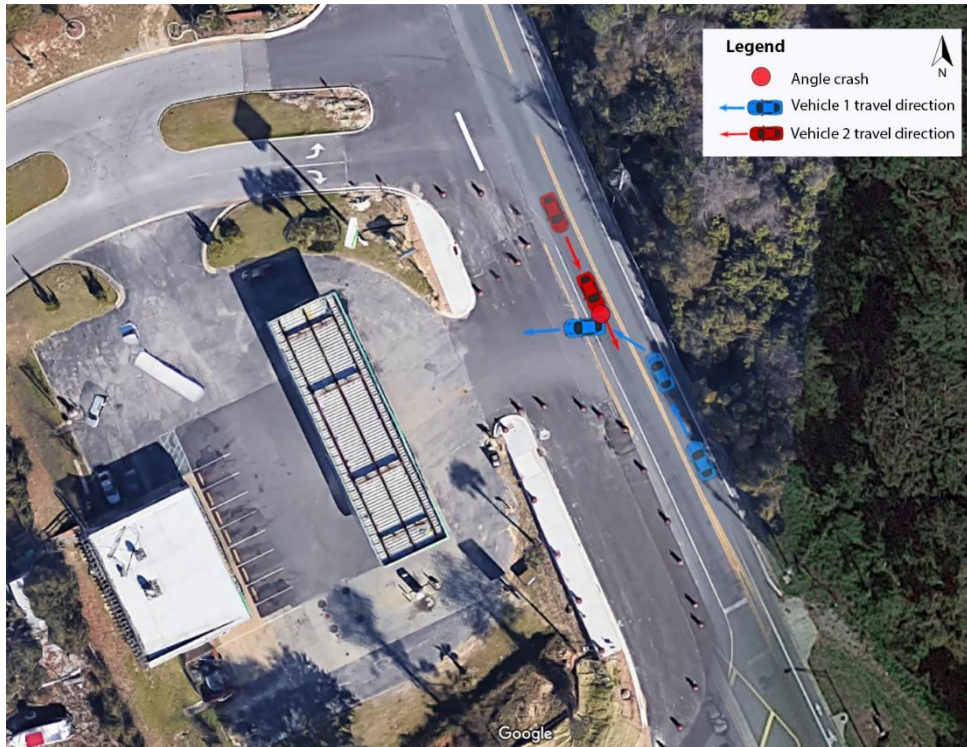
Figure 78. Left-turn crash at gas station north of interchange near ramps.
