1. REPORT NUMBER CA23-3875	2. GOVERNMENT ASSOCIATION NUMBER N/A	3. RECIPIENT'S CATALOG NUMBER N/A
4. TITLE AND SUBTITLE Pilot Testing of Work Zone Intrusion Alarms	5. REPORT DATE November 16, 2023

9. PERFORMING ORGANIZATION NAME AND ADDRESS California State University Sacramento Department of Civil Engineering 6000 J St. Sacramento, CA 95819-6029

**PILOT TESTING OF WORK ZONE
INTRUSION ALARMS**

FINAL REPORT

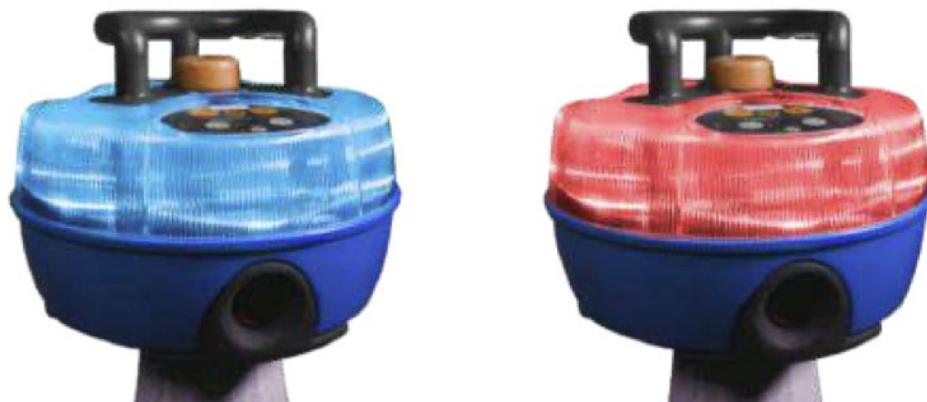
The Intellicone system uses a cone and vehicle mountable audio-visual Portable Site Alarm (PSA), shown in Figure 2.4, to notify workers of errant vehicles. The PSA connects to the nearest cellular network to communicate with other Intellicone products and can also utilize short range radio frequencies to communicate with motion sensitive cone lamp sensors (Figure 2.5). The Intellicone system offers a wide variety of communication devices that can be operated from a central location or portal. Further details of the Intellicone system's components and features can be found in Appendix A.

Figure 2.4 Intellicone System Portable Site Alarms

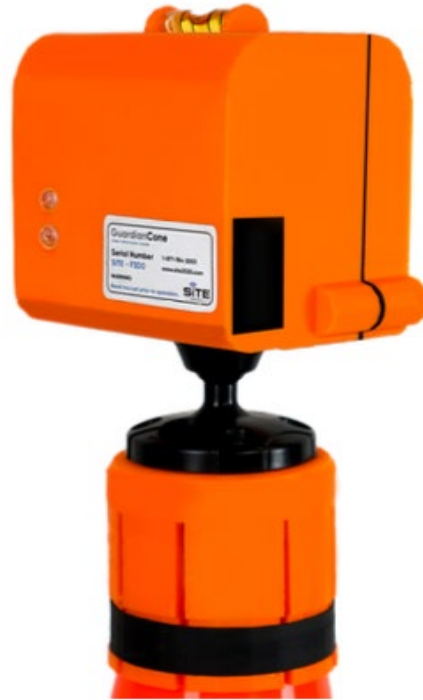
urgent alarm tone. Vibratory alerts will occur for all vehicles detected, regardless of incoming speeds.

Figure 2.12 Guardian Cone Sensor
(Source: Site20/20, 2023)

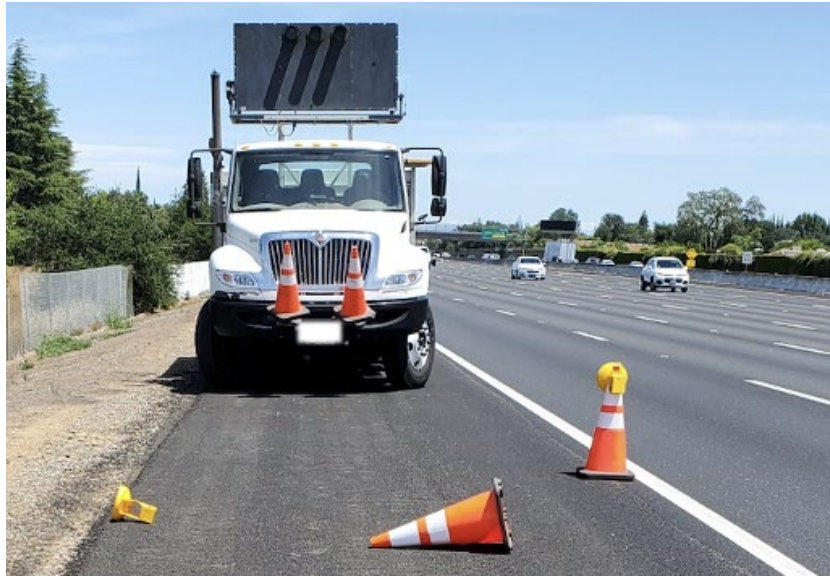
At the end of the trial, the research team deliberately triggered the Intellicone system by knocking over a cone with a lamp to observe the workers' reaction time as shown in Figure 5.7. Four workers reacted immediately to the Intellicone System alarm by halting the fence repair work and looking around for the reason of activation. After it was realized to be a false positive alarm, the workers continued to work without resetting the PSAs. By not resetting the Intellicone PSAs and continuing to work after the alarm has triggered, the workers may have assumed one of the other workers would reset the devices.

Figure 5.7 Manual Activation of Intellicone to Observe Worker Reaction Time

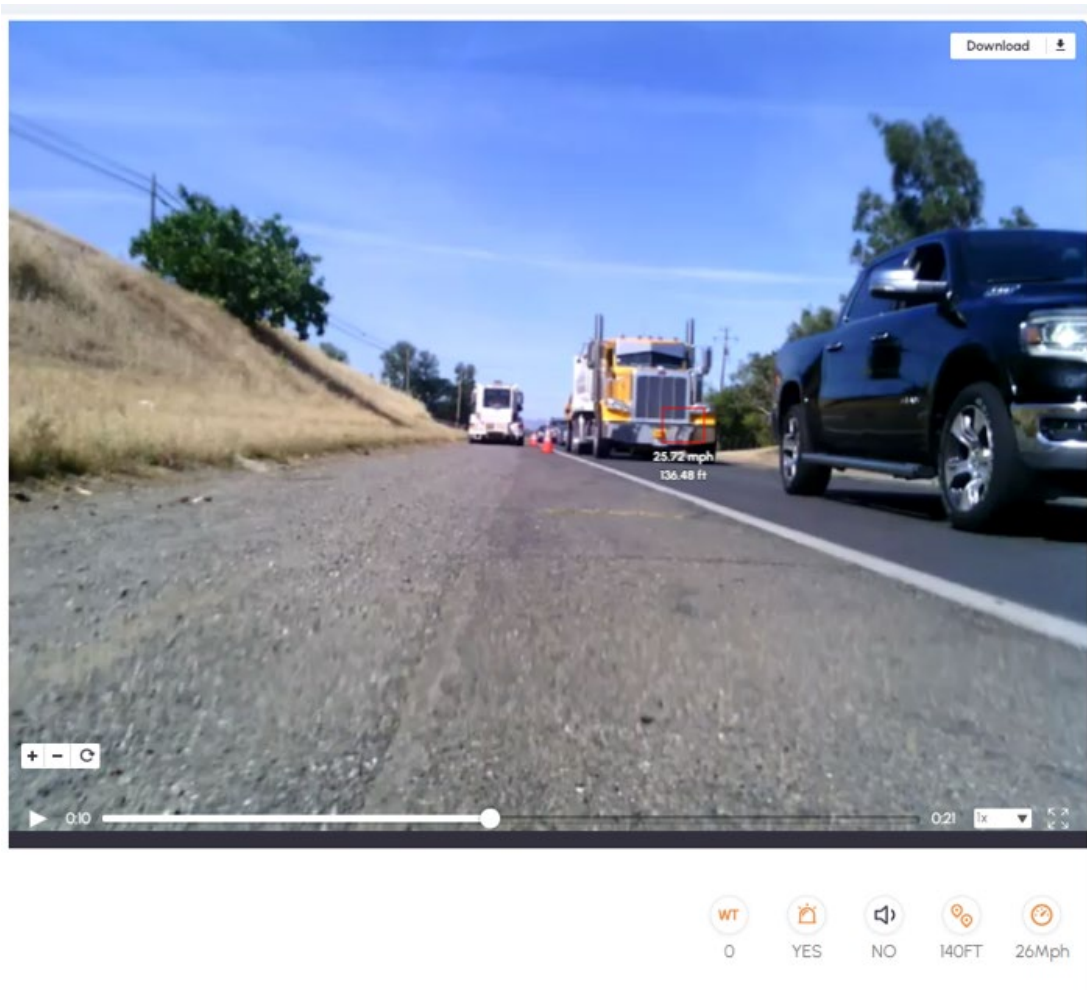
Figure 5.20 False Alarm Generated by AWARE Sentry at Flagger Location 2

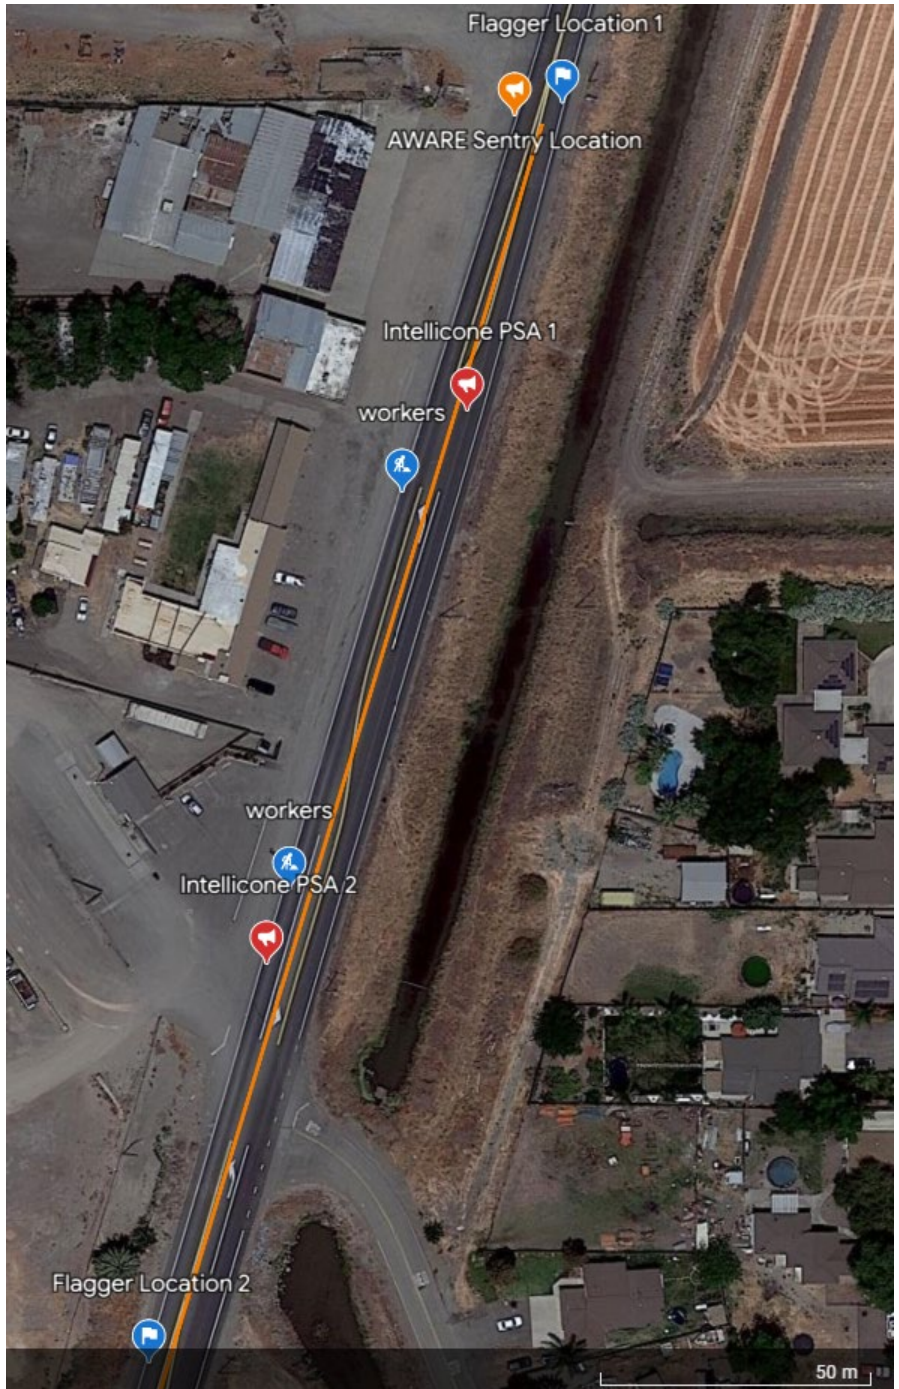
After the quick review, both the systems were handed over to the crew for transport to the work zone on CA Highway 113 near Robbins, CA during pavement crack sealing operation. The work zone was located on a section of CA Highway 113 which is a two-lane road with shoulders. Details of the work zone are presented in Table 5.2. The speed limit on the two-lane highway was 55 mph. Figure 5.22 shows the general layout of the work zone along with the placement of the two WZIA systems. It should be noted that there was a turn pocket in each direction, in the middle of the work zone, which was kept open for vehicles. The trial started at around 10:00 AM when the maintenance crew shut down one of the two lanes to set up a flagging operation, and was ended at 11:32 AM.

Figure 5.22 General Layout of Work Zone on CA Highway 113
(Source: Google Earth™)

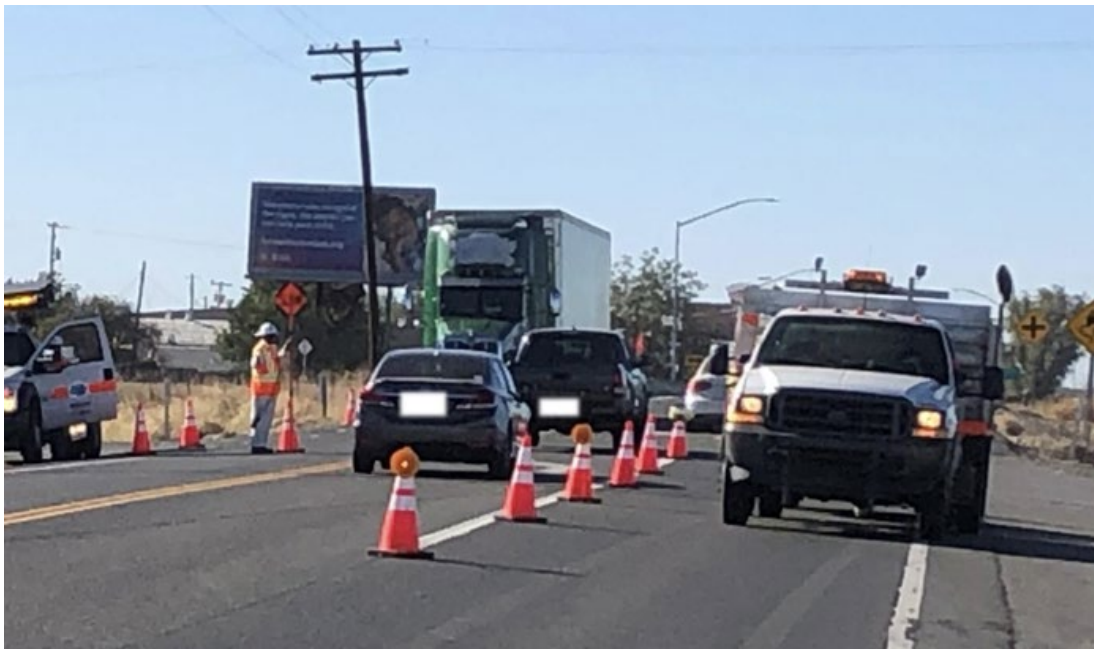
At around 10:05 AM the Intellicone lamps and Portable Site Alarms (PSA) were set up and deployed on the cones along the work zone. After placing the cones, the crew deployed 10 Intellicone lamps from the cone body truck on every other cone along the length of the work zone, each lamp spaced about 25 feet from the next, as shown in Figure 5.23. This was done to provide coverage throughout the work zone and because the cones were placed very close to each other.

Figure 5.23 Deployment of Intellicone Lamps in Active Work Zone on CA Highway 113

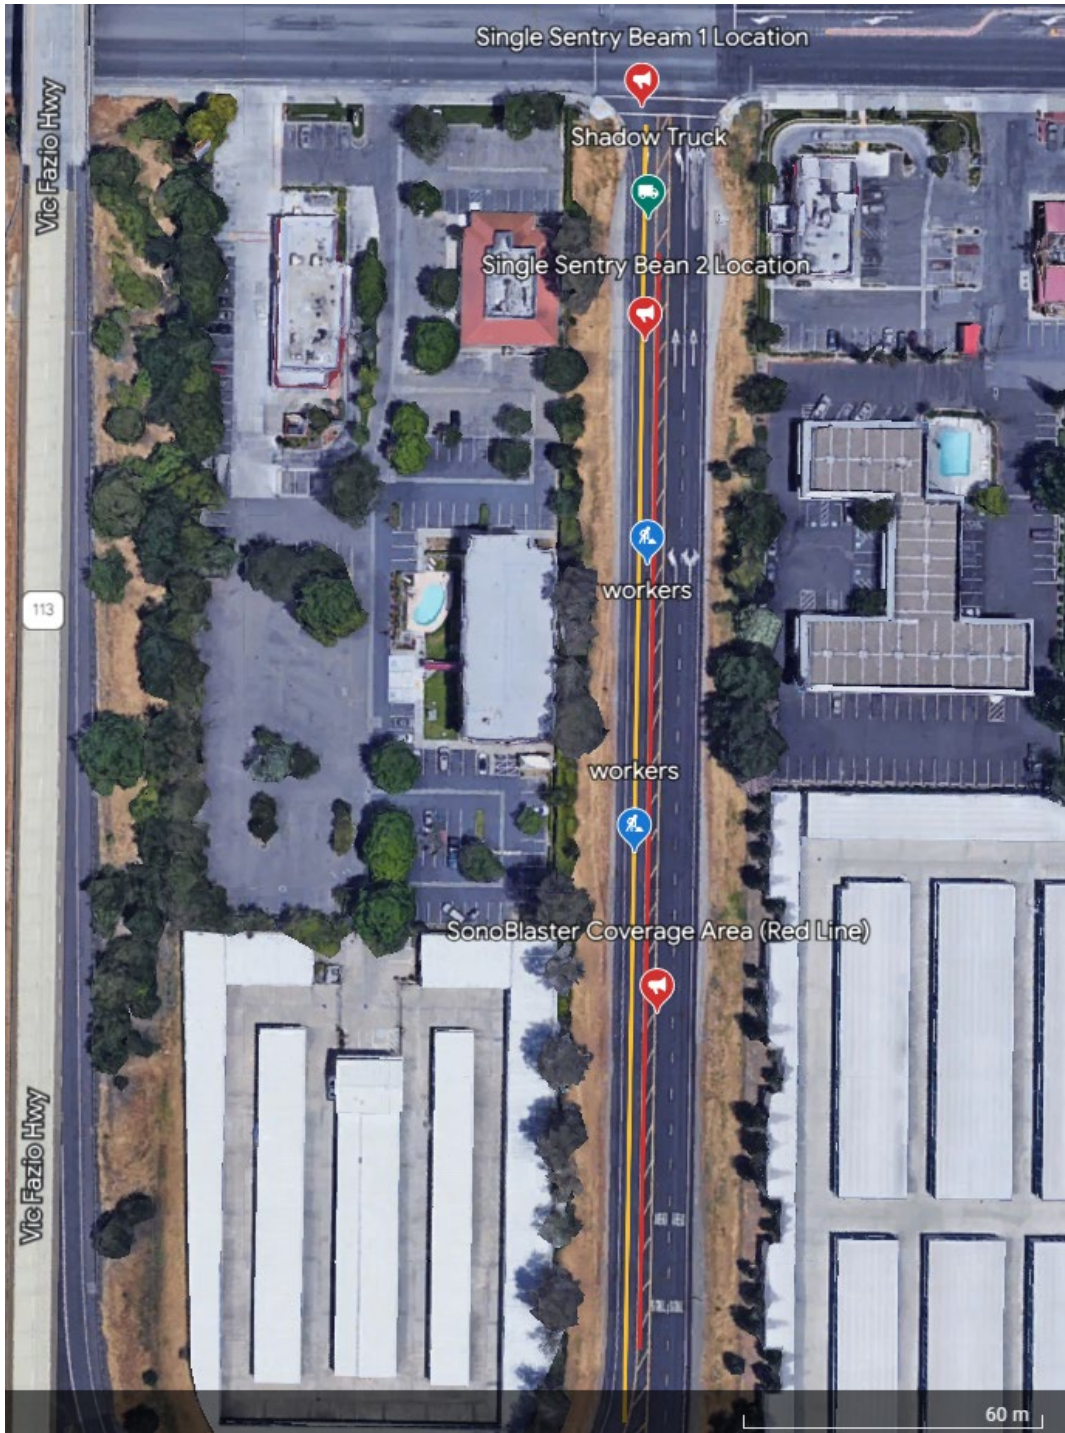
Figure 5.32 General Layout of Ramp Closure at CA Highway 113 and E Main St.
(Source: Google Earth™)

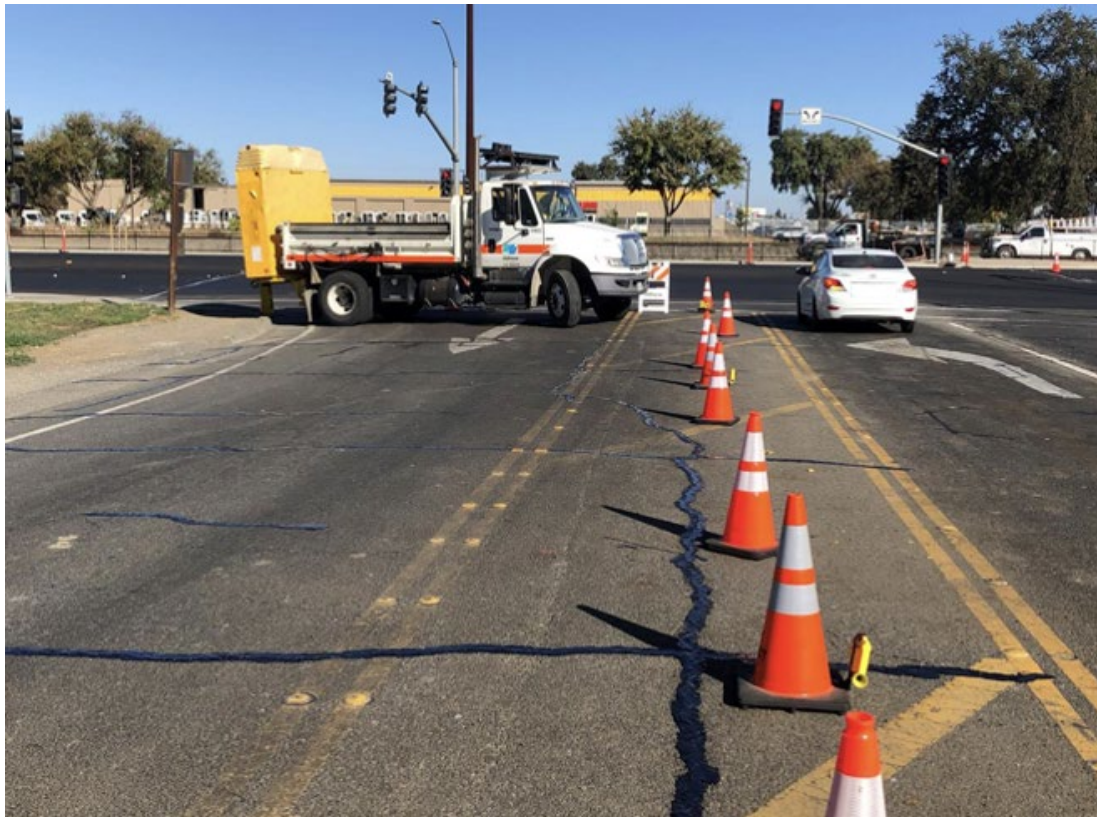
Figure 5.36 Location of SonoBlaster Deployment in On-ramp Closure

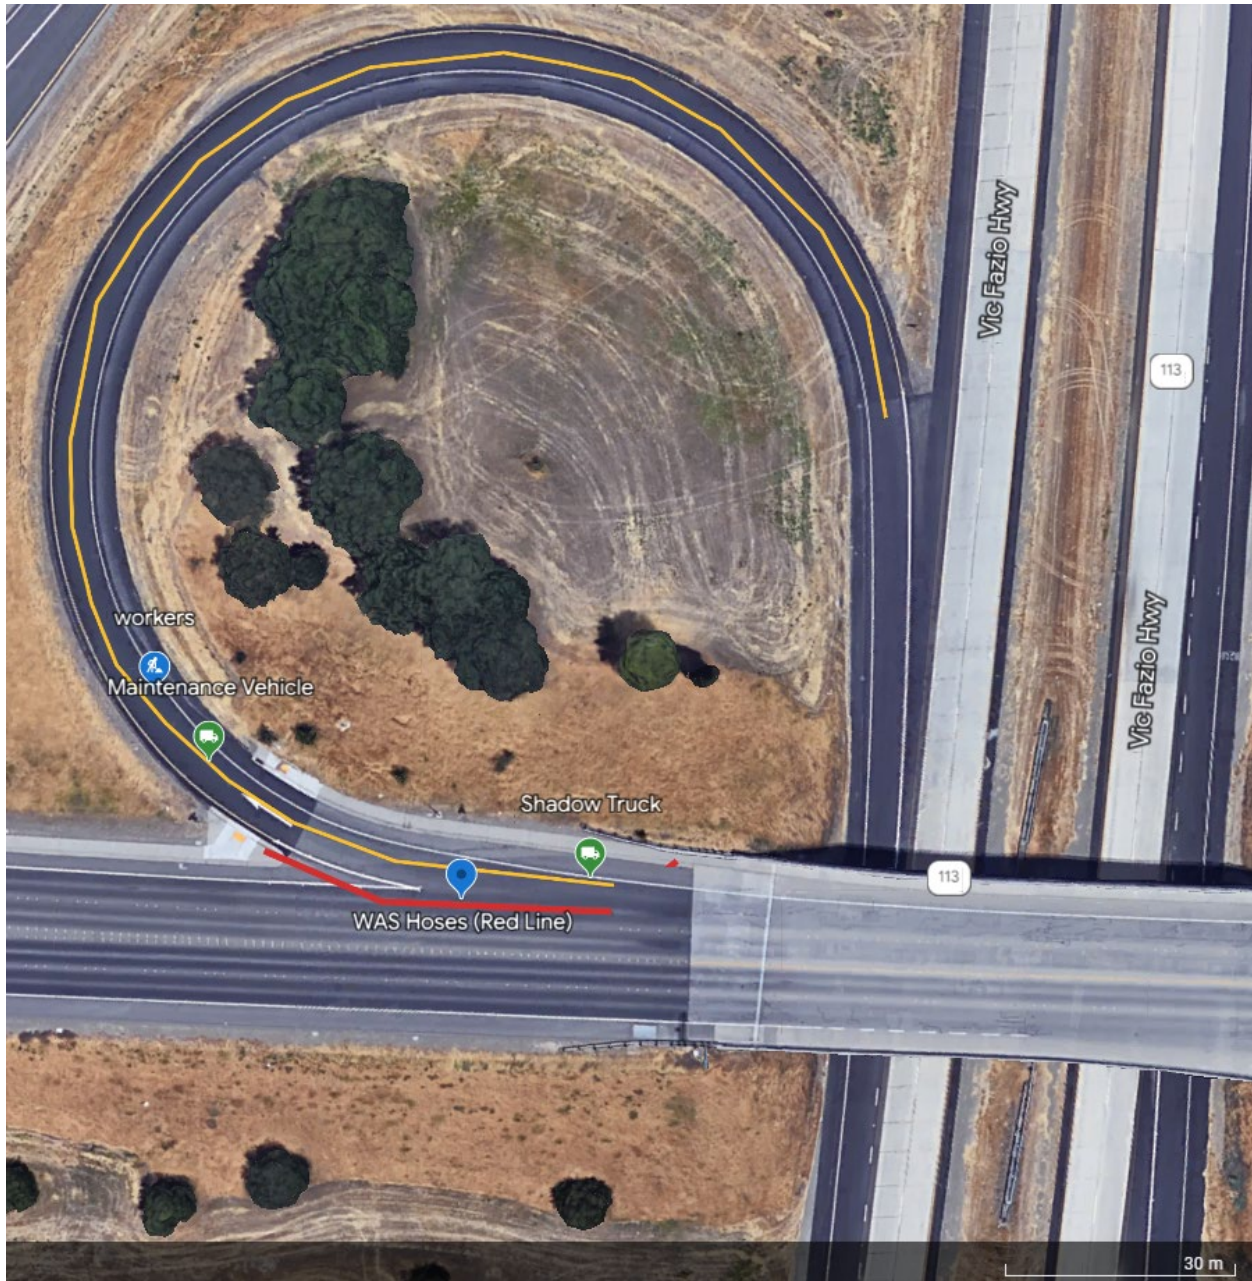
Figure 5.39 General Layout of Ramp Closure at CA Hwy 113 and E Gibson Rd.
(Source: Google Earth™)

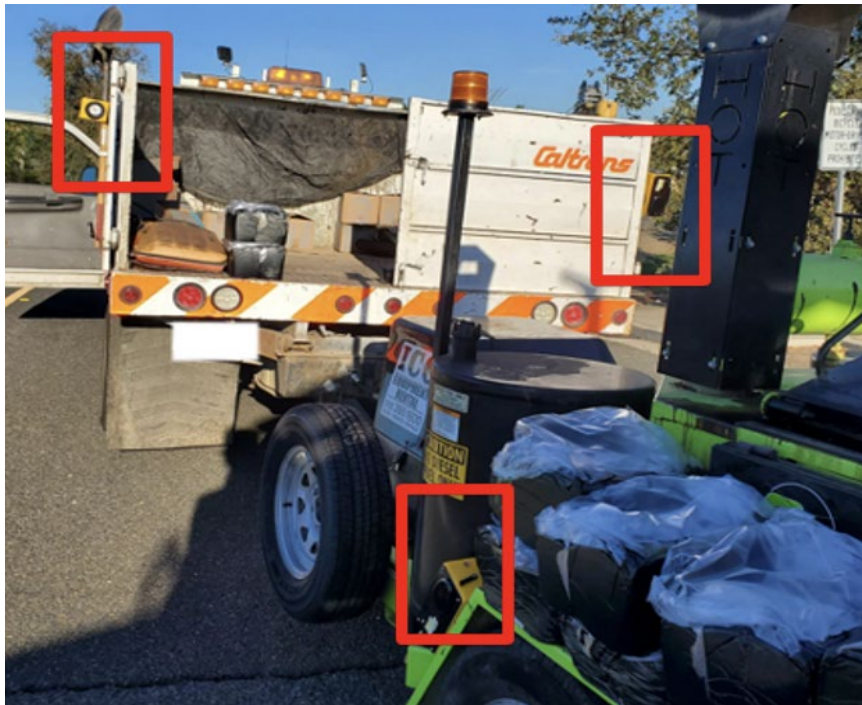
Figure 5.40 Placement of WAS Alarm Units on Side of Equipment Vehicle

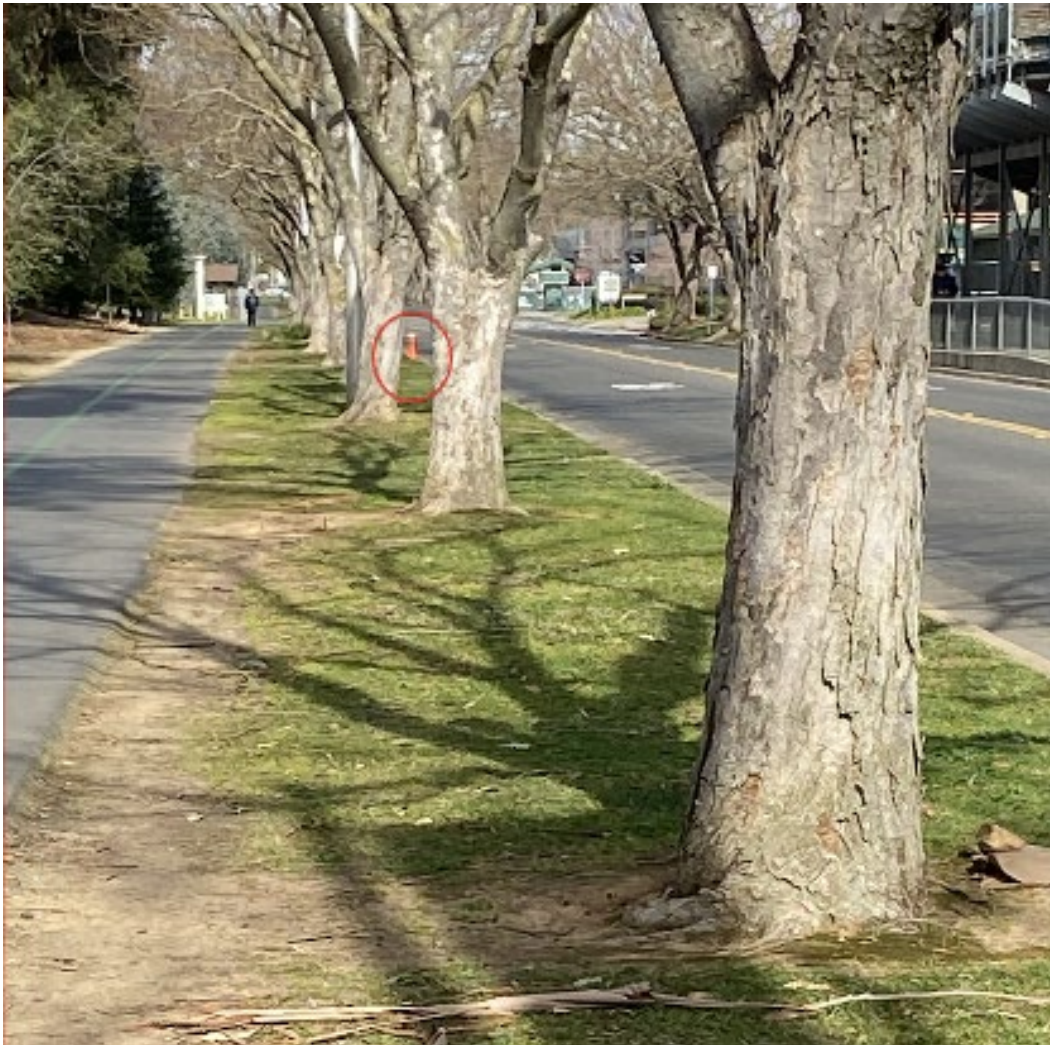
Figure 7.2 Guardian Cone Testing Without Clear Line of Sight

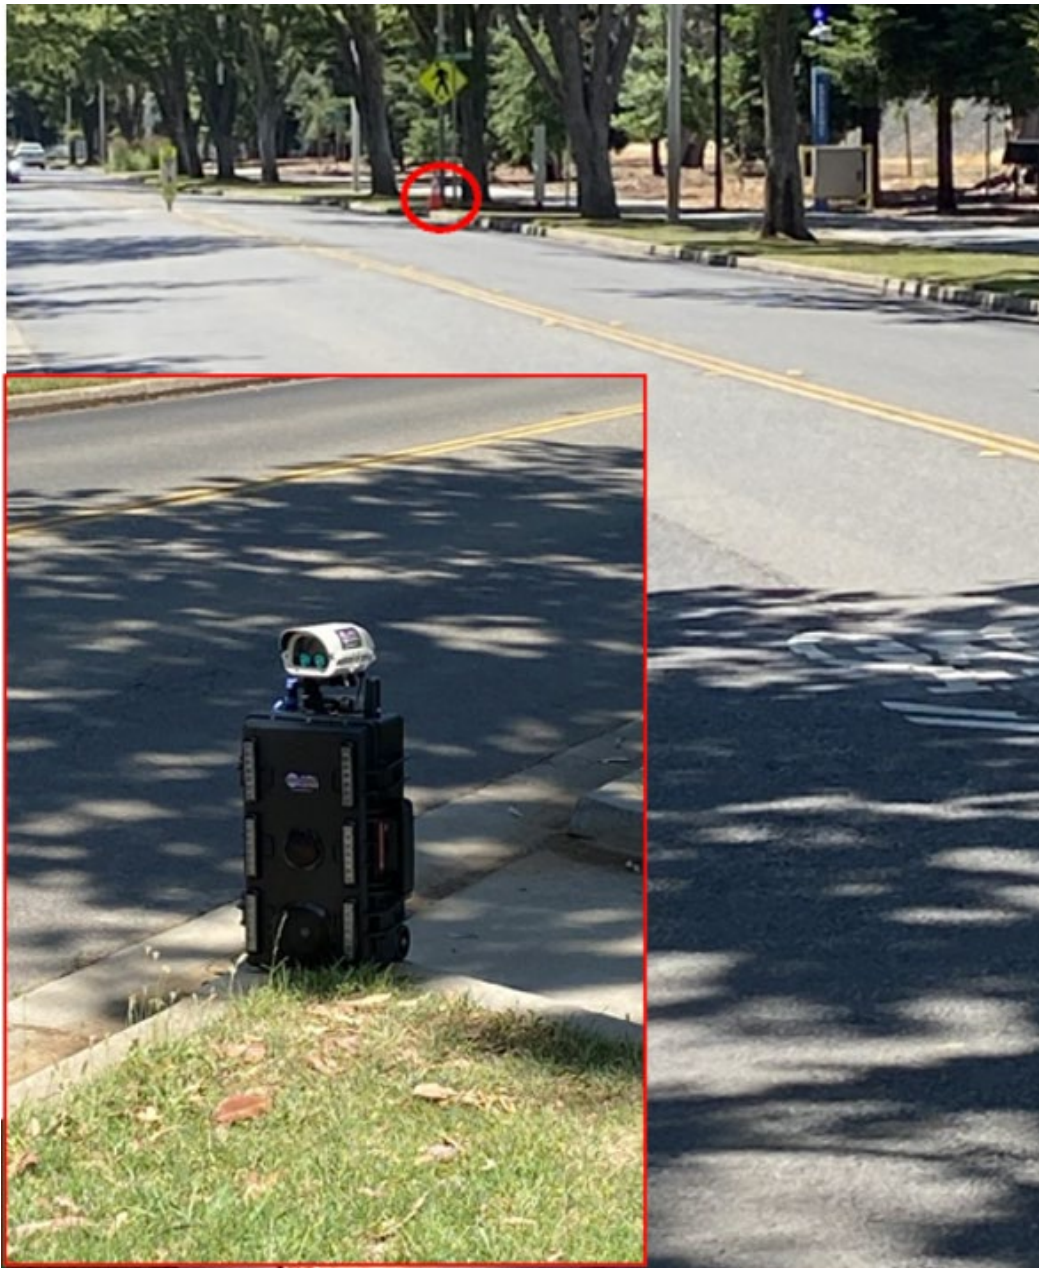
Figure 7.3 Overwatch Trial 1 Setup on Two-Lane Roadway

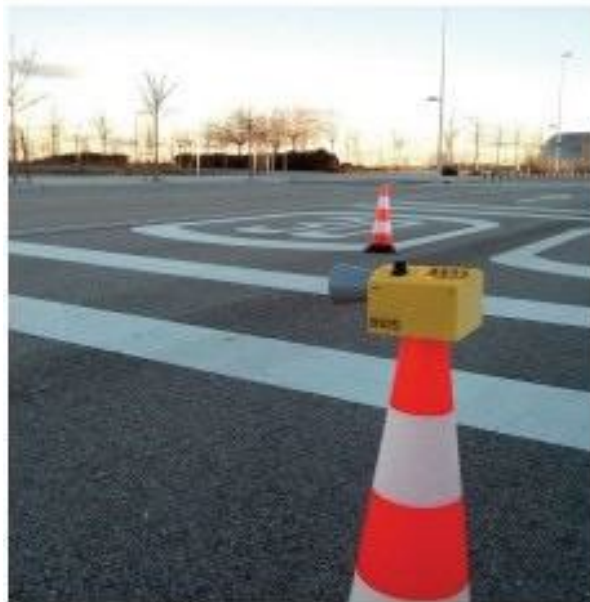
Figure A.3 Photo of WSN Sensor Node During Closed Track Testing
(Source: Martin et al., 2016)

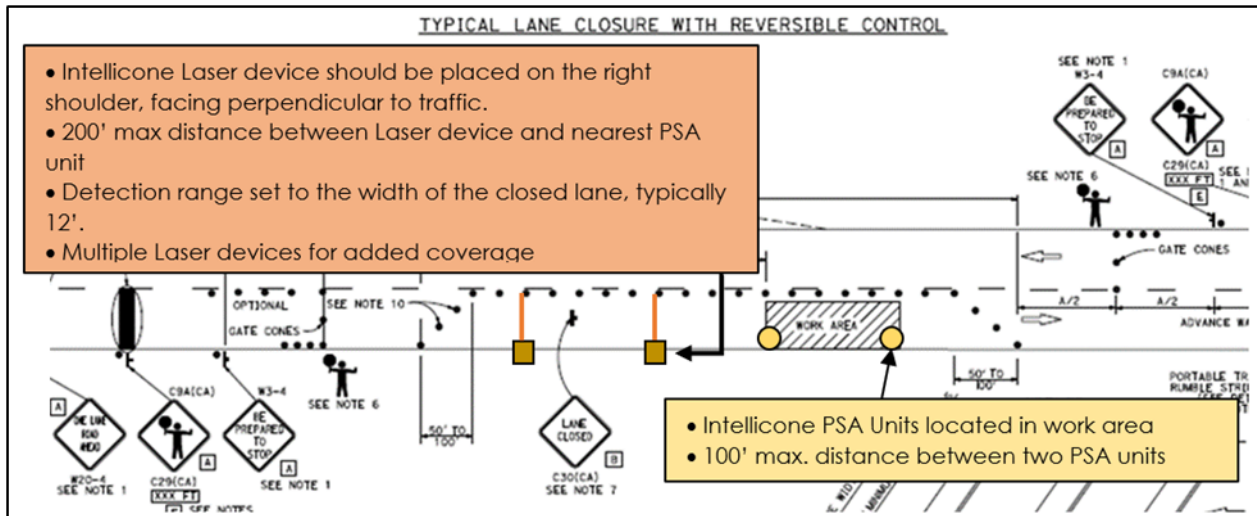
Figure E.13 Recommended Deployment Plan for Intellicone Single Sentry Beam on a Standard T-13 Closure

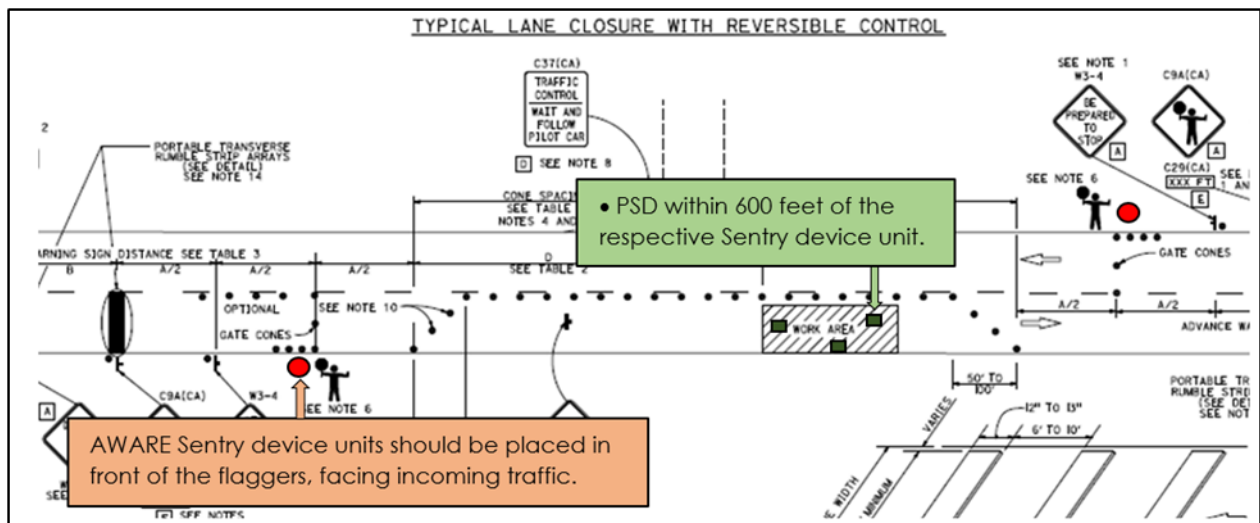
Figure E.19 Recommended Deployment Plan for AWARE Sentry on a Standard T-13 Closure
