Report # MATC-MS&T: 136-2

Performance Investigation of Earthquake Damaged Reinforced Concrete Bridges with Repaired Columns

A Cooperative Research Project sponsored by
U.S. Department of Transportation- Office of the Assistant
Secretary for Research and Technology

June 2021

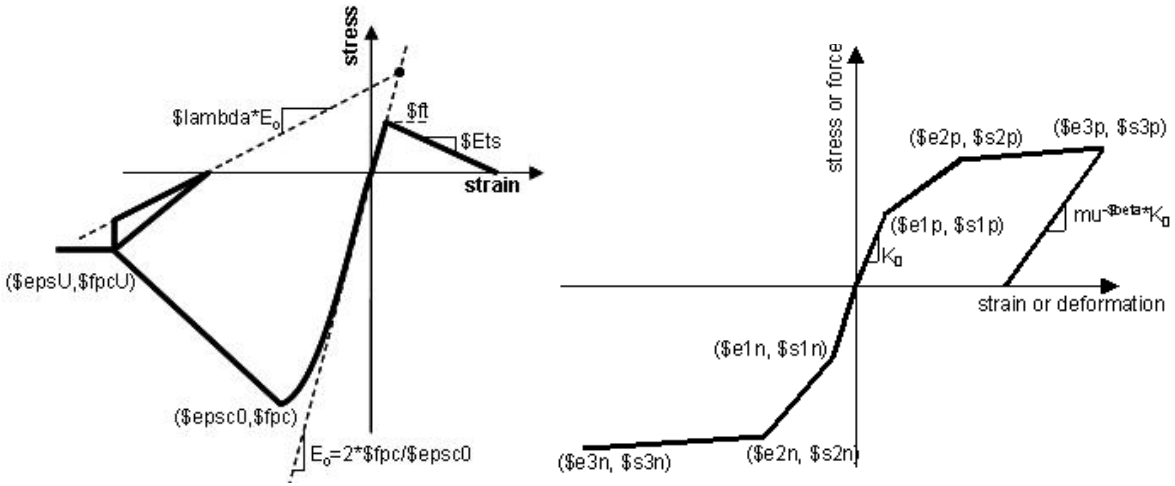
Figure 2.1 Concrete02 Material – Linear Tension Softening (left) and Hysteretic Material (right) (Mazzoni et al. 2006)

Confined and unconfined concrete was modeled in OpenSees using Linear Tension Softening Concrete02 material. The compressive stress–strain relationship of the material model is based on the uniaxial Kent–Schoff–Park concrete material model (Kent and Park 1971). The tensile stress–strain relationship is bilinear with the same modulus as the compressive elastic modulus. The effect of the confinement caused by the internal transverse reinforcement and by the FRP jacket was evaluated using Mander’s model (Mander et al. 1988). Figure 2.1 shows the stress-strain relationship, as well as the input required, of the Concrete02 Material implemented in OpenSees.

The longitudinal reinforcing steel was modeled in OpenSees as Hysteretic material. This model was preferred to the uniaxial models available in OpenSees based on previous investigation on the capability to simulate the strength degradation due to bar fracture or buckling and to achieve convergence at large strains (He et al. 2016). The hysteretic material model requires three stress–strain inputs in both tension and compression to represent the monotonic behavior of the reinforcing steel. The cyclic behavior of the steel model is controlled by additional parameters p_x (pinching factor for strain during reloading), p_y (pinching factor for stress during reloading), $D1$ (damage due to ductility), $D2$ (damage due to energy), and β (power used to determine the degraded unloading stiffness based on ductility). The behavior of reinforcing steel in tension and compression was modeled with the same values. Figure 2.1 shows the stress-strain relationship, as well as the input needed, of the Hysteretic material implemented in OpenSees.

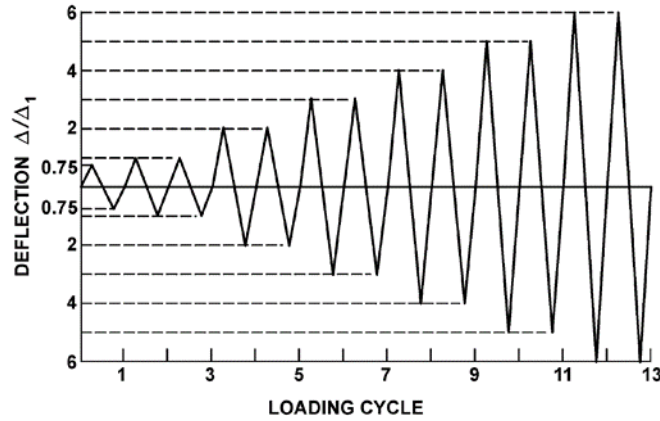
Figure 2.3 Experimental Test A: specified displacement history (Sheikh and Yau 2002)

equal to $P = 0.54P_0$, where $P_0 = [0.85f'_c(A_g - A_s) + A_s f_y]$. The column was initially subjected to three load cycles with the lateral deflection Δ_1 calculated using the theoretical sectional behavior of the column and integrating curvatures along the length of the specimen (Sheikh and Yau 2002). Δ_1 was defined as the lateral deflection corresponding to the maximum lateral load along a line that represented the initial stiffness of the specimen (Sheikh and Yau 2002). The specimen was further damaged with two cycles of $1.4\Delta_1$. Flexural cracks were observed in the hinging zone at approximately 100 to 400 mm from the stub face. Some spalling of the top cover occurred at 435 to 685 mm from the stub. Yielding of longitudinal reinforcement was also observed.

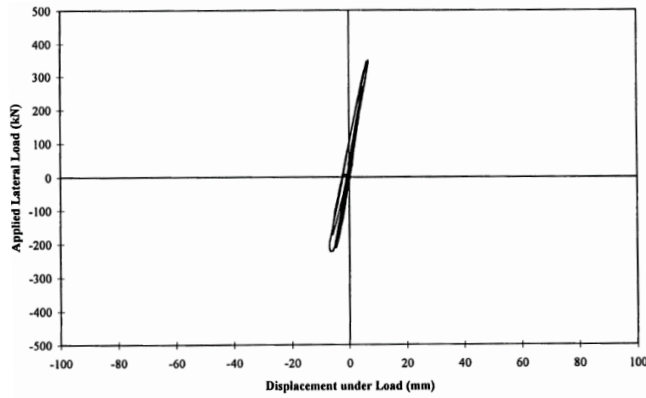
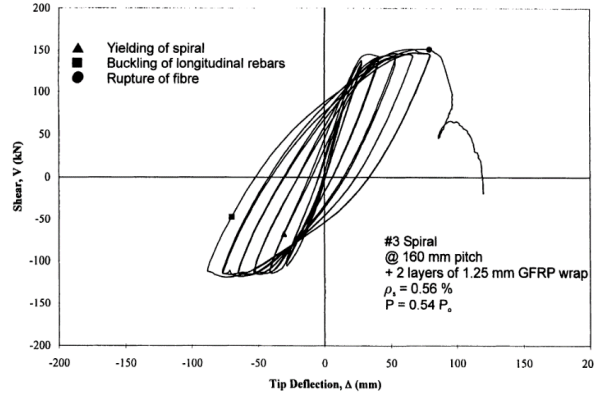
Figure A.11 Original Specimen R-INT

Figure 6.25 Shear vs. Tip Deflection Behaviour of Repaired Specimen R-INT

Figure 2.5 Experimental Test A: cyclic behavior of the original (left) and repaired (right) specimen (Yau 1998)

During the test, the lateral load and section capacity of the repaired column increased with each load cycle until failure, which was caused by jacket opening. Figure 2.4 shows a photo of the repaired column at the end of the test. Figure 2.5 shows the cyclic behavior of both the original and repaired columns.

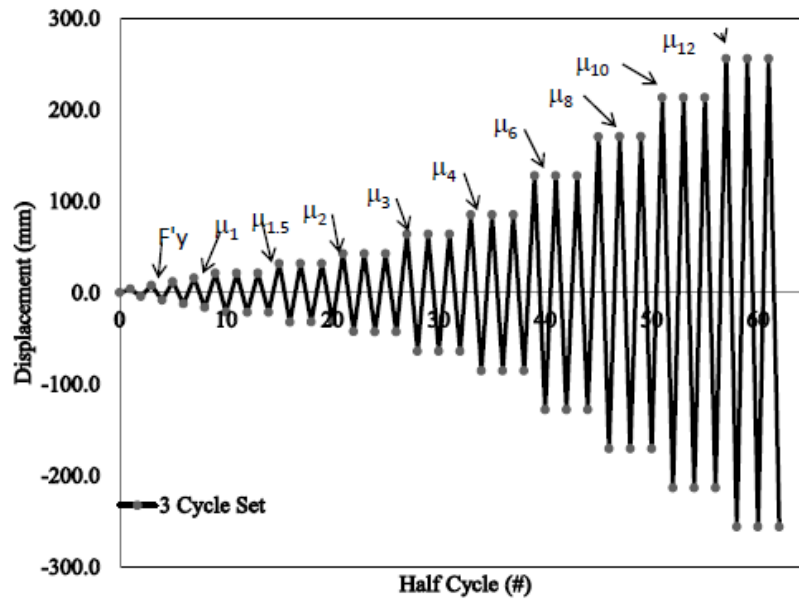
Figure 2.12 Experimental Test B: specified displacement history used during “Test two” (Rutledge 2012)

The repaired column was subjected to a loading referred to as “Test two”. During “Test two”, the repaired column was subjected to displacement-controlled symmetric three-cycle load history while simultaneously carrying an axial load ratio ($P/f'_c A_g$) of 6%, corresponding to 756 kN. The lateral load sequence, shown in figure 2.11, consisted of one cycle to a displacement $0.25F_y$, $0.50F_y$, $0.75F_y$, followed by three cycles of 1μ , 1.5μ , 2μ , 2.5μ , 3μ , 4μ , 6μ , 8μ , 10μ , 12μ , where μ indicates the displacement ductility.

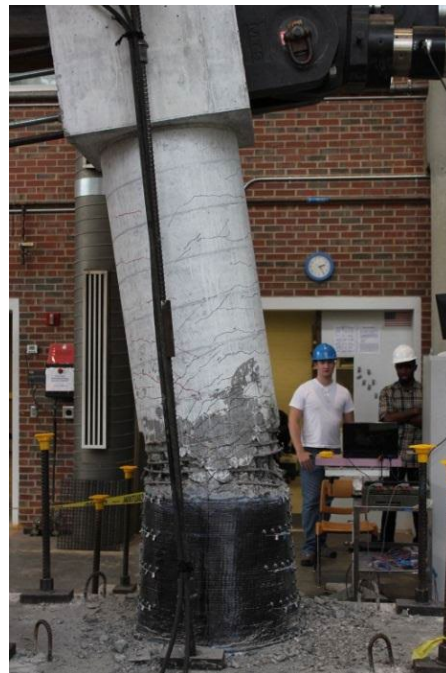
Figure 2.13 Experimental Test B: photo at peak displacement (Rutledge 2012)

by figure 2.13, the lower portion of the RC repaired column was modeled with increased stiffness and strength.

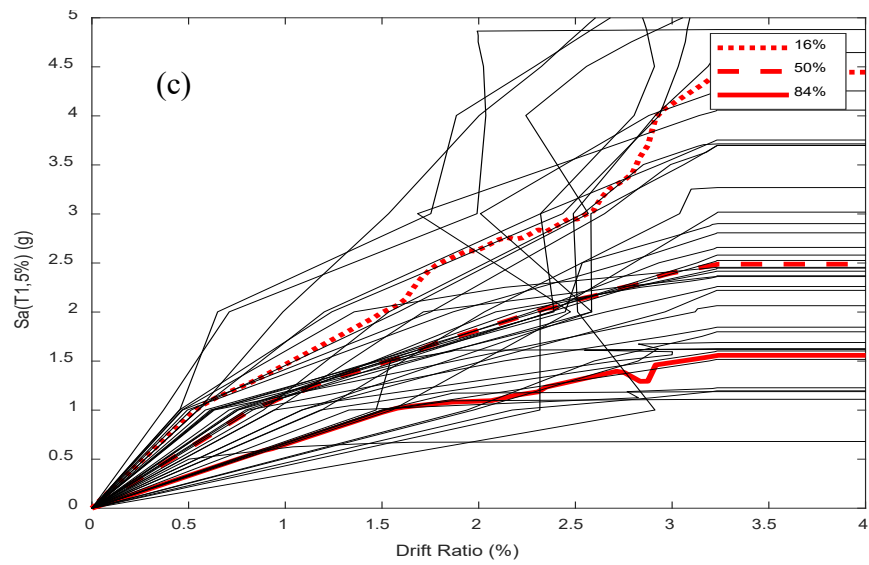
Figure 3.7 Experimental Test B: IDA curves of 40 GM records and 16th, 50th, and 84th percentiles: (a) Orig.; (b) R-1; (c) R-12; (d) R-13; (e) R-14; (f) R-123; (g) R-1234.

The IDA curves of the seven bridge models with original and/or repaired columns from Experimental Test A (Section 2.3) are shown in figure 3.6. The IDA curves of the seven bridge models with original and/or repaired columns from Experimental Test B (Section 2.4) are shown in figure 3.7. Each solid line in figures 3.6 and 3.7 represents the relationship between S_a (T1, 5%) and the drift ratio demand on the columns for each GM record. The horizontal portion of each IDA curve represents the instability or non-convergence of analysis of the bridge model, i.e., at the corresponding S_a (T1, 5%) the structure may have collapsed. The results are discussed in Section 3.3.4.

Figures 3.6 and 3.7 show the IDA curves of the seven bridge models with original and/or repaired columns from Experimental Tests A and B, respectively. In each figure, the set of IDA curves (corresponding to the 40 GM records) were summarized into curves corresponding to the 16th, 50th, and 84th percentiles, in which for a given $S_a(T_1, 5\%)$ the percentile of all drift ratio demands to the left of the curve was 16%, 50%, and 84%, respectively. The percentile curves in figure 3.6a–g and 3.7a–g show that with an increasing number of repaired columns, the initial slope of the curve decreases, which corresponds to the decreasing initial stiffness of the bridge structure.

Results of the IDA show the seismic performance of the RC prototype bridge is only slightly affected by substituting the original columns with the repaired columns considered, therefore proving the effectiveness of two different repair strategies considered in this study. Figures 3.6 and 3.7 also show for both repair systems considered, i.e., Experimental Tests A and

B, the percentile curves for R-12, R-13, and R-14 are similar. This result suggests the location of the repaired columns does not significantly impact the behavior of the bridge models with the same number of repaired columns. These findings are similar to those by He et al. (2016) who simulated the same prototype bridge but with different original and repaired columns (in terms of column cross-section, damage condition, and repair method) than those in the present study.
