U.S. Department
of Transportation
**Federal Railroad
Administration**

Mitigation of Differential Movement at Railway Transitions for U.S. High-Speed Passenger Rail and Joint Passenger/Freight Corridors

1. REPORT DATE (DD-MM-YYYY) September 2022		2. REPORT TYPE Technical Report		3. DATES COVERED (From - To) February 2020	
4. TITLE AND SUBTITLE Mitigation of Differential Movement at Railway Transitions for U.S. High-Speed Passenger Rail and Joint Passenger/Freight Corridors			5a. CONTRACT NUMBER DTFR53-11-C-00028		
			5b. GRANT NUMBER		
			5c. PROGRAM ELEMENT NUMBER

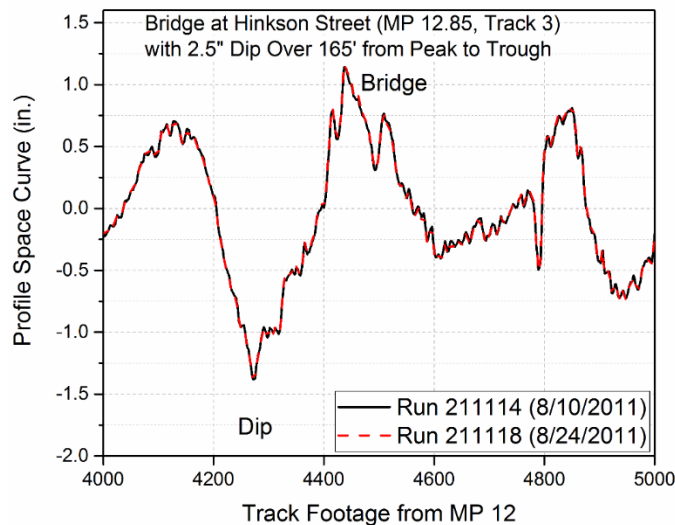
Figure 3.2: Track Geometry Data for Bridge Over Hinkson Street Near Chester, PA

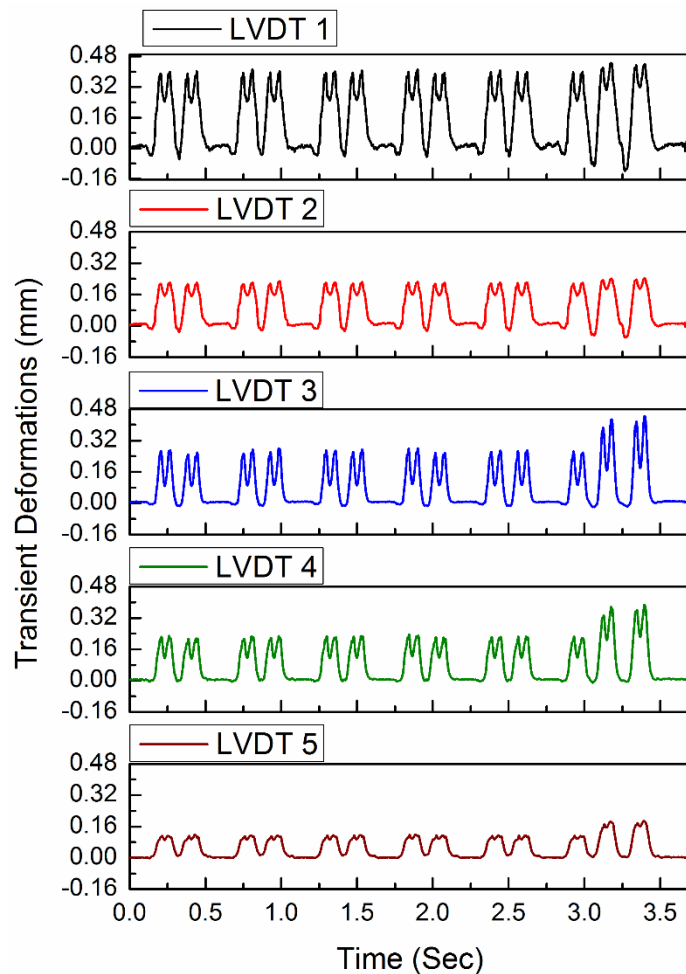
Figure 4.8: Example Transient Deformation Time-History Recorded Under Train Loading at the Upland Street Bridge Approach (Near-Bridge Location)

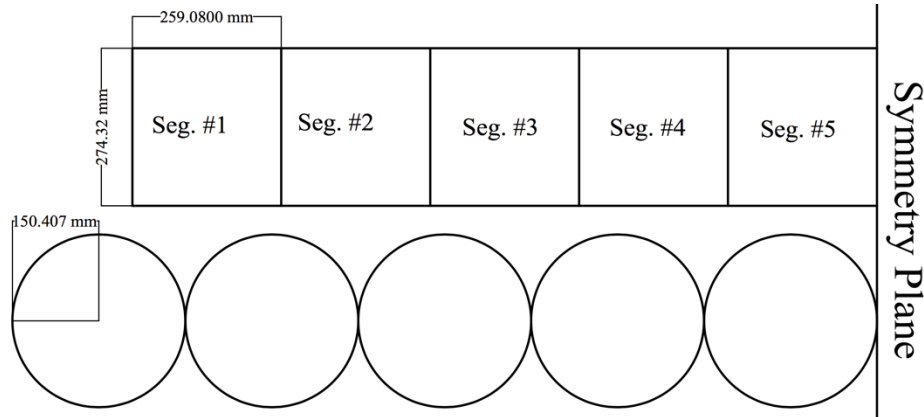
Figure 7.4: GeoTrack Half Tie Load Assignment
