**New England Transportation Consortium (NETC)**

# Investigating Thermal Imaging Technologies and Unmanned Aerial Vehicles to Improve Bridge Inspections

## Final Report

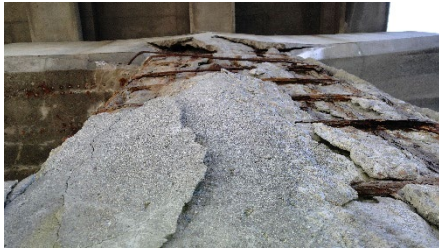
*Figure 3 - Severe Delamination / Incipient Spall*

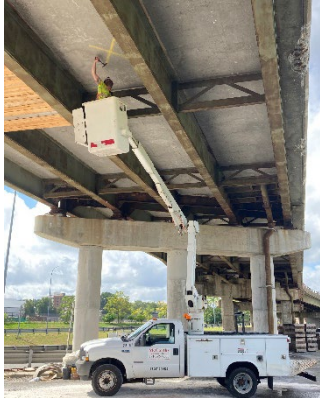
Figure 4 - Inspector Hammer Sounding Deck

Historically, bridge inspectors identify delaminated concrete by manual acoustic methods, commonly referred to as sounding. Sounding uses tools and is based on when the sound from impact changes from a clear ringing sound (sound deck) to a somewhat mute, dull, and hollow sound (delaminated deck) [3]. The delamination has an air pocket which causes a change in the acoustic response. The primary tools for manual sounding that are typically used by bridge inspectors are as follows:

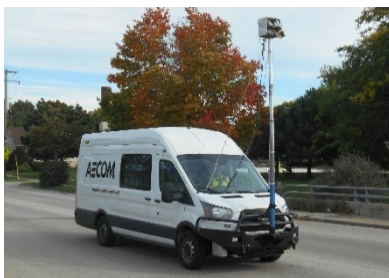
Figure 5 - Van Equipped with IR Sensor

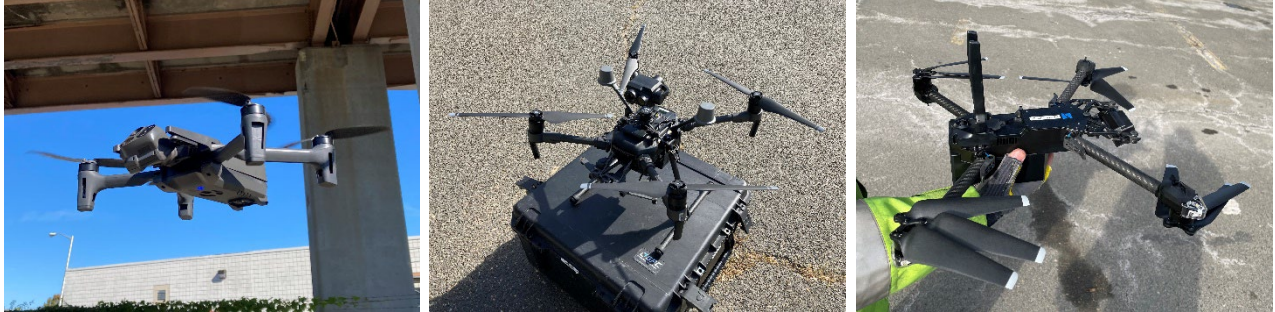
Figure 9 - Field-Tested Drones - Parrot Anafi USA, DJI Matrice 210, and Skydio X2 from left to right

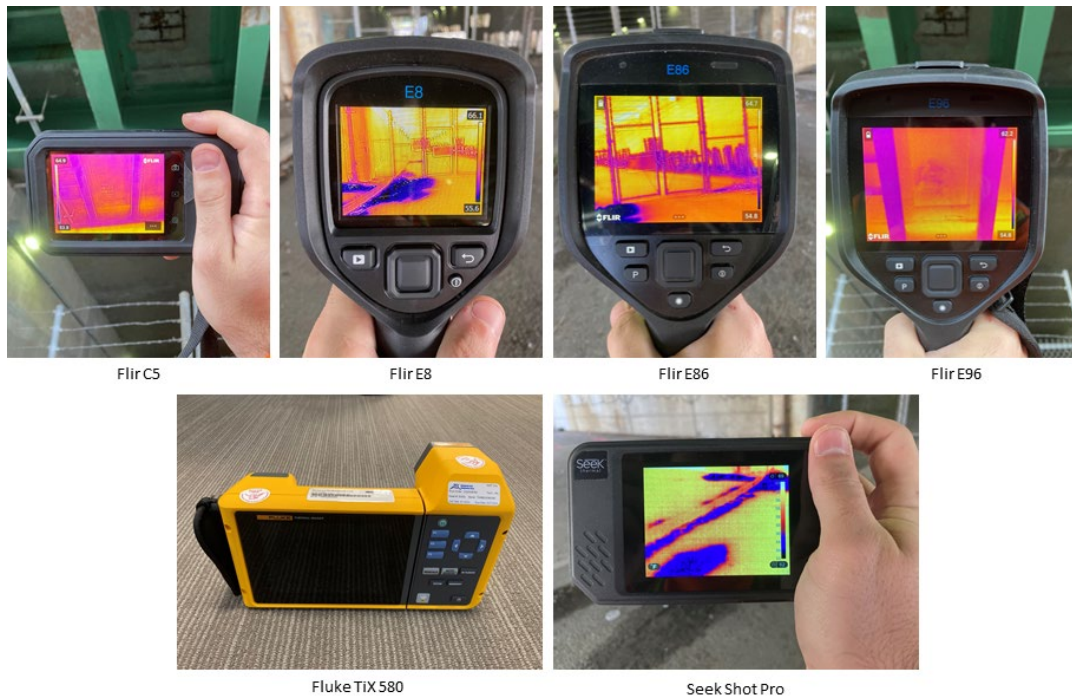
Figure 10 - Field-Tested Handheld Thermal Cameras

AECOM recommended field-testing of the Flir C5, Flir E8, Flir E86, Flir E96, Seek Shot Pro, and Fluke Ti480 Pro. While the desk scan recommended the use of a Fluke Ti480 Pro, the specific model was not available for rental during the field-testing. The vendor recommended the use of a Fluke TiX580 as an alternative. This substitution provided similar thermal resolution and specifications to the Ti480 Pro and provided the opportunity to test a different style of camera. Refer to Figure 10.

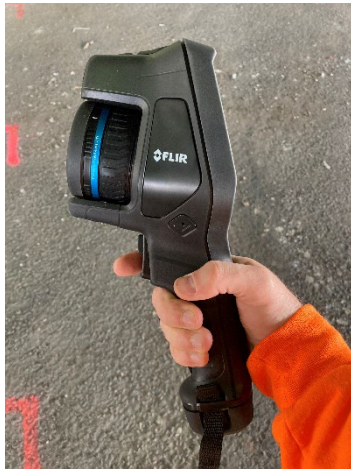
Figure 11 - Flir E96

Based on the results of the field-testing, the Flir E96 and Zenmuse XT2 thermal sensors provide the best performance for concrete delamination detection along the underside of bridges (refer to Figures 11 and 12). The Flir E96 provided the best image quality (640x480 thermal resolution) and detection capabilities out of the tested handheld thermal cameras. For the field-tested drone-mounted thermal cameras, the Zenmuse XT2 provided the best quality imagery, detection capability, and flexibility with the radiometric sensor. The Zenmuse XT2 can be mounted to the DJI Matrice 210 or DJI Matrice 300. However, during the research project, the camera has since been discontinued. The replacement model, the Zenmuse H20T, while not field-tested, is expected to perform similarly to the XT2. While the protocols for implementation will have slightly different steps for this camera, the overall recommendations and procedures will be the same. Tables 6 through 8 on Pages 17 and 18 show several positive and negative observations from field-testing.

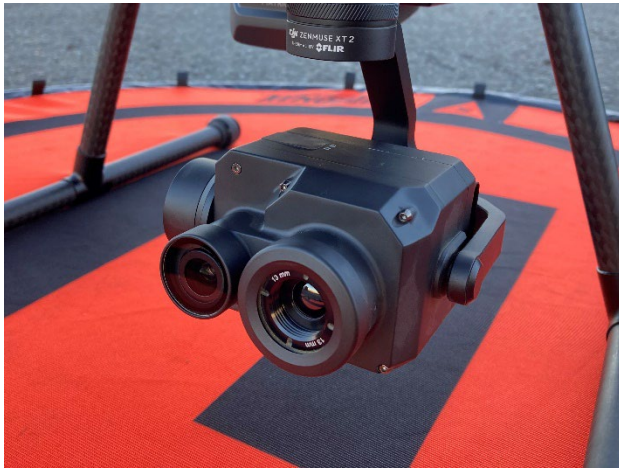
Figure 12 - Zenmuse XT2

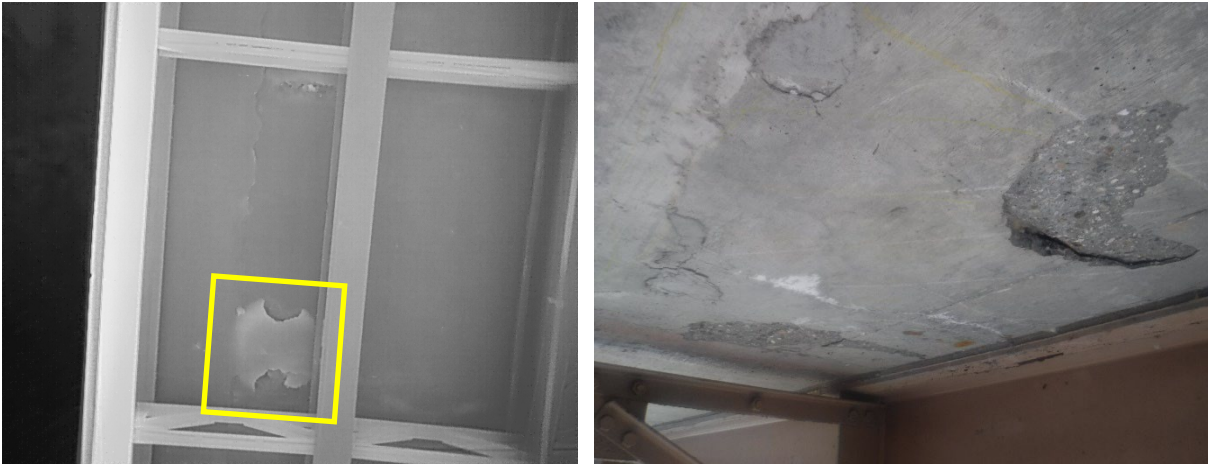
Figure 15 - Delamination without Visible Separation

- Minor delaminations detected only through manual sounding (refer to Figure 13).
- Minor delaminations with cracking (refer to Figure 14).
- Delamination without visible separation (refer to Figure 15 on Page 20).
- Delaminations with cracking and visible separation (refer to Figures 16 and 17 on Page 20).
- Delaminations along previous repairs due to voids / overpour (refer to Figure 18 on Page 21).
- Both sound patches and delaminations with patches (refer to Figures 19 and 20 on Page 21).

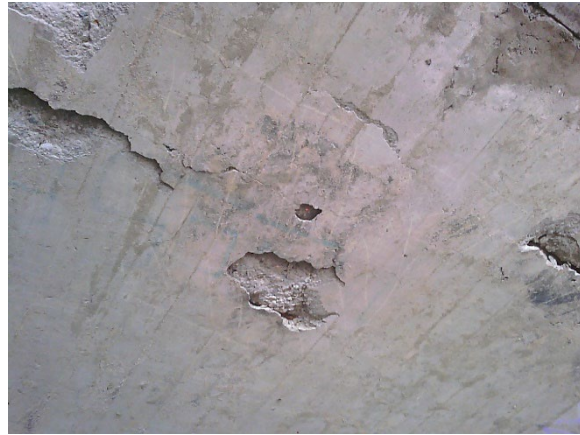
Figure 17 - Delamination with Visible Separation

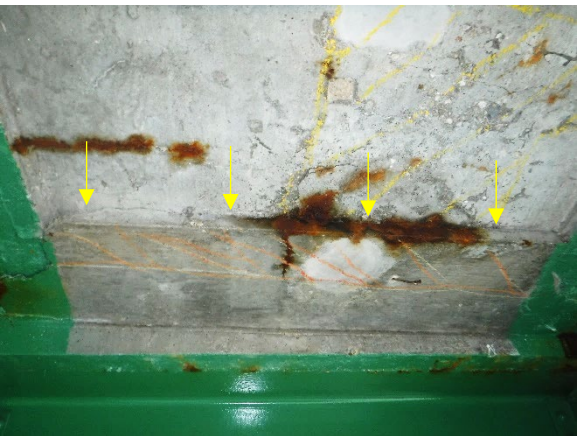
Figure 18 - Delamination along Repair due to Void / Overpour

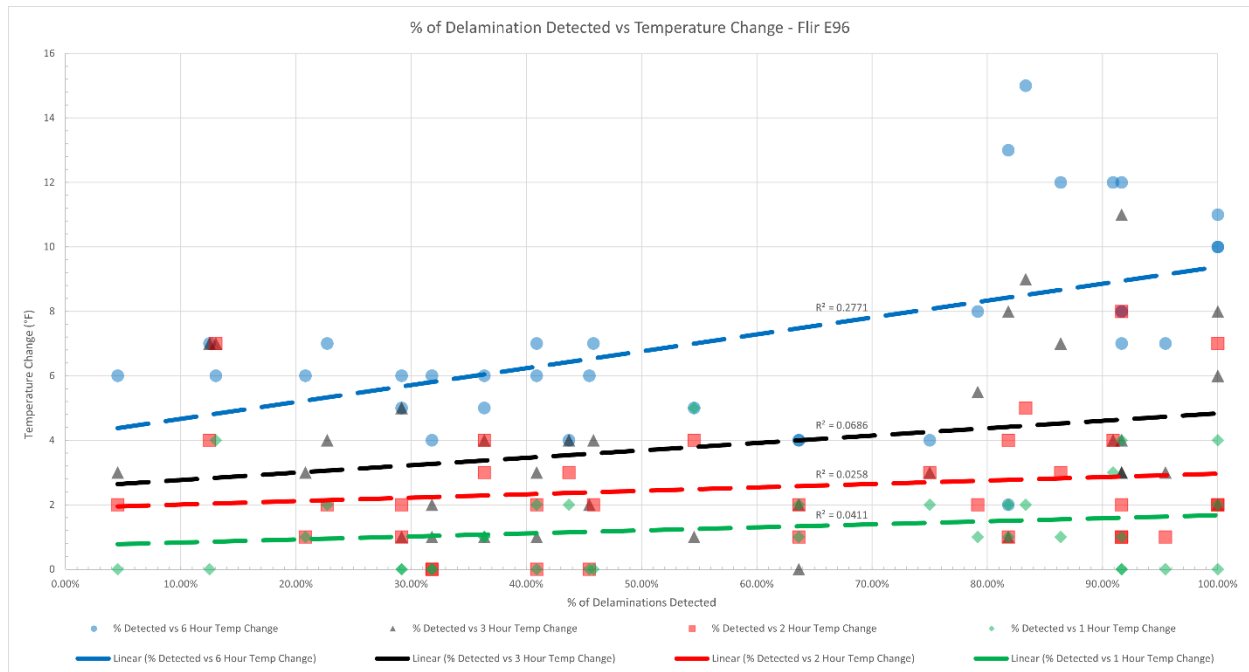
Figure 22 - Delamination Detection versus Temperature Change for Flir E96

Generally, the trend lines are not very good fits and show limited correlation. The detection rates for the Flir E96 at BIN 4E5 varied and did not always correlate to the expected results based on the temperature. For example, there were six days of data collection with a temperature swing of 7 degrees over a 6-hour period. This resulted in 22.73, 95.45, 40.91, 12.50, 91.67, and 45.83 percent detection rates which indicates other factors beyond just temperature change influencing the results. The Zenmuse XT2 trendline had a better fit for a 6-hour period, which can likely be attributed to the smaller amount of data collected and higher variation in temperature change experienced. While not the best fit, the trendlines are utilized to provide some guidance for data collection.

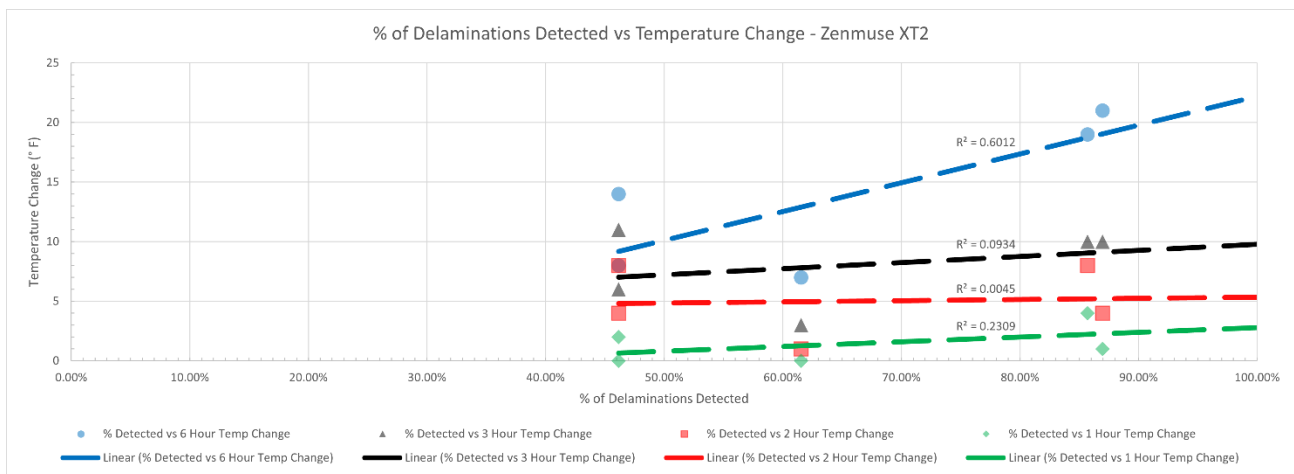
Figure 23 - Delamination Detection versus Temperature Change for Zenmuse XT2

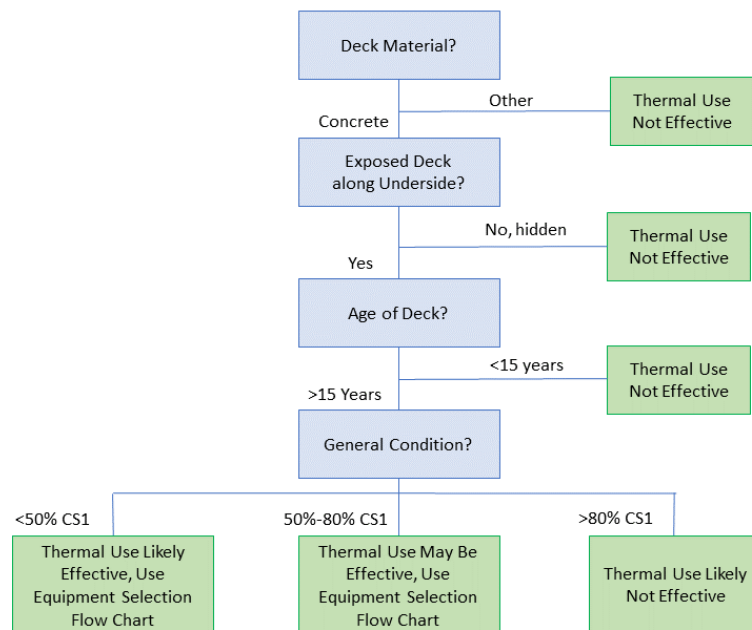
Figure 24 - Flow Chart to Determine Effectiveness for Underside of Bridge Decks

Flow charts have been developed in order to assist in determining whether thermal imaging would be an efficient tool for deck, superstructure, and substructure as part of an inspection. The intent of the flow chart is to assist in decision making based on the likelihood of delamination being present. This would help guide staffing in order to assigned bridge inspectors trained for thermal imaging to be assigned to bridges which are most likely to have concrete delamination. Refer to Figures 24 through 26 (Pages 30 and 31). Larger versions of the flow charts can be found in Appendix A. Discussion of the criteria utilized in the flow charts is discussed in the Task 3 Interim Report beginning on Page 12.

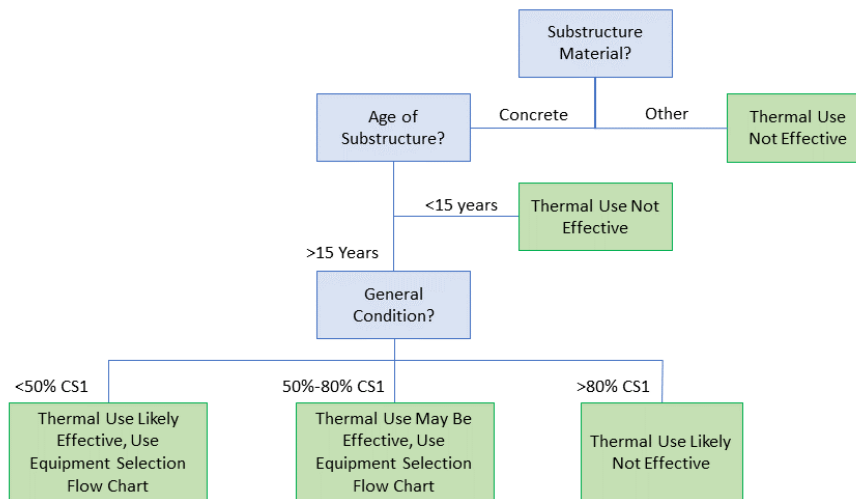
Figure 26 - Flow Chart to Determine Effectiveness for Substructure Elements

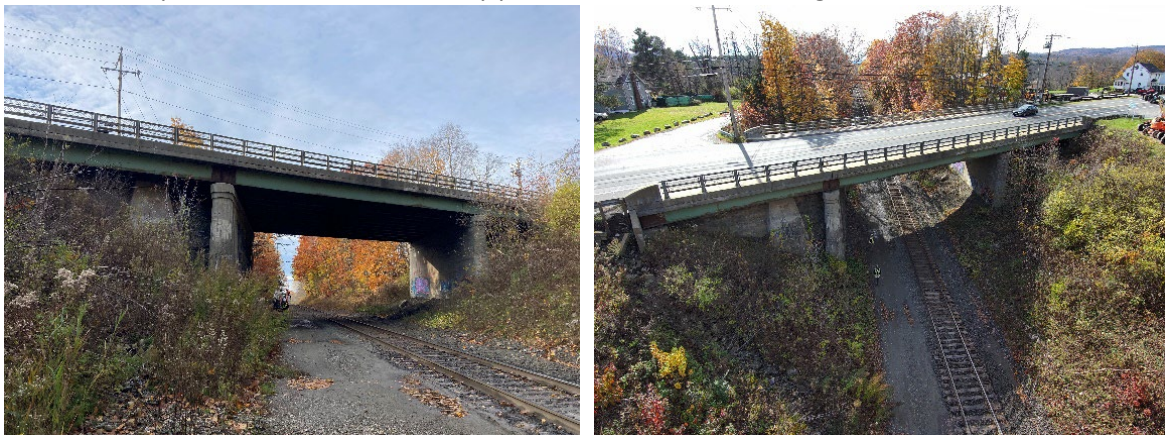
*Figure 40 - Terrestrial versus Aerial Elevation of Girder Bridge*

The use of drones potentially increases safety for inspection staff by avoiding loose terrain around embankments, climbing over railings/fences, and avoiding walking through brush and vegetation. Poison ivy is a very common hazard for bridge inspectors which can be avoided through the use of a drone. The drone can also provide improved image quality and context providing better insight into the adjacent areas for inspection planning. Figures 40 through 42 (shown below and on the following page) show several examples of traditional inventory photos versus a drone image.

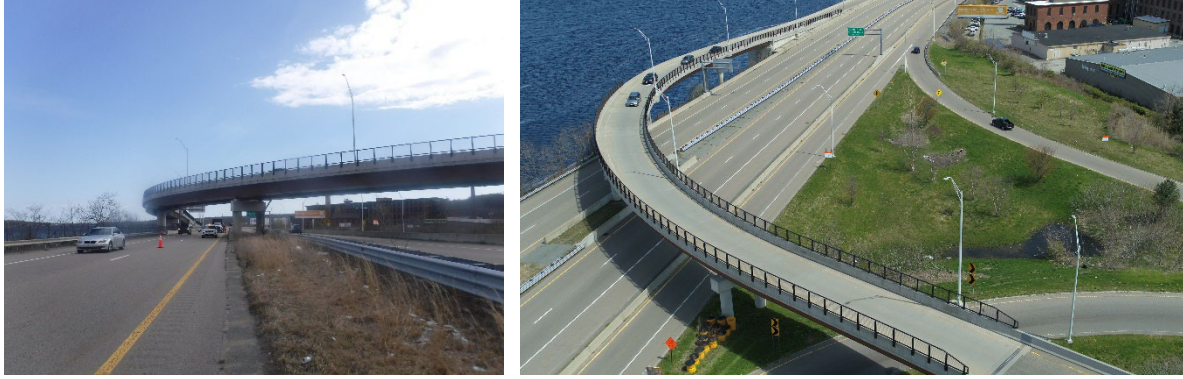
Figure 41 - Terrestrial versus Aerial Elevation of Steel Box Girder Bridge

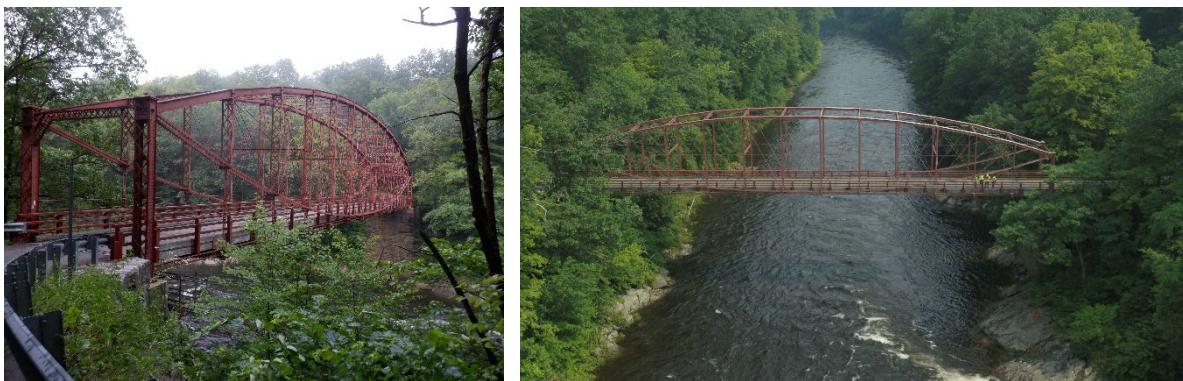
Figure 42 - Terrestrial versus Aerial Elevation of Truss Bridge

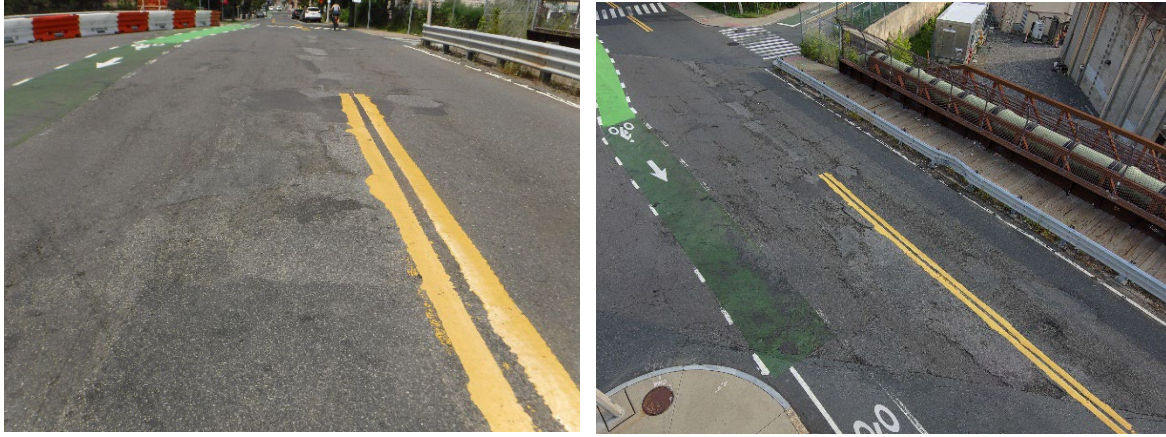
*Figure 43 - Terrestrial versus Aerial Image of Wearing Surface*

These types of images can also provide clear detail of defects to truly understand the deterioration. Each inspector can have different interpretations and ways of documenting such that the same defect can be described in multiple ways. An aerial image can help provide a clear record of the deterioration. While imagery can also be taken on the ground, the lower angle does not always provide enough context. Some detail will be lost in drone images based on the distance, so both terrestrial and aerial images should be used to adequately show the condition (refer to Figures 43 and 44, shown below and on the following page).

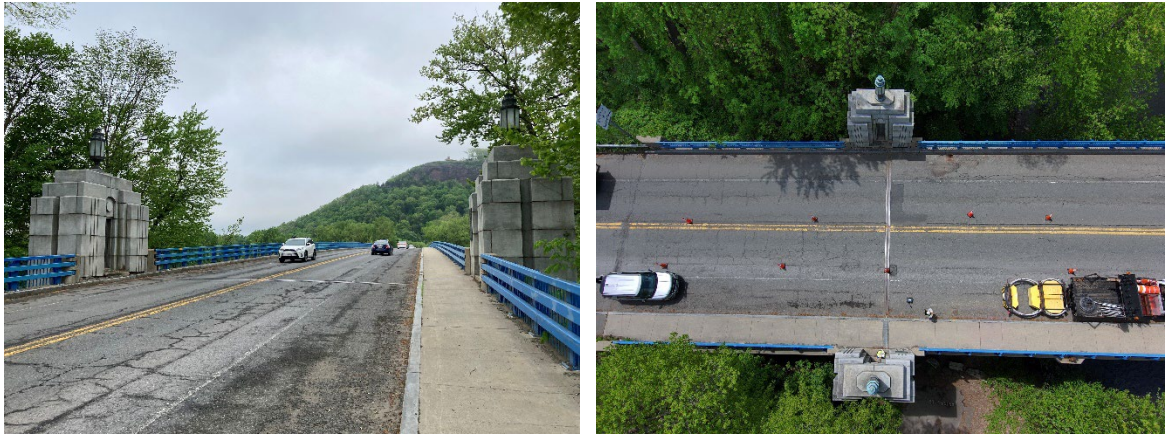
Figure 44 - Terrestrial versus Aerial Image of Wearing Surface

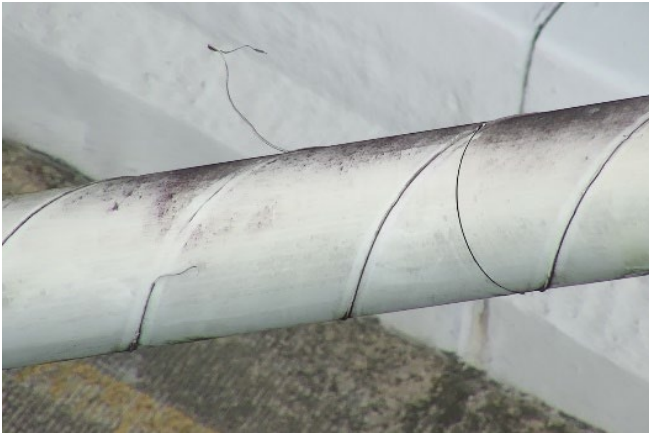
*Figure 52 - Helical Bead Damage to Cable Stay*

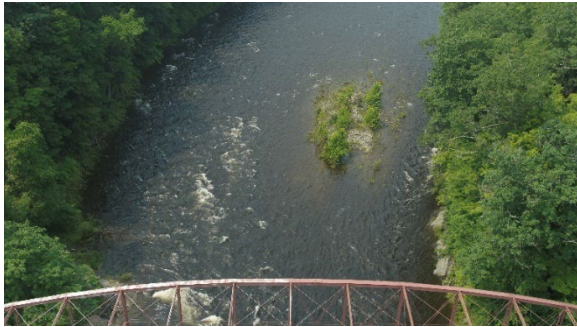
*Figure 54 - Aggradation with Vegetation Growth along Channel Upstream of Bridge*

Inspections over waterways require observations on the channel itself to monitor potential movement and scour. Drones provide a quick way to review the channel upstream and downstream of the bridge to review the condition of the channel. Drones can visually identify embankment erosions, aggradation, debris, and vegetation affecting the channel flow as well as deterioration of channel/retaining walls (refer to Figures 54 and 55). This prevents the inspector from needing to climb down an embankment or walk-through brush and trees reducing the risk of trips, ticks, and poison ivy.

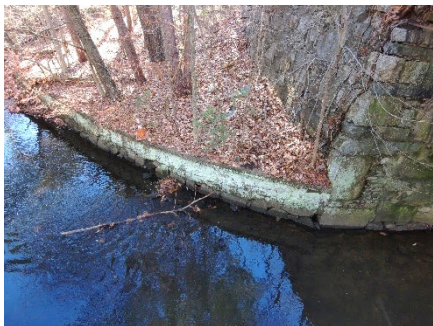
*Figure 55 - Channel Wall Deterioration Downstream of Bridge*

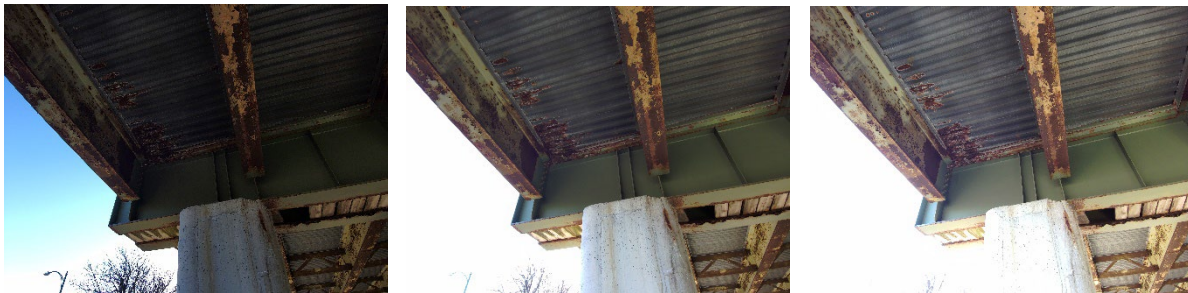
Figure 56 - Different Exposure Compensation Settings

Lighting conditions with large contrast affect image exposure. Dynamic range is the range from brightest to darkest visible area of an image. The human eye can see brighter and darker areas than image sensors. The extent of deficiencies can be lost in shadows caused by the more limited dynamic range of a sensor (refer to Figures 56 and 57). The UAS pilot will need to account for the limitations in dynamic range either through modifying the drone flight path, adjusting the exposure compensation in automatic camera mode, or establishing manual camera settings during the flight. Wider bridges may have reduced lighting underneath the center of the bridge, which may limit the usefulness of the drone visual imagery.

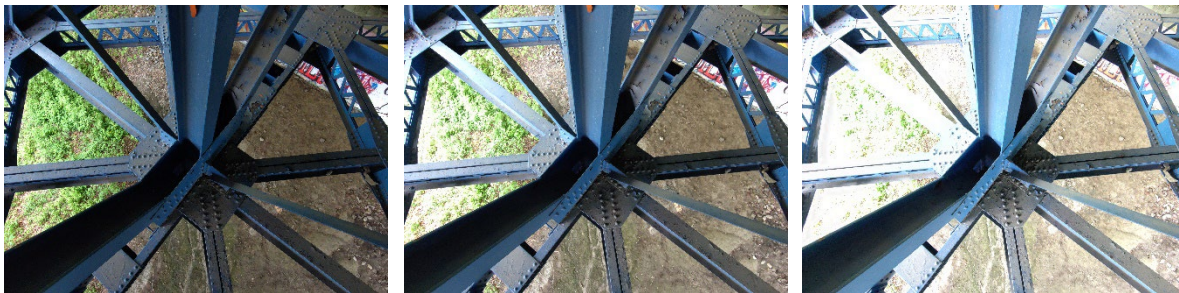
Figure 57 - Inadequate Visual Imagery due to Bridge Geometry and Lighting

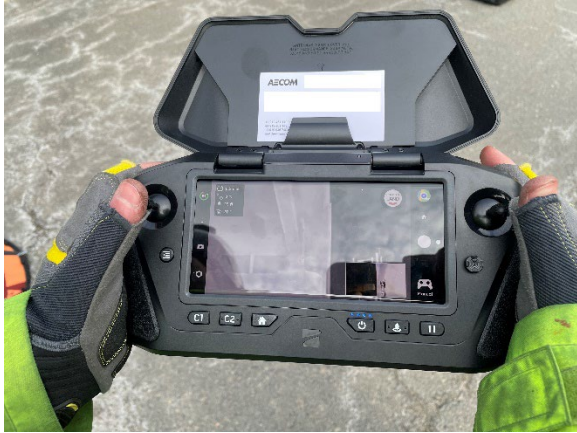
*Figure 62 - Screen Glare on Skydio Enterprise Controller*

An additional consideration for drone usage is the ability of the inspector to effectively view the screen. Sun glare can obscure the imagery when viewed in the field which can negatively impact an inspection through missing deterioration or capturing out of focus photos (refer to Figure 62). There are commercial products available in the form of glare resistance screen protectors and sunshades; however, this will vary on the specific drone model and controller (refer to Figure 63). If neither of these products are available, the inspector should try to position themselves in a shaded area. The use of a portable canopy may be beneficial for field operations to provide shade. The imagery should be reviewed on a laptop in the field prior to completing field activities and demobilizing.

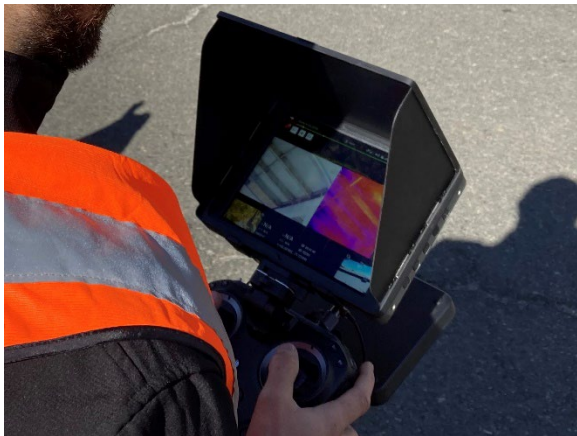
*Figure 63 - Sunshield on DJI Crystal Sky Tablet*
