NMDOT Pedestrian Safety on Arterials

**July
2024**

A Report From the
Center for Pedestrian and Bicyclist Safety

Nicholas N. Ferenchak
University of New Mexico

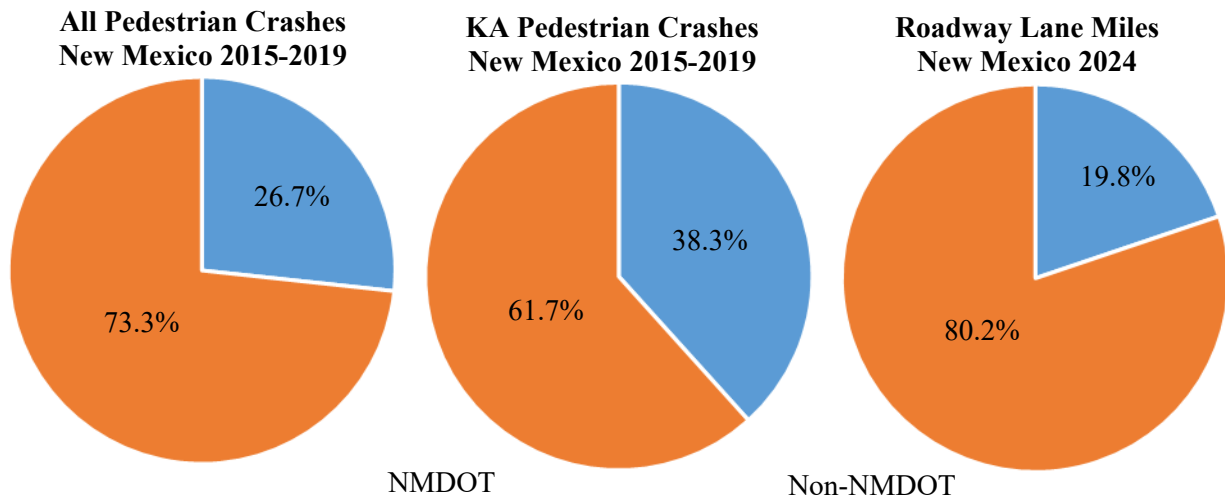
Figure 5. The distribution of pedestrian crashes relative to NMDOT roadways.

Between 2015-2019, there were 2,906 pedestrian crashes and 817 pedestrian KA crashes reported across New Mexico in the NMDOT crash dataset. 776 (26.7%) of the pedestrian crashes and 313 (38.3%) of the pedestrian KA crashes occurred within 50 feet of an NMDOT road (**Figure 5**). At the same time, NMDOT has 29,781 (19.8%) lane miles of roadway out of a total of 150,747 lane miles of roadway across the state (*FHWA, 2021*). The 19.8% of roadway lane miles in New Mexico that are owned/operated by NMDOT are slightly overrepresented since they experience 26.7% of pedestrian crashes and 38.3% of KA pedestrian crashes in the state (**Figure 5**).

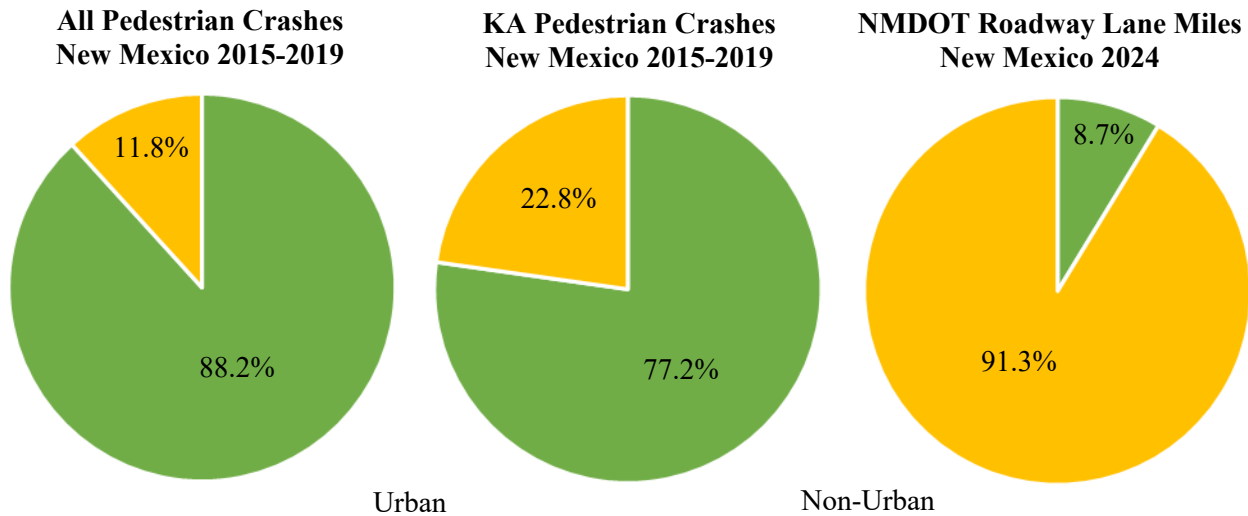
Figure 6. Pedestrian crashes on urban versus non-urban NMDOT roadways.

With 29,781 lane miles of NMDOT roadway, prioritizing locations to improve safety sounds like a daunting task (the equatorial circumference of Earth is 24,901 miles). However, while 2,564 (88.2%) pedestrian crashes and 631 (77.2%) KA pedestrian crashes in New Mexico between 2015-2019 occurred in urban areas, only 2,596 lane miles (8.7%) of NMDOT roads are in urban areas (**Figure 6**). By focusing on urban areas, we can feasibly address a vast majority of New Mexico's pedestrian safety issues (77.2%-88.2%) while only focusing on a small portion (8.7%) of NMDOT roads.

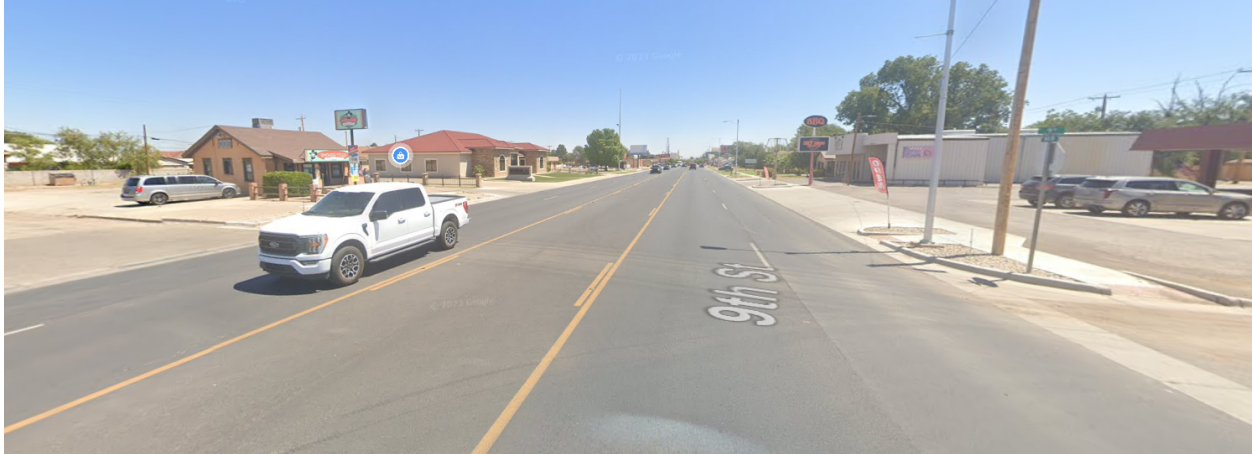
Figure 9. Photo of US-82 / W Main Street in Artesia, NM.

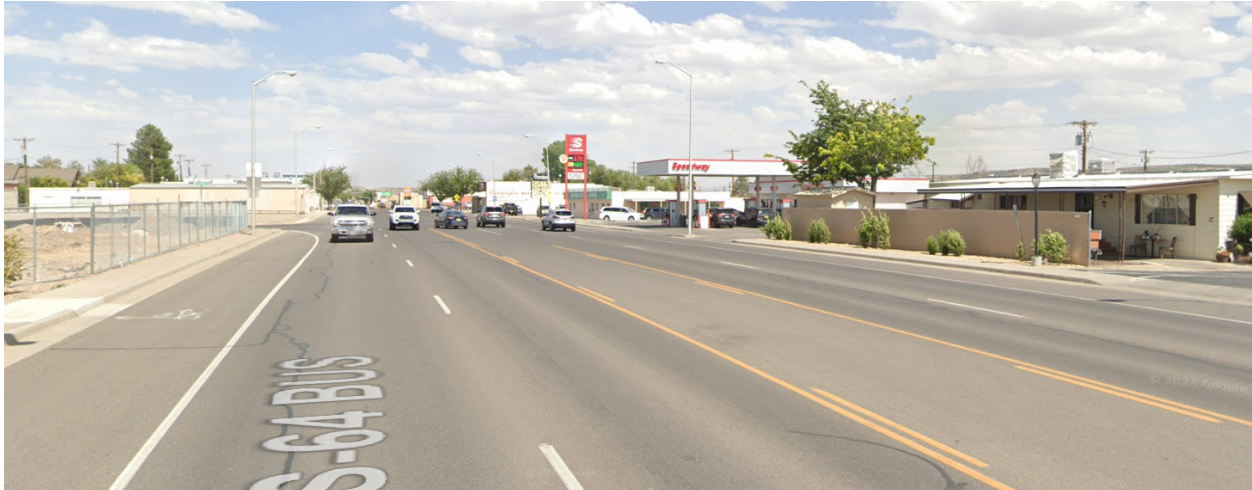
Figure 12. Photo of US-64 Business / W Broadway Avenue in Farmington, NM.

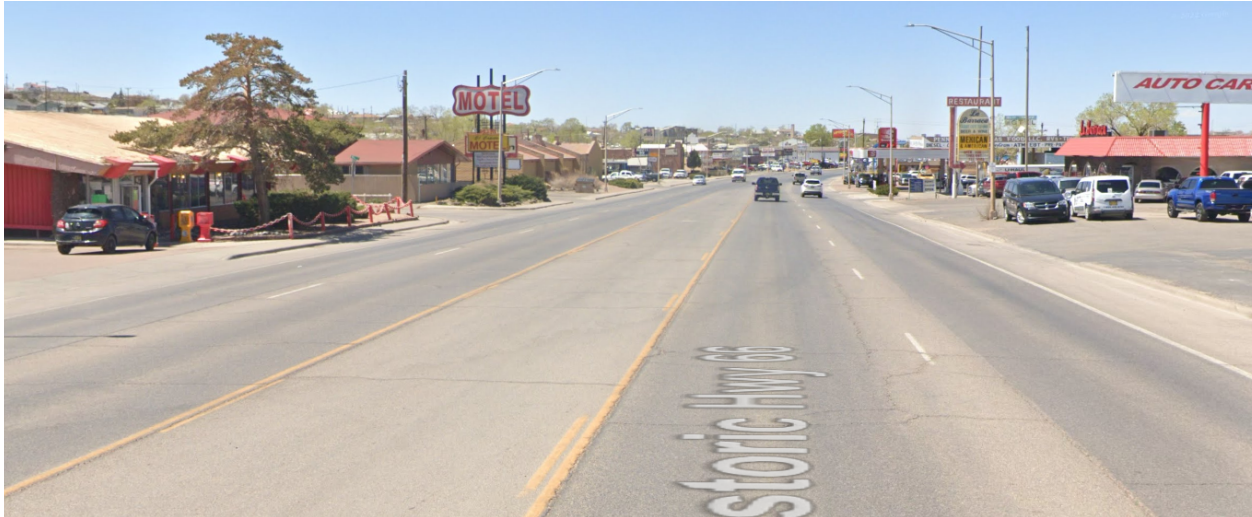
Figure 15. Photo of I-40 Business / Highway 66 in Gallup, NM.

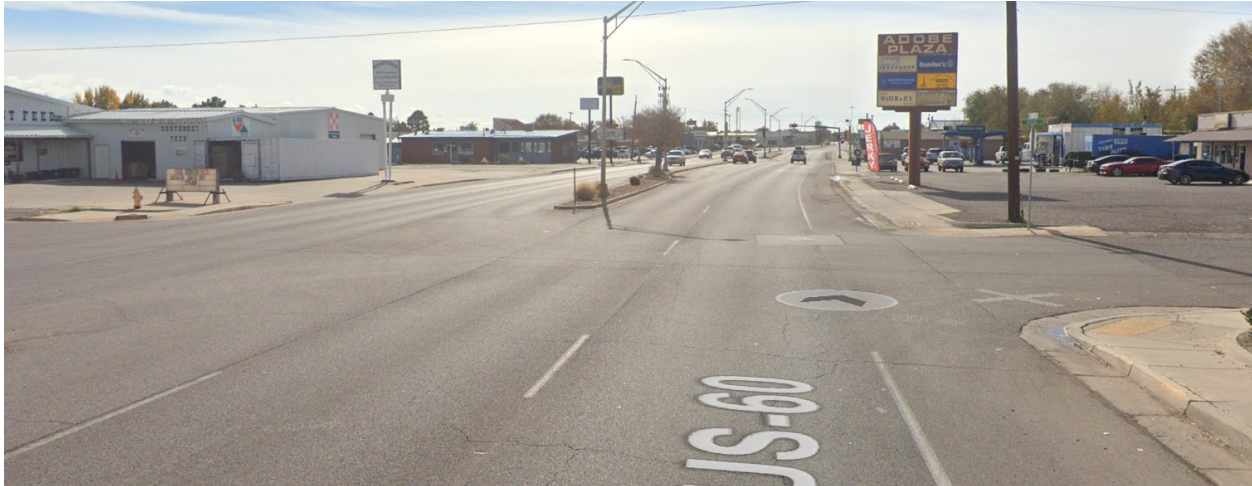
Figure 18. Photo of US-60 / California Street in Socorro, NM.

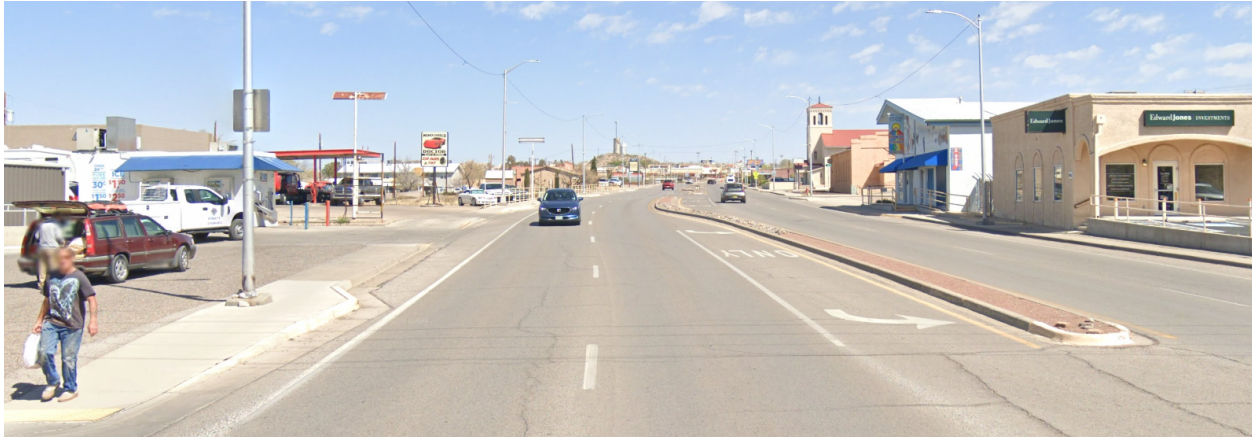
Figure 21. Photo of I-25 Business / Date Street in Truth or Consequences, NM.

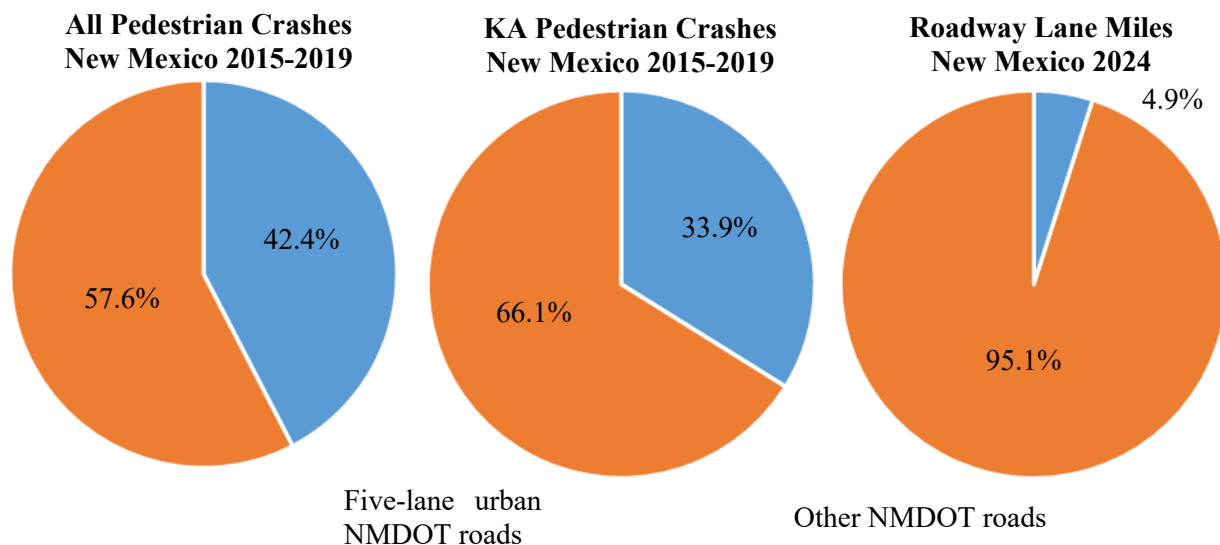
Figure 23. Distribution of pedestrian crashes relative to NMDOT roads and urban five-lane configurations.

Specifically examining NMDOT roads, 42.4% of pedestrian crashes and 33.9% of pedestrian KA crashes that occur on NMDOT roads occur on our five-lane urban road type, despite the fact that the road type only makes up 4.9% of all NMDOT lane miles (**Figure 23**).

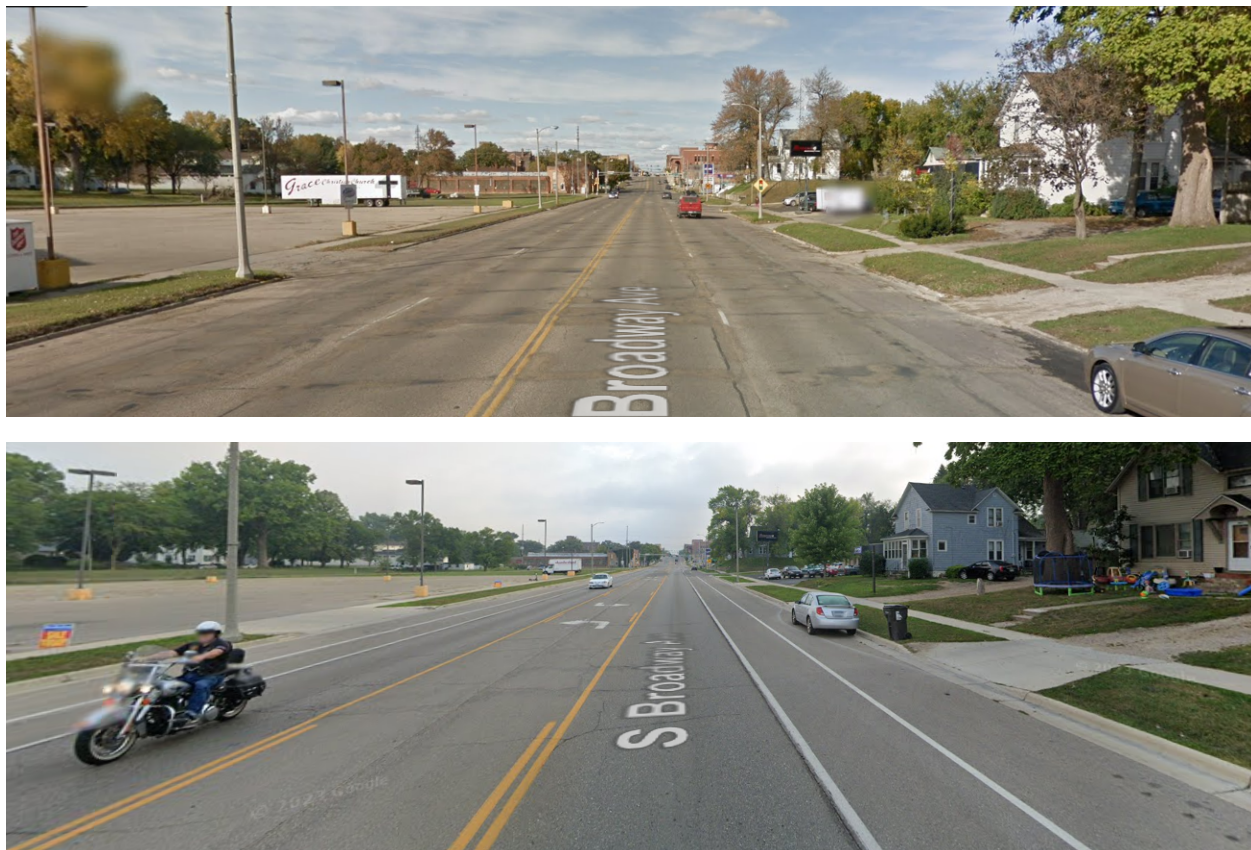
Figure 25. Photo of Highway 65 / South Broadway in Albert Lea, MN before (top) and after (bottom) road redesign.

2024a). In addition to lane reconfiguration, the project also saw replacement of sidewalks and traffic signals, new decorative lighting, trees, and curb bump-outs for pedestrians at key intersections.

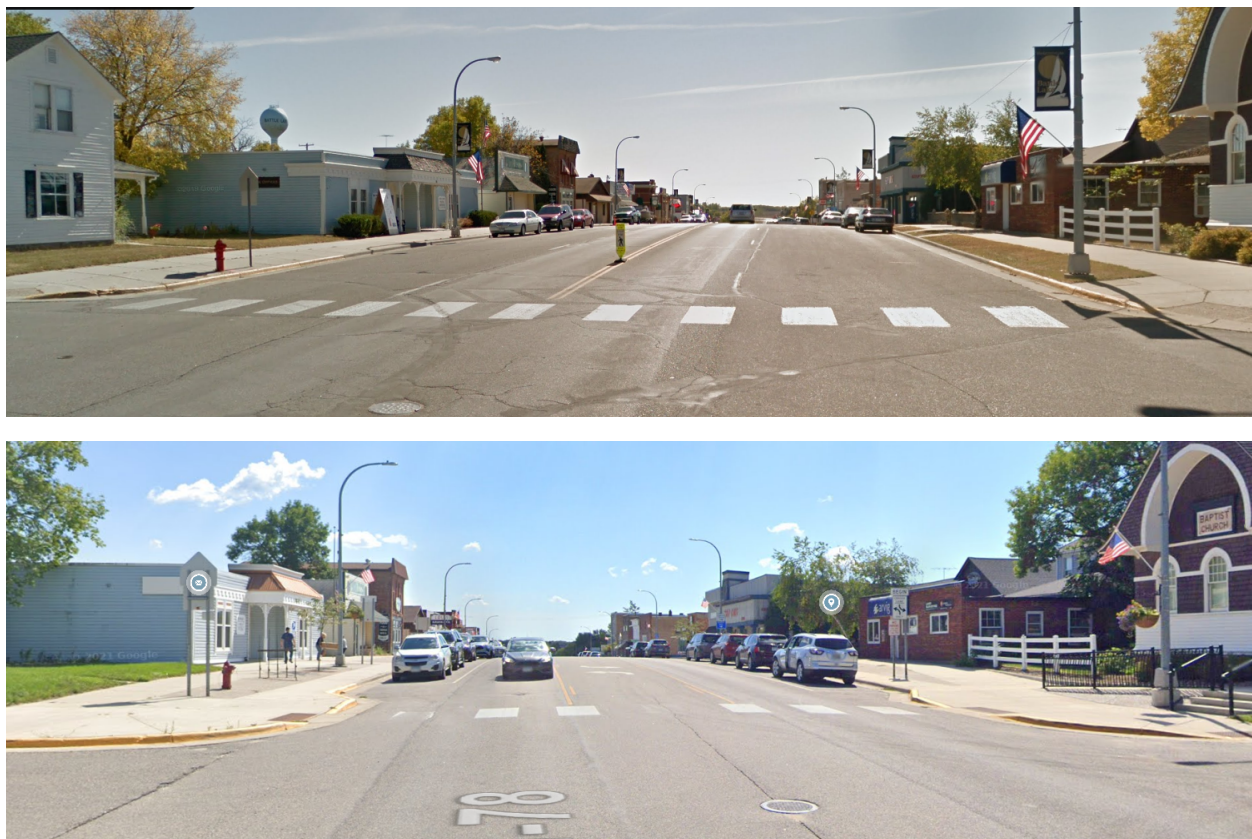
Figure 28. Photos of Highway 78 / Lake Avenue in Battle Lake, MN before (top) and after (bottom) road redesign.

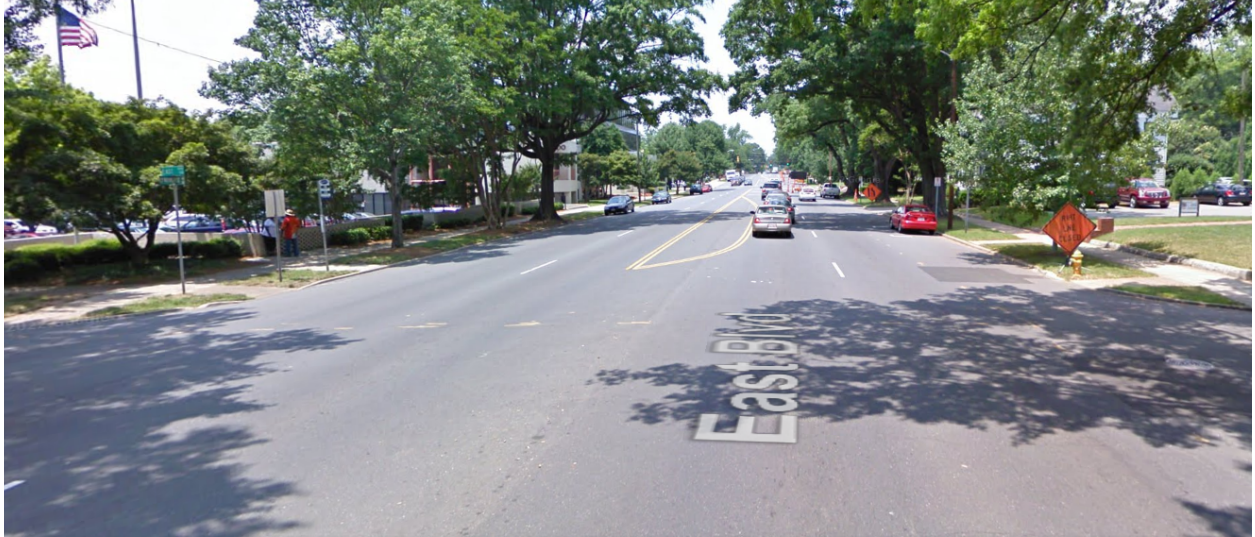
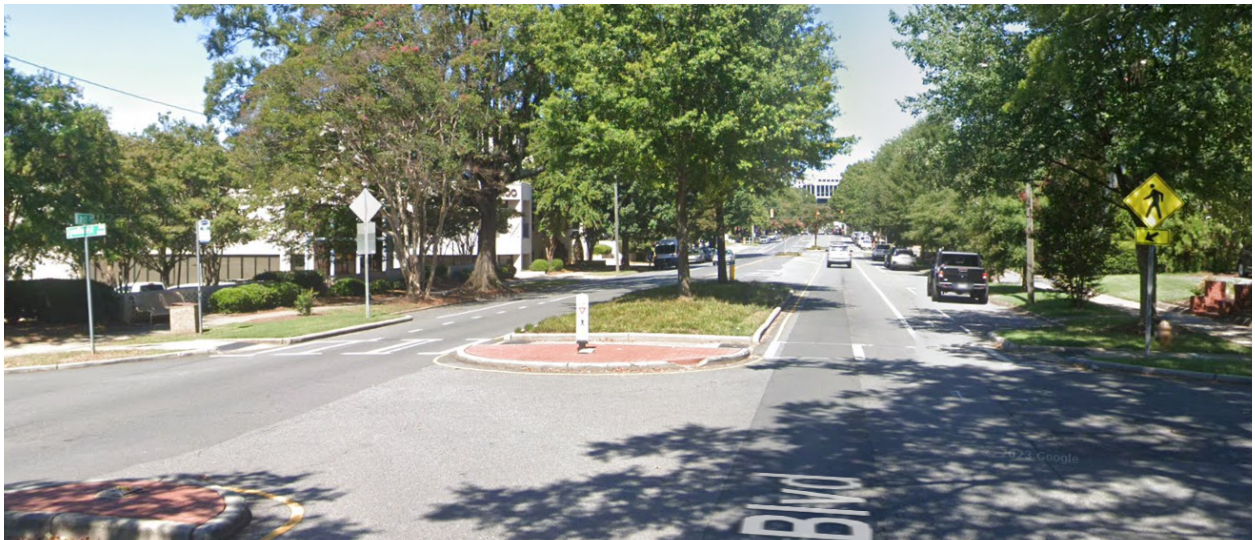
Figure 31. Photos of East Boulevard in Charlotte, NC before (top) and after (bottom) road redesign.

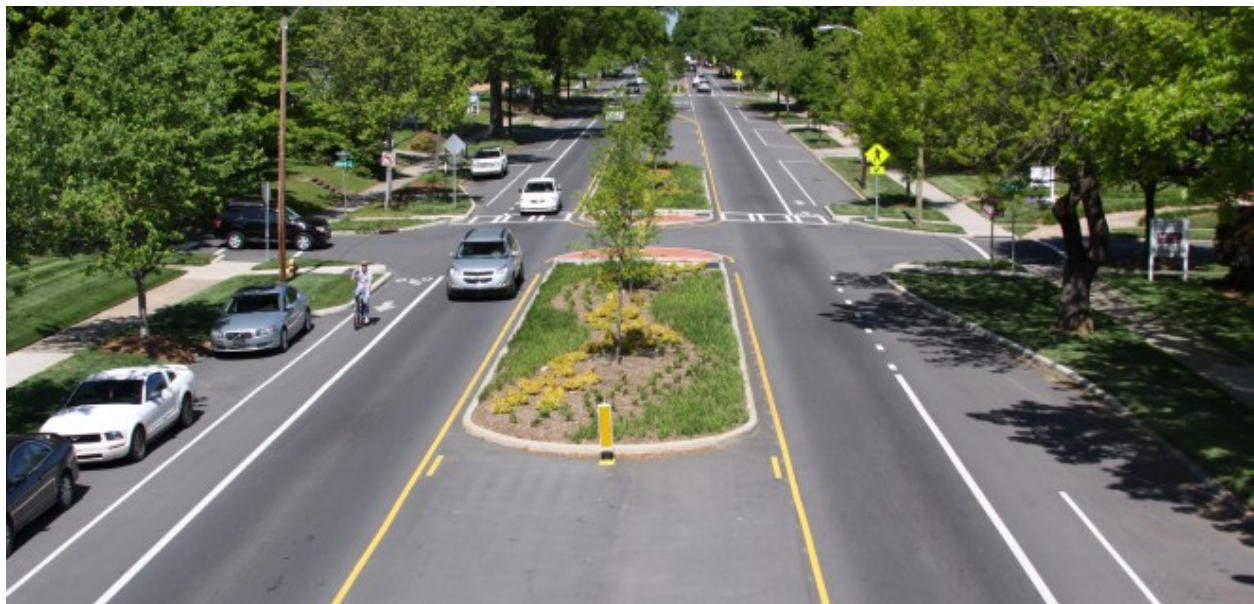
Figure 33. Pedestrian crossing on East Boulevard in Charlotte, NC after road redesign (Photo: *City of Charlotte*).

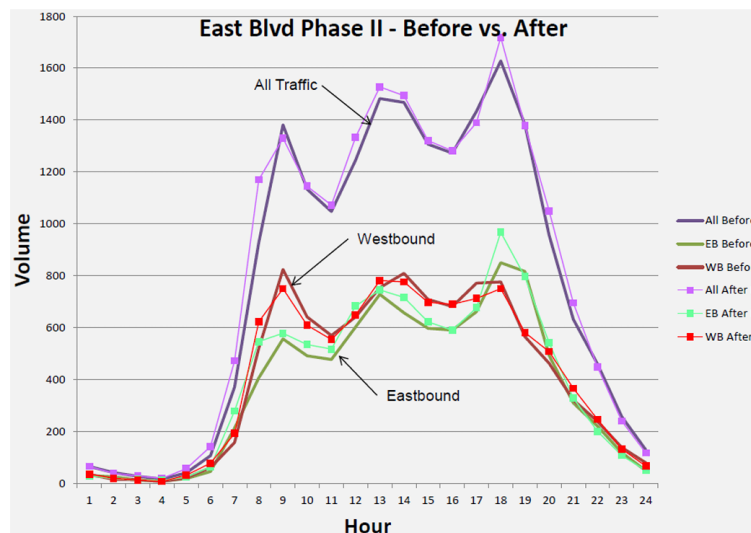
Figure 34. Traffic Volume Measurements on East Boulevard in Charlotte, NC before and after road redesign (NACTO, 2017).

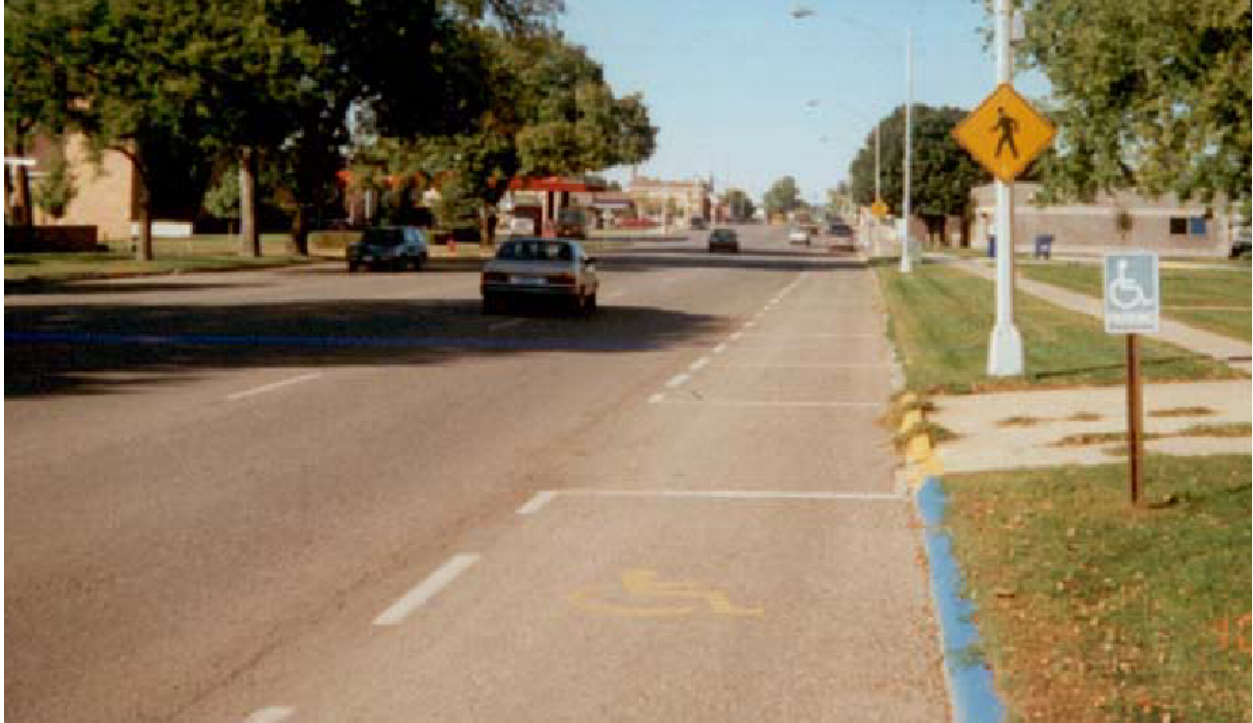
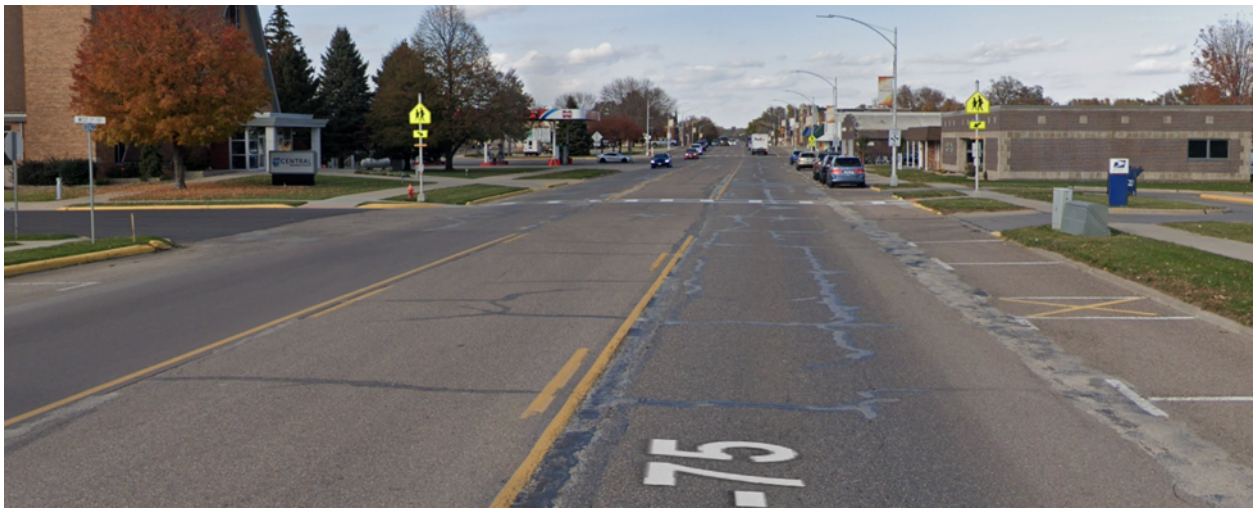
Figure 38. Photos of US-75 / Main Avenue in Sioux Center, IA before (top) and after (bottom) road redesign (*Iowa DOT, 2024*).

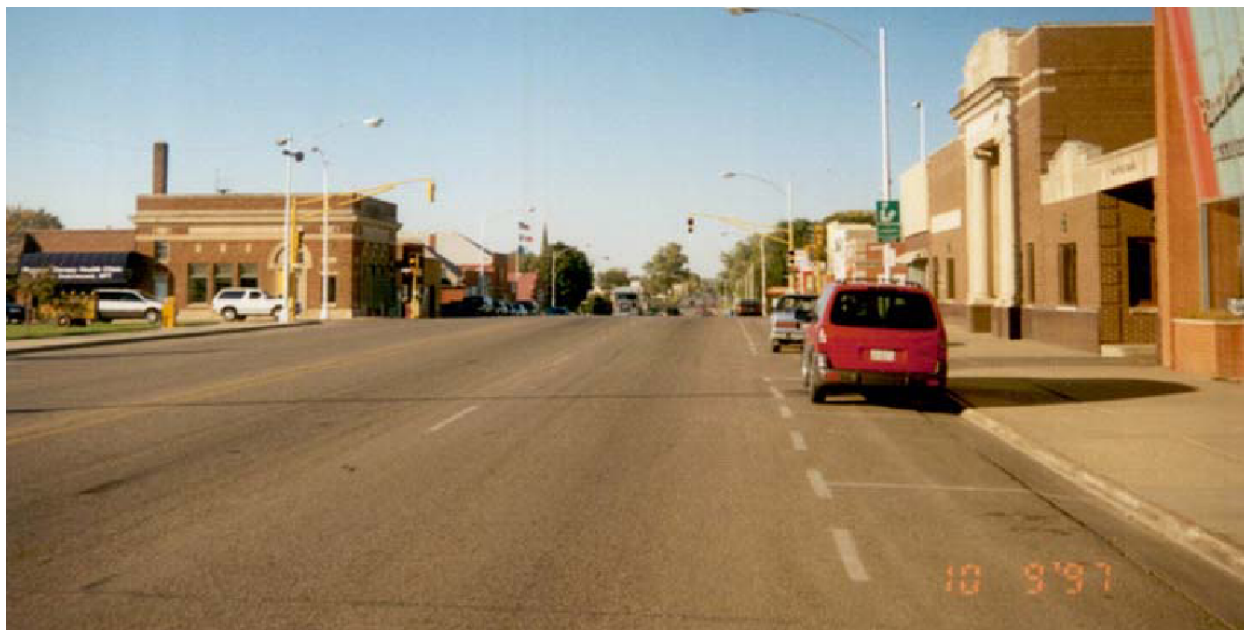
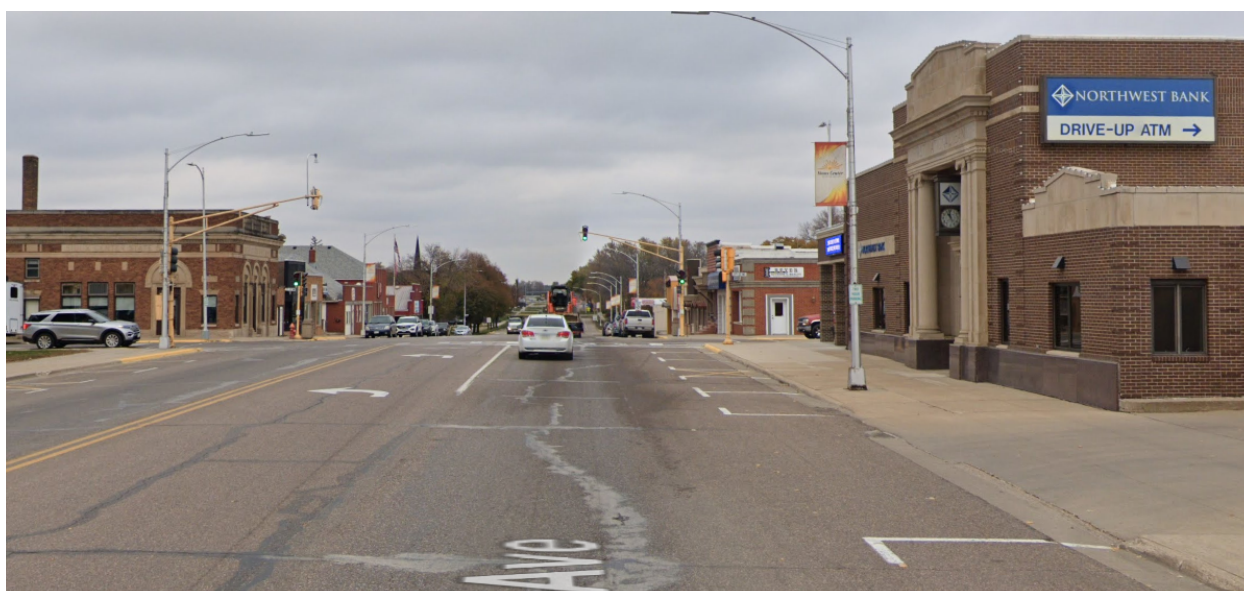
Figure 39. Photos of US-75 / Main Avenue in Sioux Center, IA before (top) and after (bottom) road redesign (*Iowa DOT, 2024*).

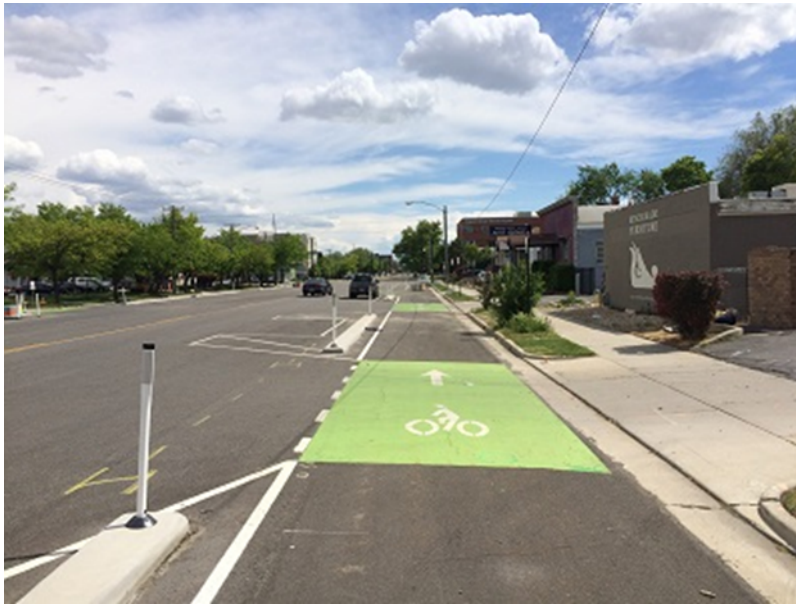
Figure 42. Example of a protected bike lane that provides driveway access.

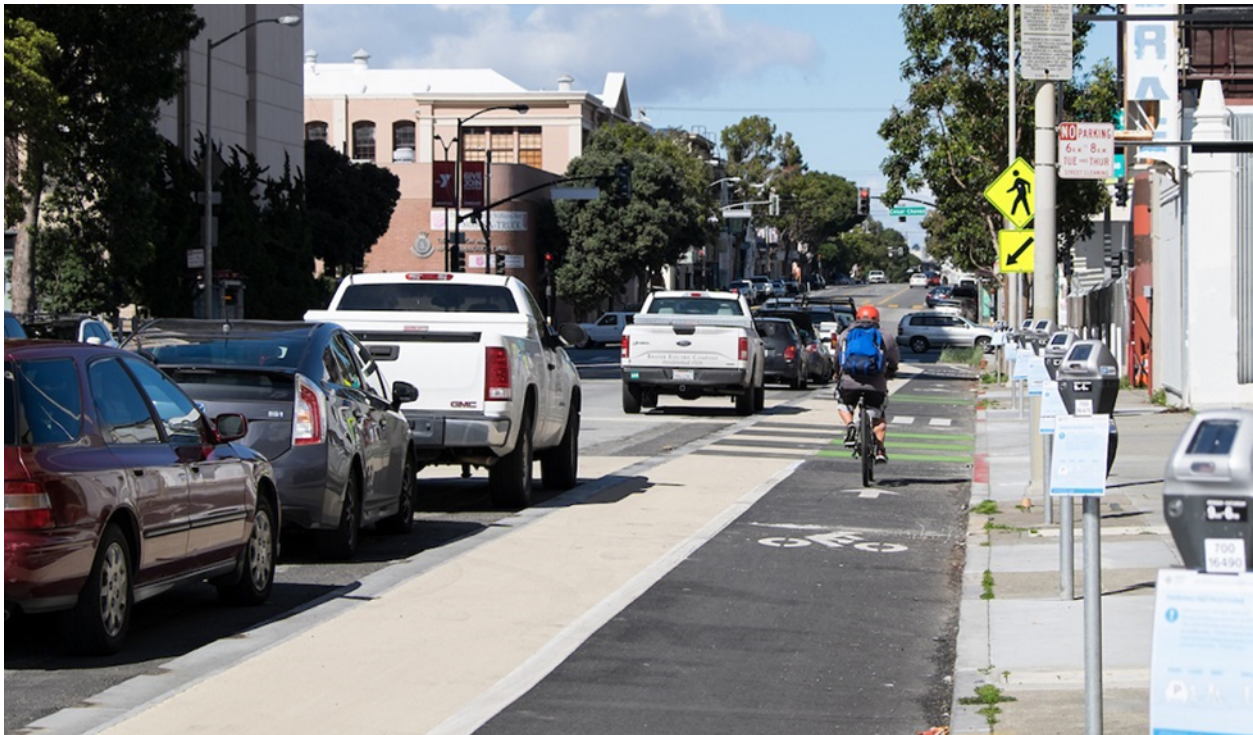
Figure 44. Example of a bike lane protected by on-street parking.

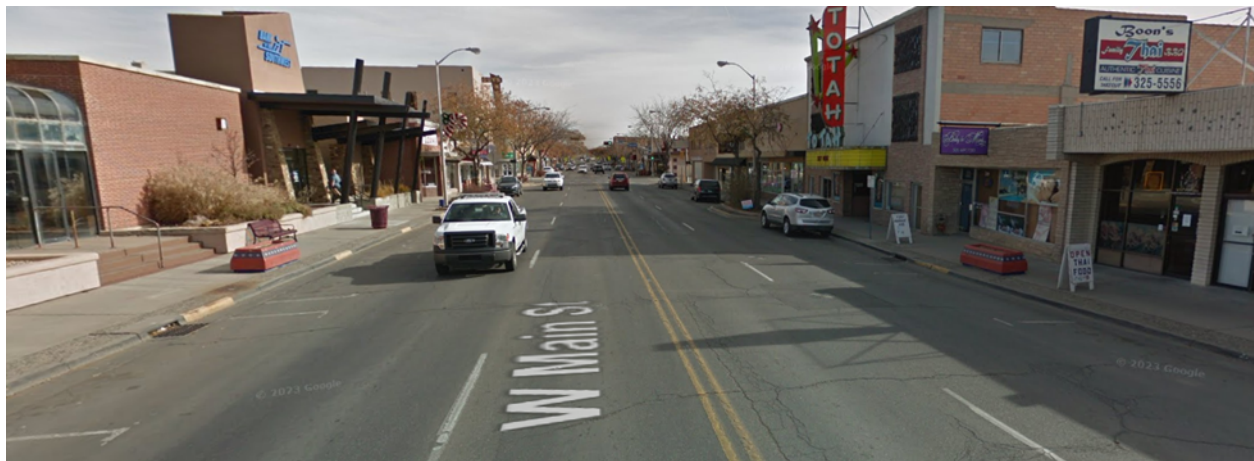
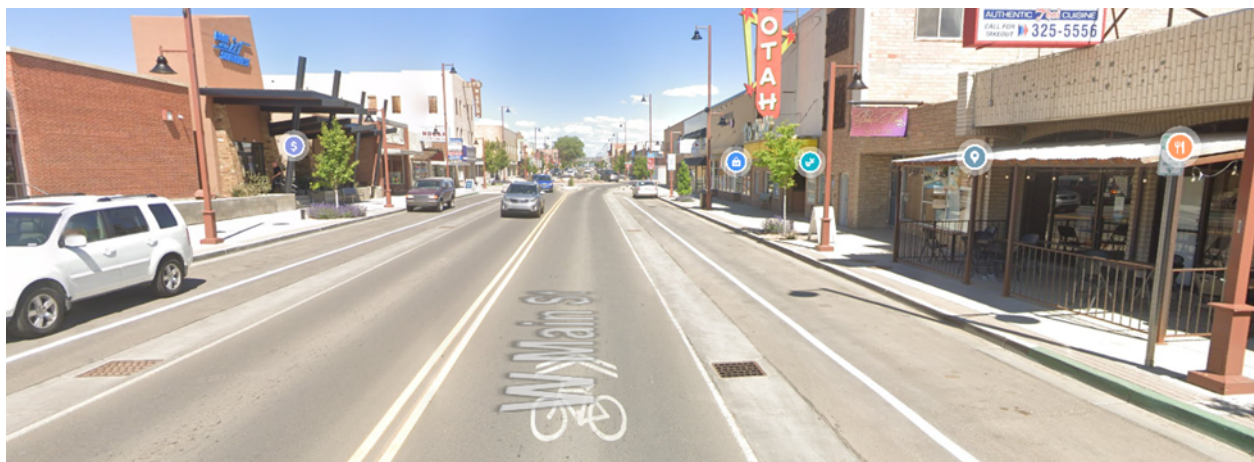
Figure 49. Photos of midblock segment of Main Street in Farmington, NM before (top) and after (bottom) road redesign.

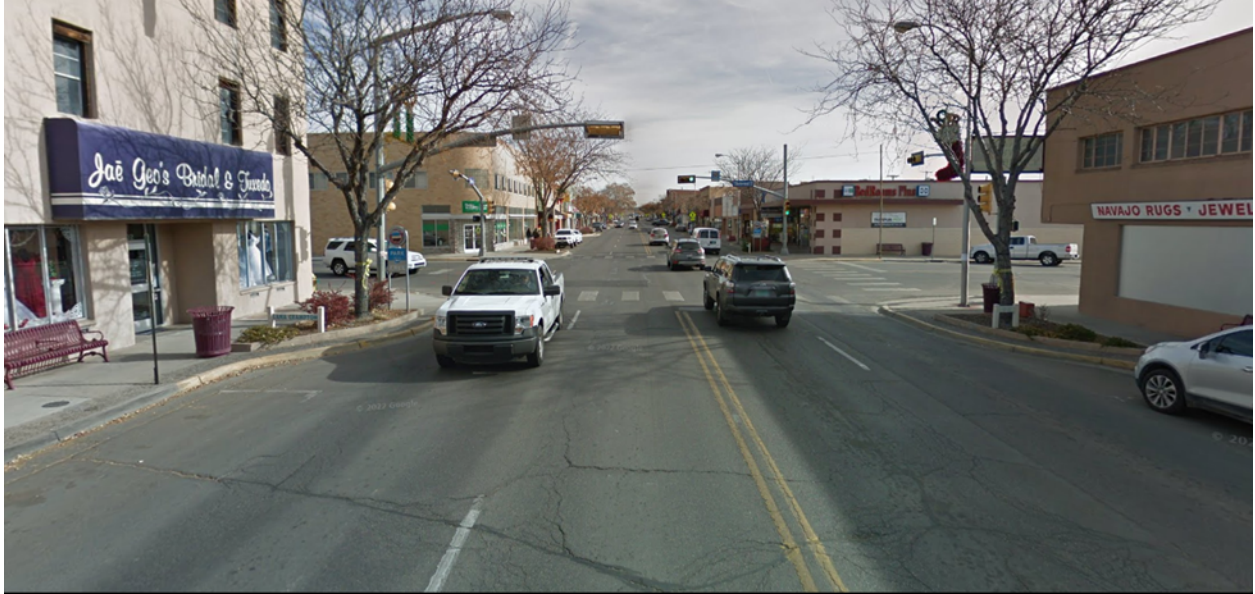
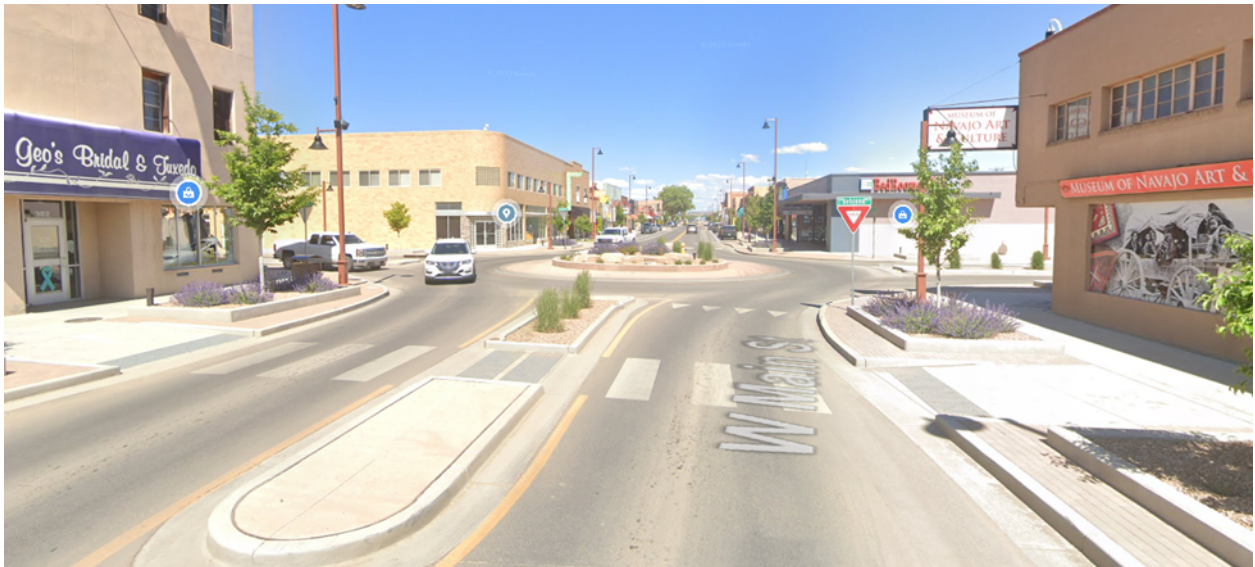
Figure 50. Photos of intersection on Main Street in Farmington, NM before (top) and after (bottom) road redesign.
