Report # MATC-UNL: 004-15

Investigation and Development of a MASH Test Level 6, Cost-Effective Barrier System for Containing Heavy Tractor Tank-Trailer Vehicles and Mitigating Catastrophic Crash Events - Phase V

Alternate Title: High-Performance, Single-Slope Concrete Barrier - Height Transition and
Foundation Considerations

August 7, 2024

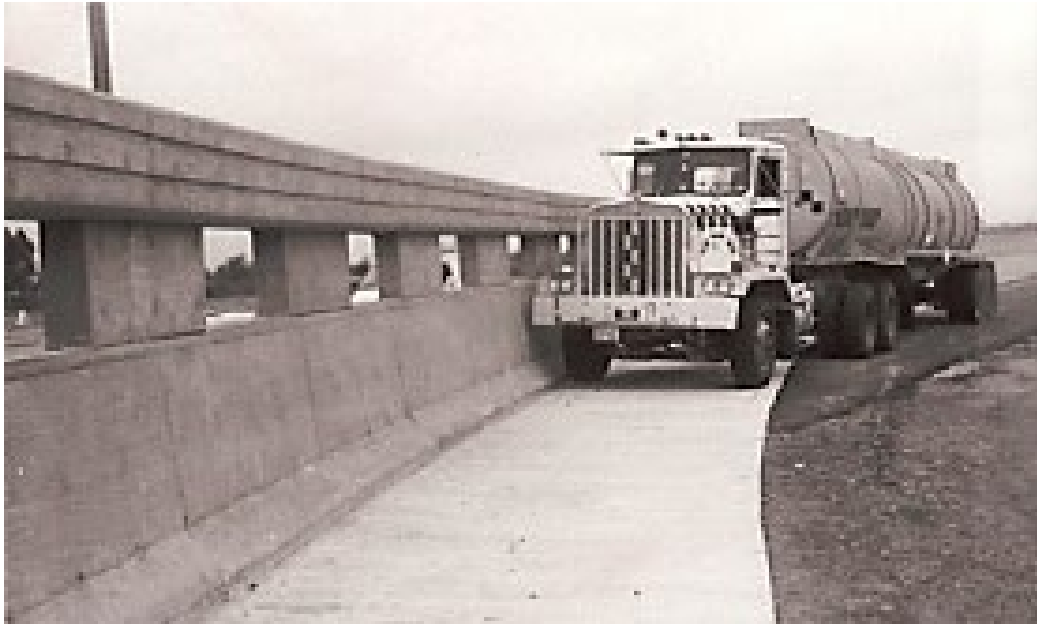
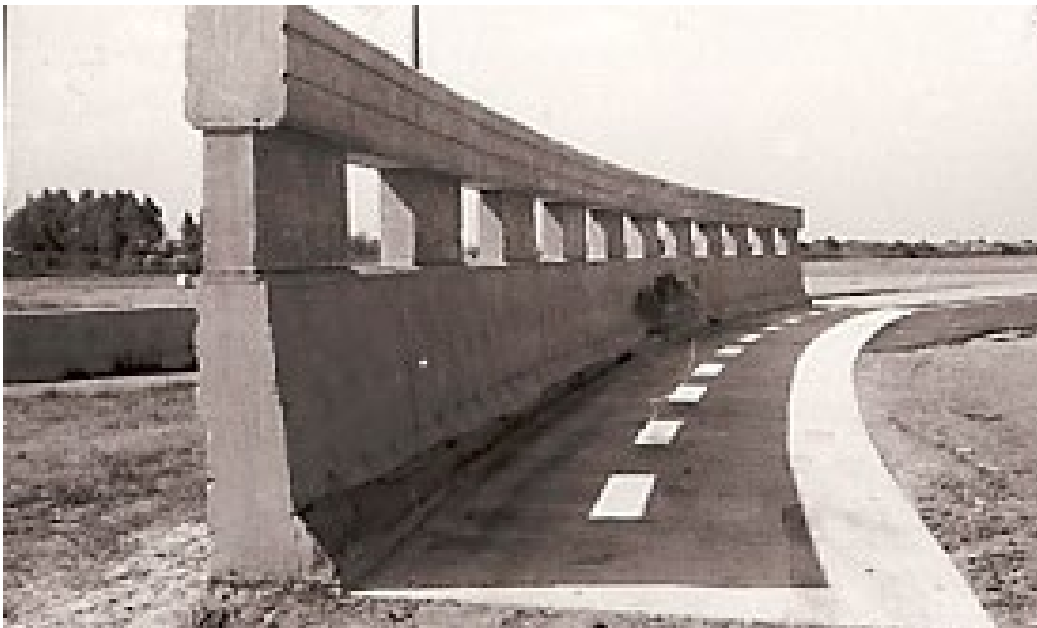
Figure 1.1 90-in. Tall, Combination Barrier System for Tractor-Tank Trailer Impact Events [4]

Thus far, only one TL-6 barrier was successfully developed and crash tested, and it was evaluated by Texas A&M Transportation Institute (TTI) researchers according to prior impact safety standards using a tractor-tank trailer [4]. This combination barrier configuration, often referred to as the *Roman Wall*, consisted of a lower solid concrete parapet with an upper concrete beam and post railing system, and it measured approximately 90 in. tall, as shown in Figure 1.1 and Figure 1.2. Note that the Roman Wall was crash tested before the publication of NCHRP

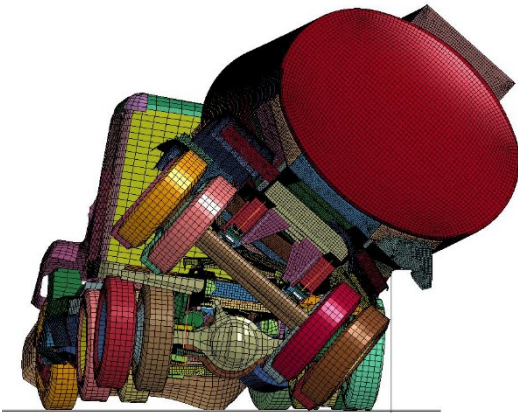
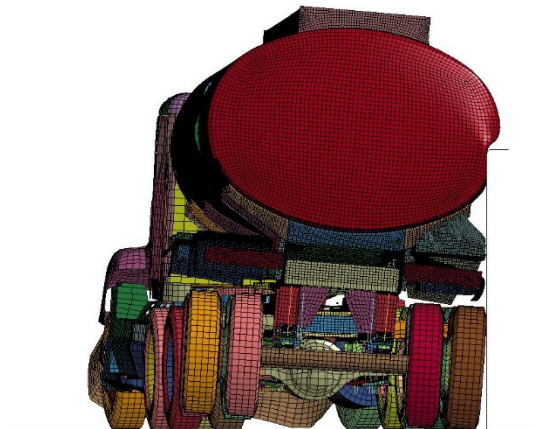
Figure 2.2 Comparison of Vehicle Positions at Time of Maximum Roll

As expected, the lower barrier heights produced higher vehicle roll angles during the impact event. A comparison of the vehicle positions at 900 ms after impact for a small sample of barrier heights is shown in Figure 2.2.

50-in. Tall Barrier

62-in. Tall Barrier

70-in. Tall Barrier

90-in. Tall Barrier

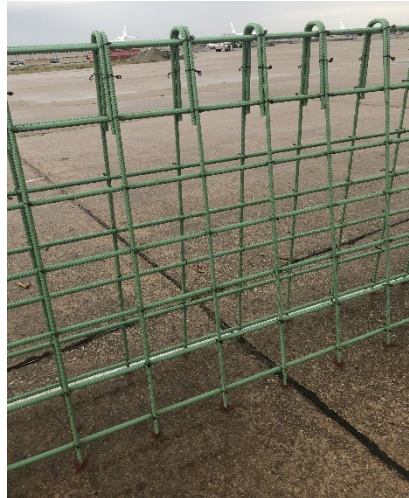
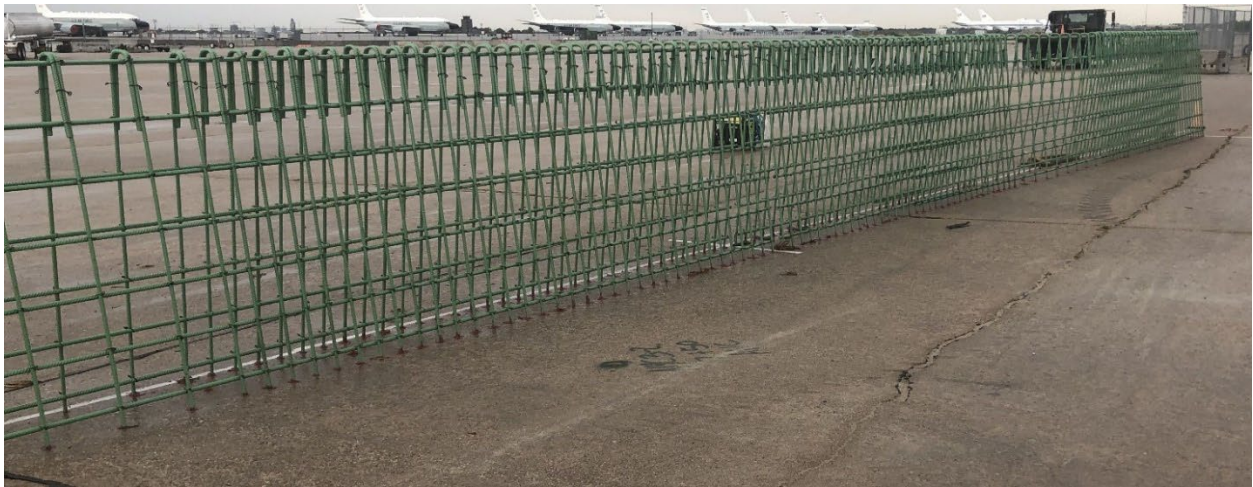
Figure 3.4 MASH TL-6 Single-Slope Concrete Barrier System, Test No. MTL6-1

The barrier was reinforced with 14 no. 6 longitudinal bars – seven bars on front face and seven on the back face. Vertical stirrup reinforcement consisted of no. 5 bars embedded into the concrete tarmac to a depth of 10 in. using Hilti HIT-RE 500 V3 epoxy anchor adhesive. The vertical reinforcing bars were spaced 5 in. apart at end sections and 12 in. apart at interior sections. All steel rebar had a minimum yield strength of 60 ksi. A 2-in. concrete clear cover was used around all steel reinforcement.

(a) Interior Section

(b) End Section

(c) TL-6 Concrete Barrier System

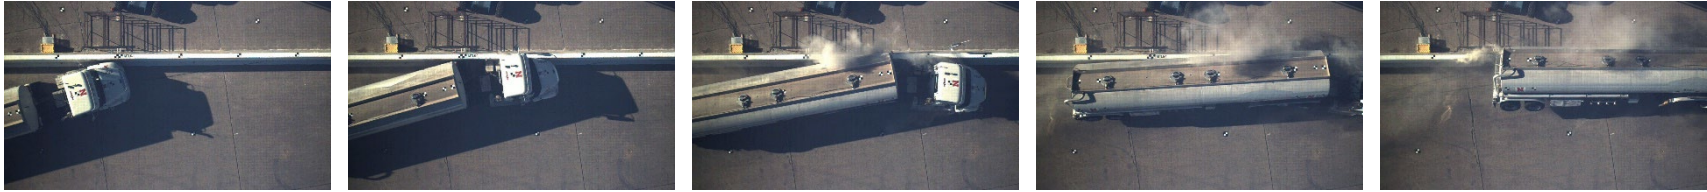
- Test AgencyMwRSF
- Test Number..... MTL6-1
- Date..... 12/8/2021
- MASH Test Designation No.6-12
- Test Article..... MASH TL-6 Concrete Barrier
- Total Length187 ft – 6 in.

- Key Component – Concrete Barrier
 - Length187 ft – 6 in.
 - Height..... 62 in. from top of tarmac
 - Soil Type..... Coarse, crushed limestone (well-graded gravel)

- Gross Static.....80,026 lb
- Impact Conditions
 - Speed51.1 mph (MASH Limit 50 ± 2.5 mph)
 - Angle 15.7 deg (MASH Limit 15 ± 1.5 deg)
 - Impact Location.....450 in. downstream from the upstream end of the barrier

- Impact Severity510.5 kip-ft > 404 kip-ft MASH 2016 limit
- Exit Conditions
 - Speed..... 36.5 mph
 - Angle 5 deg (approximately)
- Exit Box Criterion..... N/A

- Vehicle Stability.....
- Vehicle Stopping Distance310 ft downstream, 14 ft laterally behind
- Vehicle Damage..... Severe
 - VDS..... N/A
 - CDC..... N/A
 - Maximum Interior Deformation N/A

- Test Article Damage Minimal
- Maximum Test Article Deflections
 - Permanent Set..... N/A
 - Dynamic..... 0.4 in.
 - Working Width..... 37.2 in.
- Transducer Data

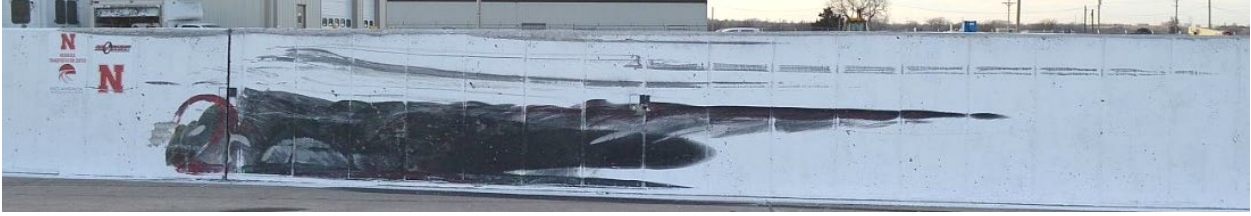
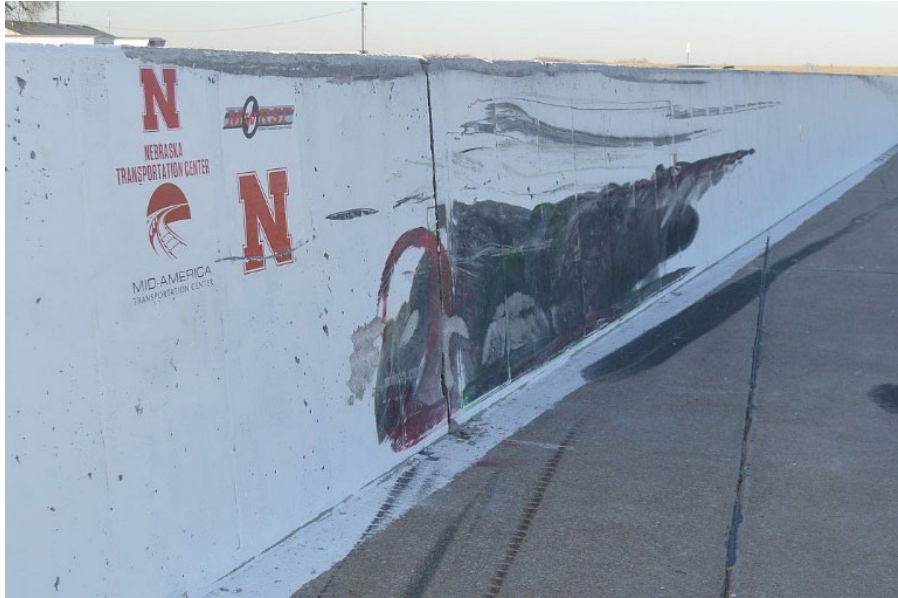
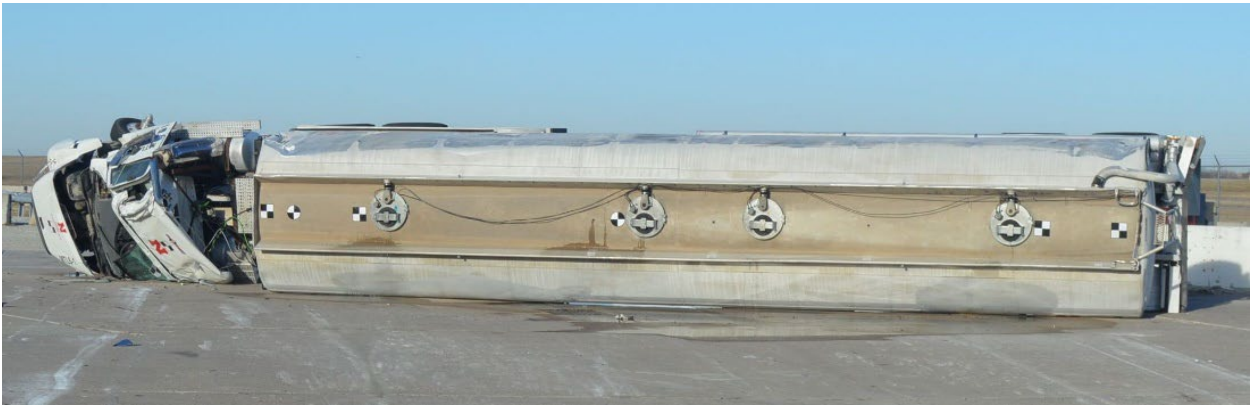
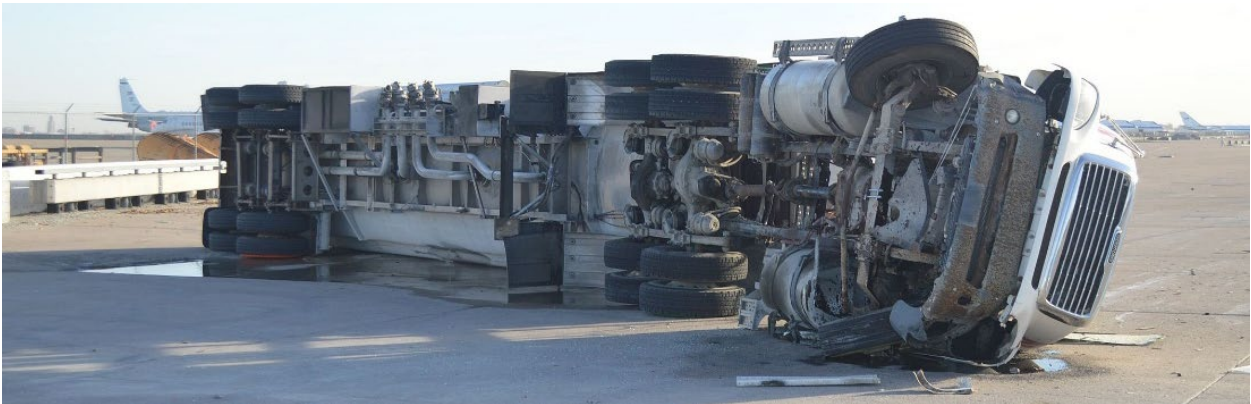
Figure 3.7 System and Vehicle Damage, Test No. MTL6-1

Vehicle and barrier damage are shown in Figure 3.7. Damage to the barrier was minimal and consisted of contact marks, scrapes, gouging, fracture of concrete at the traffic side face of the upstream and downstream edges of the expansion gap, and chipping at the top, traffic-side

edge of the barrier in the contact region. No significant structural damage was noted on the barrier, and no measurable dynamic or permanent set barrier deflections were observed. The total length of vehicle contact was 90 ft - 6 in.

Damage to the vehicle was extensive, which was primarily due to the sliding and secondary rollover events after exiting the barrier system, as shown in Figure 3.7. The cab, windshield, roof, and both side doors were crushed inward. The cab frame experienced tears, which caused the roof and door structures to collapse inward as the vehicle lifted to an upright position after the test. Scraping, minor gouging, and some peeling of the aluminum jacket were observed near locations of trailer baffles. The left side of the tank trailer had two small holes due to contact and grinding along the top of the parapet. The right side of the trailer experienced extensive scraping in the diagonal, mostly vertical direction corresponding to sliding on the concrete tarmac, with multiple small tears and holes observed in the aluminum jacket, especially near the internal baffles or end walls. The right side was flattened and crushed inward along the entire middle section, where the vehicle rolled and skidded. Several tears were observed in the jacket measuring between 2 and 3 in. long. One tear was observed in the undercarriage of the tank. Review of the tank trailer also found that the lids and seals along the top surface were leaking due to damage from the impact sequence, including subsequent rollover.

Finally, review of the damage to the tractor-tank trailer in the full-scale crash test noted holes in both sides of the tank structure due to contact with the barrier and the concrete tarmac, including leaking of newly-installed tank lids seals. As tractor-tank trailers are often tasked with transporting hazardous materials, it may be desirable to further study the damage observed in this crash test and conduct further research into improving the structural integrity and reinforcement of the tank to prevent dangerous spilling of their contents.

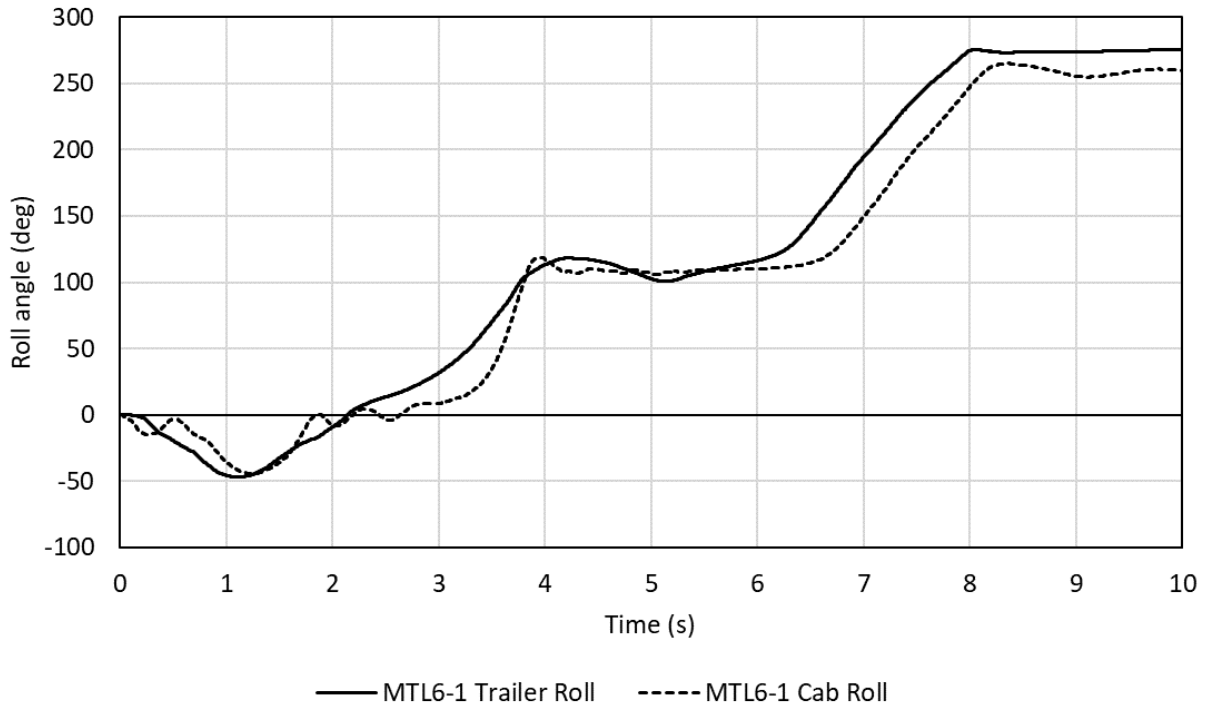
Figure 3.8 Vehicle Roll Angles, Test No. MTL6-1

Test results indicated that the vehicle was contained and redirected, but the momentum of the vehicle roll of the tank trailer and lateral movement of the fluid ballast caused the vehicle to roll 90 degrees onto the right side after exiting the barrier. Subsequently, while sliding to a stop, the rocking motion of the fluid in the interior tanks, the vehicle orientation on its side, and potential uneven surfaces on the test site tarmac contributed to a secondary 180-degree rollover event near the point of final rest. The rotational motion of the tractor and tanker trailer during the impact are shown in Figure 3.8. Review of the tractor-tank trailer vehicle roll motion shows that the initial rollover of the vehicle onto its right side was consistent with the roll of the vehicle as it exited the barrier. After the tractor-tank trailer vehicle rolled onto its right side, the vehicle slid downstream on its side for approximately 2.8 sec for a total of 6.5 sec prior to the final rollover. This relatively long period of stable vehicle translation downstream may suggest that several factors, such as fluid sloshing and uneven tarmac surfaces, may have led to the secondary roll motion, as mentioned previously.

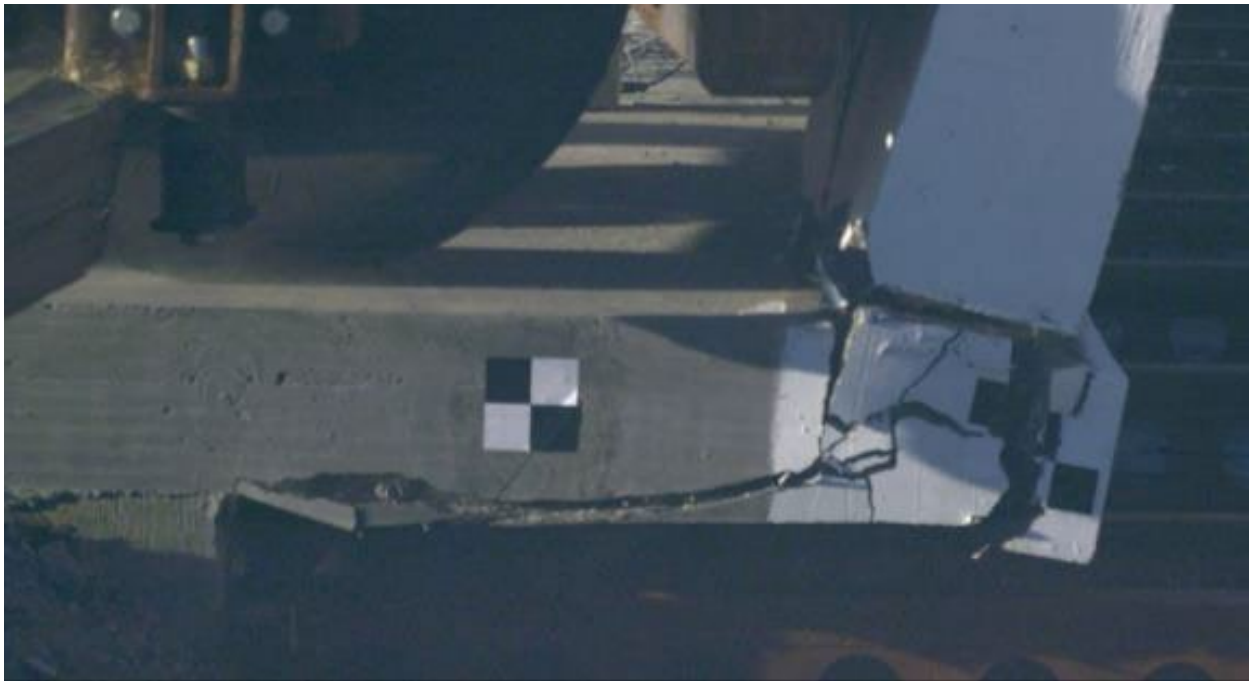
Figure 6.10 Damage in bridge deck supporting concrete parapet railing

Many of the baseline design preferences described above were intended to reduce the likelihood of the bridge deck experiencing cover spalling, diagonal tension failure, and delamination. These common damage mechanisms have been observed in several physical tests of bridge decks supporting concrete parapet railings, including an end-region impact test performed under NCHRP Project 12-119, which is shown in Figure 6.10.
