1. REPORT NUMBER CA23-3875	2. GOVERNMENT ASSOCIATION NUMBER n/a	3. RECIPIENT'S CATALOG NUMBER n/a
4. TITLE AND SUBTITLE Pilot Testing of Work Zone Intrusion Alarms		5. REPORT DATE November 16, 2023
		6. PERFORMING ORGANIZATION CODE Sacramento State
7. AUTHOR Ghazan Khan, Raven Cochrane, Kevan Shafizadeh		8. PERFORMING ORGANIZATION REPORT NO. n/a
9. PERFORMING ORGANIZATION NAME AND ADDRESS California State University Sacramento Department of Civil Engineering 6000 J St. Sacramento, CA 95819-6029		10. WORK UNIT NUMBER n/a
		11. CONTRACT OR GRANT NUMBER 65A0828
12. SPONSORING AGENCY AND ADDRESS California Department of Transportation P.O. Box 942873, MS #83 Sacramento, CA 94273-0001		13. TYPE OF REPORT AND PERIOD COVERED Final Report May 17, 2021 – November 16, 2023
		14. SPONSORING AGENCY CODE Caltrans
15. SUPPLEMENTARY NOTES

# **PILOT TESTING OF WORK ZONE INTRUSION ALARMS**

## **FINAL REPORT**

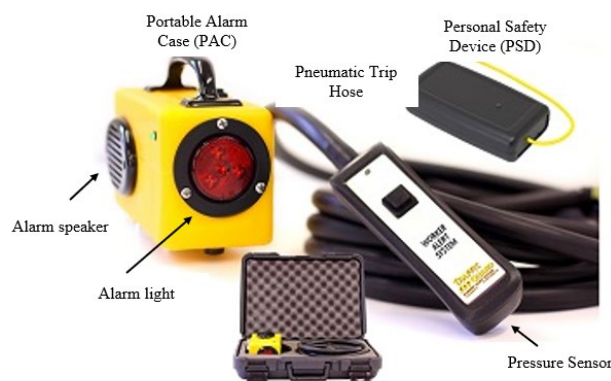
The Traffic Guard Worker Alert System (WAS), shown in Figure 2.1, is a pneumatic/microwave device that comprises of a lightweight, portable trip hose and sensor assembly to trigger a wireless alarm unit and flashing lights. The WAS features the following components:

- Poly-Plastic Alarm unit with flashing LED alarm light and alarm horn speaker
- Single 12-foot pressure sensing hose (pneumatic tube) with hose sensor/transmitter
- Personal Safety Device (PDS) with vibration and audio warning alarms

**Figure 2.1 Traffic Guard Worker Alert System Components**  
(Source: trafficsafetywarehouse.com 2017)

Once a vehicle passes over a pneumatic hose, the WAS alarm unit and PSDs will activate the auditory and vibratory alarms. The manufacturer specified a maximum range of 1,000 feet; however, the previous research found that to be unattainable. To reliably maintain a connection, the following maximum distances were recommended from the prior research (Khan et al. 2019):

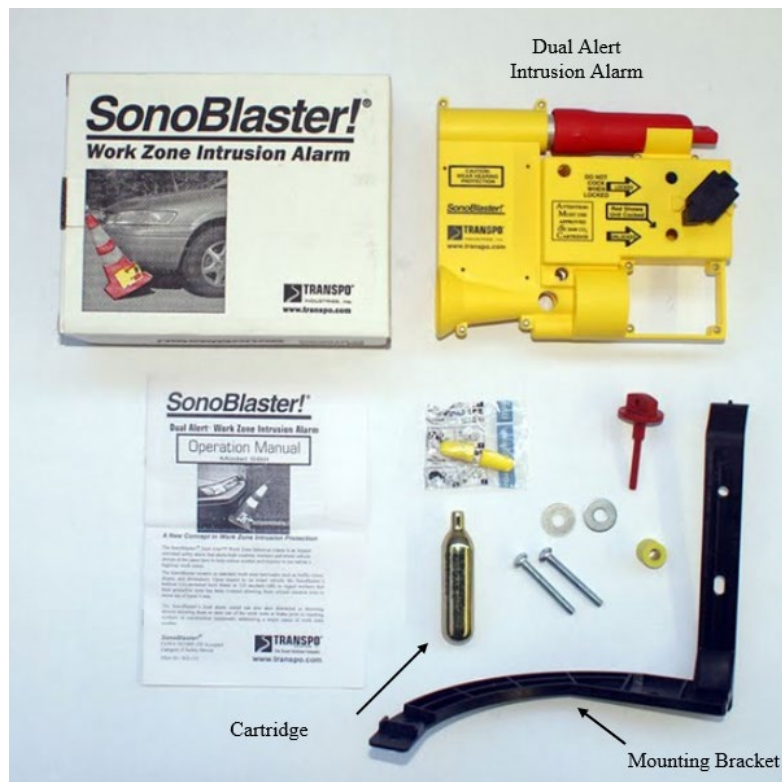
The SonoBlaster is a kinematic device that utilizes a built-in carbon dioxide (CO<sub>2</sub>) cartridge to sound a 125 dBA alarm upon impact. Once impacted, the CO<sub>2</sub> cartridge is punctured which causes the escaping gas to produce sound through an air-pressure horn. The device can be mounted on traffic cones, drums, and other work zone barriers. The main components of the SonoBlaster, shown in Figure 2.2, include:

- SonoBlaster alarm unit
- Disposable CO<sub>2</sub> cartridge
- Mounting bracket for traffic cone attachment

**Figure 2.2 SonoBlaster System Components**  
(Source: Transpo Industries Inc., 2017)

The SonoBlaster will activate the alarm if the mounted cone is tilted more than 70 degrees and sounds the 125-dBA alarm for a minimum of 15 seconds (Khan et al. 2019). After alarm activation, the spent CO<sub>2</sub> cartridge must be replaced with a new cartridge. The system does not require batteries or other power sources since it uses a disposable CO<sub>2</sub> cartridge.

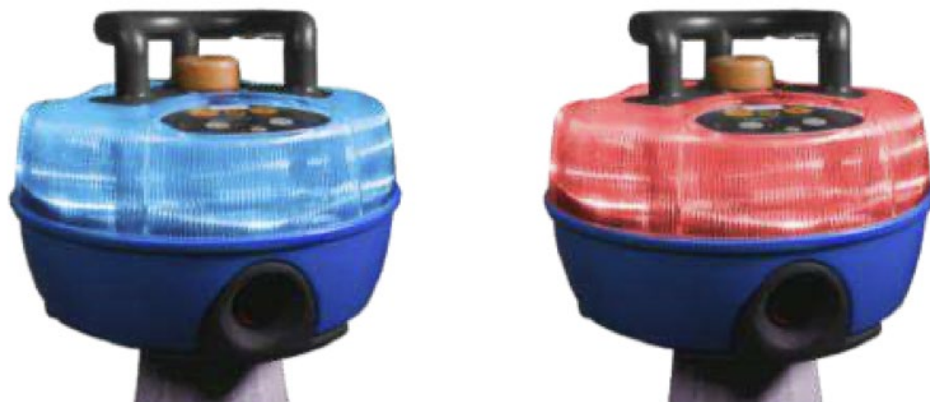
The Intellicone system uses a cone and vehicle mountable audio-visual Portable Site Alarm (PSA), shown in Figure 2.4, to notify workers of errant vehicles. The PSA connects to the nearest cellular network to communicate with other Intellicone products and can also utilize short range radio frequencies to communicate with motion sensitive cone lamp sensors (Figure 2.5). The Intellicone system offers a wide variety of communication devices that can be operated from a central location or portal. Further details of the Intellicone system's components and features can be found in Appendix A.

**Figure 2.4 Intellicone System Portable Site Alarms**

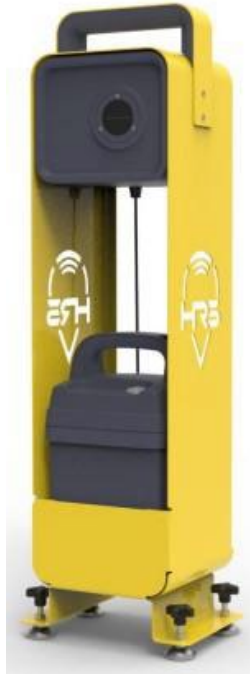
The Single Sentry Beam uses a portable continuous laser beam to detect incursions by pedestrians/workers or vehicles within its range, depending on the desired settings (Figure 2.7). The Single Sentry Beam system utilizes the Intellicone PSA units to warn workers in a work zone. The Portable Laser can communicate wirelessly with the PSAs from Intellicone System at a maximum distance of 246 feet as specified by the manufacturer.

It should be noted that the performance of the laser is subject to light conditions and may vary depending on the approach angle and vehicle size. It is recommended that the detection range be tested before use. Technical details of the device include (Highway Resource, 2021b):

- 18 kg (45 lbs.) weight with batteries
- No reflector required

- Typical lifespan of 5 years
- Operating lifetime of about 120 hours

**Figure 2.7 Intellicone Single Sentry Beam**  
(Source: Highway Resource, 2021b)

An object is detected once the beam is interrupted. Once detected, the Single Sentry will alert all nearby and connected PSAs and activate the audible warning alarm. The detection range of the laser is up to 10 meters (33 feet) for pedestrians wearing black, up to 20 meters (66 feet) for vehicles traveling at a speed of 60 miles per hour (mph,) and up to 35 meters (115 feet) for workers wearing florescent vests (Figure 2.8)

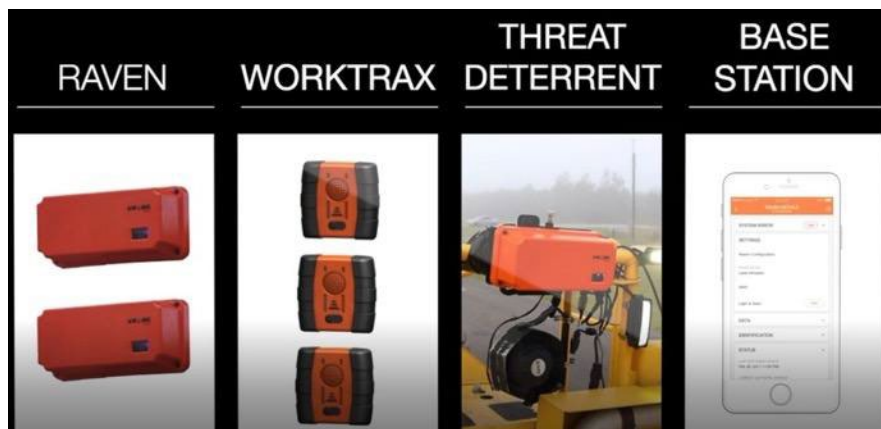
The AWARE system is comprised of the following main components as shown Figure 2.9:

- High tech mountable radar sensor (The Raven)
- Global Positioning System (GPS) based personal safety unit (WorkTRAX)
- Threat deterrent unit that includes visible and audible warnings
- Mobile application (Base Station)

**Figure 2.9 AWARE System Components**  
(Source: Oldcastle Video Team, 2021)

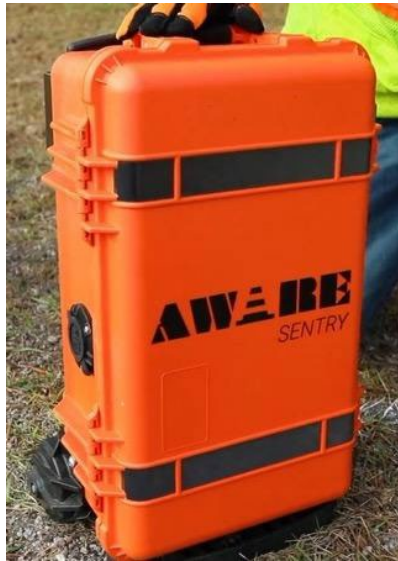
- The Raven capabilities: 600 feet range, speed, location, and trajectory monitoring of 64 vehicles simultaneously.
- Data from vehicle traffic behaviors and unsafe events, including video recordings of intrusion incidents, are continuously collected, and automatically uploaded once the device is within a known Wi-Fi range.
- Battery life of 15 hours.

**Figure 2.10 AWARE Sentry System Device**  
(Source: CRH Inc. Video Team, 2021)

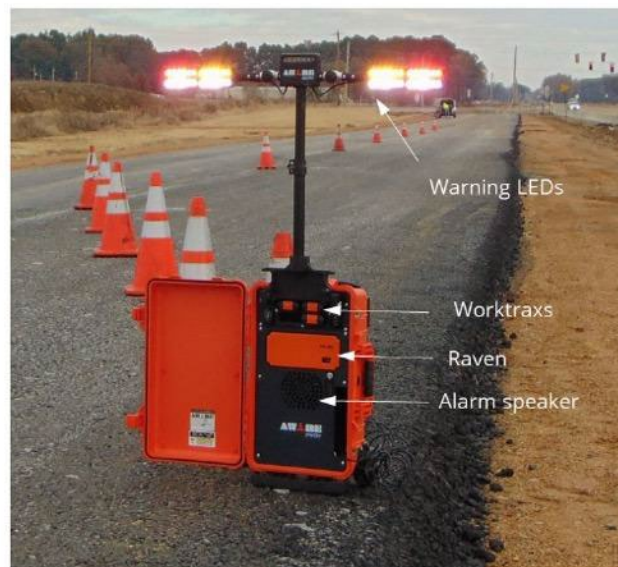
The components of AWARE are packaged in a portable box (base station) and configured as the AWARE Sentry system as shown in Figure 2.10 and Figure 2.11. The Raven, mounted in the AWARE Sentry box, monitors and detects vehicles that have a possibility of intruding the work zone at a distance of up to 600 feet. The AWARE Sentry system is activated if the Raven detects a potential intrusion within the coverage area through the assessment of up to 64 approaching vehicle speeds, locations, and trajectories (CRH Inc. Video Team, 2021). Once activated, the sentry unit will sound an audible alarm through the alarm speaker on the base station and visual flashing white and amber LED lights warning drivers and adjacent workers, as seen in Figure 2.11. Haptic and auditory alerts can also be produced by the WorkTRAX devices worn by the workers either on an armband or in the pockets of a safety vest. Other details of the AWARE Sentry System include:

**Figure 2.11 AWARE Sentry System Components**  
(Source: CRH Inc. Video Team, 2021)

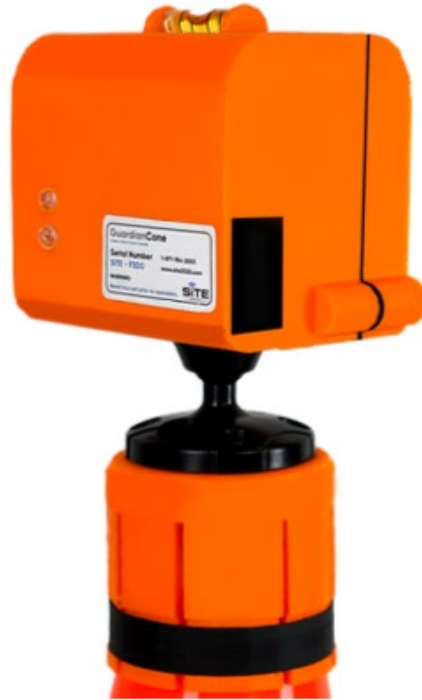
urgent alarm tone. Vibratory alerts will occur for all vehicles detected, regardless of incoming speeds.

**Figure 2.12 Guardian Cone Sensor**  
(Source: Site20/20, 2023)

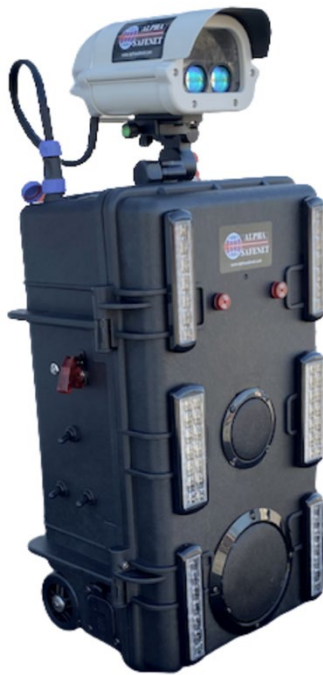
The Overwatch system also includes an Auxiliary Horn Unit (AHU) that acts as a portable speaker placed near the workers as an additional warning device. The AHU as shown in Figure 2.15 is paired with the main system unit and provides an additional alarm once the system unit is activated. Depending on the model purchased, the AHU has a connection range between 200 and 1,000 feet. The manufacturer specifications indicate the alarm sounds is at 135 dBA.

**Figure 2.14 Overwatch Device and LiDAR Head Unit**  
(Source: Alpha SafeNet, 2023)

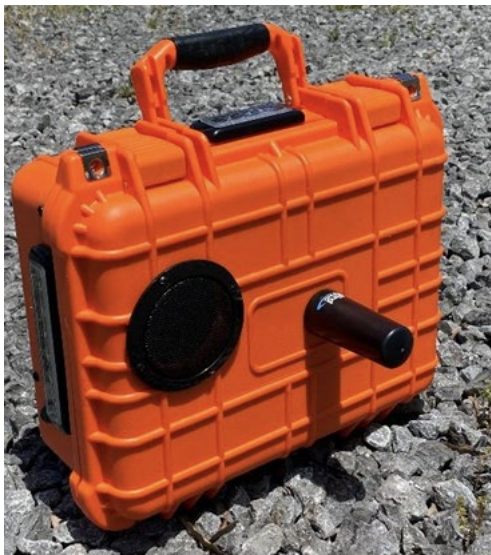
**Figure 2.15 Overwatch Auxiliary Horn Unit**  
(Source: Alpha SafeNet, 2023)

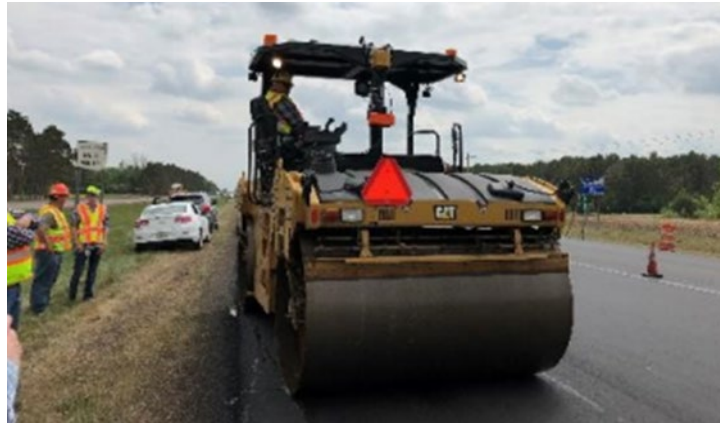
Based on the 2015 Texas A&M Transportation Institute's study of the AWARE system, Oldcastle sent representatives to conduct a new study during a Minneapolis paving project to evaluate the system's capabilities and future potential as shown in Figure 2.16 and Figure 2.17.

**Figure 2.16 Work Zone Equipment Vehicle Used for AWARE System Testing in Minneapolis**

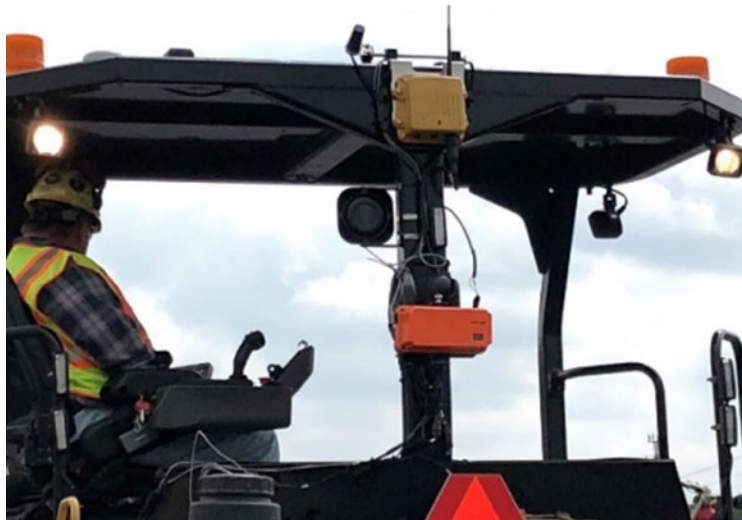
**Figure 2.17 AWARE System Sensor Placement on Work Zone Equipment**

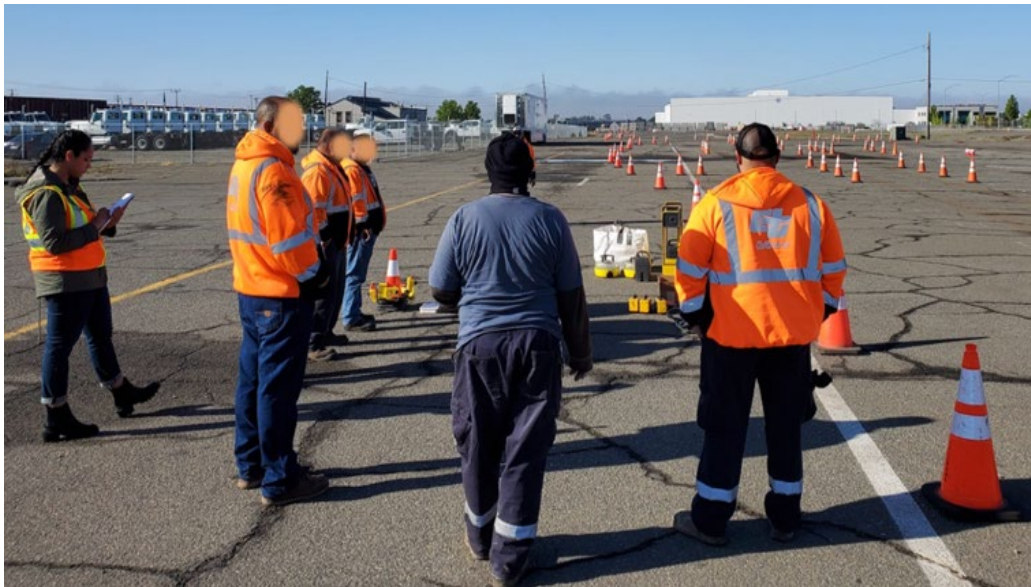
The research team conducted preliminary tests on the performance of some of the newly acquired WZIA systems (Single Sentry Beam and AWARE) that had not been evaluated in the prior research, to better understand and verify their capabilities and manufacturer specifications. The research team then proceeded to collect data on the observations and feedback provided by the maintenance staff on the selected systems. The general layout in which the training sessions occurred, including a mock T-13 lane closure set up implemented by the maintenance staff within the META facility, is shown in Figure 4.1. The details of each training session are presented in Table 4.1.

**Figure 4.1 Overview of the Training Session Setup**

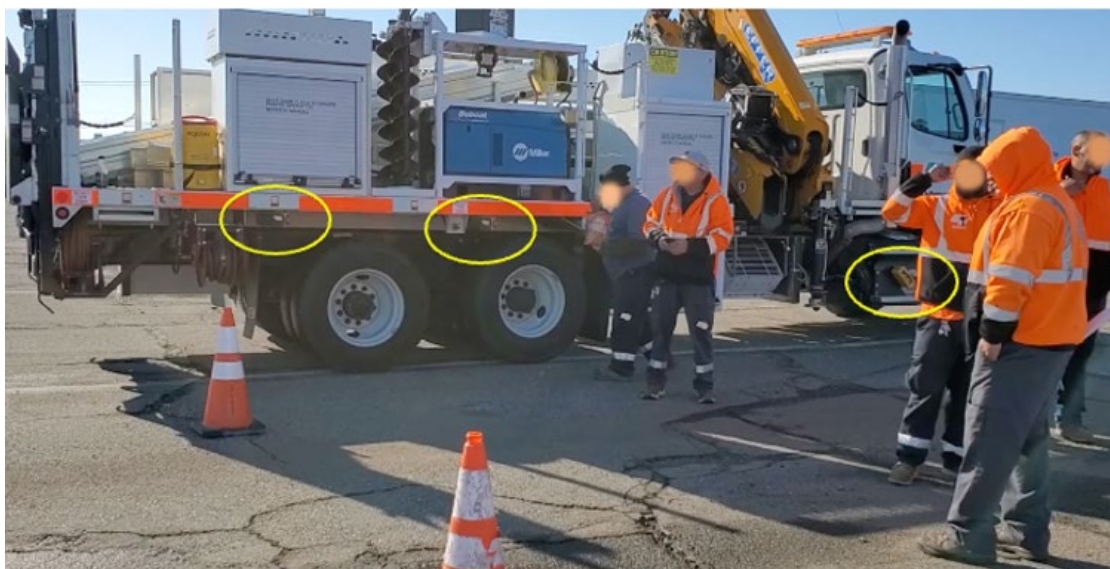
Due to some of the workers’ skepticism whether the alarm units would be heard over equipment vehicles during work zone operations, one crew member decided to bring over one of the stationed Caltrans equipment vehicles with generators to test the sound effectiveness with loud background noise. The crew members then attached the three alarm units onto the equipment vehicle using the magnet located on the alarm devices and had the equipment vehicle generators running while the alarms were tested against the noise. The alarm units’ placement on the equipment vehicle is presented in Figure 4.2. The maintenance crew felt the WAS alarm unit sound was sufficient (for the three units used) and would be most effective if one alarm unit was placed on the passenger side of the equipment vehicle and the remaining two units were placed under the truck bed, above the vehicle’s tires, with all unit speakers pointing toward the direction of the work activity area.

**Figure 4.2 WAS Alarm Units’ Sound Test using Caltrans Generator Vehicle**

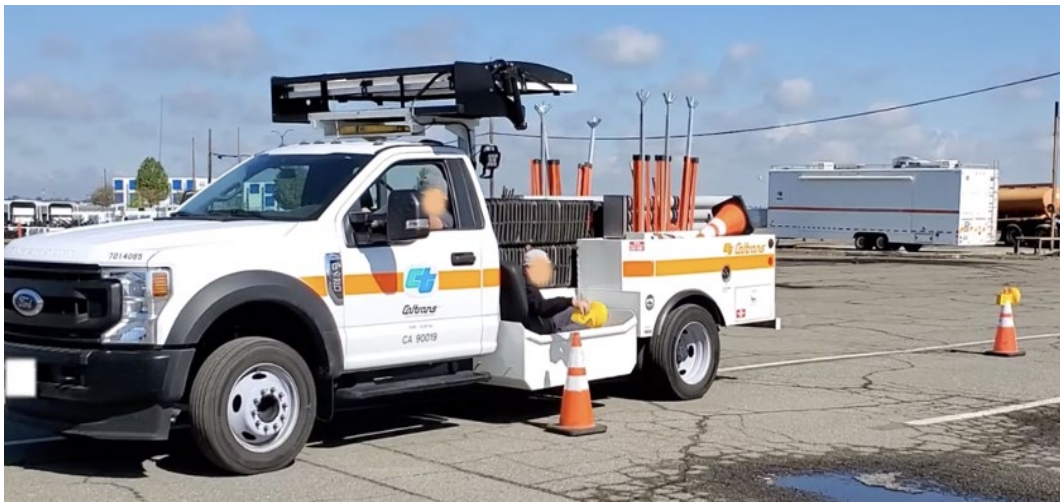
During the Intellicone System demonstration in the maintenance yard, two PSAs and 10 cone lamps were distributed to the maintenance crew. The crew were asked to share their opinion on the most effective deployment strategy for the lamps, considering lamps must be deployed manually on each cone. The crew discussed and employed two deployment strategies, both involving a Caltrans standard cone body truck. As the first option, a crew member deploying the cones installed the lamp on the cone before placing it on the ground from the cone body truck. As the second option, a crew member deployed all the cones on the ground in one pass and then repeated the pass deploying the lamps on each cone. Figure 4.3 demonstrates the crew members practicing the deployment of Intellicone lamps from a standard cone body truck. The deployment strategy for Intellicone lamps was important because concern was shown in the prior research by maintenance staff regarding exposure to traffic while manually deploying lamps, especially in long and high-speed work zones close to traffic flow.

**Figure 4.3 Intellicone Lamps Deployment from Caltrans Standard Cone Body Truck**

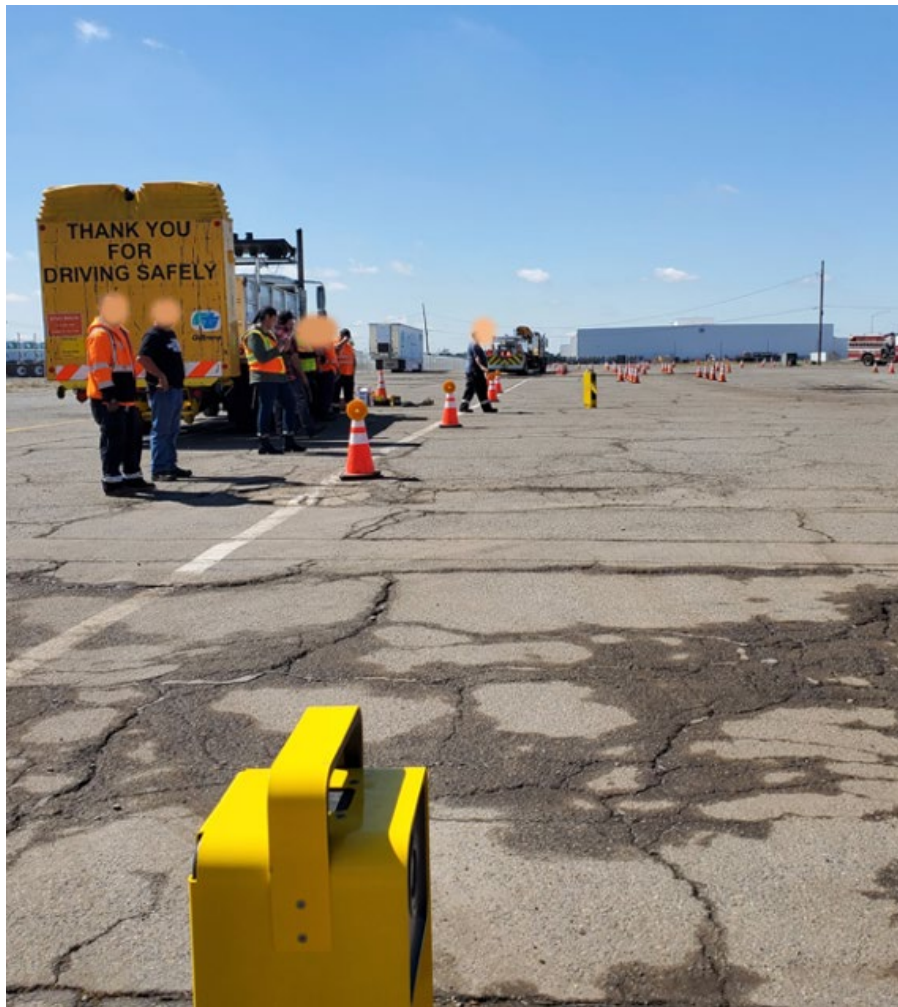
During the retrieval of the laser devices, one crew member noted that retrieving multiple laser devices after a job could be cumbersome due to the weight of the device. Further details of the general feedback and recommendations provided by the maintenance crew during the Intellicone Single Sentry Beam demonstration are presented in Table 4.4.

**Figure 4.4 Single Sentry Beam Detection Range Test**

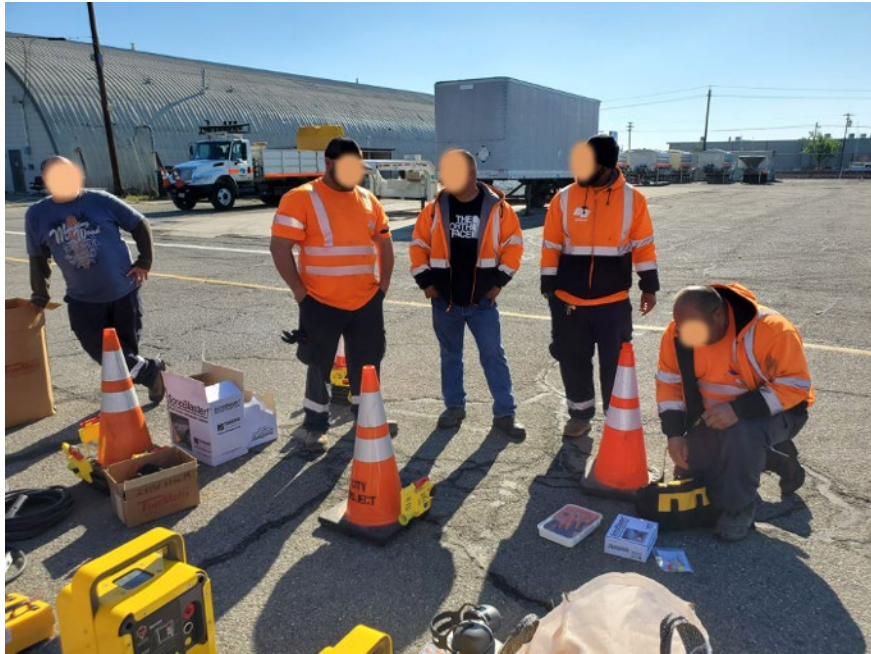
At the start of the SonoBlaster demonstration in the maintenance yard, the maintenance crew members were asked to assemble one SonoBlaster bracket and alarm unit to a cone. Initially three crew members volunteered to try the bracket assembly, though one crew member soon gave up assembling and passed the task to another crew member. It was noted that while assembling the SonoBlaster unit, none of the crew members referred to the instructions provided by the research team or the manufacturer, but instead used a preassembled SonoBlaster cone as a reference. The crew members also proceeded to use their own tools and methods in installing the device utilizing a hammer to insert screws into the base of the cone shown as shown in Figure 4.5. The time for the maintenance crew to fully assemble and install a SonoBlaster unit was 20 minutes. It was also noted that some difficulty assembling the SonoBlaster device to a cone may depend on the type of cone used, since the bracket cannot be assembled to cones that have a cleated base.

**Figure 4.5 Crew Members Installing the SonoBlaster Unit**

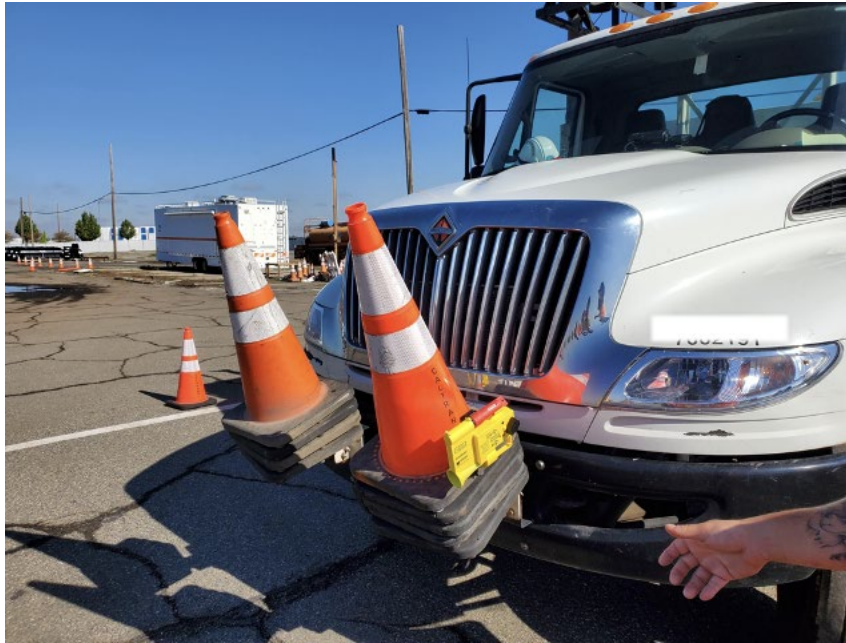
The crew were mindful of the instructions that an unlocked SonoBlaster unit may be triggered if the cone is tilted by more than 70 degrees during deployment. However, concern was shown by the crew about false alarms since cones get knocked over frequently in a work zone, especially in high-speed traffic conditions. For this reason, it was determined that the SonoBlaster devices are not ideal for testing in high-speed traffic conditions.

**Figure 4.6 SonoBlaster Cone Stacking and Deployment from Shadow Truck**

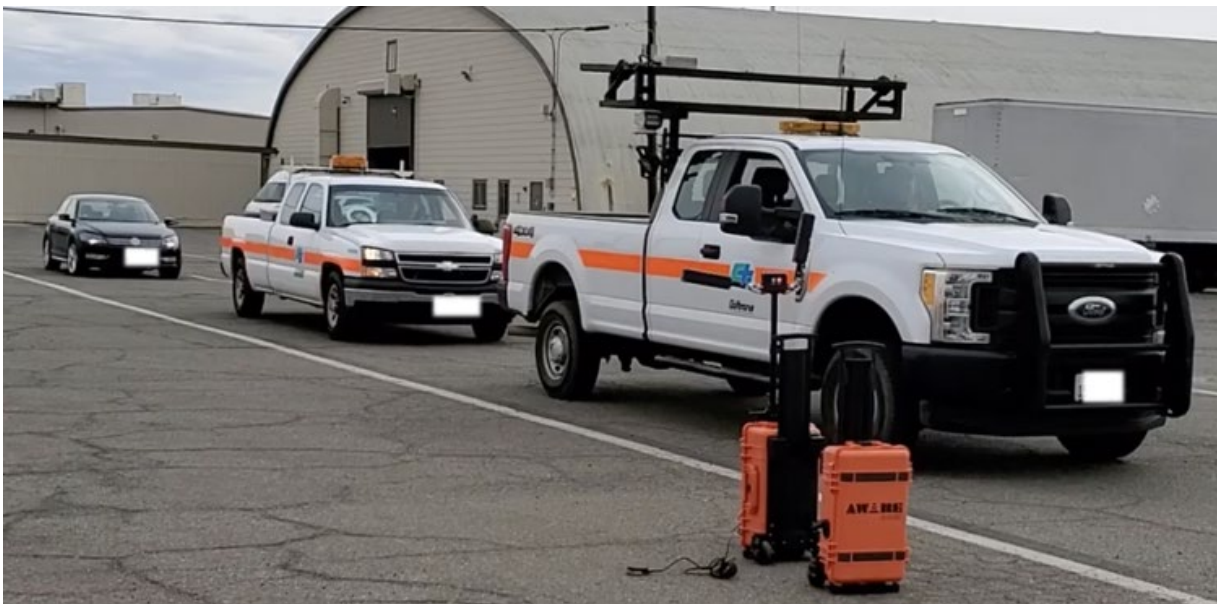
After the AWARE Sentry system was set up and deployed, the vehicle speed detection and range of the device were tested. Vehicle speeds were tested from 10 mph to 45 mph with the threshold speed set at 5 mph. It was observed that with increasing vehicle speeds, the frequency of the WorkTRAX alerts also increased. The device's ability to detect and activate the alarm if a vehicle driver decided to leave the queue was also tested, shown in Figure 4.7. The detection for out-of-queue vehicles proved successful as the device did activate the alarm every time one of the three vehicles pulled out of the queue.

**Figure 4.7 AWARE Sentry Setup and Vehicle Out of Queue Test**

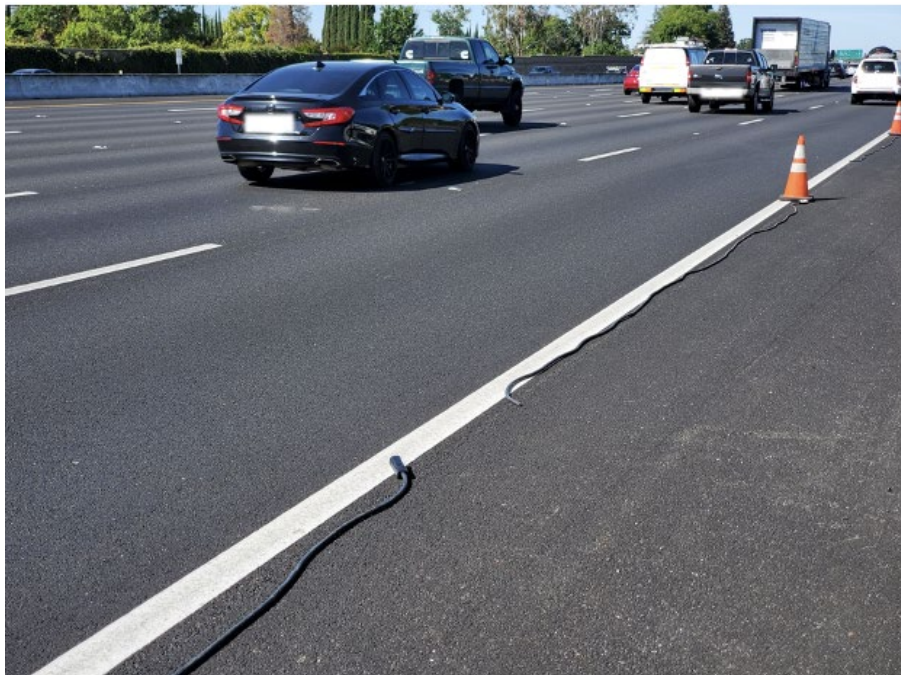
During the WAS trial, three 33-foot sensor hoses and four alarm units were deployed, and seven PSDs were distributed to the workers. The sensor hoses were placed by the crew in a line parallel to traffic on the edge of closure, starting from the location of the shadow truck and downstream of the closure (Figure 5.2). It should be noted that while the recommendations for deploying the WAS pneumatic hoses suggested placing the hoses inside the closure diagonally to capture any intruding vehicles venturing into the closure, the crew preferred to deploy the hoses parallel to the traffic flow direction. The worker deploying the sensor hoses had to be reminded to turn on one of the sensor hoses, since he forgot to do so.

**Figure 5.2 Placement of WAS Pneumatic Hose**

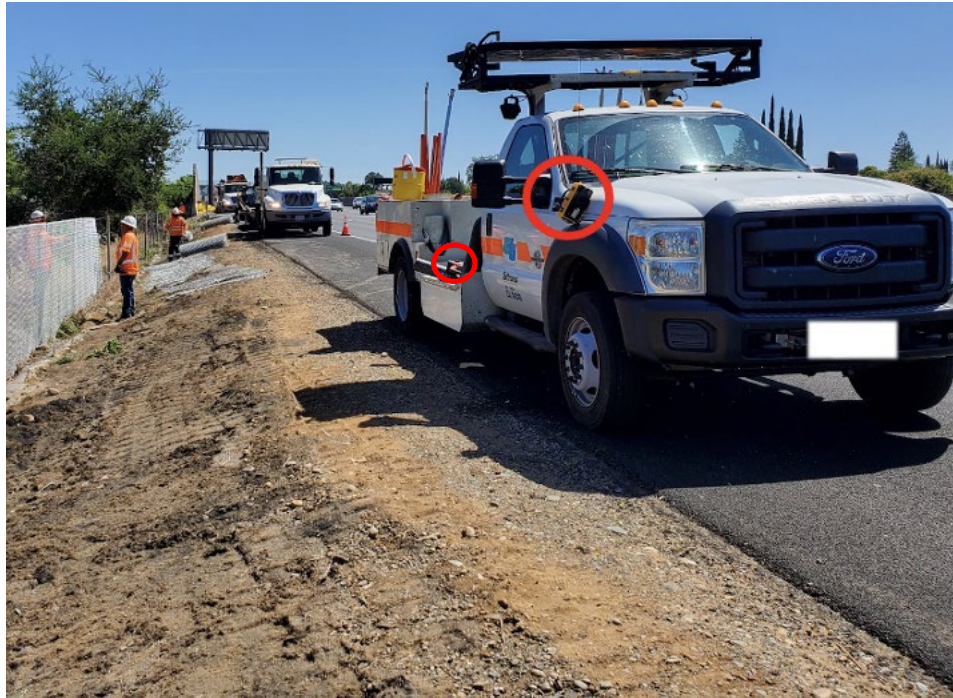
Two alarm units were placed on the shadow truck and the other two devices were placed on two work vehicles near the activity areas shown in Figure 5.3. The set up and deployment time for the devices was about 5 minutes. No physical requirements were identified for deploying the devices as they were very easy to set up.

**Figure 5.3 Location of WAS Alarm Units on Vehicles Near Activity Area**

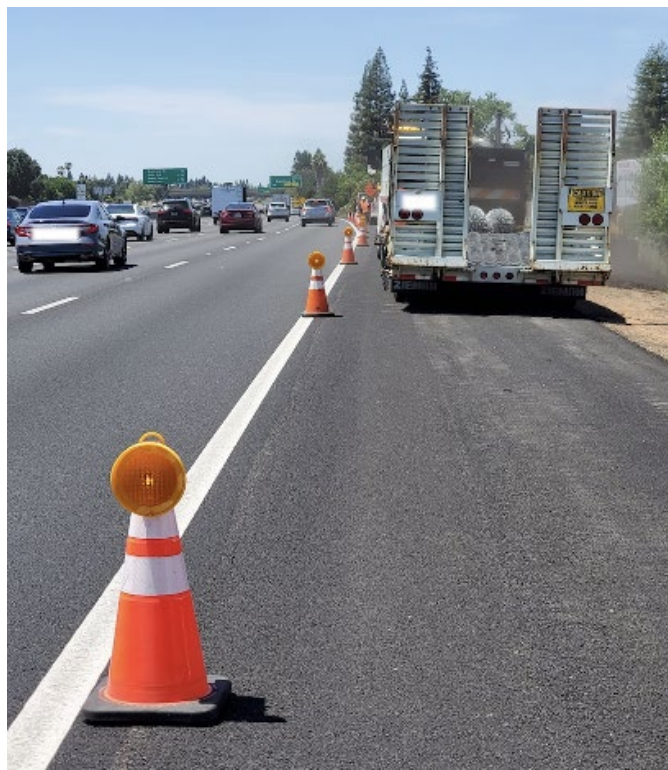
During the Intellicone trial, seven cone lamps and two Portable Site Alarms (PSAs) were deployed. Due to the limited space between the shoulder closure cones and various vehicles present on the shoulder (Figure 5.4), the Intellicone lamps were manually deployed by a worker, since it was not possible to safely deploy the lamps from the cone body truck (Figure 5.5).

**Figure 5.4 Deployment of Intellicone Lamps with Limited Space between Closure and Presence of Work Vehicles**

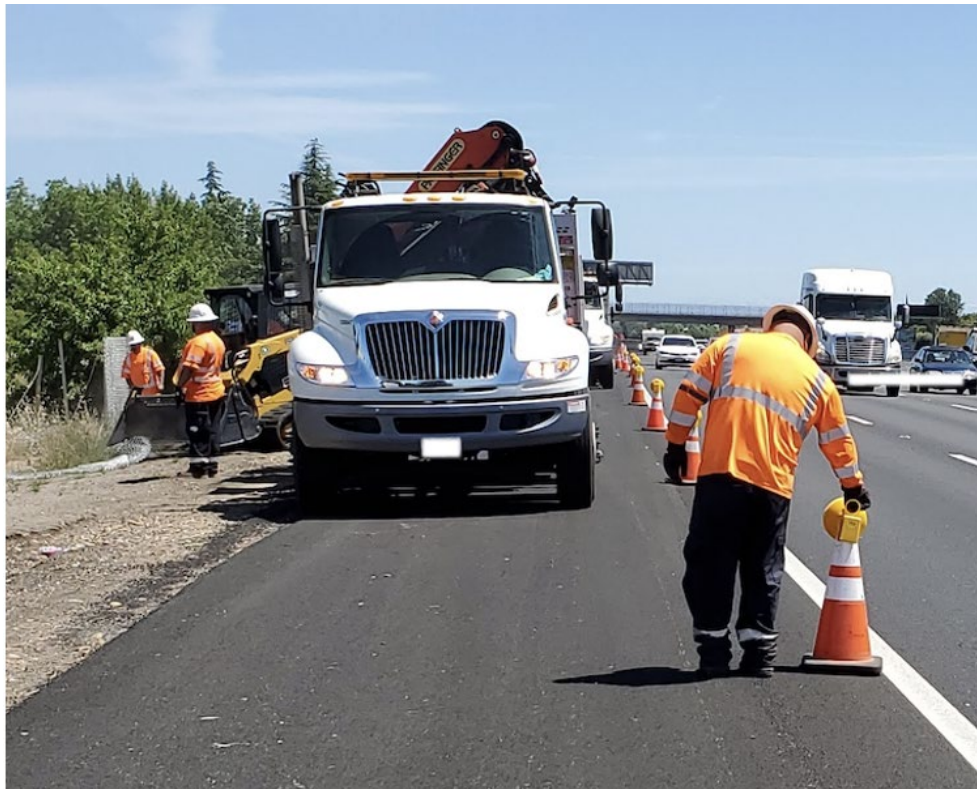
**Figure 5.5 Deployment of Intellicone Lamps by Maintenance Worker**

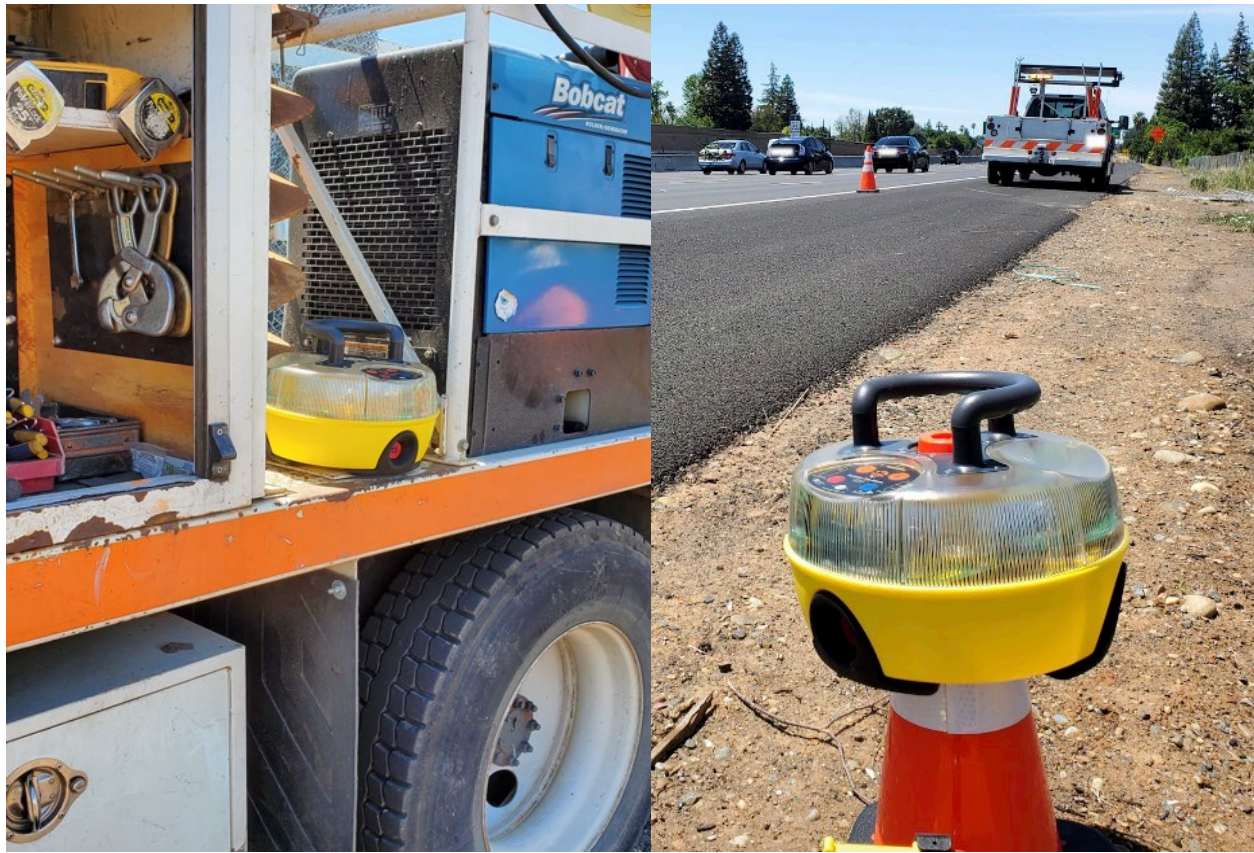
One of the PSAs was placed on the bed of a work vehicle and the second PSA was placed on a cone near the edge of the shoulder close to the activity area (Figure 5.6). Both PSAs connected to a cellular network within 2 minutes of being turned on.

**Figure 5.6 Location of Intellicone PSA Deployment on Highway 50 WB Active Work Zone**

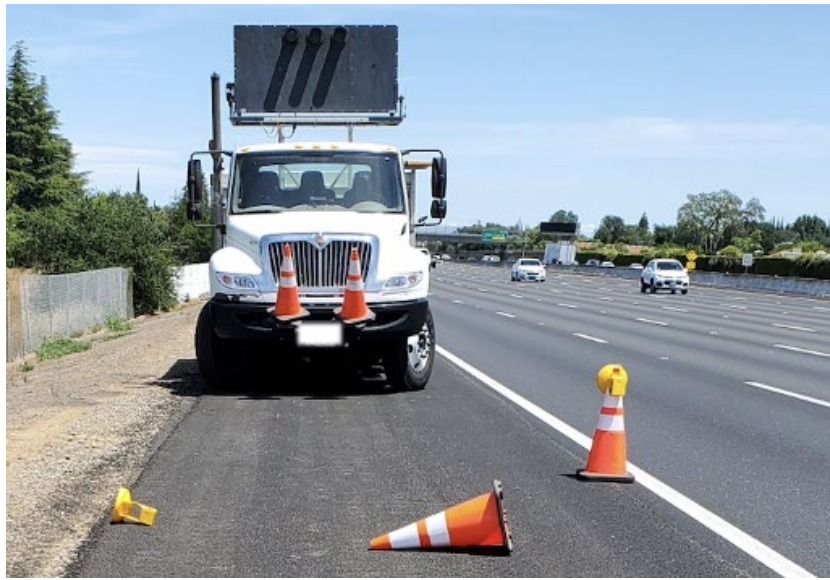
At the end of the trial, the research team deliberately triggered the Intellicone system by knocking over a cone with a lamp to observe the workers' reaction time as shown in Figure 5.7. Four workers reacted immediately to the Intellicone System alarm by halting the fence repair work and looking around for the reason of activation. After it was realized to be a false positive alarm, the workers continued to work without resetting the PSAs. By not resetting the Intellicone PSAs and continuing to work after the alarm has triggered, the workers may have assumed one of the other workers would reset the devices.

**Figure 5.7 Manual Activation of Intellicone to Observe Worker Reaction Time**

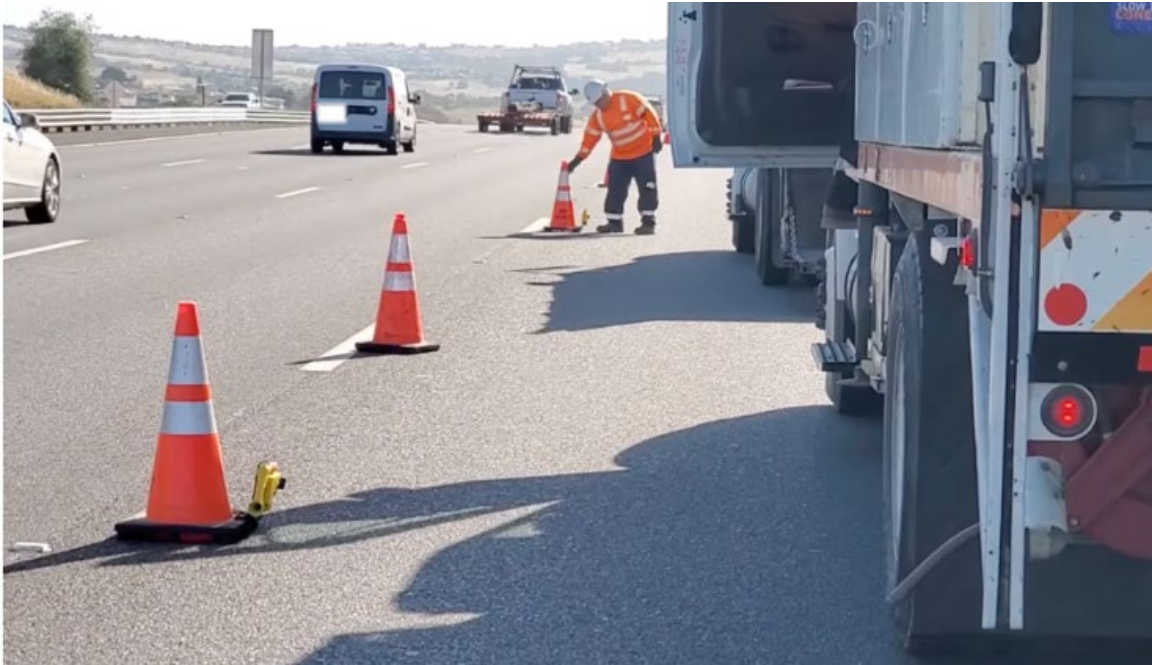
**Figure 5.11 Maintenance Worker Deployment of SonoBlaster in Work Zone**

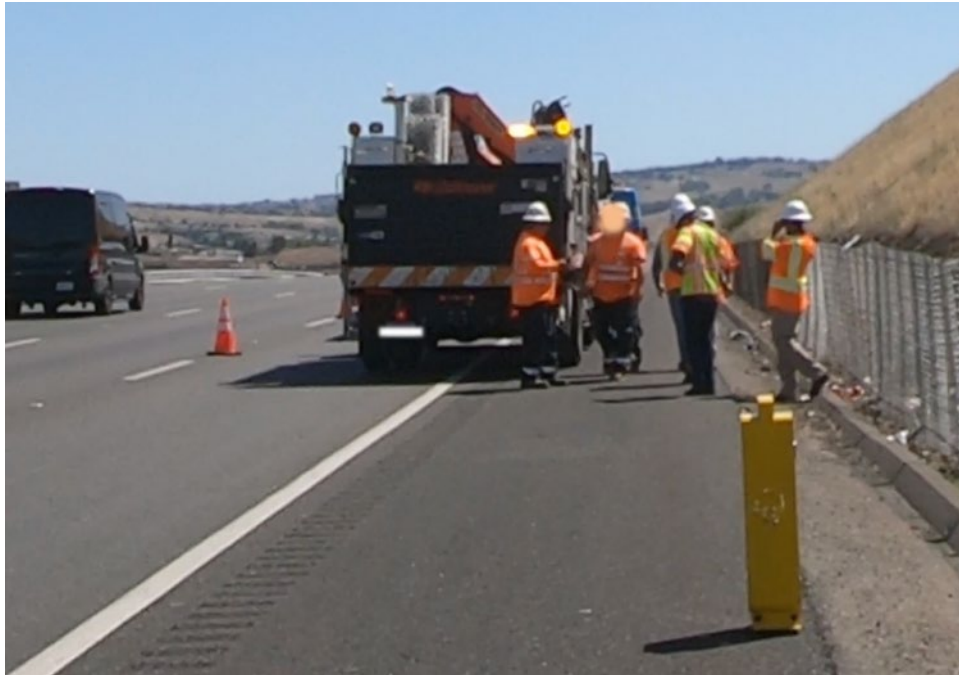
work zone may not be feasible. In this trial, the unit was transported to the work zone and offloaded from the back of a truck at the point of deployment.

**Figure 5.12 Location of Single Sentry Beam Deployment inside the Work Zone**

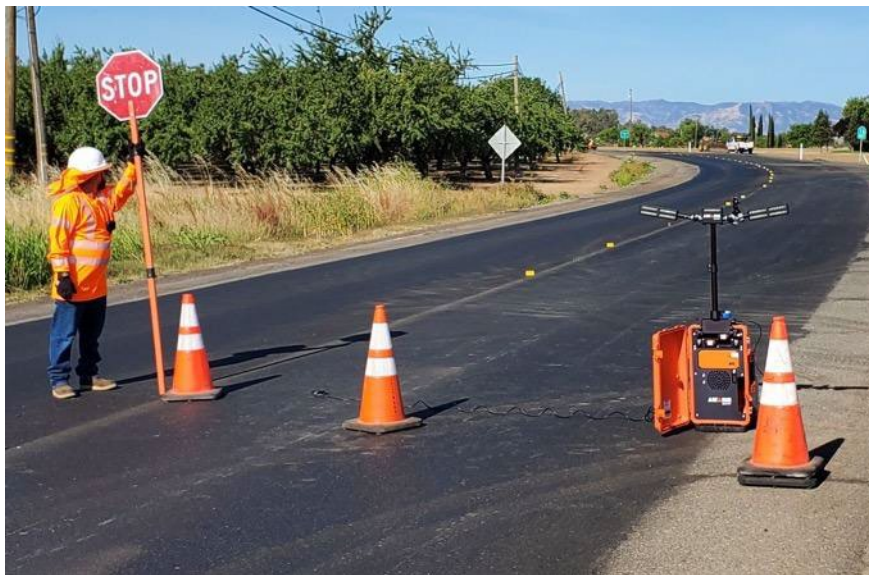
was always present while observing the operation of the AWARE Sentry unit at each location. Upon arriving in the work zone, it was noticed that the flagger at location 1 (as shown in Figure 5.13) was not part of the crew during the training sessions. The flagger was given a quick overview of the AWARE Sentry unit operation and use before deployment at “Flagger Location 1” as shown in Figure 5.13 and Figure 5.14. Three of the four WorkTRAX PSDs were distributed to the workers, while the research team retained one to track alarm triggers. About halfway through the trial, the AWARE Sentry device was moved to the “Flagger Location 2” as shown in in Figure 5.13 on the other side of the work zone.

At deployment, the AWARE Sentry speed threshold was set at 35 mph in consultation with the maintenance supervisor in the work zone as that was the speed limit set for vehicles traversing through the work zone.

**Figure 5.14 AWARE Sentry Deployment at Flagger Location on Highway 16 near Woodland, CA**

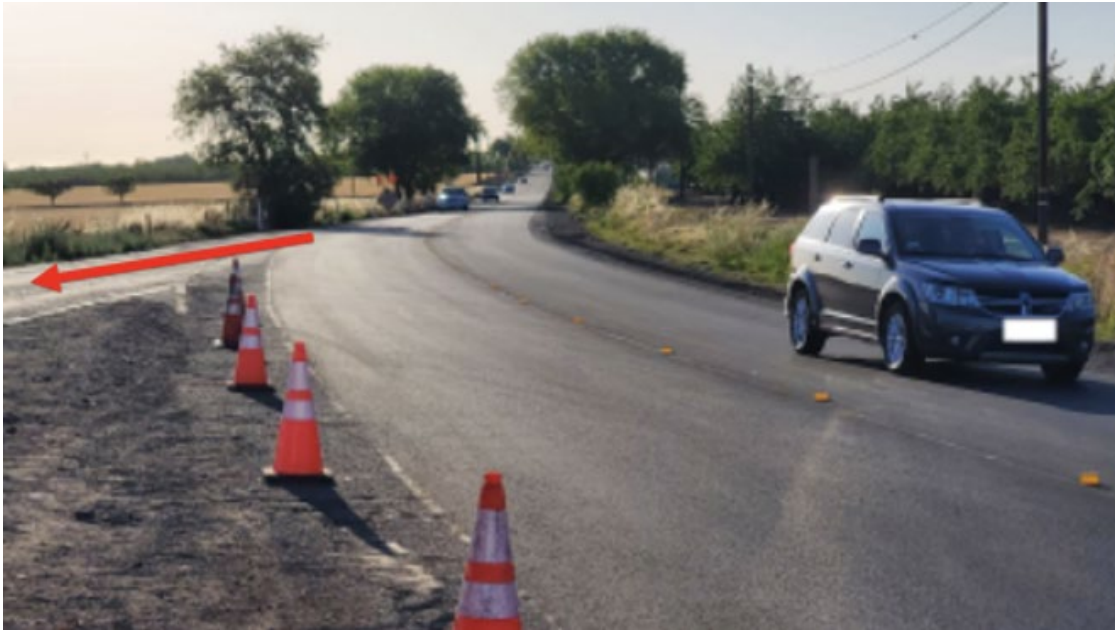
Another issue observed at flagger location 1 was the presence of a diverging side road as shown by the red arrow in Figure 5.17. Some vehicles continued down the diverging road at normal speeds, resulting in the AWARE Sentry unit sounding an alarm (1) due to excessive speed or (2) detecting a vehicle coming out of the queue in front of the flagger. Figure 5.18 shows a screenshot from the video recorded due to one of the alarms where the AWARE Sentry unit detected a vehicle traversing on the diverging road at 35.01 mph and 98.10 feet away while there was a queue of vehicles before the flagger. It can be assumed the AWARE Sentry device was mistaking the vehicles traveling down the diverged road for vehicles driving out of the queue, as was tested during the training session at the META facility.

**Figure 5.17 Diverging Side Road at Flagger Location 1 on Highway 16 near Woodland, CA**

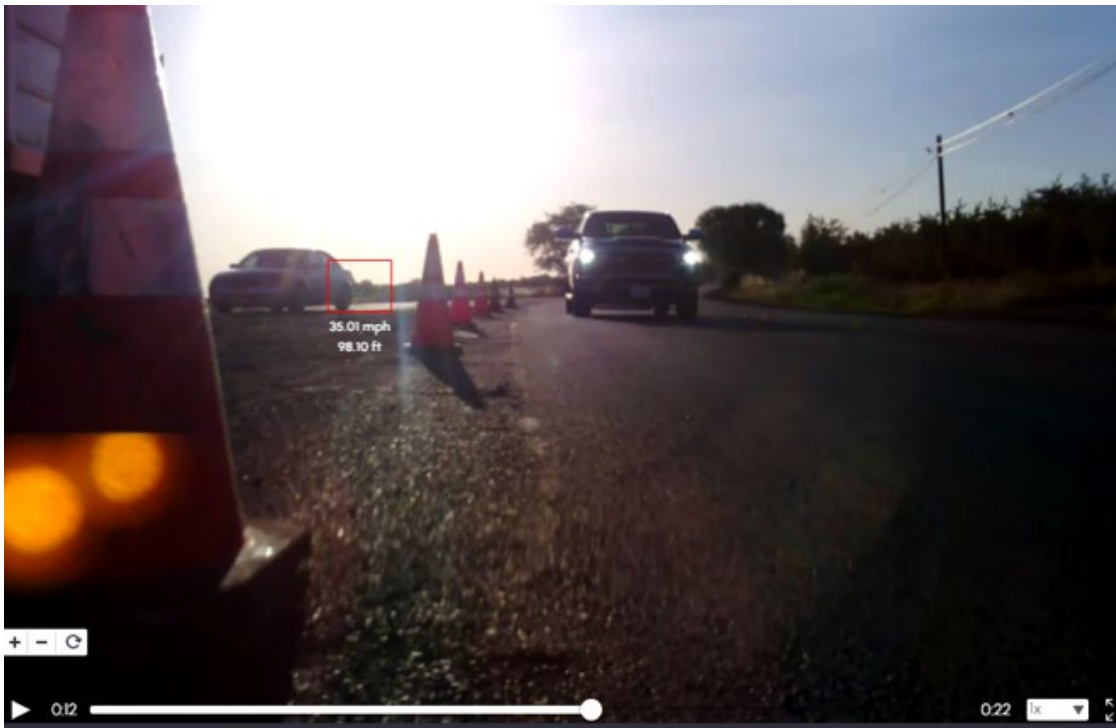
**Figure 5.18 Screenshot of Detected Vehicle Traversing on Diverging Roadway near Flagger Location 1**

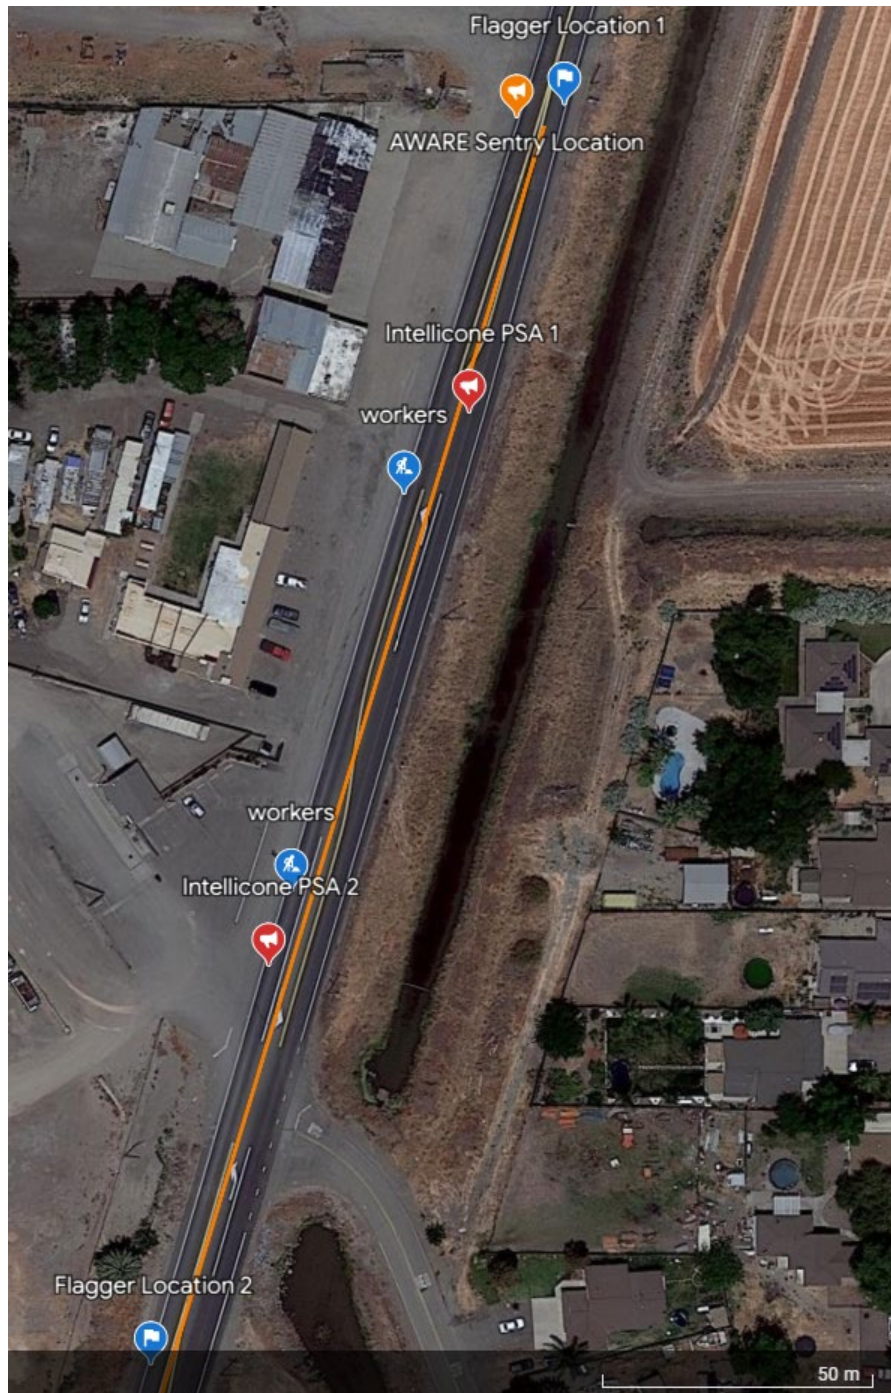
After the quick review, both the systems were handed over to the crew for transport to the work zone on CA Highway 113 near Robbins, CA during pavement crack sealing operation. The work zone was located on a section of CA Highway 113 which is a two-lane road with shoulders. Details of the work zone are presented in Table 5.2. The speed limit on the two-lane highway was 55 mph. Figure 5.22 shows the general layout of the work zone along with the placement of the two WZIA systems. It should be noted that there was a turn pocket in each direction, in the middle of the work zone, which was kept open for vehicles. The trial started at around 10:00 AM when the maintenance crew shut down one of the two lanes to set up a flagging operation, and was ended at 11:32 AM.

**Figure 5.22 General Layout of Work Zone on CA Highway 113**  
(Source: Google Earth™)
