1. REPORT NUMBER CA23-3875	2. GOVERNMENT ASSOCIATION NUMBER n/a	3. RECIPIENT'S CATALOG NUMBER n/a
4. TITLE AND SUBTITLE Pilot Testing of Work Zone Intrusion Alarms		5. REPORT DATE November 16, 2023
		6. PERFORMING ORGANIZATION CODE Sacramento State
7. AUTHOR Ghazan Khan, Raven Cochrane, Kevan Shafizadeh		8. PERFORMING ORGANIZATION REPORT NO. n/a
9. PERFORMING ORGANIZATION NAME AND ADDRESS California State University Sacramento Department of Civil Engineering 6000 J St. Sacramento, CA 95819-6029		10. WORK UNIT NUMBER n/a
		11. CONTRACT OR GRANT NUMBER 65A0828
12. SPONSORING AGENCY AND ADDRESS California Department of Transportation P.O. Box 942873, MS #83 Sacramento, CA 94273-0001		13. TYPE OF REPORT AND PERIOD COVERED Final Report May 17, 2021 – November 16, 2023
		14. SPONSORING AGENCY CODE Caltrans
15. SUPPLEMENTARY NOTES

# **PILOT TESTING OF WORK ZONE INTRUSION ALARMS**

## **FINAL REPORT**

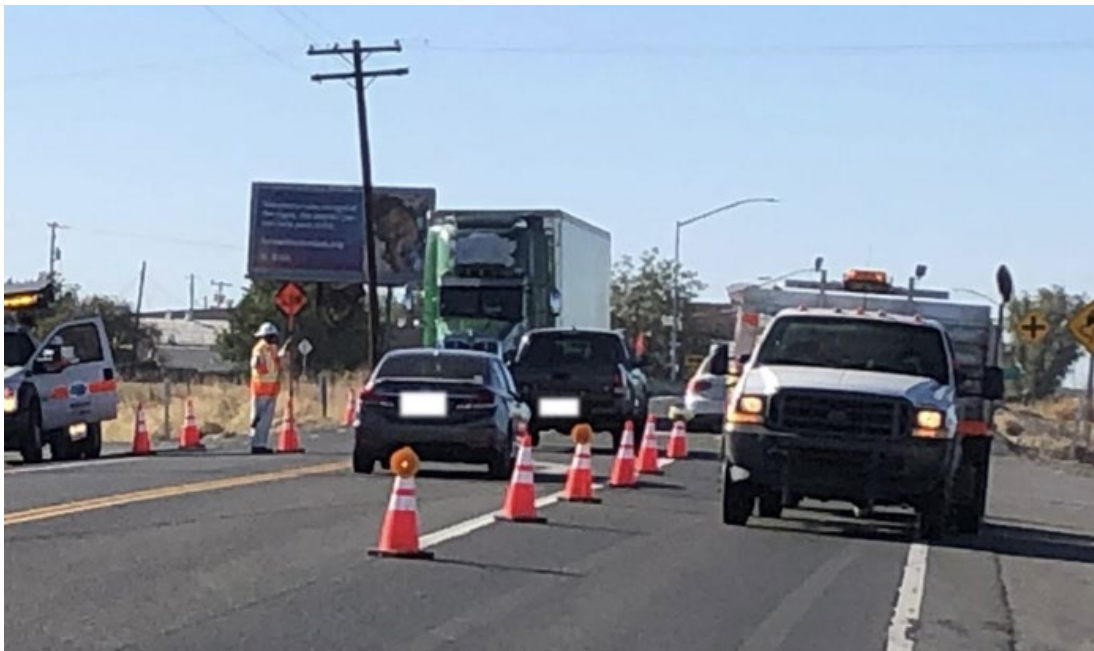
At around 10:05 AM the Intellicone lamps and Portable Site Alarms (PSA) were set up and deployed on the cones along the work zone. After placing the cones, the crew deployed 10 Intellicone lamps from the cone body truck on every other cone along the length of the work zone, each lamp spaced about 25 feet from the next, as shown in Figure 5.23. This was done to provide coverage throughout the work zone and because the cones were placed very close to each other.

**Figure 5.23 Deployment of Intellicone Lamps in Active Work Zone on CA Highway 113**

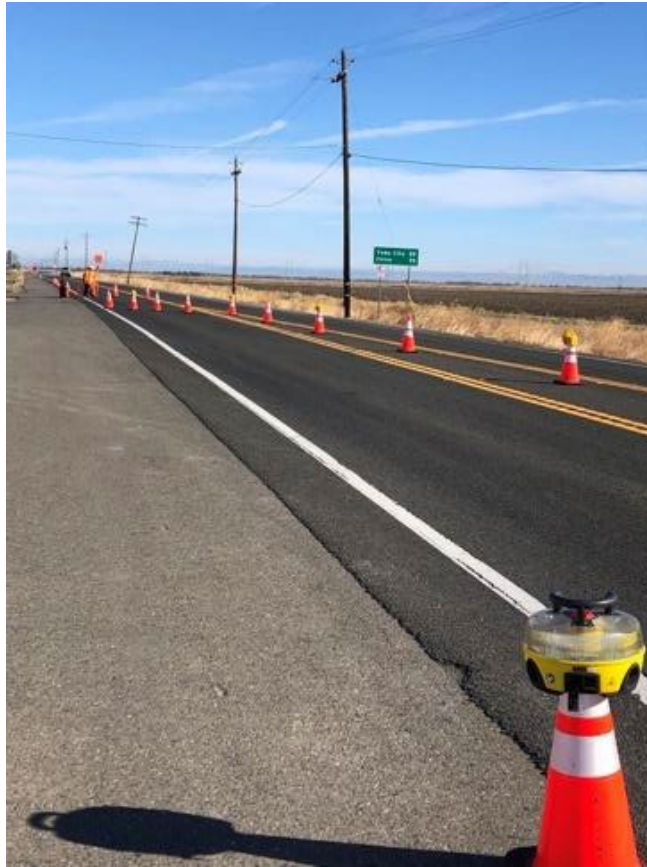
**Figure 5.24 Placement of Intellicone PSA near Shoulder of the Work Zone**

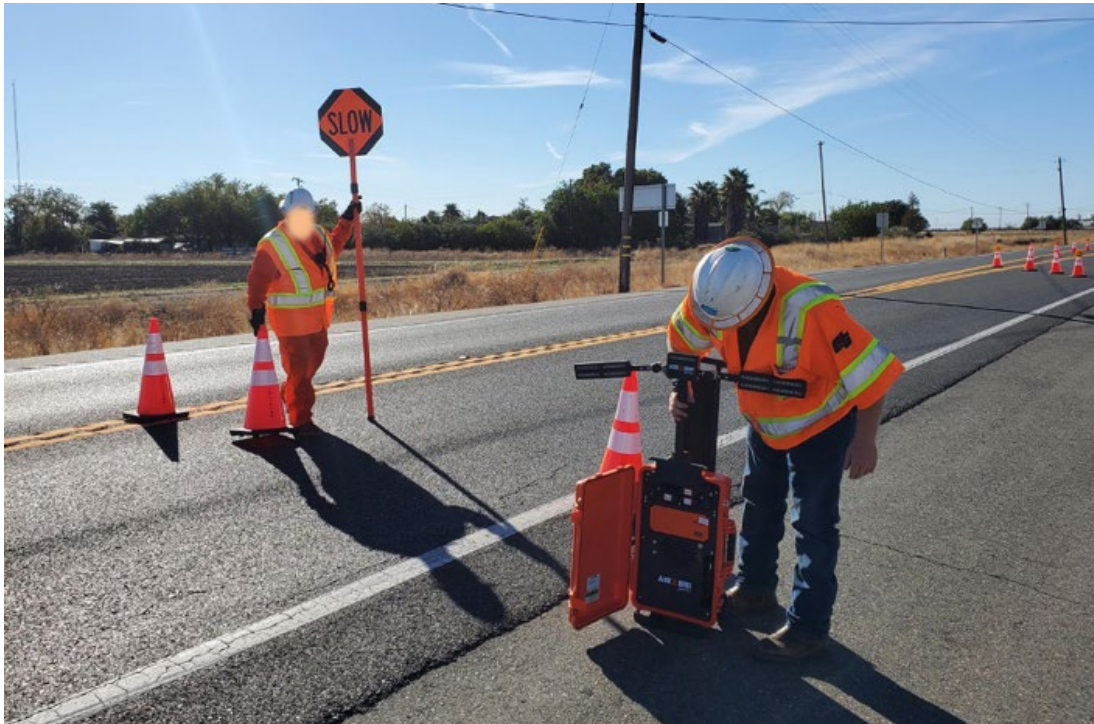
The AWARE Sentry system was deployed at around 10:20 AM at “Flagger Location 1” as shown in Figure 5.22 and Figure 5.26. All four WorkTRAX PSDs were

distributed to four workers. The threshold speed for the AWARE Sentry device was set to 35 mph using the app dashboard. The set up and deployment of the AWARE Sentry device was about 10 minutes, most of that time being spent distributing the PSDs.

**Figure 5.26 Location of AWARE Sentry Deployment at Flagger Location 1**

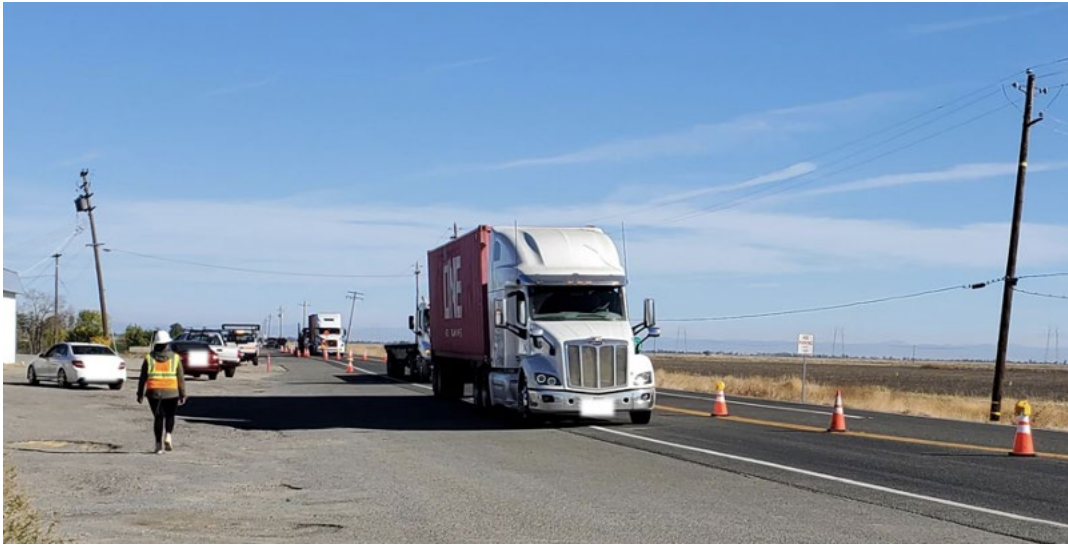
During the trial, two heavy vehicles turned into the closed lane after passing the flagger at flagger location 1, in between the spacing of the deployed cones (Figure 5.28 and Figure 5.29). The vehicles intended to make a right turn at one of the turn pockets located in the middle of the work zone. The vehicles were moving at a very slow speed and were directed out of the closure by the supervisor. None of the alarms were activated, since the vehicles crossed into the closure after passing the AWARE Sentry system and none of the Intellicone lamps were hit. After this incident, the maintenance supervisor placed additional cones and reduced the spacing between the cones to prevent further intrusions.

**Figure 5.28 Two Heavy Vehicles Intruding into the Work Zone near Flagger Location 1**

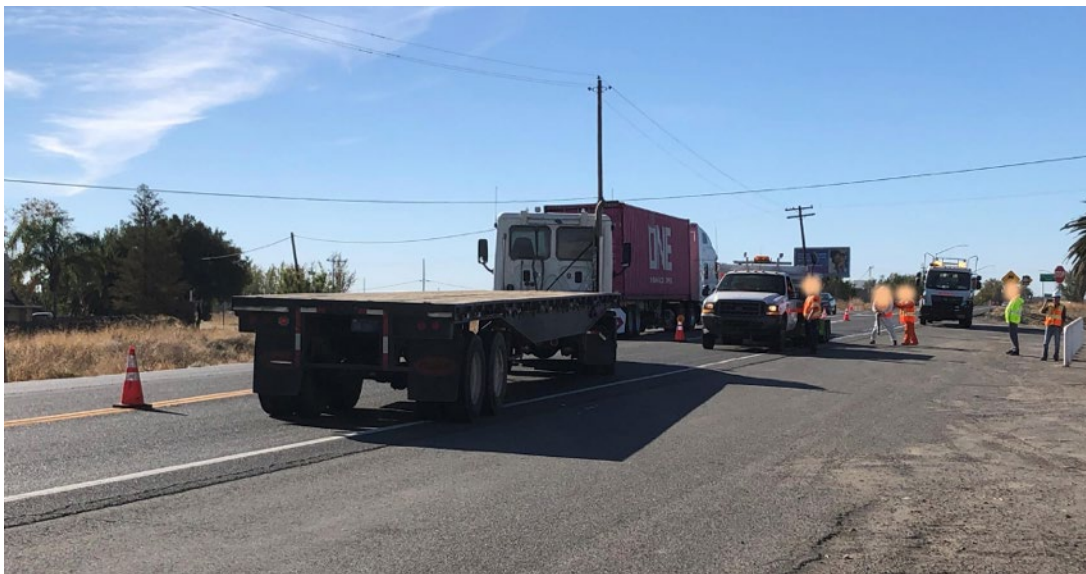
**Figure 5.29 Two Heavy Vehicles Exiting the Work Zone After Intrusion**

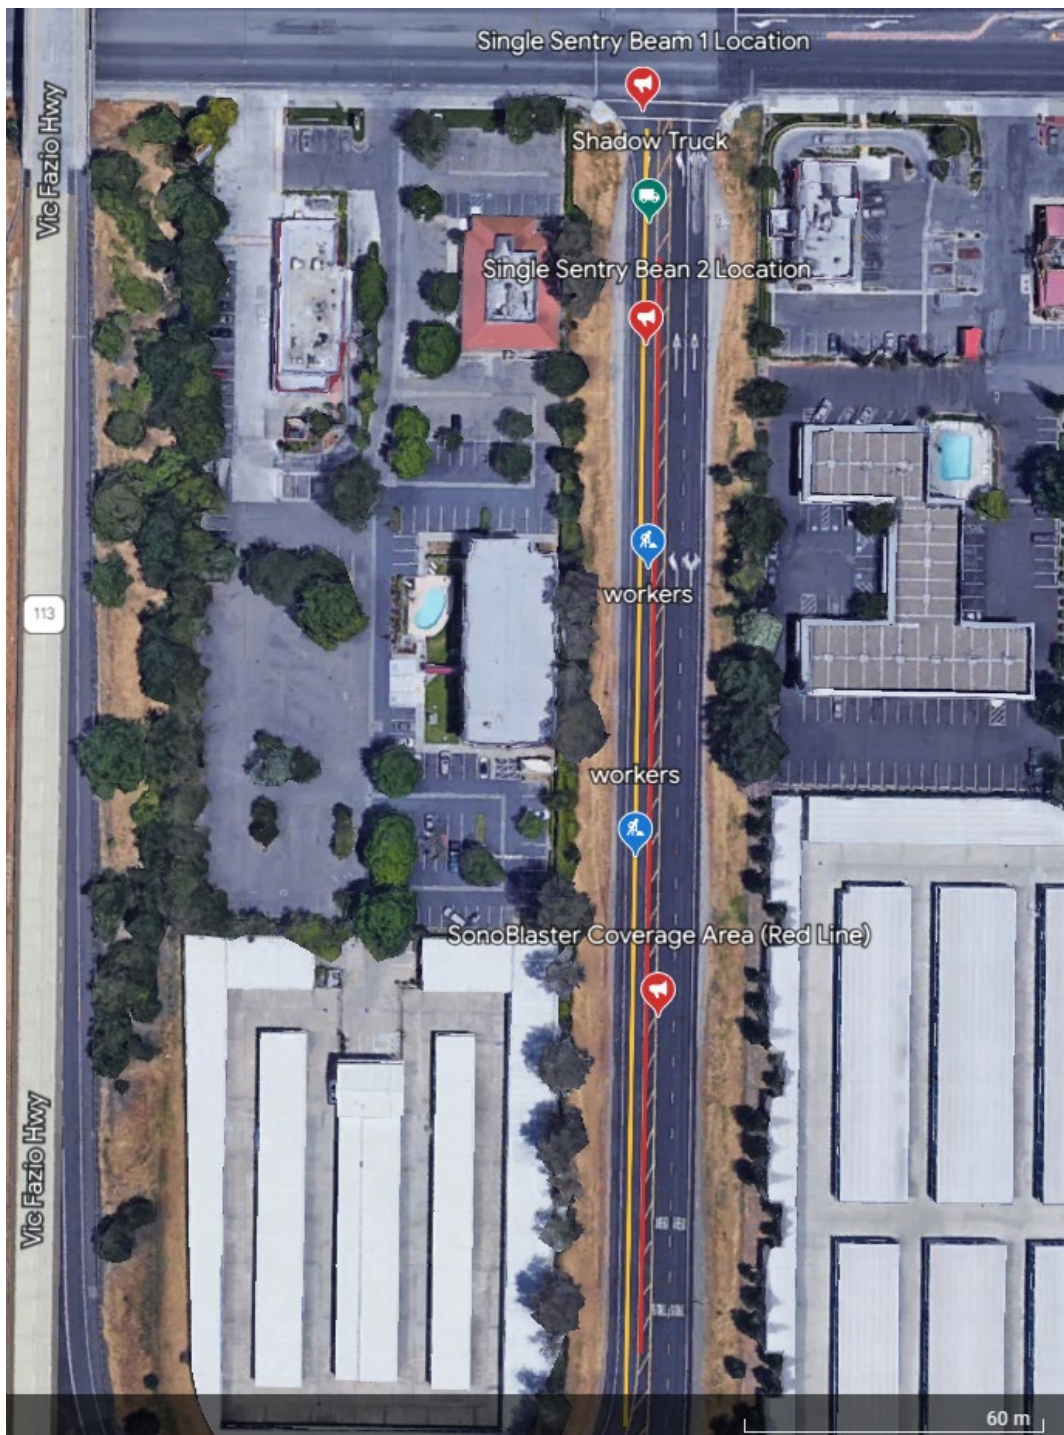
**Figure 5.32 General Layout of Ramp Closure at CA Highway 113 and E Main St.**  
(Source: Google Earth™)

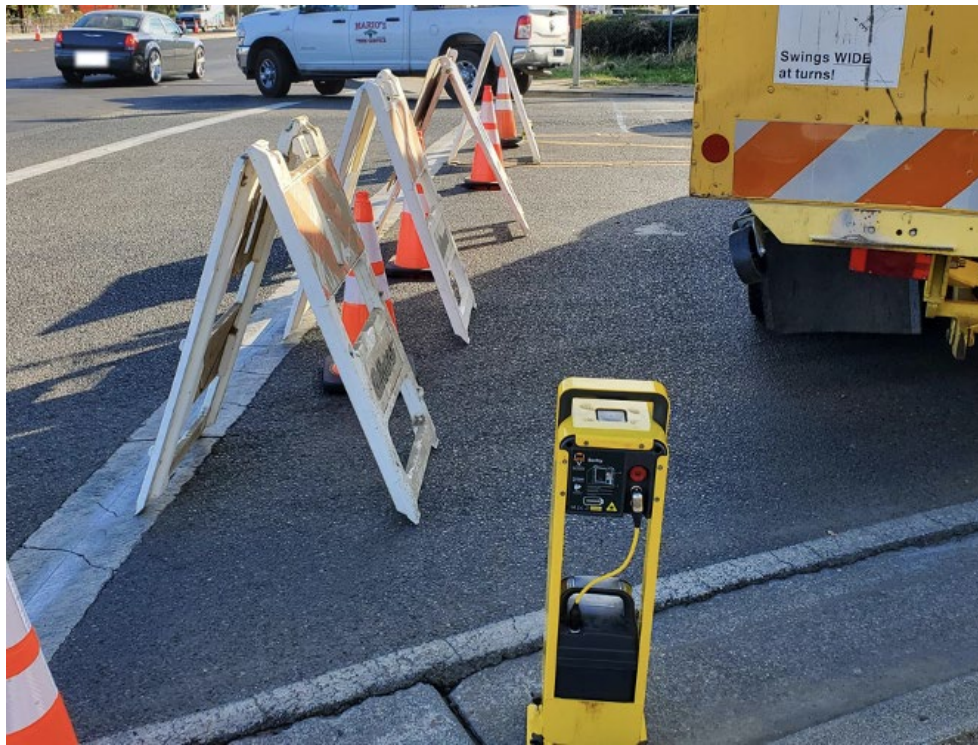
At 9:15 AM, both units of the Single Sentry Beam were deployed at the shoulder of the closed on-ramp lane with the laser detection range set equal to the width of the lane. One Laser device was deployed by the supervisor, between the ramp closure barrier at the on-ramp entrance behind the shadow truck. This device was deployed to detect any pedestrians that may try to enter the closure, as shown in Figure 5.33. The second Single Sentry Beam unit was deployed inside the closure between the location of the shadow truck and the workers' activity area to detect vehicle intrusions at the start of the on-ramp. Two Intellicone PSAs were set up and placed onto the crack filling machine as shown in Figure 5.35 either side of the vehicle. The set up and deployment time for both the Single Sentry Beam and Intellicone PSAs was less than 5 minutes, with both PSAs connecting to cellular network within 2 minutes.

**Figure 5.33 Deployment Location of Single Sentry Beam Unit Behind Shadow Truck**

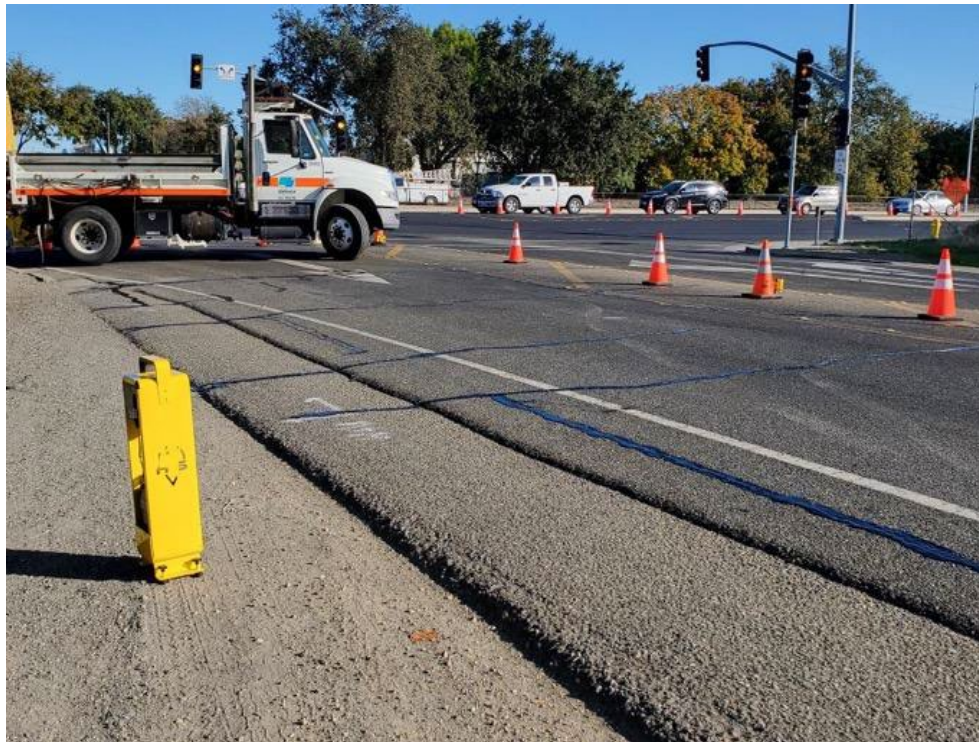
**Figure 5.34 Deployment of Single Sentry Beam within Closure on On-Ramp**

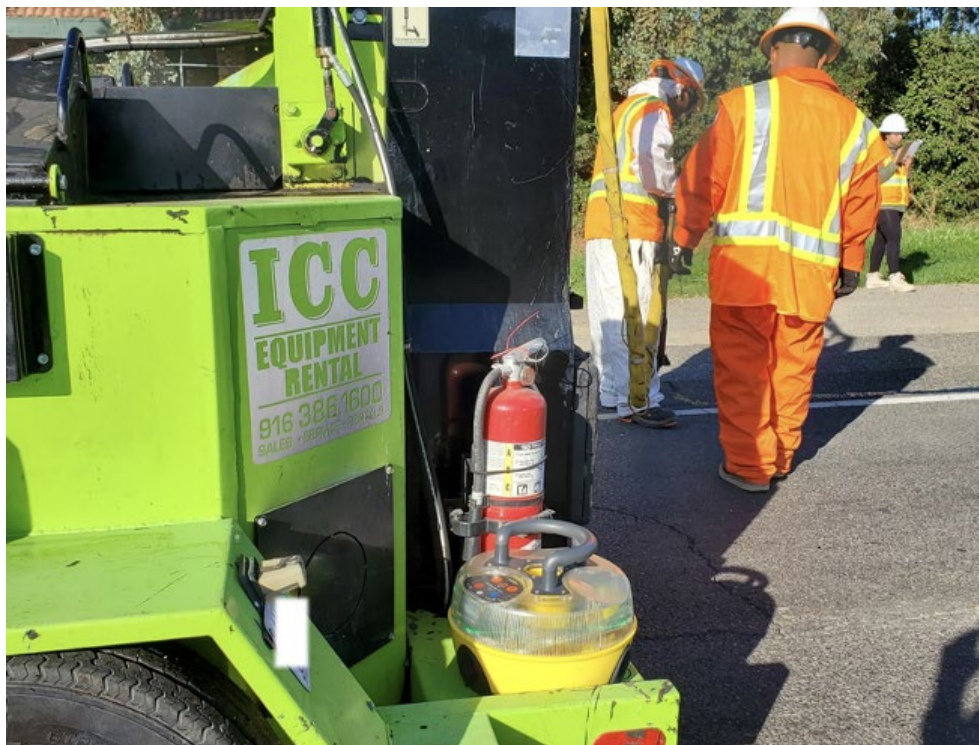
**Figure 5.35 Location of Intellicone PSA Deployment on Maintenance Vehicle**

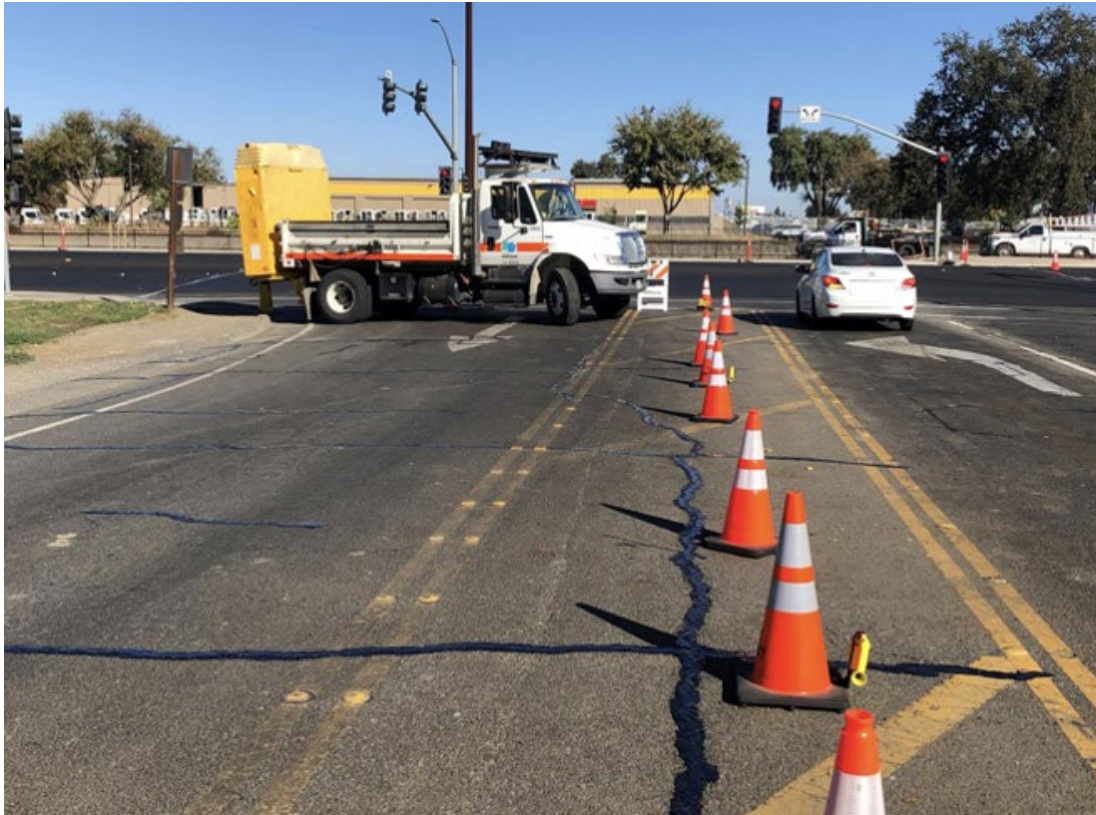
**Figure 5.36 Location of SonoBlaster Deployment in On-ramp Closure**

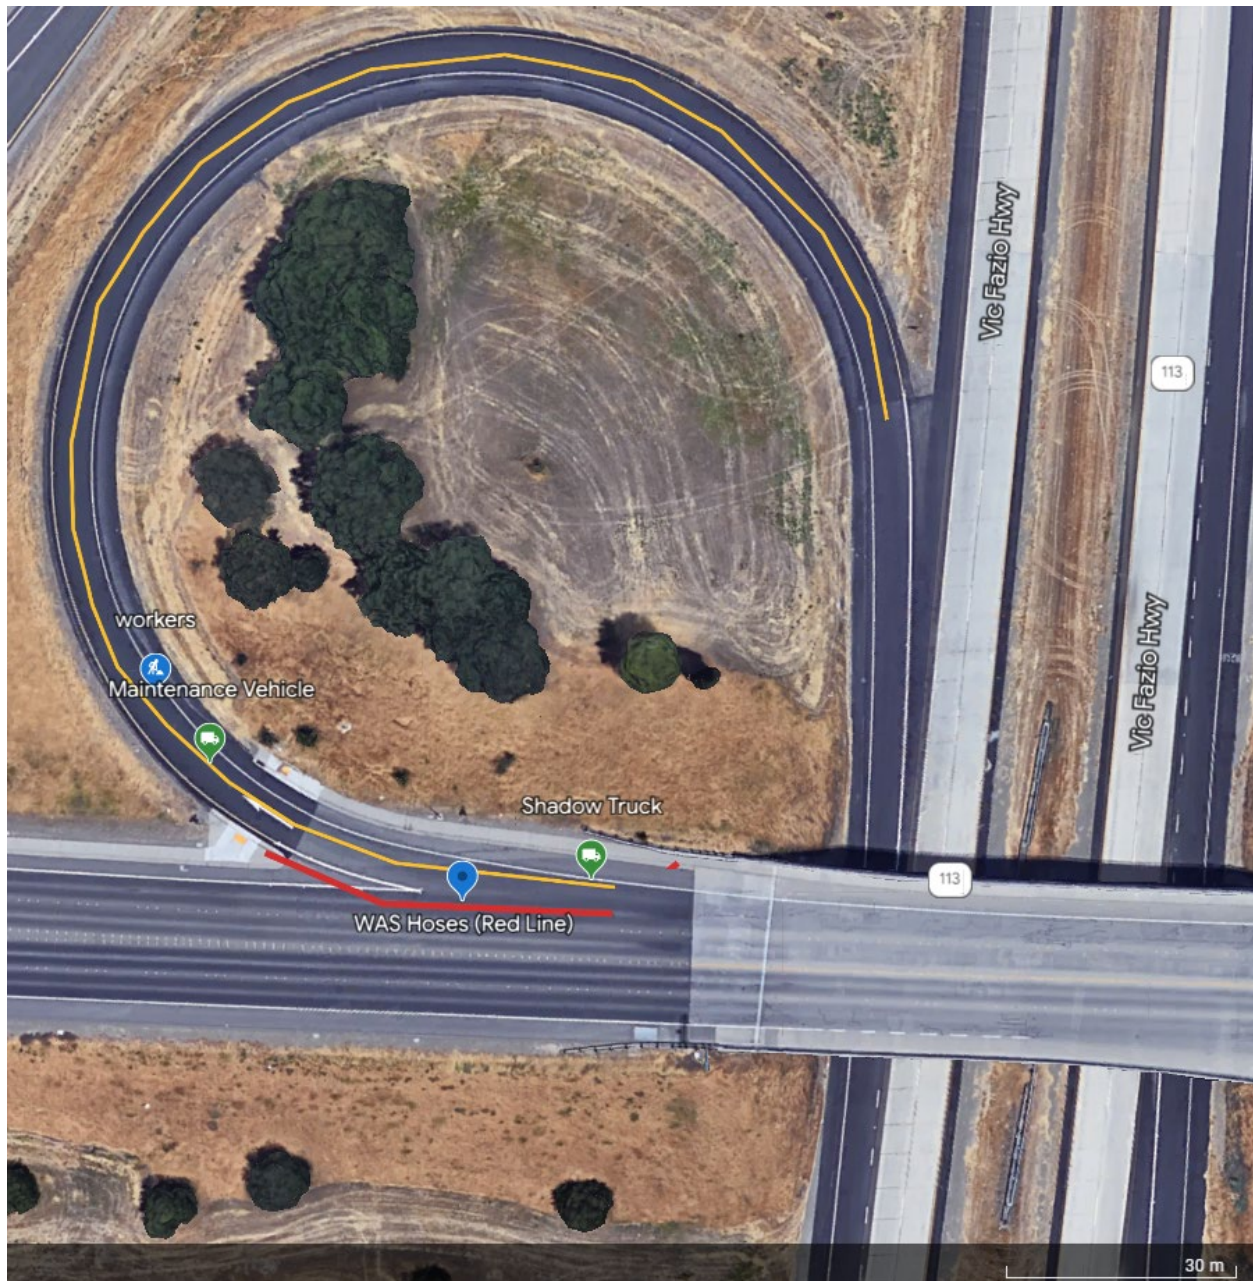
**Figure 5.39 General Layout of Ramp Closure at CA Hwy 113 and E Gibson Rd.**  
(Source: Google Earth™)

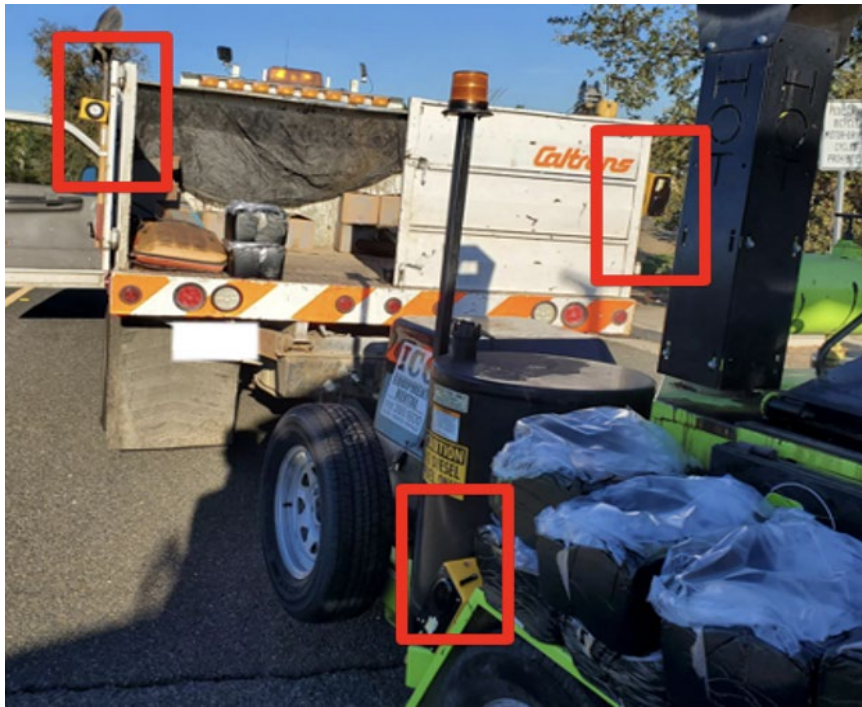
**Figure 5.40 Placement of WAS Alarm Units on Side of Equipment Vehicle**

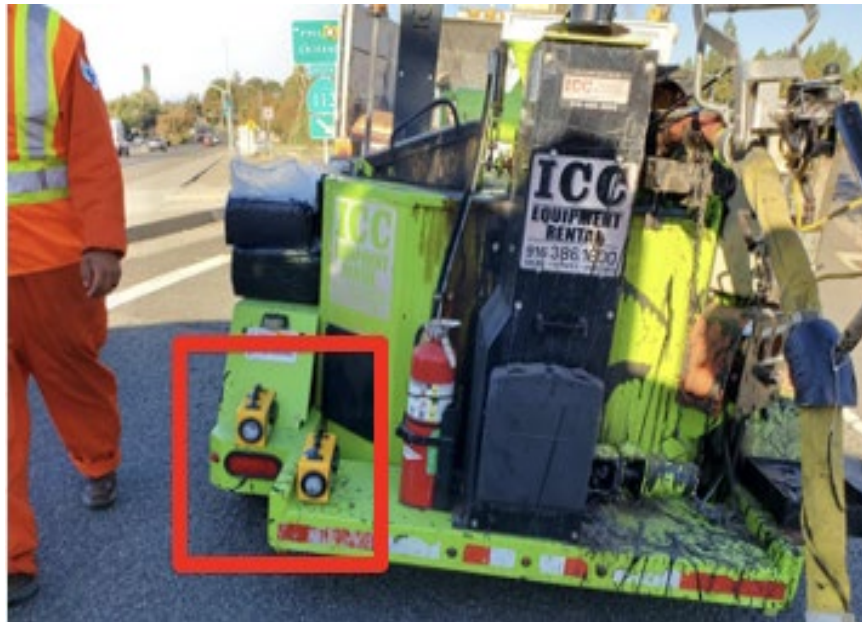
During the trial, six WAS alarm units, two pneumatic sensor hoses, and six PSDs were deployed. Two alarm units were placed on the equipment hauling vehicle and four alarm units were placed on the crack filling machine, as displayed in Figure 5.40 and Figure 5.41.

**Figure 5.41 Placement of WAS Alarm Units on Rear of Equipment Vehicle**

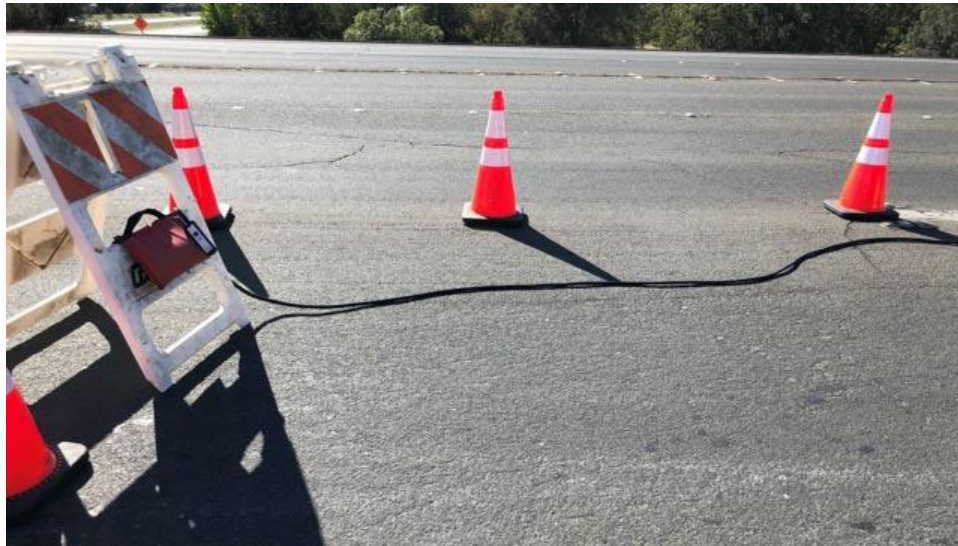
Two 30-foot pneumatic hoses were deployed by a single worker. The first hose was deployed on the left pavement marking, parallel to the road between the ramp closure barricade and the shadow truck; the second sensor was

wrapped around one of the ramp closure barriers (Figure 5.42). The second hose was placed in the gap between the front of the shadow truck and the island at the entrance to the on-ramp, with the hose sensor placed on the ground (Figure 5.43).

**Figure 5.42 Location of First WAS Hose Deployment**

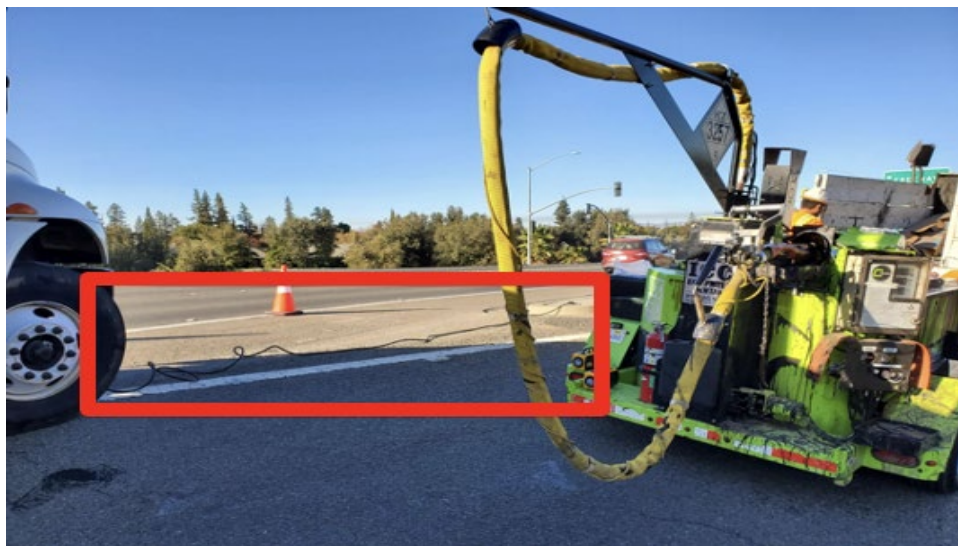
**Figure 5.43 Location of Second WAS Hose Deployment**

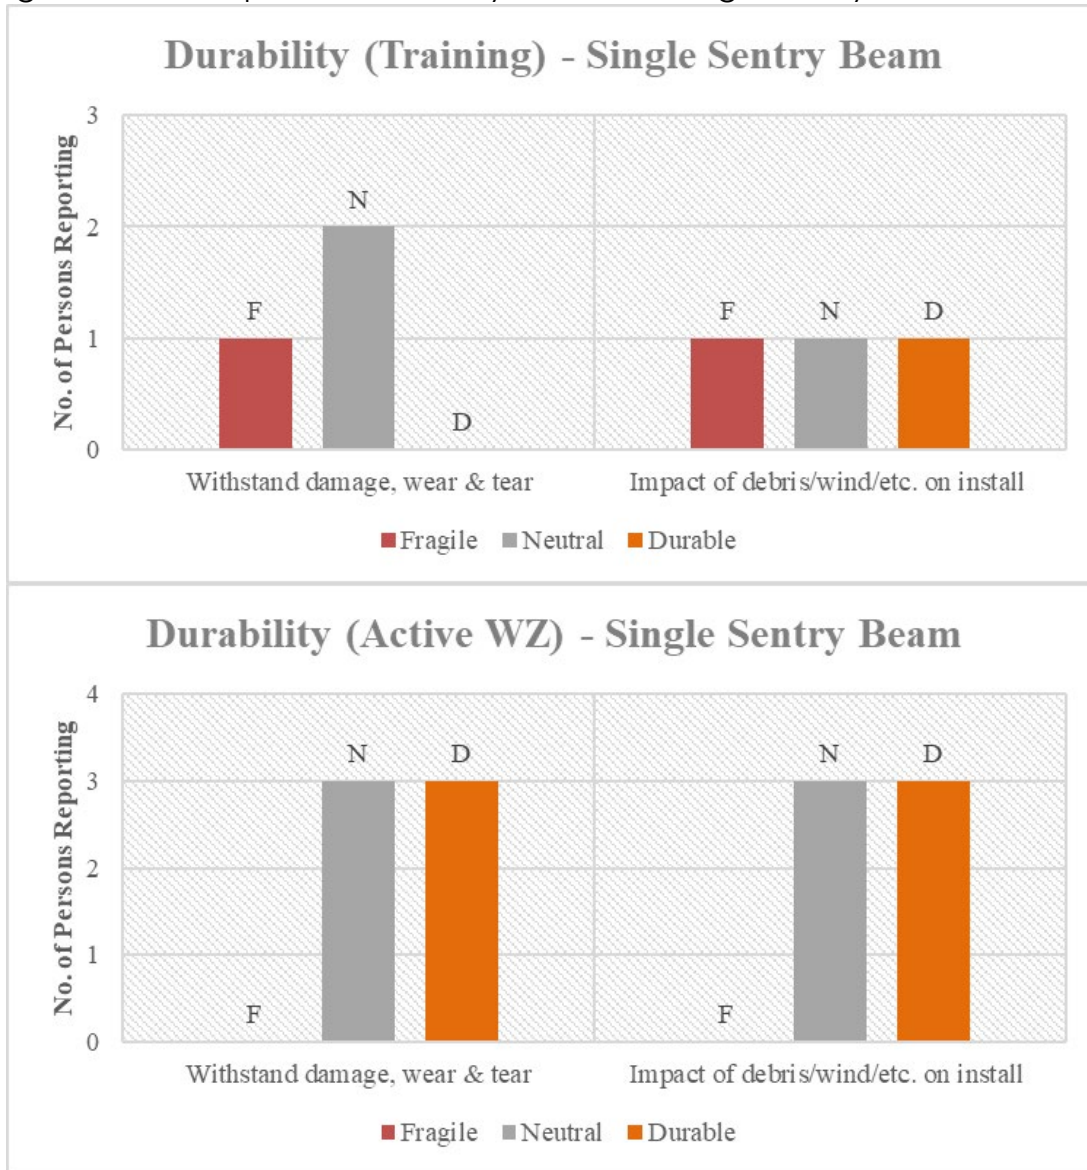
Figure 6.15 shows the survey responses, during the training sessions and active work zone testing, to questions regarding the durability of the Single Sentry Beam system. Similar to the Intellicone system survey results on this topic, while the responses were generally mixed, the results from both the surveys show that a majority of the maintenance workers did not provide a response to

questions relating to the durability of the Single Sentry Beam system. Therefore, it is difficult ascertain anything definitively from the responses. However, there are a few more "Durable" responses in the active work zone survey.

Figure 6.15 Comparison of Survey Results for Single Sentry Beam Durability

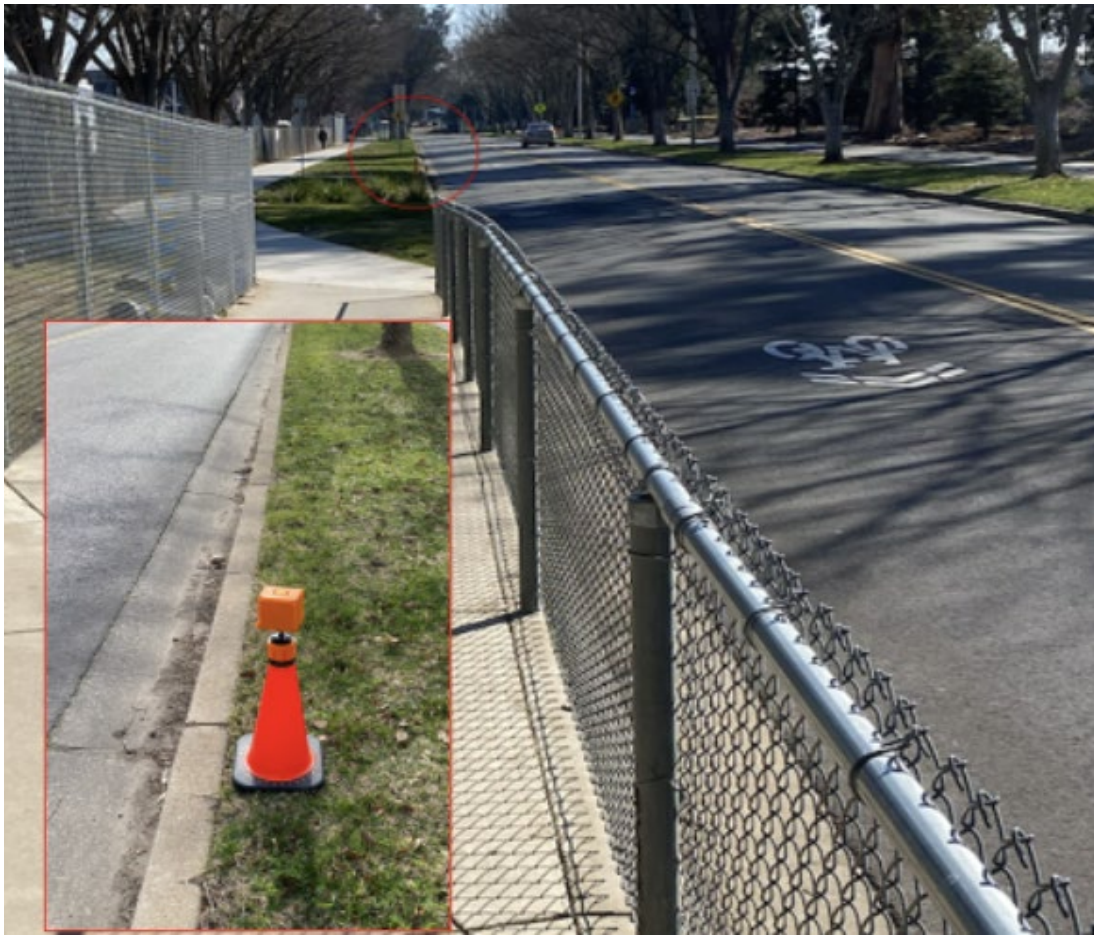
**Figure 7.1 Guardian Cone Deployment on Two-Lane Road**

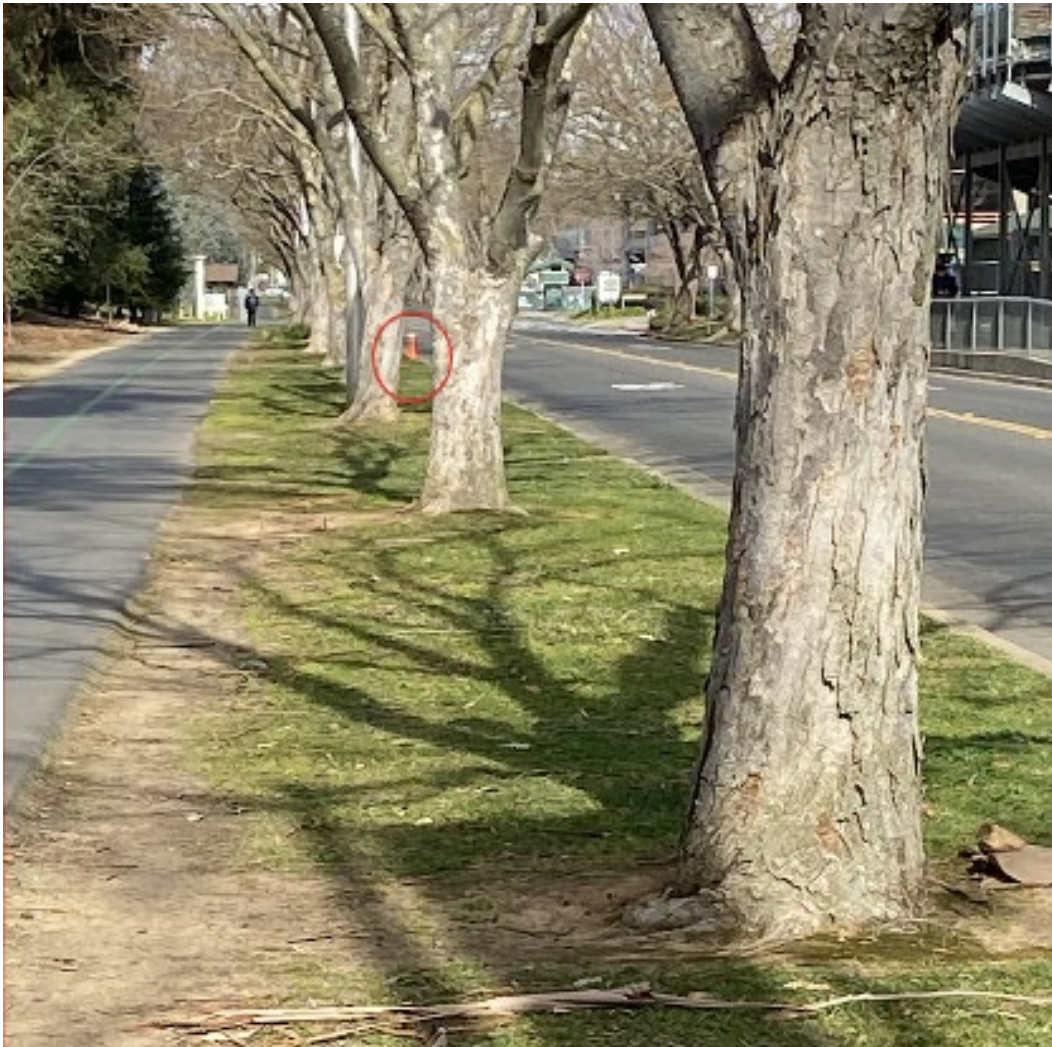
**Figure 7.2 Guardian Cone Testing Without Clear Line of Sight**

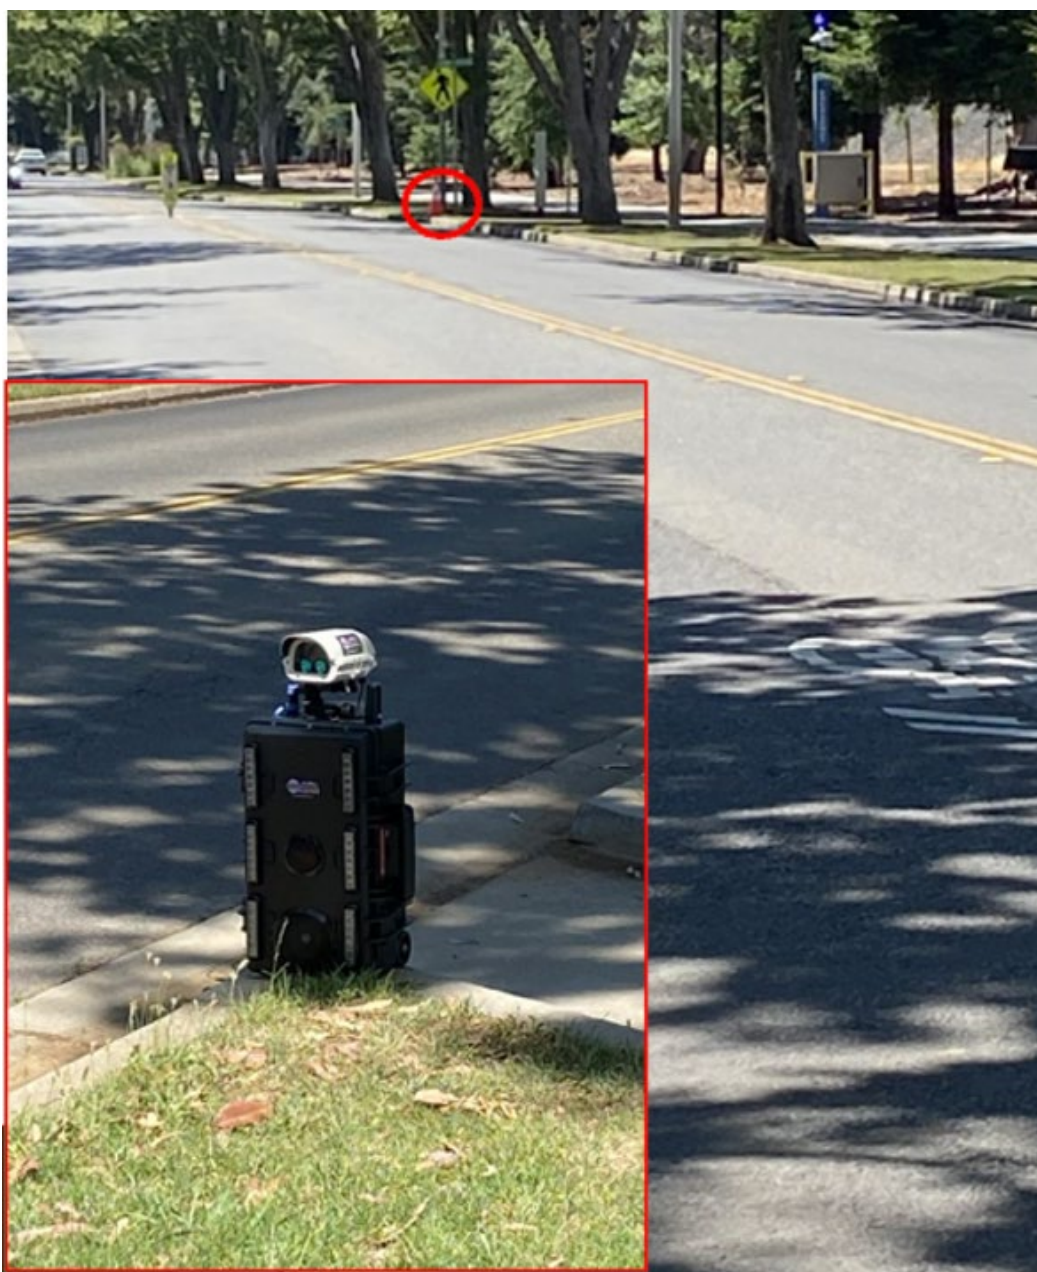
**Figure 7.3 Overwatch Trial 1 Setup on Two-Lane Roadway**

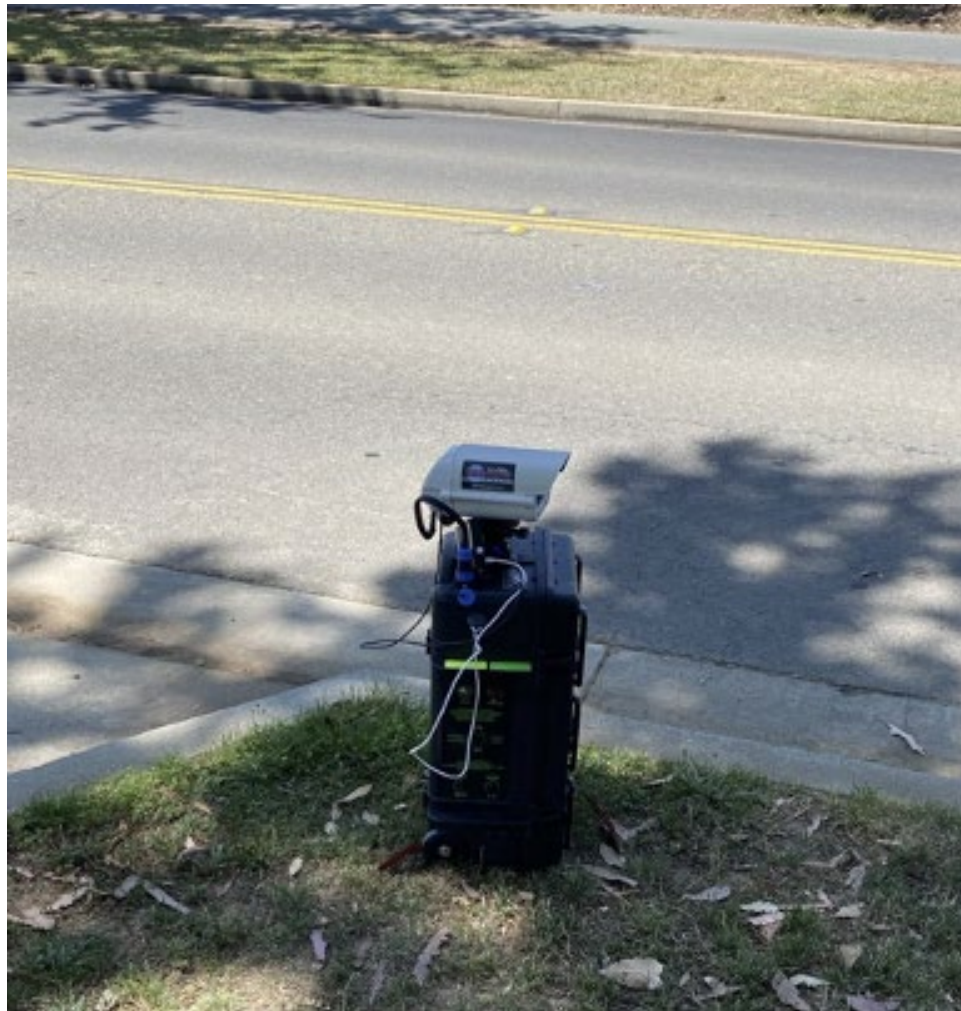
**Figure 7.5 Overwatch Trial 2 Setup on Two-Lane Roadway**

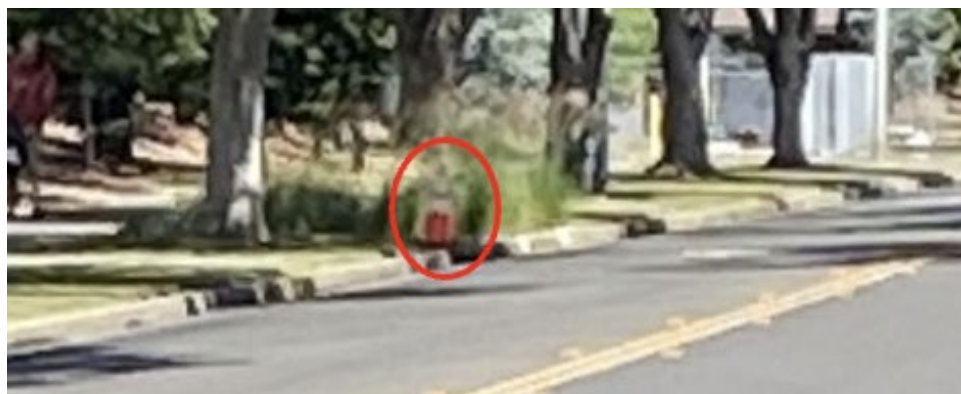
**Figure 7.6 Overwatch Trial 2 Cone Placement**

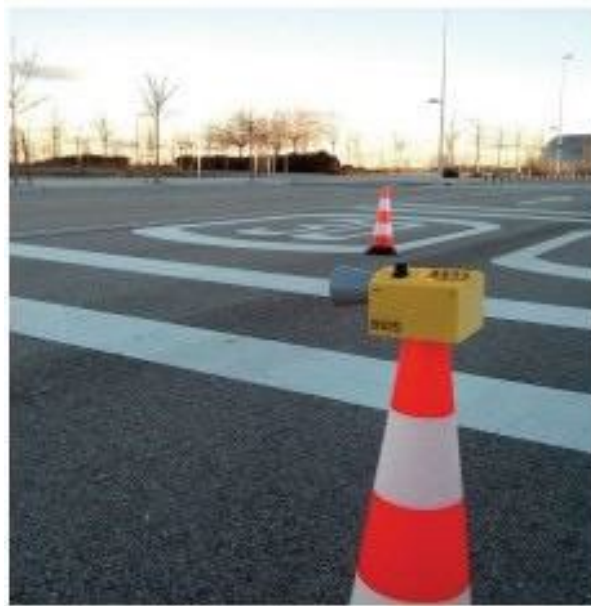
The results of the study showed that the sensor node successfully alarms the individual warning devices and detects for vehicle speeds between 30 and 90 km/h, with no missed detections out of the 10 trials. The Sensor node also successfully alarms and detects vehicles with a vehicle speed of 60km/h and a node line of sight angle between -60 and +60 degrees, with no missed detections out of the 10 trials for each angle (Martin et al., 2016). Both tests were conducted with the sensor node 3 meters away from the road as shown in Figure 2.19. Based on the results, it was concluded that the sensor node line of sight angle and vehicle speeds do not significantly impact vehicle detection.

**Figure A.3 Photo of WSN Sensor Node During Closed Track Testing**  
(Source: Martin et al., 2016)

A third test was conducted for vehicle detection accuracy based on the sensor node's distance to the road. From distances between 1 and 7 meters away from the road and out of 10 trials at each distance, there were only two missed detections at the distance of 7 meters. The results concluded that there is no significant change in average latency with sensor node distances between 1 and 52 meters. The overall conclusion of Martin's evaluation is that WSN proves to be an effective and useful tool for work zone safety, with an easy deployment and quick set up.

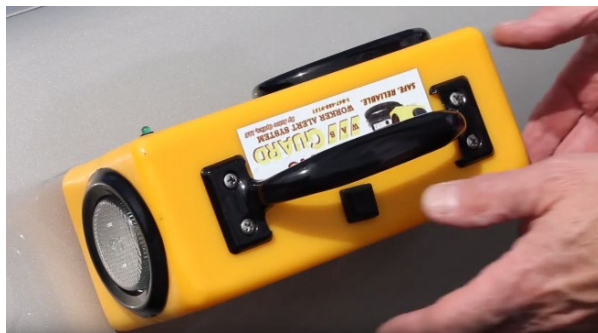
1. Charge the horn/light assembly for 6-8 hours to achieve a full charge.
2. Power the horn/light assembly ON by pressing the rubber sealed/toggle switch once.
3. The green indicator light will be illuminated on the horn/light assembly when powered on.
4. Any time the hose/sensor is stimulated by a change in pressure, the alarm should go off.
5. If it does not, refer to the third step under the next section for linking instructions.
6. When finished, press the on/Off button and place in a safe location until it is needed next.

**Figure E.1 Turning on Horn/Light Alarm**

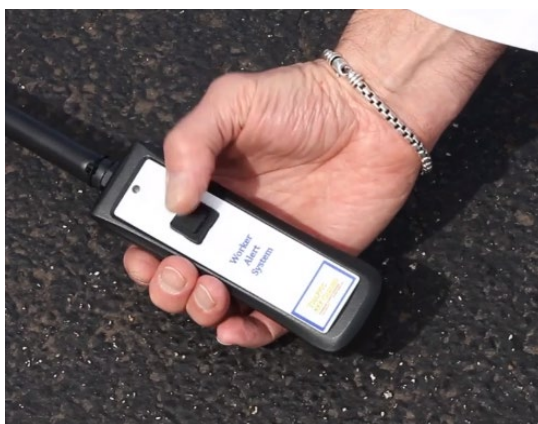
**Figure E.2 Turning on the Pressure Sensor**

1. Power Check
  - a. Check AA batteries in the pressure sensor by powering the unit on and looking for the green or red indicator light to flash quickly while the sensor calibrates.

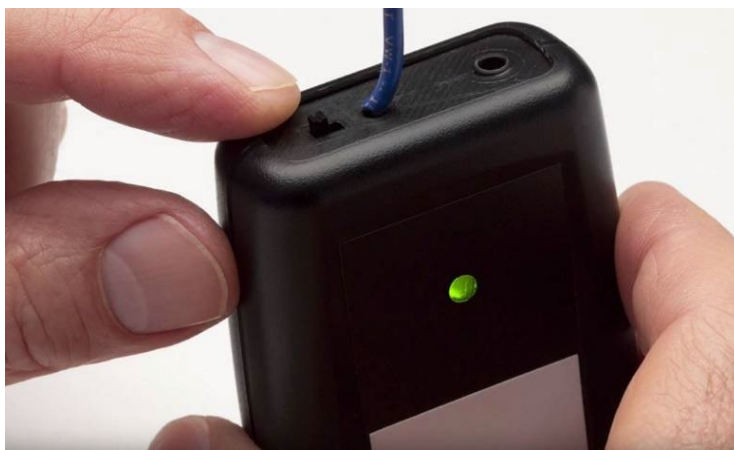
1. Check battery power by powering
  - a. If the indicator light is green, the unit has ample power
  - b. If the indicator light is yellow, the unit has medium power
  - c. If the indicator light is red, the unit is almost dead.
2. Link PSD to pressure sensor assembly
  - a. To link, activate the hose/sensor **while simultaneously** powering the PSD ON.
  - b. The unit should vibrate and send a sound to the earpiece if plugged in.

**Figure E.3 Turning on Personal Safety Device**

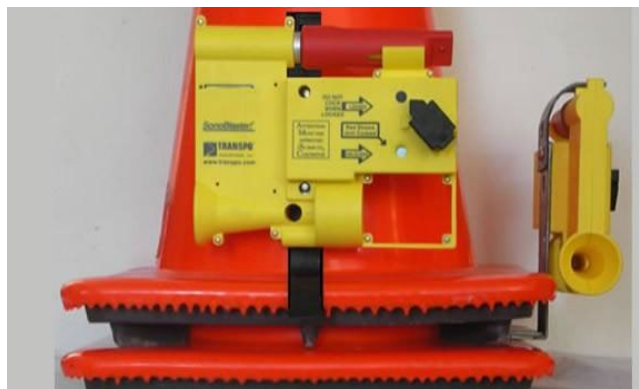
3. **Choosing Mounting Screws:** Choose the longer 2" screws provided with SonoBlaster unit for thicker bases. Use the shorter 1 1/4" screws provided with bracket for thinner bases.

4. **Attach Bracket:** Attach the bracket to the cone base using washers on the bracket and under the base of the cone. Tighten screws securely.
5. **Mount SonoBlaster Unit:** Attach the SonoBlaster to the bracket using the remaining screws & washers. Do not over tighten screws.

**Figure E.6 SonoBlaster Bracket Assembly**

1. Installation instructions recommend installing the bracket at the base of the cone (for cones with feet). However, depending on the type of the cone, the bracket may be installed on top of the base as well. However, this may reduce stacking capacity of the cones.
2. Insert the CO<sub>2</sub> cartridge carefully as improper installation may result in nonactivation of alarm.
3. Ensure the SonoBlaster unit is in locked position during handling and transportation to avoid accidental activation.

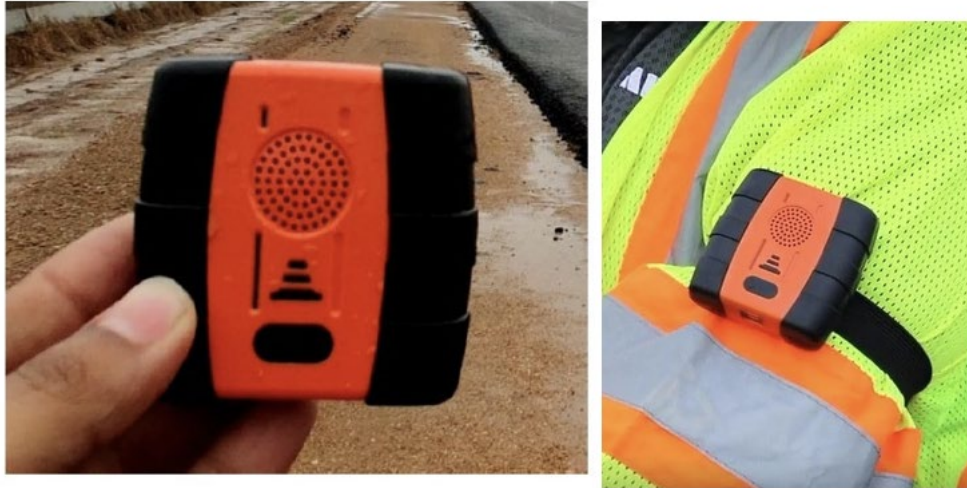
1. Remove the WorkTRAX (Personal Safety Device) devices from the case and press the power button to switch on. The device will beep and vibrate indicating it is on.
2. Press the power button again to turn off the WorkTRAX device. The device will beep and vibrate indicating it has turned off.
3. Place the WorkTRAX device on an armband or in the pocket of the safety vest.

**Figure E.16 AWARE WorkTRAX Device**

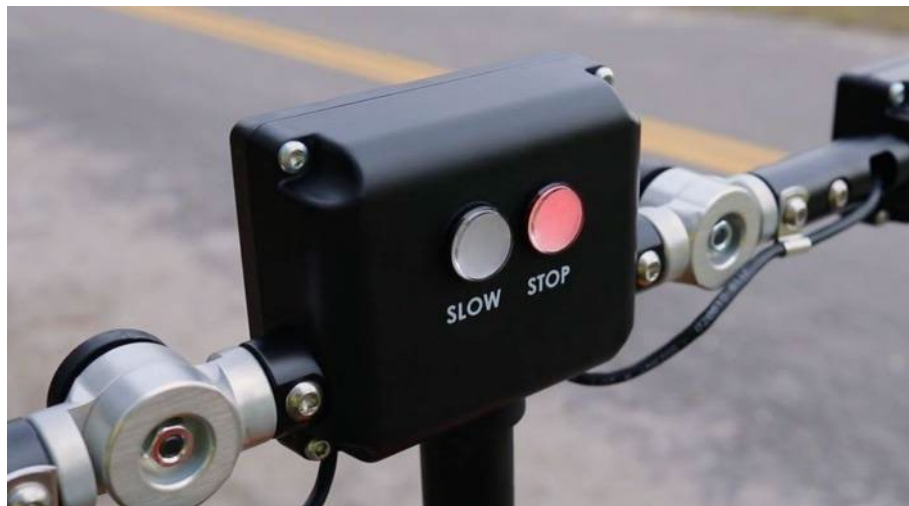
**Figure E.17 Back View of AWARE Sentry Device When Pedal is Released**
