1. REPORT NUMBER CA23-3875	2. GOVERNMENT ASSOCIATION NUMBER n/a	3. RECIPIENT'S CATALOG NUMBER n/a
4. TITLE AND SUBTITLE Pilot Testing of Work Zone Intrusion Alarms		5. REPORT DATE November 16, 2023
		6. PERFORMING ORGANIZATION CODE Sacramento State
7. AUTHOR Ghazan Khan, Raven Cochrane, Kevan Shafizadeh		8. PERFORMING ORGANIZATION REPORT NO. n/a
9. PERFORMING ORGANIZATION NAME AND ADDRESS California State University Sacramento Department of Civil Engineering 6000 J St. Sacramento, CA 95819-6029		10. WORK UNIT NUMBER n/a
		11. CONTRACT OR GRANT NUMBER 65A0828
12. SPONSORING AGENCY AND ADDRESS California Department of Transportation P.O. Box 942873, MS #83 Sacramento, CA 94273-0001		13. TYPE OF REPORT AND PERIOD COVERED Final Report May 17, 2021 – November 16, 2023
		14. SPONSORING AGENCY CODE Caltrans
15. SUPPLEMENTARY NOTES

# **PILOT TESTING OF WORK ZONE INTRUSION ALARMS**

## **FINAL REPORT**

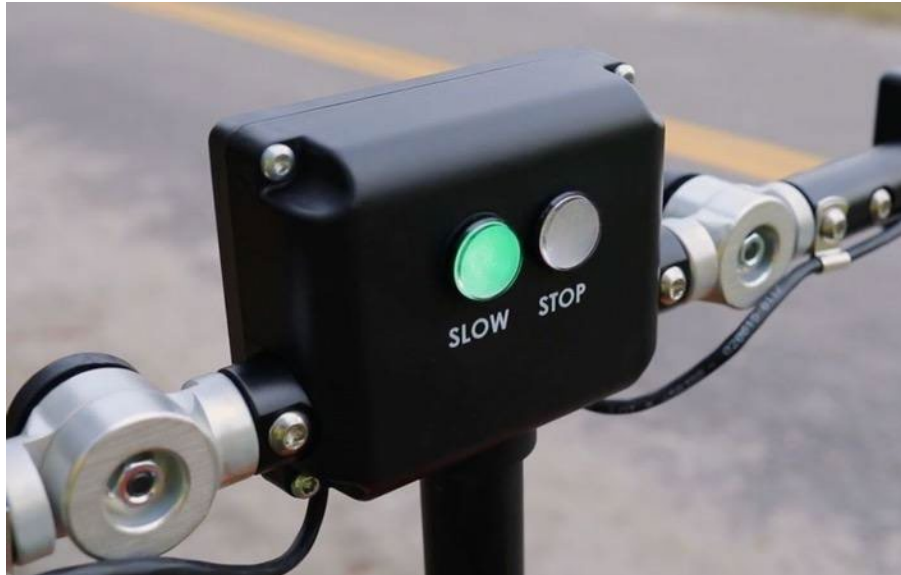
1. After removing the foot pedal from the case, the default condition of AWARE is "STOP."
2. Step and keep pressure on the foot pedal to release traffic. The light behind the light bar should switch from stop to slow.
3. Release the foot pedal to stop traffic. The light should switch from slow to stop.

Figure E.18 Back View of AWARE Sentry Device When Pedal is Pressed
