Laboratory and Field Performance of PGxx-28 and PGxx-34 Binders and New Binder Type Selection Catalog

Technical Report 5-6674-01-R1

TEXAS A&M TRANSPORTATION INSTITUTE
COLLEGE STATION, TEXAS

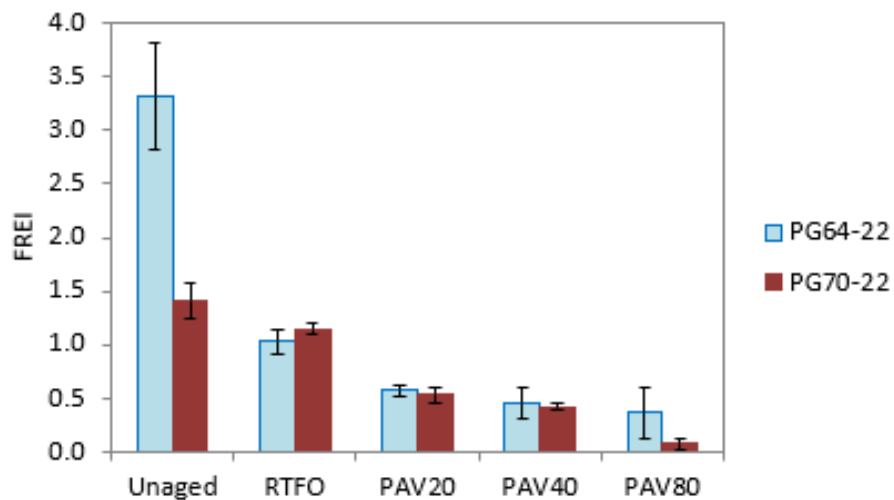
Figure 12. PLAS Test Results: Effect of Chemical Aging.

The same two asphalt binders used to identify the deficiency of the LAS test were used to evaluate the effect of aging on fatigue cracking resistance of asphalt binders at intermediate temperature using the PLAS test. For each asphalt binder, the PLAS test was performed at 15°C for five aging conditions: OB, RTFO, PAV20, PAV40, and PAV80. For each aging condition, two replicates were used. Figure 12 shows the averaged FREI value for each asphalt binder at each specific aging condition. The figure indicates that the FREI is a true indicator of asphalt binder fatigue resistance—the aged binders have lower values of FREI and, thereby, poorer fatigue resistance.

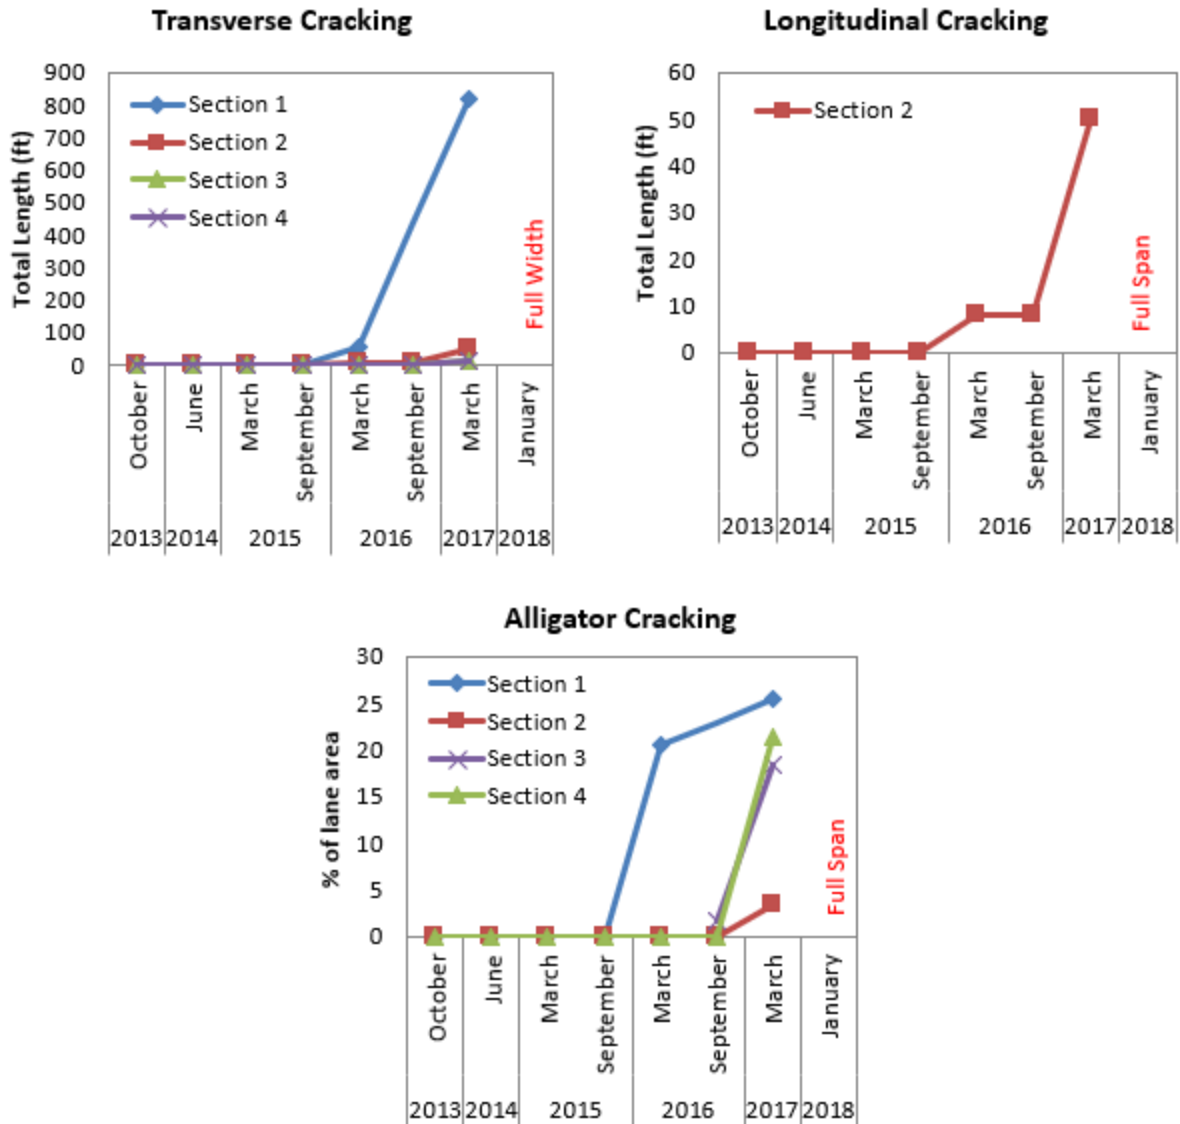
Figure 22. SH 15 Test Sections: Survey Results.

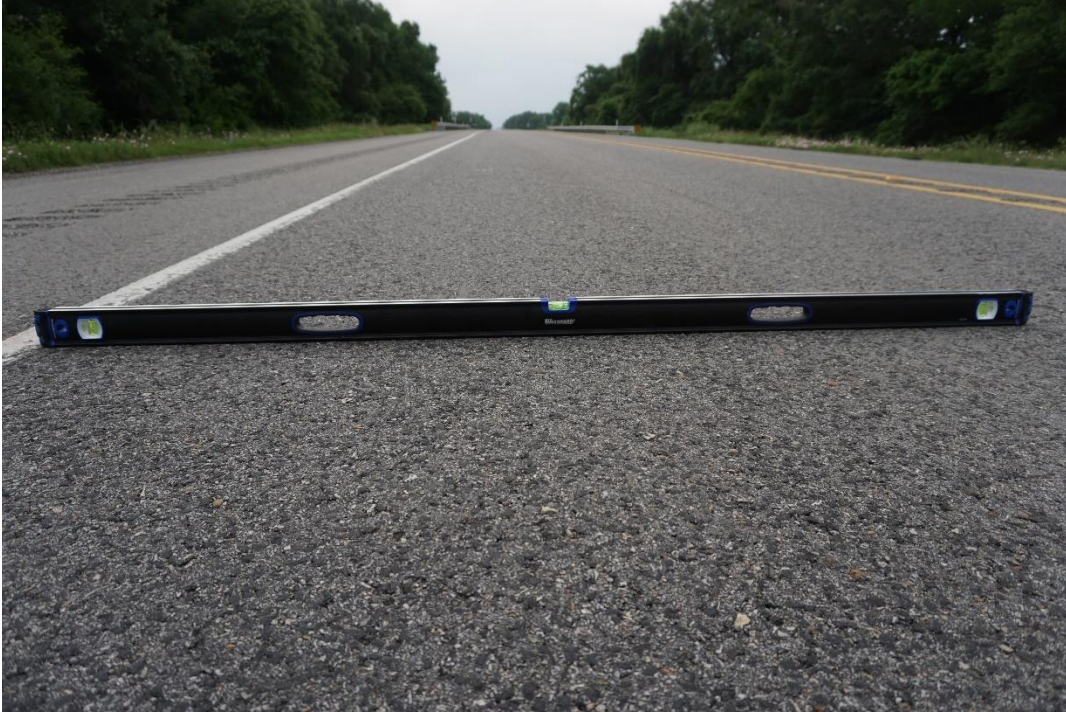
Figure 42. No Rutting on Both Test Sections on SH 7.

Since the construction in June 2020, the research team has continuously monitored the sections. The latest field survey was completed on May 5, 2022. No rutting was observed in either test section (Figure 42). Two cracks were observed on the control test section with PG64-22, as shown in Figure 43. No cracking was seen on the test section with PG64-28 (Figure 44).

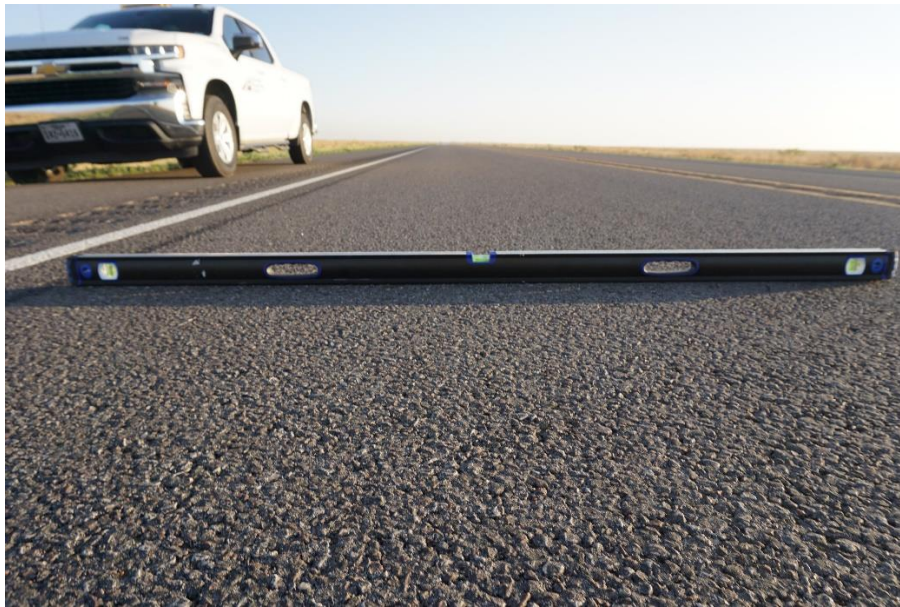
Figure 51. No Rutting on the Test Section with PG64-34 on SH 214.

Since the construction in April 2021, researchers have continuously monitored the sections. The latest field survey was completed on May 10, 2022. Neither rutting nor cracking was observed in either test section, as shown in Figure 51 through Figure 54.

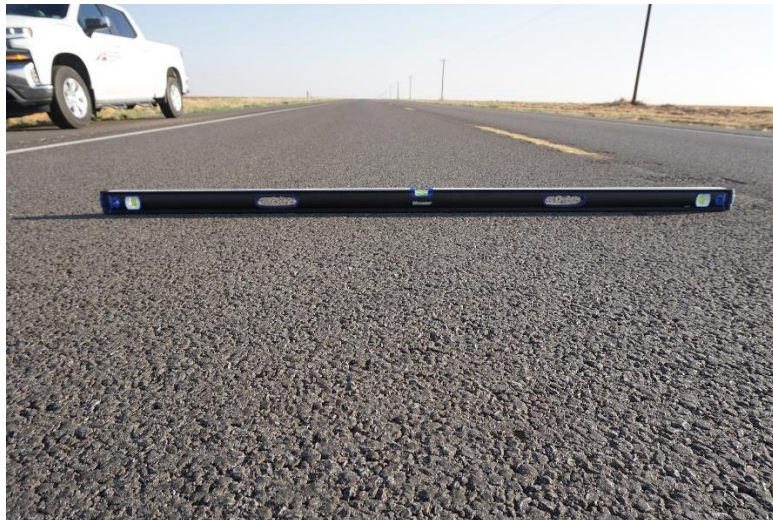
Figure 53. No Rutting on the Test Section with PG70-28 on SH 214.

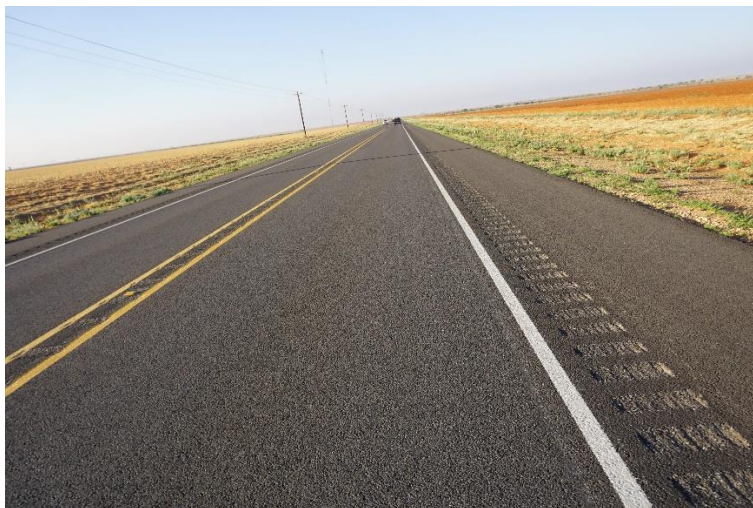
Figure 54. No Cracking on the Test Section with PG70-28 on SH 214.

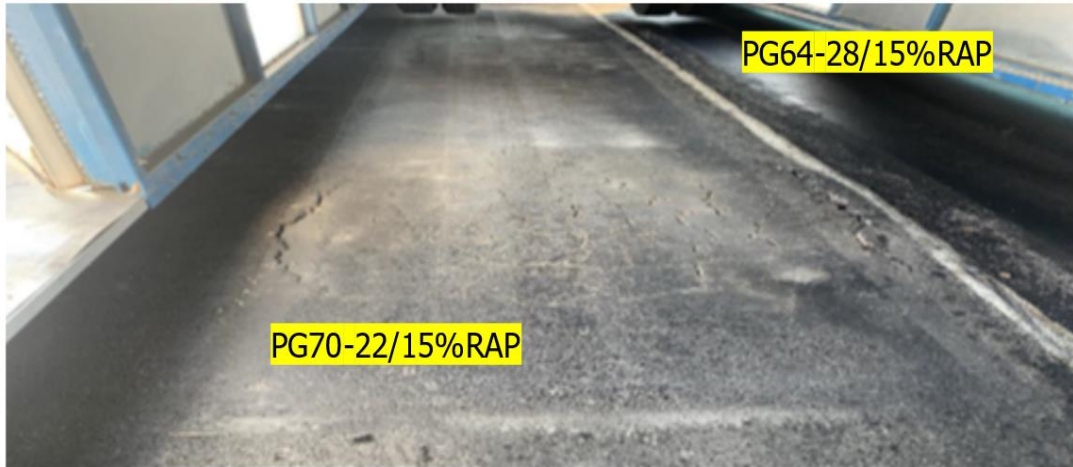
Figure 59. Fatigue Cracking on Test Section O with PG70-22 (Left) and Section P with PG64-28 (Right).

- Mix 2: PG70-22 with 15% RAP -64% fatigue cracking after 350,000 passes
- Mix 4: PG64-28 with 15% RAP -57% fatigue cracking after 350,000 passes

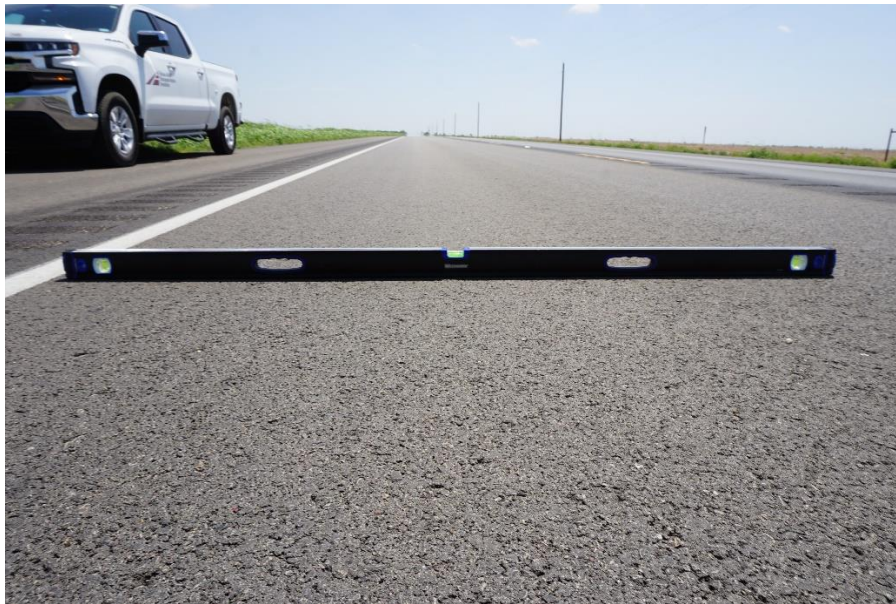
Figure 64. No Rutting on the Test Section with PG70-28 on FM 2105.

Since the construction in April 2021, the research team has continuously monitored the sections. The latest field survey was completed on May 11, 2022. Neither rutting nor cracking was observed in either test section, as shown in Figure 64 through Figure 67.

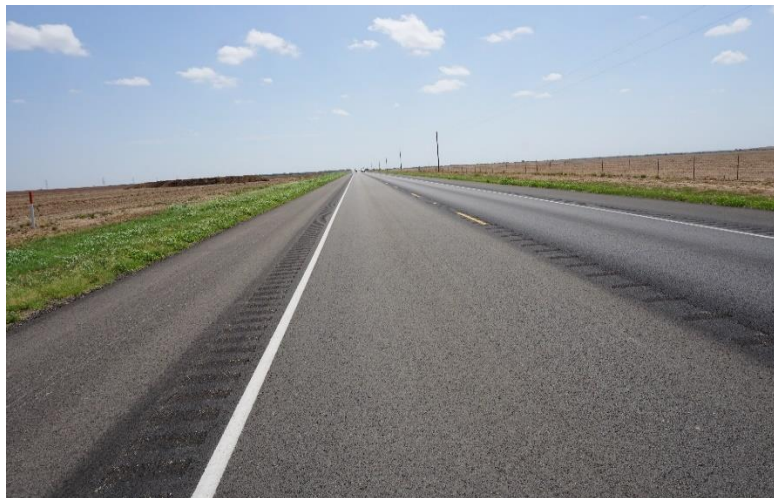
Figure 65. No Cracking on the Test Section with PG70-28 on FM 2105.

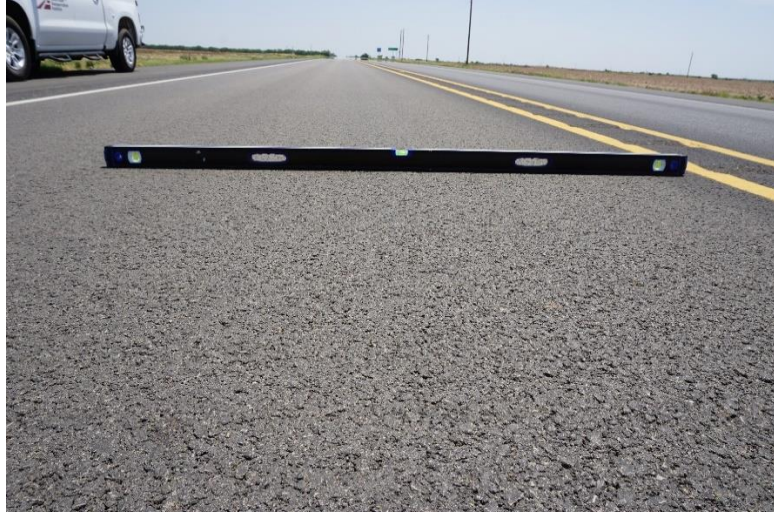
Figure 66. No Rutting on the Test Section with PG70-22 on FM 2105.

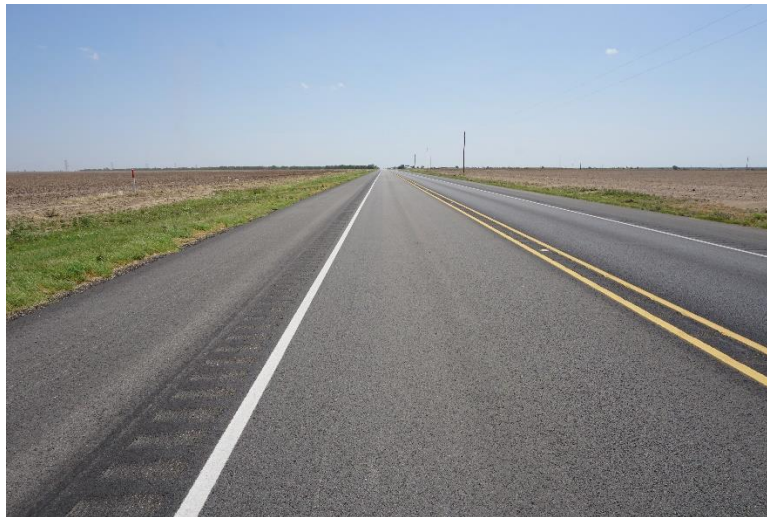
Figure 67. No Cracking on the Test Section with PG70-22 on FM 2105.

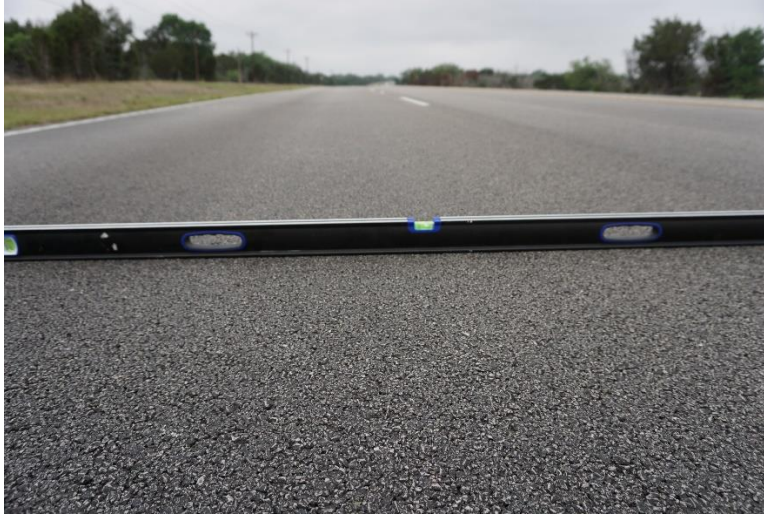
Figure 73. No Rutting on the Test Section with PG70-22 on SH 71.

Since the construction in June 2021, the research team has been monitoring the sections. The latest field survey was completed on May 4, 2022. Neither rutting nor cracking was observed in either test section, as shown in Figure 71 through Figure 74.

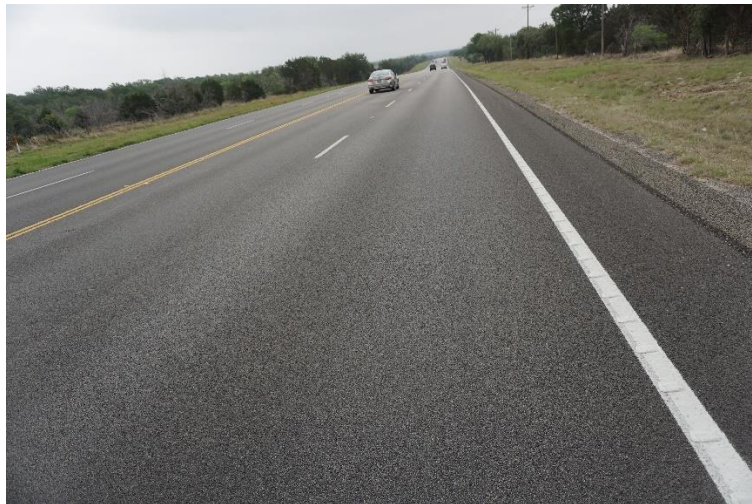
Figure 74. No Cracking on the Test Section with PG70-22 on SH 71.
