# SnowPlow Safety

Study SD91-06  
Final Report

Prepared by  
SD Department of Transportation  
Snowplow Safety Study Technical Panel

October, 1993

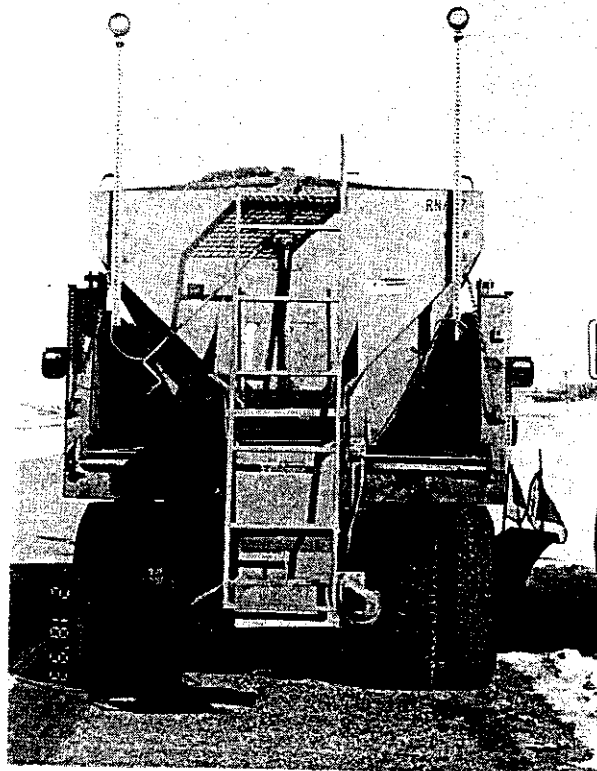
**Figure 10** Aberdeen Region Truck

Truck number DL575 had a strobe mounted with a Diamond Grade sign sheeting reflector installed on each side of the strobe in the Iowa Light configuration. This reflector did not enhance the effectiveness of the light. The reflectors were replaced with mirrors. The mirrors reflected the light toward the rear of the truck at night but during daylight conditions they had no effect on light enhancement. Two directional strobes were mounted at the rear of the sander, 12 feet above ground level. These strobes are double flash lights. This light system configuration is very noticeable. Under dark conditions the rear lights are bright. These lights can be seen one mile away in sunny conditions. The rear strobes have one power supply and the center mounted strobe has a separate power supply. When the truck had only the center strobe mounted, the light could be seen two miles away at night. This light system is shown in Figures 10 & 11.

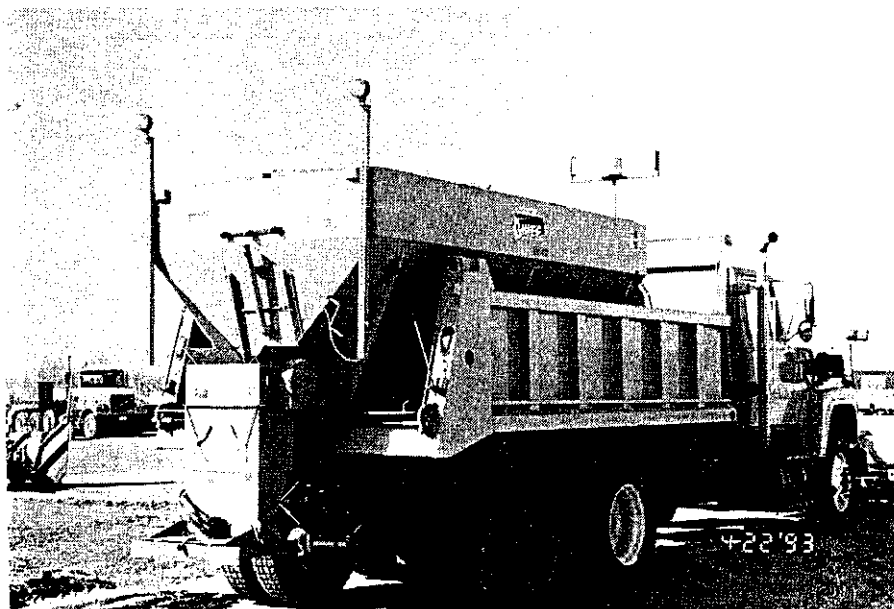
Figure 12 Aberdeen Region Truck

The DL056 snowplow truck had a 3 light system installed. It has one power supply that runs all three lights. This is a strobe system that has the Cometflash feature manufactured by Whelen. This feature provided four pulses per burst. The light is on for a longer period of time than the double flash light. The two directional lights mounted on the rear of the sander are eleven feet above ground level and the center mounted light is 9' 10" high. This system produces a very noticeable light at 200, 500, and 1,000 feet. The system is even more noticeable at night. The light system is shown in Figures 12 & 13.

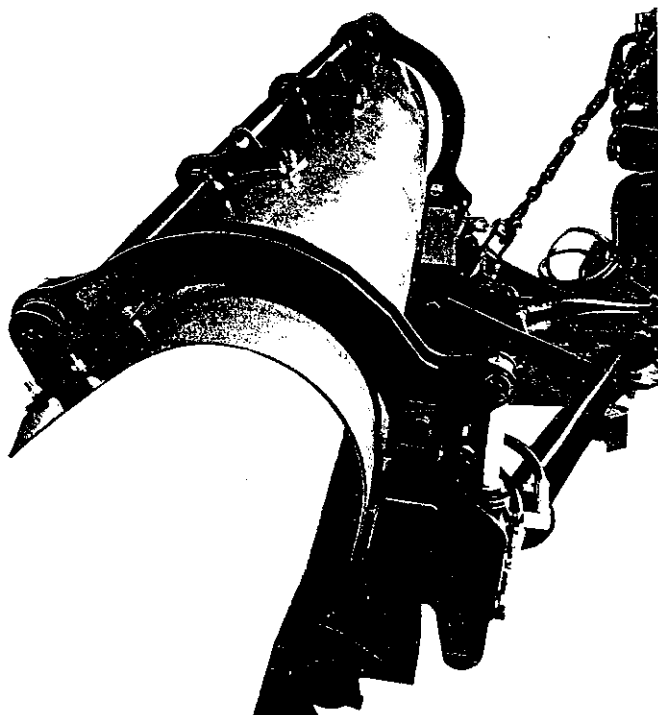
Two 3 1/2" x 6" hydraulic cylinders work automatically, in conjunction with the reversing mechanism, to form a one-way cone in whichever direction the plow is angled. This rugged, yet clean, scissor device provides an uncomplicated means of moldboard shaping.
