Final Report SPR-FY23(014)

Gravel Road Performance Enhancement

A Report on Research Sponsored by
Nebraska Department of Transportation

March 2025

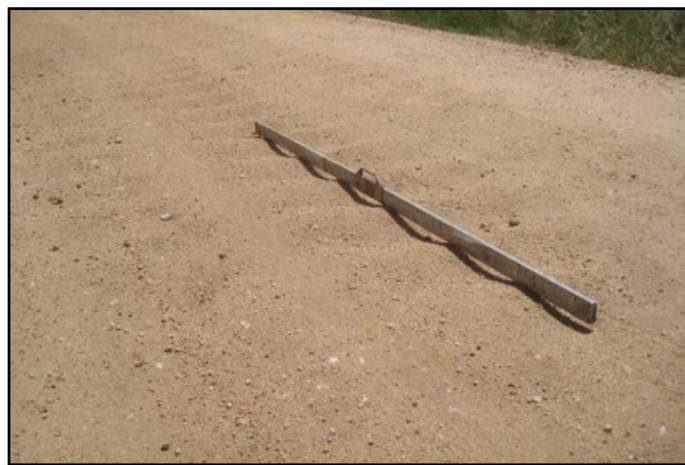
Washboarding (corrugation) refers to the undulations that typically extend across the entire width of the granular road and run perpendicular to the traffic stream (Allen & Banash, 2001). These undulations form a pattern of valleys and ridges, as shown in Figure 1.1, with the difference between them referred to as wave height. Ridge heights can range from a few millimeters to 10-20 centimeters (Alzubaidi & Magnusson, 2002). Washboarding reduces the tire–road surface contact area (Matsuyama et al., 2020), compromising driving safety, reducing vehicle speed, and lowering fuel efficiency.

Figure 1.1 Poor riding quality due to washboarding (D. Jones, 2017)

The most common cause of this distress is the presence of excessive sandy materials along with an insufficient amount of plastic fines on the granular surfaced roads. Minimal cohesion among road surface materials also plays a significant role. Additionally, the loss of fines due to high vehicle speeds, continuous change of speed, sudden acceleration, or braking exacerbates this issue (Allen & Banash, 2001).

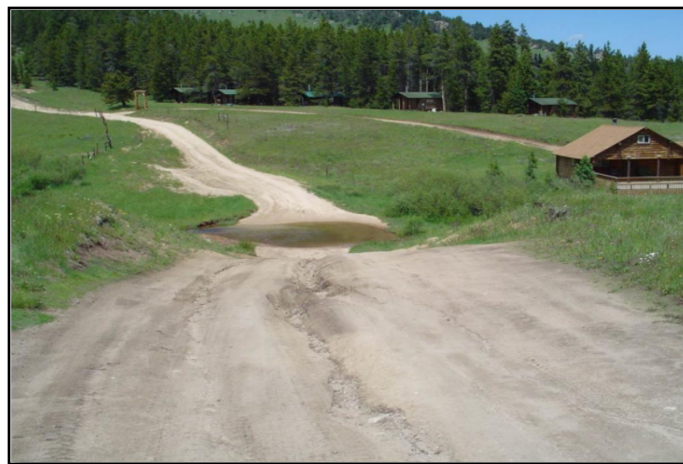
Another major distress is the loss of crown, which occurs when a road's surface flattens, as shown in Figure 1.2. A road's crown is the slightly elevated, curved contour of the road surface that allows water to drain off to the sides of the road. According to FHWA and other research studies, a recommended crown slope is 1/2 inch per foot or 4% - 6% on the cross slope. If the crown is insufficient, water accumulates in the center of the road. Conversely, if the crown is too high, drivers begin to lose control as their vehicle begins to drift toward the shoulder (FHWA, 2015; Persson, 1993; Srombom, 1987).

Figure 1.2 Loss of crown (WTTC, 2014)

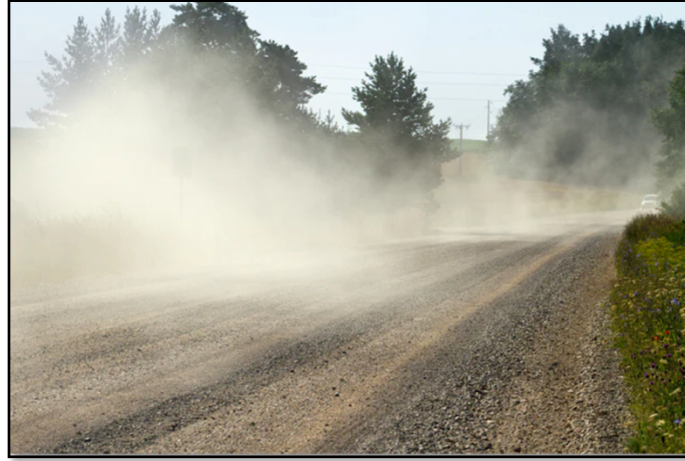
Figure 1.3 Unacceptable levels of dust (Oransi, 2020)

On gravel roads that can accommodate up to 100 vehicles daily, traveling at speeds of 75 km/h, an annual loss of up to 25 tons of gravel-wearing coarse aggregate can occur per kilometer (T. E. Jones, 1984). This results in an approximate 4 mm reduction in road thickness for a road 7 m in width. The loss of aggregate material necessitates frequent maintenance and aggregate replacement, leading to increased costs (Persson, 1993). As a result, dusting is therefore one of the primary deterioration mechanisms of a gravel road and will be discussed in more detail in subsequent sections.

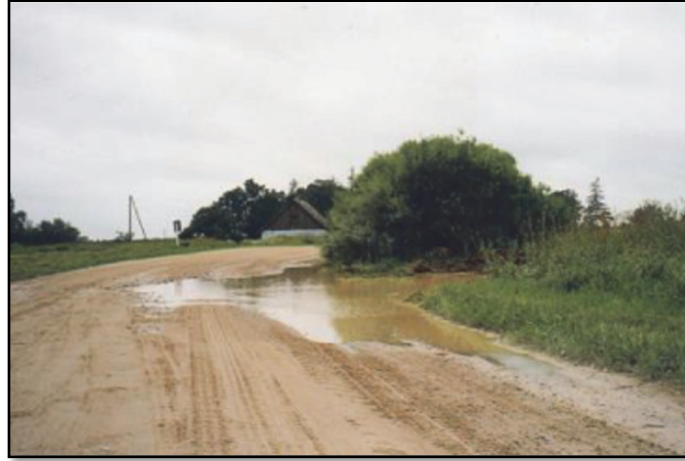
A drainage problem on a granular surfaced road occurs when water is not properly routed or removed from the road surface as displayed in Figure 1.4. Poor drainage can lead to various other distresses. The more irregular the road, the slower the water drains. As a result, the crossfall on a gravel road must be significantly steeper than on a paved road. Crown deteriorates due to vehicle overloading, excessive wearing, and inadequate bearing capacity of roads. Additionally, high shoulders, formed from displaced aggregate and soil, prevent proper drainage. Instead of flowing into ditches, water is obstructed by these elevated shoulders and remains on the roadway.

Figure 1.4 Impassible gravel road due to poor drainage (Saha & Ksaibati, 2017)

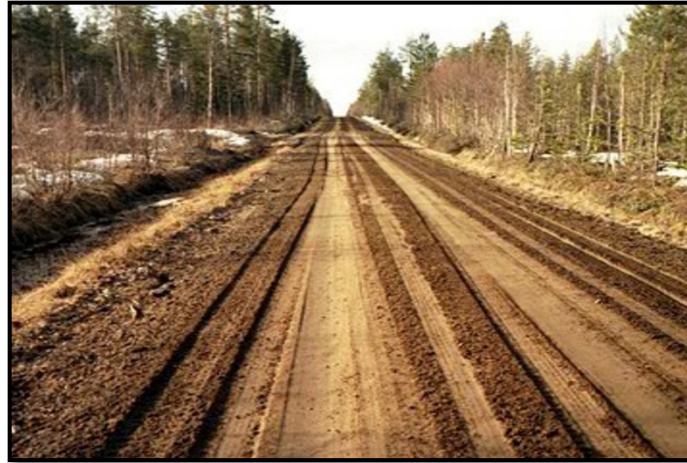
Rutting is defined as a depression in the wheel path parallel to the midline of the roadway as shown in Figure 1.5. Rutting increases fuel consumption and the risk of skidding. Minor rutting (less than 1 in.) may simply indicate heavy traffic volume and can typically be addressed through routine regrading and surface drainage maintenance. However, deeper rutting (over 3 in.) suggests insufficient gravel thickness or inadequate subgrade support. This defect is very serious and usually indicates that major reconstruction is required. Ruts also allow water to penetrate the pavement instead of draining off, accelerating deterioration. As a result, the bearing capacity of granular surface roads is significantly reduced. Rutting also diminishes the rideability or smoothness. Proper compaction can help mitigate rutting by reducing the extent of surface deformation.

Figure 1.5 Severe rutting damage (ROADDEX, 2014)

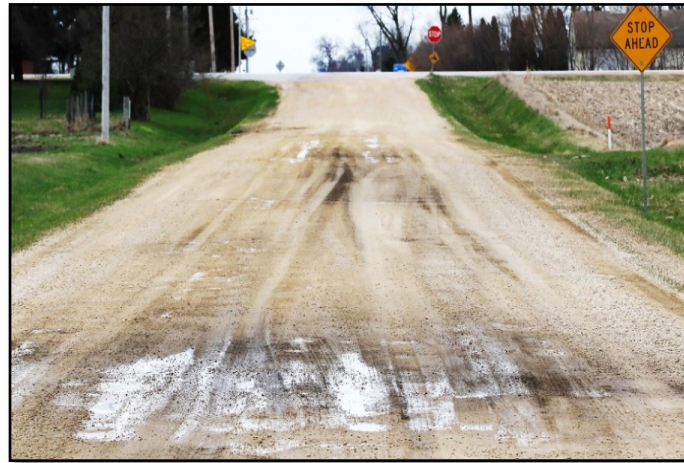
Figure 1.6 Seasonal damages due to freezing-thawing cycles (Jennifer DeWitt, 2019)

subgrade and pavement frost susceptibility, groundwater levels, and temperature fluctuations. (Persson, 1993).

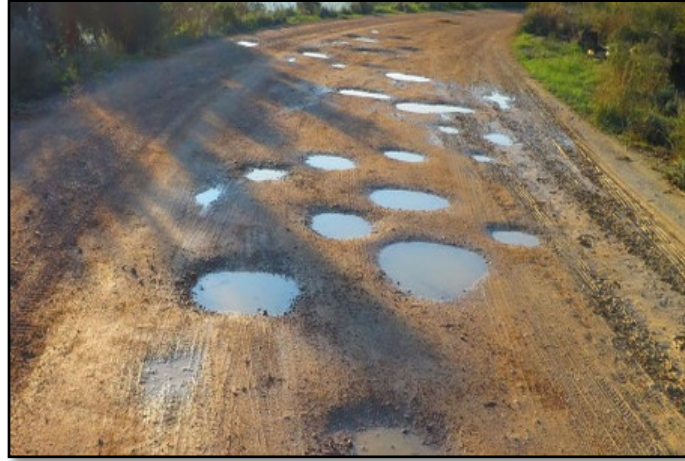
Potholes primarily develop in areas where the subgrade is saturated. As vehicles pass over these weakened sections, the subgrade fails, leading to progressive surface deformations. They expand more rapidly when water accumulates inside the hole. The road continues to deteriorate due to surface material loss or the formation of weak patches in the subsurface soil (Alzubaidi & Magnusson, 2002). Potholes can also occur due to insufficient crown, usage of substandard material, and design flaws.

Figure 1.7 Formation of Potholes (KC Morgan, 2023)

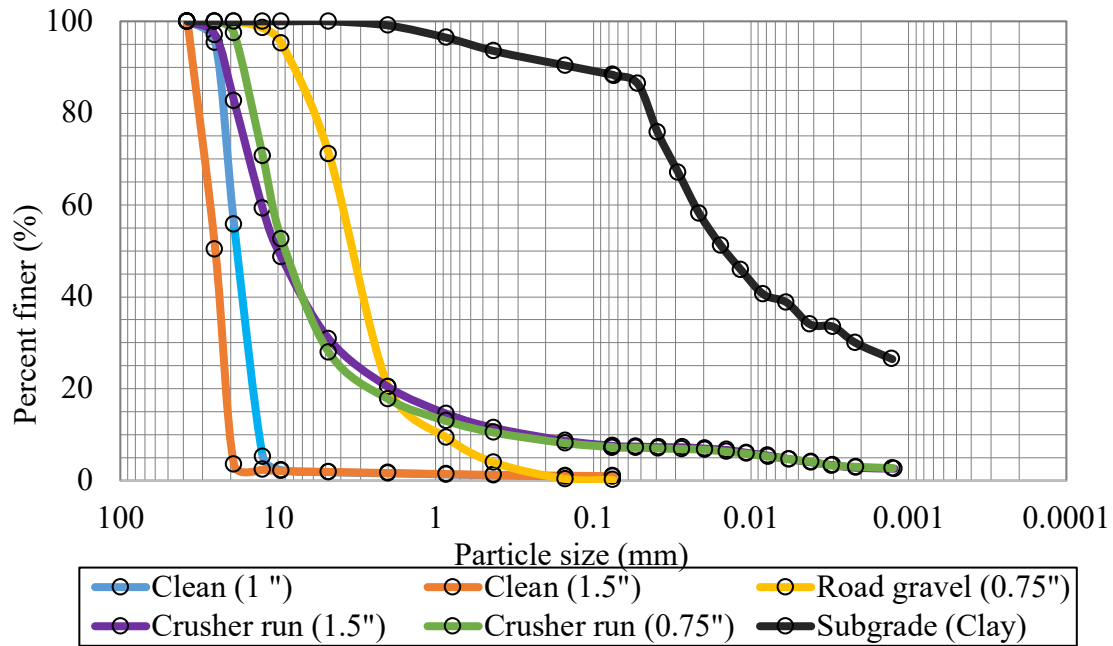
The particle size distribution (PSD) curves for all the collected materials covering both coarse and fine fractions were combined. Figure 3.7 gives the Douglas County PSD curves. Figure 3.8 shows the PSD of Harlan County and Figure 3.9 shows the virgin materials PSD from Scottsbluff County. The PSD curves of the materials collected from Cherry County are showed in Figure 3.10.

Figure 3.7 Gradation size distribution of Douglas County virgin materials

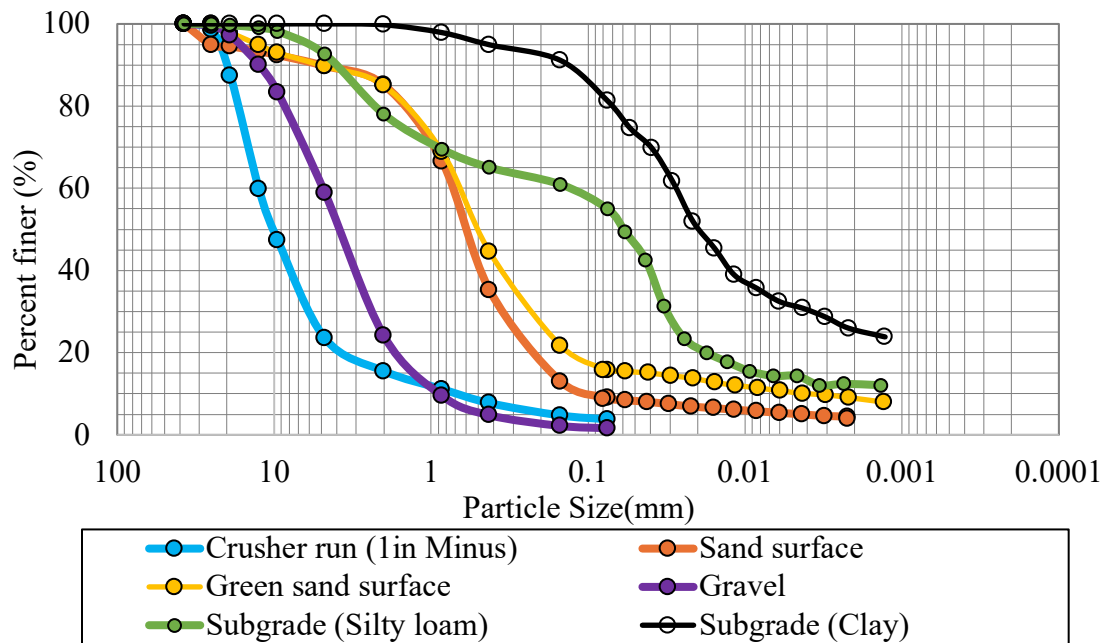
Figure 3.8 Gradation size distribution of Harlan County virgin materials

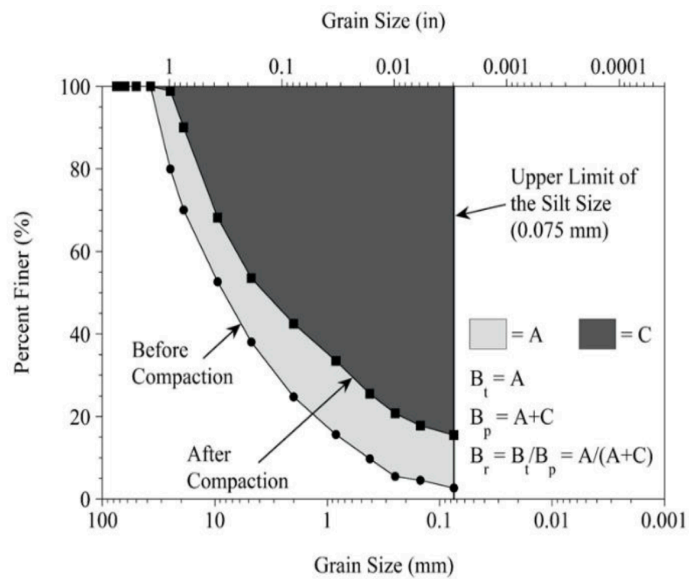
Figure 3.13 Hardin's concept to evaluate the degradation of aggregates (Hardin, 1985),

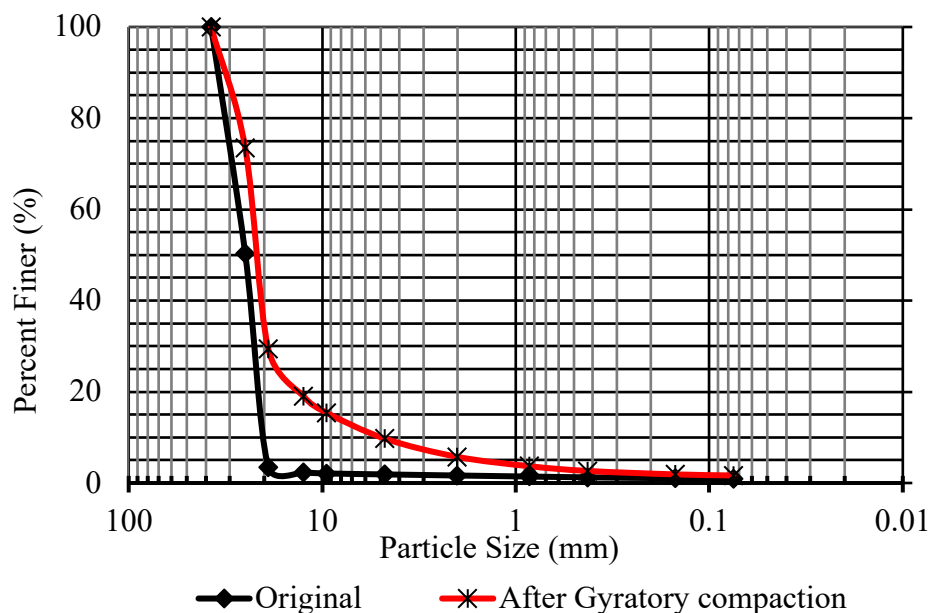
Figure 3.14 Sample gradation curves-before and after gyratory compaction test (DV1- Douglas Clean 1.5")

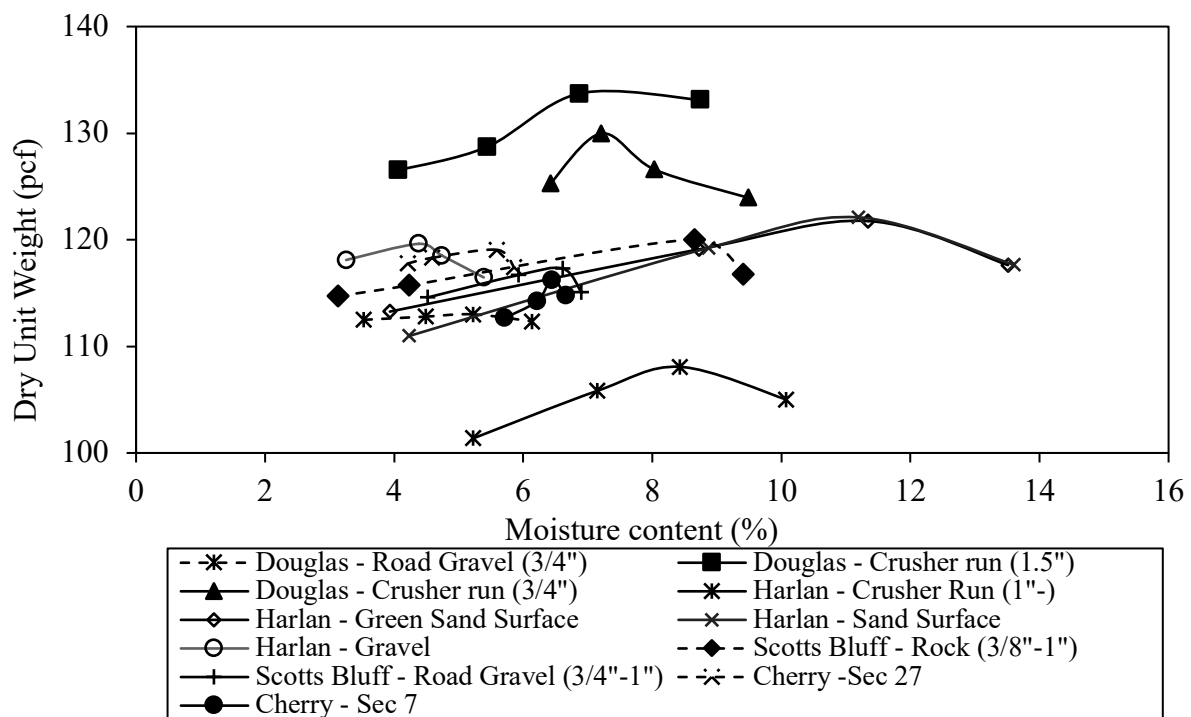
Figure 3.16 shows the compaction curves of the surface materials, and Figure 3.17 reports the compaction curves of the subgrade materials. Among these results, the MDU values for surface materials (except clean materials) ranged from 111 pcf to 138 pcf; OMC values were between 4.4% and 11.3%. Douglas crusher run materials exhibited the highest MDU values. This is explained by their well-graded nature, as evidenced by their gradation curves. The wide range of particle sizes promotes effective packing, thereby enhancing the material's compaction characteristics. Conversely, the Harlan crusher run material had the lowest MDU value. This material also had the lowest specific gravity, which may explain its lower MDU compared to other crusher run materials.

For clean materials, the MDU values were 107 pcf and 109 pcf; there was no OMC value since the materials were very coarse (gravel content > 90%). The average results from both the oven-dry and saturated state tests were used to determine their compaction characteristics, providing a comprehensive evaluation of their performance under varying moisture conditions.

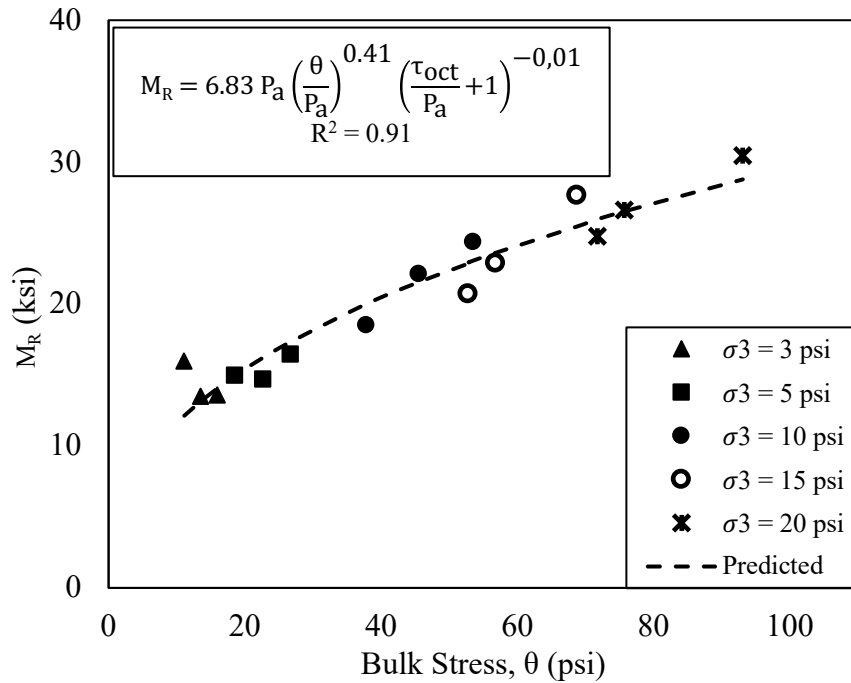
$= \frac{\sqrt{2}}{3} \sigma_d$ (ksi), P_a is atmospheric pressure, and k_1 , k_2 , k_3 are the regression constants.

Figure 4.3 Bulk stress (θ) model fit for the (M_R) of Cherry - Section 27 (CV1).
