# **KTA-Tator, Inc.**

## **STEEL BRIDGE COATING AND RECOATING WARRANTY REQUIREMENTS FINAL REPORT**

**July 30, 2024**

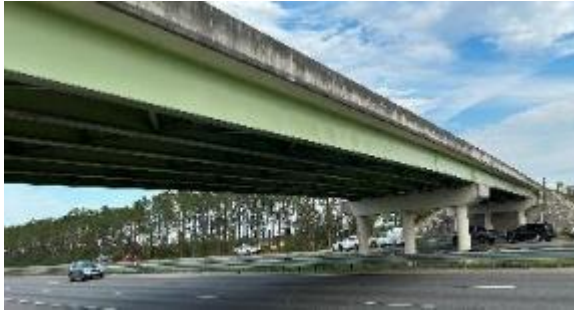
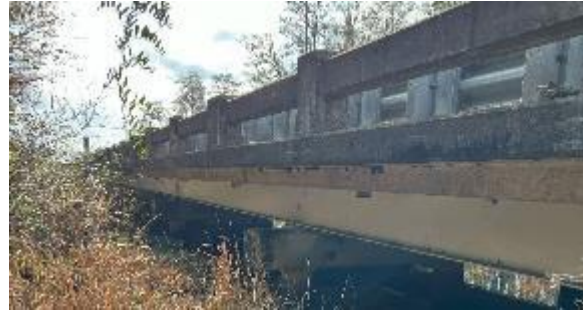
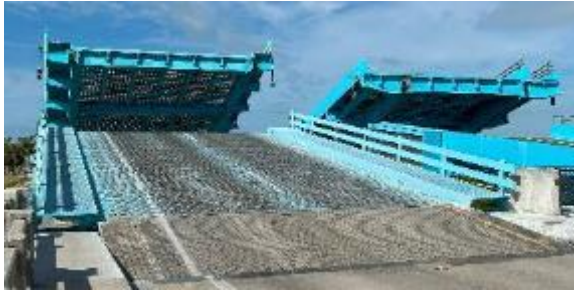
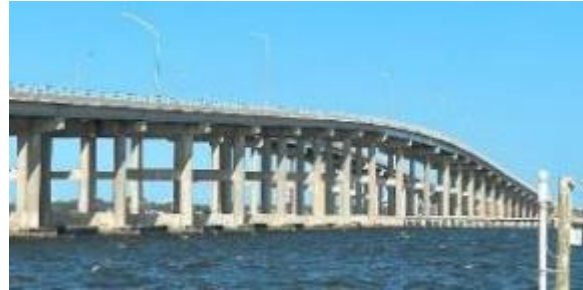
**Figure 4-2: Photos of Bridge Types**

Overpass

Waterway-No lift

Waterway - Mechanical Lift

Waterway above 60 feet

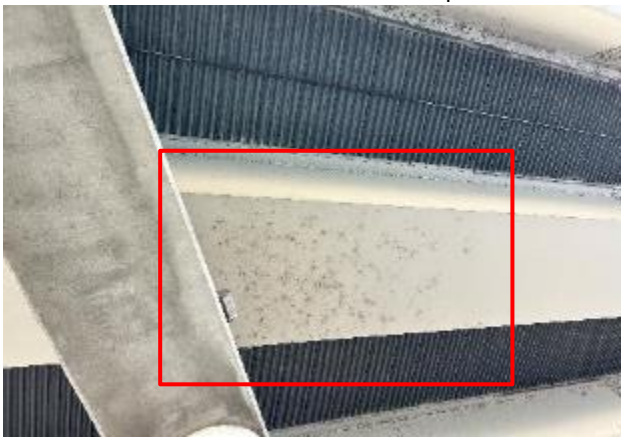
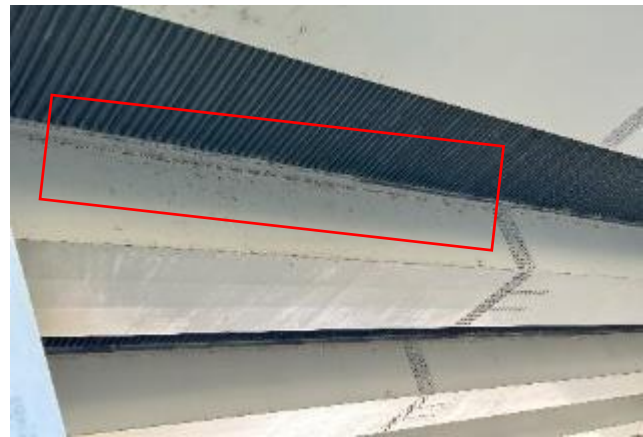
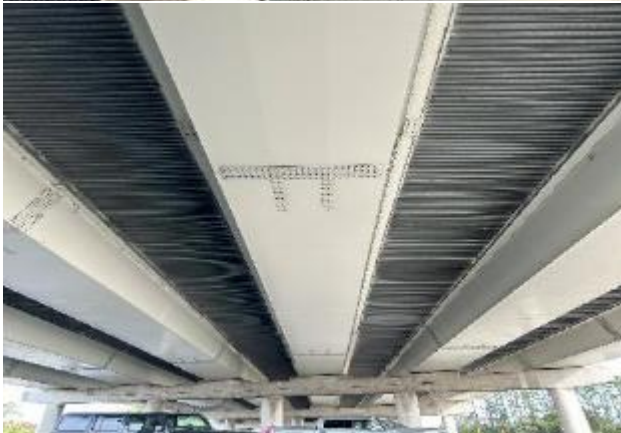
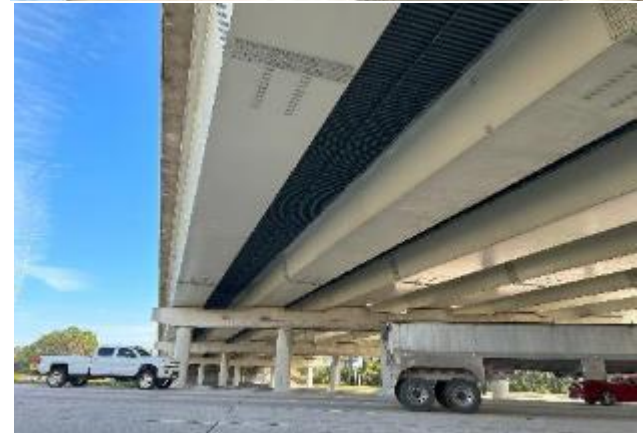
Inspected on 1/23/2023 & Painted 2016 OC

**SSPC VIS 2 Area Rusted: 0.0-0.01%**

**Delamination: None**

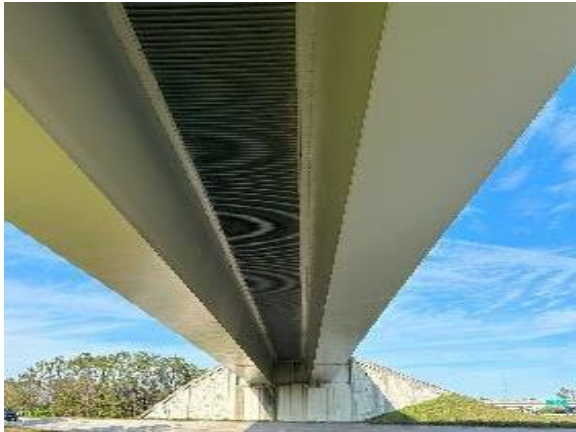
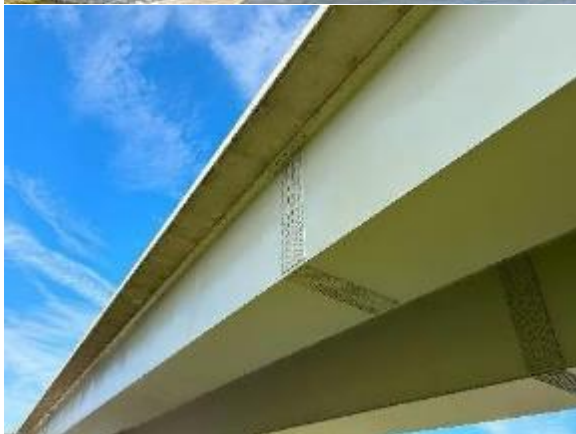
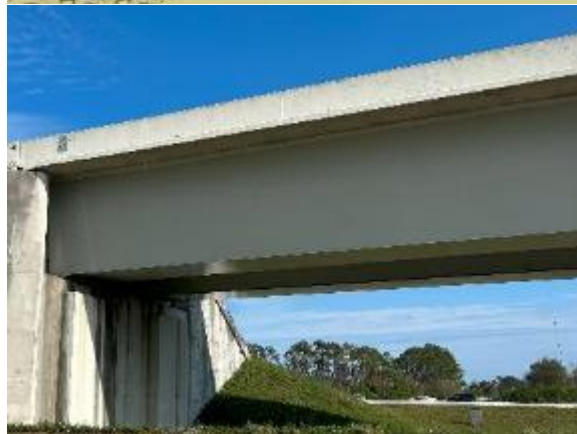
Inspected on 1/23/2023 & Painted 2016 OC

SSPC VIS 2 Area Rusted: 0.0-.01%

Delamination: None

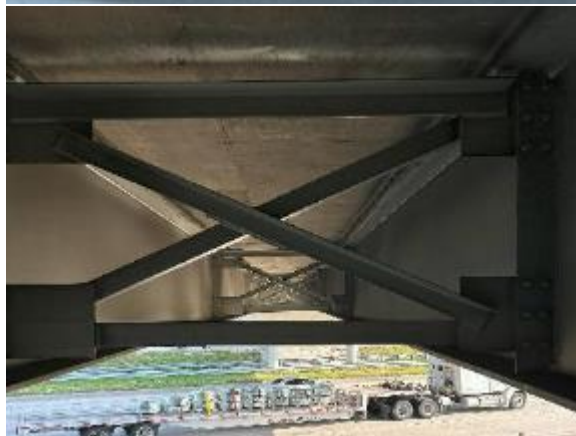
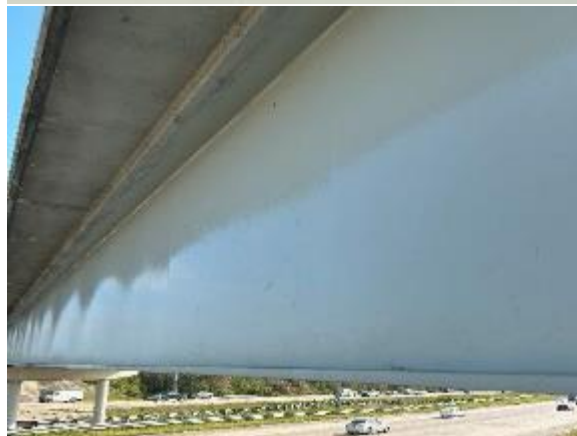
Inspected on 1/23/2023 & Painted 2016 OC

**SSPC VIS 2 Area Rusted:** 0.0-0.01%

**Delamination:** 0.01-0.03% (Two small instance not to metal but previous coating)

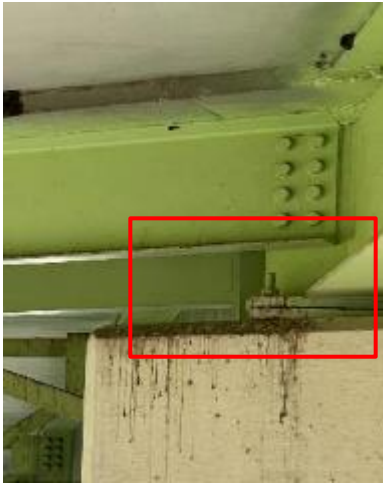
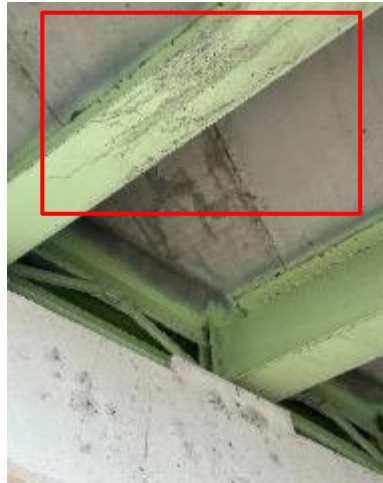
**Bridge #100351**  
Valroy Road Over I-75 (SR-93) - District 7

**SSPC VIS 2 Area Rusted:** 3.0-10.0% at crevies on brackets, 0.01-0.03% on edges of the some of the girders

**Delamination:** None but clear coat has contaminates

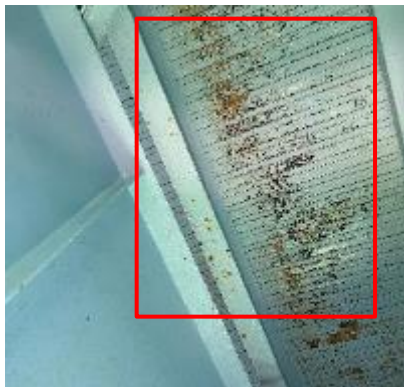
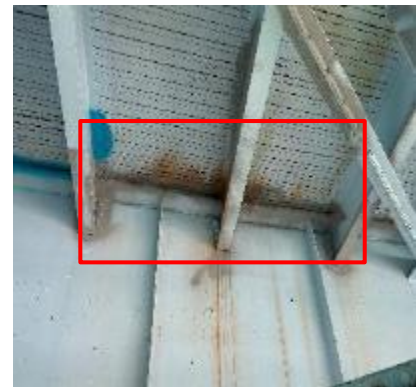
**Bridge #150028**  
SR-666 (ICWW)- District 7

**SSPS VIS 2 Area Rust:** 0.3-1.0% on diagonal, 1.0-3.0% on Guardrails, 0.3-1.0% on floorbeams, 0.3-1.0% on girders, 0.3-1.0% inside Mechanical Room

**Delamination:** None

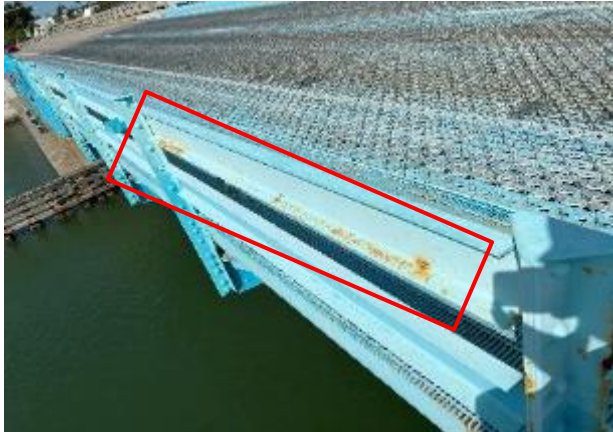
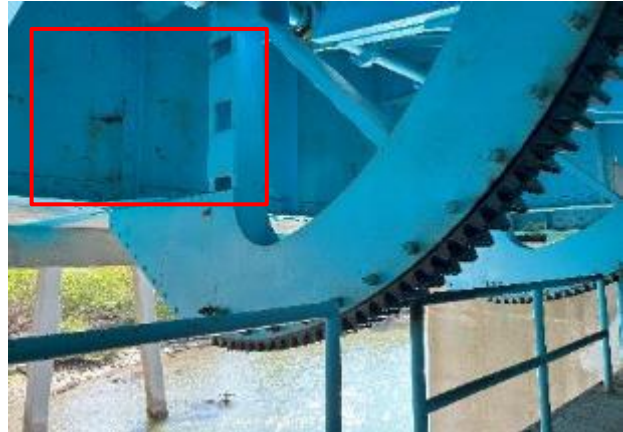
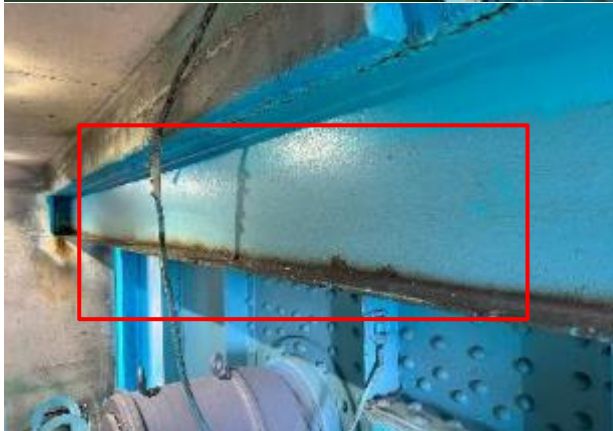
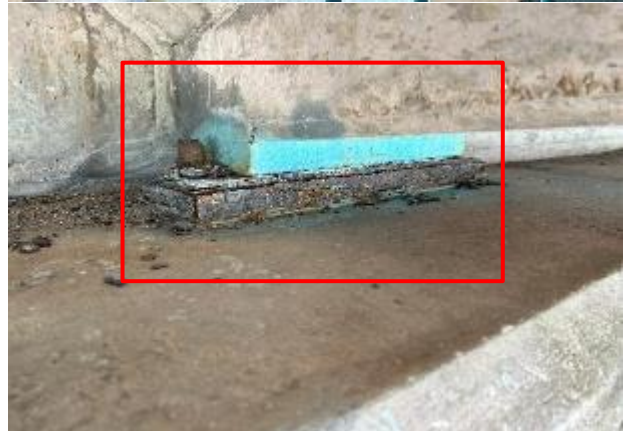
Inspected on 1/24/2023

**SSPS VIS 2 Area Rusted:** 0.03-0.1% on cross beams, 1.0-3.0% on Guardrails, 1.0-3.0% on Floor beams, 0.03-0.1% on Girders, 0.03-0.1% inside Mechanical Room

**Delamination:** Cracking noticeable on the guardrails

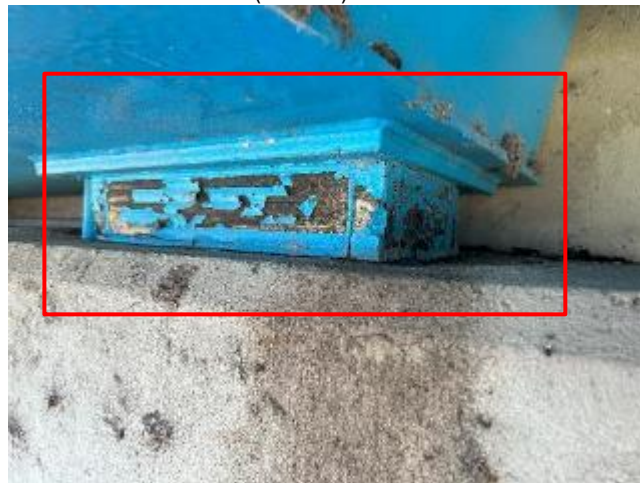
Inspected on 1/25/2023 & Painted 2008 (Full RR)

**SSPS VIS 2 Area Rusted:** 0.01-0.03% overall, 3.0-10.0% on the bearings.

**Delamination:** None

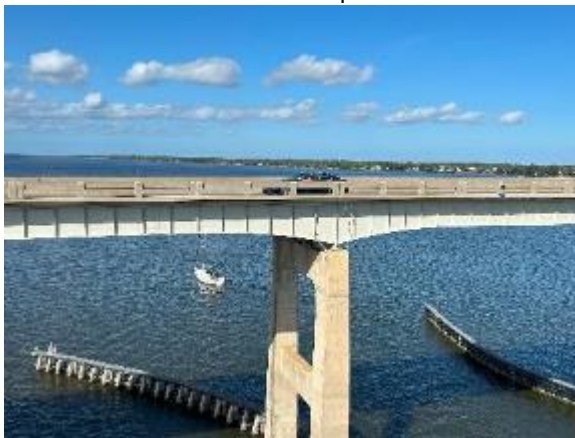
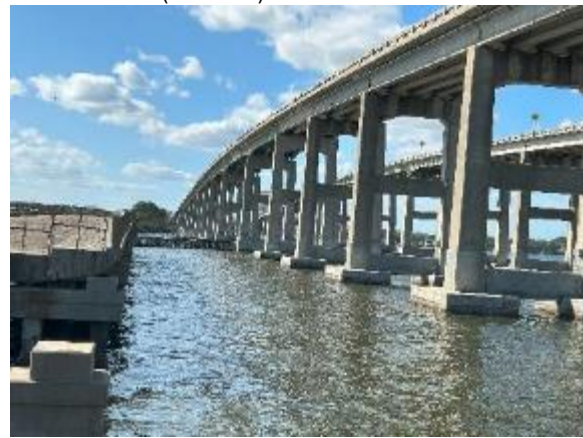
Inspected on 2/7/2023 & Painted 3/23/2017 (Metalize)

**SSPS VIS 2 Area rusted:** 0.0-0.01%

**Delamination:** None

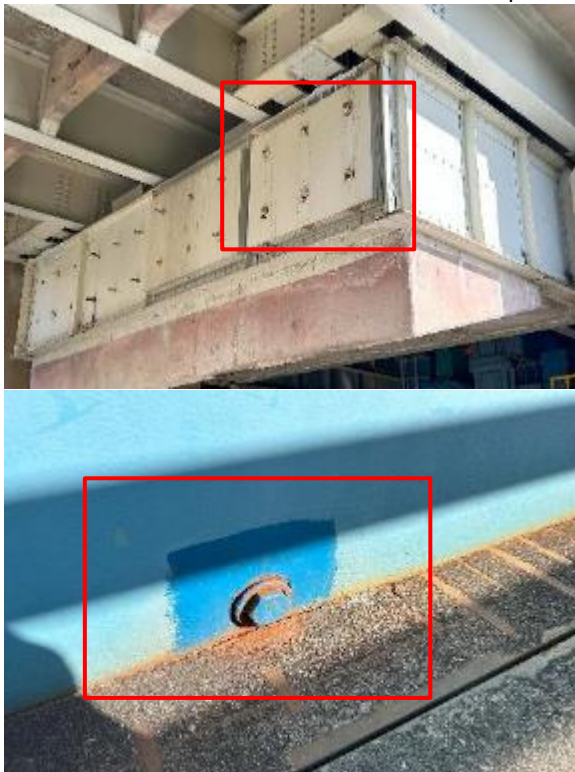
Inspected on 2/7/2023

**SSPS VIS 2 Area Rusted:** 0.01-0.03% below roadway, 0.1-0.3% on guardrails

**Delamination:** Some cracking on guardrails

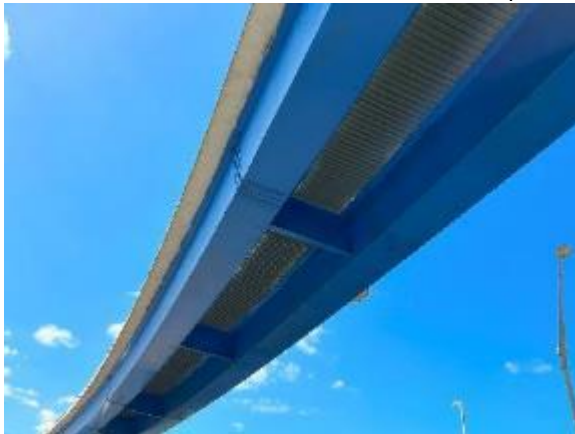
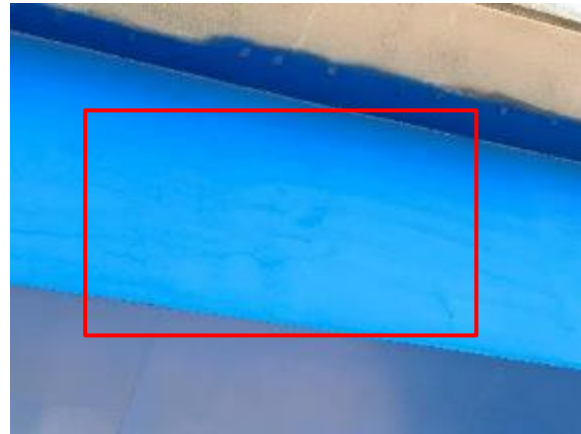
Inspected on 2/8/2023

**SSPS VIS 2 Area rusted:** 0.0-0.01%

**Delamination:** None

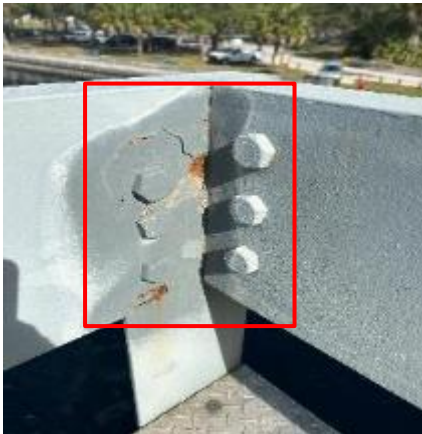
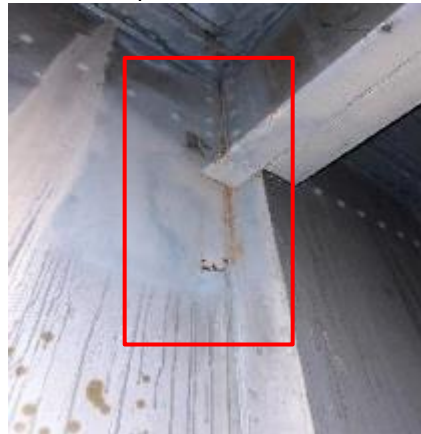
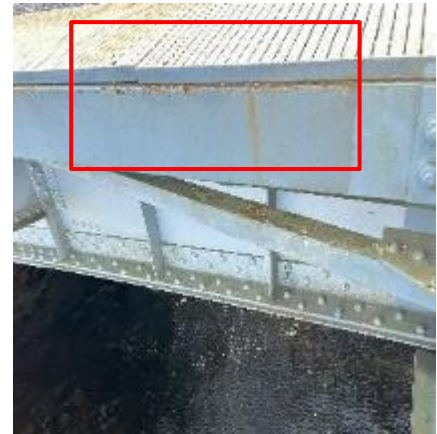
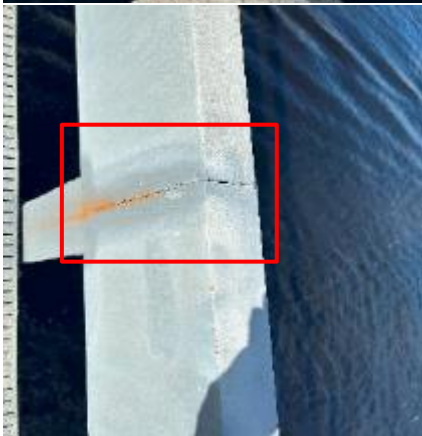
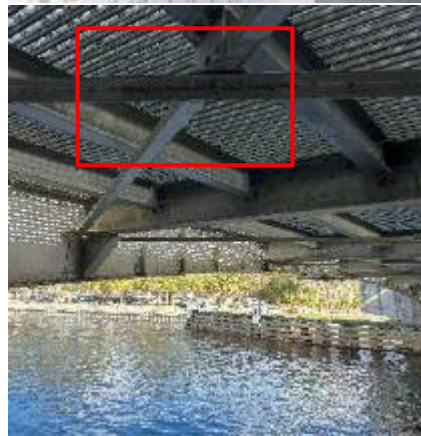
**Bridge #110063**  
SR-44 over St. Johns River- District 5

**SSPS VIS 2 Area Rusted:** 0.3-1.0% on cross beams, 1.0-3.0% on guardrails, 0.3-1.0% on floor beams, 0.3-1.0% on girders, 0.3-1.0% inside mechanical rooms

**Delamination:** 1.0-3.0% seen throughout

Bridge #110063 (SR-44 over St. Johns River) had areas of delamination on 1-3% of the surface area. It appears that the delamination is overcoated, aged coating but if it was evident at a warranty inspection repair would be required. The bridge does not have 515 NBE data available.

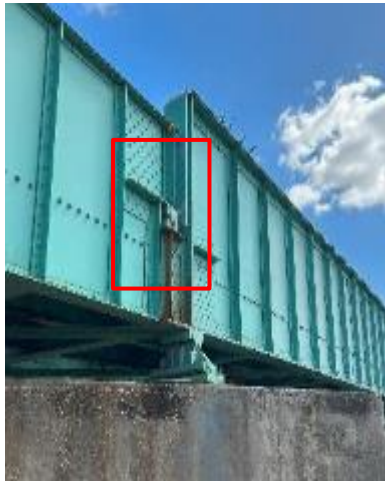
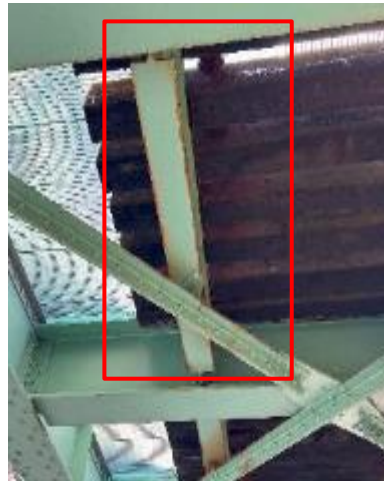
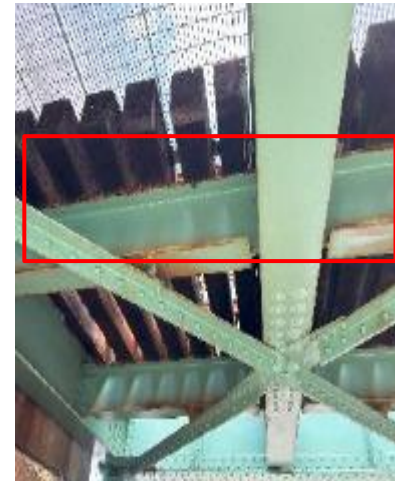
### Bridge #750255

**SSPS VIS 2 Area Rusted:** 0.01-0.03% on interior of girders, appears to have crevice corrosion in some areas attached to interior girders

**Delamination:** None

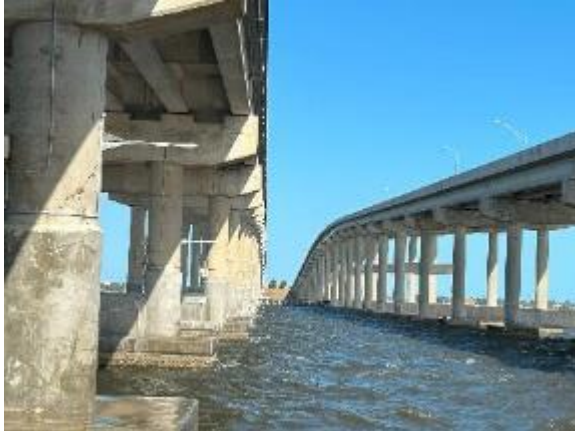
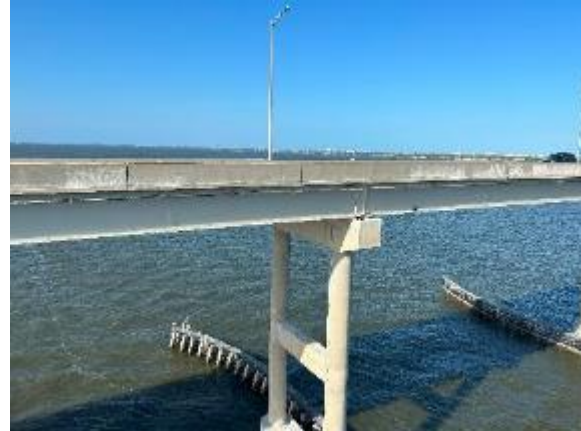
Inspected on 2/9/2023 & Painted 6/24/2014 (Portions Duplex coated)

**SSPS VIS 2 Area rusted:** 0.0-0.01%

**Delamination:** None

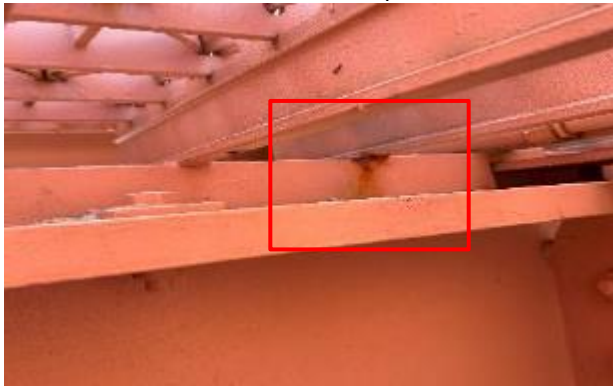
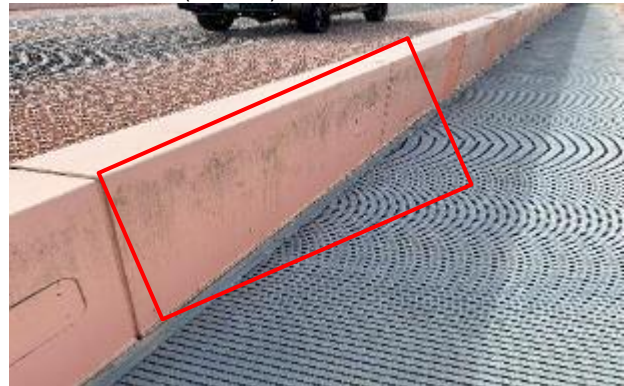
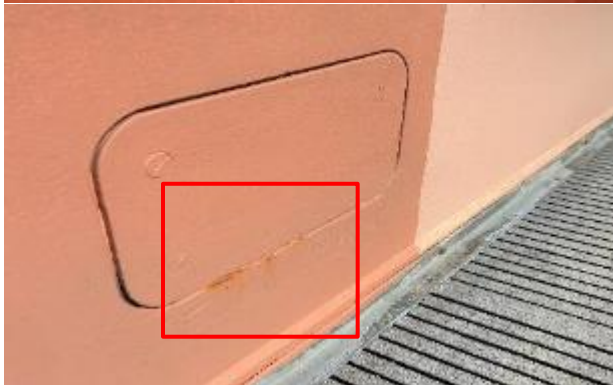
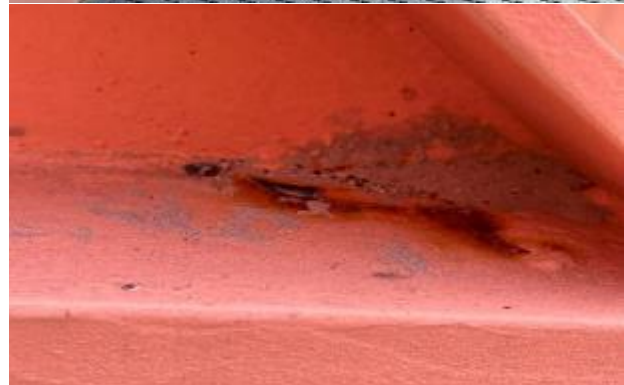
Inspected on 2/9/2023 & Painted 1/29/2019 (Full RR)

**SSPS VIS 2 Area Rusted:** 0.03-0.1% on cross beams, 0.01-0.03% on guardrails, 0.03-0.1% on floor beams, 0.01-0.03% on exterior girders, 0.0-0.01% inside the mechanical rooms

**Delamination:** None

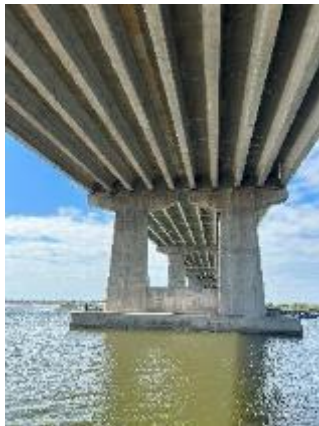
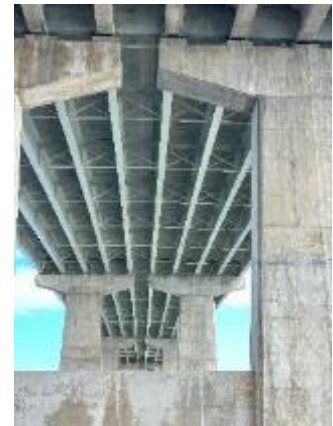
**Bridge #790148**  
SRA1A over Halifax River-District 5

**SSPS VIS 2 Area rusted:** 0.03-0.1% seen from underneath on dock.

**Delamination:** None

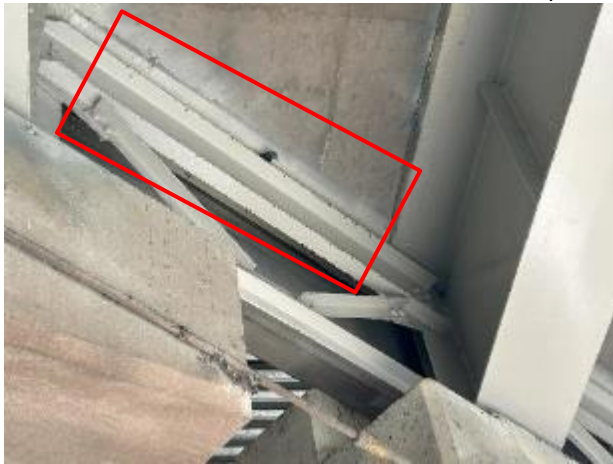
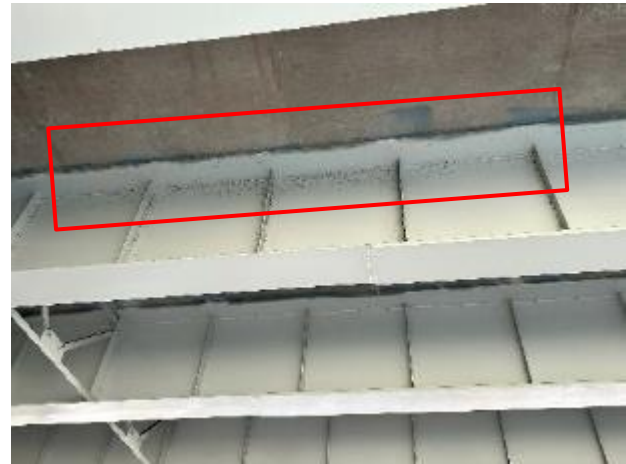
Inspected on 3/1/2023

**SSPS VIS 2 Area Rusted:** 0.01-0.03% on some diagonal edges.

**Delamination:** None

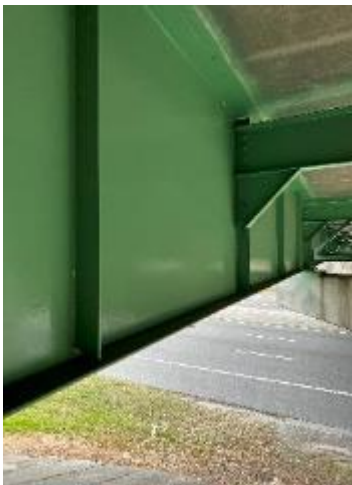
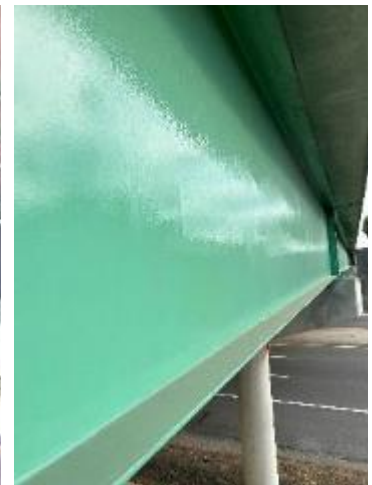
I-295 SB (SR-9A) over US-1 (SR-15)-District 2

**SSPS VIS 2 Area Rusted:** 0.0-0.01%

**Delamination:** Small, quarter-sized spot

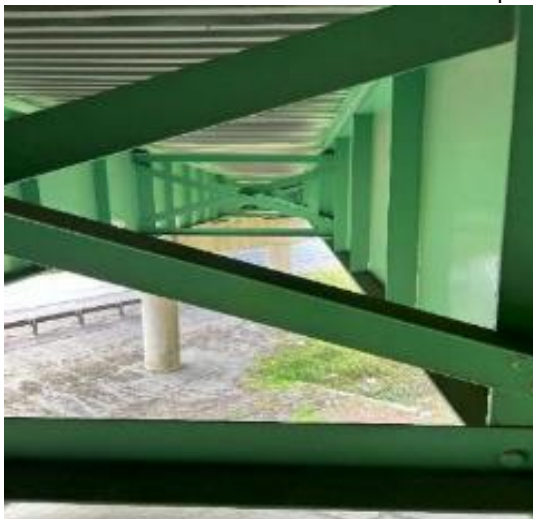
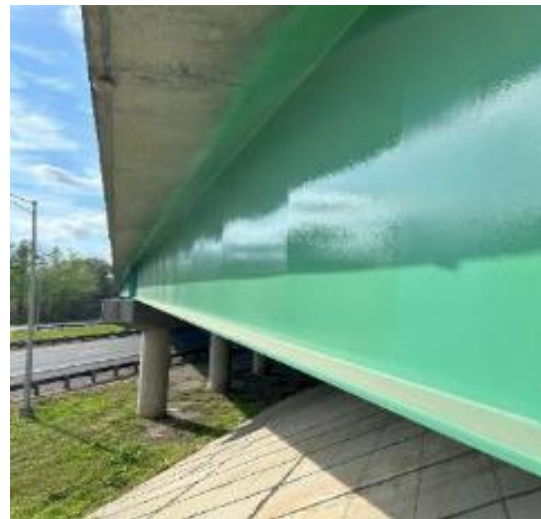
Inspected on 3/1/2023

**SSPS VIS 2 Area Rusted:** 0.0-0.01%

**Delamination:** None

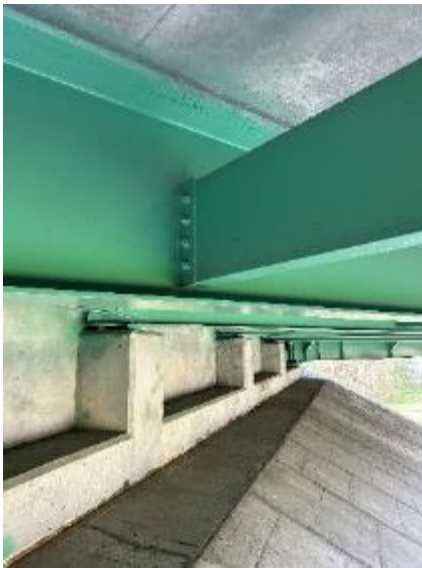
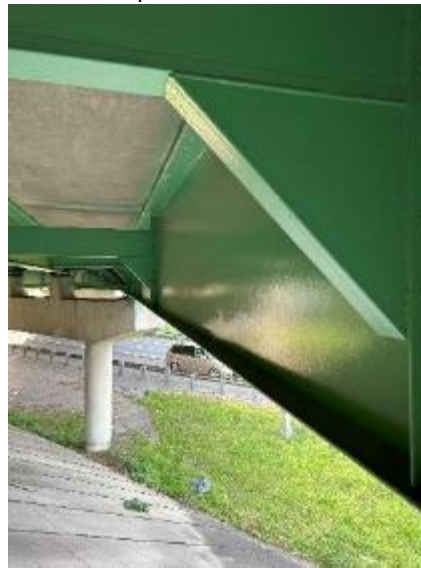
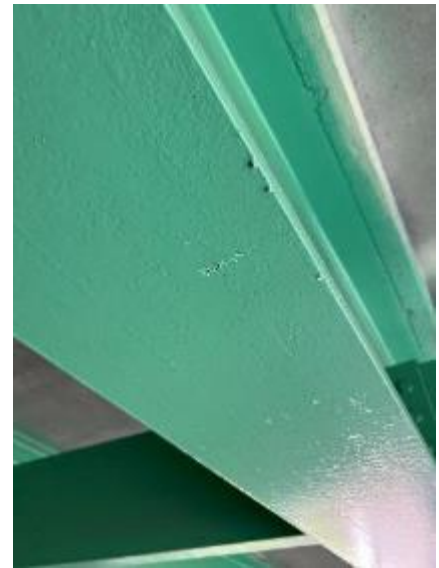
Inspected on 3/1/2023

**SSPS VIS 2 Area Rusted:** 0.0-0.01%  
**Delamination:** None  
**Notes:** Small blisters in clean coat  
**DFT:**  $\bar{X}$  = 13.98 Min = 12.1 Max = 18.9

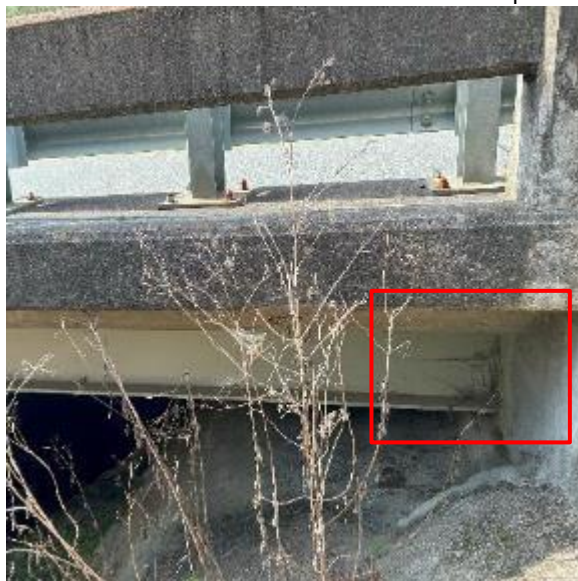
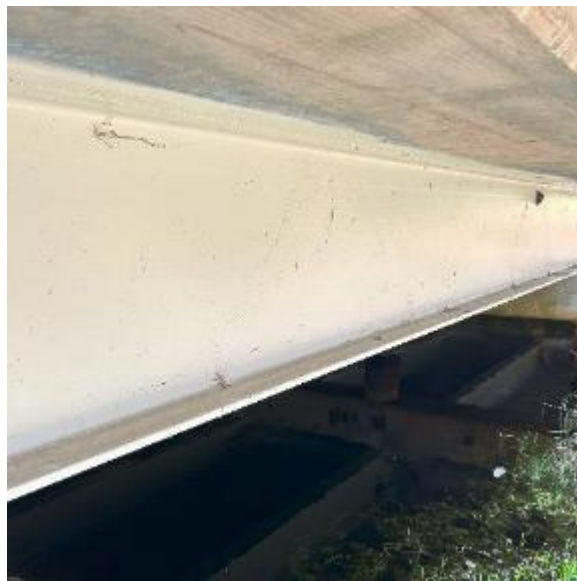
Inspected on 2/28/2023

**SSPS VIS 2 Area Rusted:** 0.0-0.01%

**Delamination:** None

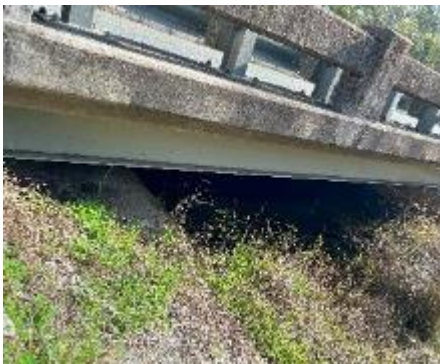
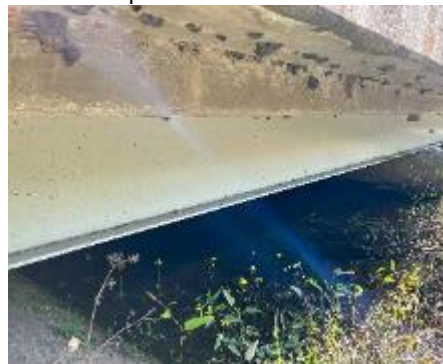
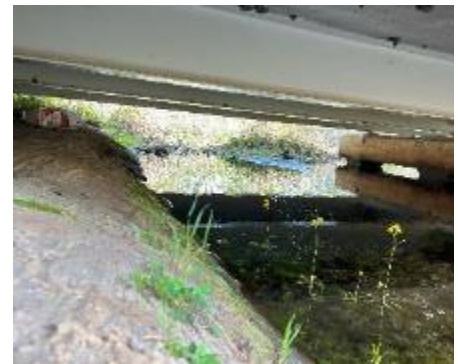
**SSPS VIS 2 Area Rusted:** 0.0-0.01%

**Delamination:** None

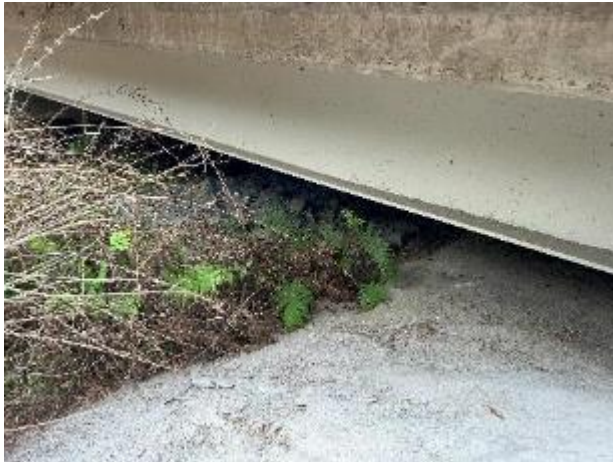
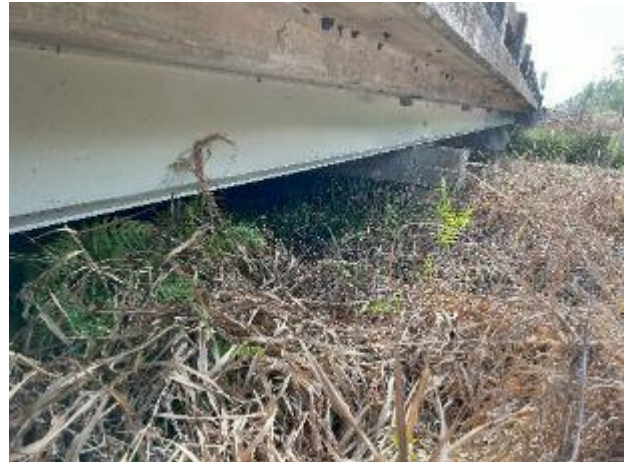
Inspected 2/28/2023

**SSPS VIS 2 Area Rusted:** 0.0-0.01%

**Delamination:** None

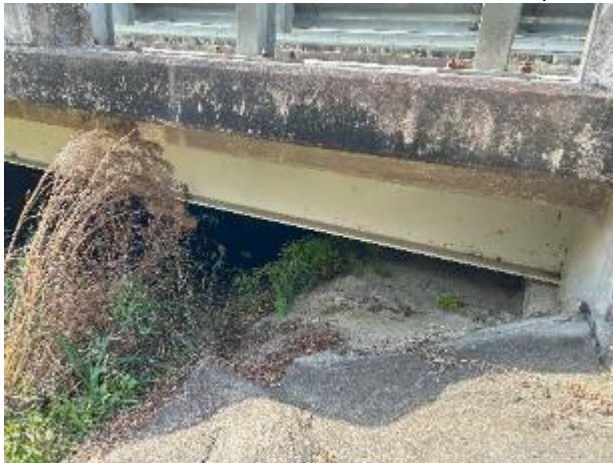
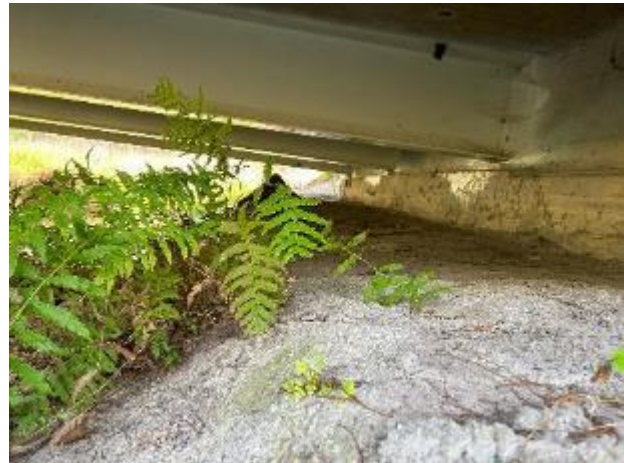
Inspected on 2/28/2023

**SSPS VIS 2 Area Rusted:** 0.0-0.01%

**Delamination:** None

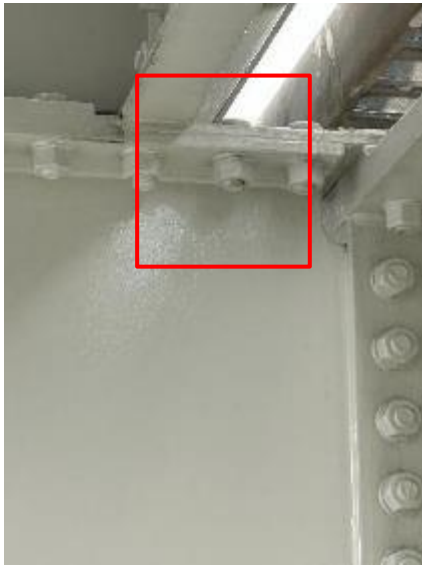
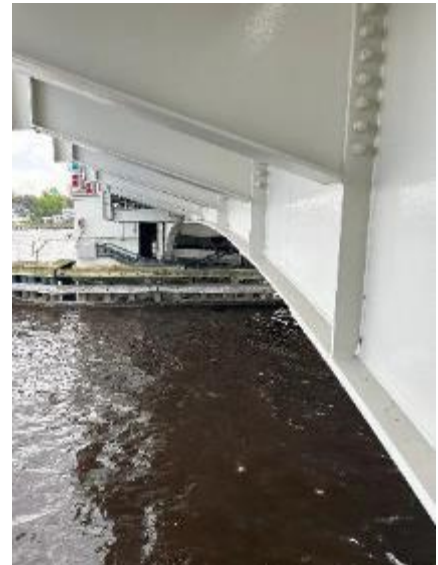
Inspected on 2/28/2023

**SSPS VIS 2 Area Rusted:** 0.01-0.03% on some bolts, 0.0-0.01% on rest of the bridge

**Delamination:** None

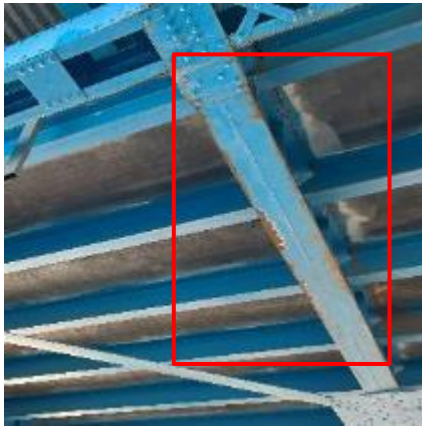
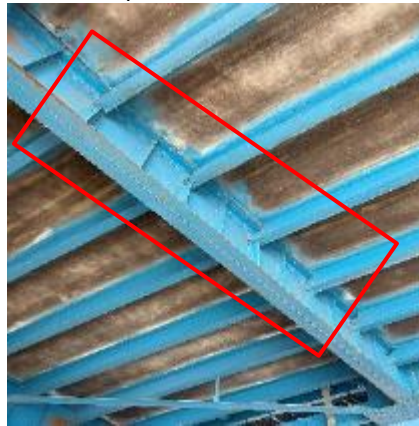
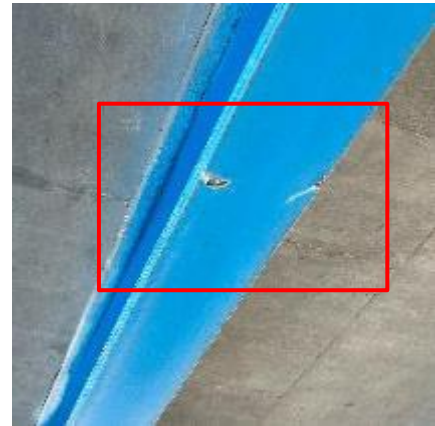
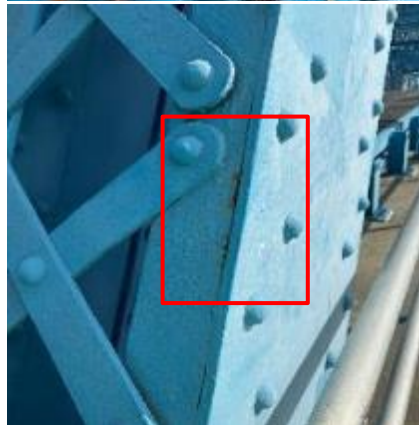
**SSPS VIS 2 Area Rusted:** 1.0-3.0% on the floor beams above the water, 0.3-1.0% on edges of girders, 0.3-1.0% on roadway bracing and some bolts

**Delamination:** 0.03-0.1% different parts have delamination, and some have been attempted to be touched up. (Size vary in areas with delamination)

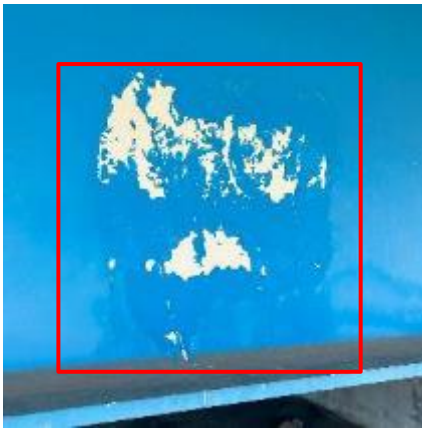
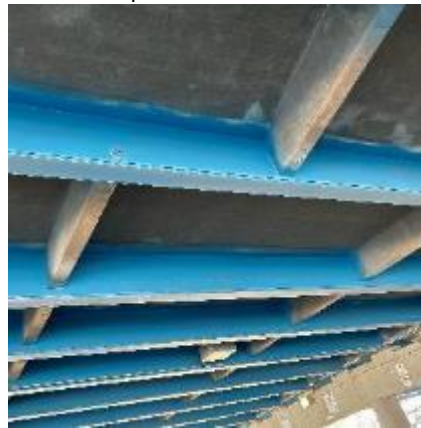
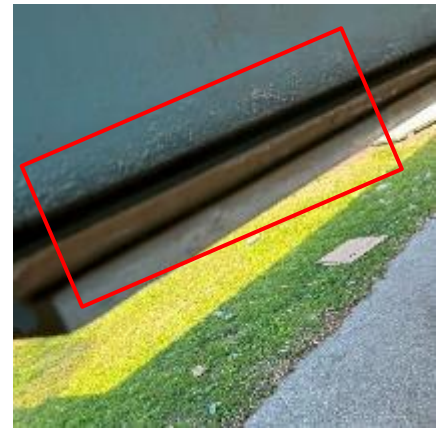
**SSPS VIS 2 Area Rusted:** 0.01-0.03%

**Delamination:** 0.03-0.1% down to the primer in some spots

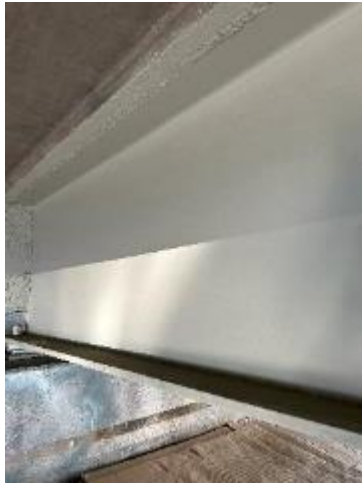
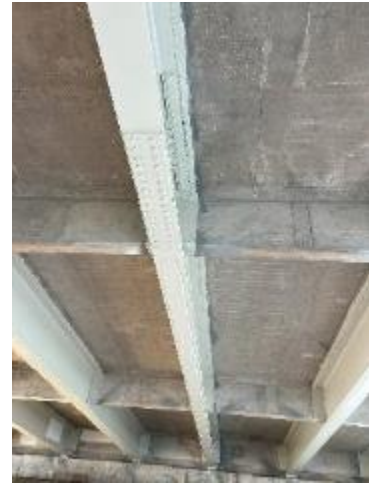
**SSPS VIS 2 Area Rusted:** 0.0-0.01%

**Delamination:** None

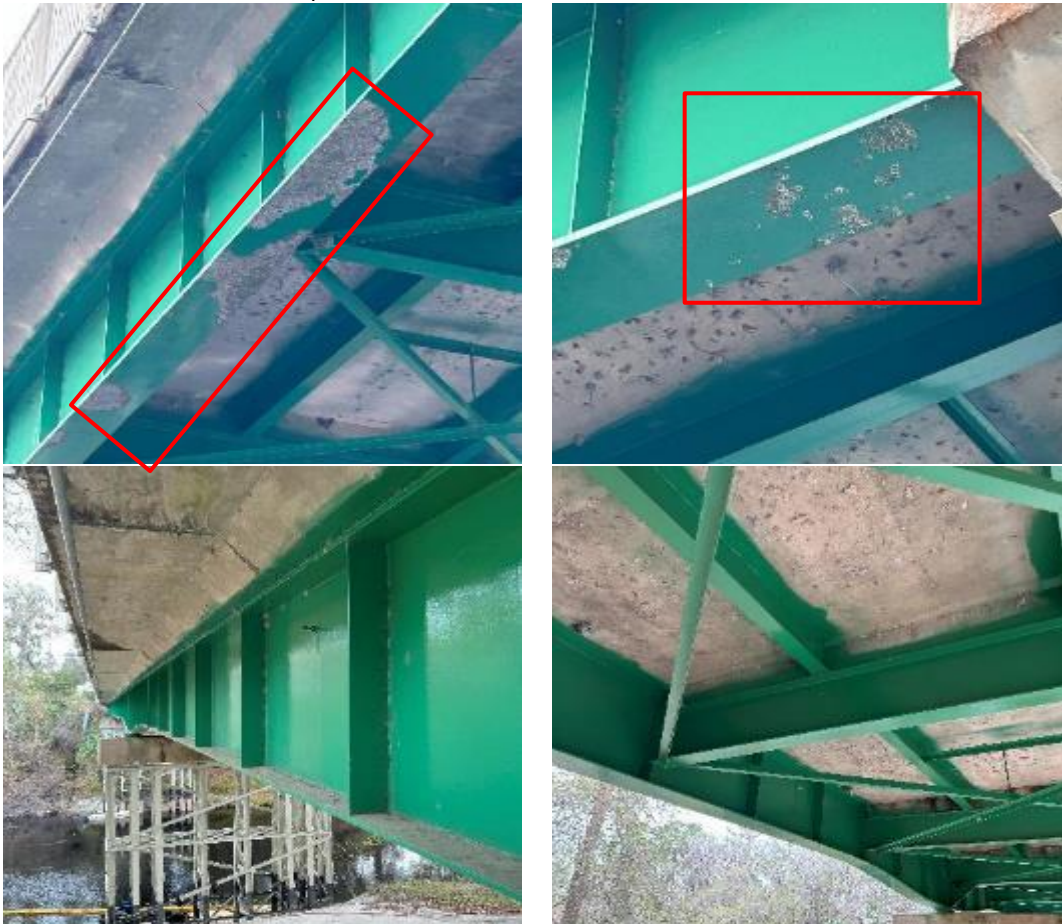
Inspected on 2/28/2023 & Painted 4/17/2013 OC

**SSPS VIS 2 Area Rusted:** 3.0-10% on lower flange of edge girder, 0.0-0.01% on all other areas

**Delamination:** 3.0-10% on lower flange of the edge girder
