EVALUATION OF AN  
EMERGENCY CALL BOX SYSTEM

Research Report 132-1F

Evaluation of an Emergency Call Box System  
Research Study 2-8-68-132

TEXAS TRANSPORTATION INSTITUTE  
Texas A&M University  
College Station, Texas

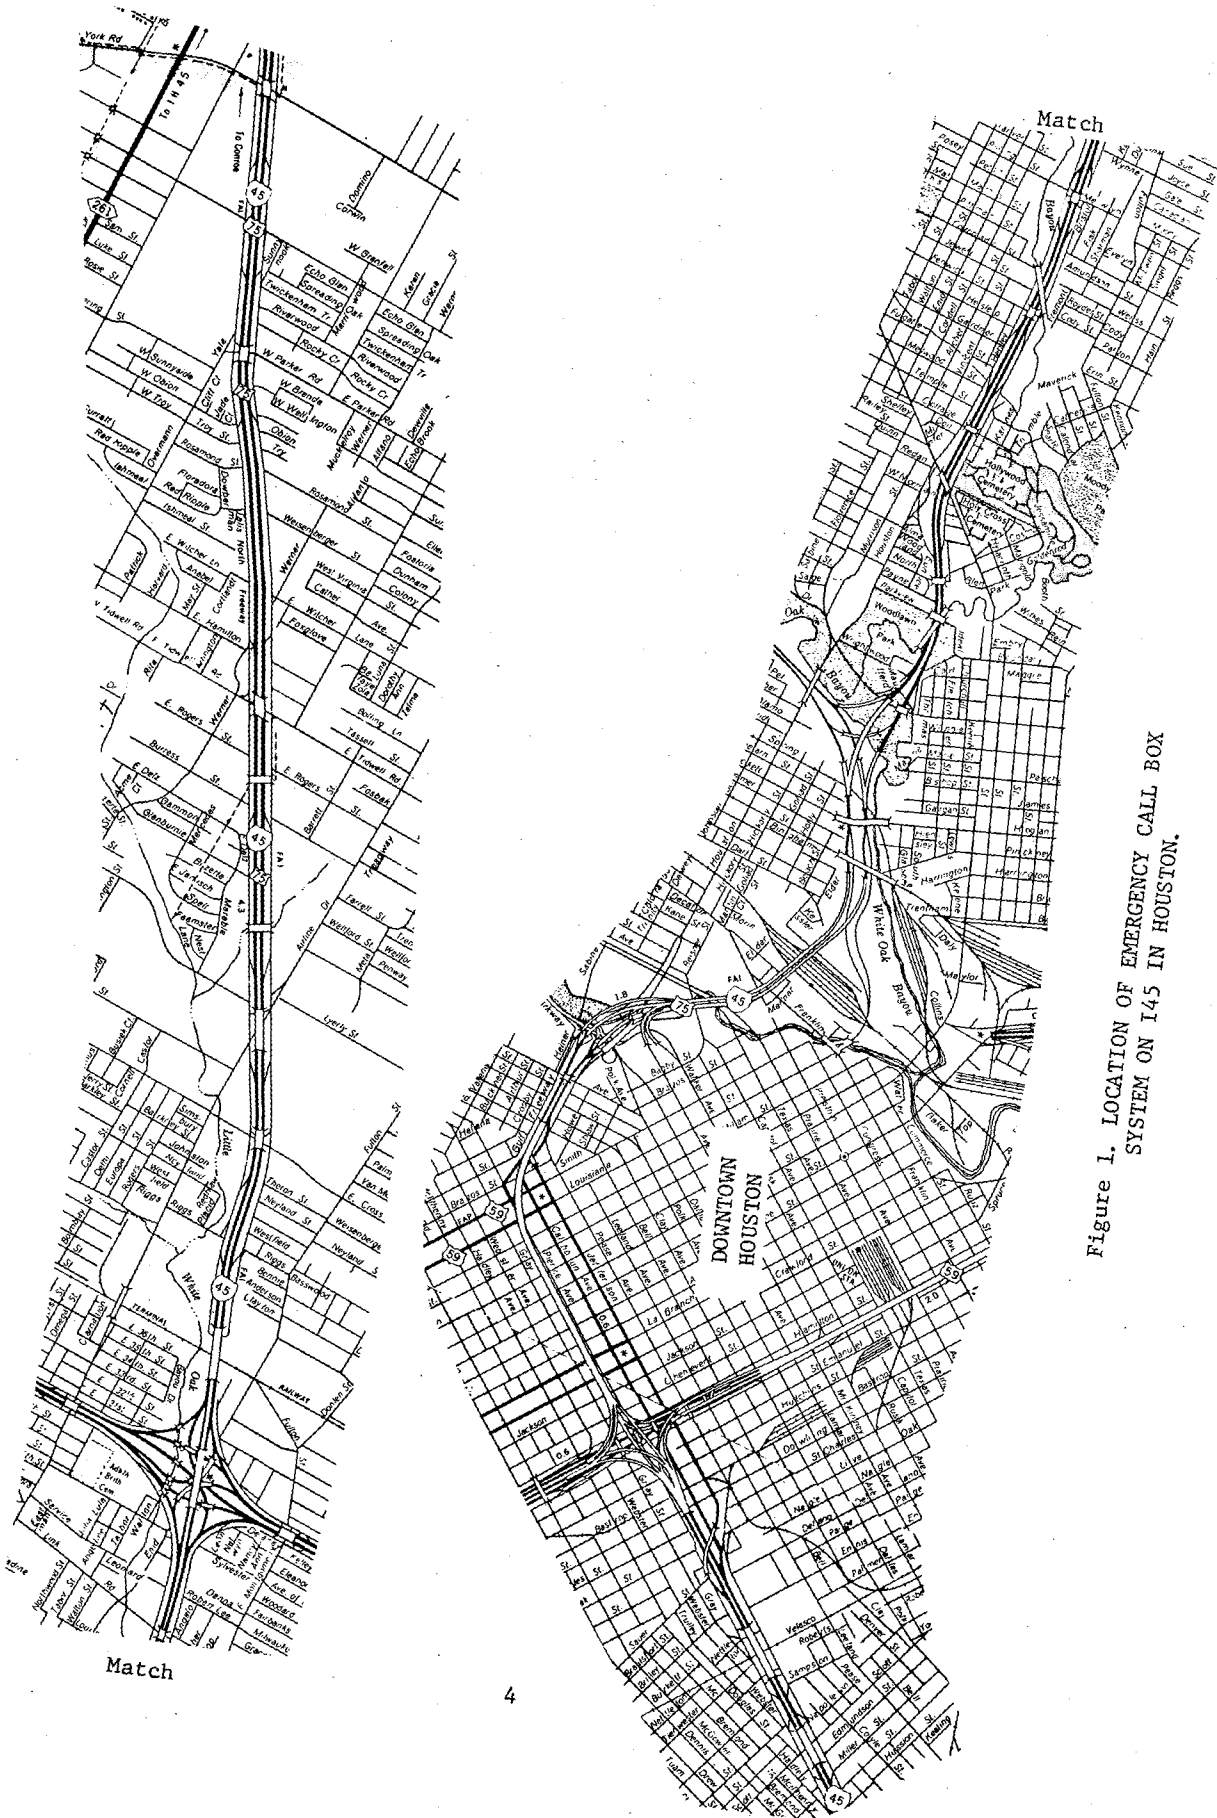
Figure 1. LOCATION OF EMERGENCY CALL BOX  
SYSTEM ON I45 IN HOUSTON.

The system was installed on the main lanes and major interchange ramps of I45 from Scott Street to Little York Road in Houston (Figure 1). The system is 11.1 miles in length with call boxes spaced at approximately  $\frac{1}{4}$ -mile intervals. Maximum walking distance to a box is therefore  $\frac{1}{8}$ -mile or 660 feet. Assuming that stops occur randomly, the average walking distance to a box is then 330 feet. The system incorporates battery operated radio call boxes, with 65 master transmitter boxes and 80 secondary (slave) boxes. Secondary units depend on an interconnected master unit for signal transmission to the receiving unit located in the Houston Police Department. A master unit can support up to three secondary units. Figure 2 shows a typical call box installation.

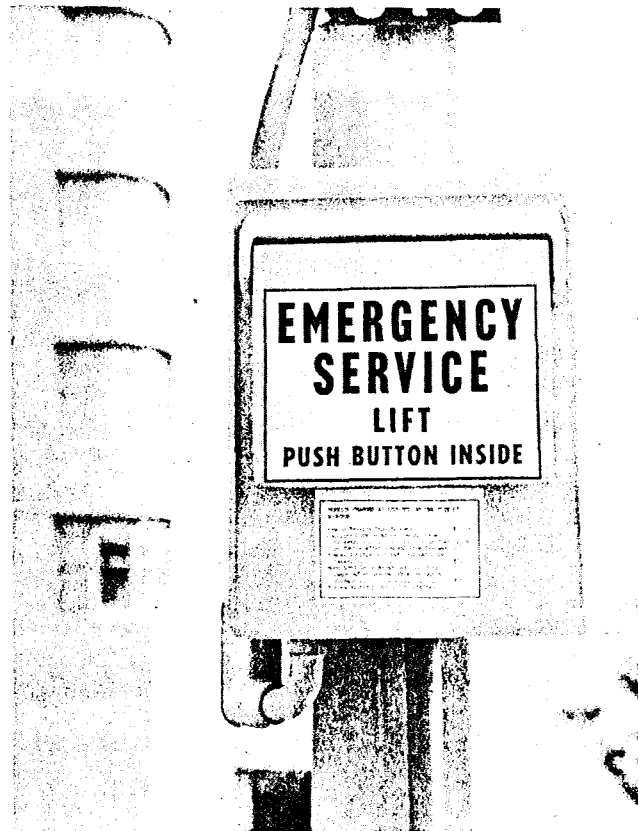
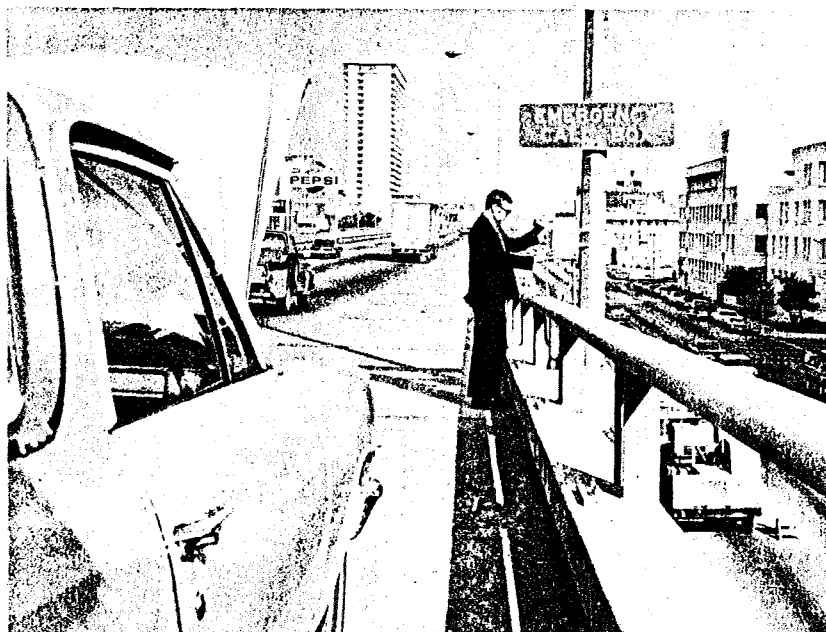
Figure 2. TYPICAL CALL BOX INSTALLATION.

Call boxes are located so that a stranded motorist is not required to cross main-lane traffic to place a call. Thus, a typical location contains four boxes (one master, three secondaries) located on either shoulder in each direction of travel. No call box is located on the median where no median shoulder exists.

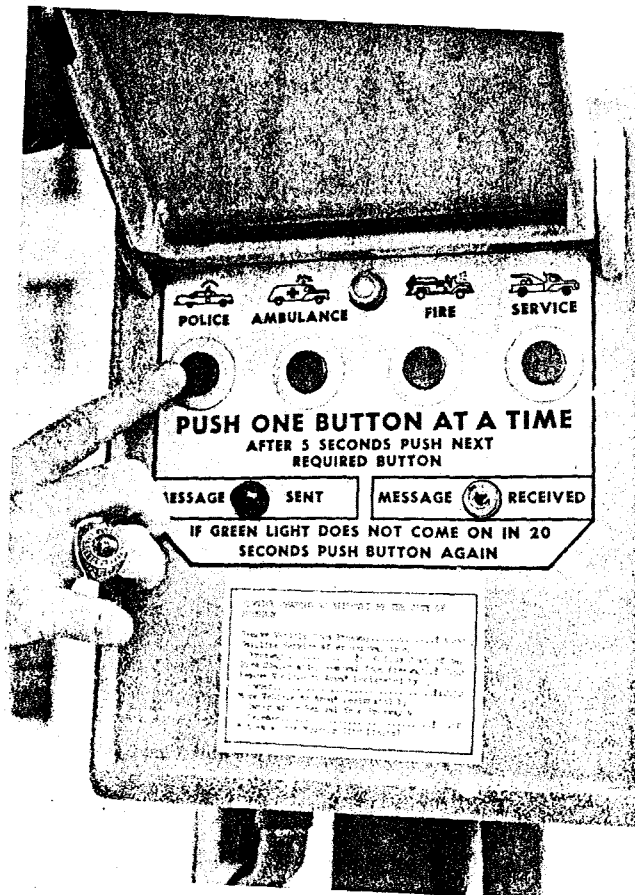
Figure 3. FACEPLATE OF CALL BOX.

Each call box has four buttons providing for the request of police, ambulance, fire, or service (tow truck). An illustration of the faceplate on the call box is shown in Figure 3. Provision is made for verification of calls through "Message Sent-Message Received" lights on the call box face. These are activated as the radio message is transmitted and when acknowledgement is made from the receiving console. Battery condition of the call box is indicated on the receiving console when a call is made. When a call box battery deteriorates to 85% charge a call is placed indicating the battery condition. The battery can normally continue to function for two additional weeks after falling below the 85 level, giving adequate time for maintenance. The boxes make a "check-in" call once a day so that malfunctions can be located and corrected. A tamper-knockdown call is automatically placed when any box is tilted causing the closure of a mercury switch in the box.

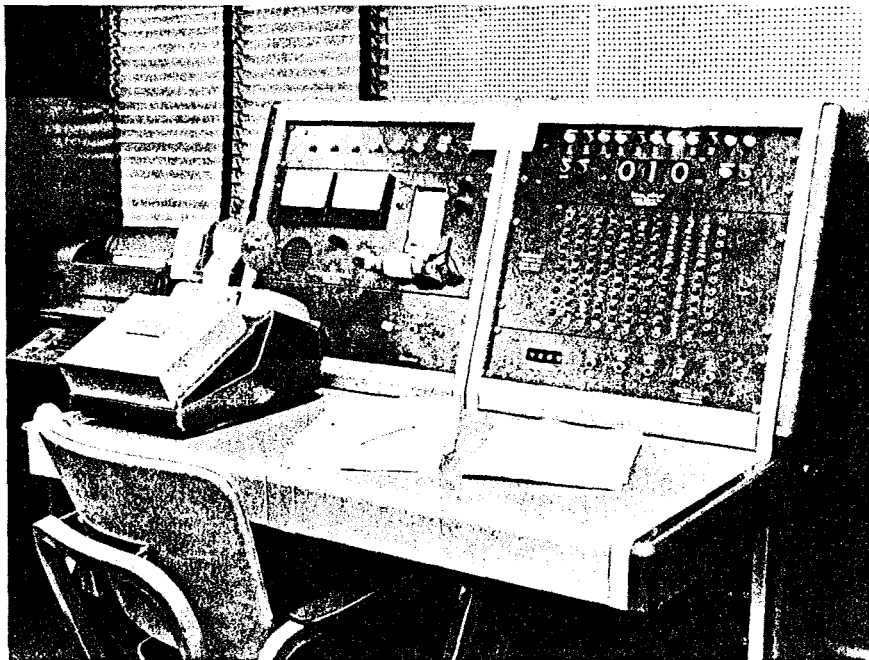
Figure 4. RECEIVING CONSOLE.

The receiving console is located in the dispatch room of the Houston Police Department and is shown in Figure 4. The console unit decodes radio calls, as well as records and displays the information received. Features of the console include: indicator lights which give a visual display of the call; printed tape record of calls; audible alarm actuated by a call; and signal waveform recorder for use by maintenance personnel.

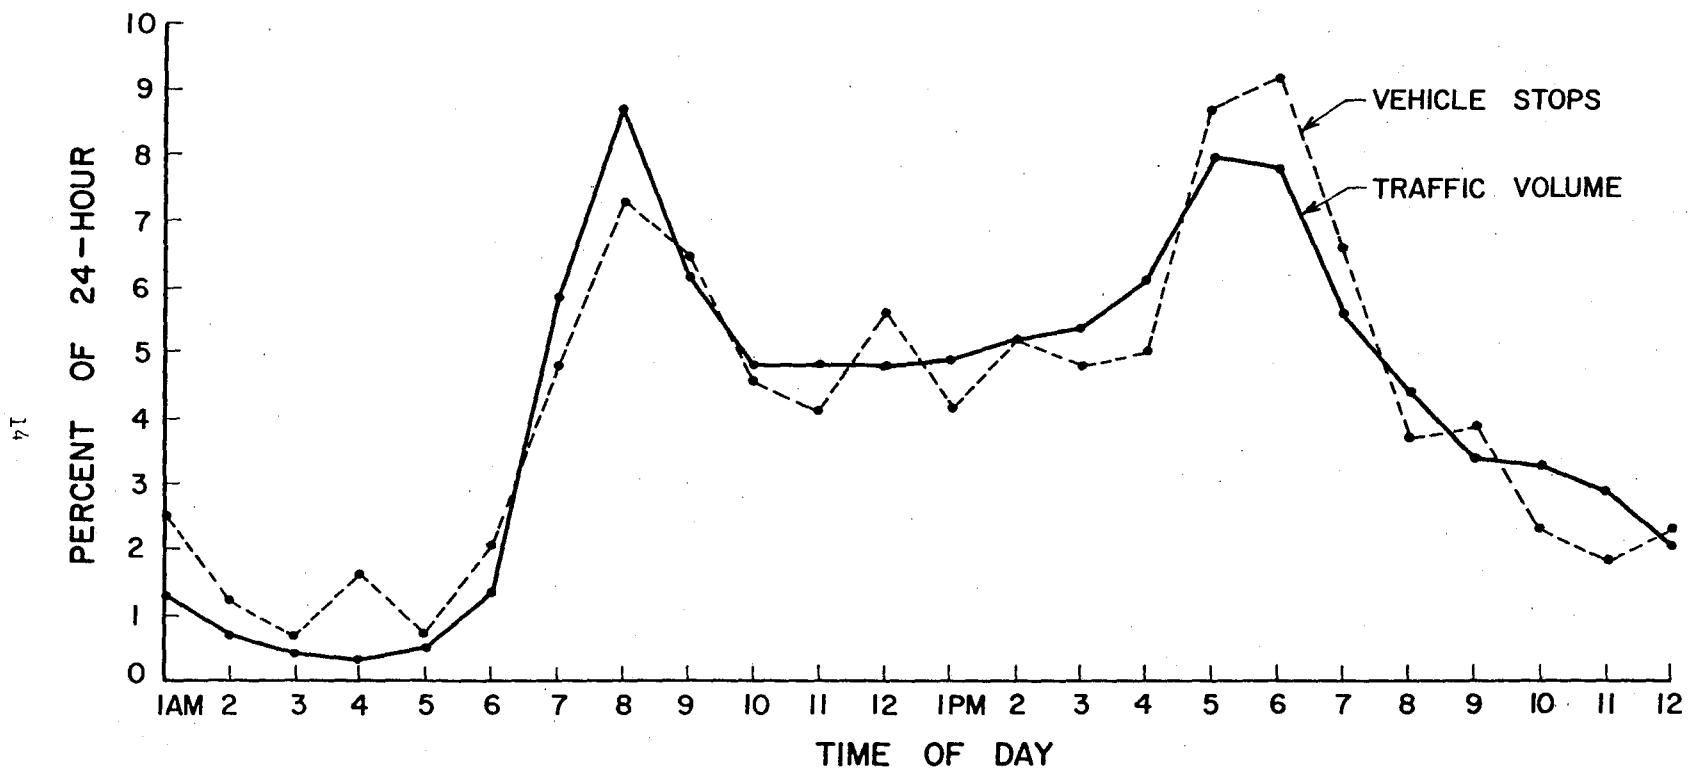
FIGURE 6. DISTRIBUTION OF VEHICLE STOPS AND TRAFFIC FLOW ON WEEKDAYS.

There was a total of 1,040 stops observed during the two patrol studies. Distribution of vehicle stops and traffic volume by day of the week is shown in Table 1. Figure 6 gives a similar comparison between distribution of stops and traffic volumes for an average weekday. The direct relationship of the number of stops to traffic volume is apparent.

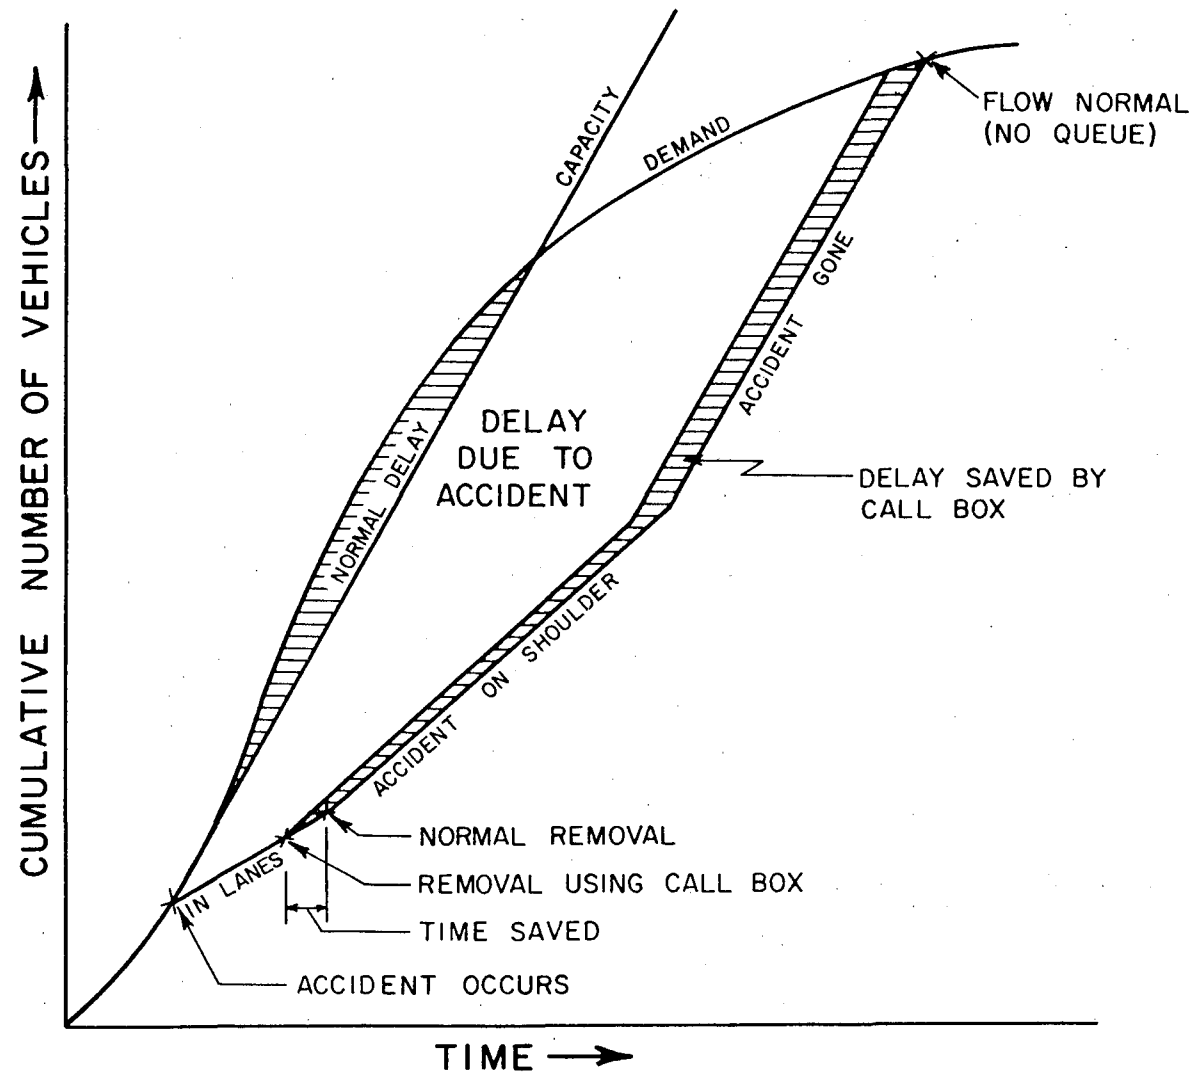
FIGURE 9. RELATIONSHIP OF FLOW CAPACITY AND DELAY.

The relationships between capacity, flow, and delay (illustrated graphically in Figure 9) were used to estimate the delay caused by an accident. Traffic flow is the slope of the service volume curve and delay is the area between the demand and service volume curves. When an accident occurs, a severe drop in capacity results (slope decreases requiring a longer period of time to service the demand). The area bounded by the normal service volume curve and service volume curve for an accident represents the delay created by the incident. Use of the call box system saves the driver of the disabled vehicle a varying amount of time in obtaining assistance as shown in Table 27. These average values are used to estimate the motorist savings for each section. An estimation of the delay prevented at an accident scene by the call box system is then the average time saved times the number of vehicles which pass the scene that are affected by the reduction in reporting time.

The relationship described above was used to estimate aggregate delay due to peak period weekday accidents in the three sections. Since each accident is unique in location, magnitude and time of occurrence, some assumptions were necessary. The location in each section where the greatest number of accidents occurred was used to compute delay. It was assumed that all southbound morning peak accidents occurred at 7:30 AM and all northbound evening peak accidents occurred at 4:55 PM. Both times fall at the approximate midpoint of the peak period traffic demand. Only weekday accidents occurring during the southbound morning peak period (7-9 AM) and the northbound evening peak period (4-6 PM) were assumed to create significant traffic delay. This is a conservative estimate since many accidents occur in
