# Countermeasures to Improve Pedestrian Safety on Arterials:

## Design Recommendations for Urban NMDOT Roadways

### Final Report

**Report R922070**

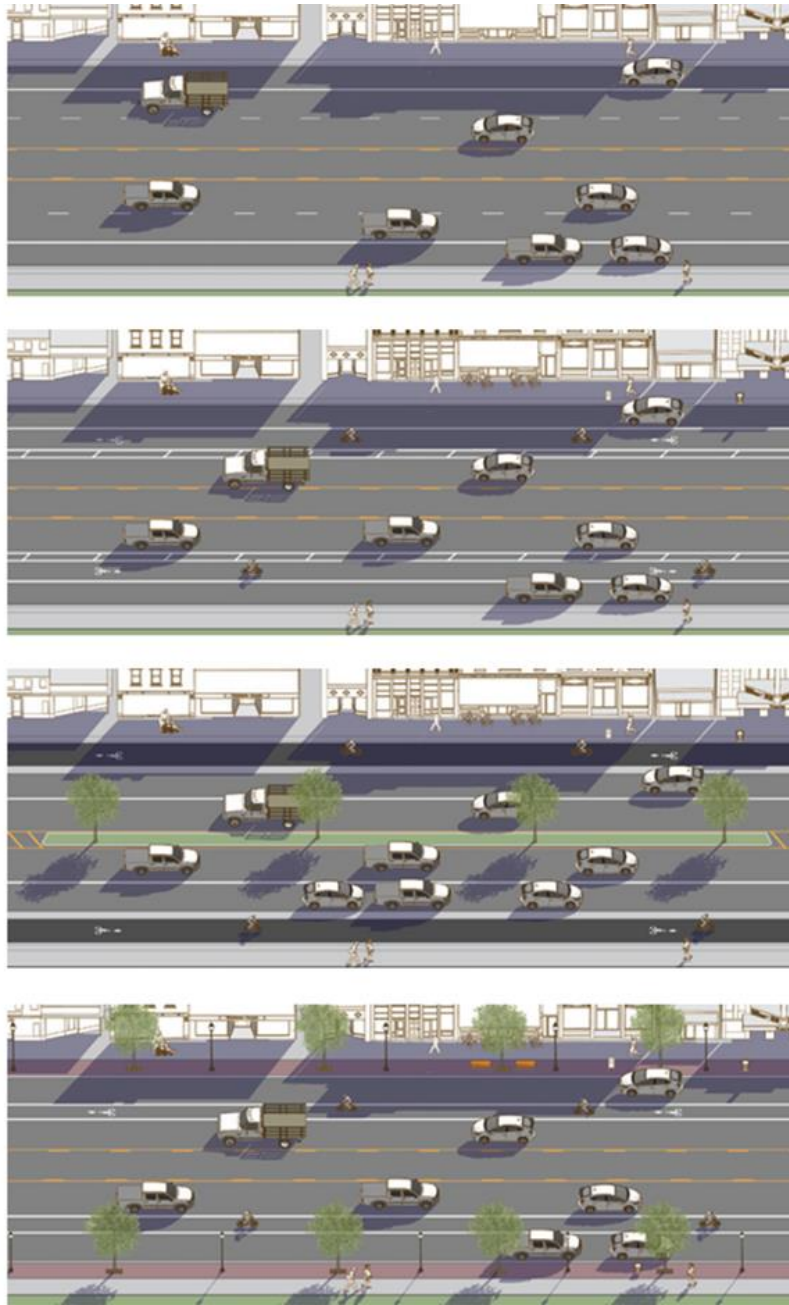
**FIGURE 1. Example of five-lane Main Street (top picture) conversions to Road Diet with Bike Lanes (2nd from top); Median and Separated Bike Lanes (3rd); Streetscape Expansion with Bike Lanes (bottom). (8)**

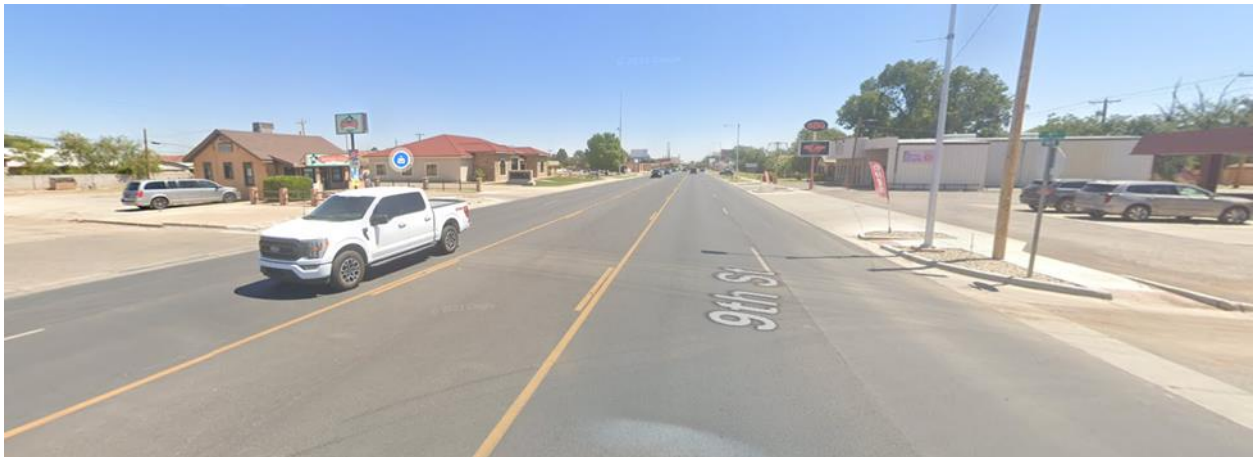
**FIGURE 9. Photo of US-82 / W Main Street in Artesia, NM**

Functional Classification	Minor Arterial
ADT (2022)	4,026
Lanes	5
Speed Limit	35 mph
Width	96'
Distance between Traffic-Controlled Crossings	1,764'

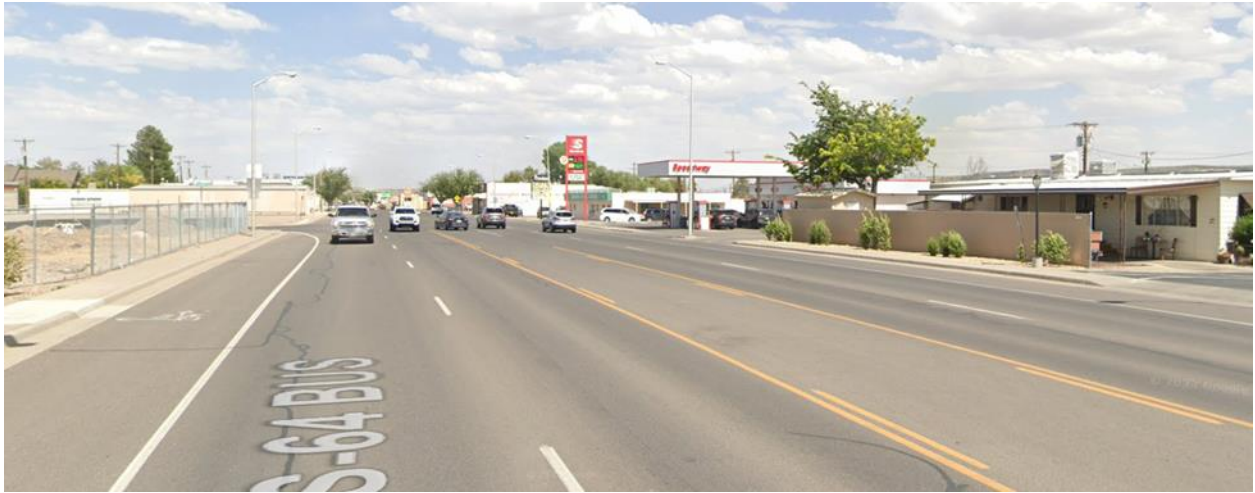
**FIGURE 12. Photo of US-64 Business / W Broadway Avenue in Farmington, NM**

Functional Classification	Principal Arterial
ADT (2022)	10,827
Lanes	5 (+2 parking)
Speed Limit	35 mph
Width	90'
Distance between Traffic-Controlled Crossings	1,094'

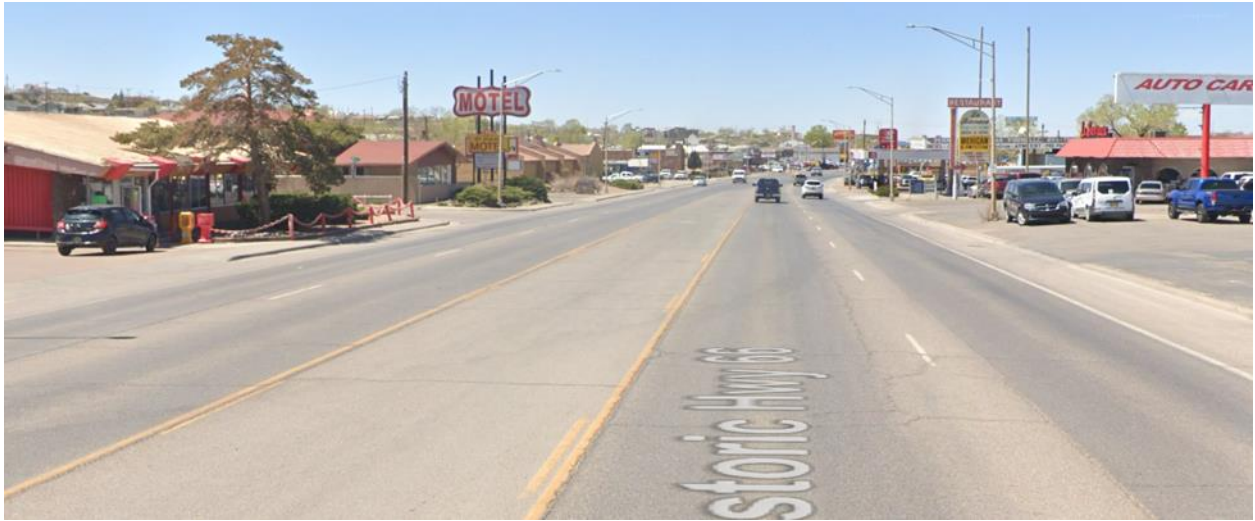
**FIGURE 15. Photo of I-40 Business / Highway 66 in Gallup, NM**

Functional Classification	Principal Arterial
ADT (2023)	12,888
Lanes	5
Speed Limit	35 mph
Width	80'
Distance between Traffic-Controlled Crossings	2,305'

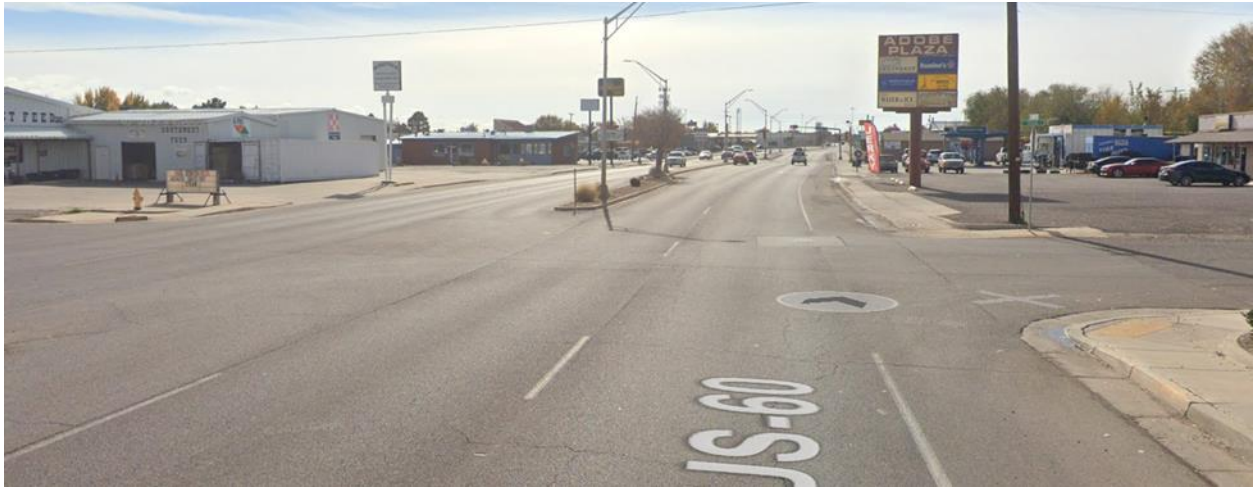
**FIGURE 18. Photo of US-60 / California Street in Socorro, NM**

Functional Classification	Principal Arterial
ADT (2022)	9,085
Lanes	5
Speed Limit	35 mph
Width	96'
Distance between Traffic-Controlled Crossings	1,335'

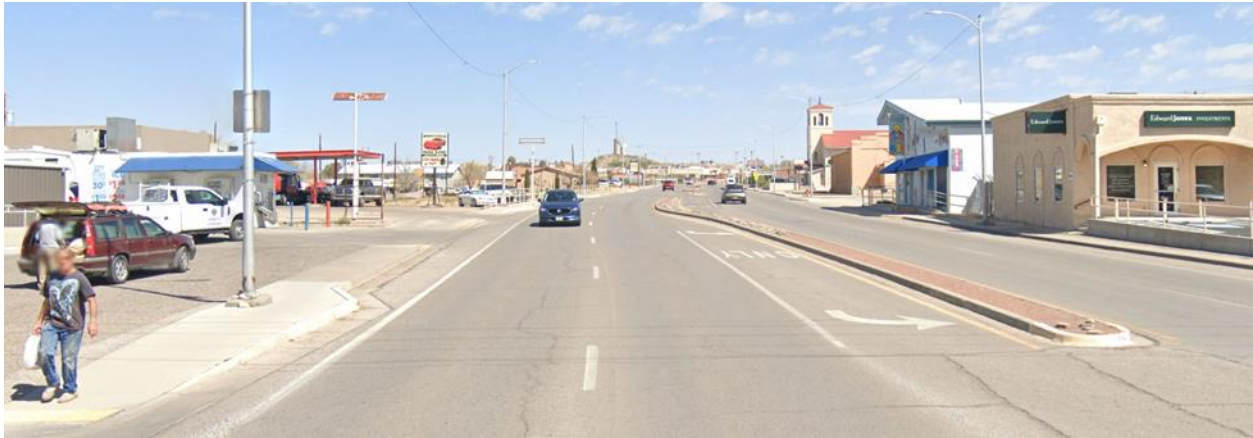
**FIGURE 21. Photo of I-25 Business / Date Street in Truth or Consequences, NM**

Functional Classification	Principal Arterial
ADT (2022)	8,083
Lanes	5
Speed Limit	35 mph
Width	88'
Distance between Traffic-Controlled Crossings	2,112'

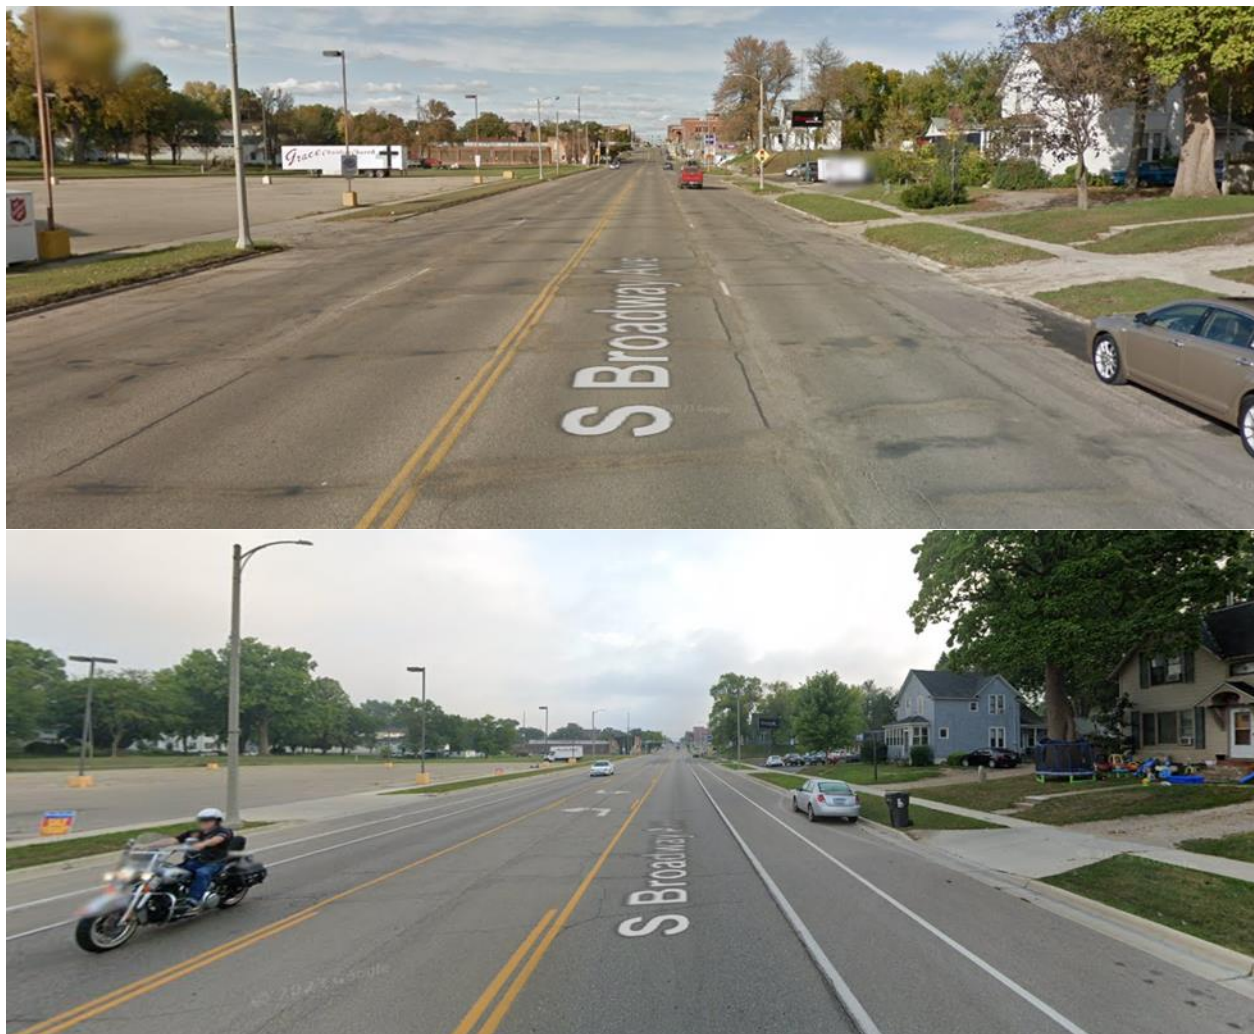
**FIGURE 25. Photo of Highway 65 / South Broadway in Albert Lea, MN before (top) and after (bottom) road redesign**

The road redesign was a traditional road diet that had a four-lane configuration (two travel lanes in each direction) converted to a three-lane configuration with bike lanes on each side of the street (Table 6 and Figures 25 & 26). The road carried between 5,000 and 7,000 vpd both before and after the realignment and the total road width (from outside of sidewalk to outside of sidewalk) was 98 feet, which are both similar to the NMDOT roadways profiled above (14). In addition to lane reconfiguration, the project also saw replacement of sidewalks and traffic signals, new decorative lighting, trees, and curb bump-outs for pedestrians at key intersections.

<b>Before</b>	<b>After</b>
Functional Classification	Minor Arterial	Minor Arterial
ADT (2013, 2022)	7,000	5,420
Lanes	4	3
Speed Limit	30 mph	30 mph
Width	98'	98'
Distance between Traffic-Controlled Crossings	1,333'	1,333'

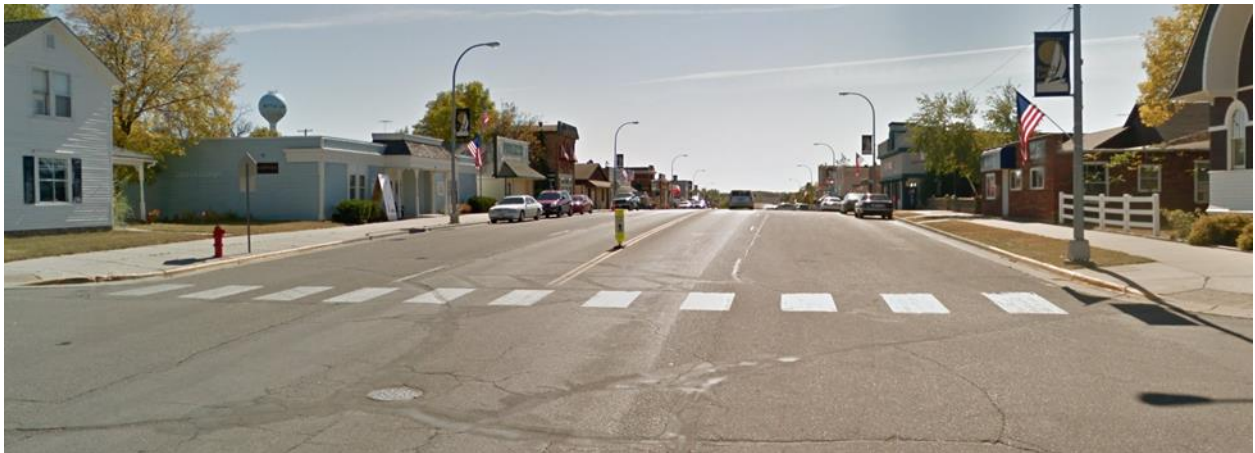
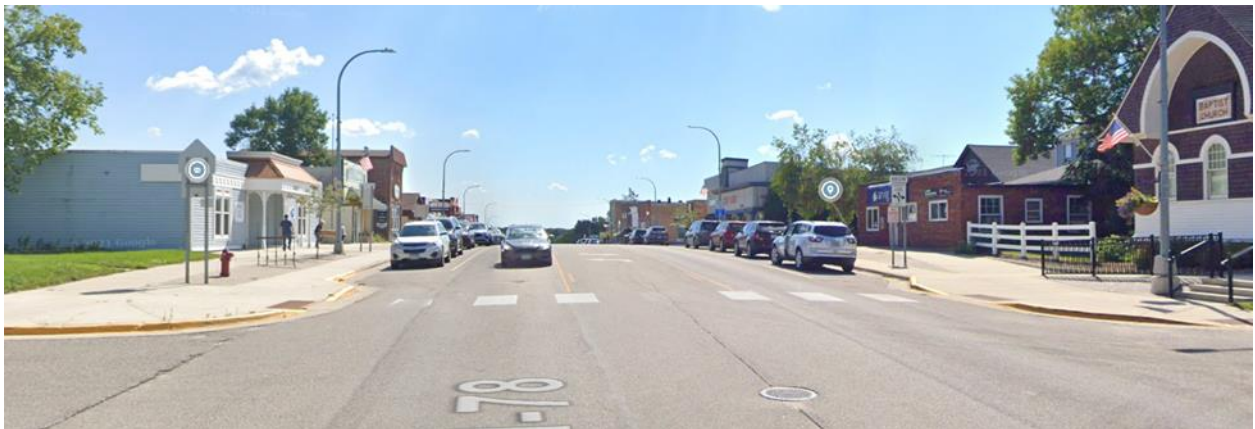
**FIGURE 28. Photos of Highway 78 / Lake Avenue in Battle Lake, MN before (top) and after (bottom) road redesign**

<b>Before</b>	<b>After</b>
Functional Classification	Minor Arterial	Minor Arterial
ADT (2013, 2021)	3,250	4,250
Lanes	4	3
Speed Limit	30 mph	30 mph
Width	94'	94'
Distance between Traffic-Controlled Crossings	n/a	n/a

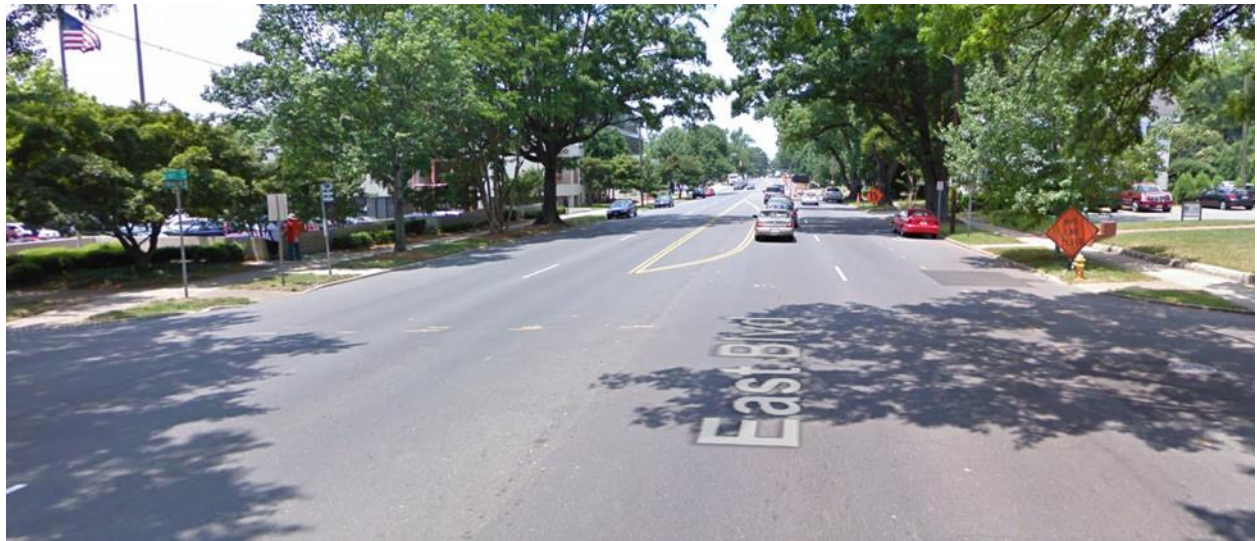
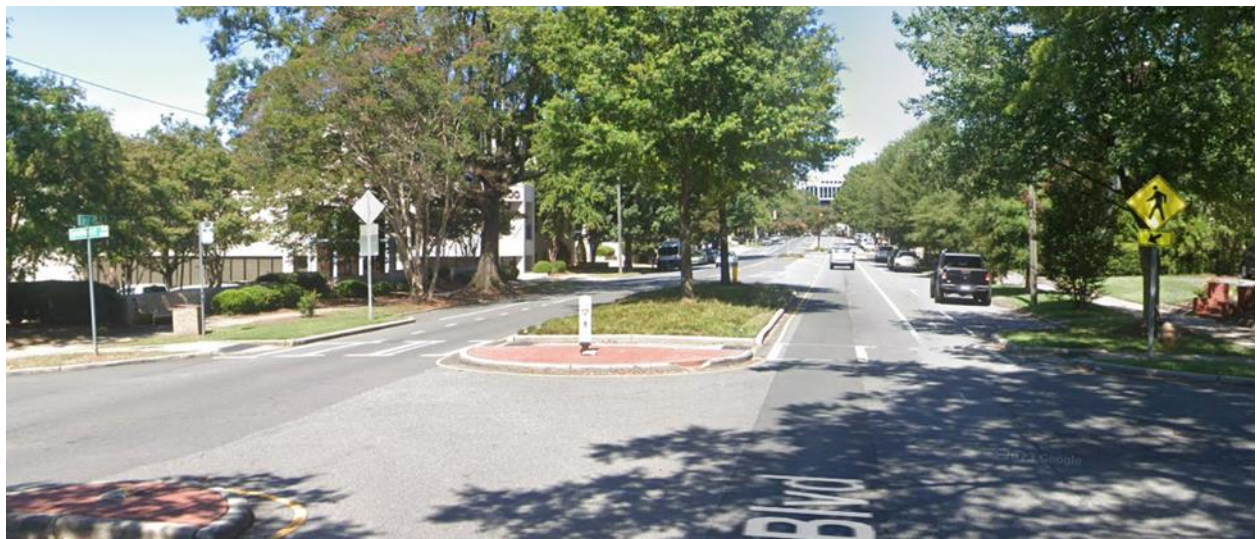
**FIGURE 31. Photos of East Boulevard in Charlotte, NC before (top) and after (bottom) road redesign**

<b>Before</b>	<b>After</b>
Functional Classification	Major Collector	Major Collector
ADT (2013, 2021)	18,600	19,700
Lanes	5	3
Speed Limit	35 mph	35 mph
Width	100'	100'
Distance between Traffic-Controlled Crossings	1,078'	1,078'

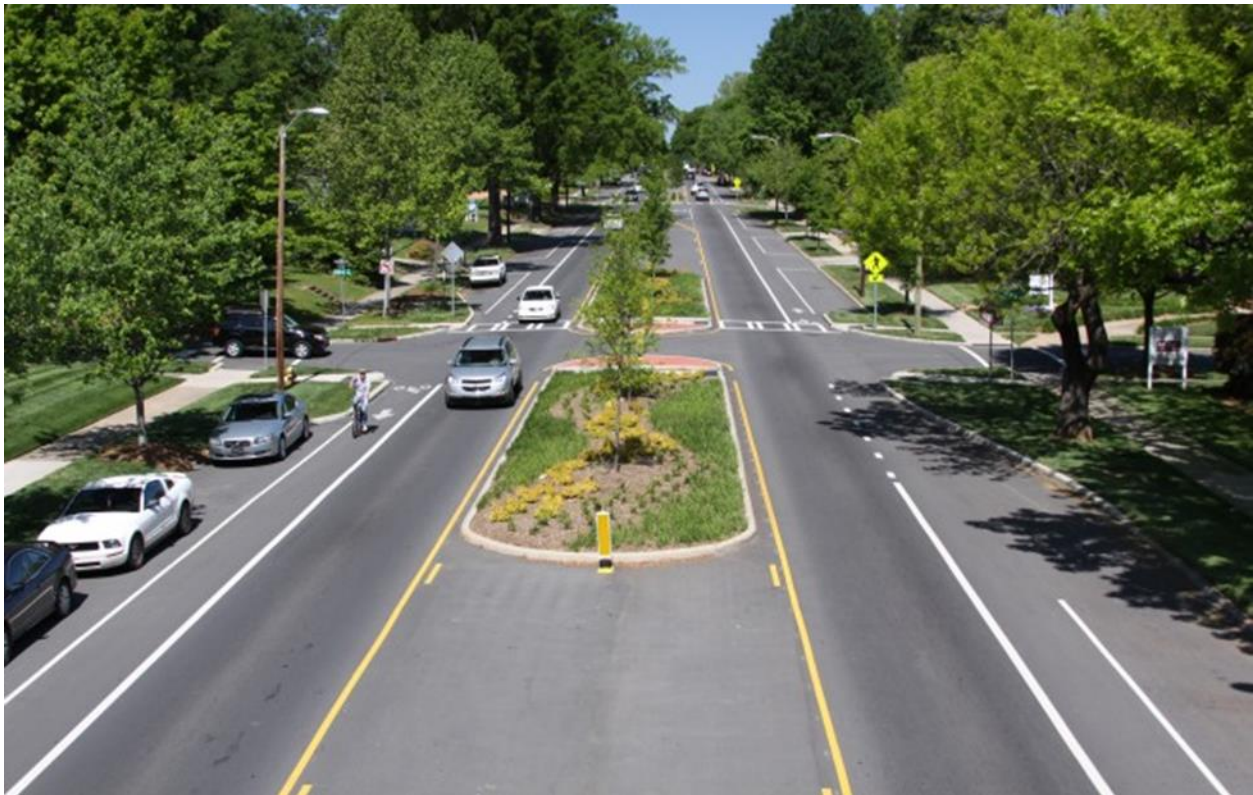
**FIGURE 33. Pedestrian crossing on East Boulevard in Charlotte, NC after road redesign (Photo: City of Charlotte)**

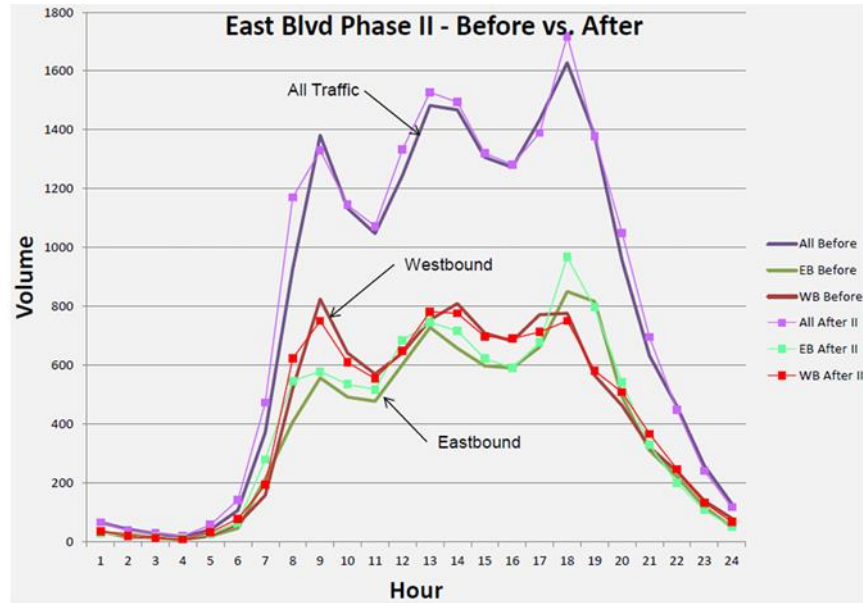
**FIGURE 34. Traffic Volume Measurements on East Boulevard in Charlotte, NC before and after road redesign (17).**

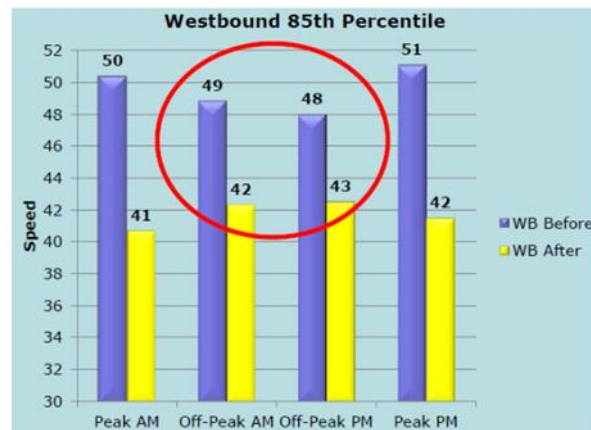
**FIGURE 35. 85th percentile speeds for East Boulevard road redesign (17)**

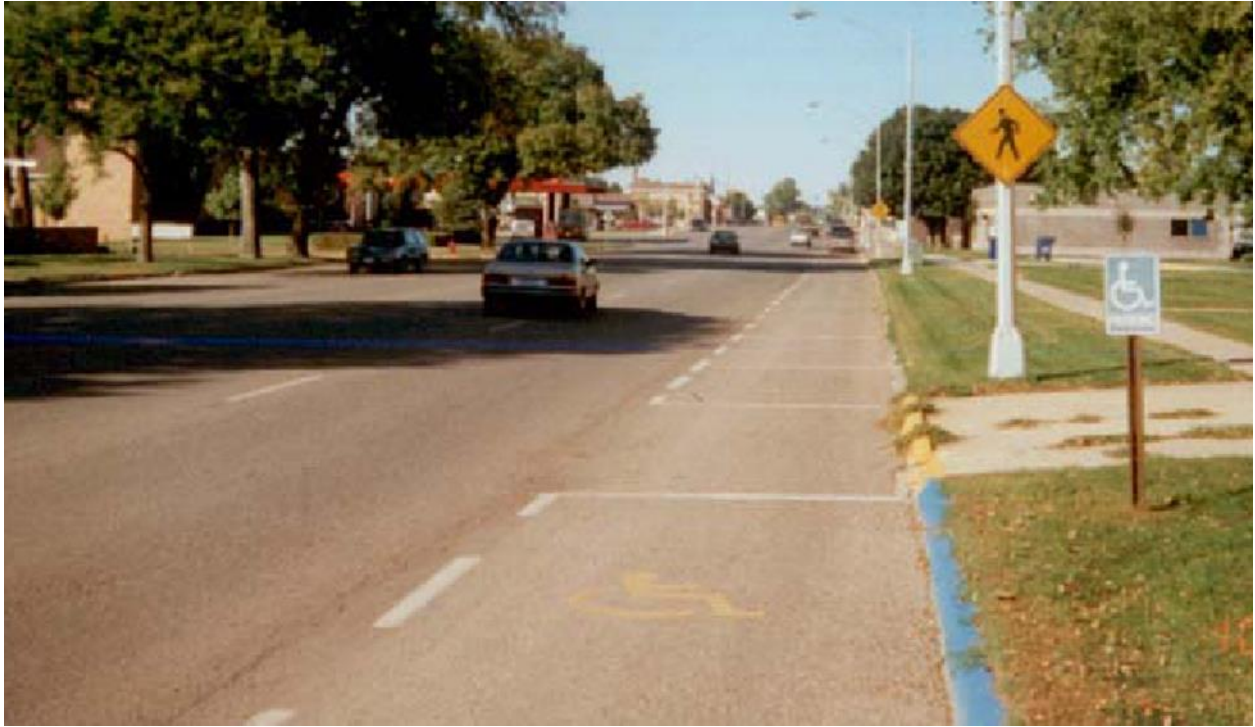
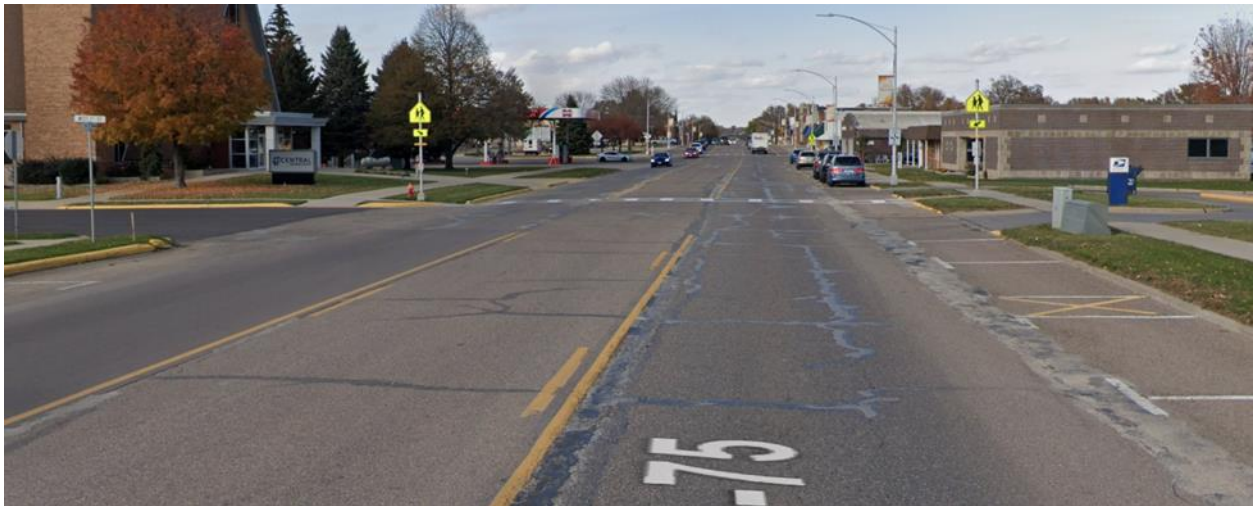
**FIGURE 38. Photos of US-75 / Main Avenue in Sioux Center, IA before (top) and after (bottom) road redesign (Iowa DOT, 2024)**

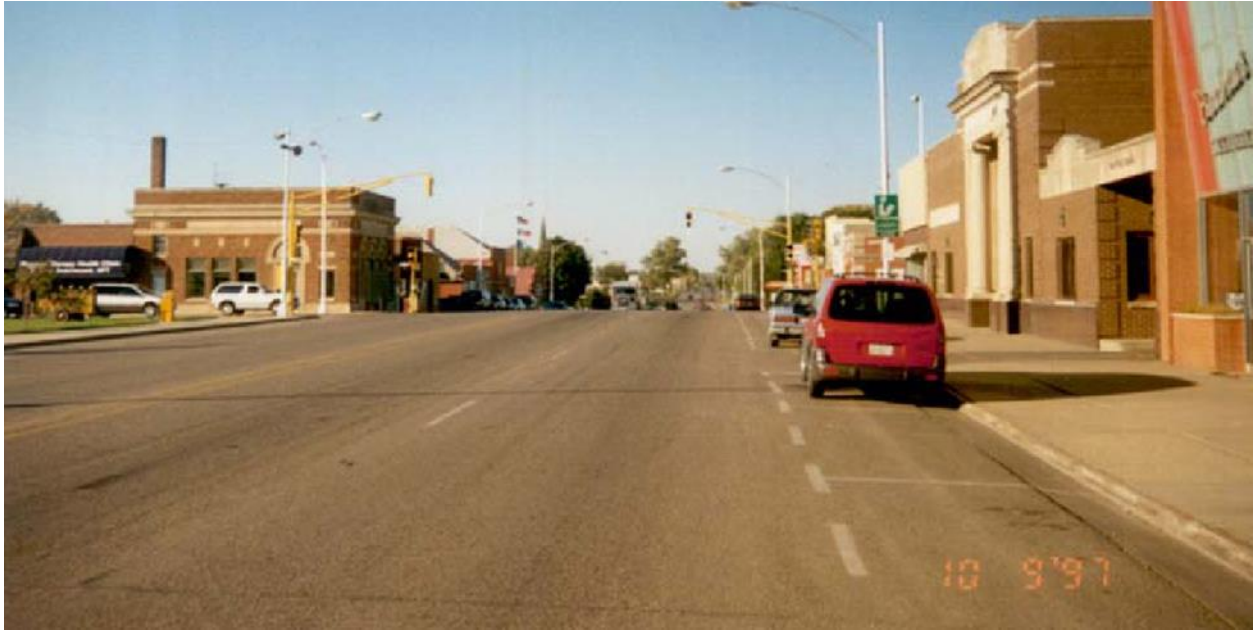
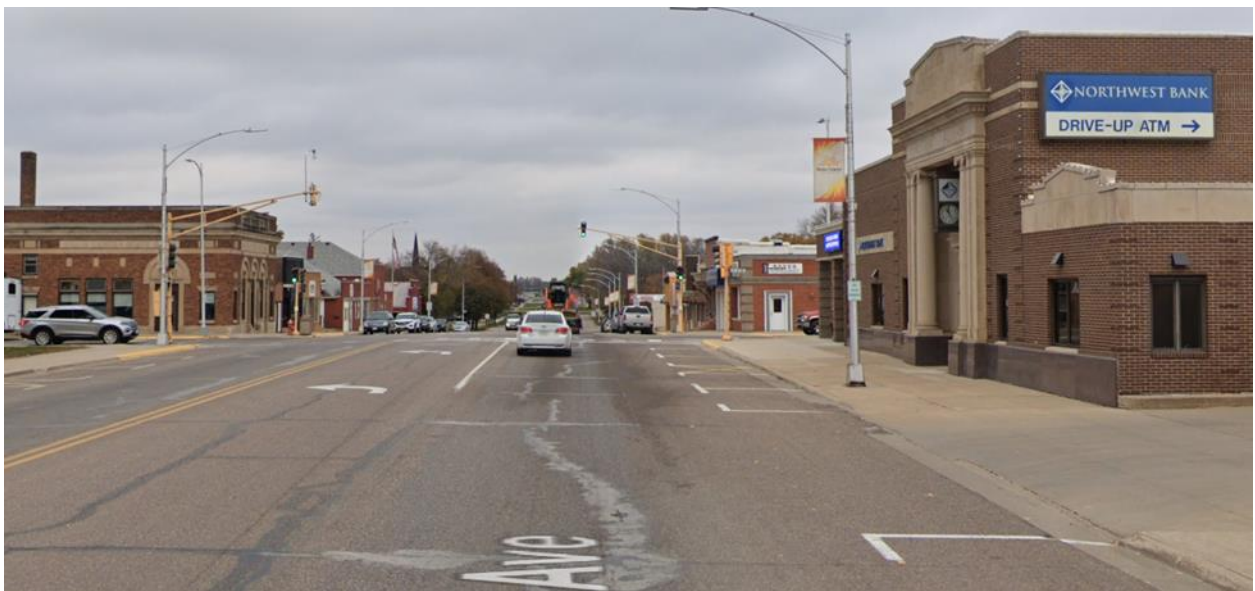
**FIGURE 39. Photos of US-75 / Main Avenue in Sioux Center, IA before (top) and after (bottom) road redesign (Iowa DOT, 2024)**

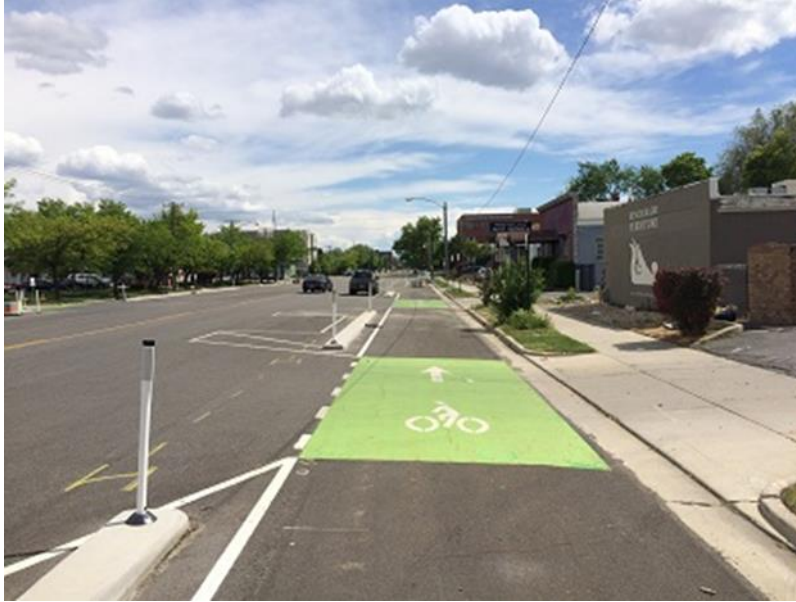
**FIGURE 42. Example of a protected bike lane that provides driveway access.**

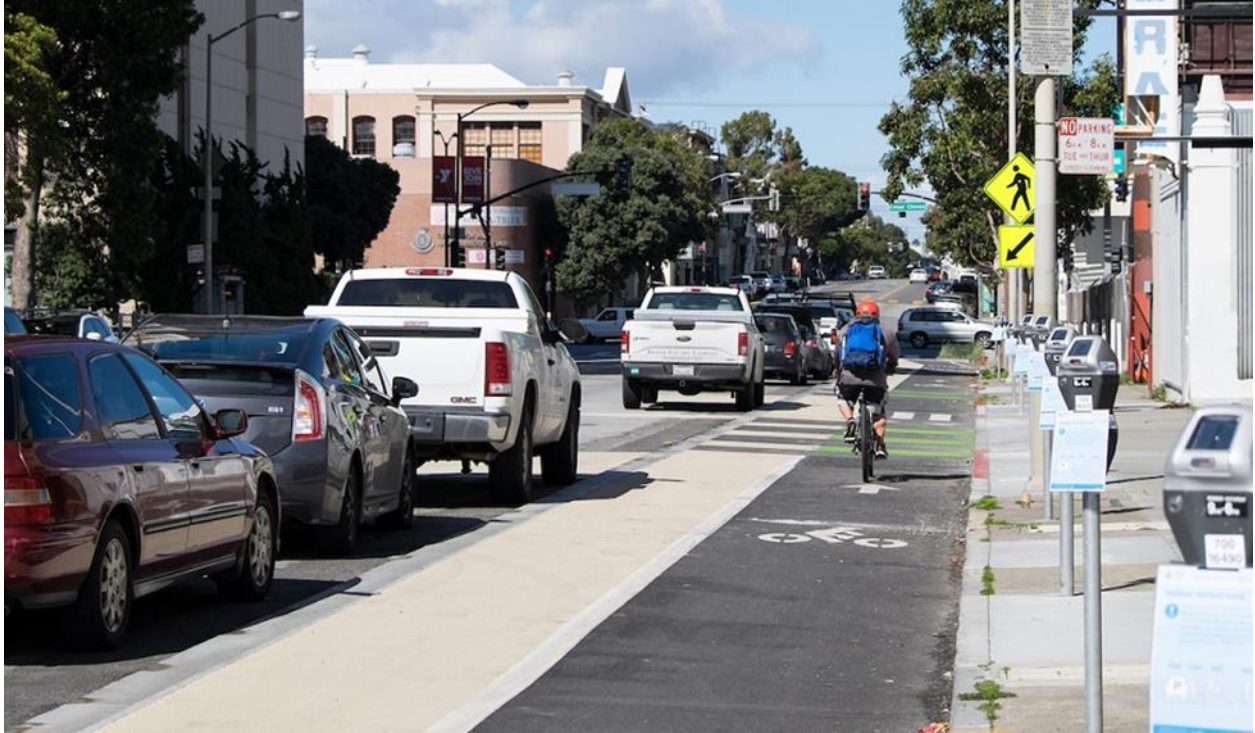
**FIGURE 44. Example of a bike lane protected by on-street parking.**

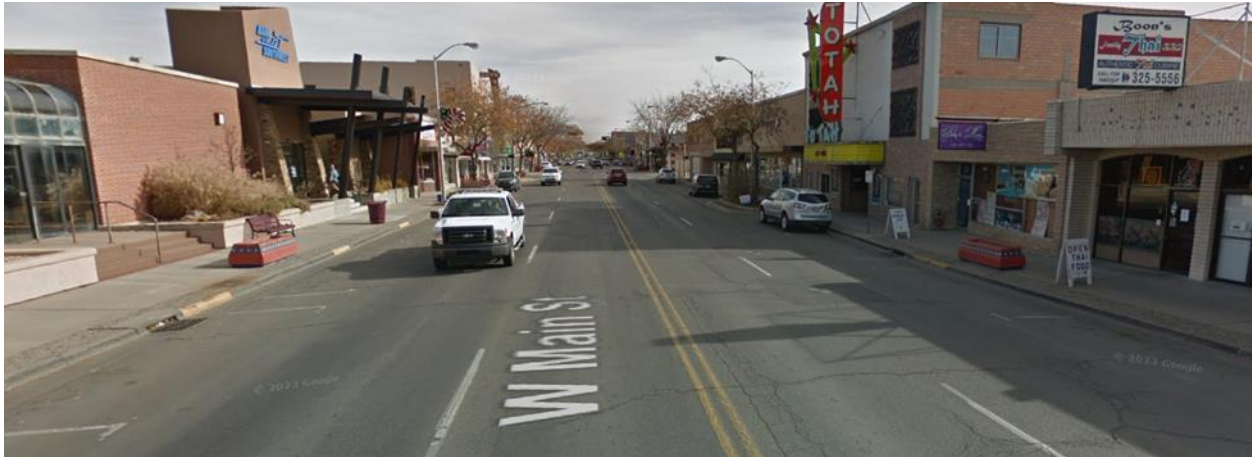
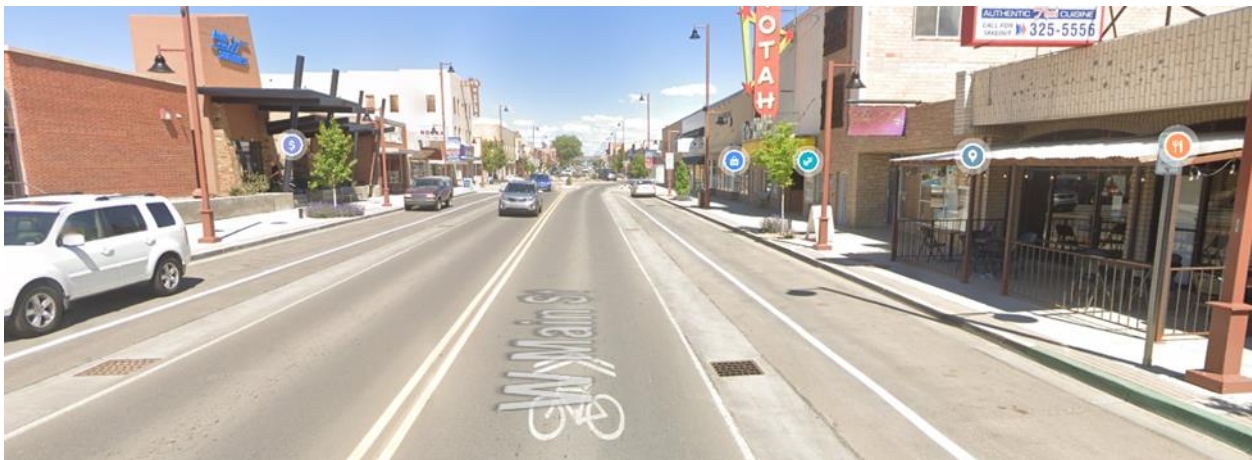
**FIGURE 48. Photos of midblock segment of Main Street in Farmington, NM before (top) and after (bottom) road redesign**

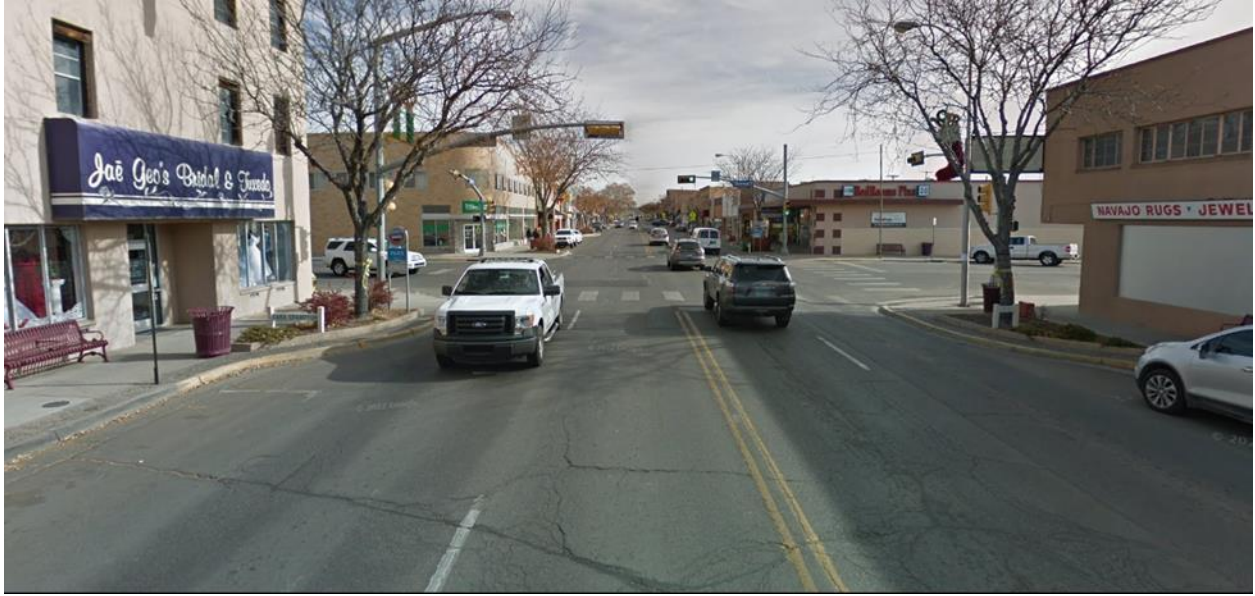
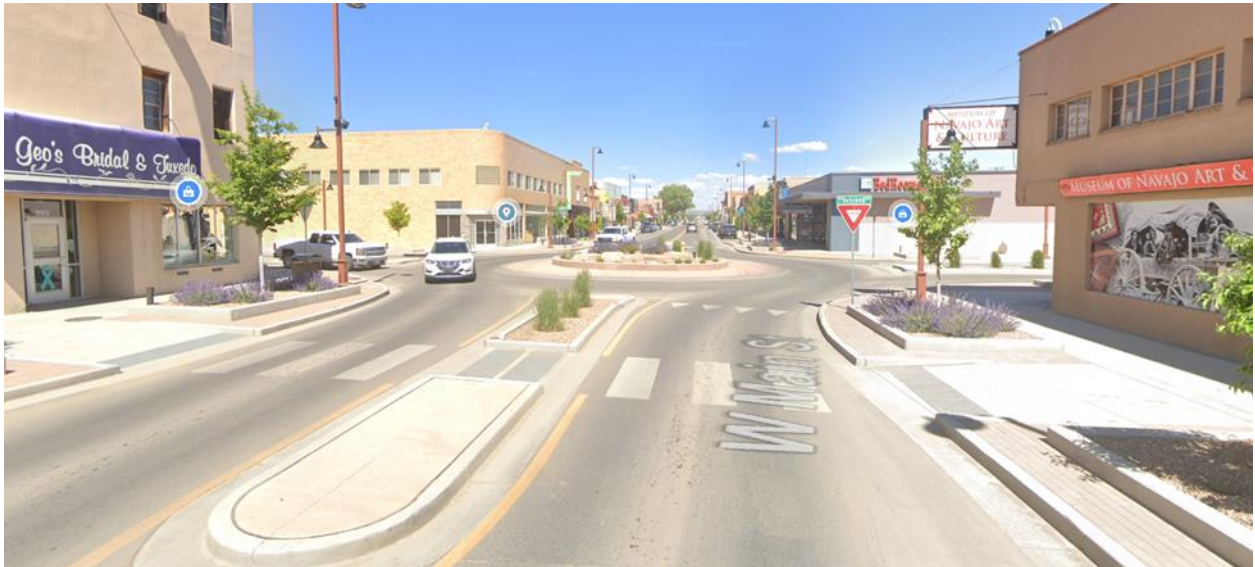
**FIGURE 49. Photos of intersection on Main Street in Farmington, NM before (top) and after (bottom) road redesign**
