1. Report No. FHWA/TX-04/1752-13		2. Government Accession No.		3. Recipient's Catalog No.	
4. Title and Subtitle IMPLEMENTATION ISSUES ASSOCIATED WITH TRAIN MONITORING DEPLOYMENTS				5. Report Date September 2003

Report 1752-13
IMPLEMENTATION ISSUES ASSOCIATED WITH TRAIN
MONITORING DEPLOYMENTS

By
Leonard G. Ruback, Research Scientist
Texas Transportation Institute

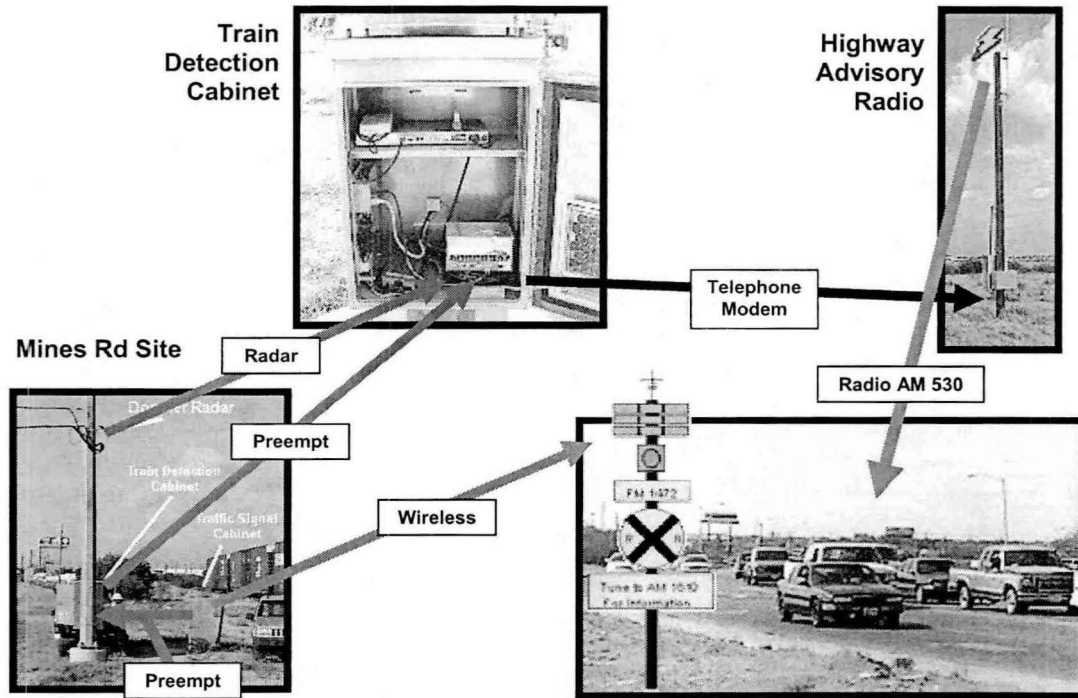
Figure 1. Wireless Advisory Rail Network Architecture.

informs the traveler of train direction and blockage duration at Mines Road. Figure 1 shows the Wireless Advisory Rail Network (WARN) architecture. Installation and testing began in the Summer of 2001, with full operation beginning in the Summer of 2002.

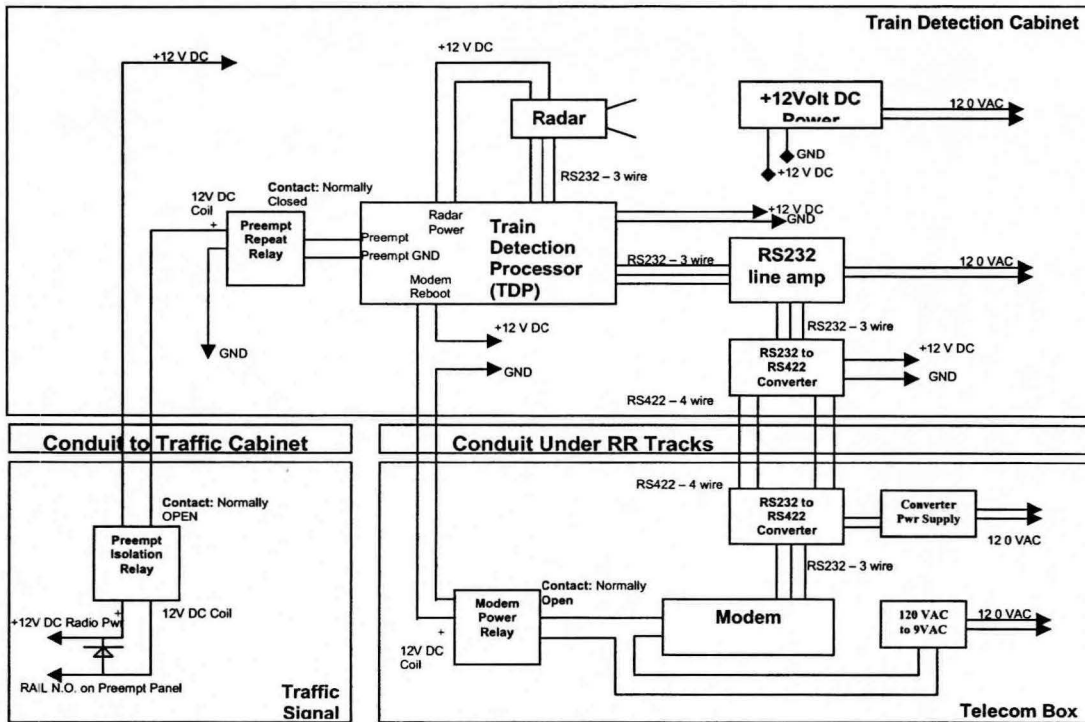
Figure 2. Mines Road WARN System final wiring diagram.

Early deployment called for all Mines Road equipment to be installed in a pole cabinet located adjacent to the railroad grade crossing (west side) at Mines Road. The radar, control computer, and the modem were collocated in the cabinet. The telephone communication line was pulled in the cabinet from a nearby telco field box. Due to upcoming construction in the area, project leadership decided to move the equipment to a new pole located across the railroad from the original line (east of the railroad tracks). Standard operating practice does not allow for power and communication lines to run in the same conduit. The solution was to break the original package of equipment into two locations, the new pole cabinet and a new cabinet near the telco field box. Figure 2 shows the new arrangement.

Given the longer distance between the control computer and the modem, a different wireline communication technique was required. The solution was to migrate from a RS232 link to an RS422 link. The RS422 link is specifically designed for longer distance runs and is a common replacement for RS232. The use of RS422 requires RS232 to RS422 communication converters at both ends of the underground link (both the control computer and the dialup modem support only RS232). The pole cabinet houses the control computer and the RS422 converter to connect with the telco box. The telco box now contains the modem, the modem power reset relay, and the RS422 communication converter.

Testing revealed that the RS422 communication converter uses power from the RS232 host port to power its own RS232 circuits. It was found that this extra power drain was causing the voltage levels on the host RS232 port to drop to undetermined levels (as mandated by the RS232 standard). The problem was seen on both the control computer and the modem RS232 ports. The root cause of the issue is the widespread use of charge pump RS232 integrated circuits that take 5 volts dc and transform into +10v and -10v for use by the RS232 circuitry. The extra power draw is too much for these circuits and the pumped voltage fails to remain steady. The solution was to build a small RS232 amplifier to remove the loading of the RS422 communication converter circuitry.

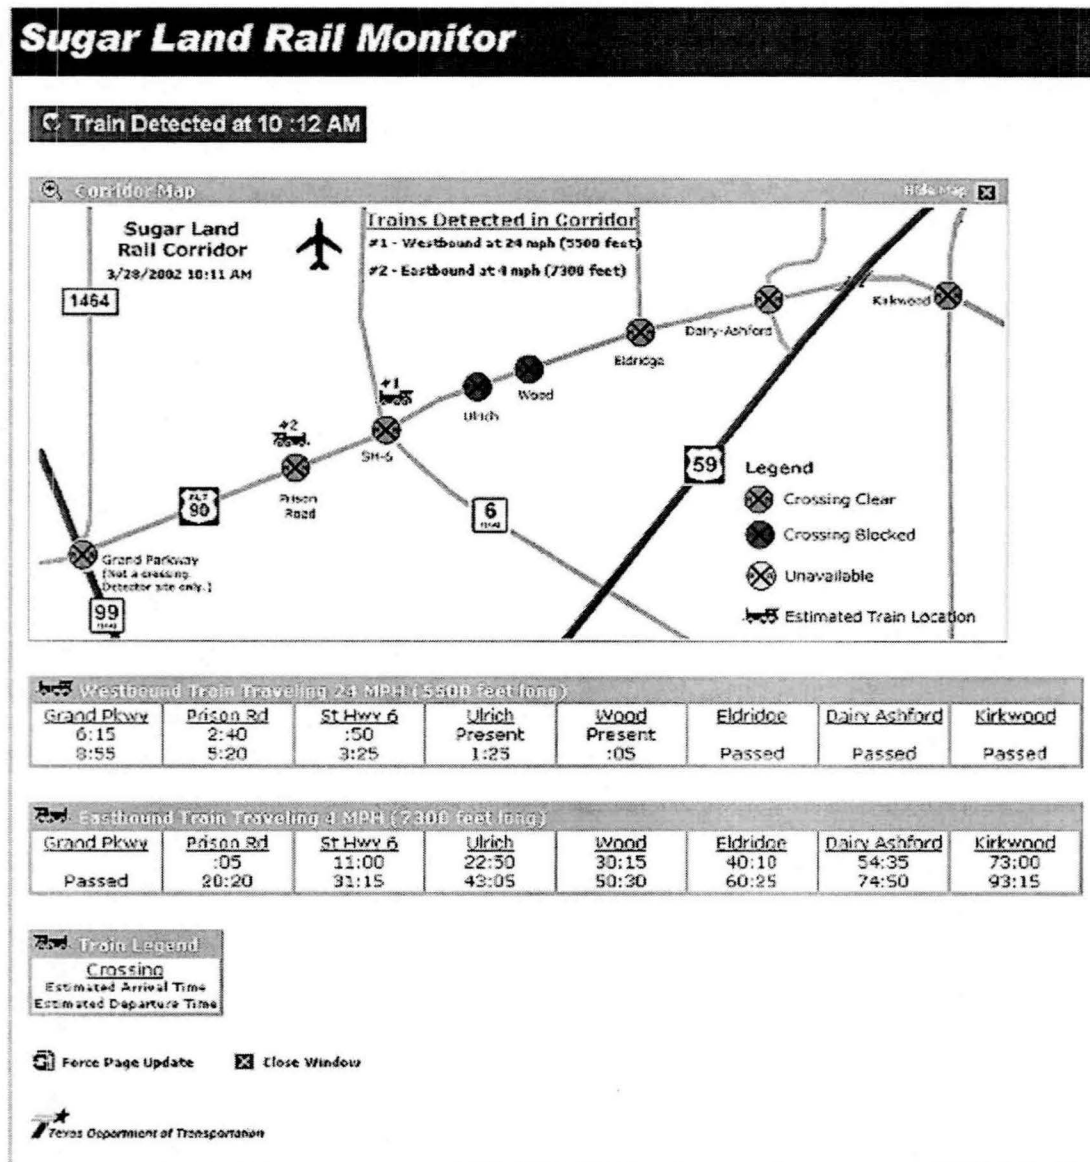
Figure 3. Sugar Land Rail Monitor Kiosk Webpage

The Sugar Land Rail Monitoring System covers the 6.4 mile US 90A rail-highway corridor between Kirkwood and Grand Parkway in Sugar Land, Texas. The adjacent Union Pacific rail line is one of the oldest in the state and hosts, on average, more than 30 trains per day from several railroad companies. The rail monitoring project was developed by the TxDOT Houston District and the Texas Transportation Institute as part of the ITS Priority Corridor Program. The system monitors for the presence, speed, direction, and length of the trains using the TransLink® Rail Monitoring System. The Sugar Land deployment also monitors the grade crossing for closures via traffic signal preemption. Real-time train status and downstream crossing blockage and clearance times are calculated and displayed on a graphic map of the corridor. The corridor status map is available at two Sugar Land fire stations and emergency services dispatch via an Internet kiosk permanently set to the rail monitor webpage. Installation of the train detection stations began in September 2001 with full system testing being completed in early 2002. The system was pronounced fully operational with all field sites and kiosks online in April 2002. The rail monitor webpage is used daily by Sugar Land emergency services to assist in their dispatching efforts. Recently, the rail monitor was made available to the Internet public at large, hosted by the Houston TranStar website (<http://traffic.tamu.edu/rail>).

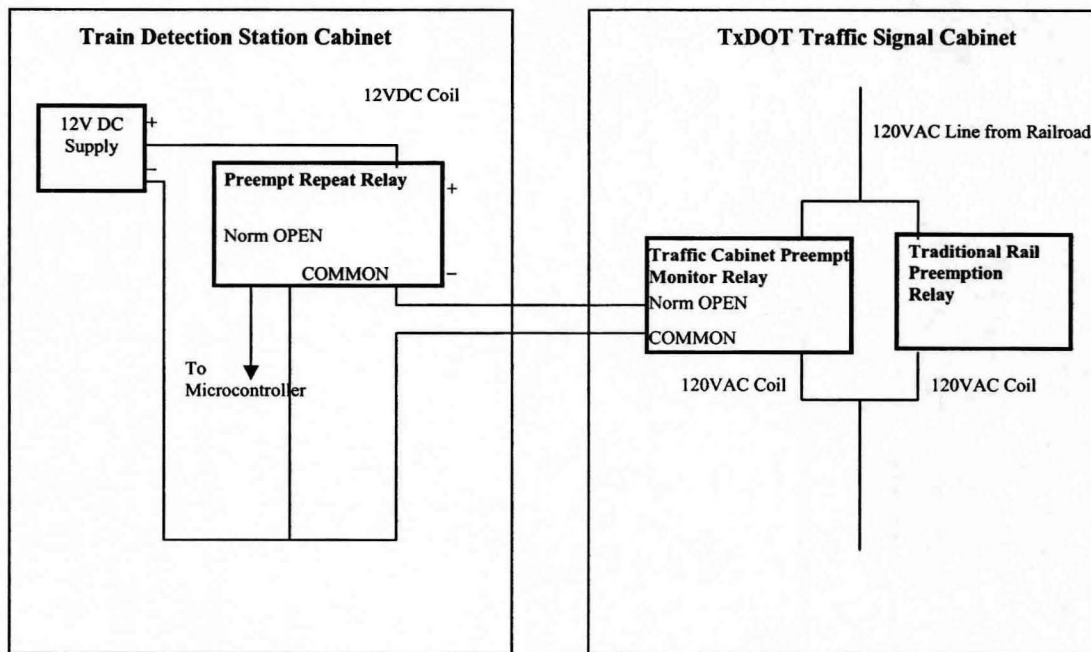
Figure 4. Sugar Land Train Detection Station Preempt Sensing Design.

As part of the system deployment plan, preempts at critical intersections were to be monitored as a positive indication of the grade crossing gates being down. A unified plan among all parties involved was needed for the design of the preempt sense system. The traffic signal preempt would be monitored in the traffic signal cabinet and measured in the train detection cabinet. The two cabinets (traffic signal and train detection) are a significant distance apart, therefore electrical isolation between the two cabinets was needed. The isolation will protect the traffic signal equipment from any possible power surges brought in by the line linking the traffic cabinet and the train detection cabinet. After discussions with TxDOT Houston District staff, the decision was made to sense the preempt using a relay in parallel with the normal train preempt relay in the traffic signal cabinet. The preempt sense relay would have the same 110VAC coil, and its operation and/or availability would in no way compromise the actions of the traffic signal controller. The contacts of the preempt sense relay open or close a copper wire path originating in the train detection cabinet. In essence, the loop provides a "call" on a microcontroller that is easily measured. An additional relay is used in the train detection cabinet to provide extra isolation and to deliver a good logic ground to the microcontroller. The extra relay also gives the ability to "induce" a preempt by simply pulling the relay out of its socket in the train detection cabinet.

All of the train detection stations were built separate from traffic signal cabinets. The train equipment was installed, in most cases, across the street from the traffic signal cabinet, thus, the AC line power and a pair of communication wires (for sensing preempt) were run overhead between the traffic cabinet and the train cabinet. The overhead wires and longer runs made the train cabinet system susceptible to power surges from lightning. The prototype systems in College Station and the installation in Laredo have not experienced problems due to power surges. Equipment in Sugar Land experienced several failures due directly to power surges in the AC lines and communication lines.

It became evident that all the paths into the train detection cabinet needed to be "hardened" to eliminate, or at least greatly reduce, the amount of damage caused by the outdoor environment. Filtered surge protection was applied to the AC line and the twin line for the preempt detection. A lightning suppressor was also installed in line with the CDPD antenna. No equipment damage has been sustained after the cabinets were hardened.
