FIELD PERFORMANCE EVALUATION OF CRAFCO 'ROADSAVER' SELF-LEVELING SEALANT

**Final Report
October, 1998**

Joints have been sealed with CRAFCO Roadsaver in a 61 meter (200 foot) test section on project STP-324(78) (Figure 1). STP-324(78) is located on U.S. Highway 412, east of the City of Woodward, beginning at the intersection of Lakeview drive and extending west (Figure 2).

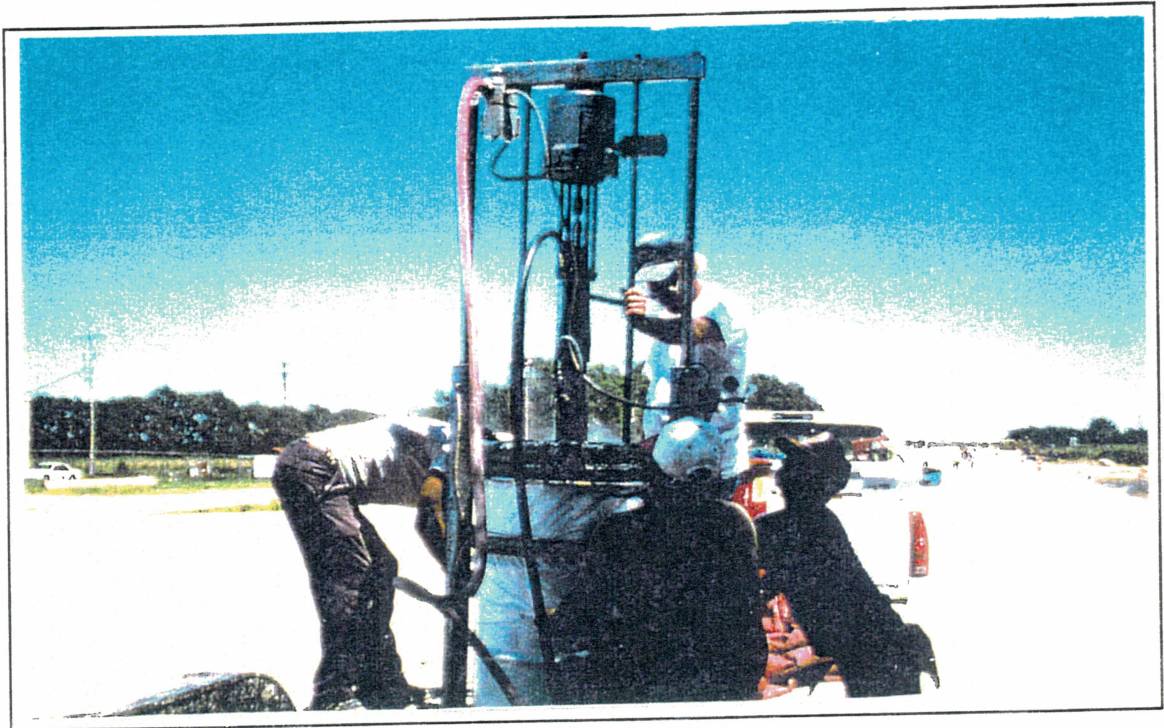
Figure 5. Pyles air powered bulk dispensing machine

During the sealing operation, one worker used a high pressure hose to clean the joints while another worker followed with the sealant applicator wand. The sealant was applied to the joint using a Pyles air powered bulk dispensing machine (Fig. 5) with a hand held wand (Fig. 6) at a slow walk.

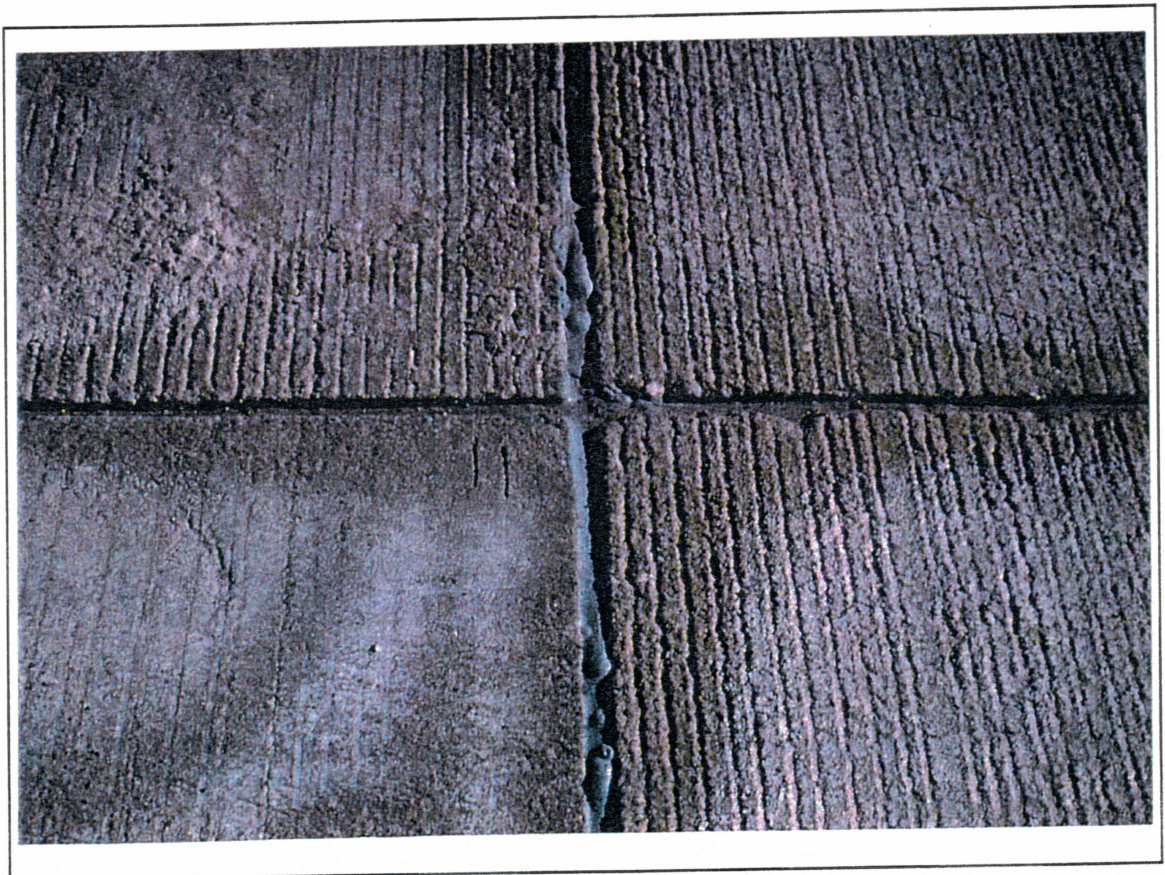
Figure 7. Bubbles in sealant

The day after the sealant was installed a survey of the test joints was made. The sealant seemed to have good adhesion to the pavement. Locations where bubbles had formed were present through most of the test section (Fig. 7). No bubbles had formed in the control section.

Test and control sections were surveyed at six month intervals for three years. No failures occurred during this time. The bubbles noticed after construction were surface in nature and did not seem to cause any problems with the overall performance of the Crafcro product. Performance of the two sealants have been compared on the basis of the number, type, and size of failures occurring and both appear to be suitable for highway joint sealing operations.
