**Deep Learning Based Automated Data Collection Technology for Coastal Highway Pavements**

August 31, 2025

**Final Research Report**

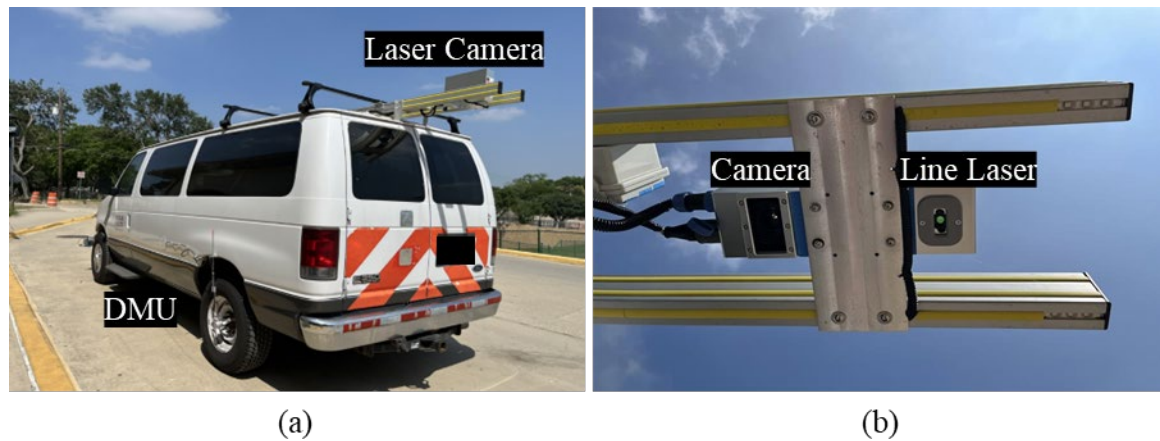
Figure 4. Pavement survey vehicle: (a) Position of distance measurement unit (DMU) and line laser sensor camera; (b) Line laser and camera.

Attached to the vehicle was a HyMIT HY3D4K laser sensor, which would capture visual data of the road surface via 2D images and their respective 3D laser scans as the driver operated the vehicle. A strong line laser was emitted from the sensor spanning 14' across the transverse direction at a longitudinal resolution of 7mm and 1.042mm in the transverse direction. With this, a single image of the pavement surface covers 47' longitudinally and the pixels where distresses were present would return a darker intensity from the rest of the pavement surface while objects

with higher elevation from the road appeared brighter in 3D images. The data was recorded perpendicularly to the direction at which the vehicle was travelling, which minimized the error for distress profiles to be obscured from how the sensor was angled with respect to the surface of these sections. Combined, approximately 45,000 images of pavement surface data were collected across the three states.

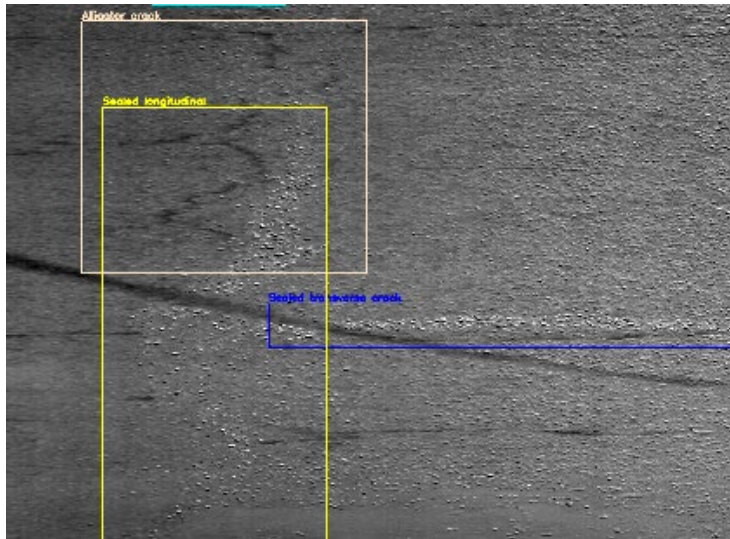
Figure 9: Overlap of distress & non-distress boxes.

image, the types with higher priority and salience were selected for labelling with the annotation boxes. From Figure 9, the event of a distress and non-distress appearing at the same location were labelled accordingly. This meant that if an alligator crack and sealed crack were in the same region, both were annotated with their respective labels. Figure 10 shows the distribution of distresses in both the inland ACP dataset, where 3,855 images have been labeled covering a distance of 34.4 miles, and the coastal ACP dataset, consisting of 2,753 images over 24.5 miles. The most prevalent distresses in both ACP datasets are transverse and longitudinal cracks.

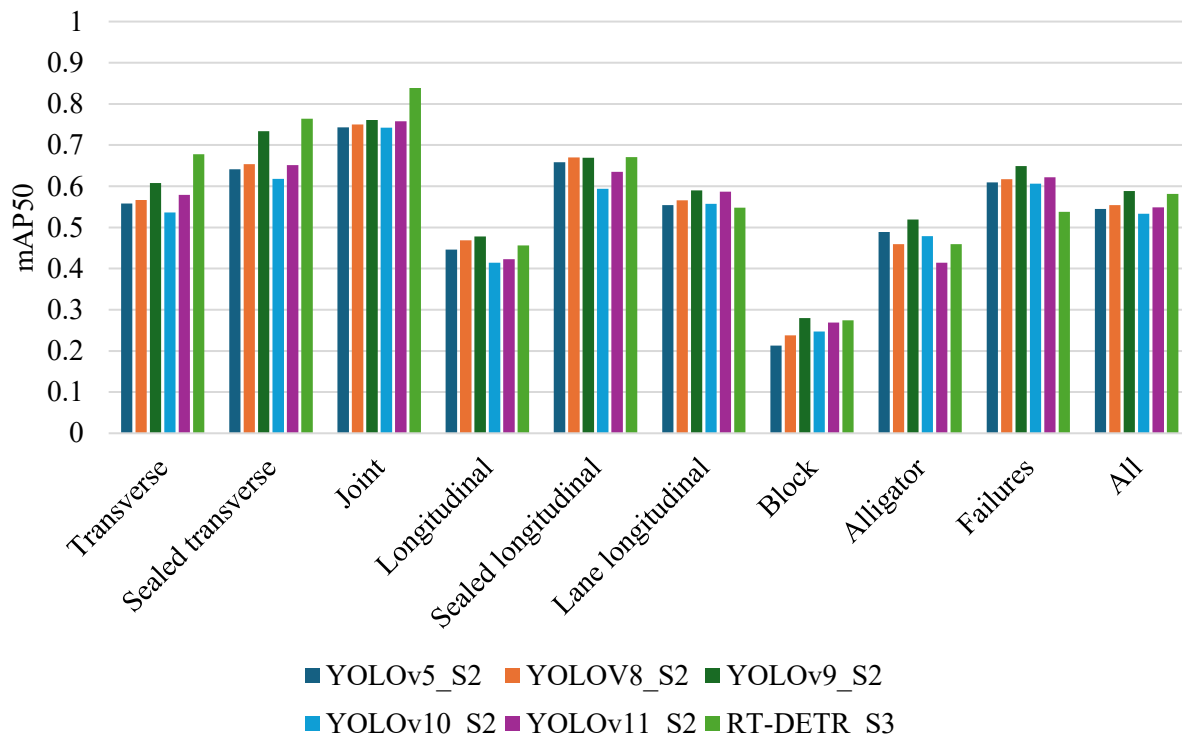
Figure 22. mAP50 scores for each model on inland ACP dataset.

Across nearly every metric for each model, the joints had the highest scores within the selection phase of the study. Their well-defined, linear shape and consistent depth into the ACP surface allowed the DL models to mostly yield scores above 70% with the object class. Sealed cracks and failures were the next highest scoring distresses, scoring above 60% in each metric with the exception of failures in terms of recall. Their appearance in the dataset gave them an advantage over other distresses as sealed cracks would have higher visibility in both image types while failures would present themselves with wider surface areas of darker pixels in 3D images. Transverse and lane longitudinal cracks would obtain precision scores higher than 60% but would only surpass 50% in recall and mAP50. There were several instances of these two distresses in the inland ACP dataset, with transverse cracks having the most labels and lane longitudinal cracks third-most labels of any class.
