Synthesis Report on the Use and Design of Snow Sheds to Protect Transportation Corridors Against Avalanches

1. Report No. CDOT-2020-13	2. Government Accession No.	3. Recipient's Catalog No.	
4. Title and Subtitle Synthesis report on the use and design of snow sheds to protect transportation corridors against avalanches		5. Report Date September 2020	6. Performing Organization Code

SYNTHESIS REPORT ON THE USE AND DESIGN OF SNOW SHEDS TO PROTECT TRANSPORTATION CORRIDORS AGAINST AVALANCHES

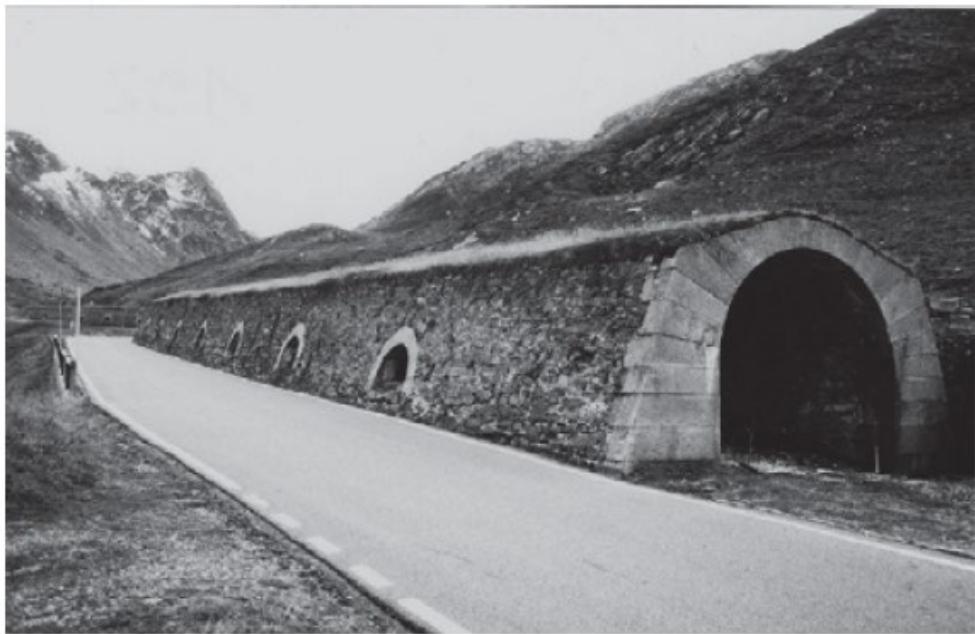
Figure 2: 312m long stone-arched snow shed built at Splügenpass in 1843. The snow shed was in operation until 1950 (Photo: Margreth and Platzer, 2008).

Globally, snow sheds are among the most important permanent mitigation structures to protect transportation corridors from avalanches (Margreth and Platzer, 2008). Snow sheds have historically been constructed using a variety of materials, including: timber, stone, reinforced concrete and corrugated metal pipe (CMP). In the European Alps, snow sheds are among the oldest structural avalanche protection measures, with some of the earliest structures built under the direction of Napoleon between 1801 and 1805 (e.g. Simplon Pass, Switzerland). Some of these structures are still present today (e.g. snow shed on Splügenpass, Switzerland built in 1843) (Margreth and Platzer, 2008) (**Figure 2**).

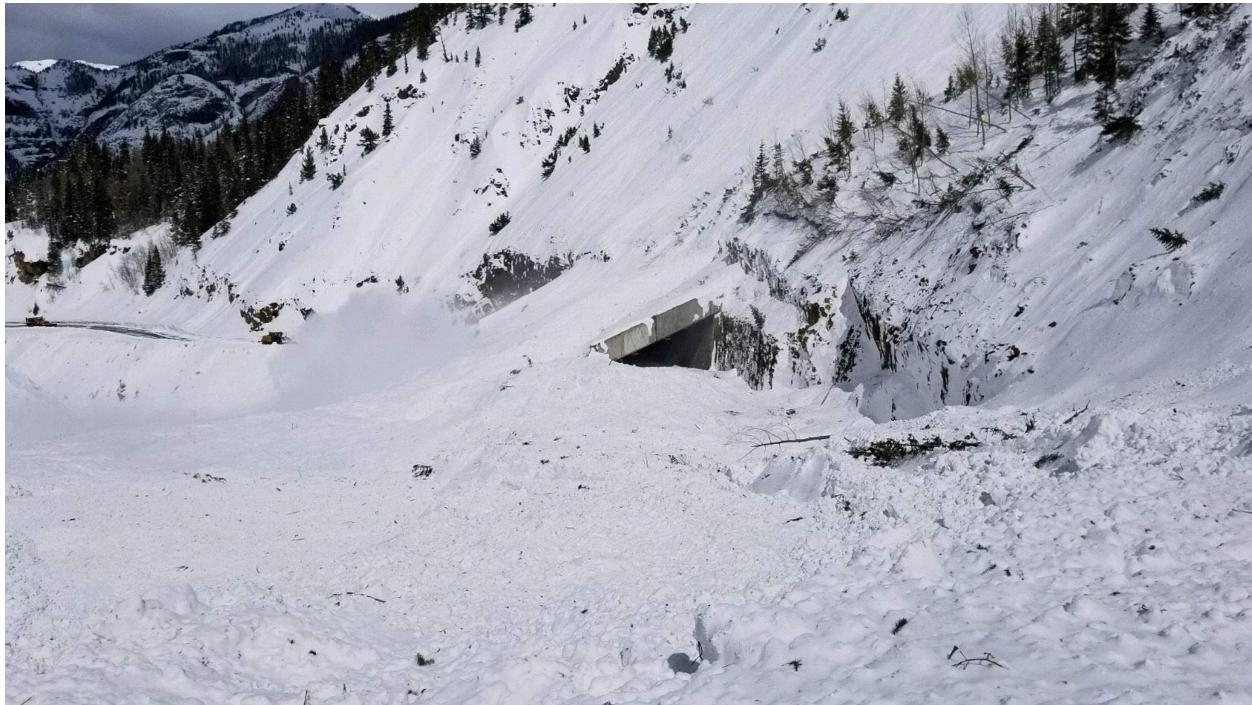
Figure 4: The Riverside snow shed covered in avalanche debris following mitigation work by the Colorado Department of Transportation. March, 2019 (Photo: CDOT).

In March 1992, a small avalanche blocked the highway roughly 100 ft (30 m) to the north of the snow shed, stranding two motorists and two CDOT employees in the snow shed. Two additional CDOT employees were buried by a second avalanche in the same vicinity while clearing the road, and one of them did not survive the avalanche (Mears, 1992b). The Riverside Shed is still in use today. The stretch of Highway 550 between Ouray and Durango crosses 95 avalanche paths, and is managed with forecasting, explosives mitigation, and road closures, in addition to the Riverside Shed. The recent March 2019 avalanche cycle resulted in both portals being over topped and the closure of Red Mountain pass for several months (**Figure 4**).

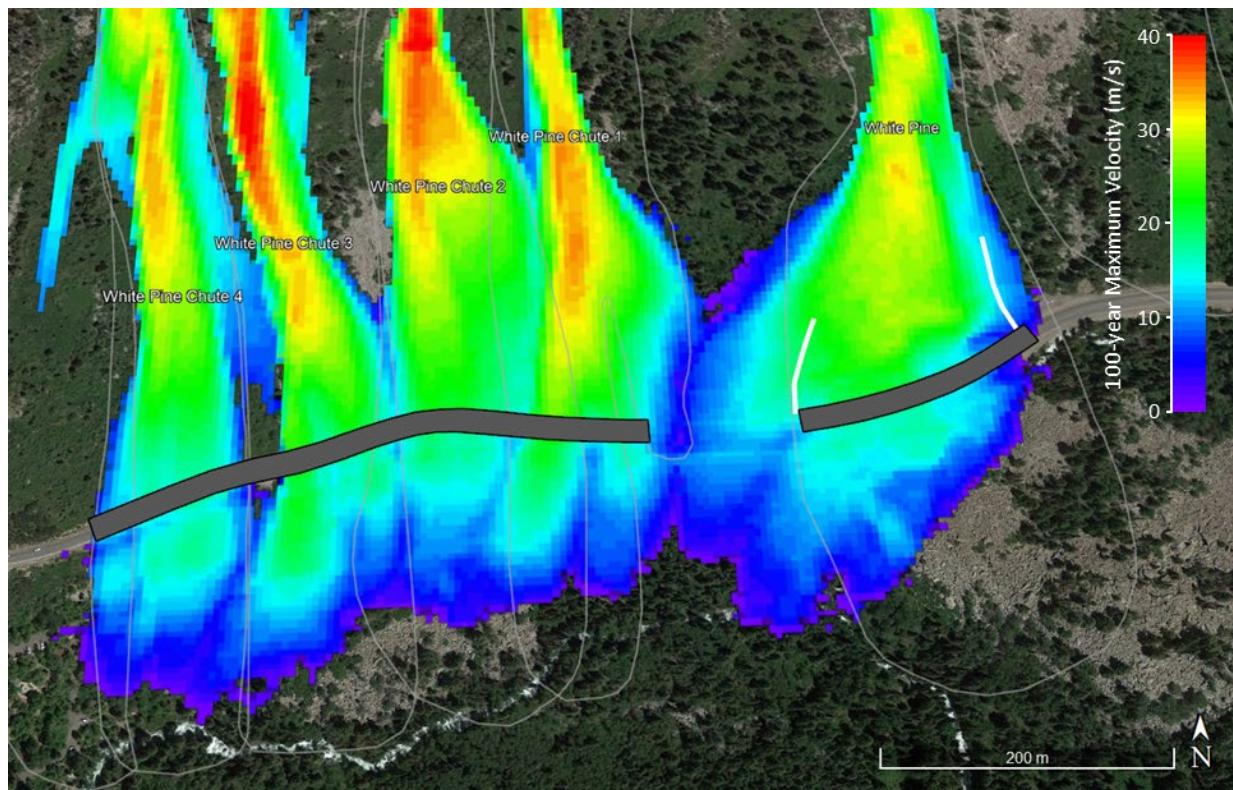
Figure 5: White Pine Chutes 1-4 and White Pine, RAMMS 100-year velocity (m/s), and proposed snow sheds (grey) and guiding berms (white). Light grey outlines indicate the maximum path boundaries according to updated avalanche path mapping (from Dynamic, 2018b)

F&P (2006) and Schaefer (1999) proposed a total of 2485 ft (757 m) for the three snow sheds in the White Pine Chutes 1-3, White Pine and Little Pine avalanche paths. These proposed snow sheds would not mitigate the hazard on White Pine Chute 4. All of these paths are located near mile marker 9, just below the white pines trail head parking area, in the lower canyon. Dynamic (2018b; 2019) used a combination of field-based investigations, historical observations, and RAMMS avalanche modelling and proposed slightly shorter total snow shed length of 2465 ft (751 m) and included mitigation of White Pine Chutes 4. They achieved this with the proposed addition of guiding berms for White Pine and Little Pine paths, which shortens the overall length of the required snow shed and reduces the likelihood of overspills at the portals (**Figure 5**).

Without guiding berms in place, Dynamic (2019) proposed that the snow sheds would need to be longer to reduce the likelihood of overtopping the snow shed entrances. They recommended a total increase of 500 ft (152 m), with White Pine increasing from 640 ft (195 m) to 835 ft (254 m) (195 ft / 60 m increase), and Little Pine increasing from 465 ft (141 m) to 770 ft (235 m) (305 ft / 93 m increase), and no change in length for the White Pine Chutes 1-4 snow shed because guiding berms were not previously recommended, but did recommend a 10 ft (3 m) parapet wall be included on the western end of this snow shed to prevent avalanche snow entering the western portal (from overspills).

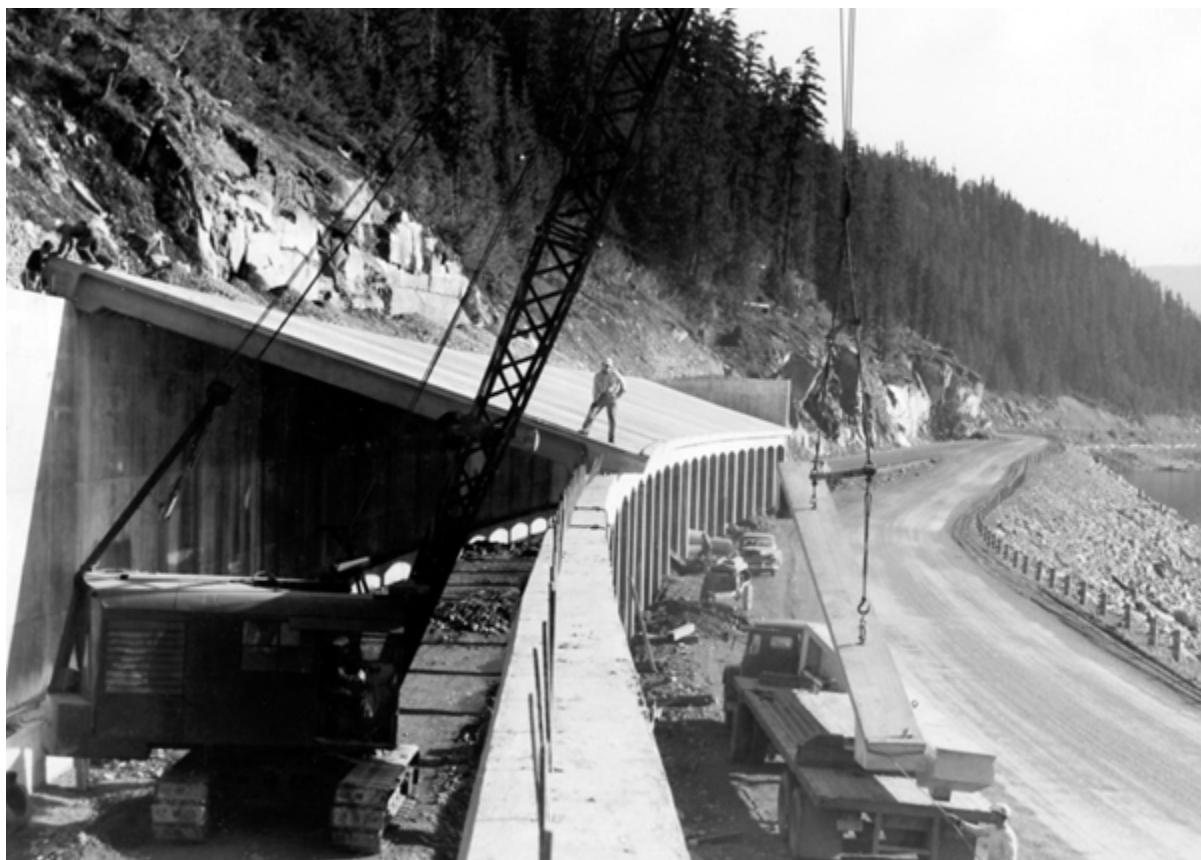
Figure 6: The concrete East Shed was built along Lake Keechelus on I-90 on Snoqualmie Pass in 1950 and now since been removed. (Photo: Washington State Archives³)

\$1.2 million in 1950 (equal to \$12.8 million in 2020, a unit cost of \$84,200/meter or \$25,600/ft) (**Figure 6**). At the same time, the West Shed was built along an area known as Airplane Curve. Both sheds were built to cover both lanes of the two-lane highway at the time. The West shed remained in place until its removal in the early 1980's. The highway was widened to four lanes in the late 1950's, but the sheds remained unchanged. If an avalanche blocked the unprotected eastbound lanes, traffic was re-routed through the East Shed. However, before the implementation of an avalanche forecasting and control program in 1971, it was not uncommon for vehicles to be caught in avalanches prior to road closures. The West Shed was removed as part of a highway improvement project in the 1980's and was not replaced with a modern structure. However, the back wall was left in place, and the fill behind it was removed, resulting in a small but effective catchment dam, which is still currently in use. In 2014, the East Shed was removed and replaced with two three-lane bridges designed to allow avalanche debris to pass under the road (Jones et al., 2014; Wilbur and Stemberis, 2010).

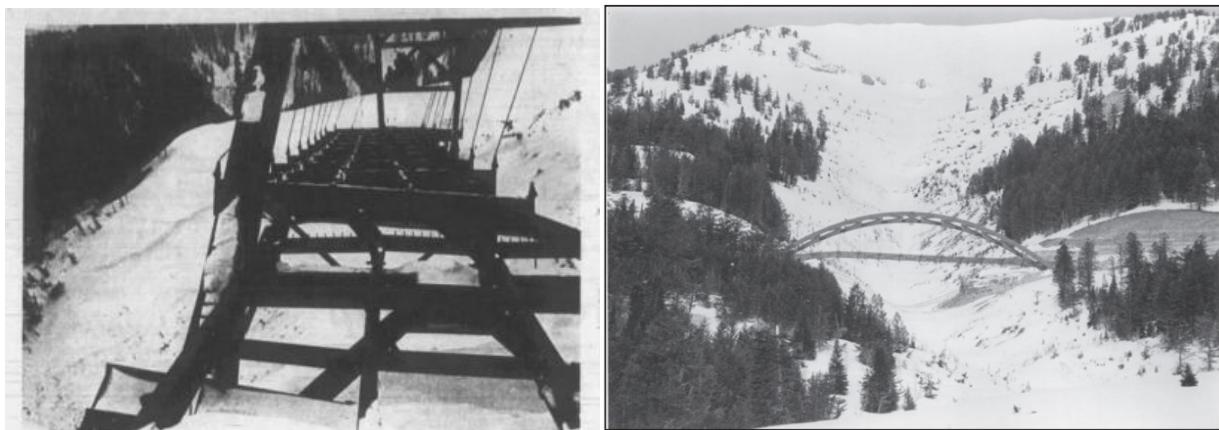
Figure 7: The Crater Lake Bridge over the Glory Bowl avalanche Path, Teton Pass (Photo: Jackson Hole Historical Society and Museum)⁴

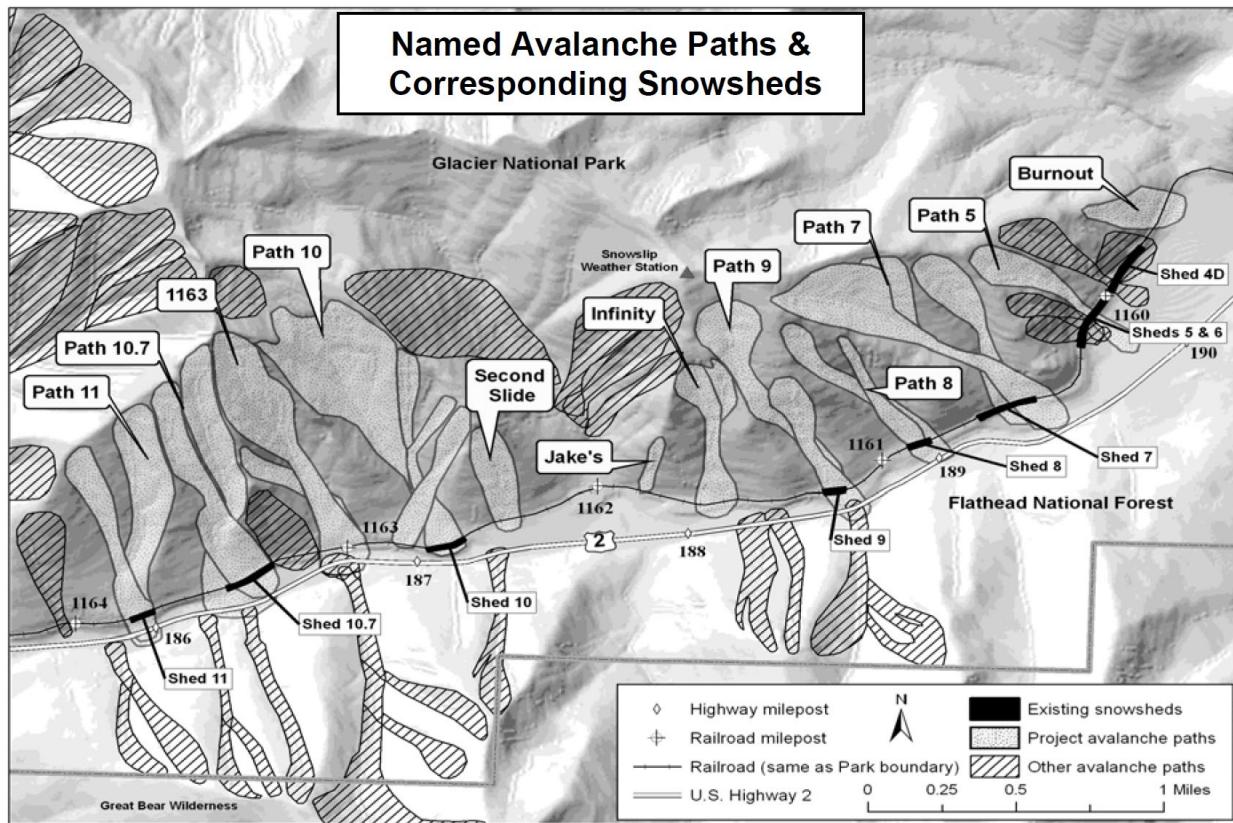
Figure 8: Named Avalanche Paths and corresponding Railway snow sheds (Hamre and Steiner, 2006)

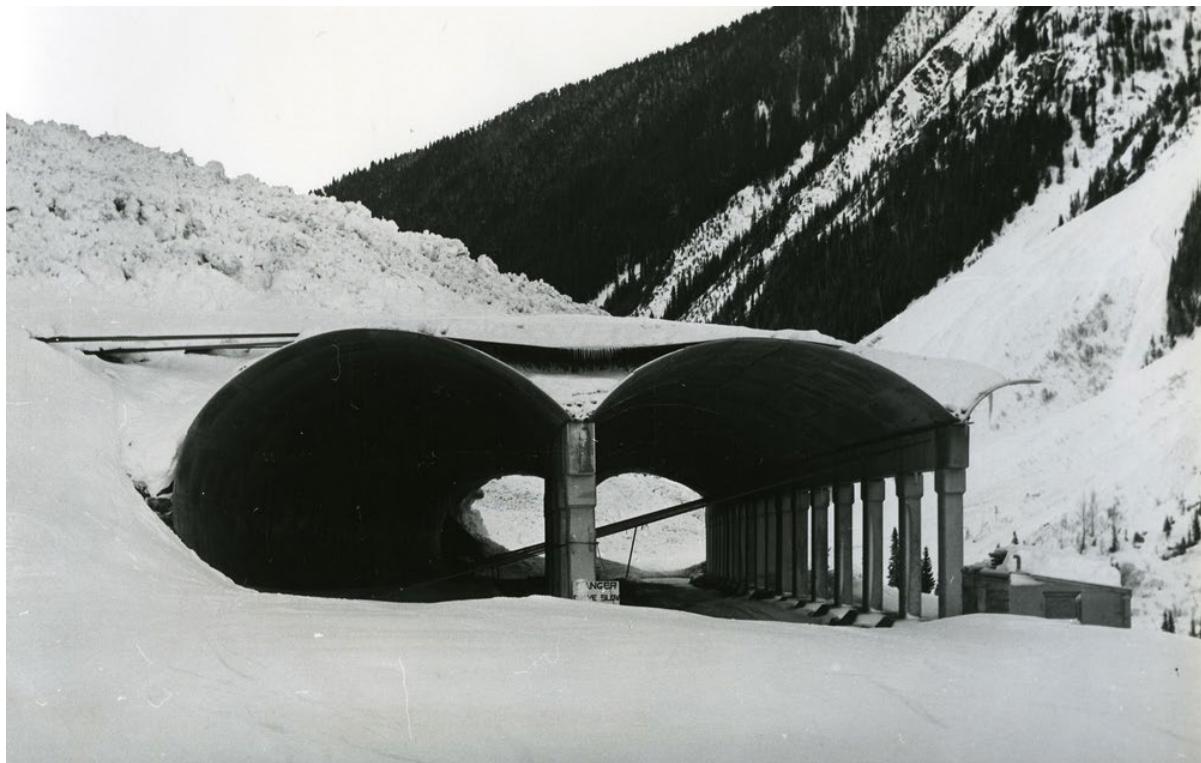
Figure 9: Pioneer snow shed built with multi-plate construction, 1961. This shed was joined with the Tupper #1 shed in 1966 (Photo: Peter Schaeerer⁵).

The original highway through Rogers Pass included six snow sheds because the Pioneer and Tupper #1 sheds were originally constructed as separate sheds. The original layout had approximately 30 m of uncovered highway between the two sheds which created problems for snow removal. The two sheds were joined in 1966 and, while the two parts feature different construction methods, they are now treated as a single snow shed with the common Tupper #1 name.

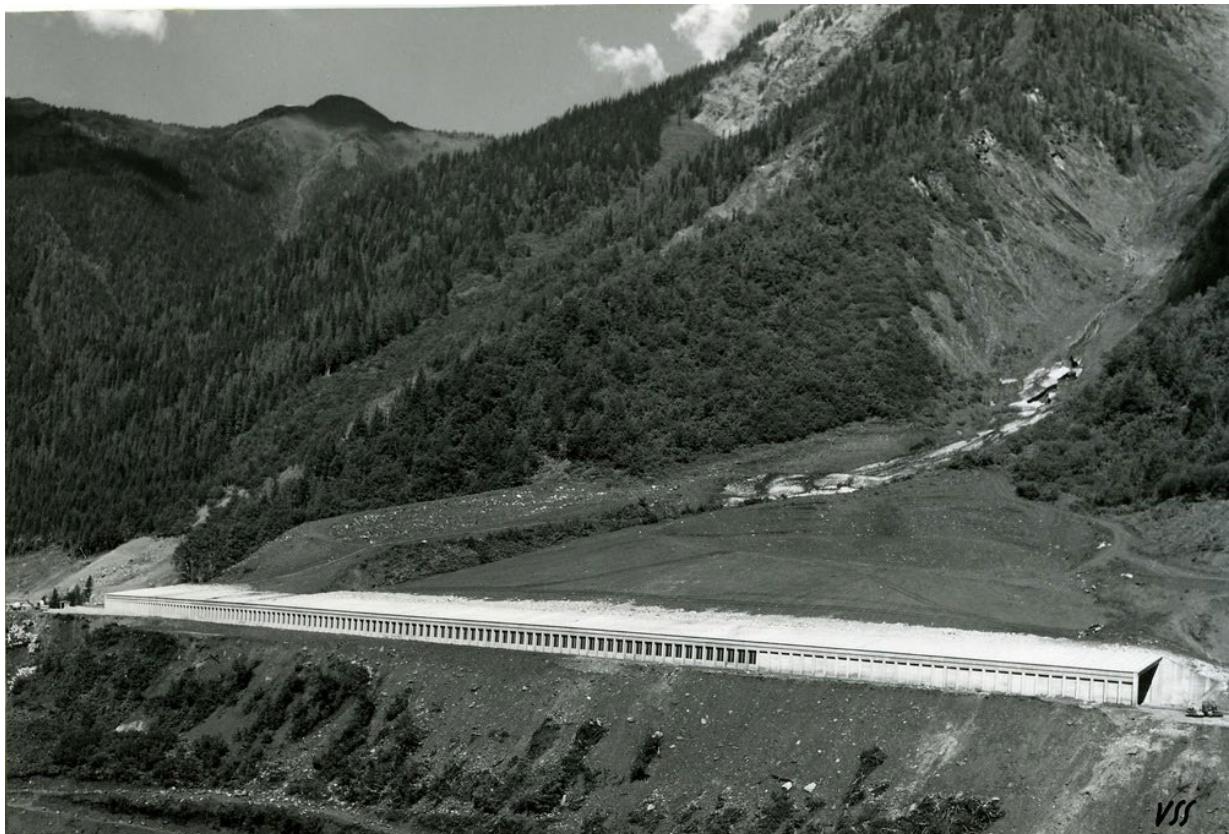
Figure 10: Lanark snow shed built using prefabricated concrete, prior to construction of the wingwalls. Note the guiding berm on the left. (Photo: Peter Schaeerer)⁶

In addition to the five Parks Canada snow sheds on the Trans-Canada Highway through Rogers Pass, three snow sheds are located immediately west of the GNP western park boundary. These three sheds are owned and maintained by the BC MoTI: Lanark, Twin and Jack McDonald Snow Sheds (**Figure 10**).

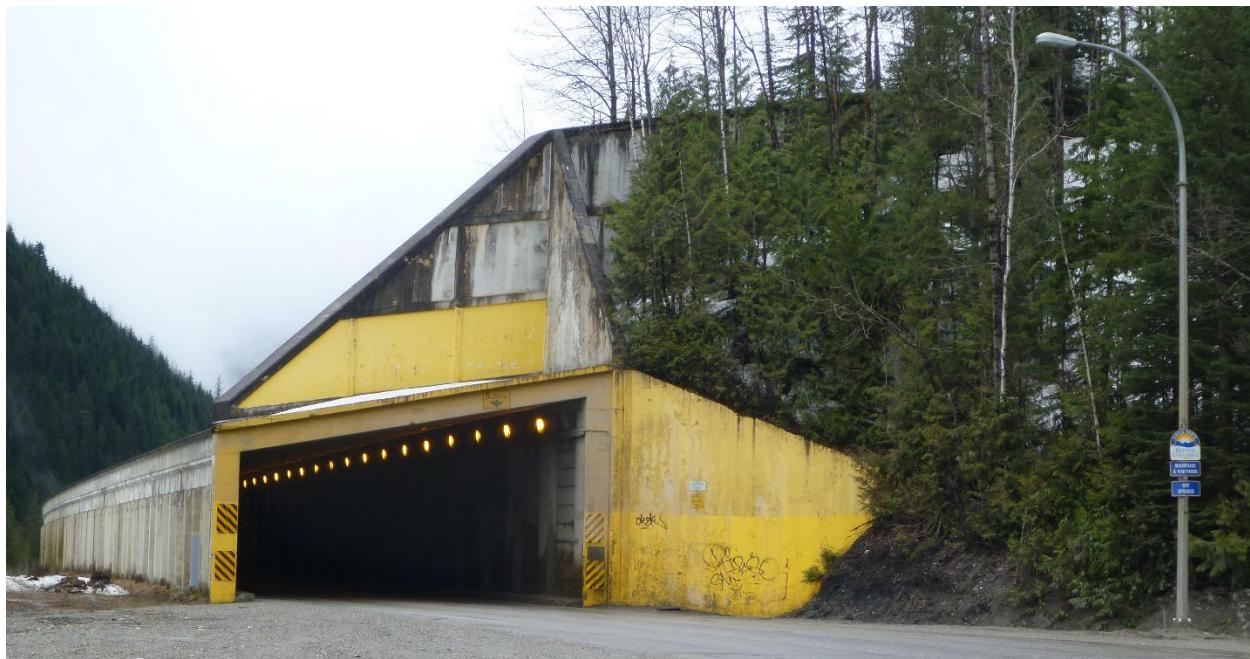
Figure 11: The cantilevered wing walls on the Lanark snow shed were constructed after the construction of the snow shed. The structures of the wing walls are independent from the shed structure and the additional load from the walls does not affect the snow shed (Photo: Alan Jones).

While well-designed, and based on all of the information at the time, real-world experiences resulted in some unexpected challenges – examples include the 1 Jan 1963 avalanche event on Lanark snow shed that resulted in both portals / entrances being overtapped, trapping two cars and several people inside. This resulted in revisions to the snow shed design and in 1964. Tall concrete containment wing walls were added above both entrances of the Lanark shed (Woods, 2014). These wing walls were built using cantilevered methods so that the structure of the walls are independent from the shed structure, and the additional load from the walls does not affect the snow shed (**Figure 11**).

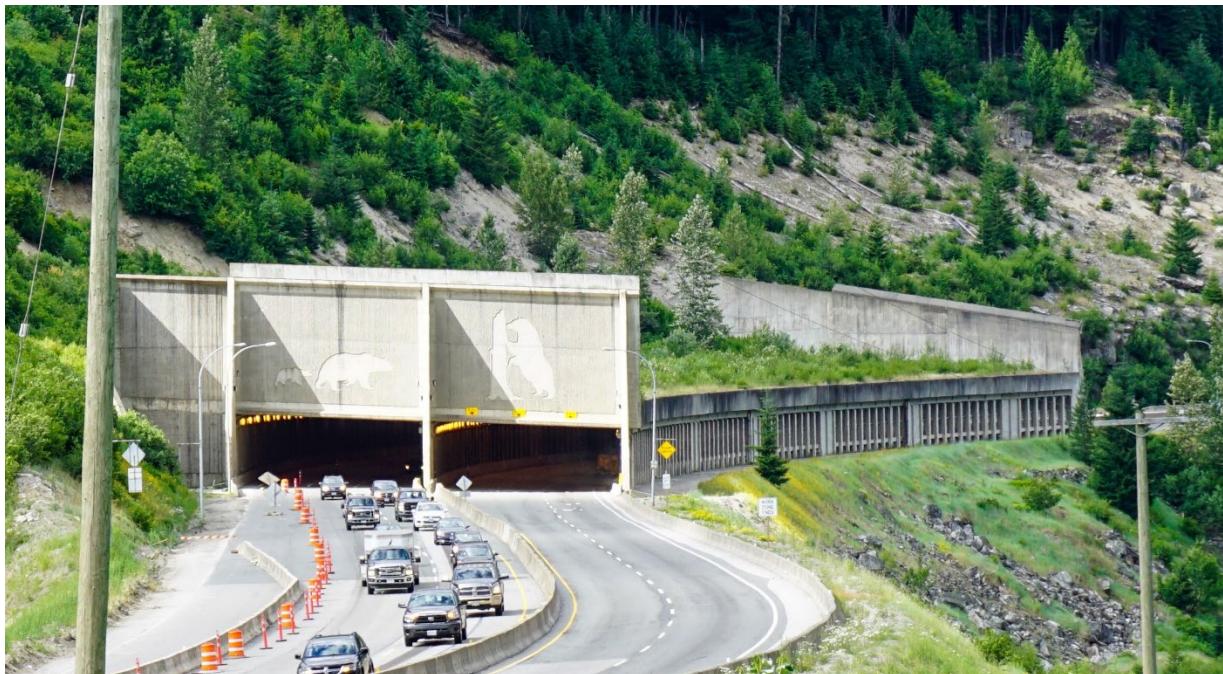
Figure 12: Great Bear snow shed, Coquihalla Highway 5, British Columbia, Canada. Photo is looking eastwards, with steep (8%) grade requiring eastbound trucks to have chains, which increases wear on the roadway surface (and has exposed heat coils). Note the significant horizontal curve which results in super elevation of the highway grade (Photo: Ryan Buhler).

The shed was originally constructed with an electric heating system (coils) under the concrete road slab; however this system resulted in melting and freezing of water and icing problems, and was thus turned off after several winters of operation. Additionally, there were noted issues of truck chains and snow plow blades wearing down the concrete slab and exposing heating coils.

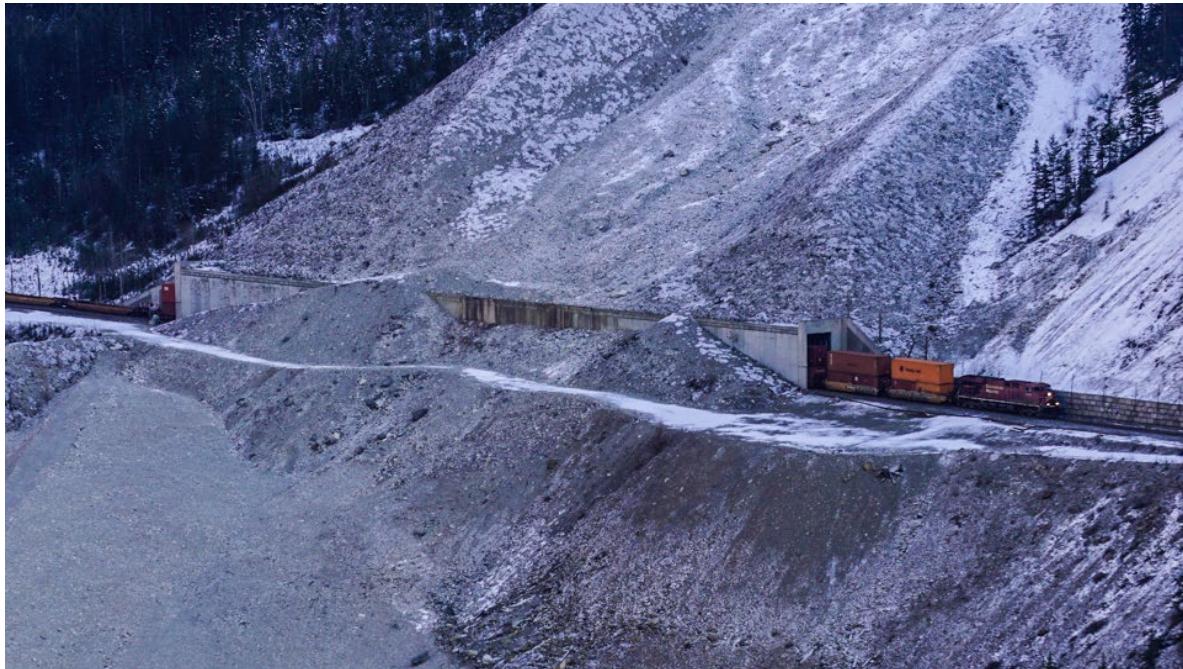
Figure 14: Mt. Stephen snow shed in Yoho National Park, British Columbia, Canada. The shed protects the railway from avalanches, debris flows, and icefall hazards. Avalanches pass over the railway track and affect the highway (Photo: Ryan Buhler).

al., 2006; Hungr, 1986). Concrete retaining walls were added at each portal to keep debris from spilling onto the track. It was designed to protect the railway from debris flows and icefall hazards as well as avalanches. Upslope guiding berms direct the avalanche flow over the snow shed (**Figure 14**).

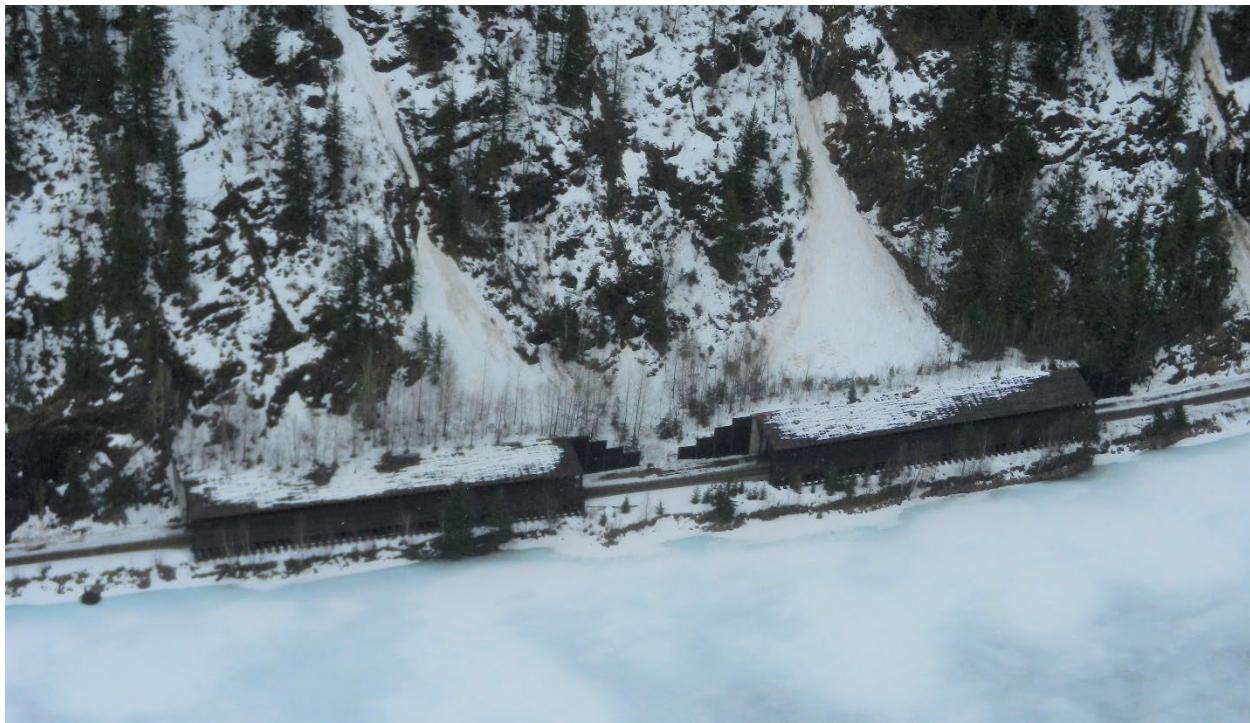
Figure 15: Two wood structure snow sheds that protect the Canadian Pacific Railway at Three Valley Gap near Revelstoke, British Columbia, Canada. Avalanches flow across the shed onto the lake, currently frozen in this photograph (Photo: Alan Jones).

West of Revelstoke, BC, in the Three Valley Gap area are two CPR snow sheds which are constructed with concrete upslope retaining walls, wood structures and metal roofing (**Figure 15**). These are likely the only remaining wood-structure avalanche snow sheds in Canada. Further details for all of these snow sheds are presented in **Appendix A**.

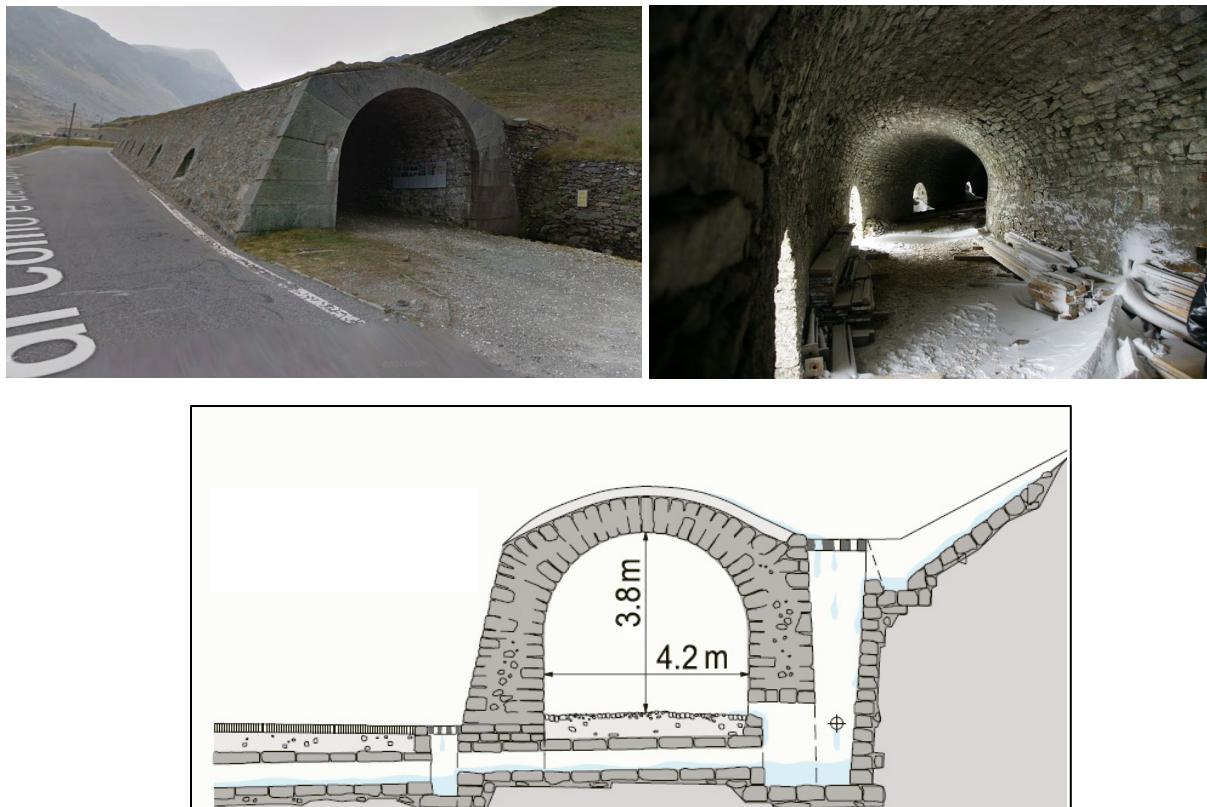
Figure 18: Snow arch snow shed on Splügenpass (constructed 1843 – 1846, length 312 m) as viewed from the outside (Photo: Google Earth, 2020⁸), the inside and the cross section (Photo and cross section: Denkmalpflege / Monument Preservation des Kantons Graubünden, Switzerland)

Stone Arch: A stone or rock arch is an older style of snow shed, which is generally no longer used. The snow shed on Splügenpass is an Alpine mountain pass of the Lepontine Alps is an example of a stone arch snow shed. The snow shed is located on the pass road that connects the Swiss, Grisonian Splügen to the north with the Italian Chiavenna. Since the opening of the San Bernardino road tunnel in 1967, the pass has lost its former importance, and is no longer kept open in winter. In 1843, a 312 m (1,024 ft) long avalanche gallery was designed and built, but today is out of use albeit largely preserved. This rock arch snow shed covered the lateral extent of the avalanche path, and included windows on the downslope side for lighting and ventilation. While no longer in use, this snow shed / gallery design is a good example of a stone arch, and provides the basis of subsequent snow shed designs throughout the Alps (**Figure 18**).

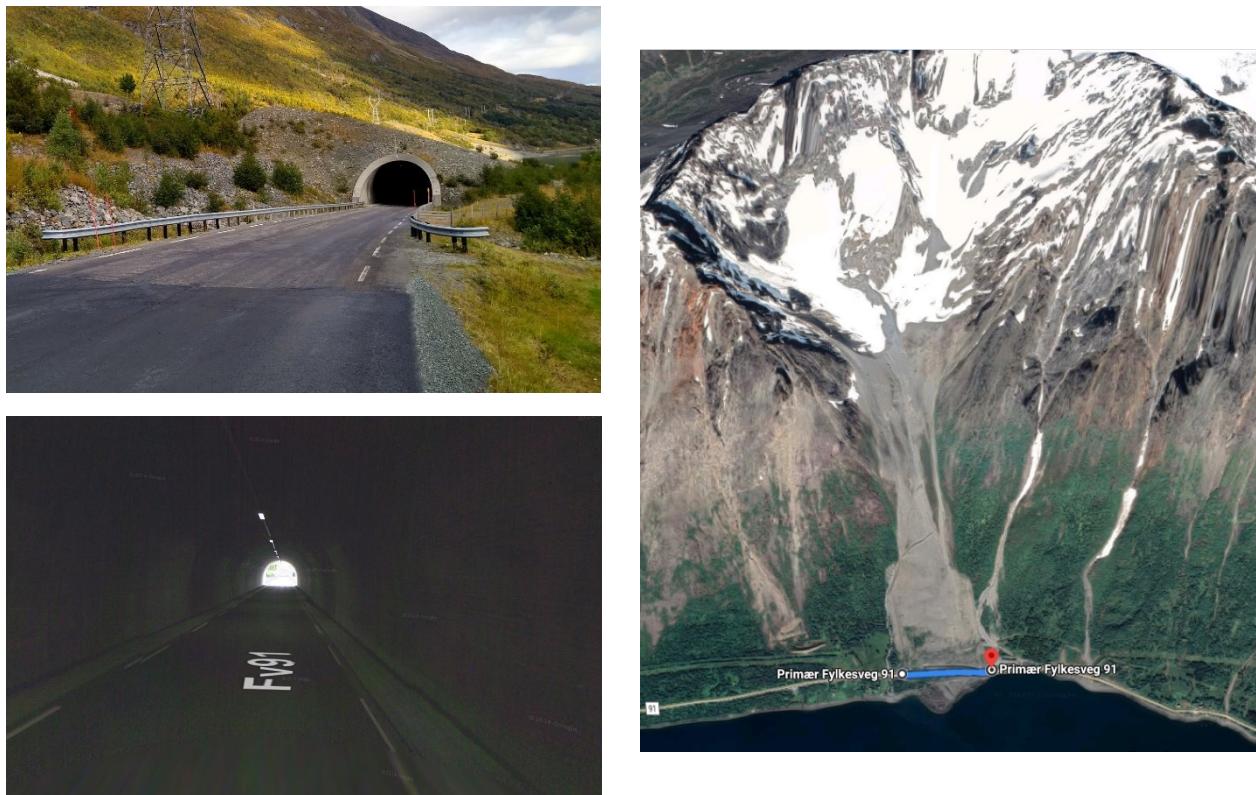
Figure 23: A snow shed near Svensby, Lyngen, Norway using a pre-cast concrete arch and backfill design. The guiding berm can be seen in the Google Earth Image Photo: Jordy Hendrikx and Google Maps, 2020¹⁴

The snow sheds along the Fv91 road near Svensby, Lyngen, Norway are good examples of pre-cast concrete arch design, with similar 320 m and 160 m snow sheds located within 1 km of each other. The longer snow shed also has guiding berms to protect both portals (**Figure 23**). Neither of these two snow sheds have mechanical ventilation, but both have artificial lighting.

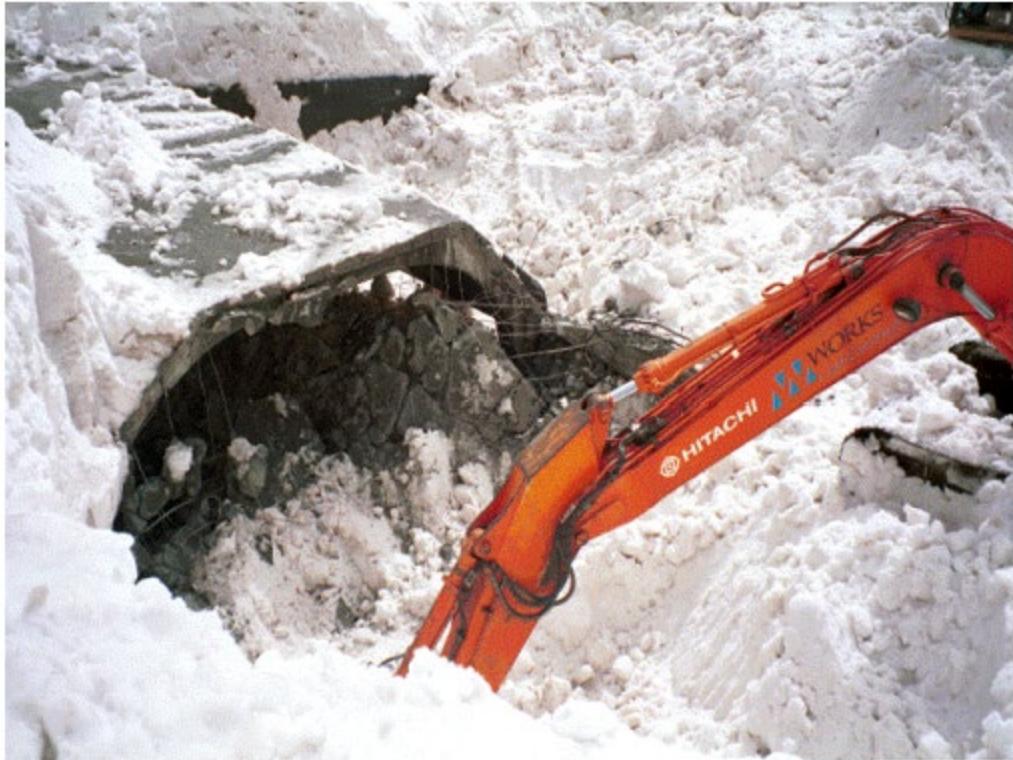
Figure 28: An avalanche on October 7, 1996 damaged the east portal of Homer tunnel. Impact pressures of 650-700 kPa were estimated, and resulted in damage to the reinforced-concrete portal structure (Conway et al., 2000).

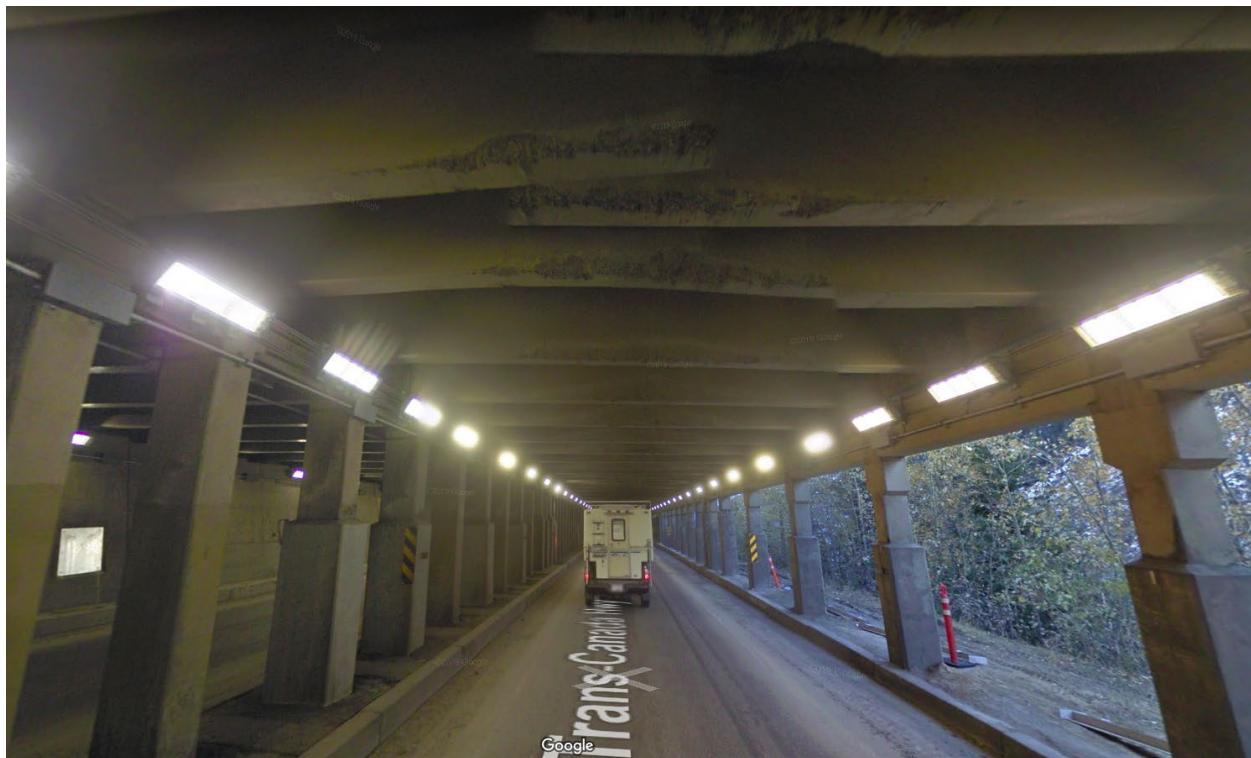
Figure 32: Overhead damage to the Tupper #1 snow shed has occurred where the original metal arch-shaped Pioneer shed joins the flat-roofed concrete Tupper #1 shed (Photo: Google Earth, 2020).

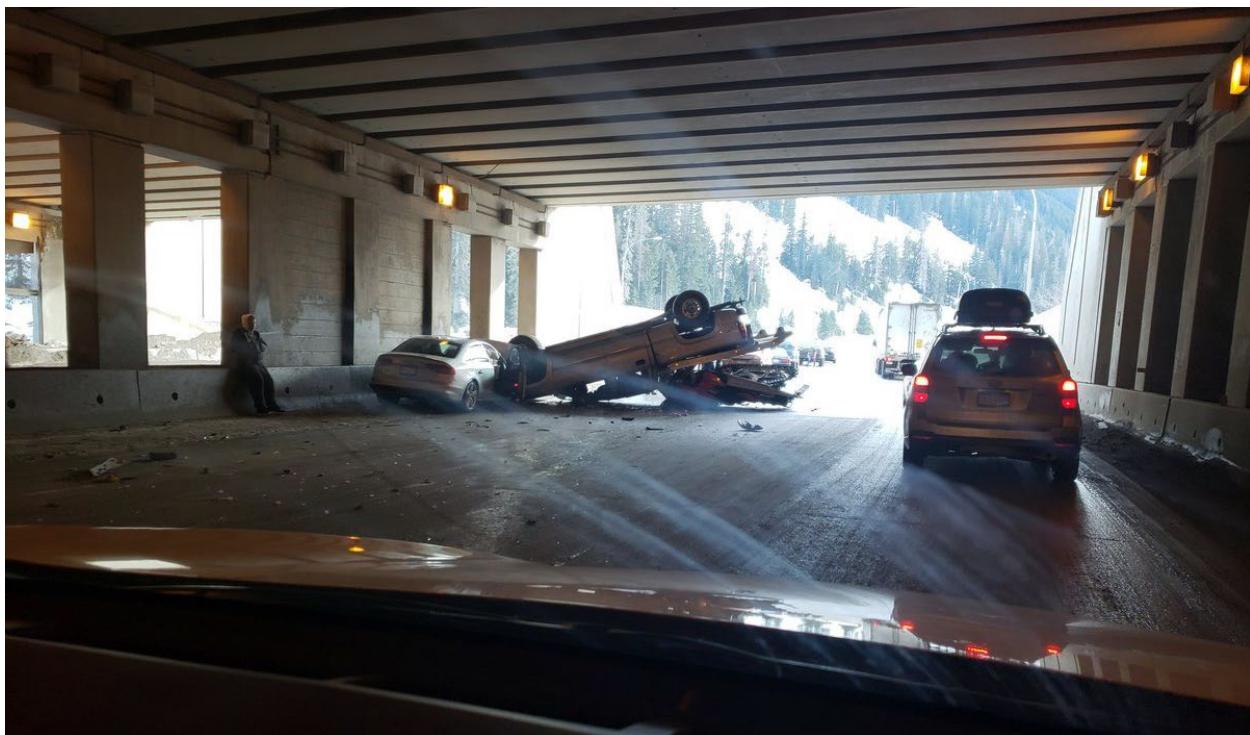
Figure 33: In March 2019, icing in the Great Bear snow shed lead to a five-vehicle collision which sent two people to the hospital (Photo: Global News, 2019)³¹.

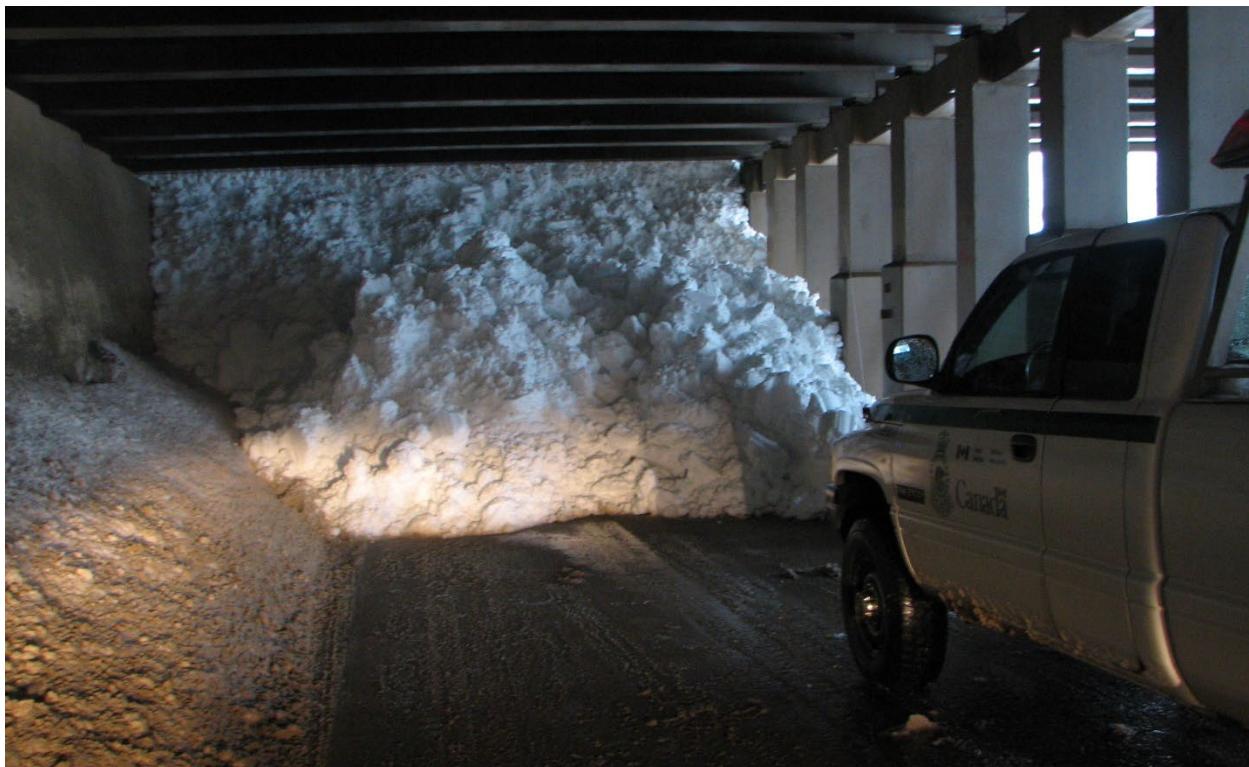
Figure 34: A 2007 overspill in the Tupper #1 snow shed completed blocked the shed portal and caused a lengthy road closure while the deposit was removed.(Photo: Parks Canada).

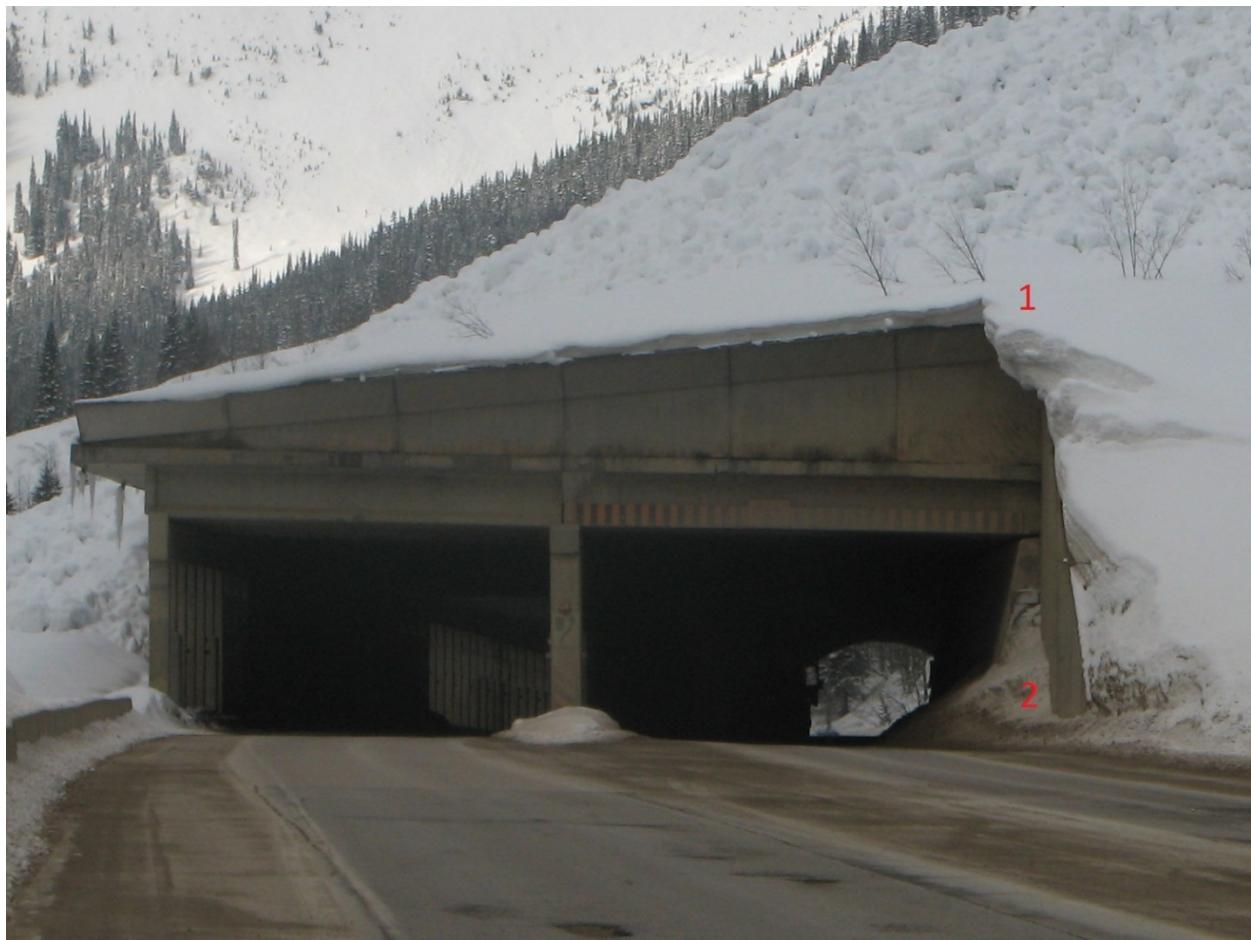
Figure 35: Two snow shed maintenance issues: (1) overhanging cornice snow and (2) snow accumulation at the portal (Photo: Alan Jones)

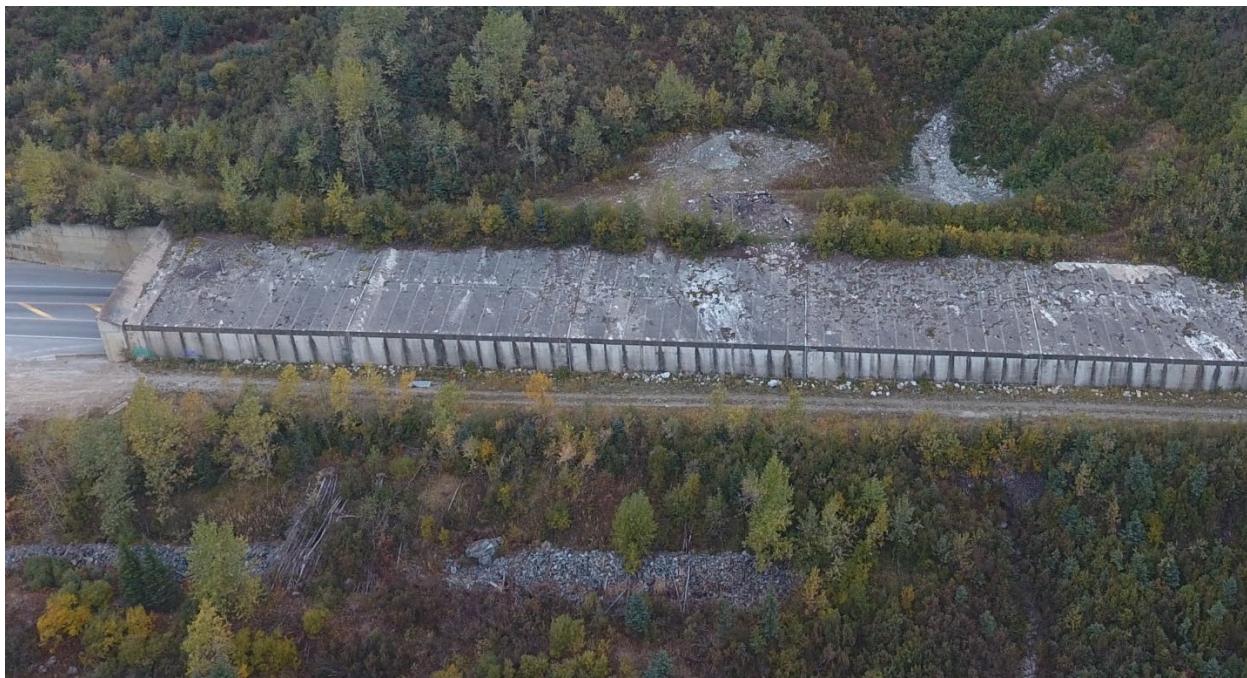
Figure 36: Single Bench snow shed in Rogers Pass, BC showing evidence of debris and rockfall impacts on the concrete roof slabs (Photo: Dynamic Avalanche Consulting)

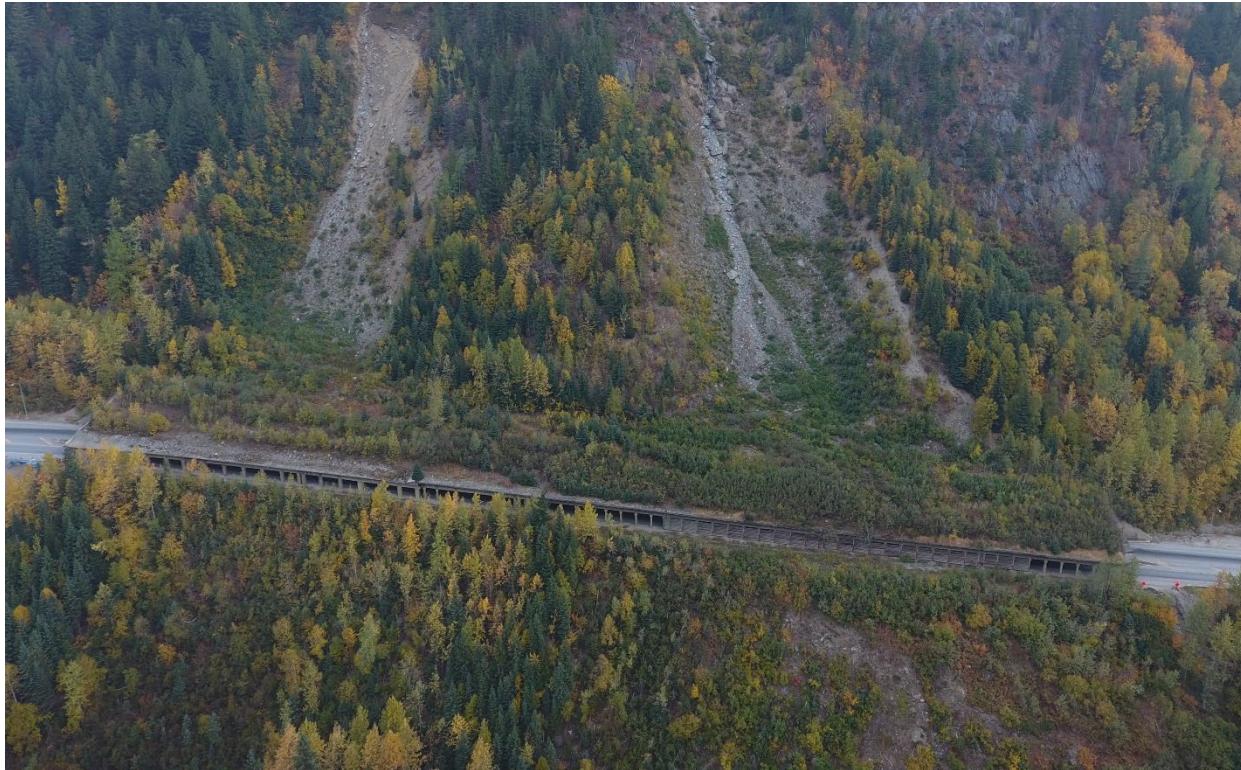
Figure 37: Debris and vegetation accumulation on top of the combined Tupper #1 (right) and Pioneer (left) snow sheds observed in 2017. A major shed rehabilitation program by Parks Canada has removed this debris and improved the management of surface and subsurface water (Photo: Dynamic Avalanche Consulting).
