Synthesis Report on the Use and Design of Snow Sheds to Protect Transportation Corridors Against Avalanches

1. Report No. CDOT-2020-13	2. Government Accession No.	3. Recipient's Catalog No.	
4. Title and Subtitle Synthesis report on the use and design of snow sheds to protect transportation corridors against avalanches		5. Report Date September 2020	6. Performing Organization Code

SYNTHESIS REPORT ON THE USE AND DESIGN OF SNOW SHEDS TO PROTECT TRANSPORTATION CORRIDORS AGAINST AVALANCHES

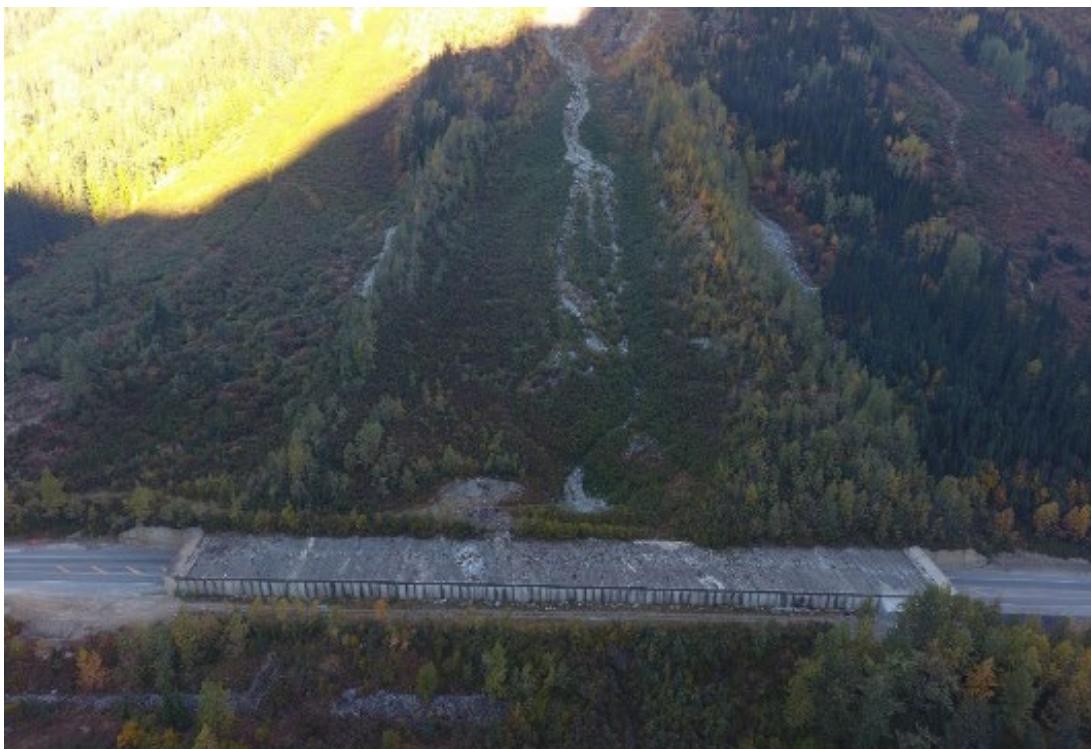
Figure 40: Single Bench avalanche path above the Single Bench snow shed. Single Bench avalanche path is the main path in the center of the photo, directed over the shed and confined by lateral guiding berms. The Mounds avalanche path is immediately west (photo left) of the shed. The Crossover avalanche path affects the shed from the opposite (south) side of the valley, requiring protection of the downslope shed wall (Photo: Dynamic Avalanche Consulting)

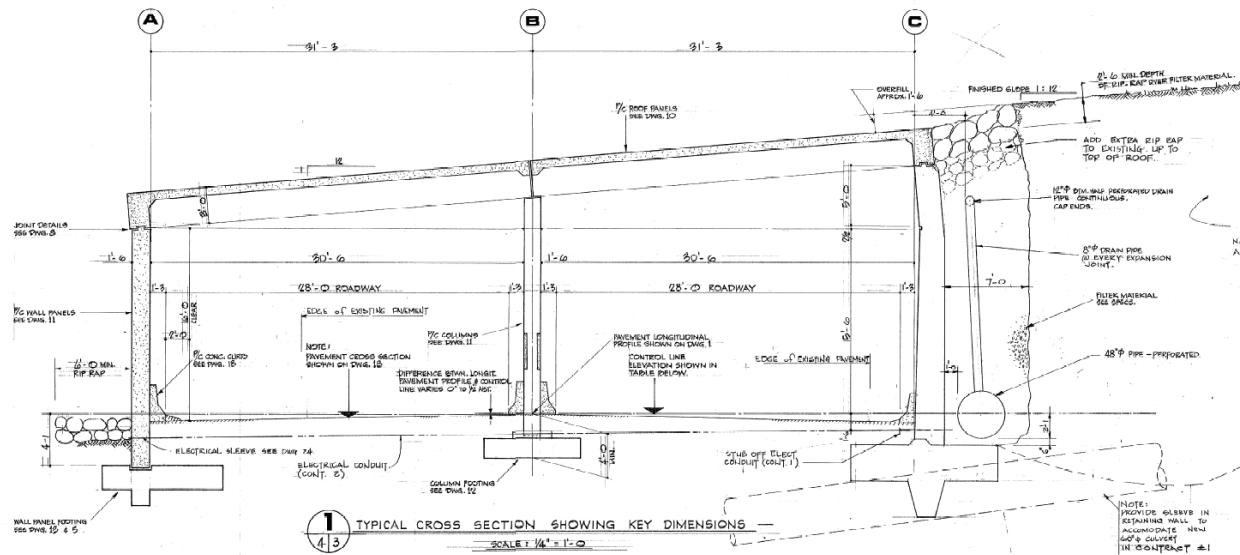
Figure 42: Single Bench snow shed typical cross section (Source: Parks Canada Agency)

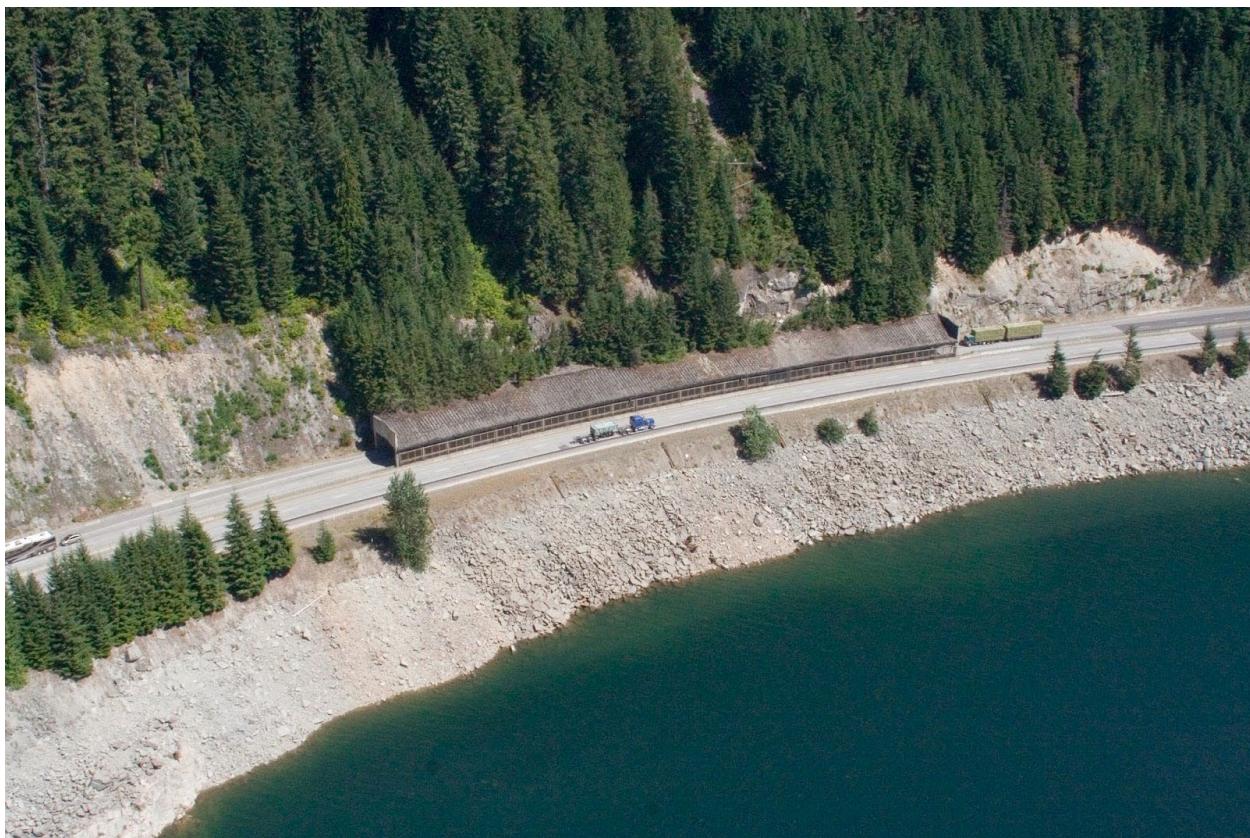
Figure 43: Aerial view of the East Shed in summer prior to its removal, showing the exposed east bound lanes, and covered west bound lanes. (Derrey, 2014)

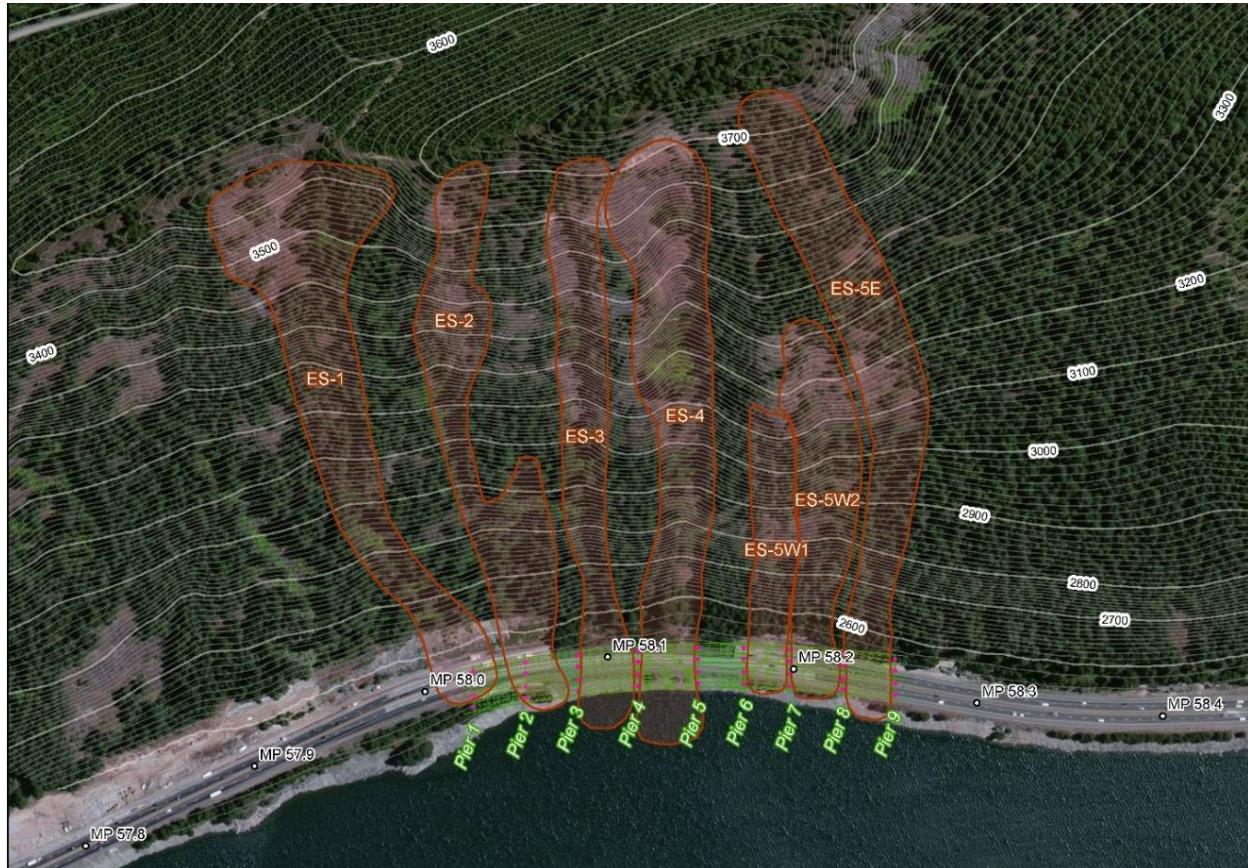
Figure 44: East Shed project area overview showing location of current highway, Keechelus Lake, seven East Shed avalanche paths, and proposed locations of bridges (green lines) and piers (pink dots) (from Jones et al., 2014)

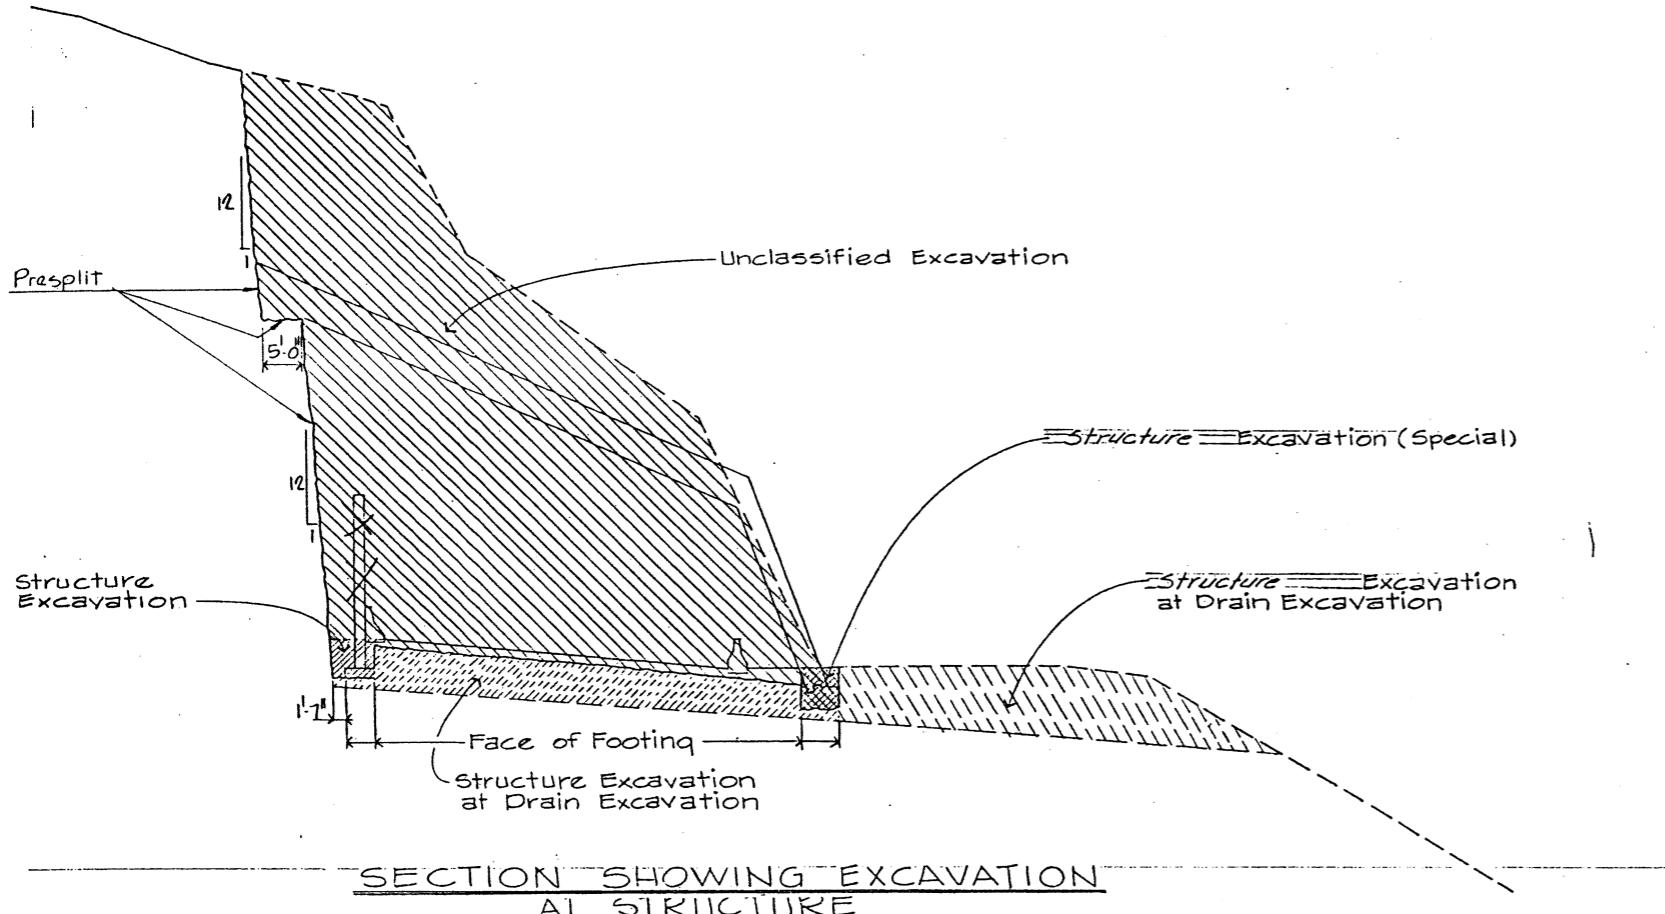
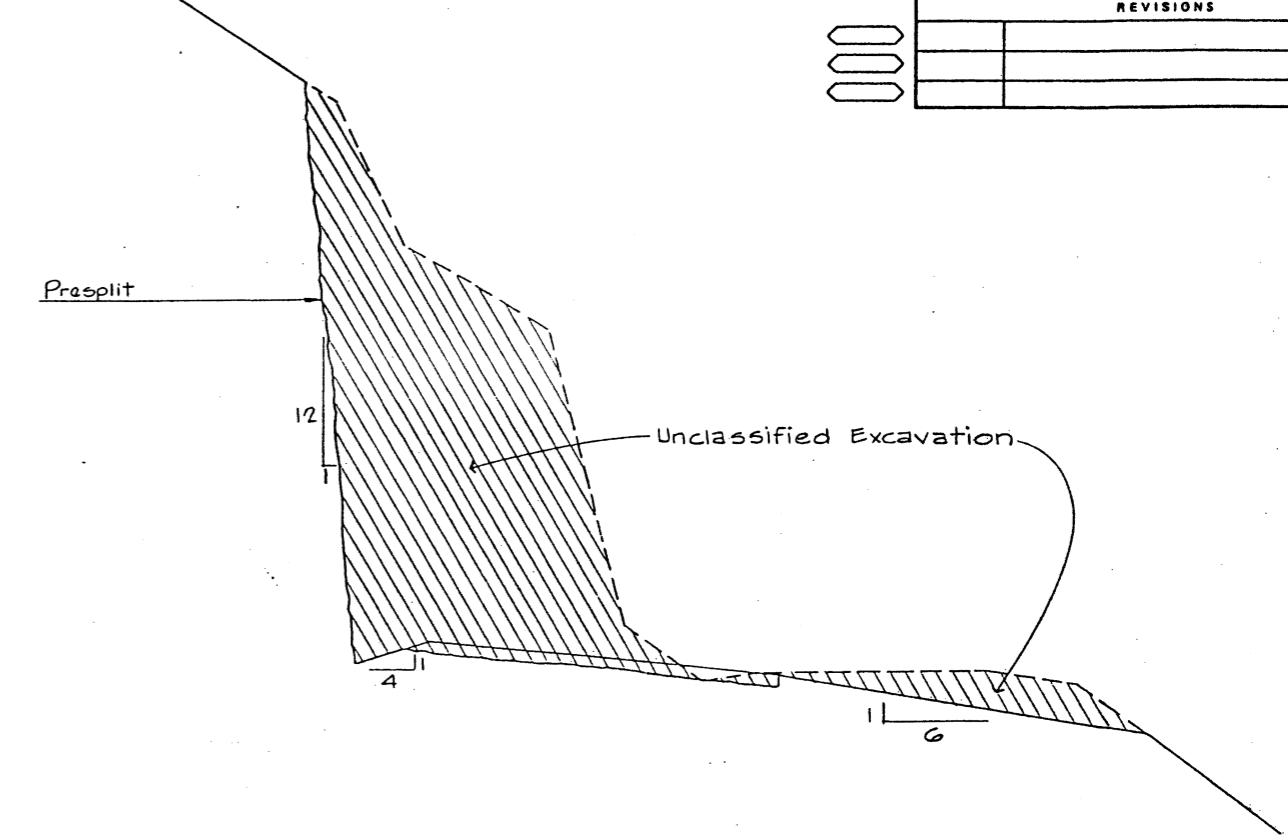
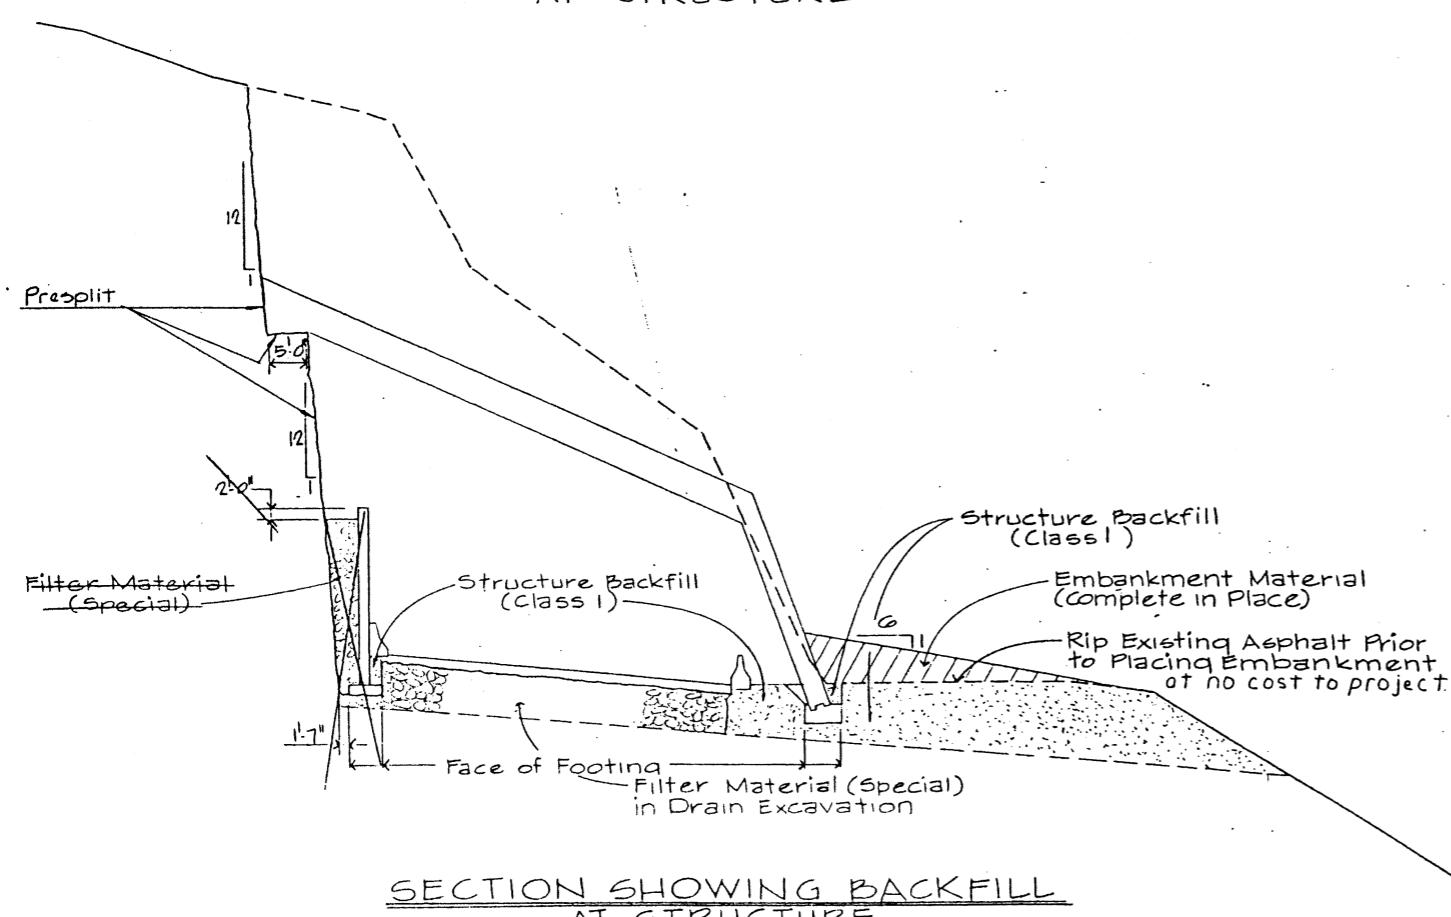
DIVISION OF HIGHWAYS	
PHASE 1	
EXCAVATION & BACKFILL	
SECTIONS	
Designer <u>D. WEIR</u> Detailer <u>M H</u>	Structure Numbers <u>M-06-AG</u>
Drawing Number B 17 of 18 Drawings

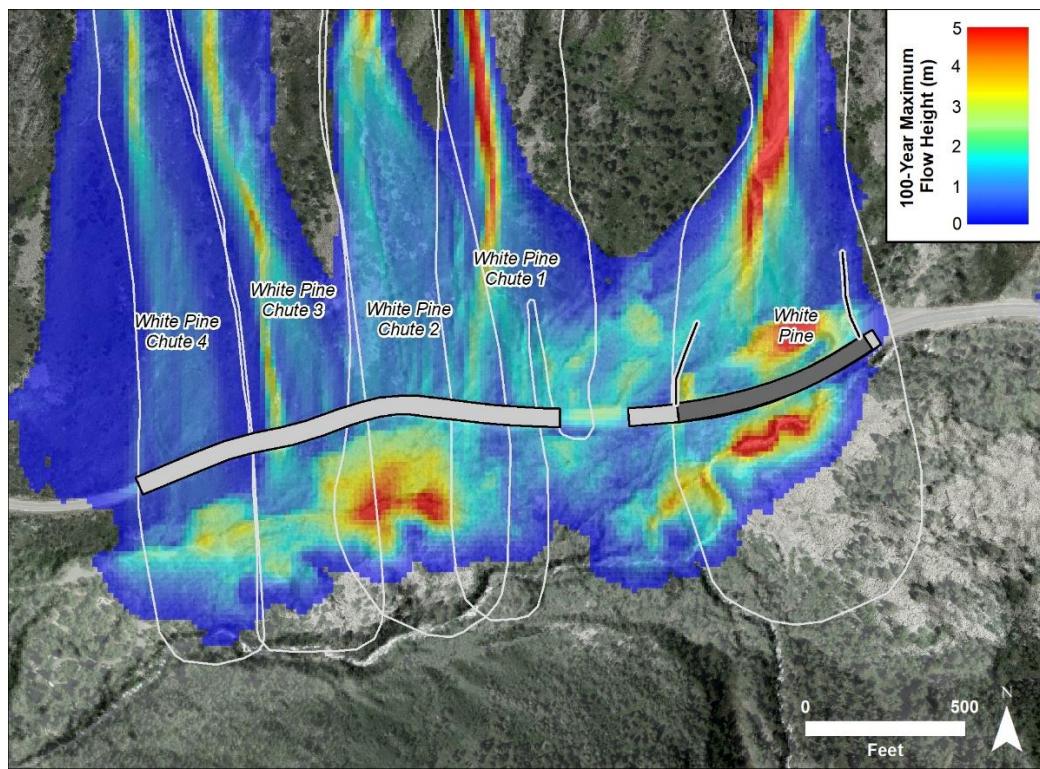
Figure 1a: White Pine Chutes 1-4 and White Pine, RAMMS 100-year maximum flow heights (m), proposed snow sheds with guiding berms (dark grey) and lengths without guiding berms (light grey).

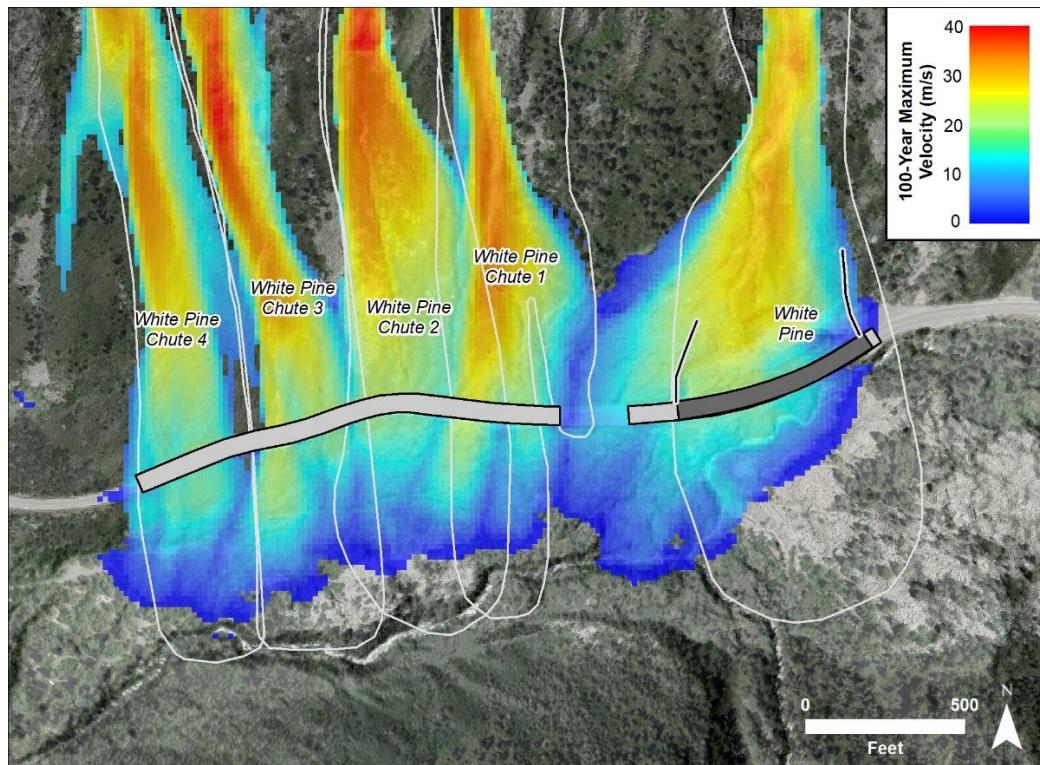
Figure 1b: White Pine Chutes 1-4 and White Pine, RAMMS 100-year velocity (m/s), and proposed sheds with guiding berms (dark grey) and lengths without guiding berms (light grey).

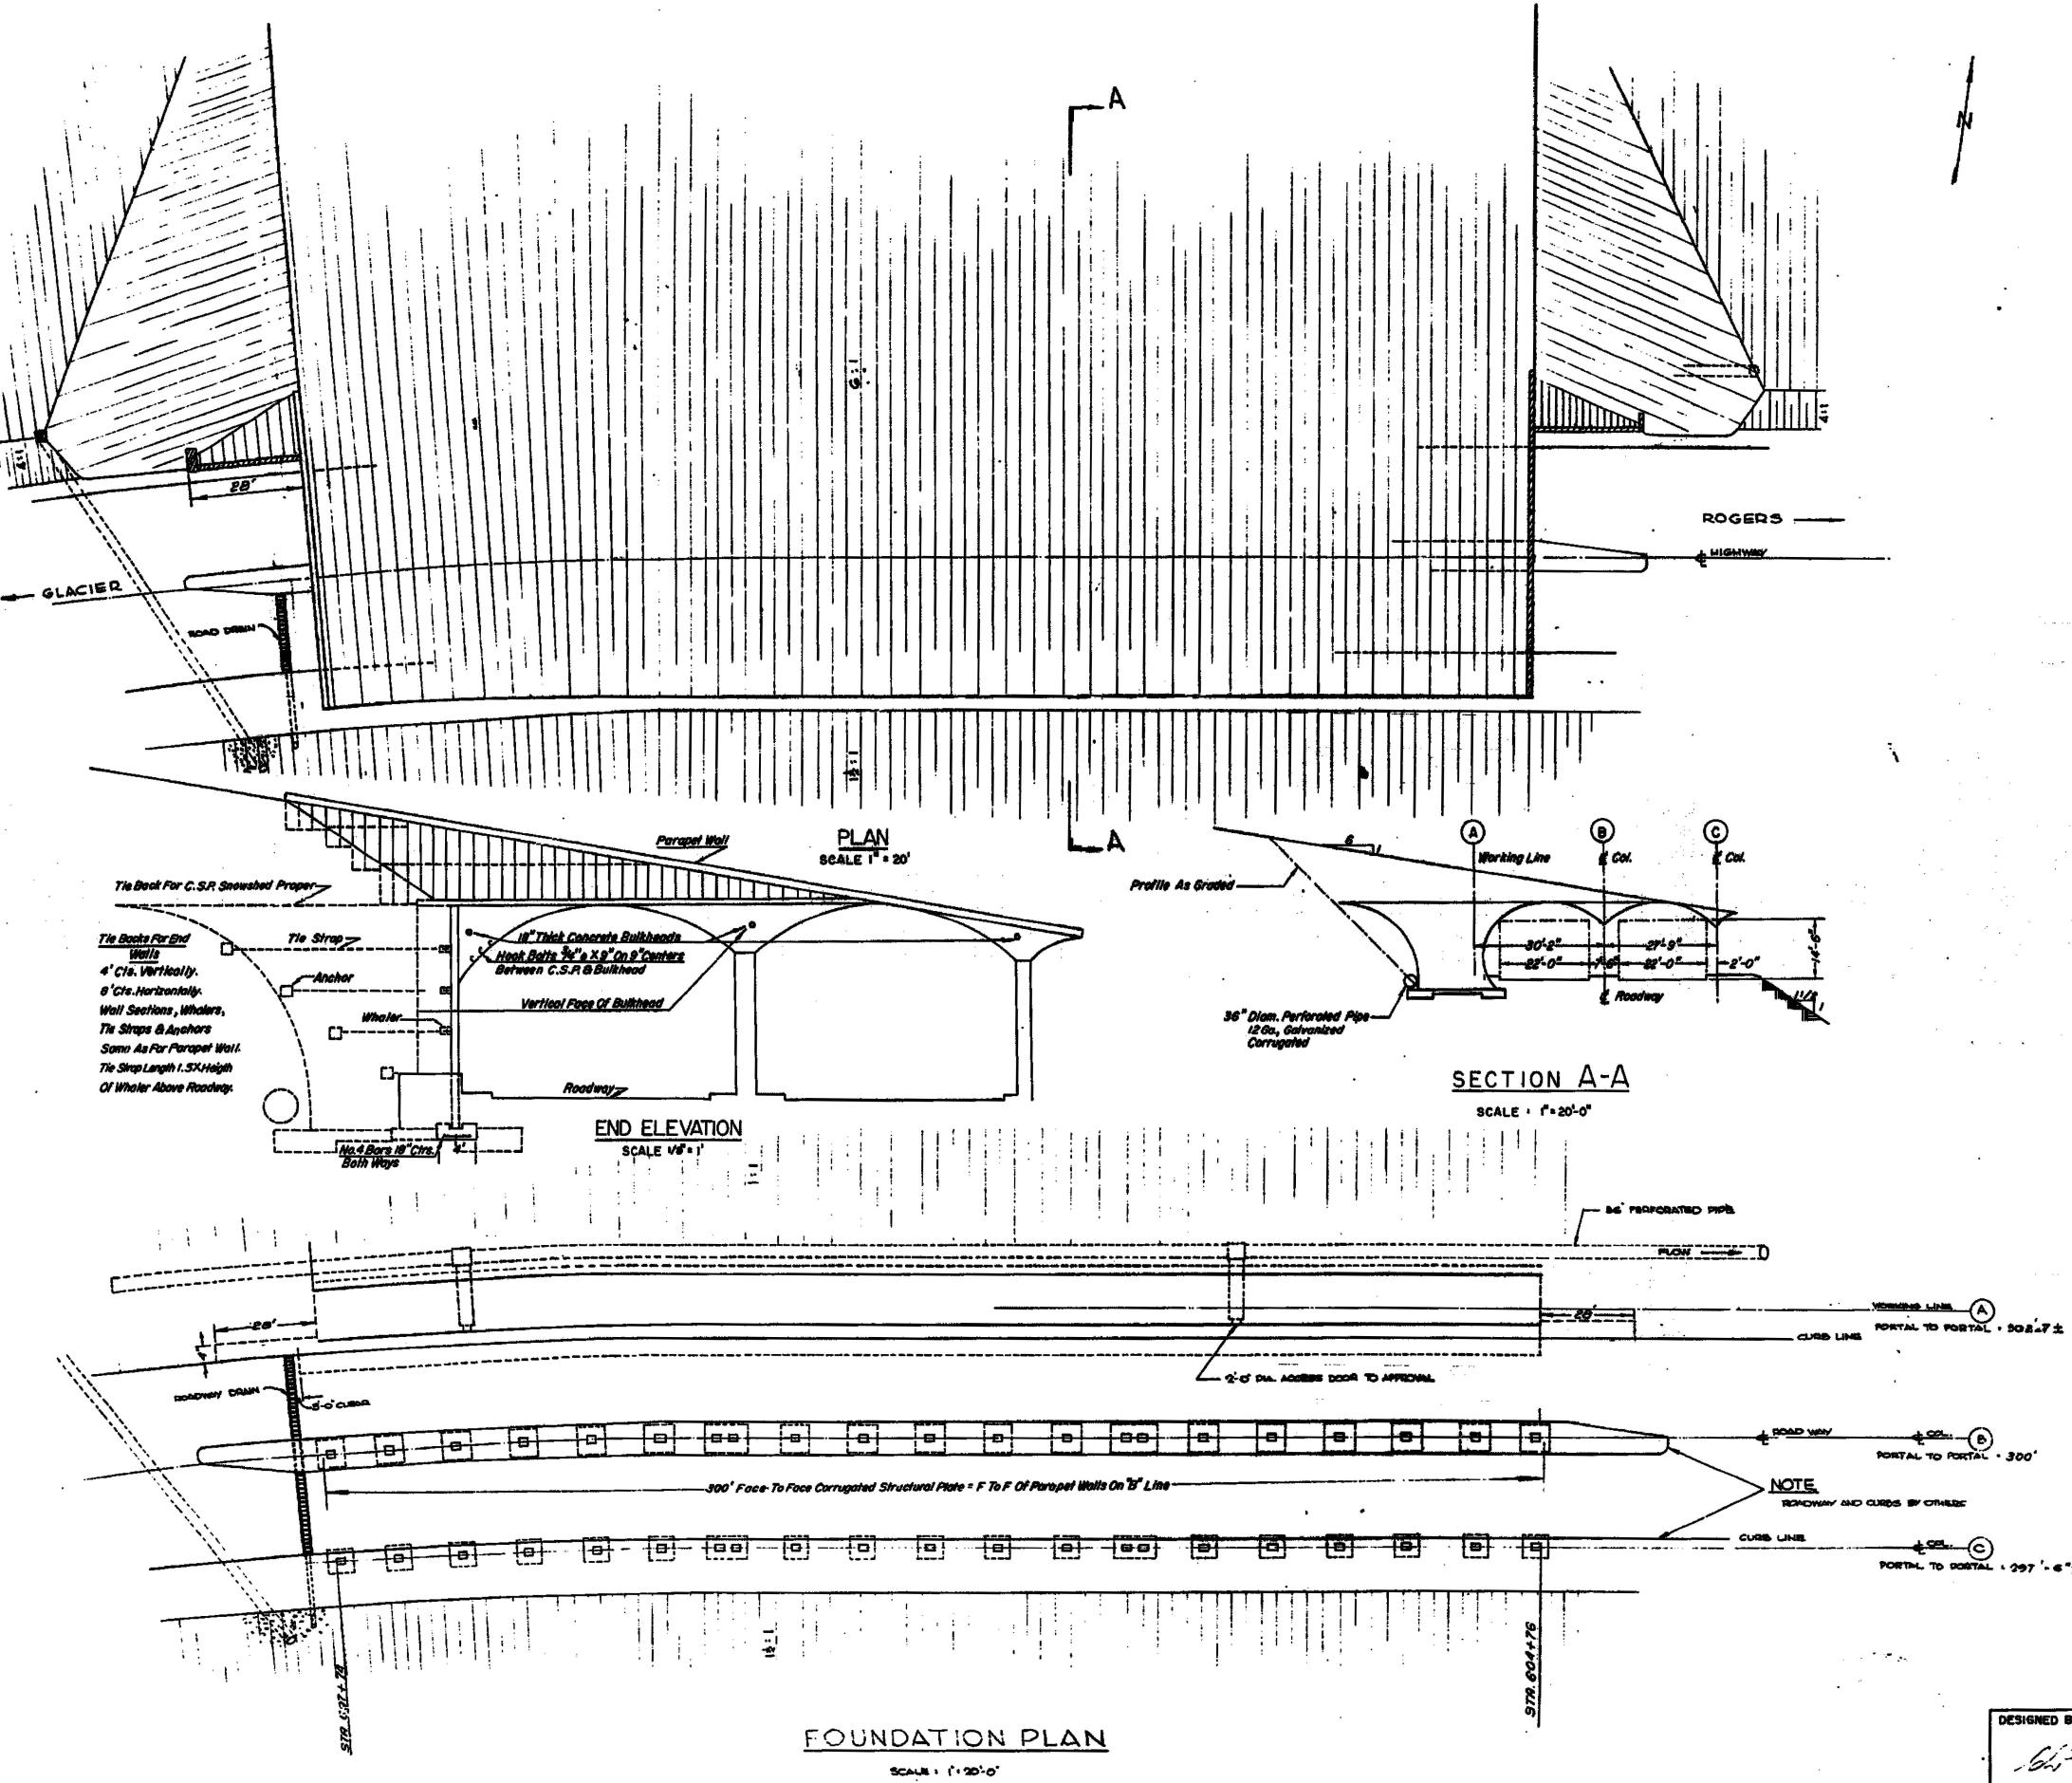
DEPARTMENT OF PUBLIC WORKS		
CANADA		
DEVELOPMENT ENGINEERING BRANCH		
STRUCTURES DIVISION		
NO. 1 SNOWSHED		
T.C.H. MILE 11.01		
GLACIER NATIONAL PARK		
CORRUGATED STRUCTURAL PLATE ALTERNATIVE		
GENERAL LAYOUT		
JOB SUPERVISOR S. STAMER APPROVED DATE 26/4/60 <i>M. Thompson</i> CHIEF STRUCTURES DIVISION	DESIGN DRAWN TRACED PROJECT NO.	CHECK CHECK CHECK DATE
DESIGNED BY <i>G. F. ...</i>	APPROVED DATE 27/4/60 <i>J. M. ...</i> CHIEF ENGINEER	DATE
SHEET 2A OF 19
