FINAL REPORT ~ FHWA-OK-15-05

EXPECTED LIFE OF SILANE WATER REPELLENT TREATMENTS ON BRIDGE DECKS PHASE 2

M. Tyler Ley, Ph.D., P.E.

October 2015

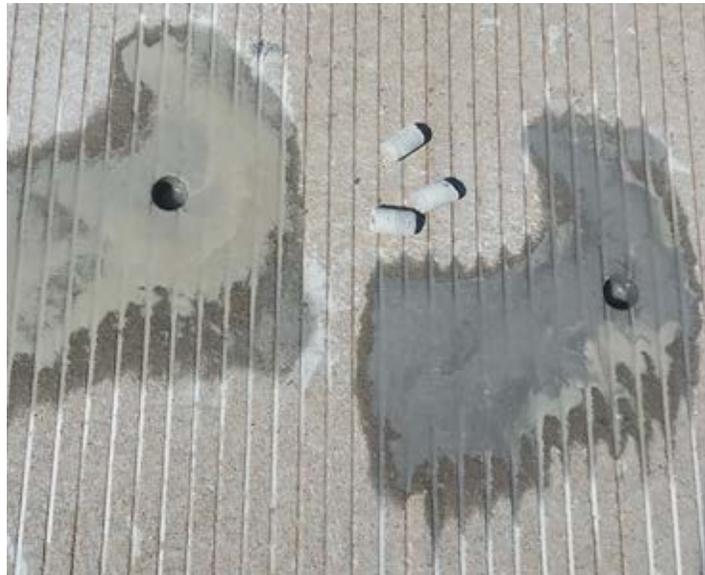
Figure 1- Example of cores were taken from bridge decks

Cores that were approximately 3/4" mm in diameter by 1" in height were taken from the driving lane and shoulder of 60 bridge decks (**Fig. 1**). Six cores were taken from each bridge for a total of 360 cores. Three cores were taken from the shoulder and three from the travel lane. These cores were taken at parallel locations so that the amount surface wear could be compared. Cores were taken from areas that were clear of debris, cracks, oil, and salt scaling damage. These cores were collected with a cordless drill. This technique allowed two researchers to sample each bridge in about 1 h. This minimized the requirement for traffic control and allowed more samples to be collected. Since the cores were small, this minimized damage and patching to the
