EVALUATION OF ASPHALT BINDERS

CONSTRUCTION REPORT

May, 1996

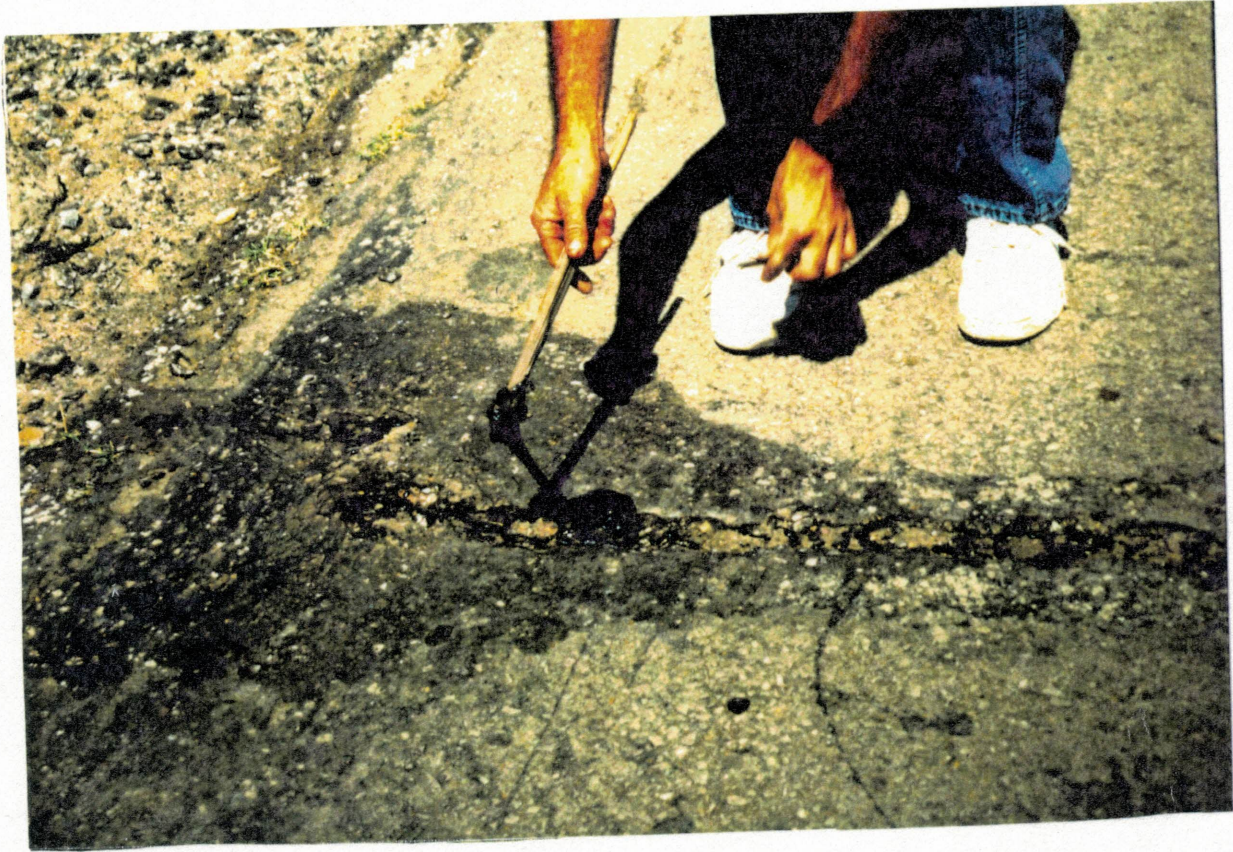
Figure 4. Uncured CRS-2 in Cracks.

Cracking was also a considerable problem before NH-186(190) Transverse cracks had developed throughout the project area, with spacing between the cracks varying from 15 to 30 m (50 to 100 ft). The transverse cracks were 25 to 50 mm (1 to 2 in) wide at the surface. ODOT Maintenance Forces had attempted to keep the cracks sealed. Crack sealing had been done with CRS-2, and in many of the cracks, CRS-2 had accumulated over time. Some of the CRS-2 had not cured, leaving the tops of many of the wider cracks, forming reservoirs of soft, viscous material which made crack patching difficult during construction (Figure 4). All of the full width transverse cracks had formed depressions extending 0.3 to 0.6 m (1 to 2 ft) on each side of the crack. These depressions were deepest adjacent to the crack. Depression depths ranged from 50 to 125 mm (2 to 5 in) Figure 5 shows this condition. Some of the rutted areas had longitudinal cracks in the bottom of the ruts. Other areas had random and block cracking. In places where cracks intersected, sections of pavement or patching material (whichever made up the surface) often spalled out, leaving "holes in the pavement (Figure 6).

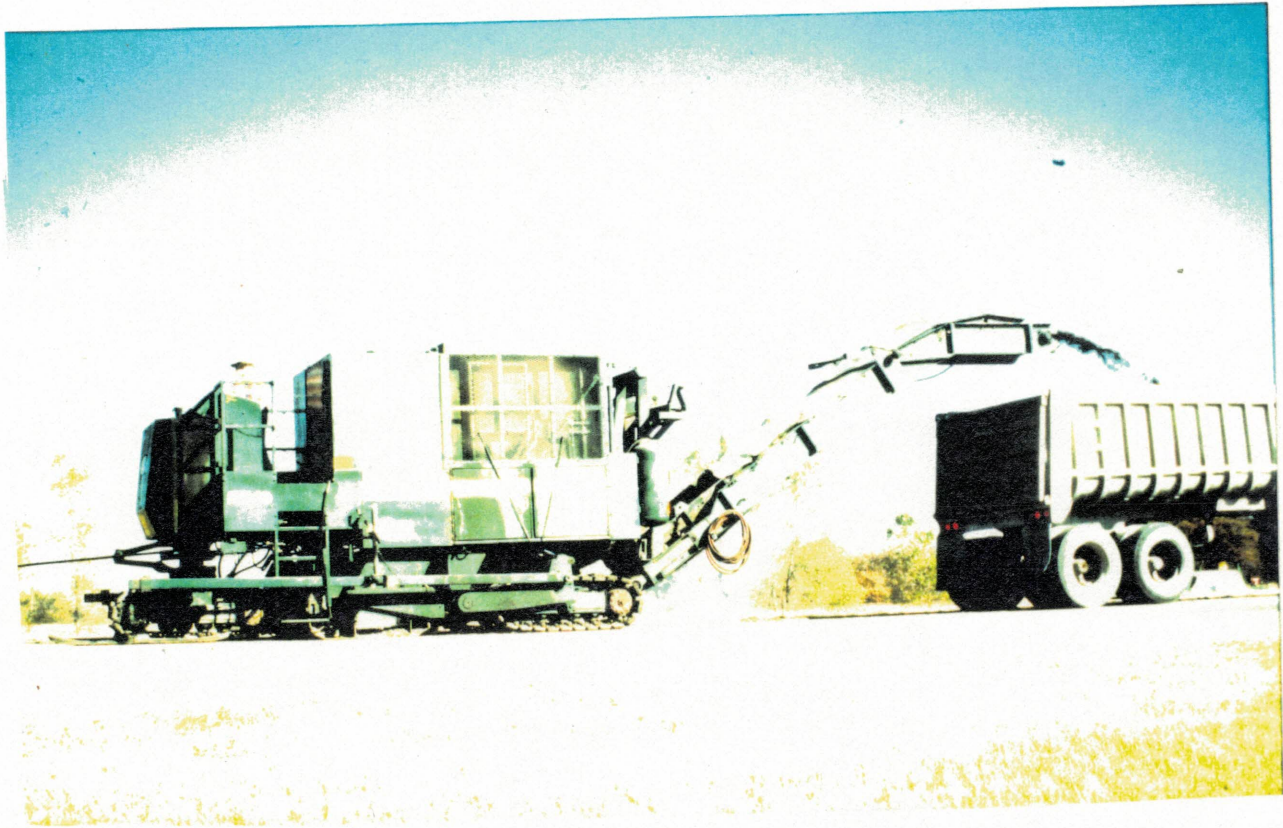
Figure 7. Coldmilling, Project NH-186(190)

Coldmilling (Figure 7) was done to a depth of approximately 51 mm (2 in). Ruts, depression cracks, and other surface irregularities in the existing roadway made milling to a uniform depth impossible. Milling was done to depth necessary to provide a smooth grade after it was complete. Employees of the subcontractor doing the miling, and ODOT field personnel kept the depth as close as possible to 51 mm (2 in), although actual depth was slightly greater or less than 51 mm (2 in) at most locations.

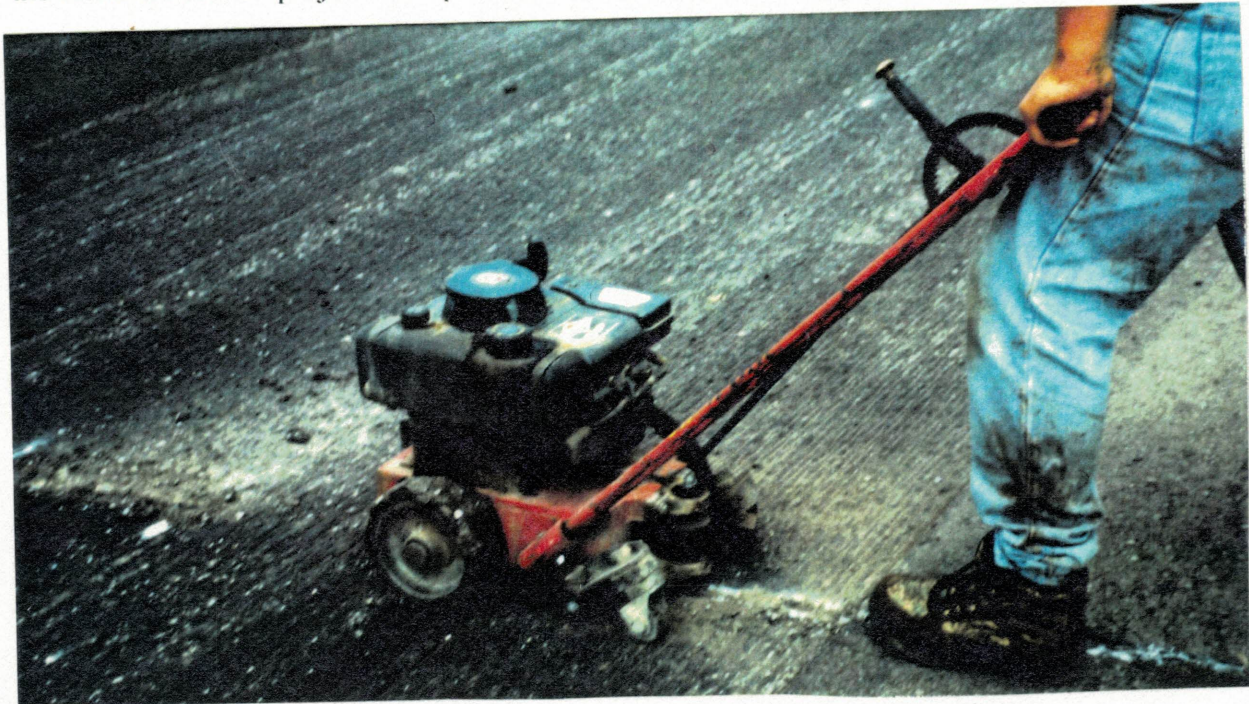
Figure 9. Routing Cracks.

When employees of the subcontractor doing the crack treatment attempted to router the cracks (Figure 9), the built up CRS-2 made it difficult to see the crack edges as the crack meandered across the roadway. Also, the CRS-2 stuck to router bits, making it difficult to distinguish crack edges. Plans required cracks be routed to a depth of 102 mm (4 in). The subcontractor doing the work was only able to get a small number of bits long enough to router to that depth (127 mm or 5 in bits). The bits they had broke regularly. After all of the bits in the small stock they had when work began had broken, additional bits had to be fabricated by a local machine shop. Each time the bits on hand broke, the routing operation stopped until more bits could be fabricated.

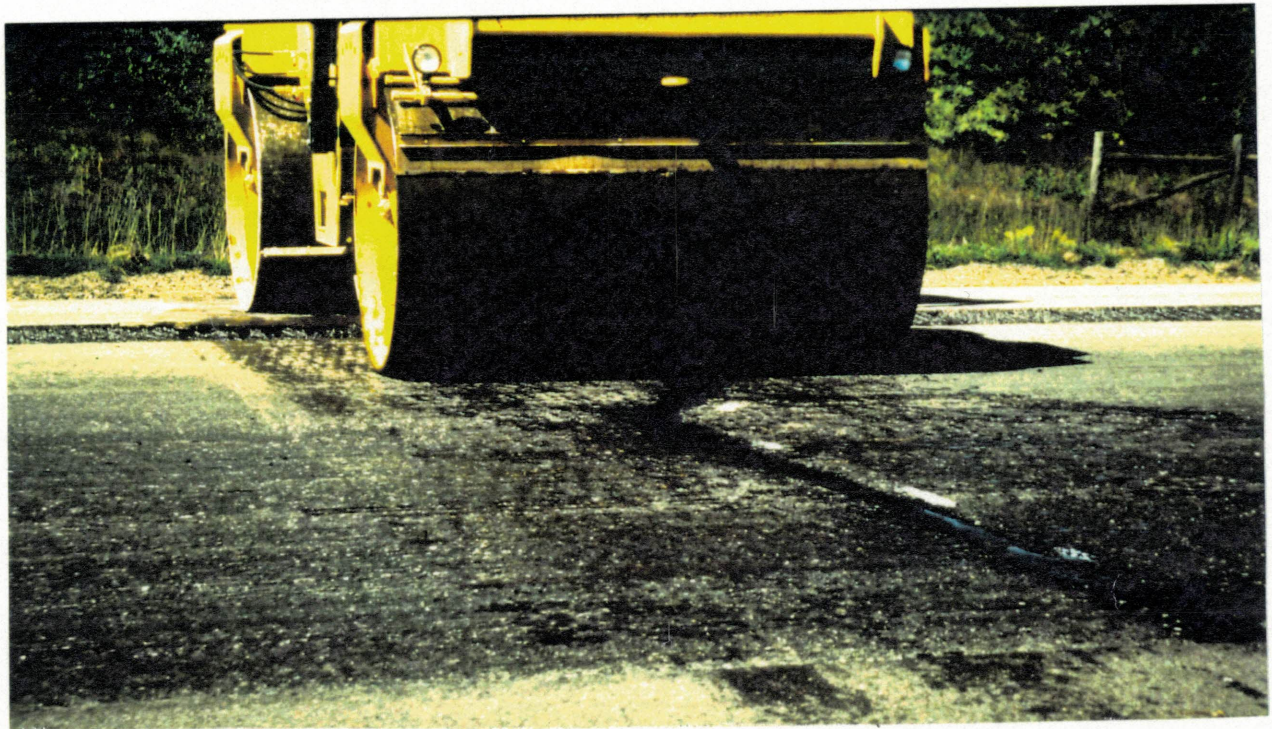
Figure 11. Rolling “Modified Type “B” Mix Used as Crack Patch Material.

At this point, crack repair operations were halted. After a meeting on this problem, the contractor and ODOT field personnel agreed that other methods of crack cleaning and patching would be substituted for those shown on the plans. The new method was to consist of patching with a "modified Type asphalt concrete" (ODOT's Type "B" without the 19 mm (3/4 in) and 12 mm (1/2 in) aggregate). It was also decided that no more crack routing was to be done before patching. Cracks would be cleaned with compressed air, then patched. Patching consisted of placing the modified "B" mix in the crack and making a small mound of "B" mix over it, then rolling the material into the crack with a 15-ton roller (Figure 11). This method proved to be

more successful than that on the plans (material in the cracks stayed flush with the surface), and the new method was much faster than that planned. Where the micro surfacing had sunk into the CRS-2 in the cracks, the new method was used to bring patch surfaces up to grade. Cracks on the remainder of the project were patched in this manner also.

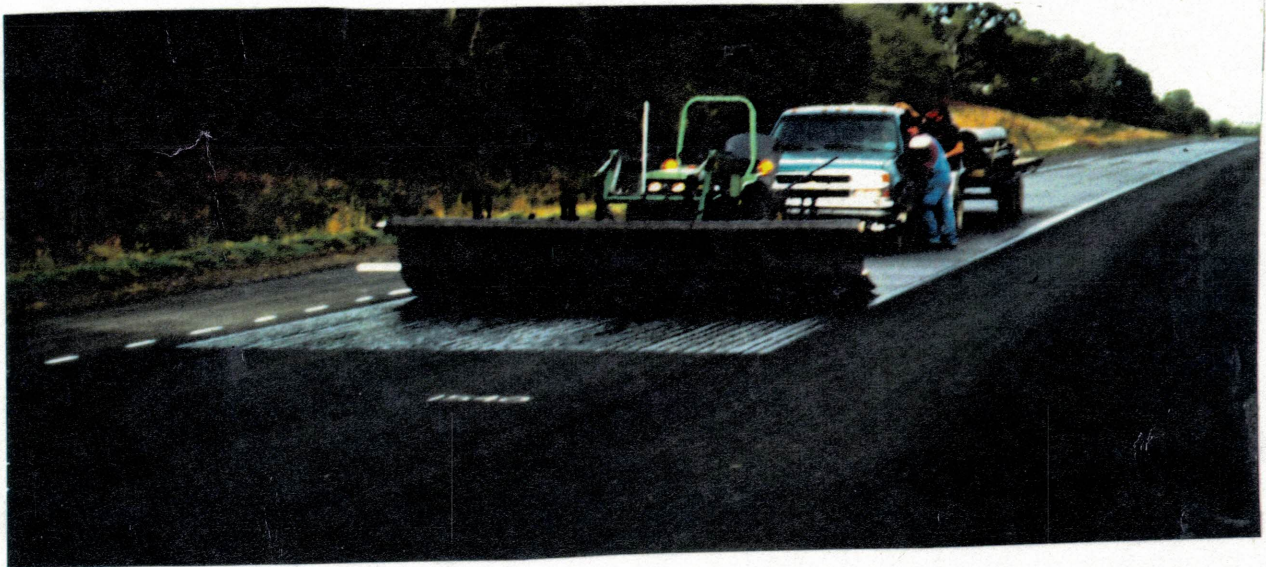
Figure 15. Full width fabric application.

a tractor-mounted roller, (Figure 15) did the fabric application for the entire project. Except for construction vehicles, no traffic ran on the fabric between application and laydown of the Type "B" surface over the fabric.

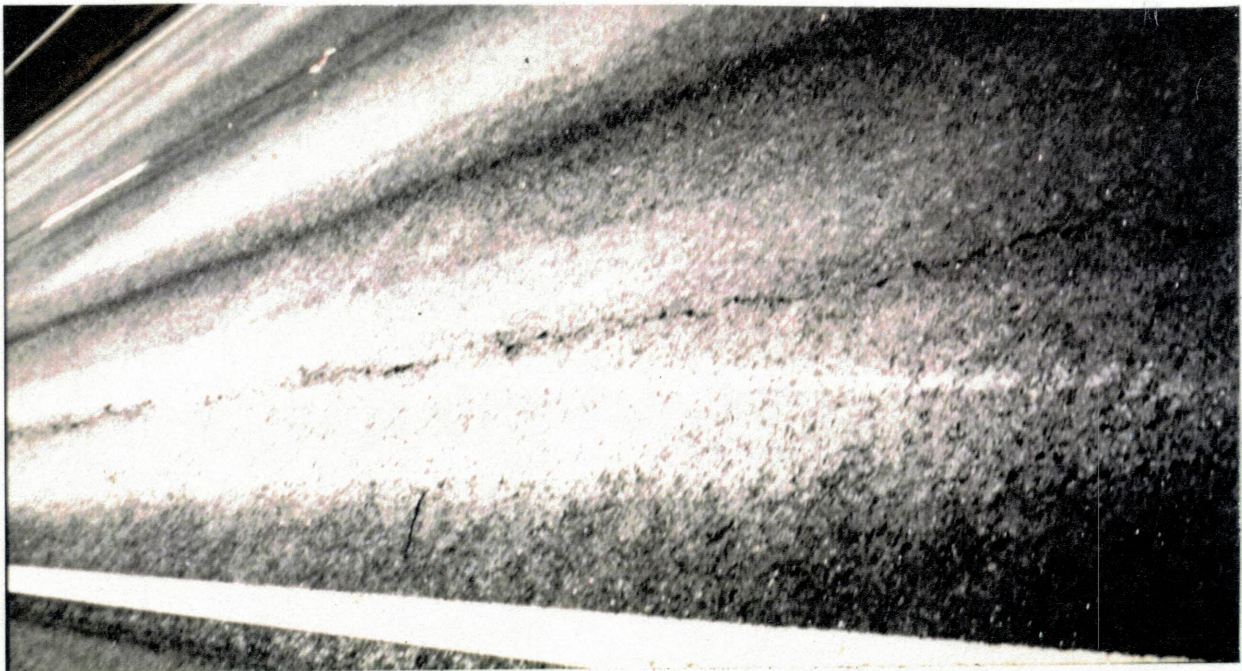
Figure 19. Typical Cracking in AC-30 Section.

The 0.8 km (1/2 mi) long AC-30 Section has longitudinal cracking in one wheel path or the other of the outside (east) driving lane, over approximately 60 percent of its length. The 91 m (300 ft) long crack mapped section (Appendix "B") has relatively more cracking than the rest of the section, with approximately 75 percent of its length cracked. A smaller percent (approximately 10 percent) of this section has longitudinal cracking in both wheel paths. Cracks typical of those in this section on February 12, 1996, are shown in Figure 18.

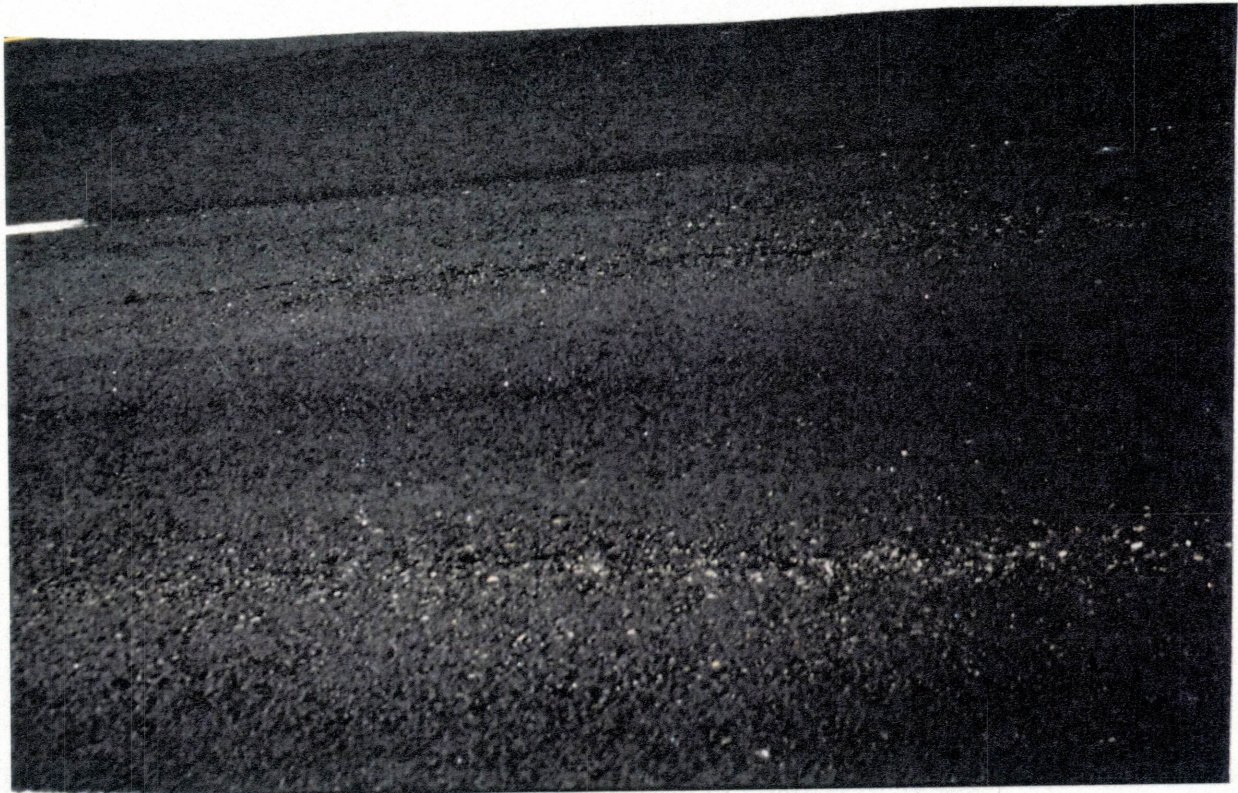
Figure 20. Typical Cracking in AC-40 Section.

This section also had longitudinal cracks in the wheel paths of the outside lane. Approximately 90 percent of the 0.8 km (1/2 mi) long section has cracking in at least one wheel path, with approximately 75 percent cracked in both wheel paths. The 91 m (300 ft) long crack mapped section had cracking, in at least one wheel path over 100 percent of its length, with approximately 75 percent of the total length cracked in both wheel paths of the outside lane. Figure 19 shows typical cracking in the AC-40 section. The cracked mapped section is included in Appendix "B".

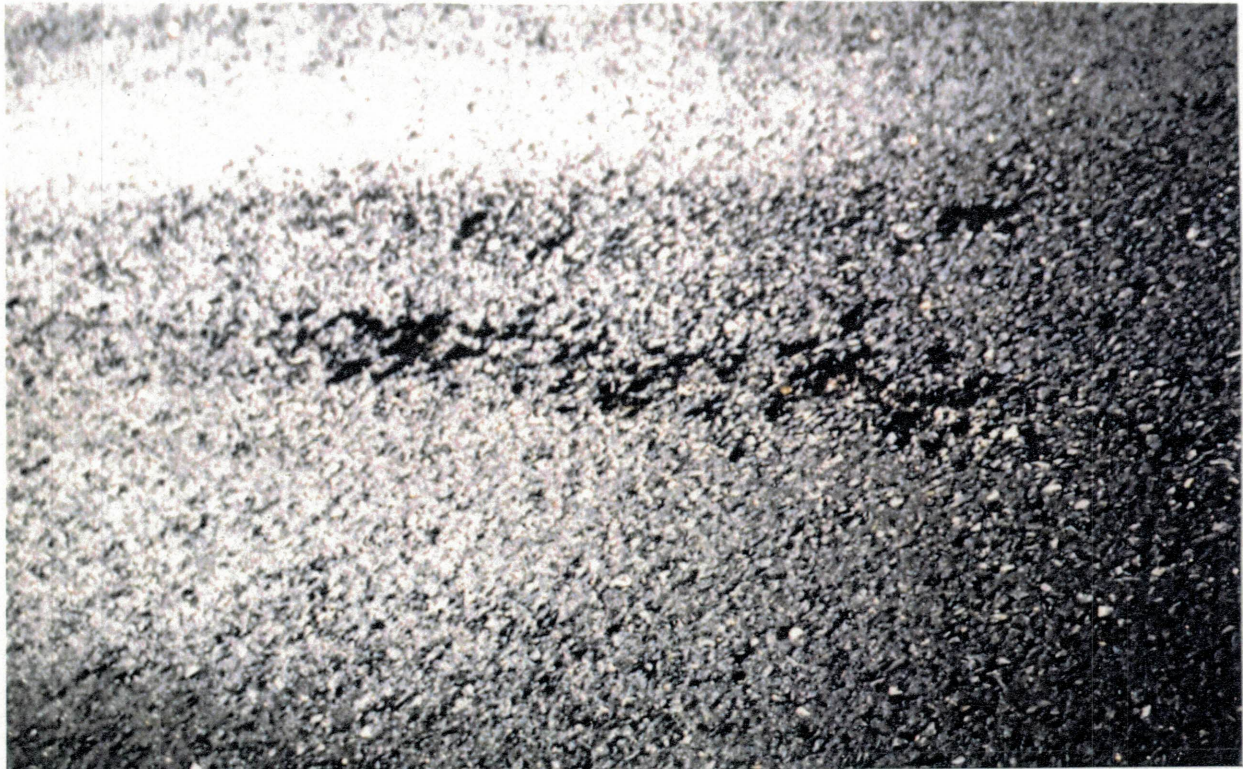
Figure 21. Ravelling of Aggregate From Surface Course.

Aggregate is raveling off of the surface course (Figure 20). The aggregate often breaks easily when scraped with a screwdriver. Breaks are generally one of two types. Breaks either along planes, as shale breaks, or the individual rock simply crushes under traffic. A large percentage of the breaks are along a horizontal plane. The broken off portion of the individual rock is then lost, leaving what remains of it in a small "hole" or depression. Some rocks break vertically, along one or more planes. Later, the broken pieces work loose under traffic and are lost. Where these
