# GUARDRAIL END ACCIDENT ANALYSIS

By J.L. Gattis  
John P. Varghese  
Larry E. Toothaker  
S.R.K. Narla

Oklahoma Transportation and Infrastructure Center  
The University of Oklahoma

December 1992

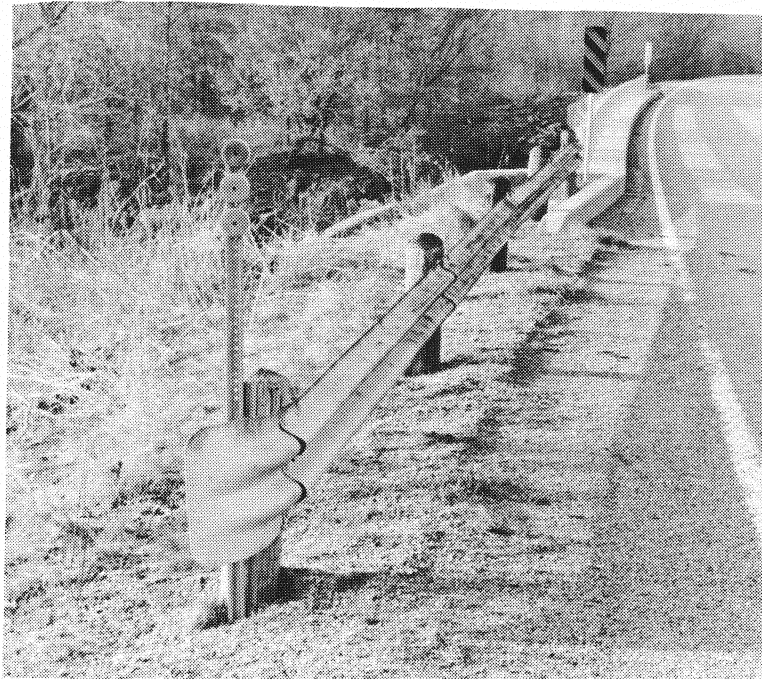
FIGURE 2.1 Exposed end treatment

Figure 2.1 shows an example of an exposed end treatment. This was the old standard end treatment. When hit by a vehicle, these older end treatments may penetrate the front or side of a vehicle, snag the vehicle, or get under the vehicle. Any of these situations may increase the severity of the accident.

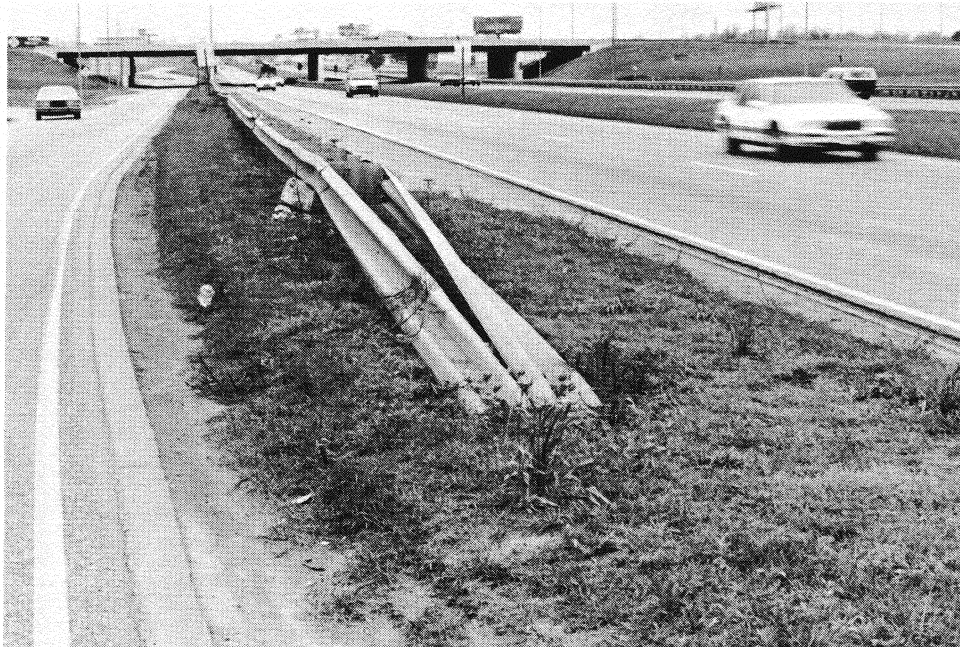
FIGURE 2.5 Double-faced turned-down end treatment

At some narrow medians, double-faced guardrails with turned-down ends have been used to protect fixed objects like light poles, sign posts, etc. An example is shown in Figure 2.5.

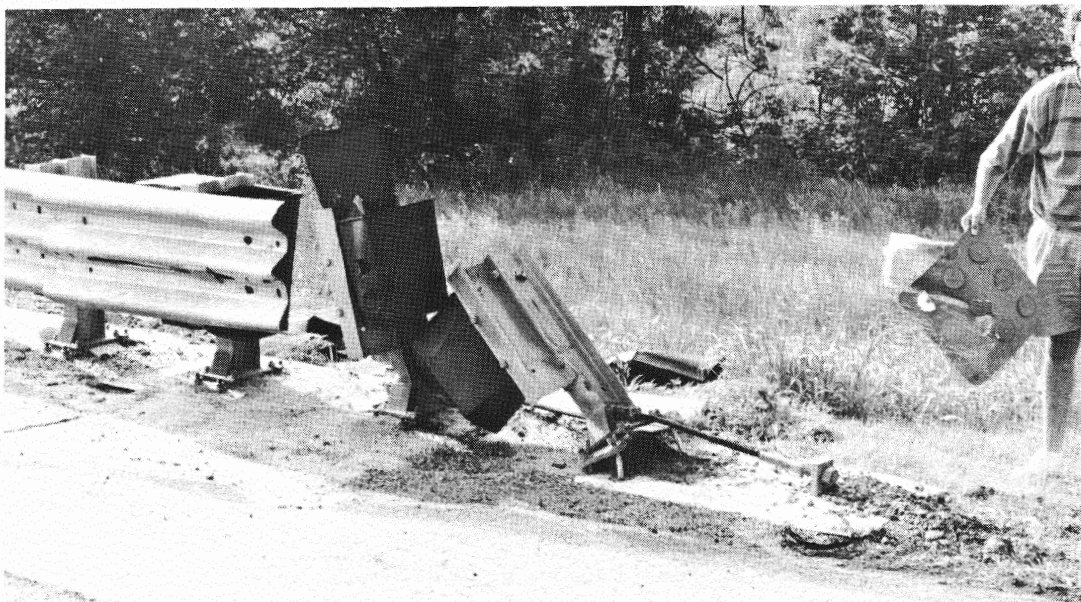
FIGURE 2.7 Sentre impact on Oklahoma turnpike

Figure 2.7 shows a 1992 Sentre impact on the Turner Turnpike. From the tire marks, it appeared that the impact was not fully head-on, but rather had a right-to-left force component. The bolts at the base did not shear upon impact, but rather pulled out of the base.

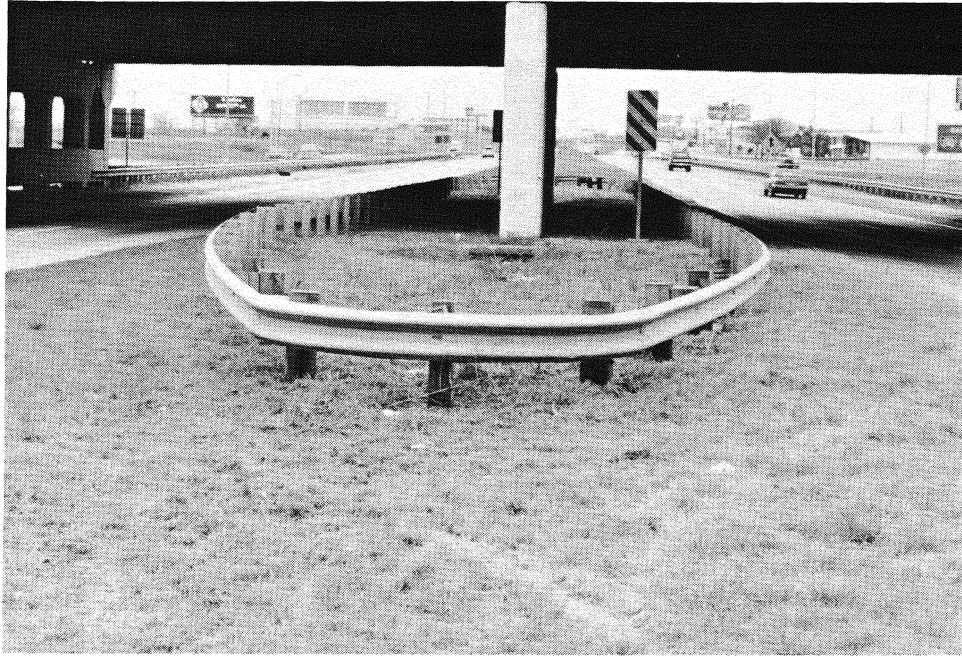
FIGURE 2.8 Parabolic end

A parabolic end is shown in Figure 2.8. These ends can be found in some medians, protecting vehicles from fixed objects like bridge pillars or sign posts in the median.

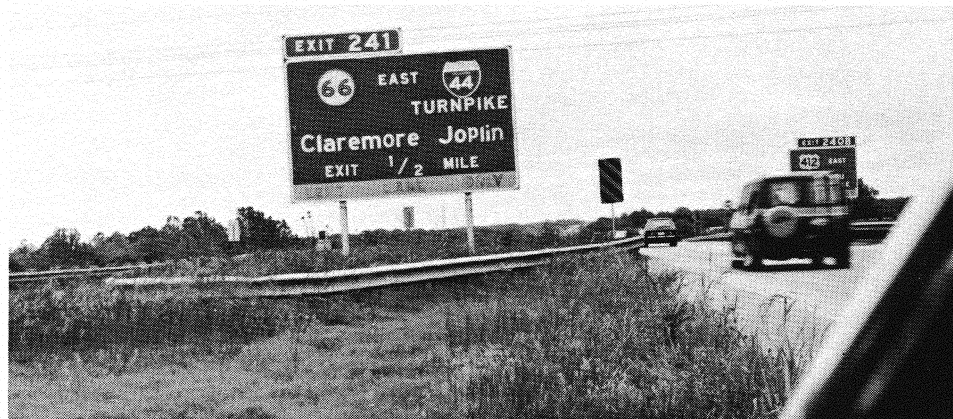
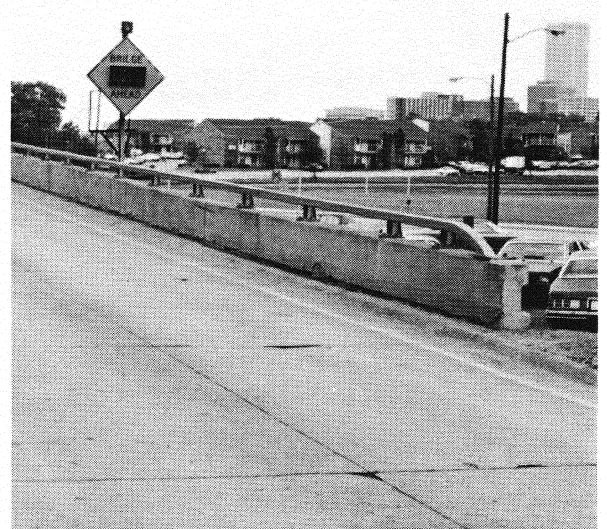
FIGURE 3.8 Examples of accident report limitations

While reviewing the accident reports, the researchers found a few reports that appeared to contain incorrect information. Three problems with accident reports are highlighted in the accompanying drawings and photographs. Figure 3.8 shows excerpts from three accident reports.
