# QUICKCHANGE MOVEABLE CONCRETE BARRIER SYSTEM

## FINAL REPORT

July, 1992

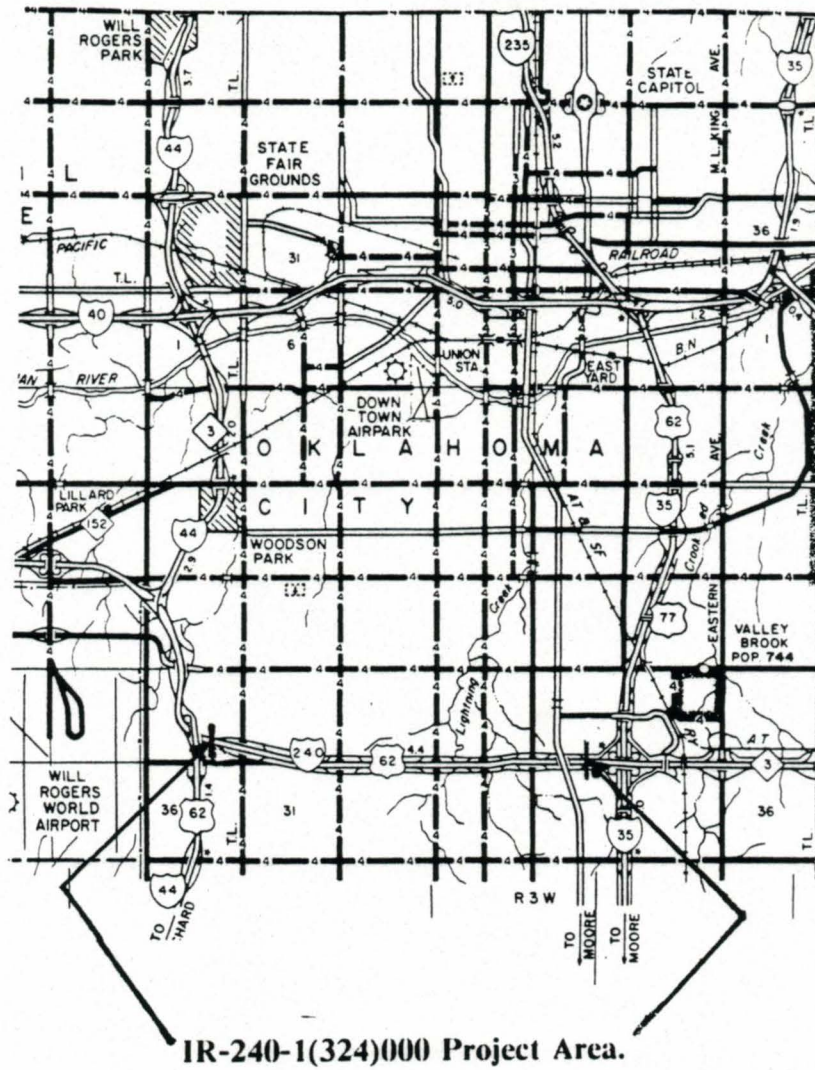
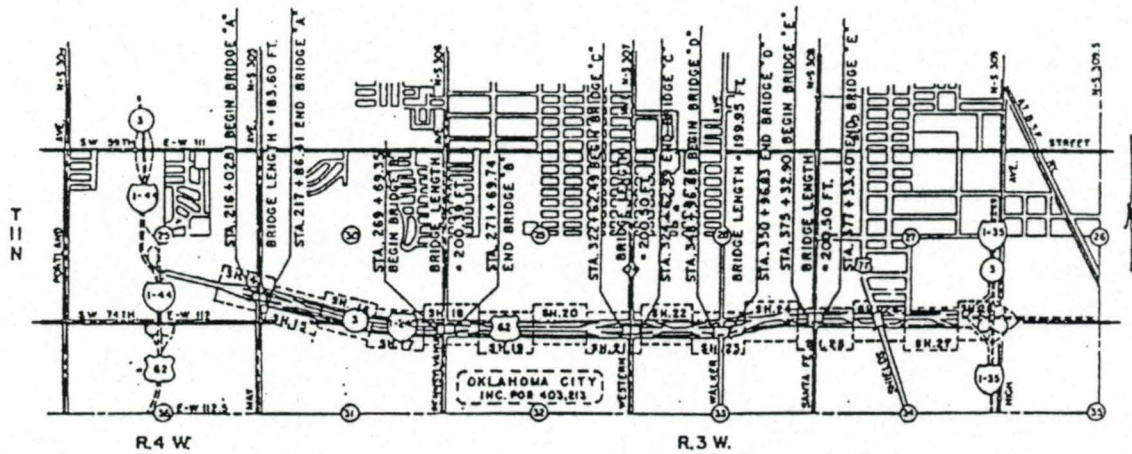
Figure 1. IR-240-1(324)000 Project Location.

IR-240-1(324)000 Project Area.

The Oklahoma Department of Transportation (ODOT) has completed Project IR-240-1(324)000, a four mile long reconstruction project on I-240 in Oklahoma City (Figure 1.) The project was located in an area where several shopping centers and businesses adjoined I-240. This section of I-240 carries an ADT of approximately 70,000, which includes large numbers of commuters.

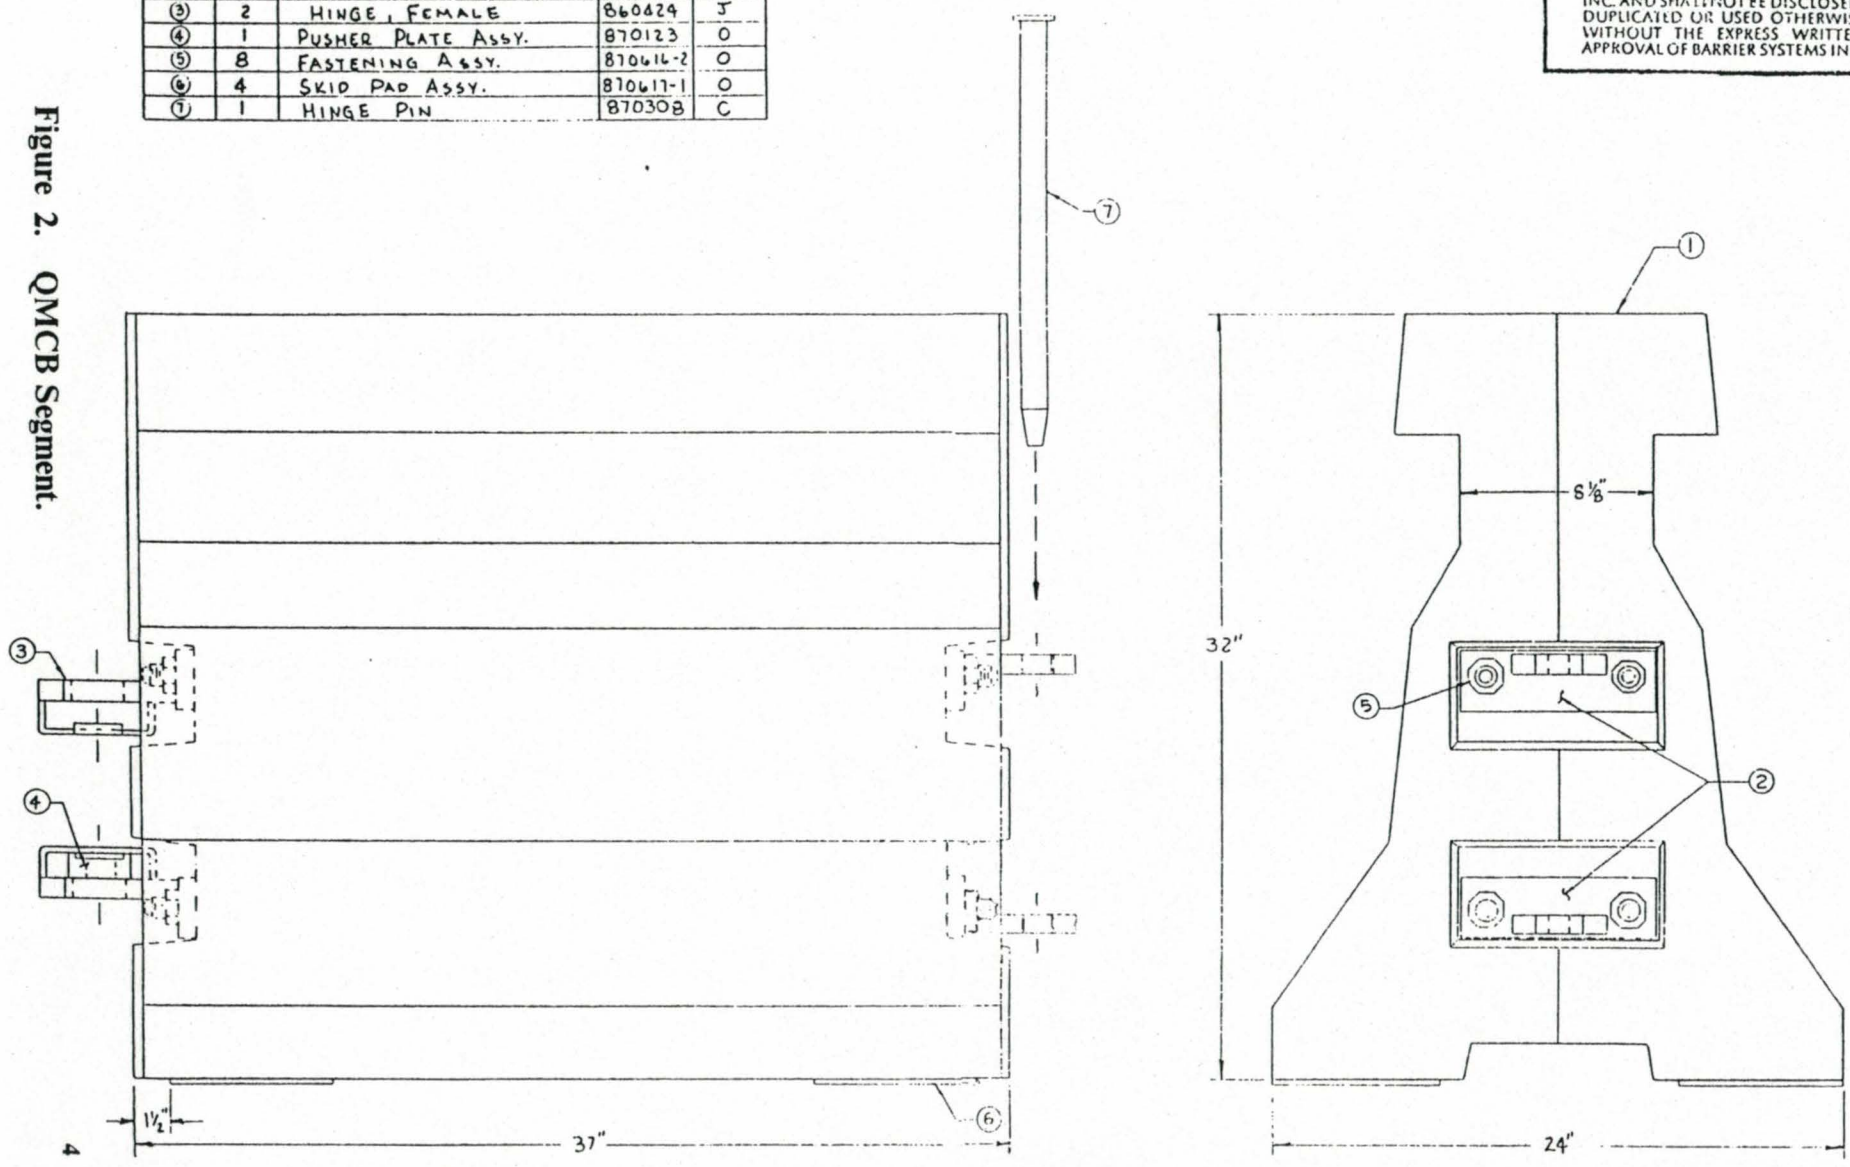
Figure 2. QMCB Segment.

The barrier wall of the QMCB System consists of a "chain" of 3.28 foot (one meter) long reinforced concrete barrier segments. The cross section of each segment is similar to that of New Jersey Barrier with a flange on both sides at the top of the segment (Figures 2 and 3). Rubber pads are attached to the bottom of each segment to minimize the possibility of "creep". Four 7/8 inch diameter steel rods run the length of each segment and are attached to hinges at either end (1,2). Each segment weighs roughly 1,400 pounds.

Any number of segments may be pinned together at the hinges to form a continuous concrete barrier wall of the length desired for a particular task. The "T" shaped flange at the top of each segment allows it to be picked up, and moved by the Transfer and Transport Vehicle (TTV), as described in the following paragraph. ODOT Special Provisions covering QMCB wall are included in Appendix A.

To shift the QMCB Barrier wall, the operator drives the TTV into position such that the carrier wheels are located on each side of the "T" shaped flange on the segments (Figure 2). Then, as the TTV moves forward, the barrier wall segments are lifted by the incline on the pickup mast, located on the front of the conveyor track (Figures 4 and 5). The TTV has identical controls on each end and can shift the barrier while travelling in either direction. Also, it has the capability of lifting barrier segments up to 30 inches vertically to accommodate curbs, adjacent structures, or other obstacles.

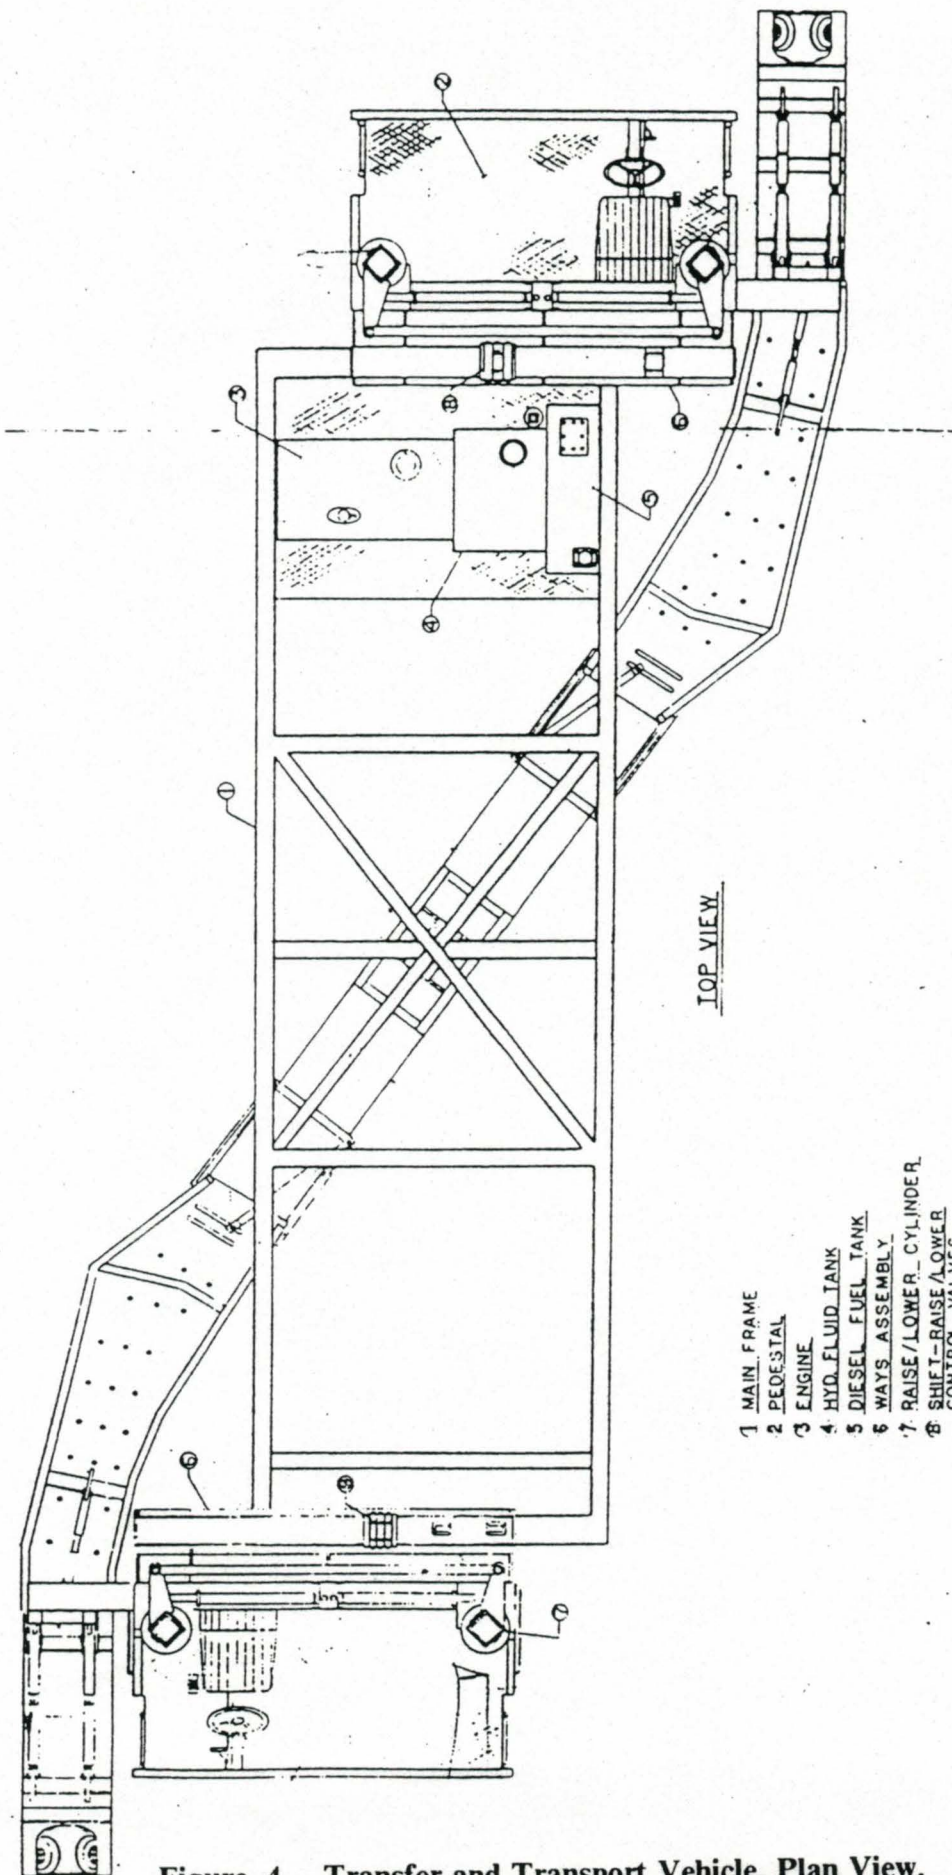
Figure 4. Transfer and Transport Vehicle, Plan View.

TOP VIEW.

- 1 MAIN FRAME
- 2 PEDESTAL
- 3 ENGINE
- 4 HYD. FLUID TANK
- 5 DIESEL FUEL TANK
- 6 WAYS ASSEMBLY
- 7 RAISE/LOWER CYLINDER
- 8 SHIF-RAISE/LOWER CONTROL VALVES

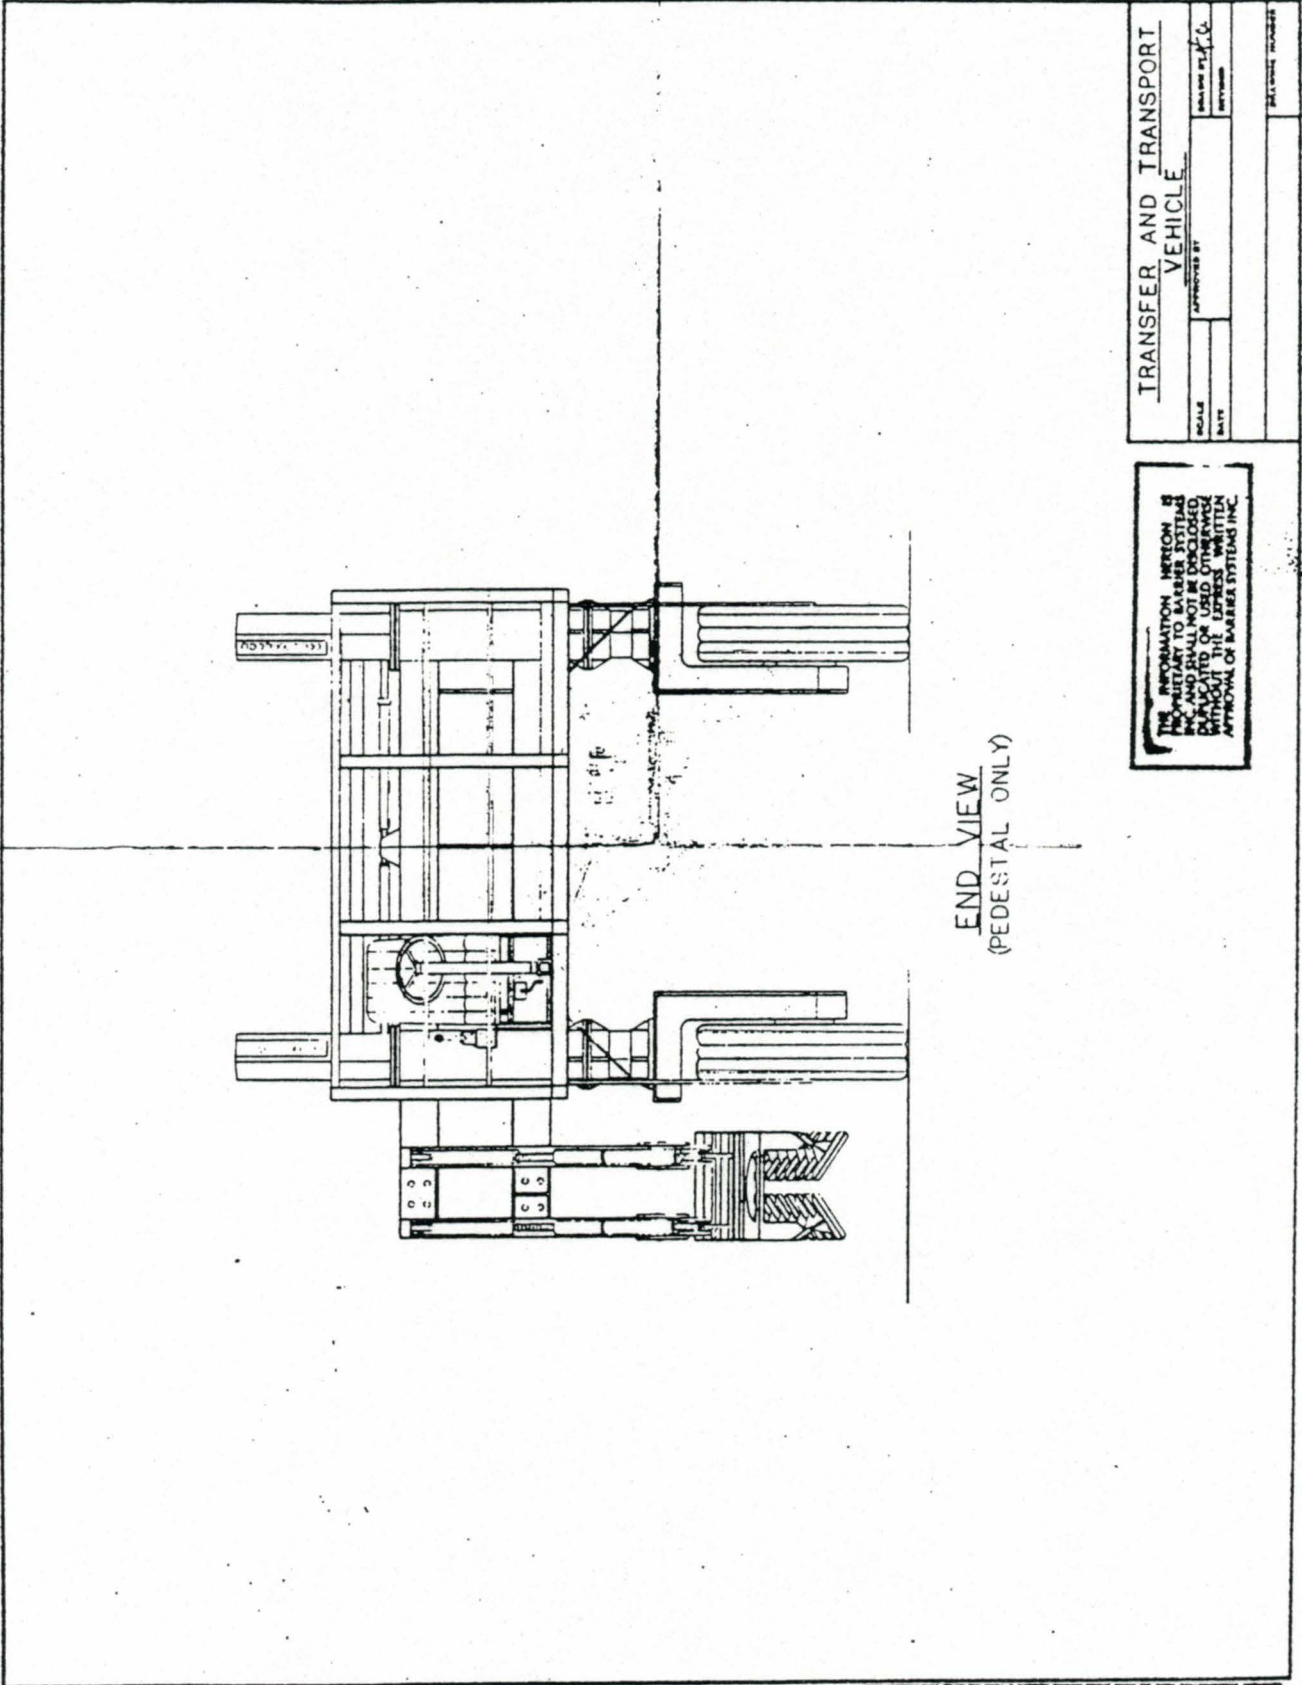
Figure 5. Transfer and Transport Vehicle, End View.

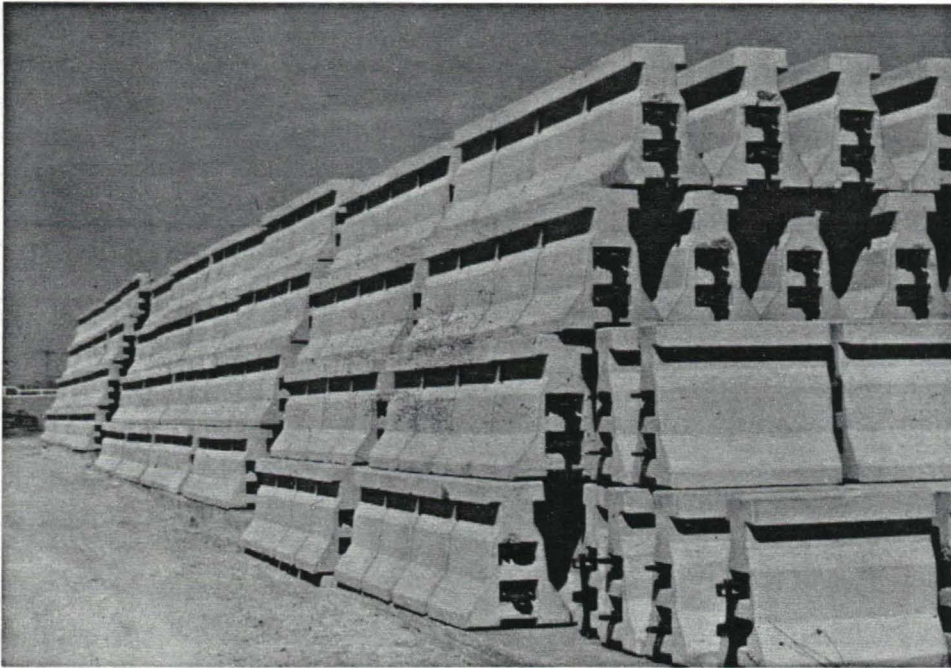
**Figure 6. Stacked four (4) Segment Lengths of QMCB.**

After QMCB segments are poured, and forms are stripped off, they are cured, linked together in four (4) segment lengths, and stacked (Figure 6). Stacking is done by a crane using a clamp designed to pick up barrier units (Figure 7). The clamp is available through Barrier Systems, Inc.

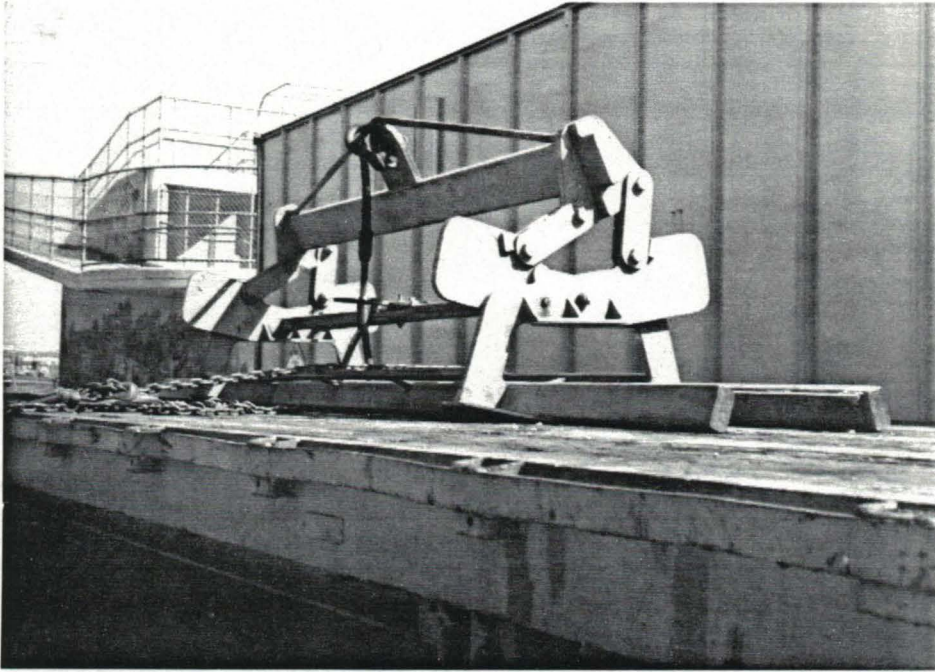
**Figure 7. Clamp Used to Lift Barrier Segments.**

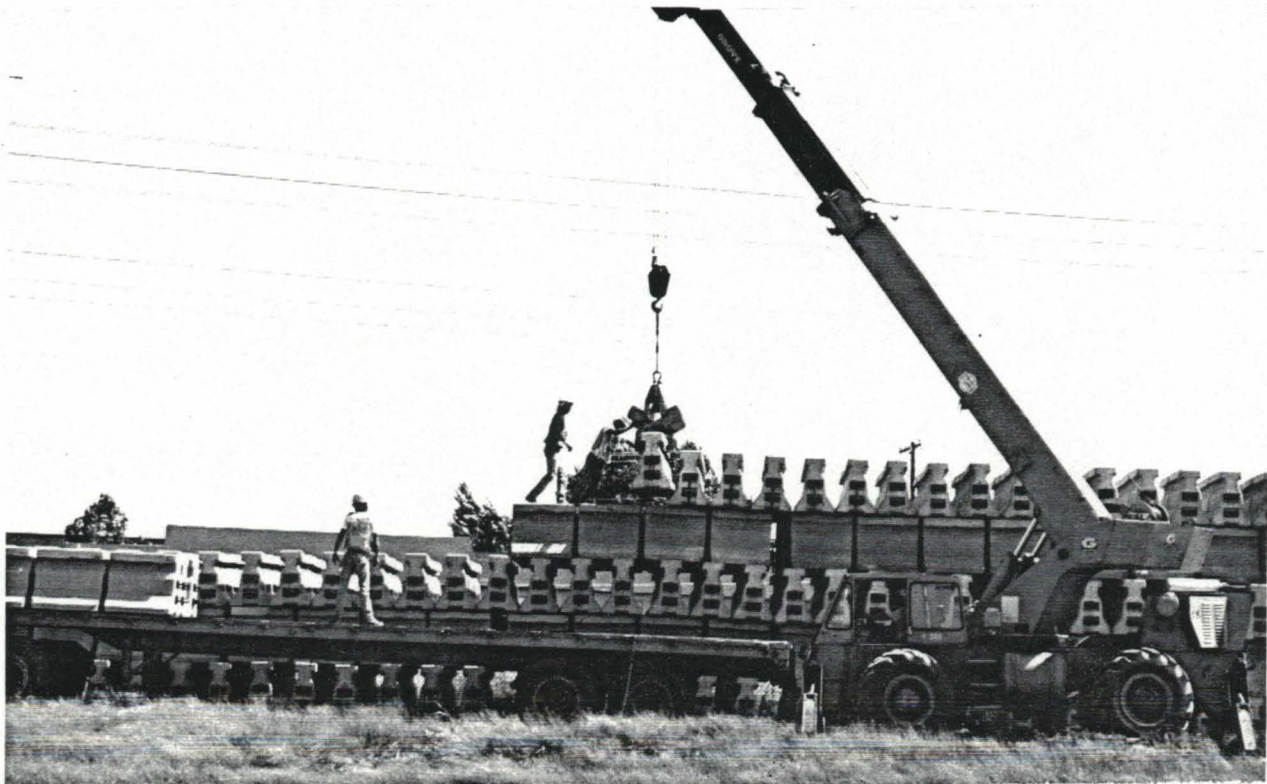
**Figure 8. Stockpiling QMCB Segments.**

Barrier units stay in four (4) segment (13.12 feet or 4.0 meter) lengths from this point on. They are then loaded on flatbed trucks, and delivered to the project site. At the site they are placed in their initial configuration by a mobile crane, handling four (4) connected segments at a time. Any number of units are then connected to form the required length of barrier wall. As portions of a project are completed, segments that are no longer needed are removed in the same manner. Trucks take them to stockpile locations, and they are stacked by crane (Figure 8).

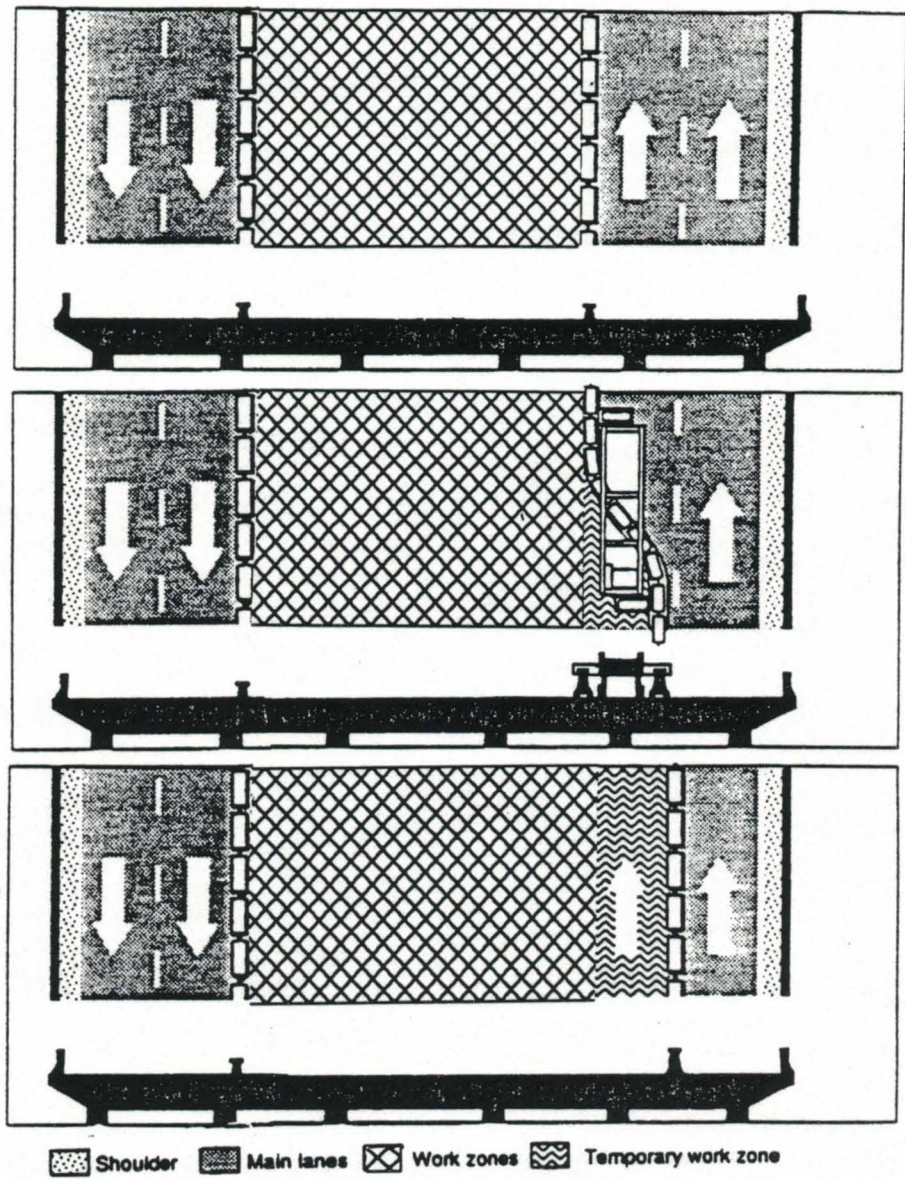
Figure 9. Barrier Wall Shift Sequence for Work in Median Area.

QMCB walls were used to separate I-240 traffic from construction operations during work on bridges and in the median. Barrier wall configurations for these operations are shown in Figures 9 and 10.

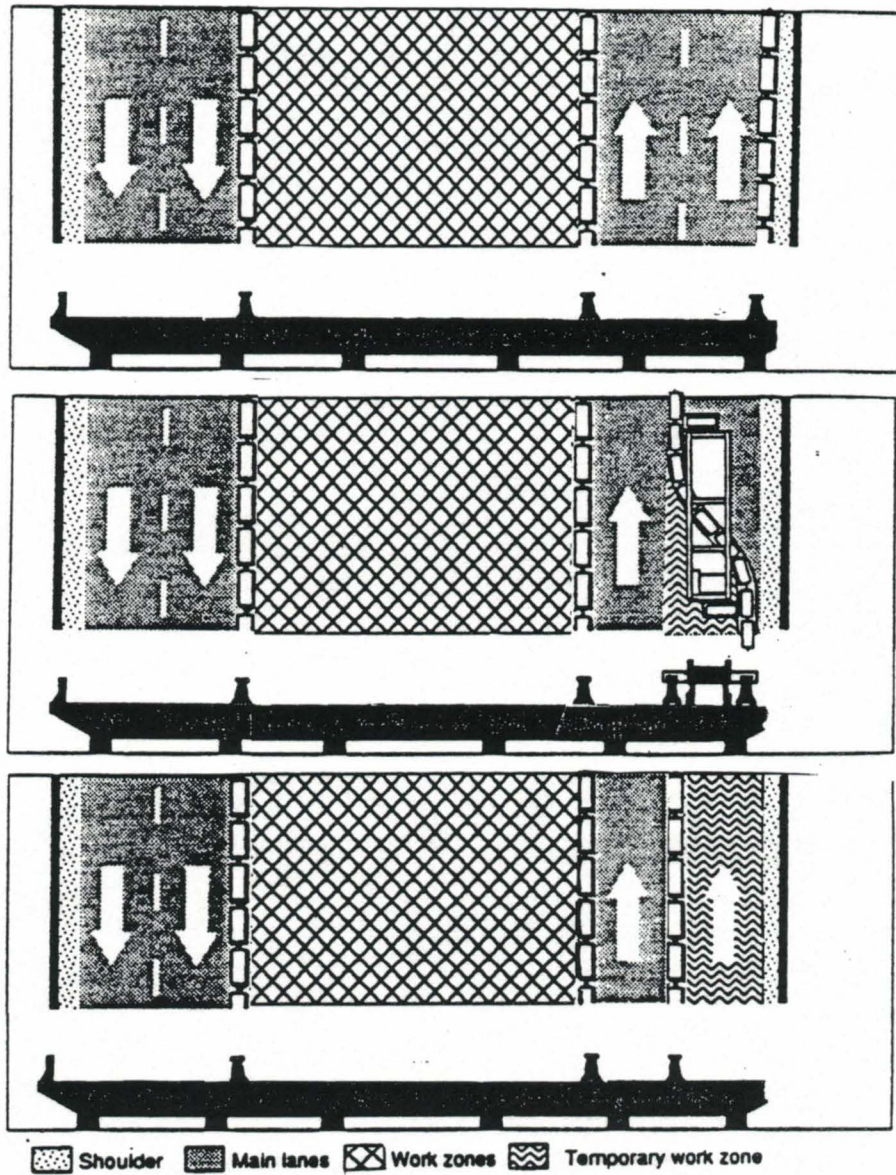
Figure 10. Barrier Wall Shift Sequence for Bridge Widening.

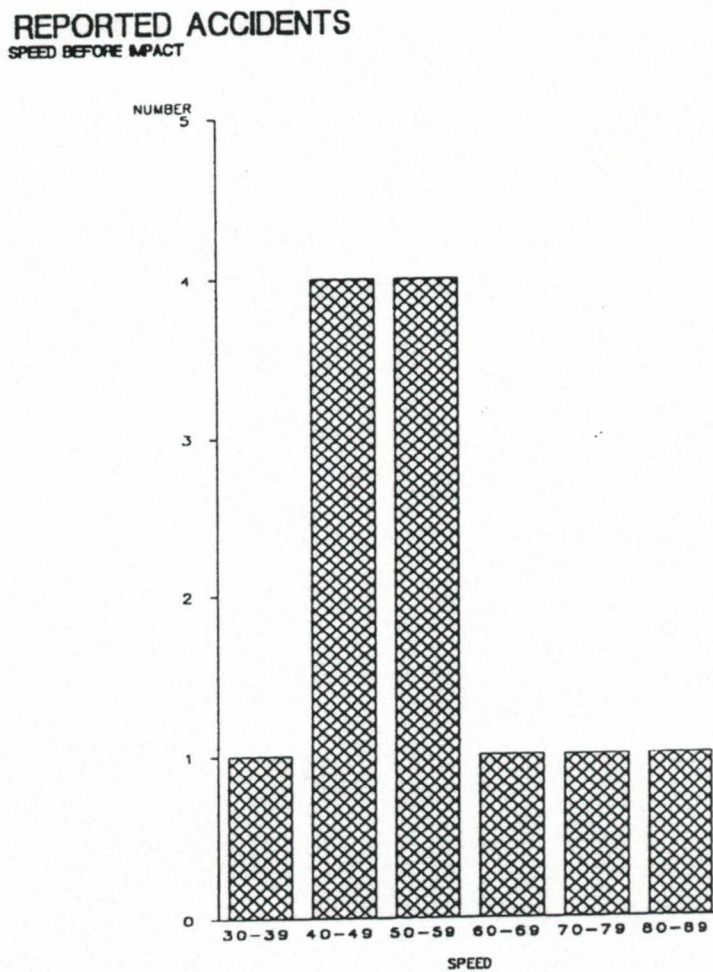
**Figure 11. Speeds at Impact, Barrier Wall Collisions.**

Estimated vehicle speeds, at the time of contact, ranged from 10 to 65 mph. Accidents had already occurred, been investigated by Oklahoma Highway Patrol (OHP) troopers, and vehicles had been removed by the time the ODOT Research Division received reports on them. Angles of impact were not estimated or reported, as OHP Troopers do not ordinarily record this information. None of the impacting vehicles continued through the wall into the work area. With each collision, there was some barrier displacement, and straightening of the wall was required after each impact.

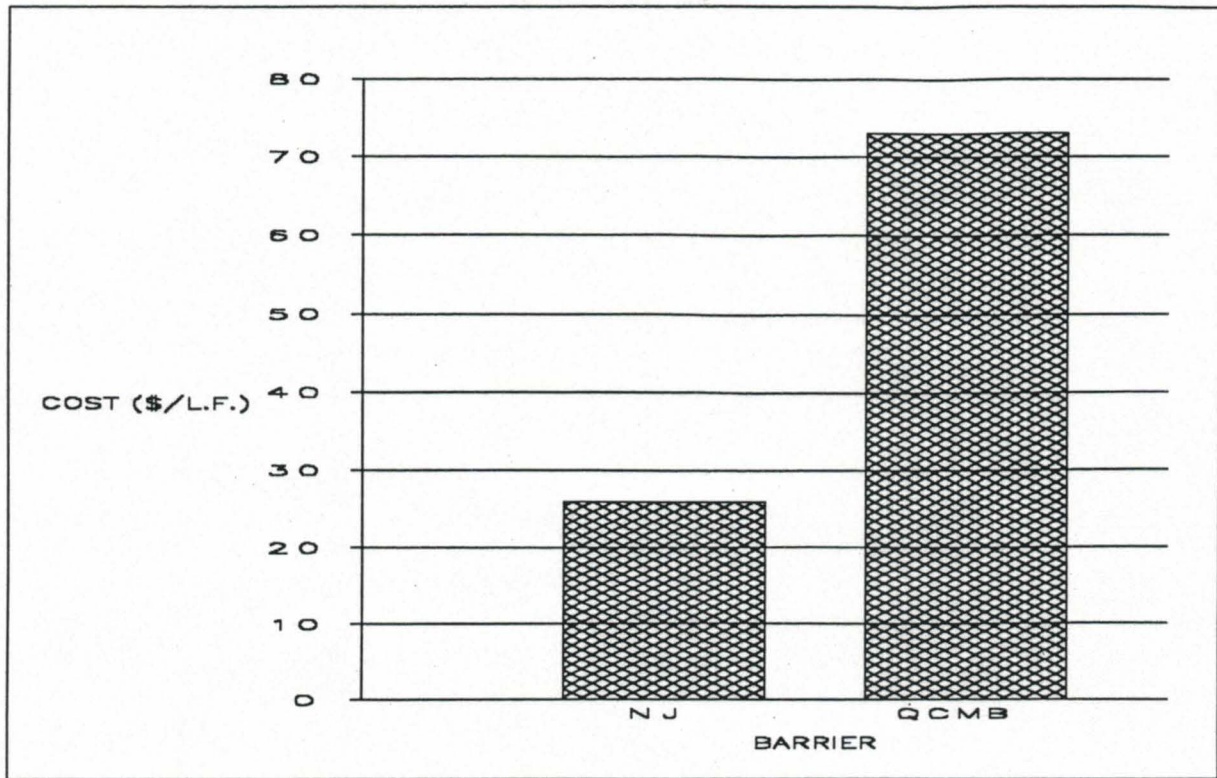
**Figure 12. Purchase Price, New Jersey and QMCB Barrier.**

The \$73.00 per L.F. purchase cost for QMCB Barrier Wall is considerably higher than the \$26.00 per L.F. cost of New Jersey Barrier (Figure 12.). A significant proportion (approximately 15 percent) of the QMCB segments now have chipped corners and/or chipping under the flanges (Figure 13.). According to Nielson's employees, this type of damage is due to wear during barrier wall shifts, and loading and unloading, rather than to collisions. This type of damage would indicate that the service life of QMCB segments will be related to the number of times placed on, or removed from worksites, and the number of times it is shifted. A shorter service life would be expected for QMCB segments, relative to that of New Jersey Barrier. If the expected shorter life proves to be correct, this will further increase the differences in cost, on a life cycle basis.

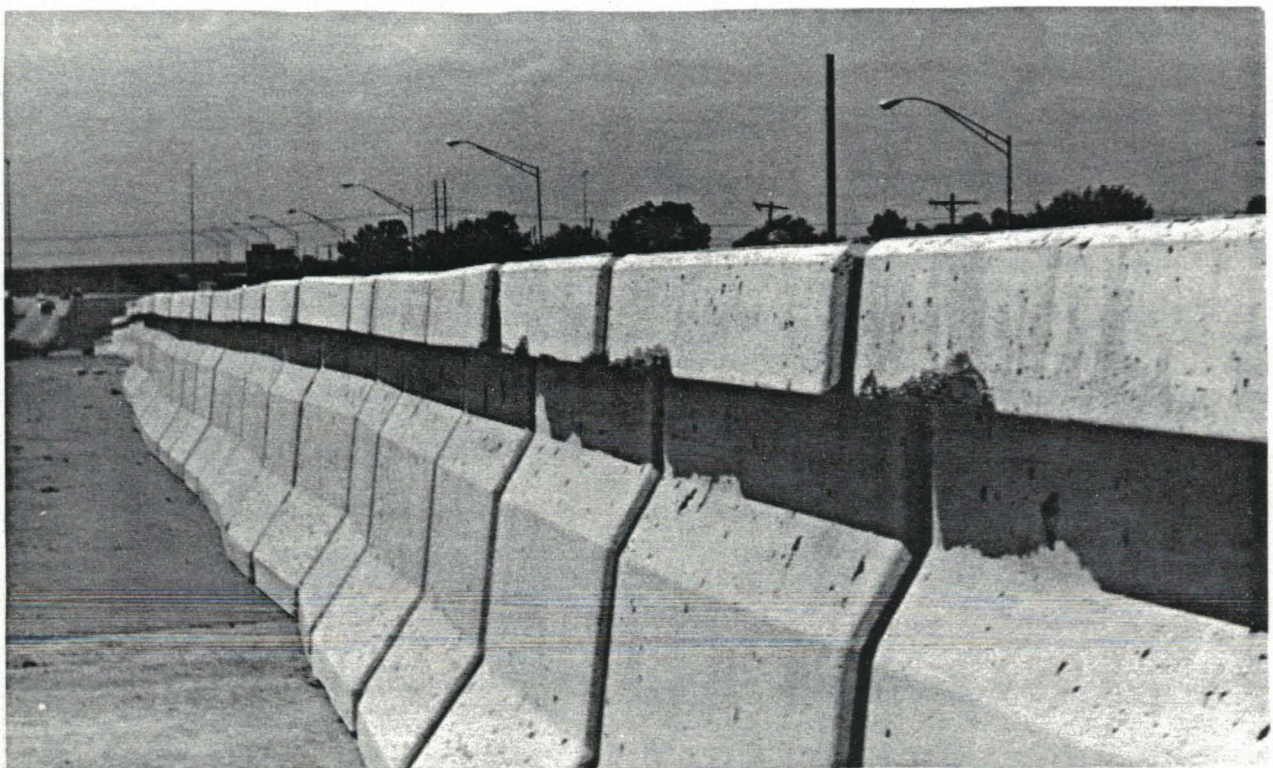
**Figure 13. Chipping Under Flanges on Barrier Segments.**

Barrier segments have shown some signs of wear over the duration of this project. A fairly large proportion of the segments, roughly 15 per cent, have corners chipped off at the base or chipping under the flanges. During work on IR-240-1(324)000, approximately 15 segments (0.34 percent) were damaged severely enough so that they were no longer usable. According to Nielson's employees, all were damaged during loading, unloading, and stacking operations associated with initial placement and removal. Chipping under the flanges, and chipped corners occurred during barrier shifts.

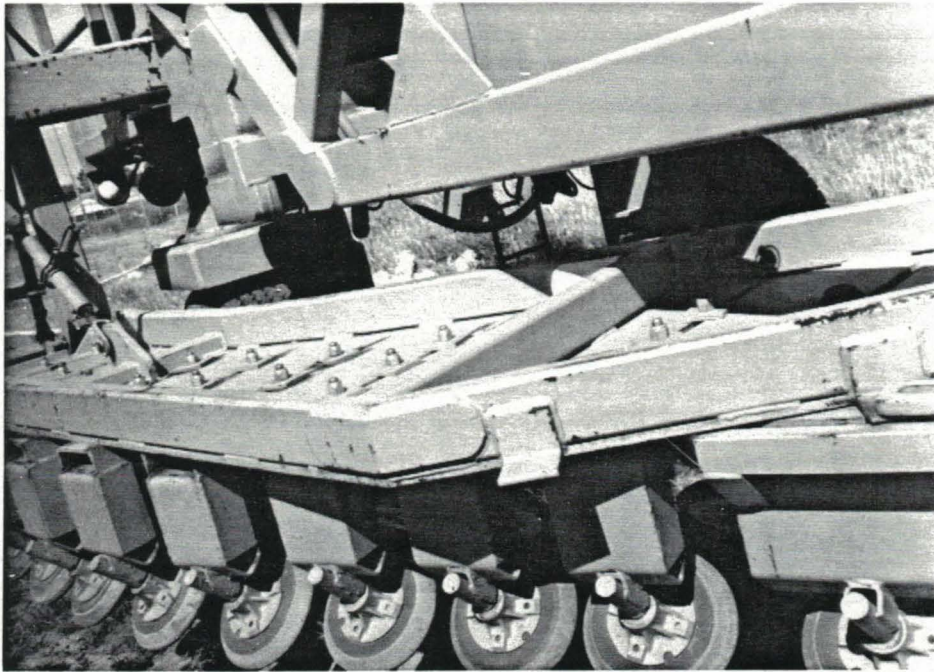
**Figure 14. Carrier Wheel Assemblies.**

When the width of a barrier shift is changed, for example, from 14 feet to 6 feet, the number of carrier wheel assemblies must be changed. This requires removal or addition of assemblies which are bolted in place in the conveyor track (Figure 14). If the project requires barrier shifts of different widths, adequate time must be scheduled between shifts for the mechanic to make these changes.

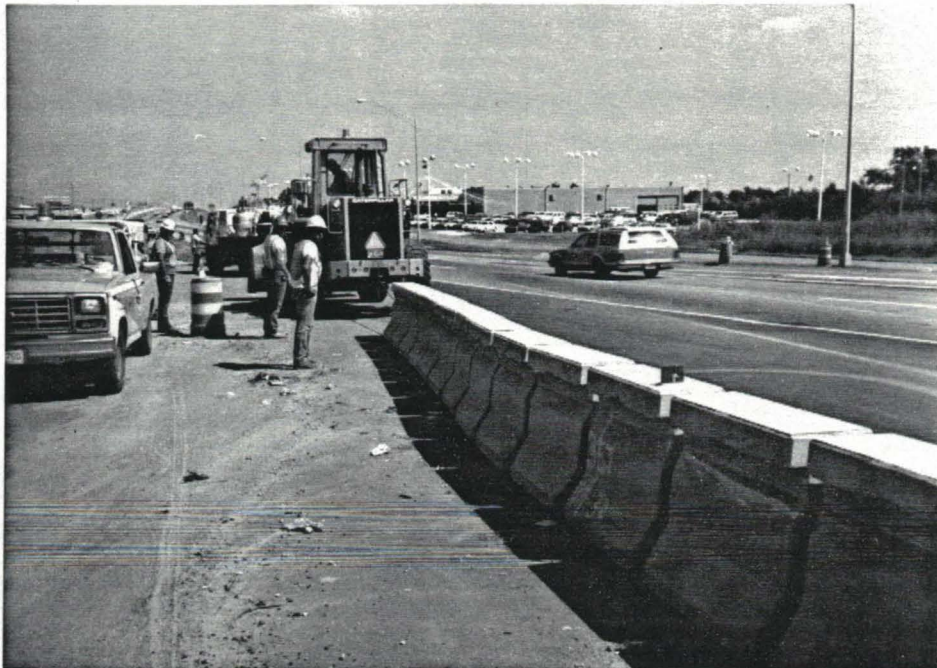
**Figure 15. Straightening a "Kink" in the QMCB Wall.**

TTV operators noticed that the barrier wall tended to "kink" during shifts when it was deployed on a noticeable curve. When this occurred, the TTV had to back up, then the wall had to be straightened by work vehicles, before the barrier shift could continue (Figure 15). This happened frequently in areas where the wall was curved to flare it away from the traffic.

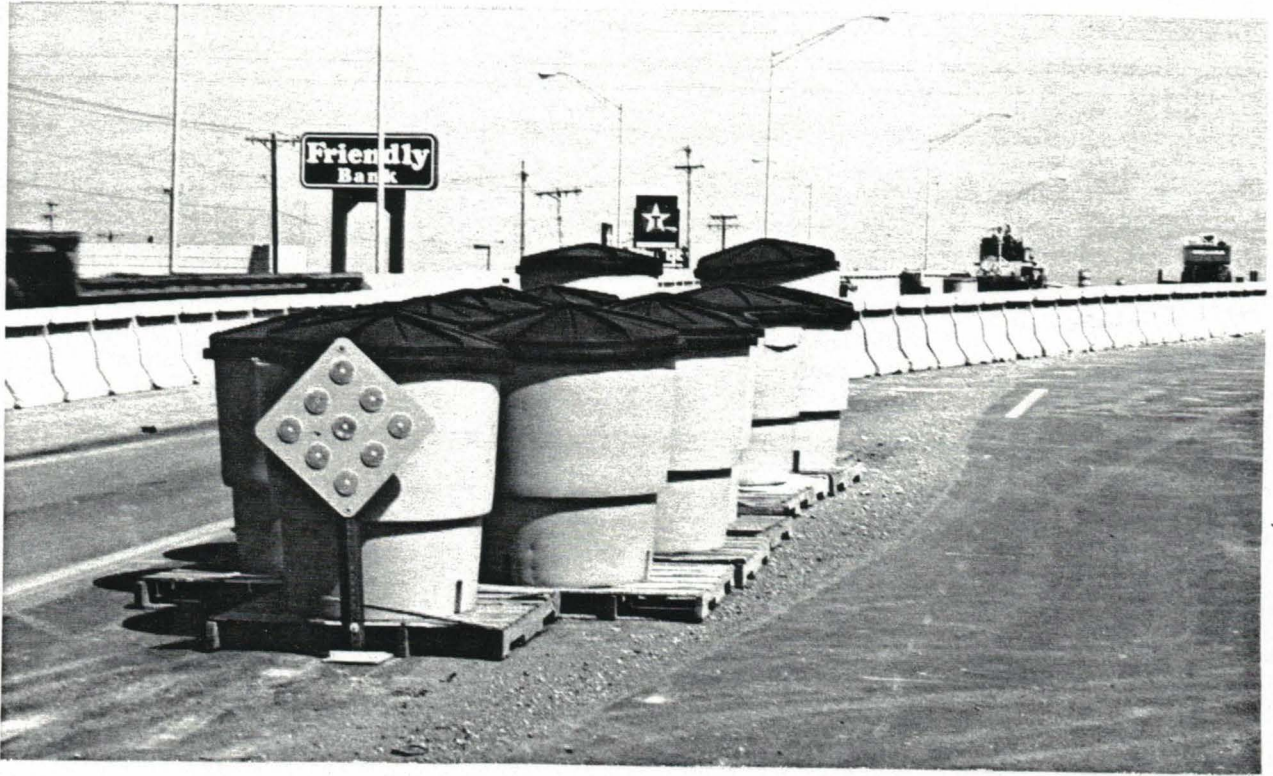
Figure 16. End Protection for QMCB Wall on Project IR-240-1(324)000.

On Project IR-240-1(324)000, crash attenuator end protection was required for barrier walls positioned near traffic lanes. End protection consisted of arrays of sand barrels (Figure 16). When the barrier was shifted, the end protection had to be moved also. Sand barrels are not designed to withstand frequent moves, and they were often damaged during moves. The subcontractor responsible for traffic control moved the barrels using a small forklift (Figure 17). Barrels were placed on wooden pallets to allow for forklift handling. The pallets also broke frequently during moves. No collisions involving the sand barrel end protection occurred during work on this project.

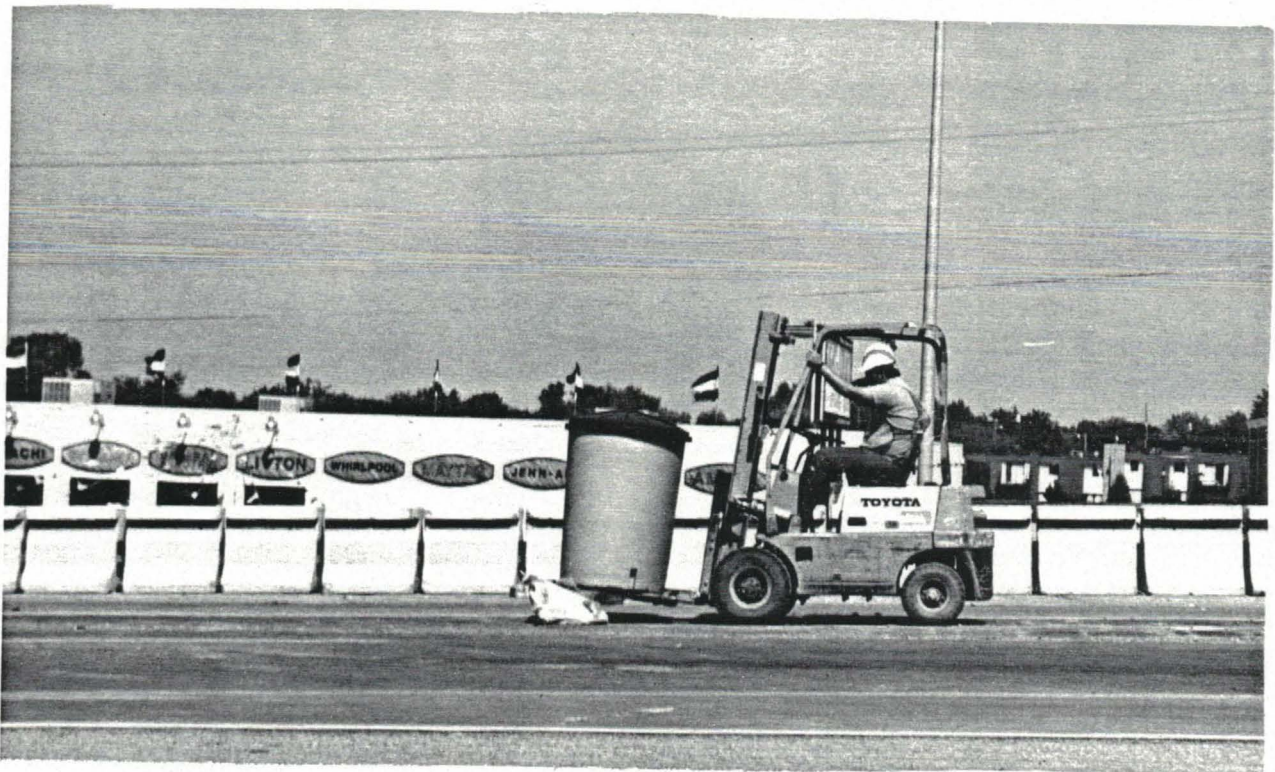
Figure 17. Moving End Protection Prior to Barrier Wall Shift.

Moving the end protection created a "bottleneck" situation when barrier walls were shifted. Sand barrels had to be moved one at a time by forklift. Relocating the sand barrel array took roughly 30 minutes. This had to be done in advance of barrier wall shifts which required approximately five (5) minutes per 1/2 mile of barrier wall shifted.
