STATE OF OKLAHOMA  
DEPARTMENT OF TRANSPORTATION  
RESEARCH AND DEVELOPMENT DIVISION

FINAL REPORT  
Project No. 2722

***EVALUATION OF COATINGS  
APPLIED OVER  
CORRODED STRUCTURAL STEEL SURFACES***

May 1990

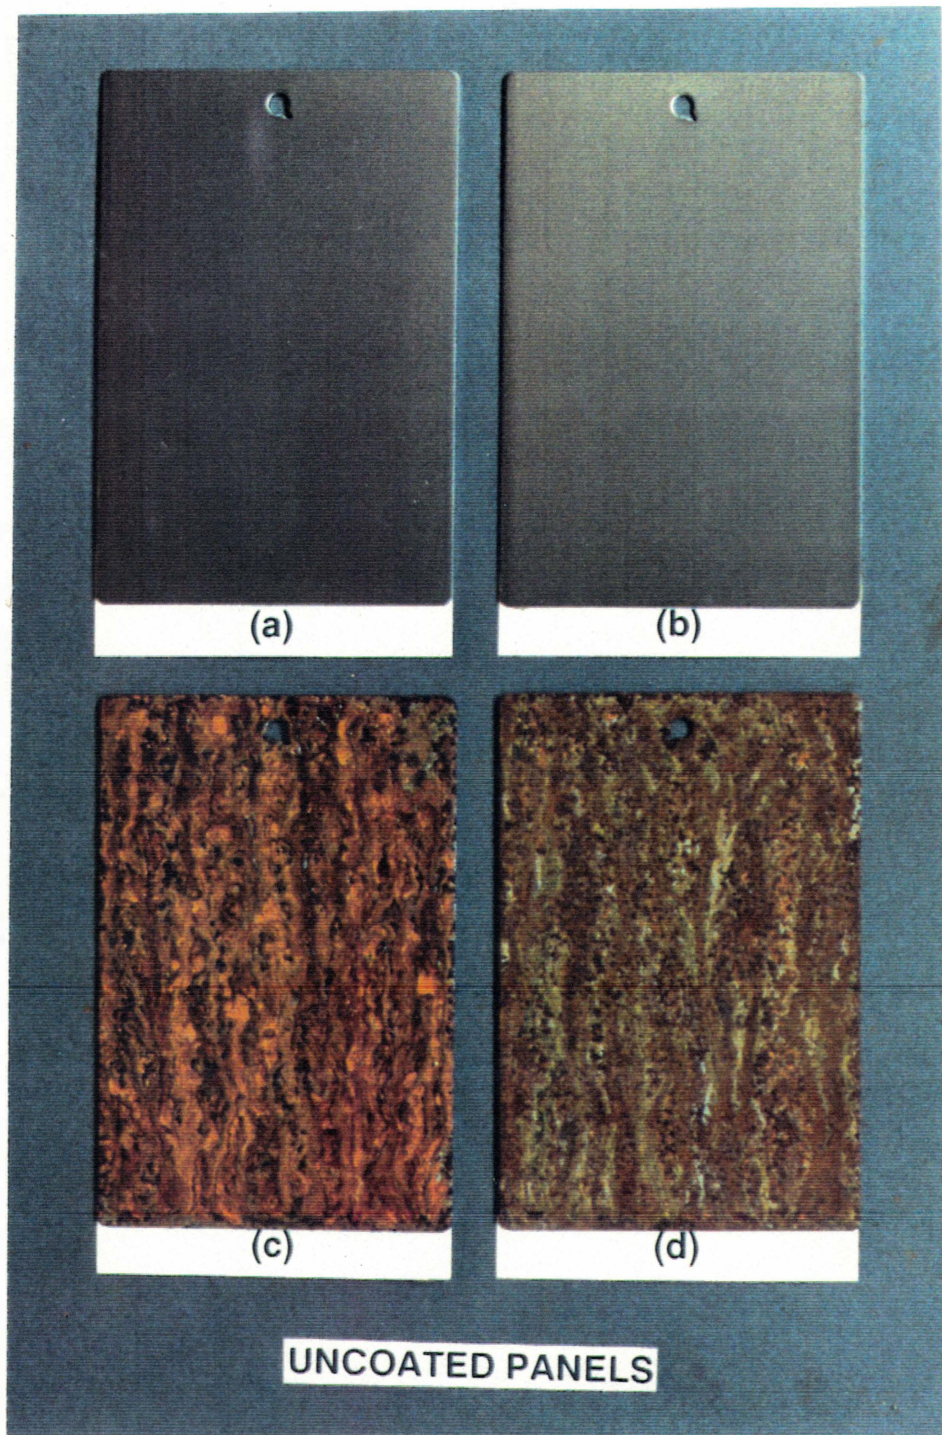
**Figure 1:** Test panels surface appearance before coating applications: (a) panel without any treatment, (b) grit blasted only, (c) grit blasted and pre-corroded, and (d) grit blasted and pre-corroded followed by hand tool cleaning.

The coatings were applied to both pre-corroded and non-corroded steel surfaces. The test panels were "Q" panels, 4 in x 6 in x 0.32 in thick with a dull matte finish. The panels were grit blasted before processing with "Zero Blasting" glass beads, BT-10, size range 100-170 mesh. Panels were pre-corroded by exposure in a salt fog chamber constructed for this project. The chamber test conditions conformed to ASTM B-117, except that the test temperature was ambient (23°C). The uncoated panels were exposed for 216 hours (9 days). This produced a thick but non-uniform rust. These samples were dried for 7 days, and then the loose scale was removed in accordance with SSPC procedure SP2, Hand Tool Cleaning. The condition of the panels in the as-received, grit blasted, corroded, and hand cleaned conditions are shown in Figure 1.

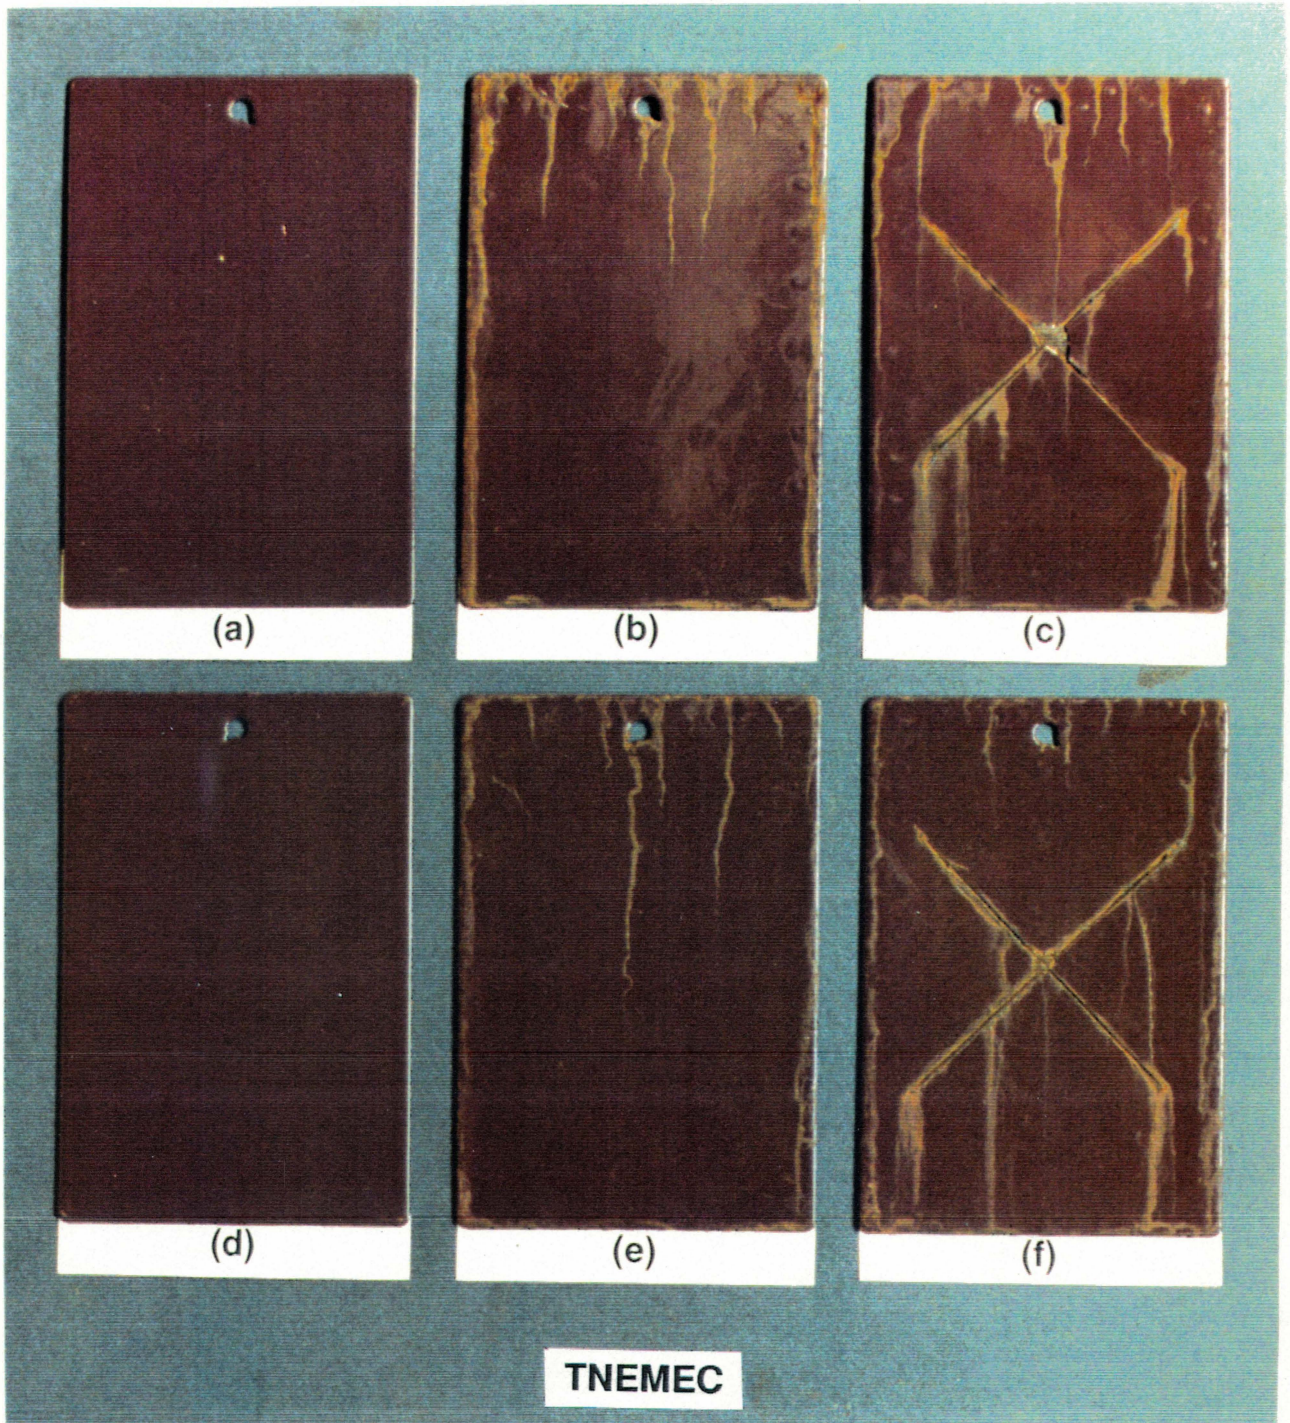
**Figure 2:** Coatings exposed to salt fog environment applied on surfaces prepared by: **(a,b,c)** grit blasting only, and **(d,e,f)** grit blasting followed by pre-corrosion and hand tool cleaning. Reference panels **(a)** and **(d)** illustrate the coating conditions before exposure.

The Tnemec coating, Figure 2, performed well on the scales of blister size and blister frequency on the non-corroded surface. Small blisters developed after about 800 hours. On the pre-corroded surface blisters developed after about 700 hours. The blister size rating was 6 and the frequency rating was 4 at 1200 hours. This corresponds to pinpoint to 1/16 inch blisters with a medium-dense frequency. The rust rating remained 10 for the 1200 hours of test. The scribe rating of the pre-corroded surface was 9 at 1200 hours, which was better than that of the non-corroded surface which degraded to 6 after about 1000 hours.

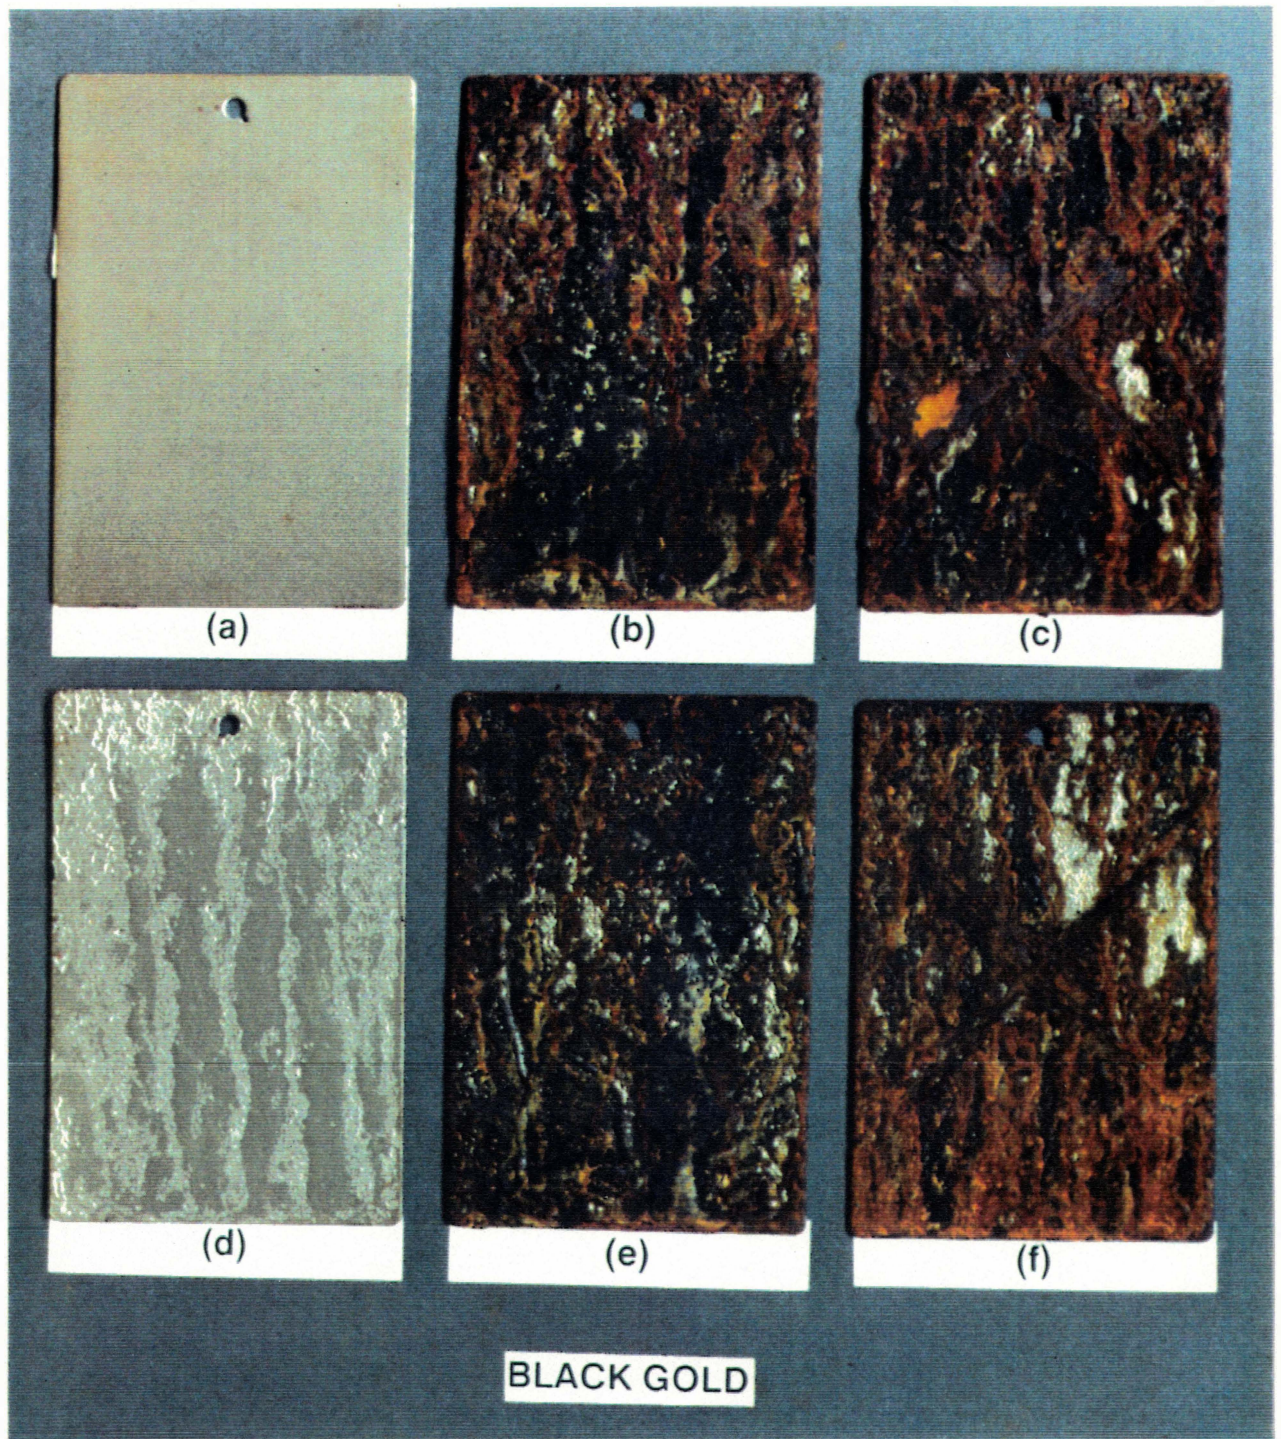
**Figure 3:** Coatings exposed to salt fog environment applied on surfaces prepared by: (a,b,c) grit blasting only, and (d,e,f) grit blasting followed by pre-corrosion and hand tool cleaning. Reference panels (a) and (d) illustrate the coating conditions before exposure.

The Tri-F Black Gold coating, Figure 3, was one of the thinner coatings, so the roughness of the pre-corroded surface shows through the coating (see Figure 3, panel d). The coatings on both the non-corroded and the pre-corroded surfaces began to blister after 24 hours of salt fog exposure. After 96 hours the coatings were densely blistered. Both blister size and blister frequency were at a rank of 2, i.e., 3/8 inch and larger blisters and dense blistering. The rust rating degraded markedly after 600 hours for both the non-corroded and pre-corroded surfaces. The scribe rating began to degrade after 100 to 150 hours. On all four scales of comparison the performance of the Black Gold was inferior to that of the other coatings.

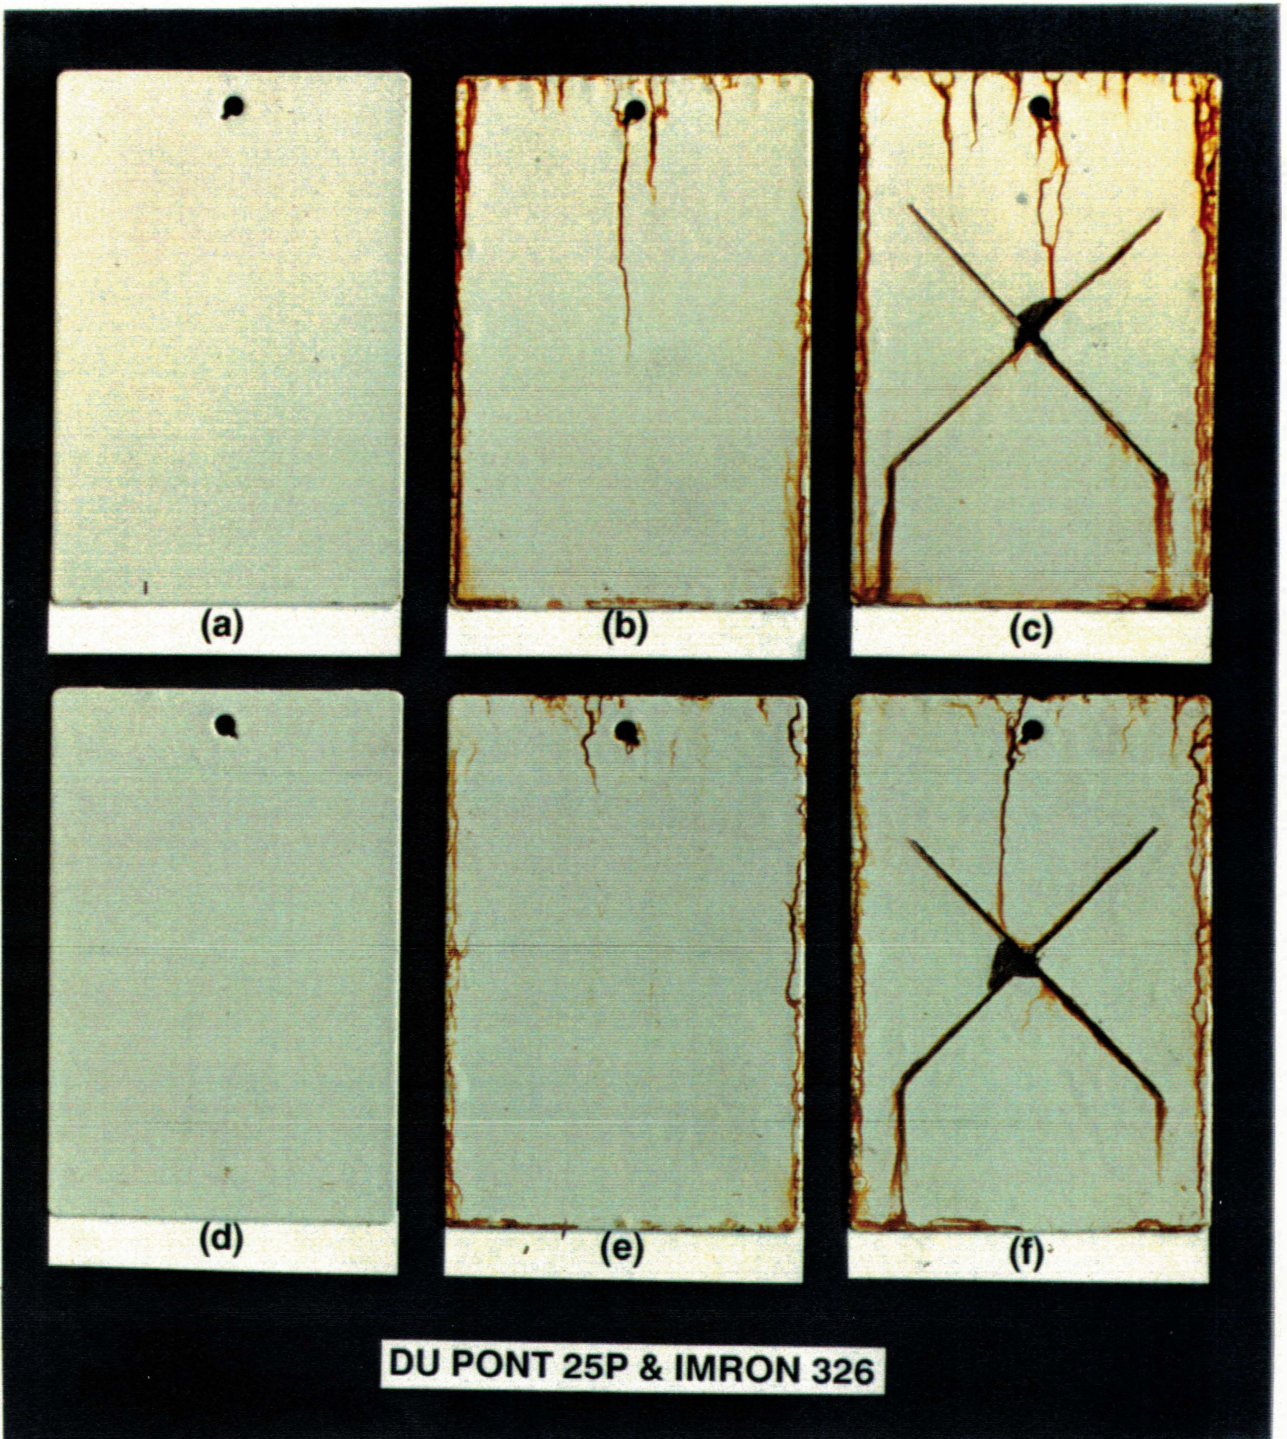
**Figure 4:** Coatings exposed to salt fog environment applied on surfaces prepared by: (a,b,c) grit blasting only, and (d,e,f) grit blasting followed by pre-corrosion and hand tool cleaning. Reference panels (a) and (d) illustrate the coating conditions before exposure.

The DuPont coating, Figure 4, performed quite well on the scales of blister size and blister frequency. The coating on the non-corroded surfaces exhibited no blistering after 1200 hours. The coating on the pre-corroded panels showed some blistering after 800 hours, but degraded only to a rating of 8 on both the blister size and frequency scales. This represents a few pinpoint blisters. The non-scribed panels exhibited no rusting. The scribe rating for the non-corroded panels was good with creepage from the scribe of less than 1/64 inch after 1000 hours. The pre-corroded panels showed undercutting after 600 hours, but performed as well as the non-corroded panels with a scribe rating of 7.

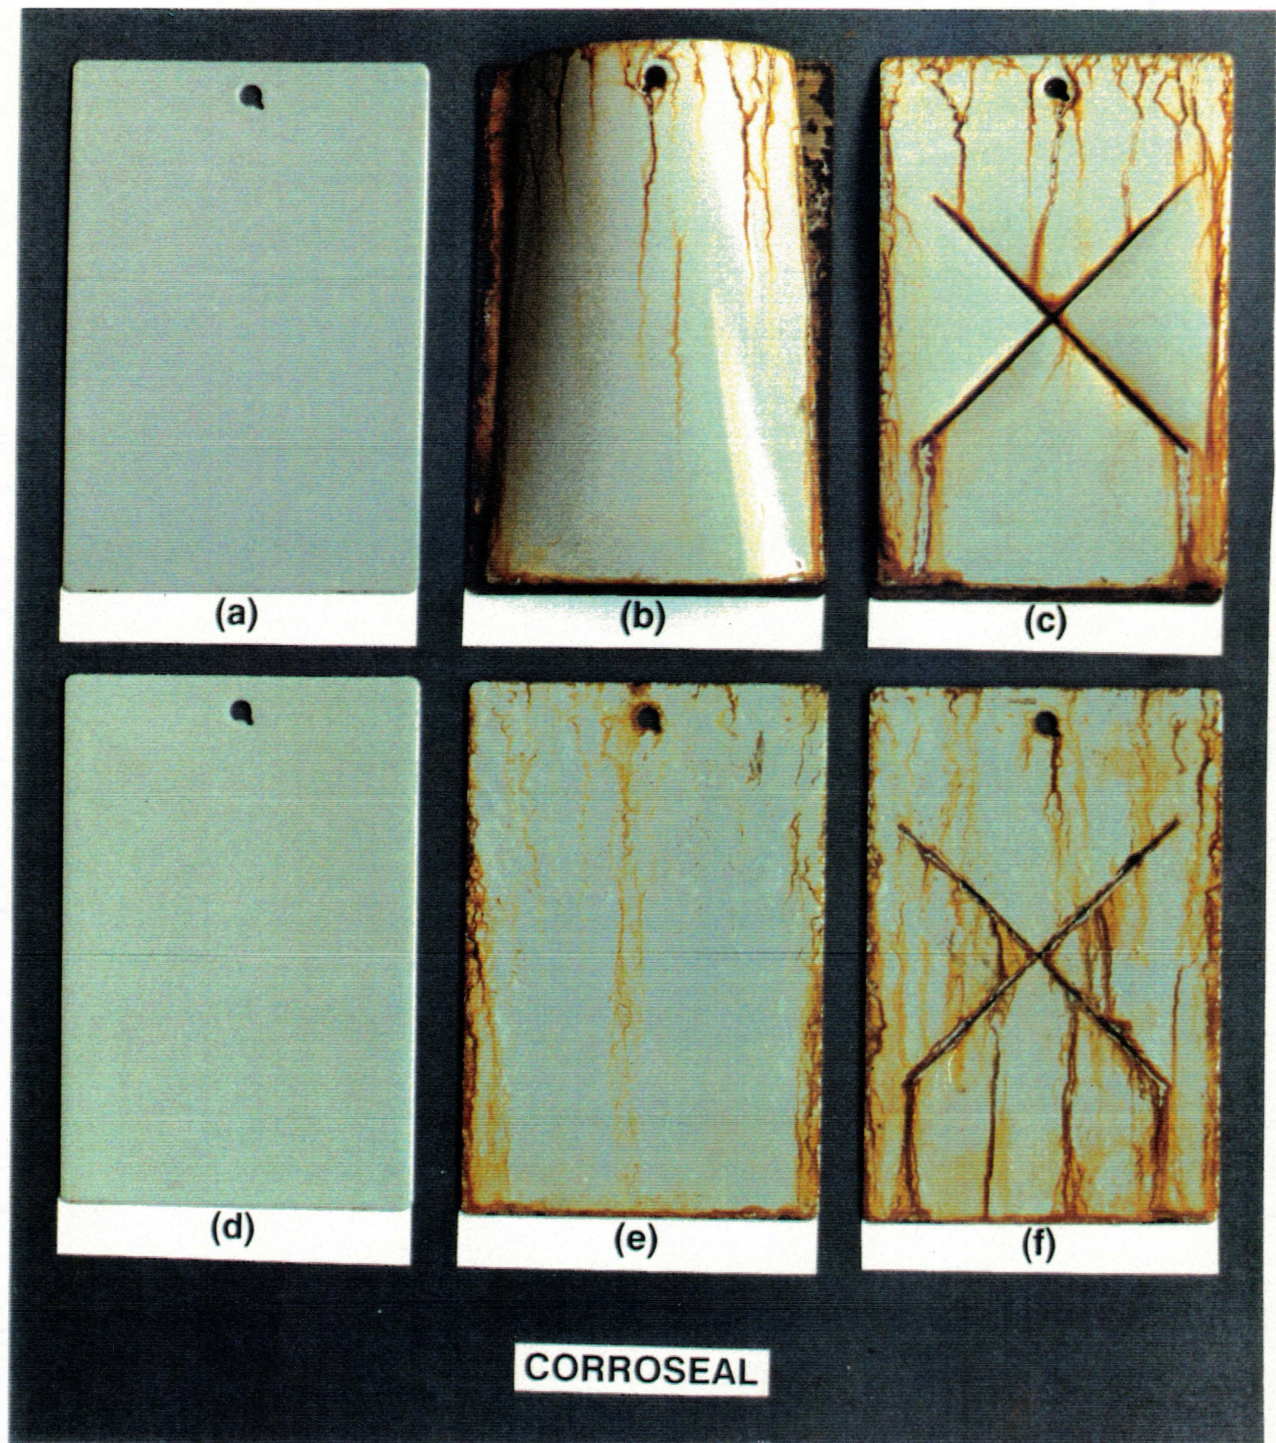
**Figure 5:** Coatings exposed to salt fog environment applied on surfaces prepared by: **(a,b,c)** grit blasting only, and **(d,e,f)** grit blasting followed by pre-corrosion and hand tool cleaning. Reference panels **(a)** and **(d)** illustrate the coating conditions before exposure.

The Corroseal coating, Figure 5, on the non-corroded surface performed quite well with blister size and frequency ratings of 10 up to near the end of the test period. At about 1150 hours the entire coating disbonded from the surface as can be seen in Figure 5, panel (b). The coating on the pre-corroded surface did not disbond, but it developed blisters after about 425 hours. The blister size rating degraded to 4 after 750 hours and the

blister frequency degraded to 4 after about 875 hours. This represents medium-dense blistering up to a size of 1/6 inch. The rust rating was 10 for the coating on the non-corroded surface and 9 for the pre-corroded surface. The scribe rating was good, a 9, for the coating on the pre-corroded surface after 1200 hours. On the non-corroded surface, the scribed coating disbonded after about 1050 hours, so the scribe rating went to zero. Apparently, Corroseal bonds better to a rusted surface than to a clean surface.

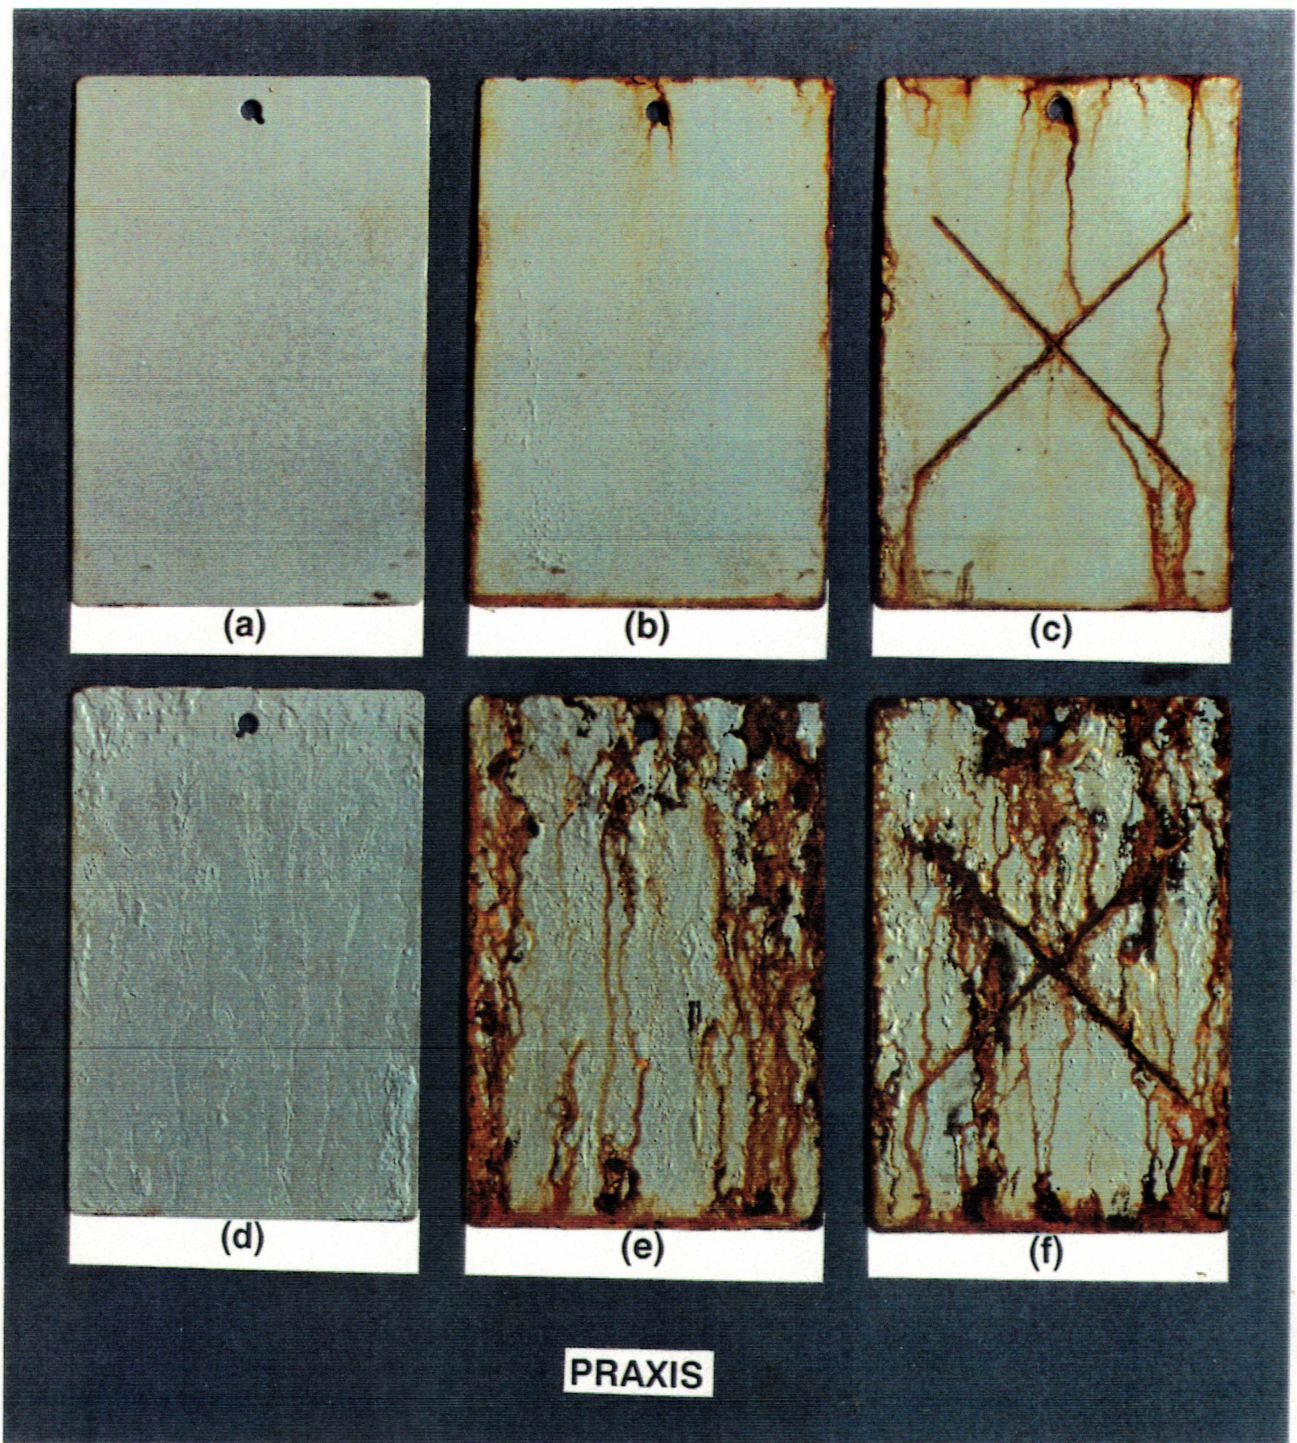
**Figure 6:** Coatings exposed to salt fog environment applied on surfaces prepared by: (a,b,c) grit blasting only, and (d,e,f) grit blasting followed by pre-corrosion and hand toolcleaning. Reference panels (a) and (d) illustrate the coating conditions before exposure.

The Praxis coating, Figure 6, was a thin coating, about 2 mil dry film thickness. The coating applied over the pre-corroded surface was rough (see Figure 6, panel d). On the non-corroded surface blistering began after about 800 hours. Blister size was 6 and blister frequency 8 after 1200 hours. This corresponds to a few blisters from pinpoint to 1/16 inch in size. On the pre-corroded surface the coating began to blister after about 475 hours, but blister size rating remained 8 throughout the test. Blister frequency increased with time reaching a level of 4 after about 850 hours. This corresponds to medium-dense, pinpoint blisters. The rust ratings of the coatings on both the non-corroded and the pre-corroded surfaces were recorded as a 10 throughout the test. However, these observations were apparently in error. Examination of the panels (as indicated in Figure 6) after completion of the tests showed extensive rusting through ruptured blisters and flaked coating. A rust rating no better than 6 is appropriate for the pre-corroded panels after 1200 hours of exposure. The scribe rating was better on the pre-corroded surface than on the non-corroded surface.

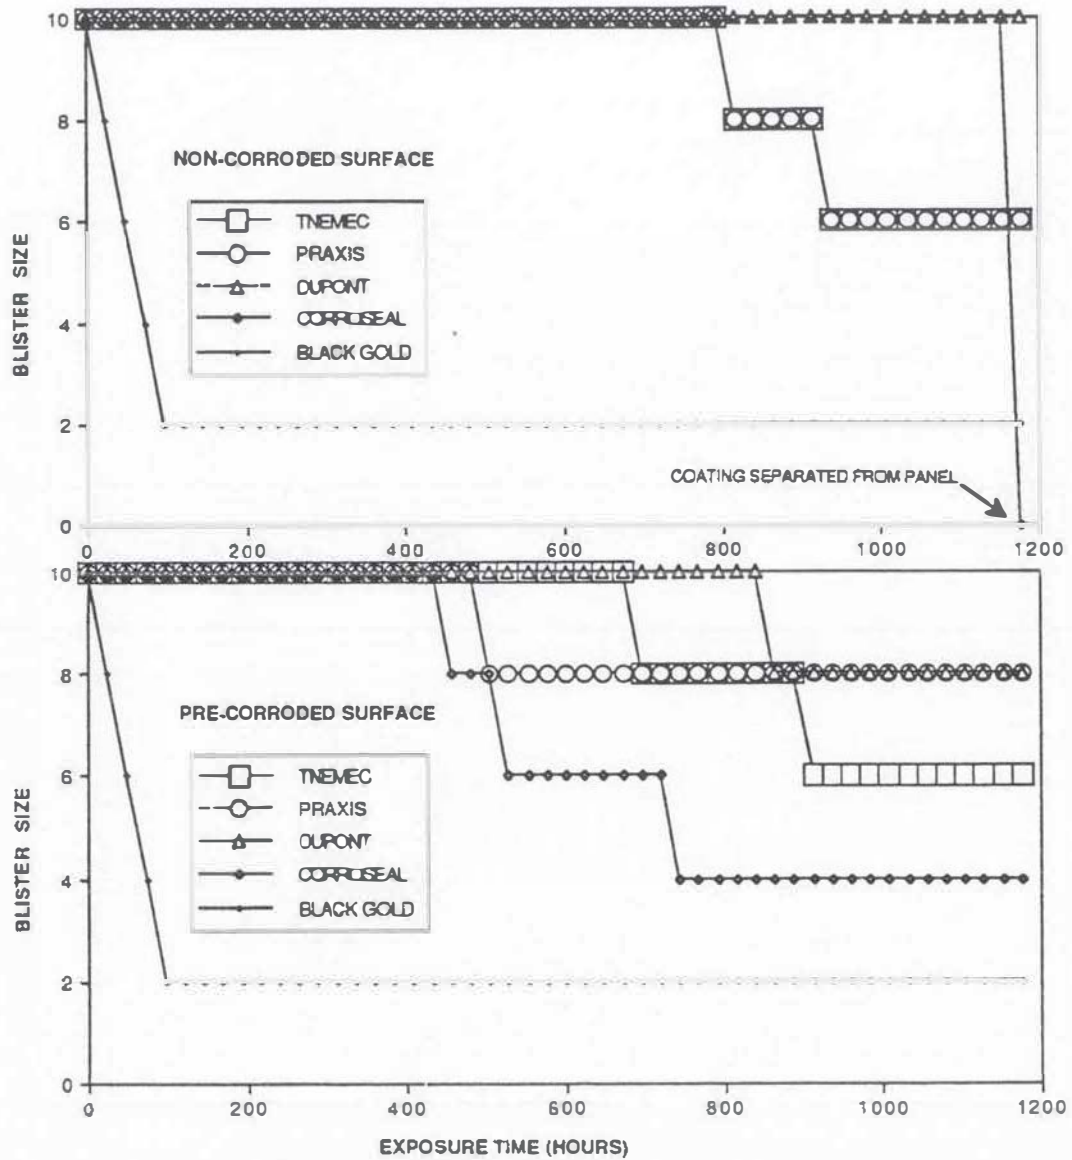
Figure 7. Blister size vs. exposure time in salt fog chamber for the five test coatings on (a) non-corroded and (b) pre-corroded panel surfaces.

The visual observation data in Appendix C were consolidated for easier inspection by averaging the replicate data and plotting blister size, frequency, and rust rating for the unscribed panels, and only the scribe ratings for the scribed panels. These summary data for all 5 coatings are presented in Figures 7-10. Blister size is plotted in Figure 7, Blister Frequency in Figure 8, Rust Rating in Figure 9, and Scribe Rating in Figure 10.

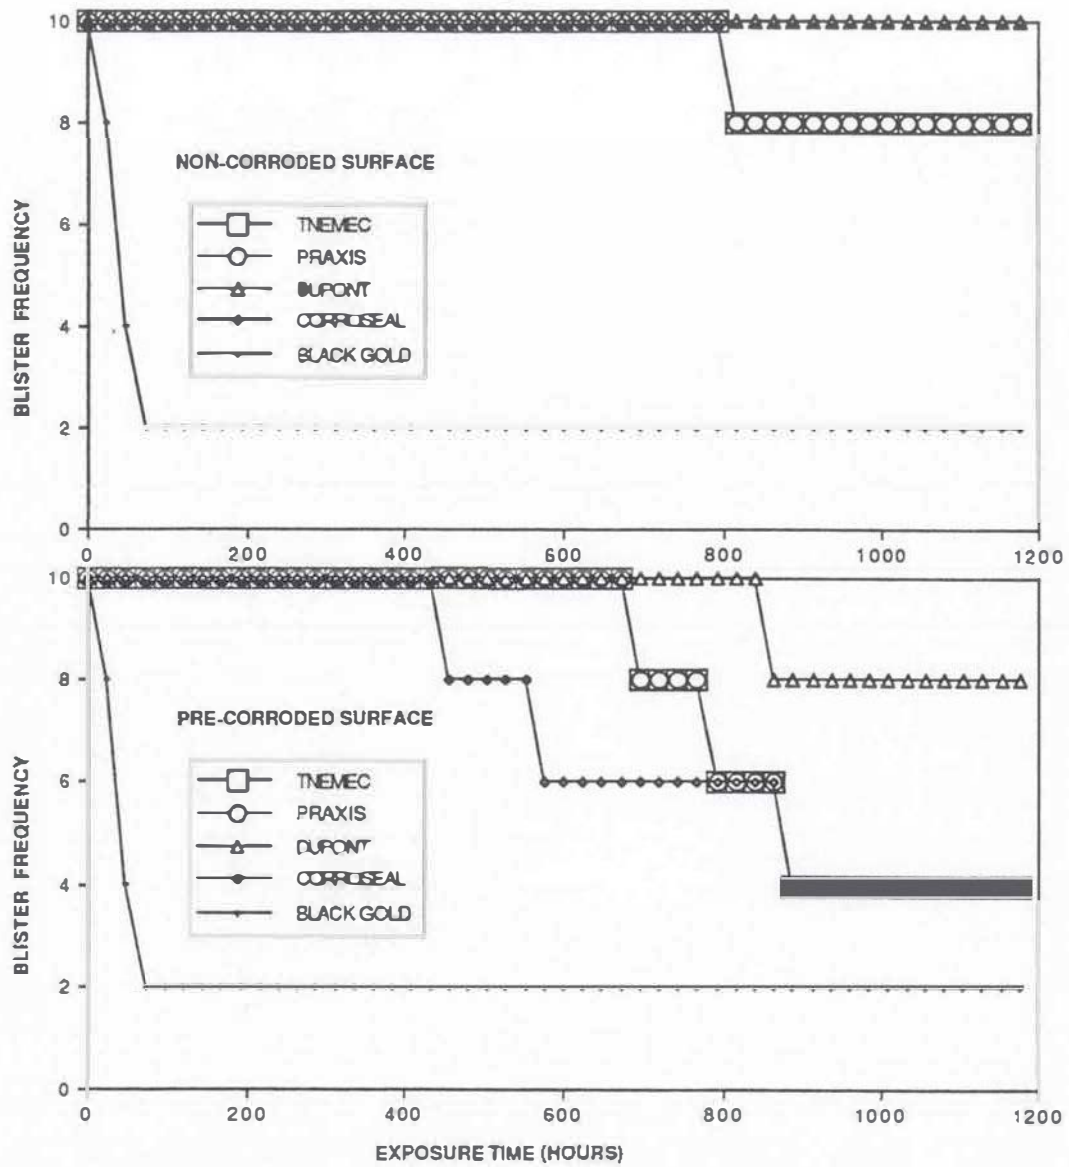
Figure 8. Blister frequency vs. exposure time in salt fog chamber for the five test coatings on (a) non-corroded and (b) pre-corroded panel surfaces.

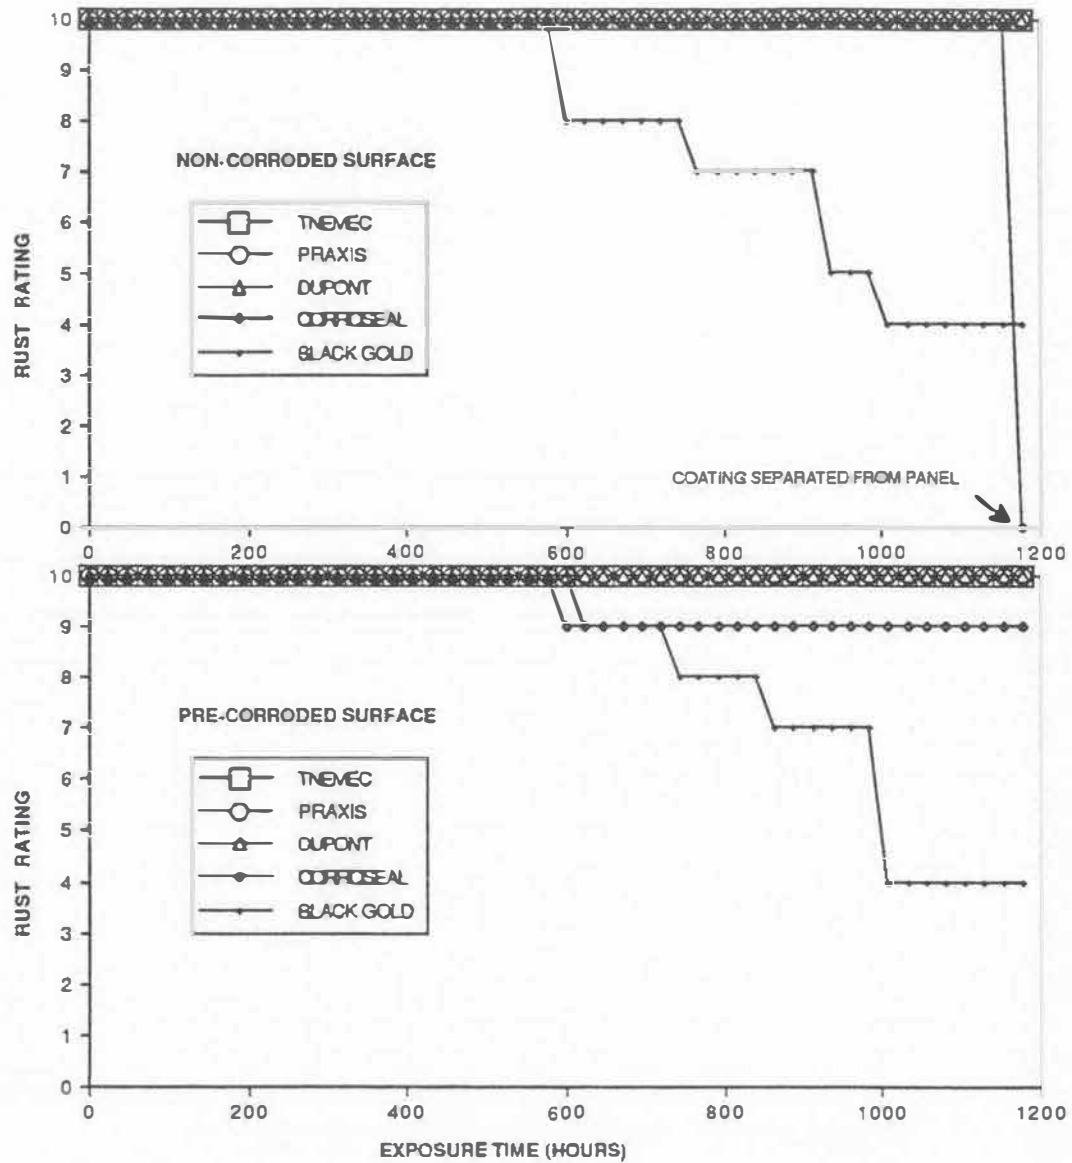
Figure 9. Rust Rating vs. exposure time in salt fog chamber for the five test coatings on (a) non-corroded and (b) pre-corroded panel surfaces.

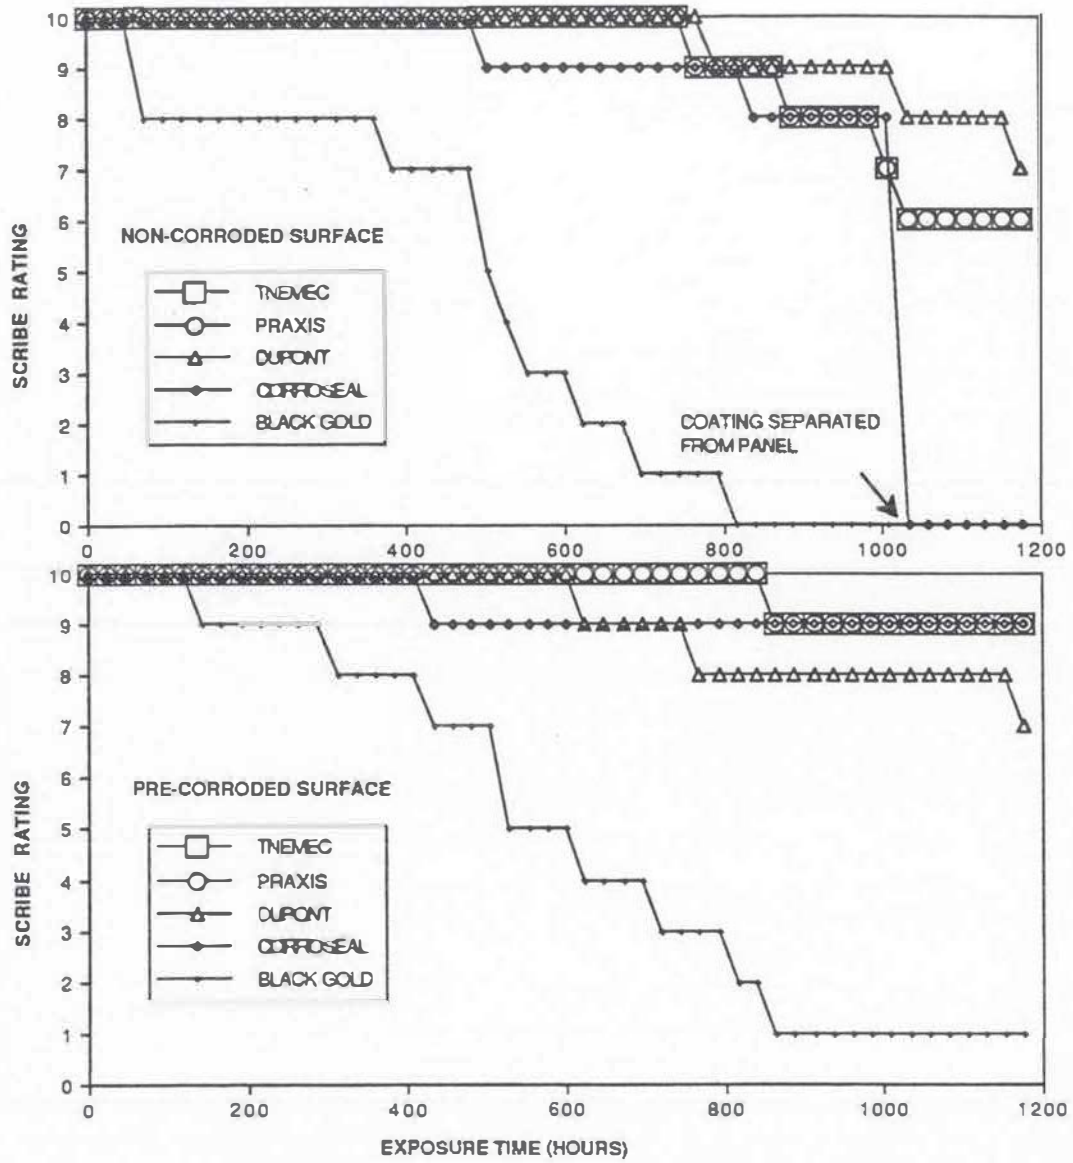
Figure 10. Scribe rating vs. exposure time in salt fog chamber for the five test coatings on (a) non-corroded and (b) pre-corroded panel surfaces.

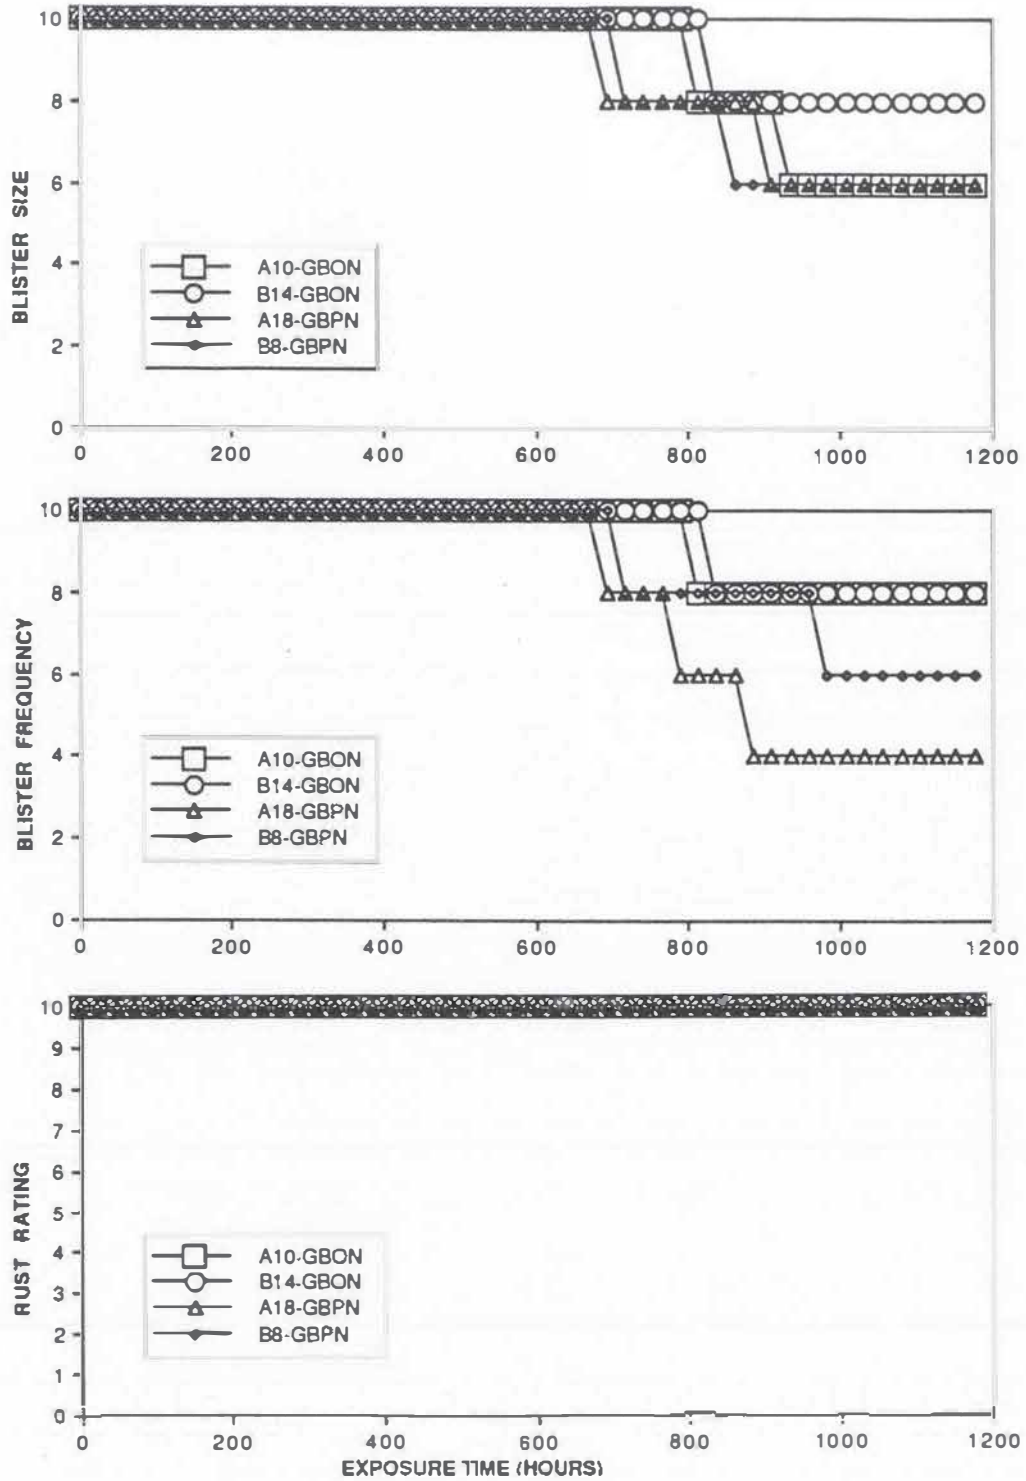
Figure C1. Daily visual observation data on Tnemec coated non-scribed panels: (a) blister size, (b) blister frequency, (c) rust rating.

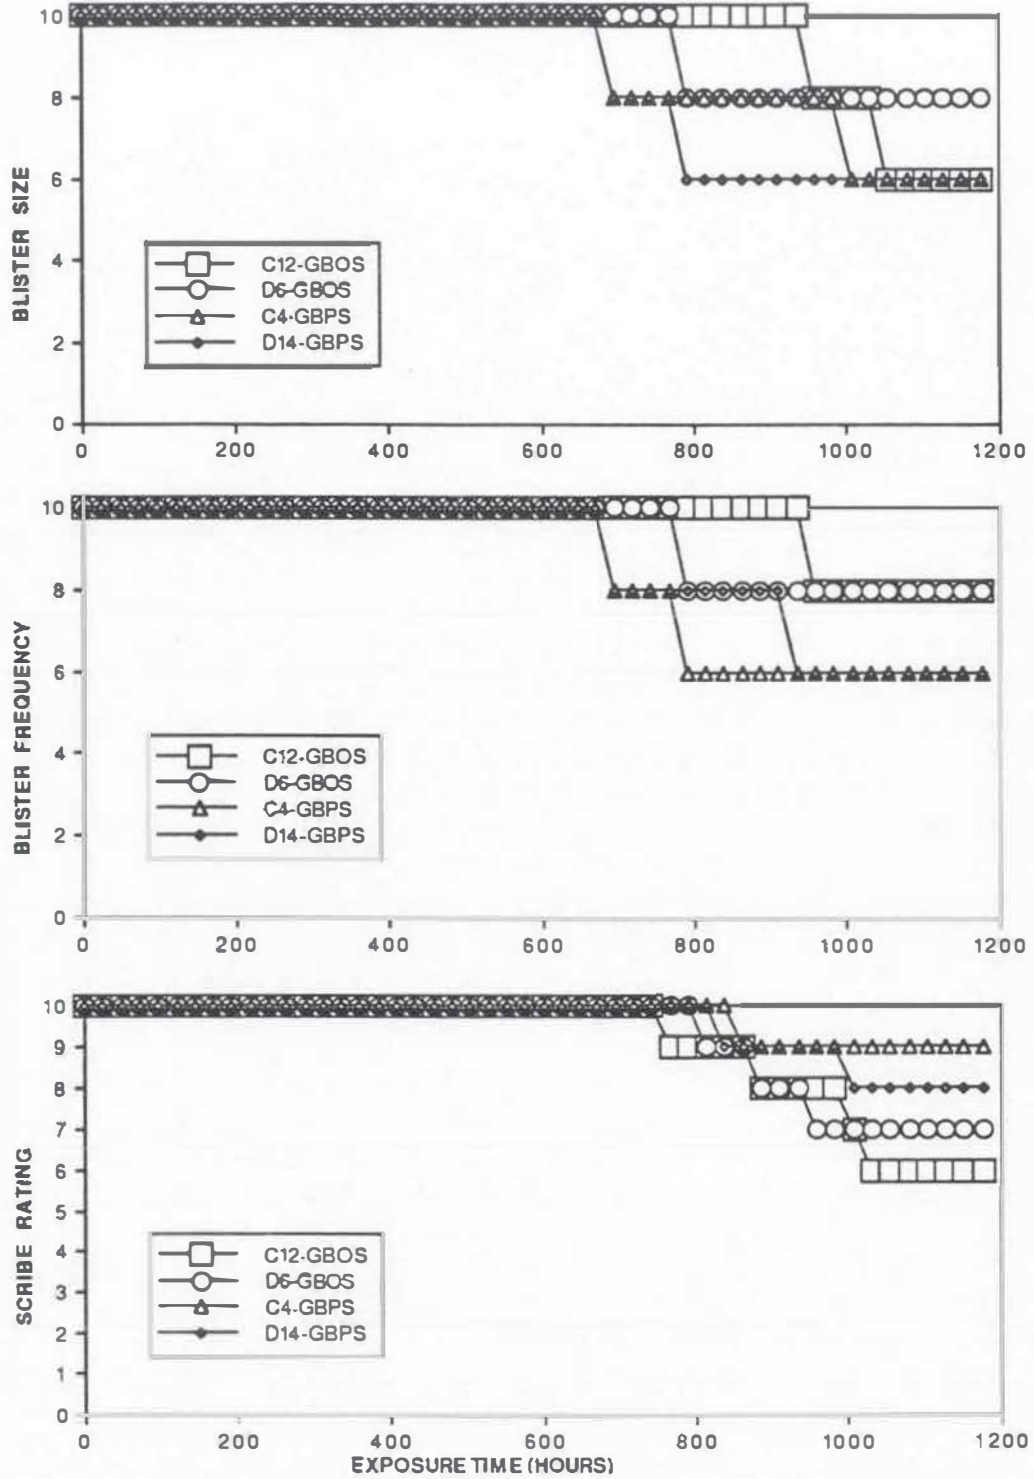
Figure C2. Daily visual observation data on Tnemec coated scribed panels: (a) blister size, (b) blister frequency, (c) scribe rating.

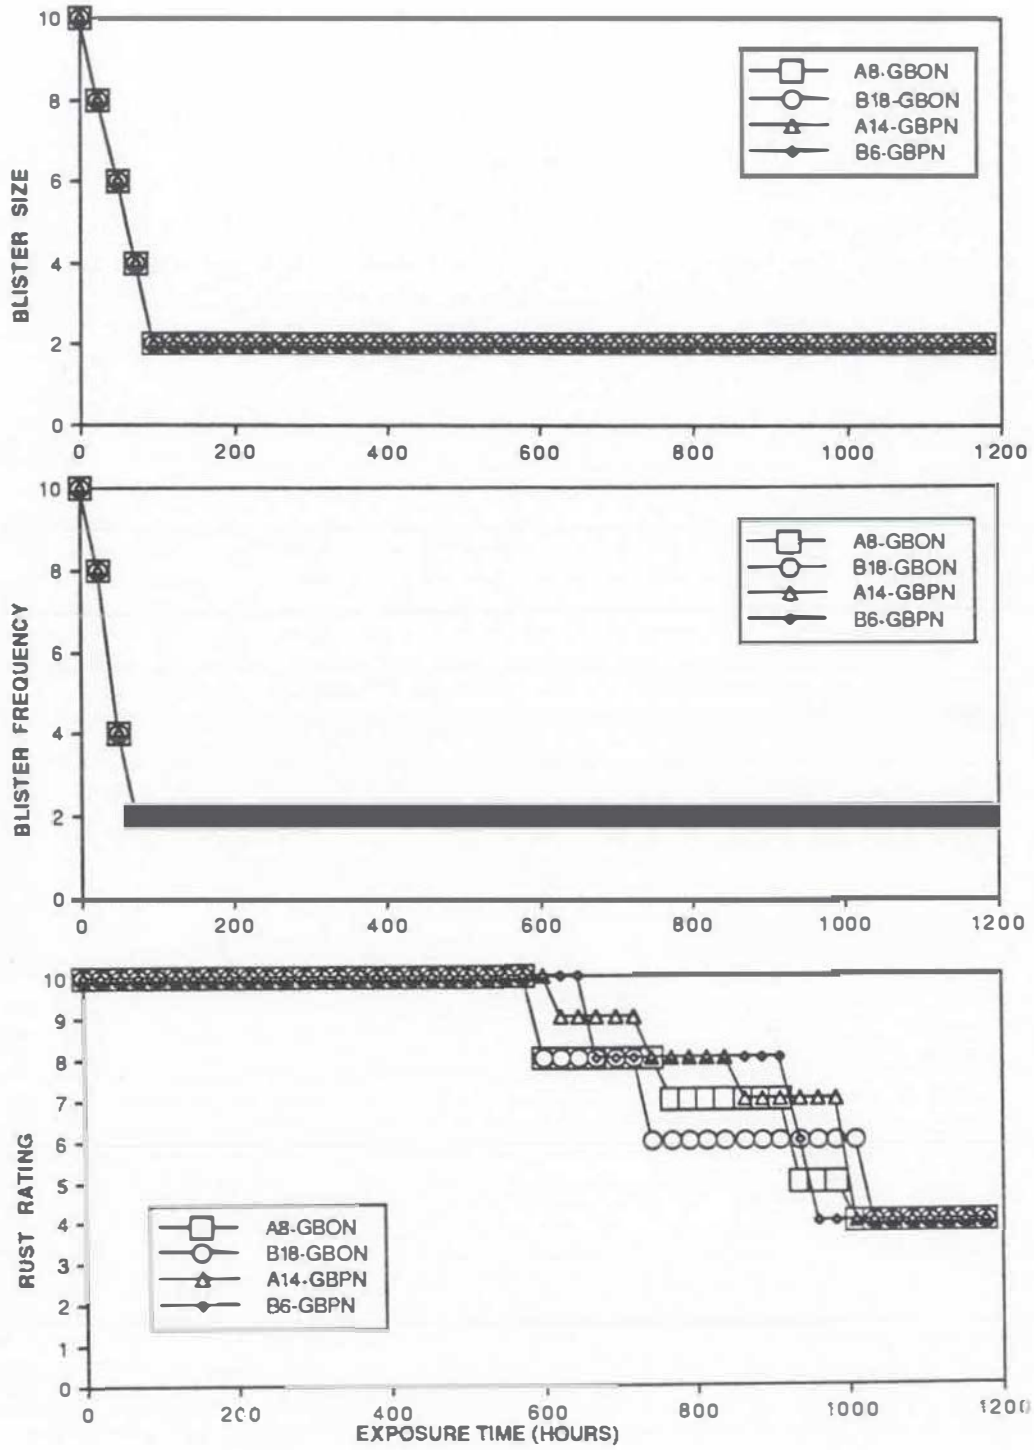
Figure C3. Daily visual observation data on Black Gold coated non-scribed panels: (a) blister size, (b) blister frequency, (c) rust rating.
