STATE OF OKLAHOMA  
DEPARTMENT OF TRANSPORTATION  
RESEARCH AND DEVELOPMENT DIVISION

FINAL REPORT  
Project No. 2722

***EVALUATION OF COATINGS  
APPLIED OVER  
CORRODED STRUCTURAL STEEL SURFACES***

May 1990

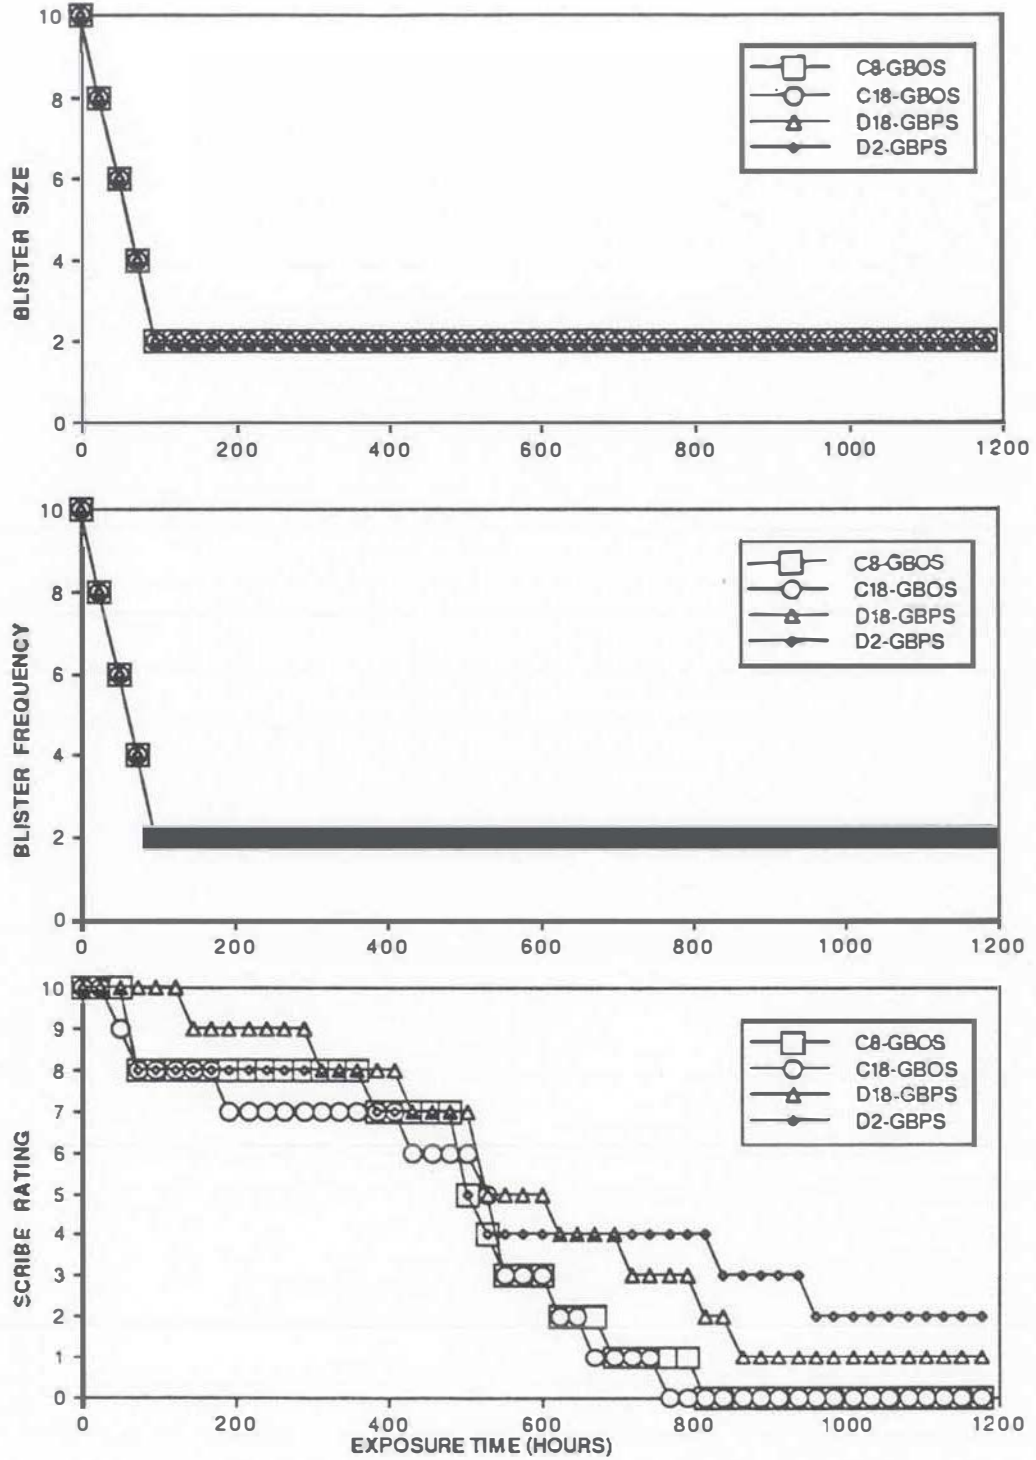
Figure C4. Daily visual observation data on Black Gold coated scribed panels: (a) blister size, (b) blister frequency, (c) scribe rating.

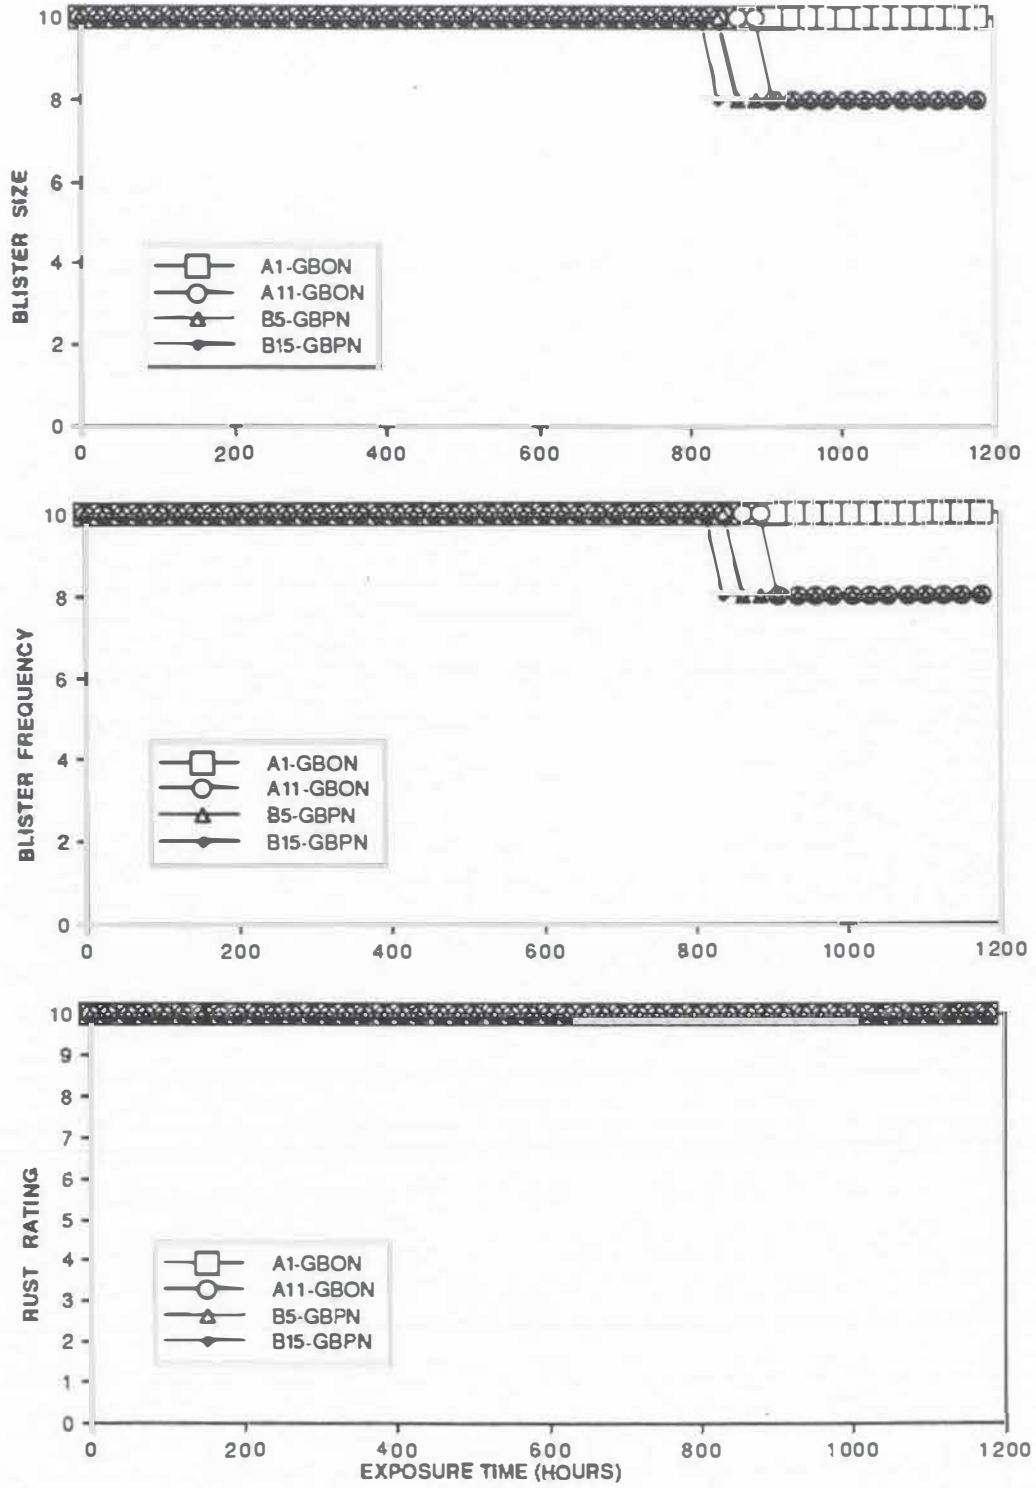
Figure C5. Daily visual observation data on DuPont coated non-εcribed panels: (a) blister size, (b) blister frequency, (c) rust rating.

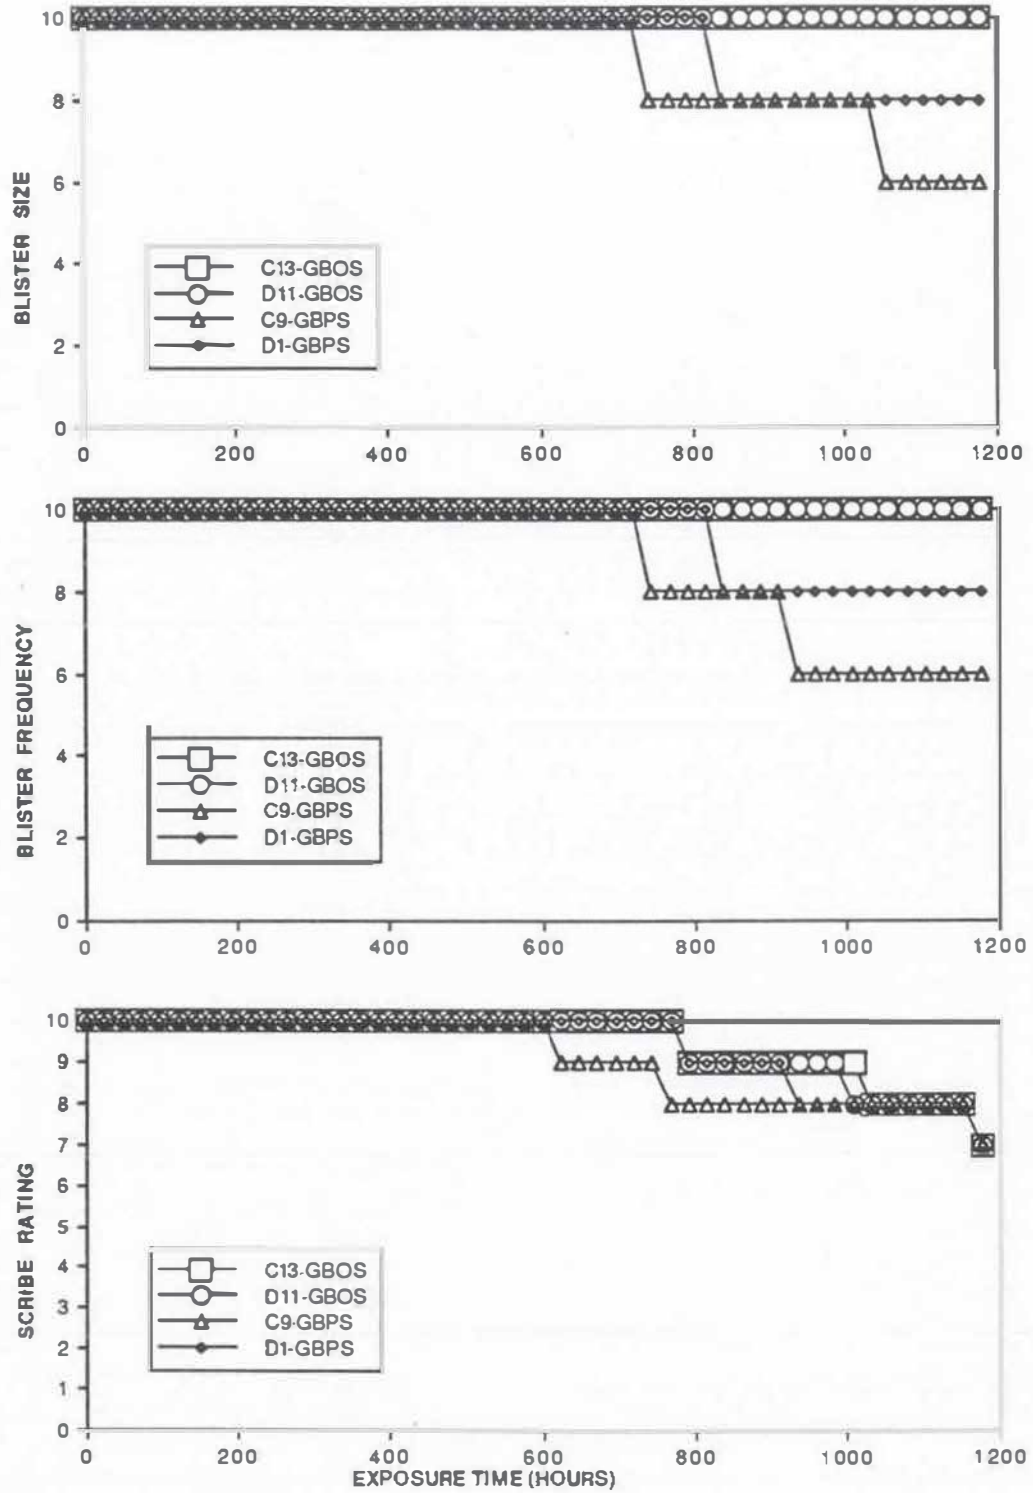
Figure C6. Daily visual observation data on DuPont coated scribed panels: (a) blister size, (b) blister frequency, (c) scribe rating.

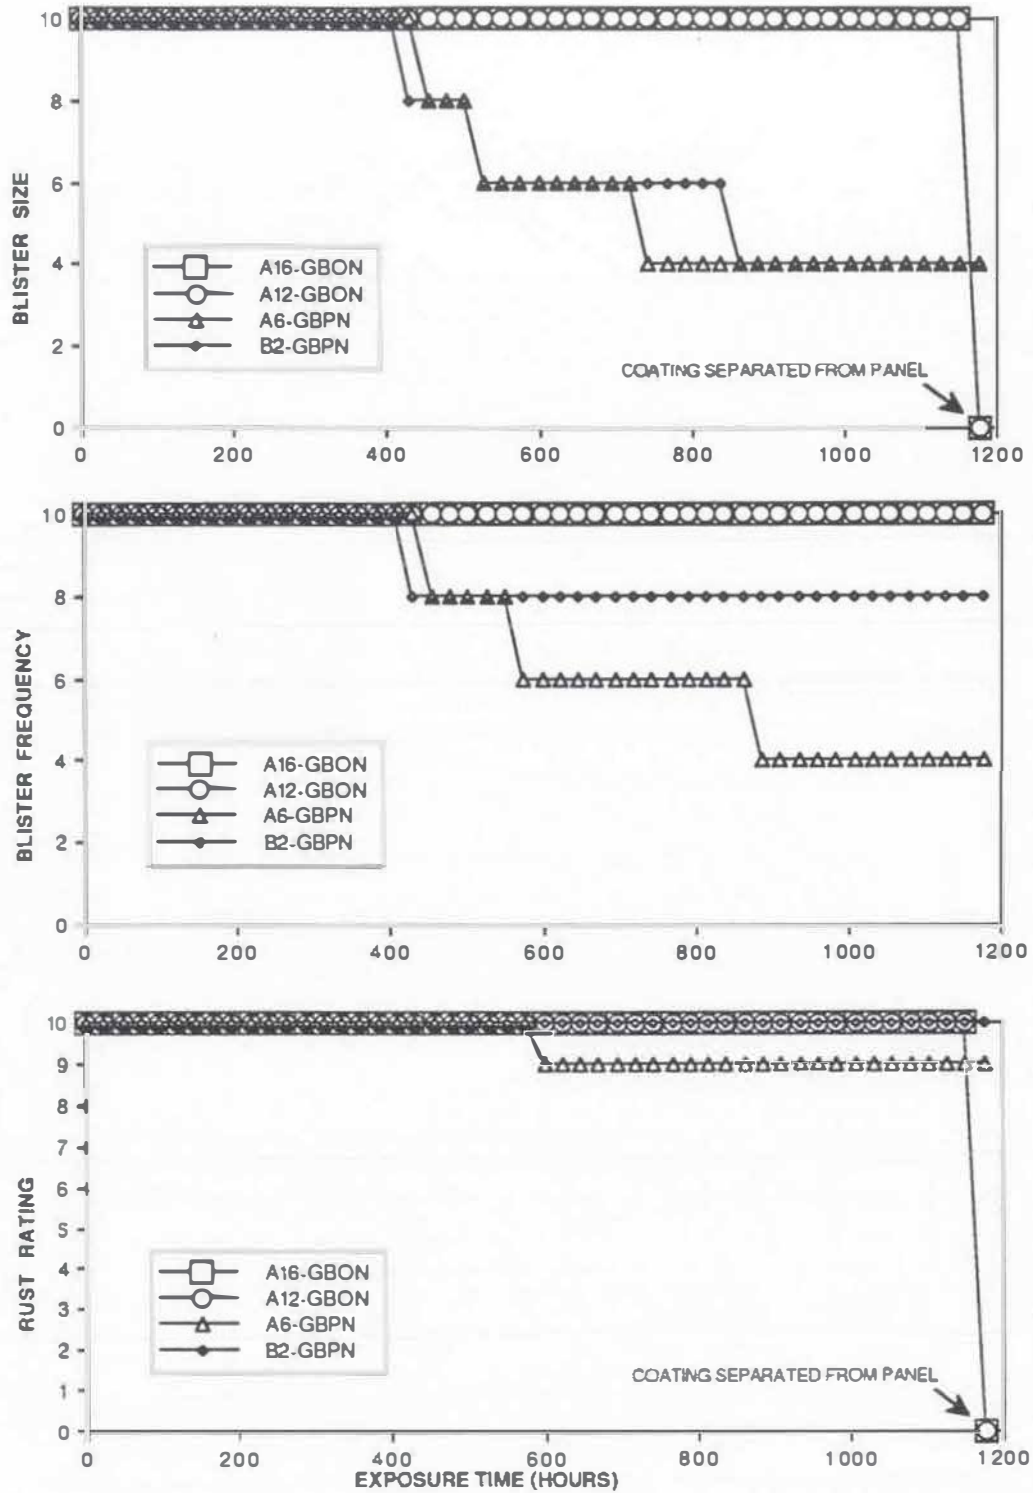
Figure C7. Daily visual observation data on Corroseal coated non-scribed panels: (a) blister size, (b) blister frequency, (c) rust rating.

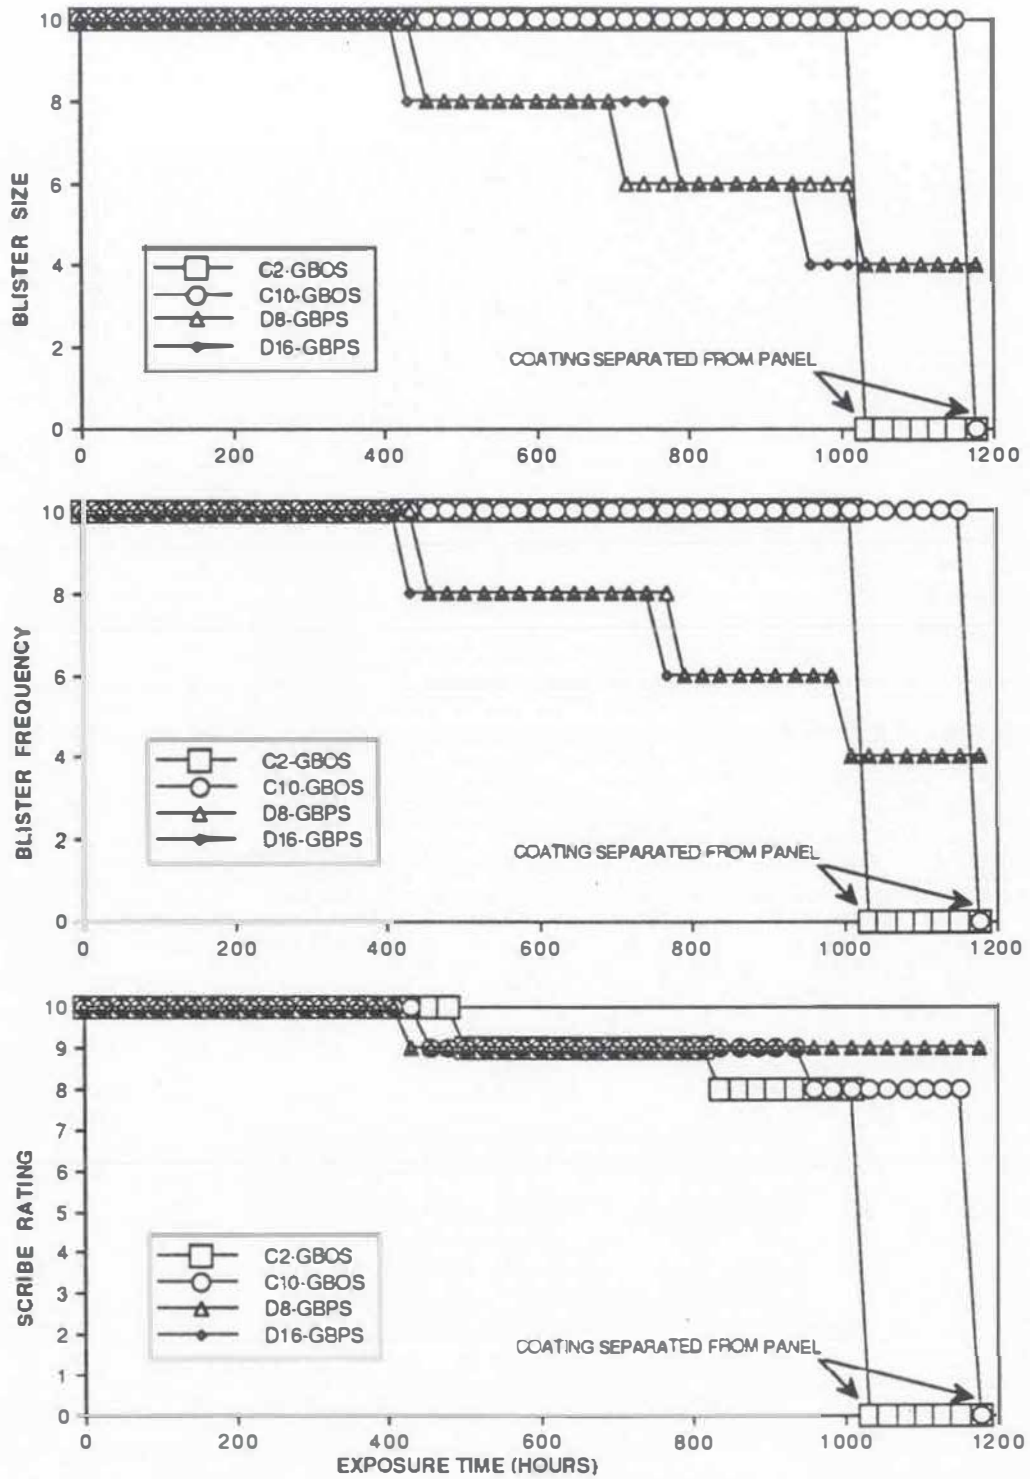
Figure C8. Daily visual observation data on Corroseau coated scribed panels: (a) blister size, (b) blister frequency, (c) scribe rating.

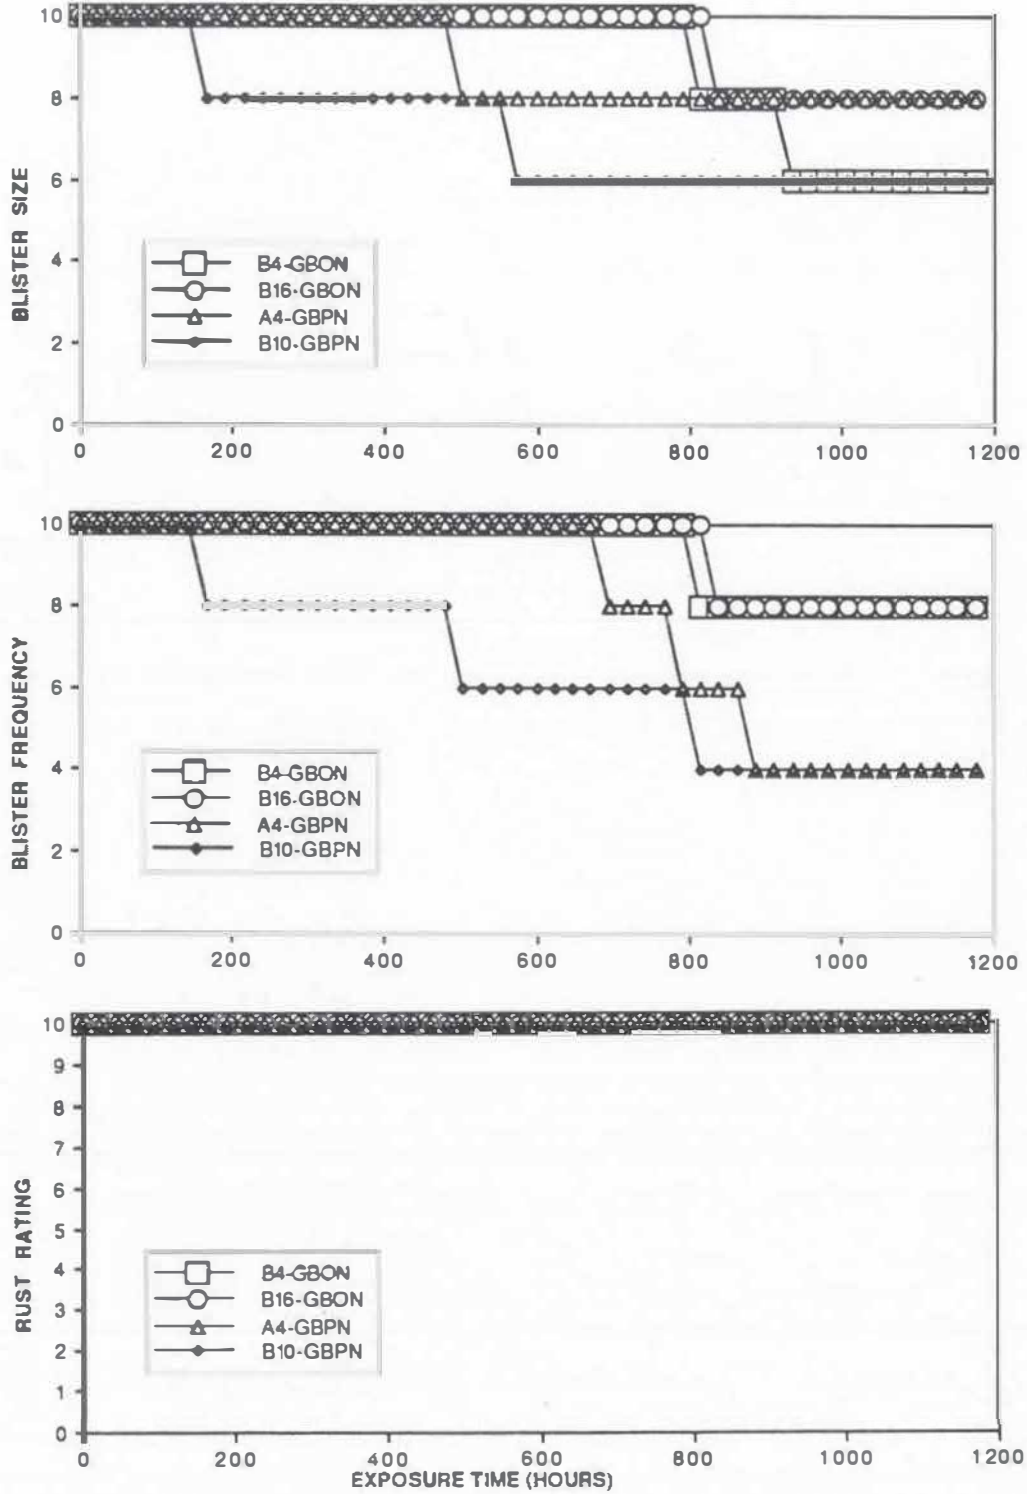
Figure C9. Daily visual observation data on Praxis coated non-scribed panels: (a) blister size, (b) blister frequency, (c) rust rating.

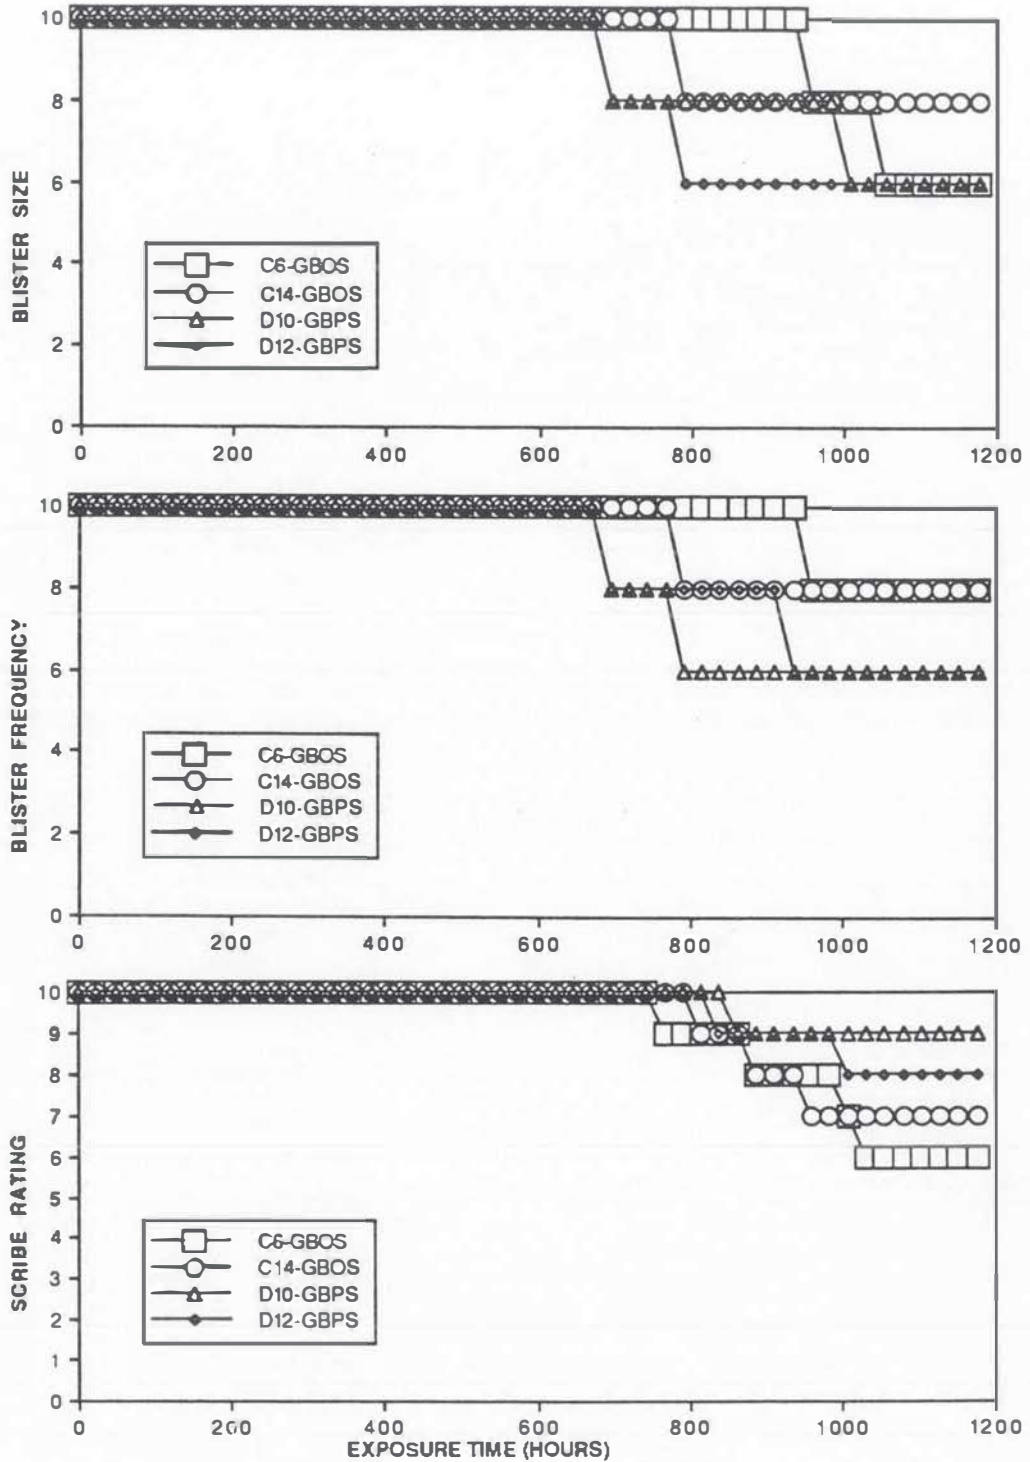
Figure C10. Daily visual observation data on Praxis coated scribed panels: (a) blister size, (b) blister frequency, (c) scribe rating.
