U.S. Department
of Transportation
Federal Railroad
Administration

Illinois High-Speed Rail Four-Quadrant Gate Reliability Assessment

1. AGENCY USE ONLY (Leave blank)		2. REPORT DATE October 2009		3. REPORT TYPE AND DATES COVERED September 2004 - September 2008	
4. TITLE AND SUBTITLE Illinois High-Speed Rail Four-Quadrant Gate Reliability Assessment				5. FUNDING NUMBERS RR97/EG081 RR97A1/EG222

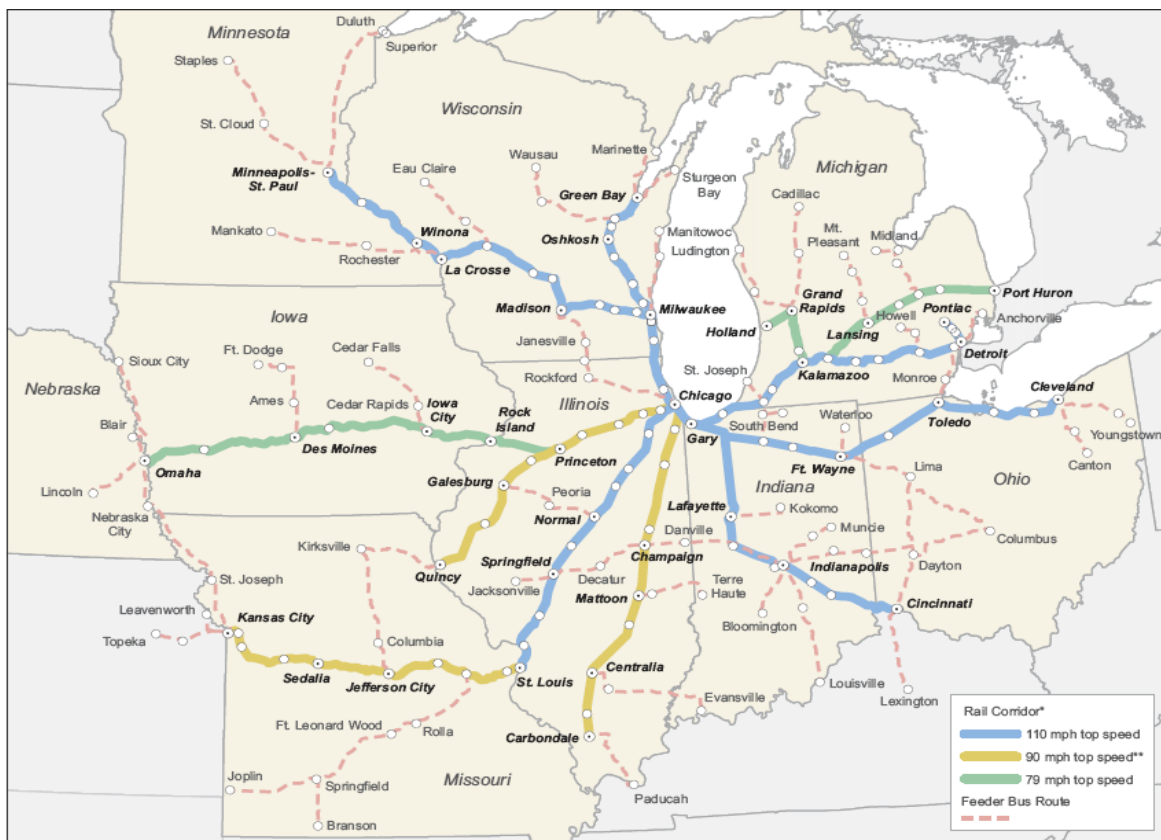
Figure 1. Midwest High-Speed Rail Network (Transportation Economics and Management Systems, Inc., and HNTB Corp., 2004)

The Chicago HSR corridor established a “hub-and-spoke” system centered on Chicago, IL, with termination points in St. Louis, MO, Detroit, MI, and Milwaukee, WI (FRA, 1997). This effort, part of the broader Midwest Regional Rail Initiative (MWRRI), will eventually interconnect nine states over a 3,000-mile (4,631 km) system shown in Figure 1. The overall goal of the MWRRI is to achieve reliable and frequent HSR service with trains operating at speeds between 90–110 mph (145–177 km/h). The features of this service will include new train sets, track infrastructure improvements, four-quadrant gate warning device technology at high-speed highway-rail grade crossings, and railroad signals accommodating the increased speed regimens (Transportation Economics and Management Systems, Inc. et al., 2004).

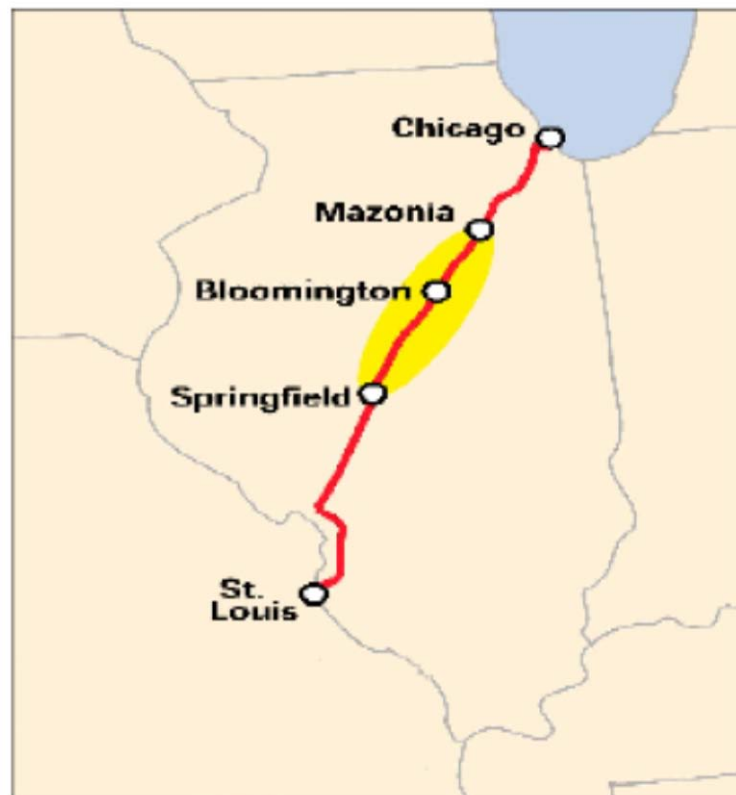
Figure 2. Illinois HSR Corridor (Tse, 2005)

Figure 2 shows the HSR corridor between Chicago and St. Louis. The corridor is owned and operated by the Union Pacific Railroad (UPRR), and contains a mix of freight, intercity conventional passenger rail, and commuter rail service. The majority of the line is single track and at the time the HSR program was initiated, Amtrak operated three daily round-trip passenger trains. In 2006, the frequency was increased to five daily round-trip trains.

The yellow highlighted portion in Figure 2, between Springfield and Mazonia, has undergone extensive track rehabilitation, including construction of 12 miles (19 km) of double track and 22 miles (35 km) of freight sidings, and now satisfies FRA Class 6 track regulations for 110 mph (177 km/h) train service.

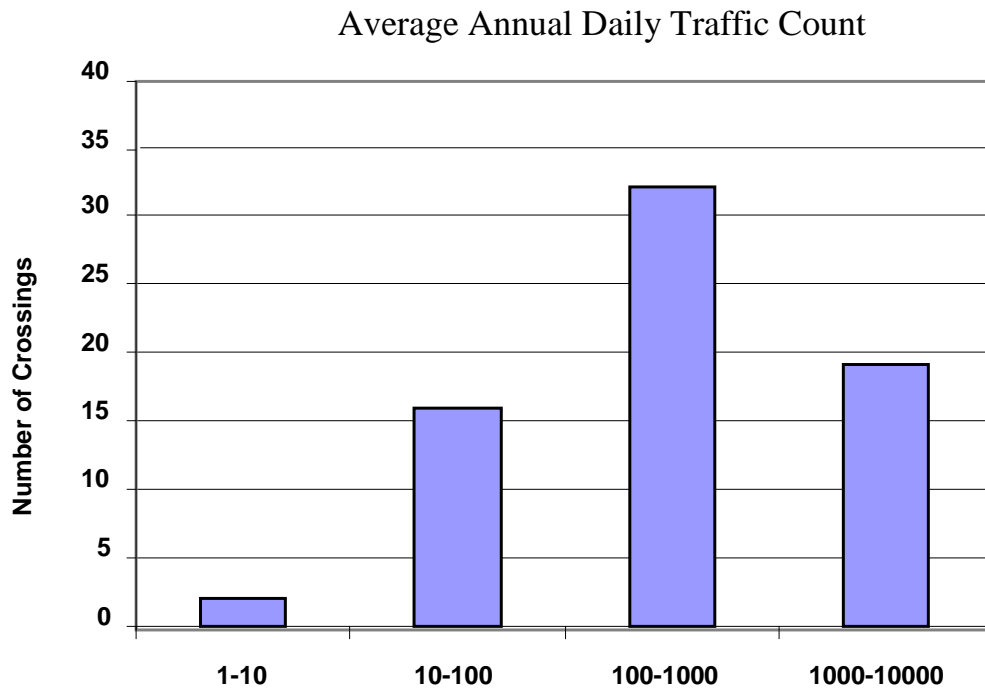
Figure 3. AADT Distribution of the 69 Four-Quadrant Gate Crossings

Of the 69 four-quadrant gate crossings, 62 were classified as rural and seven were classified as urban. As depicted in Figure 3, average annual daily traffic (AADT) at more than two-thirds of the crossings is less than 1,000.¹ This type of low-motor vehicle traffic environment lends itself particularly well to the implementation of four-quadrant gate crossing operations at speeds between 90 and 110 mph (145–177 km/h).

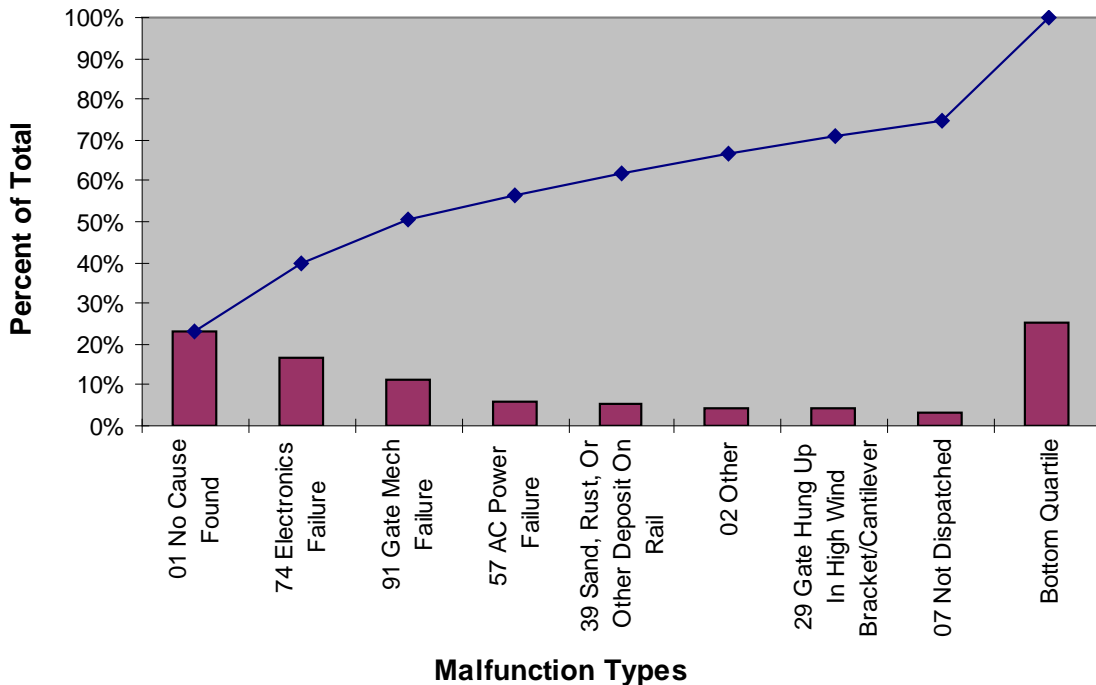
Figure 8. Pareto Distribution of Malfunctions from Data Set II by Reported Cause.

Data Set II entrance and exit gate malfunction data were used to analyze the impact of the four-quadrant gate/vehicle detection system on the HSR corridor timetable. The data collection period spanned 677 days between February 2004 and December 2005. In total, 889 unique trouble tickets were tabulated, equating to an average of 1.31 malfunctions per day. Altogether, 37 different malfunction types were identified as being specific to the grade crossing equipment. Analysis of the data showed that seven malfunction types, as depicted by the Pareto distribution in Figure 8, contributed to 80 percent of the total number of trouble tickets. The other 30 types accounted for the remaining 20 percent.

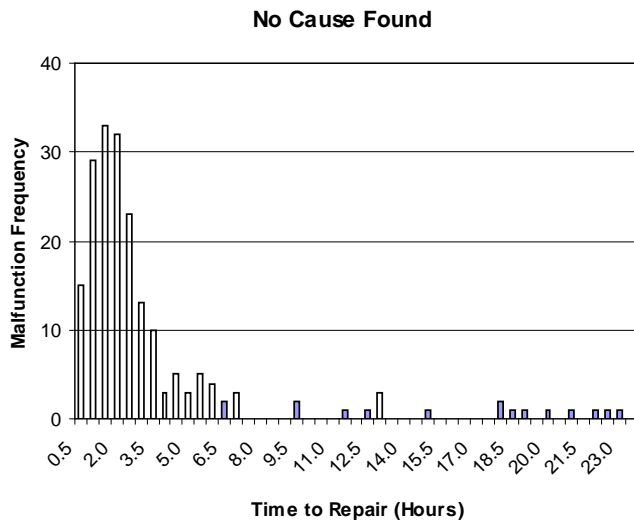
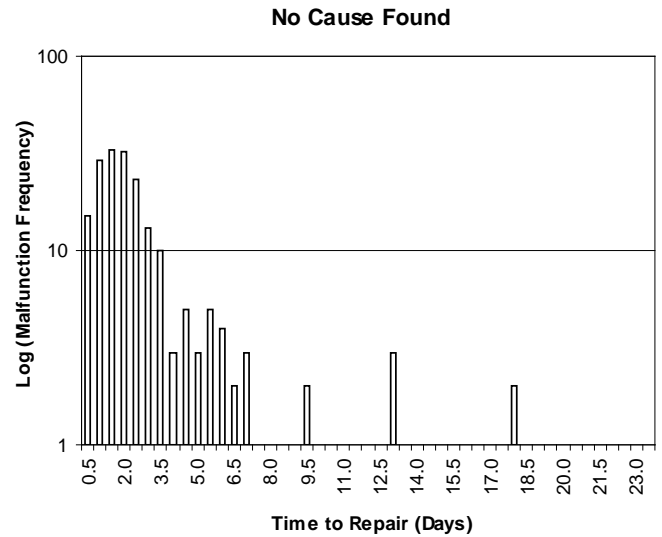
Figure 9. Example of Log-Normal Distribution

For this type of application, the geometric mean, which is related to the log-normal distribution, provides a more realistic average time to fix estimate. Figure 9 shows an example of a log-normal distribution compared to a normal distribution how the data distributions for the *No Cause Found* type responded to the geometric mean.

a) An example of an-adjusted log-normal distribution.

b) An example of a log-normal distribution on log-normal scale.

c) Unadjusted No Cause Found malfunction frequency distribution.

d) No Cause Found malfunction frequency distribution on log-normal (geometric mean) scale.
