## **Airborne Evaluation of Retro-Reflective Beads**

April 2010

DOT/FAA/AR-TN10/8

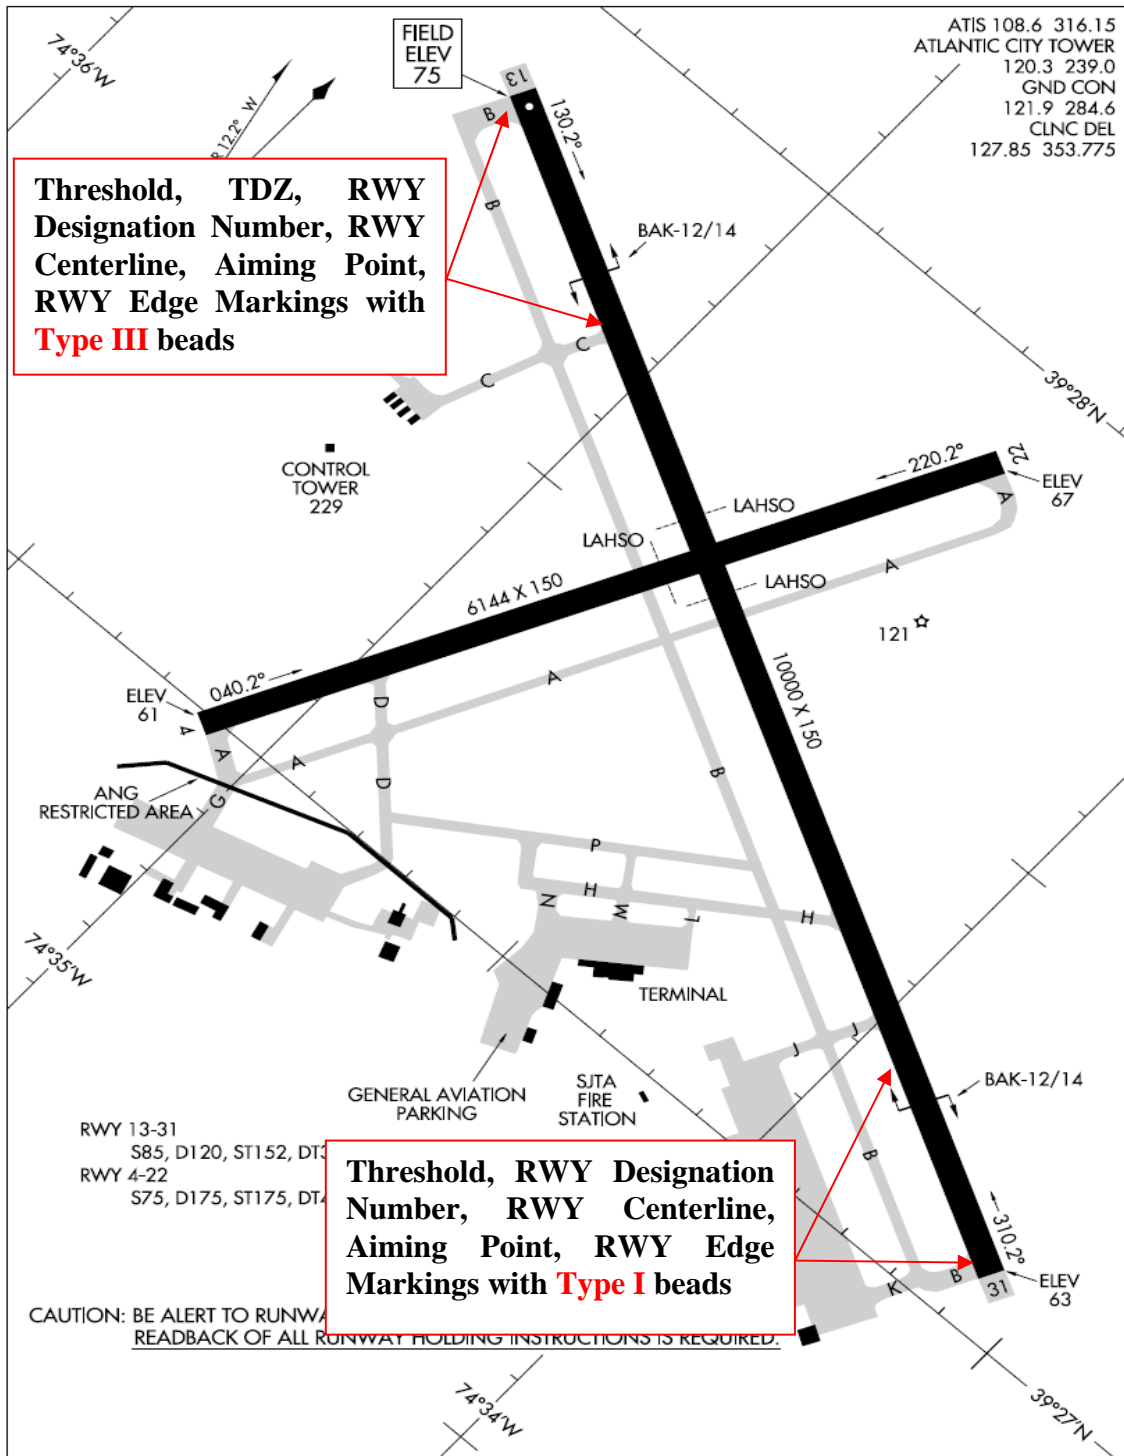
Figure 1. Atlantic City International Airport Diagram

**Threshold, TDZ, RWY Designation Number, RWY Centerline, Aiming Point, RWY Edge Markings with Type III beads**

**Threshold, RWY Designation Number, RWY Centerline, Aiming Point, RWY Edge Markings with Type I beads**

Phase one was conducted using the opposite ends of Runway 13/31 at ACY in November 2008. Type I and Type III retro-reflective beads were applied to standard waterborne paint at an application depth of 14-mil wet film thickness. Threshold Markings, Threshold Bar, Runway Designation Number, Runway Centerline, Touchdown Zone, Aiming Point, and Runway Edge markings were evaluated. Throughout the evaluation, objective data were collected to determine the chromaticity and retro-reflectivity readings. Figure 1 shows an airport diagram of ACY indicating where the Type I and Type III retro-reflective beads were applied to the runway markings.

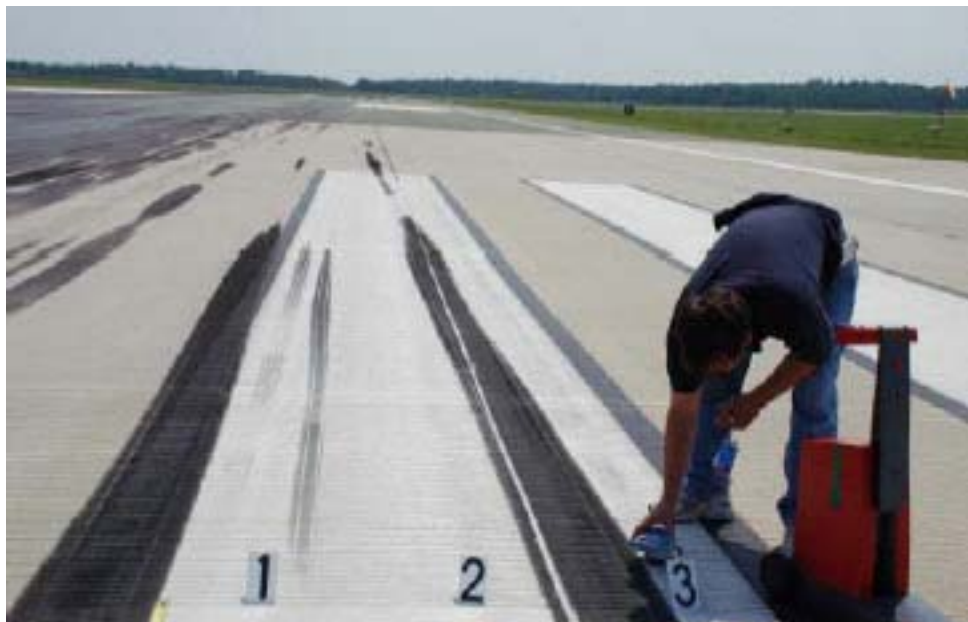
Figure 3. Airport Safety Technology R&D Sub-Team Member Taking Chromaticity Readings

Color readings were taken with a Spectro-Guide 45/0 Spectrophotometer, BYK-Gardner USA, which produces three coordinates ( $Y$  = depth,  $x$  = width,  $y$  = height) for its readouts (figure 3). The Spectro-Guide was setup for the standard coordinate system CIE 1931 XYZ color space, created by the International Commission on Illumination (CIE). The readings obtained were then compared to the color coordinate boundaries for white, as shown in figure 4.

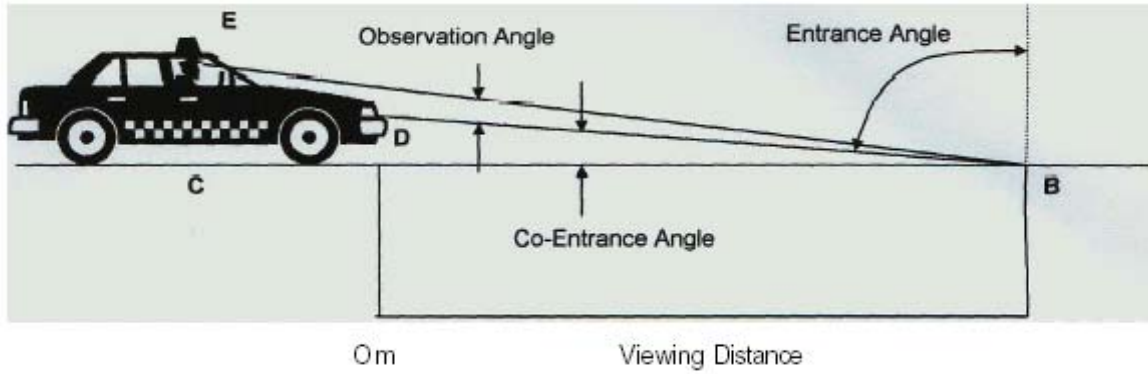
Figure 5. Thirty-Meter Geometry Measurement for Retro-Reflectivity

The 30-meter geometry for retro-reflectivity, which is distance from the headlights to the pavement markings, is the standard used by the highway departments, as shown in figure 5. The National Institute of Standards and Technology does not have a reference standard for retro-reflectometers. No standard has been developed for aircraft due to variability of cockpit heights. Therefore, the standards for the highway department are used.

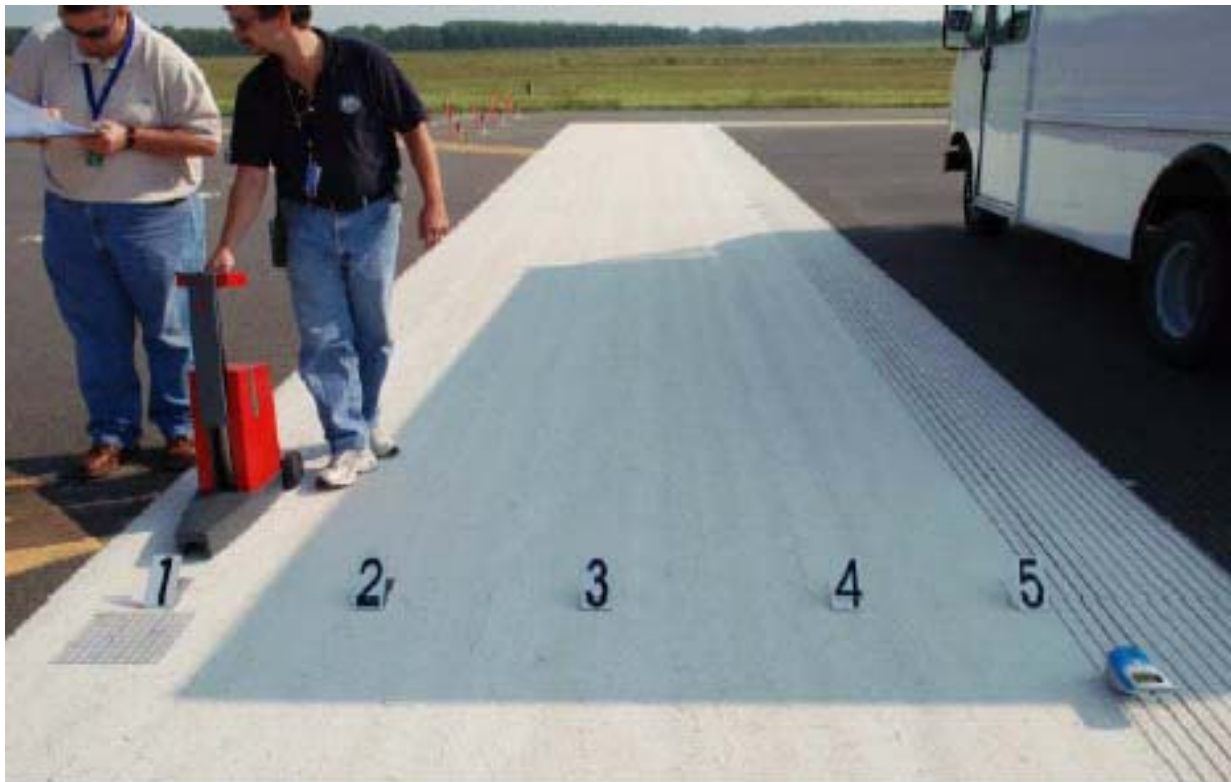
Figure 6. Airport Safety Technology R&D Sub-Team Members Taking Retro-Reflectivity Readings

Using the LTL-X Retrometer built by Delta Lights and Optics of Denmark, six readings per marking were taken, as shown in figure 6. Prior to each use, the instrument was calibrated.

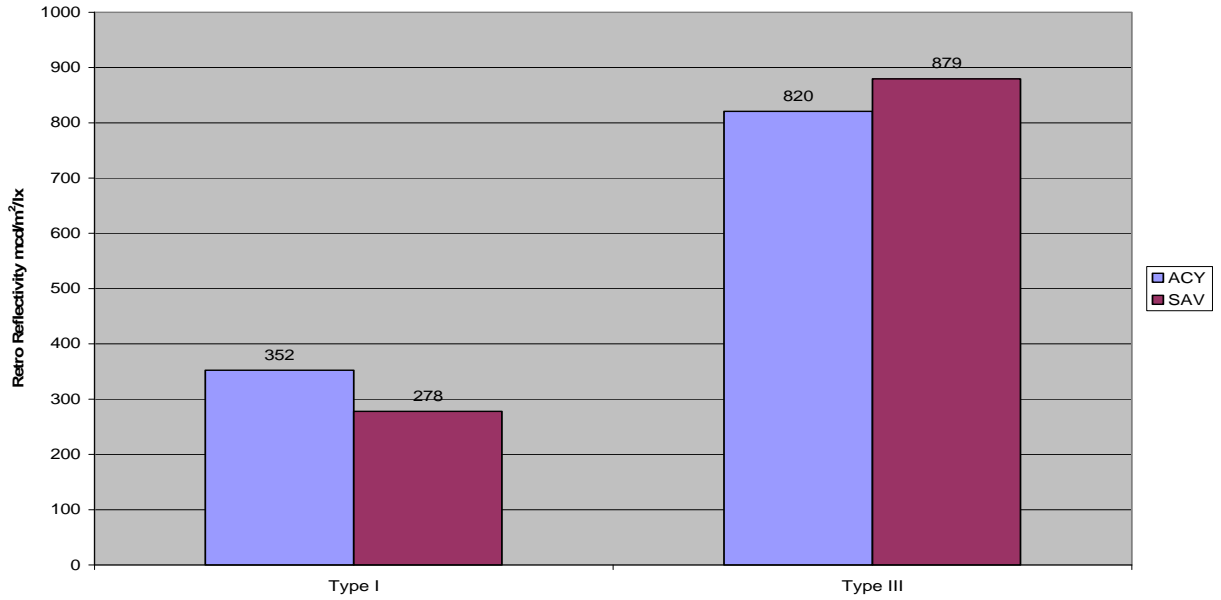
Figure 7. Overall Average of Retro-Reflectivity Readings at Start of Evaluation

Figure 7 shows the initial overall average of retro-reflectivity readings for runway markings at ACY and SAV taken immediately after installation. Two different contractors applied the markings at the test sites, and the readings indicated the application of the paint markings were “typical” installations. (See appendix B for additional data.)

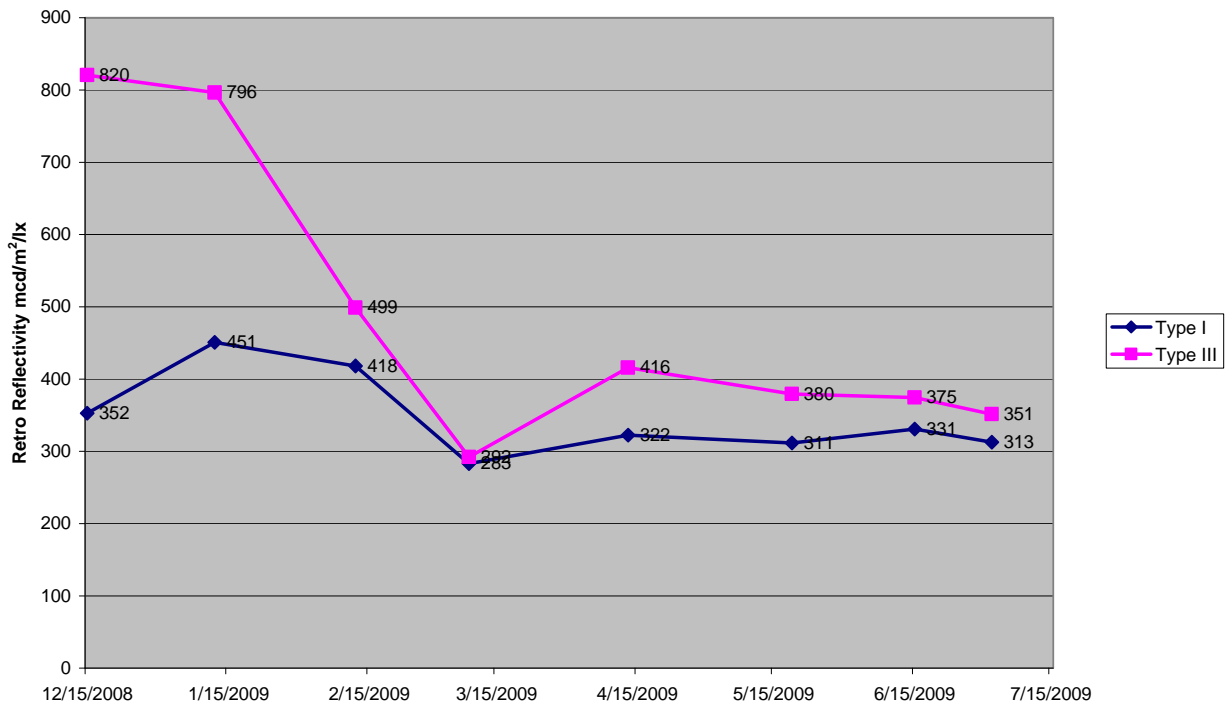
Figure 8. Overall Average of Retro-Reflectivity Readings at ACY Over 8 Months

The ACY evaluation provided the length of time necessary to capture the rate of retro-reflective degradation. Figure 8 shows that, initially, markings with Type III beads were more retro-reflective; however, after 4 months, both Type I and Type III beads leveled out at essentially the same value, which was above the recommended level of 100 mcd/m<sup>2</sup>/lx. All the retro-reflective bead evaluations that were conducted up to this point have demonstrated the same leveling out aspect.

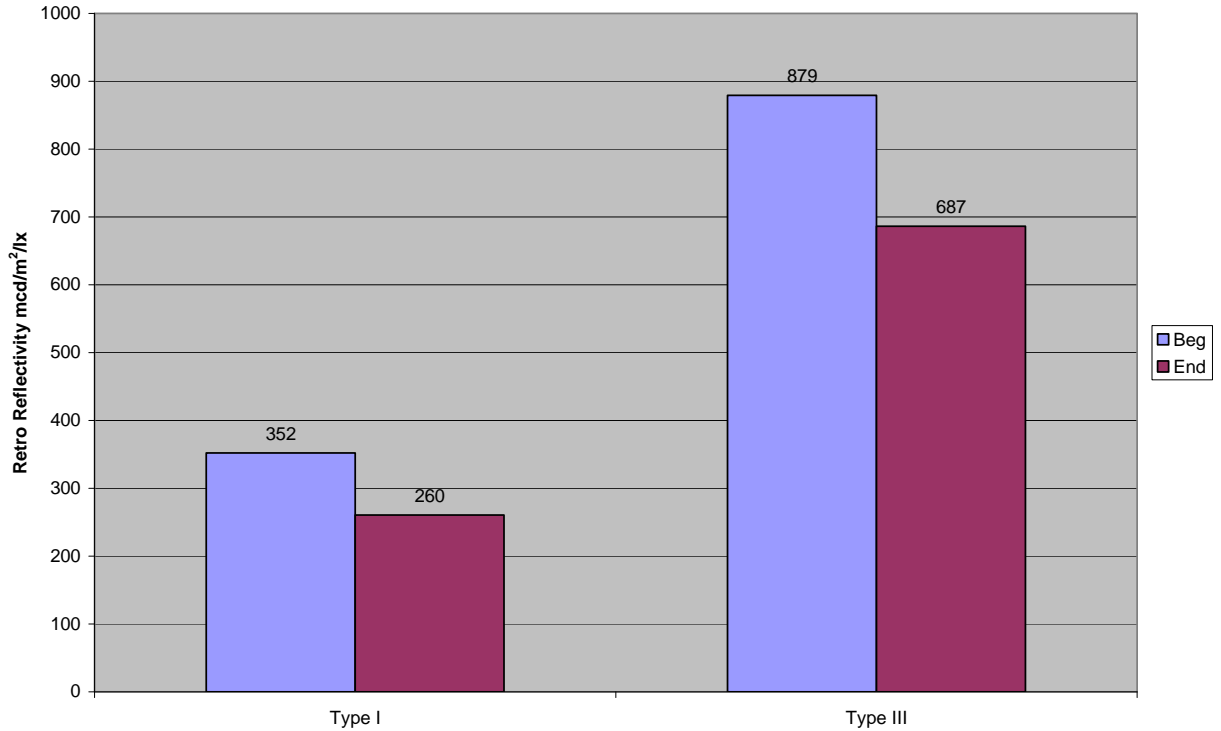
Figure 9. Overall Average of Retro-Reflectivity Readings at SAV Over 2 Months

Figure 9 shows the SAV data for a 2-month period.

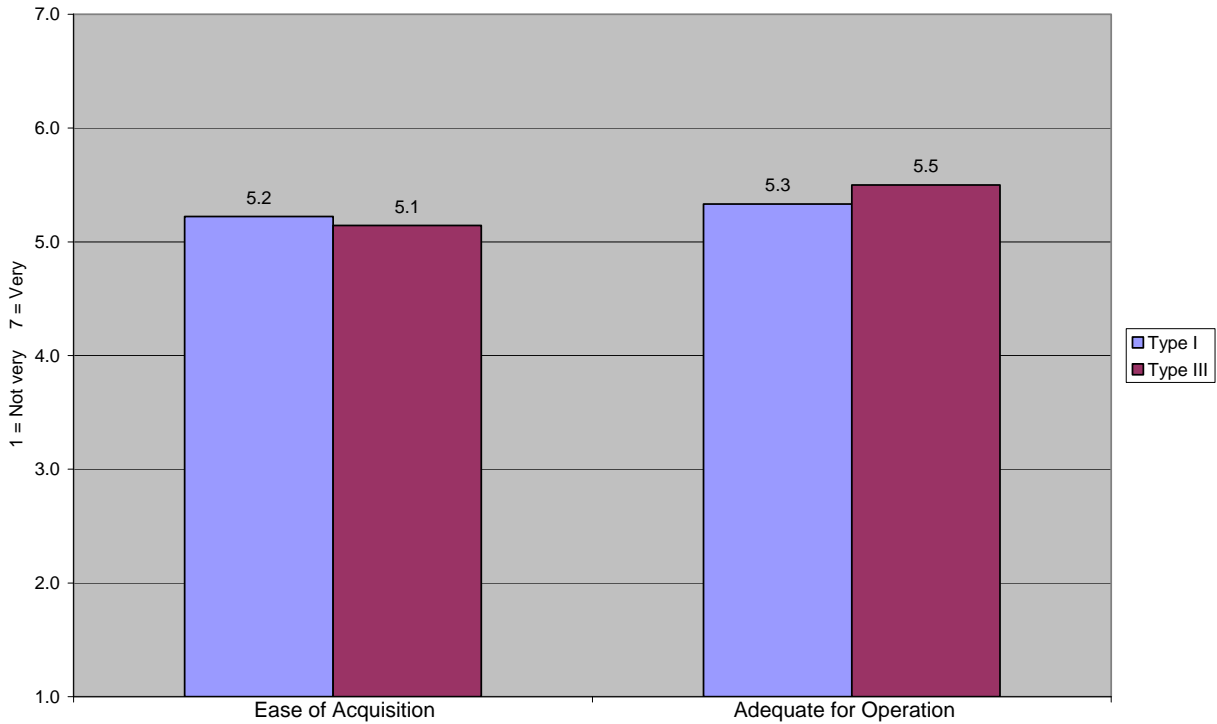
Figure 10. Comparison of ACY Type I and III Retro-Reflective Beads Regarding Ease of Runway Marking Detection and Adequacy Regarding Conspicuity

Figure 10 shows a comparison of Type I and Type III retro-reflective beads in relation to the statements “Were the markings easy to detect?” and “Were the runway markings adequate in regards to conspicuity to complete the landing operation safely?” (labeled “Ease of Acquisition” and “Adequate for Operation,” respectively, in the figure.) Using a seven-point Likert scale where 1 implied “Not Very Easy” and 7 implied “Very Easy,” observers noted that ease of detection for Type I retro-reflective beads had an average response of 5.2, and Type III retro-reflective beads had an average response of 5.1. Conspicuity to complete the landing operation safely had an averaged response of 5.3 for Type I retro-reflective beads and 5.5 for Type III retro-reflective beads.

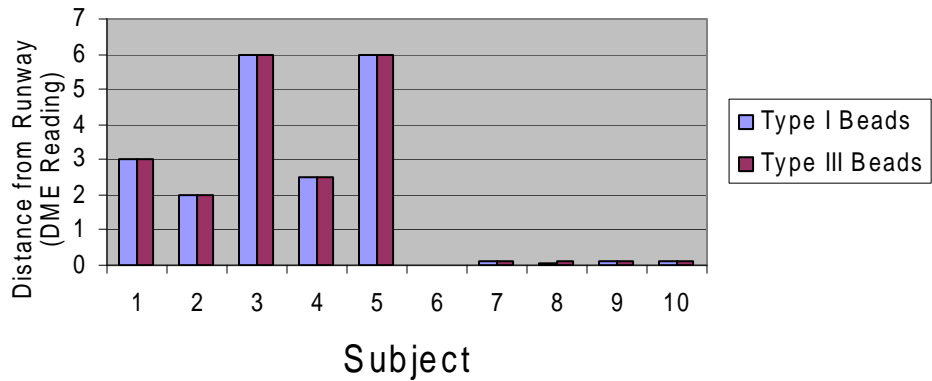
Figure 11. Test Subject Responses Regarding Visibility and Conspicuity of Runway Markings at SAV

Based on the subjective information obtained from the test subjects, it was determined that the average distance from the runway threshold that both Type I and Type III bead markings were visible and conspicuous was 3.9 miles. Of the ten test subjects, one did not list a distant measuring equipment reading, regarding visibility and conspicuity. A comment was made that “markings on the right (south Type III) side of the runway became visible just slightly before the left (north Type I).” Figure 11 shows the responses from the subjects at SAV regarding the markings’ visibility and conspicuity.
