**TxDOT Report 0-7150-R1**  
**Artificial Intelligence for Pavement Condition Assessment from 2D/3D**  
**Surface Images**

*Texas State University, Ingram School of Engineering; San Marcos, Texas*

Submitted March 2026; Published April 2026

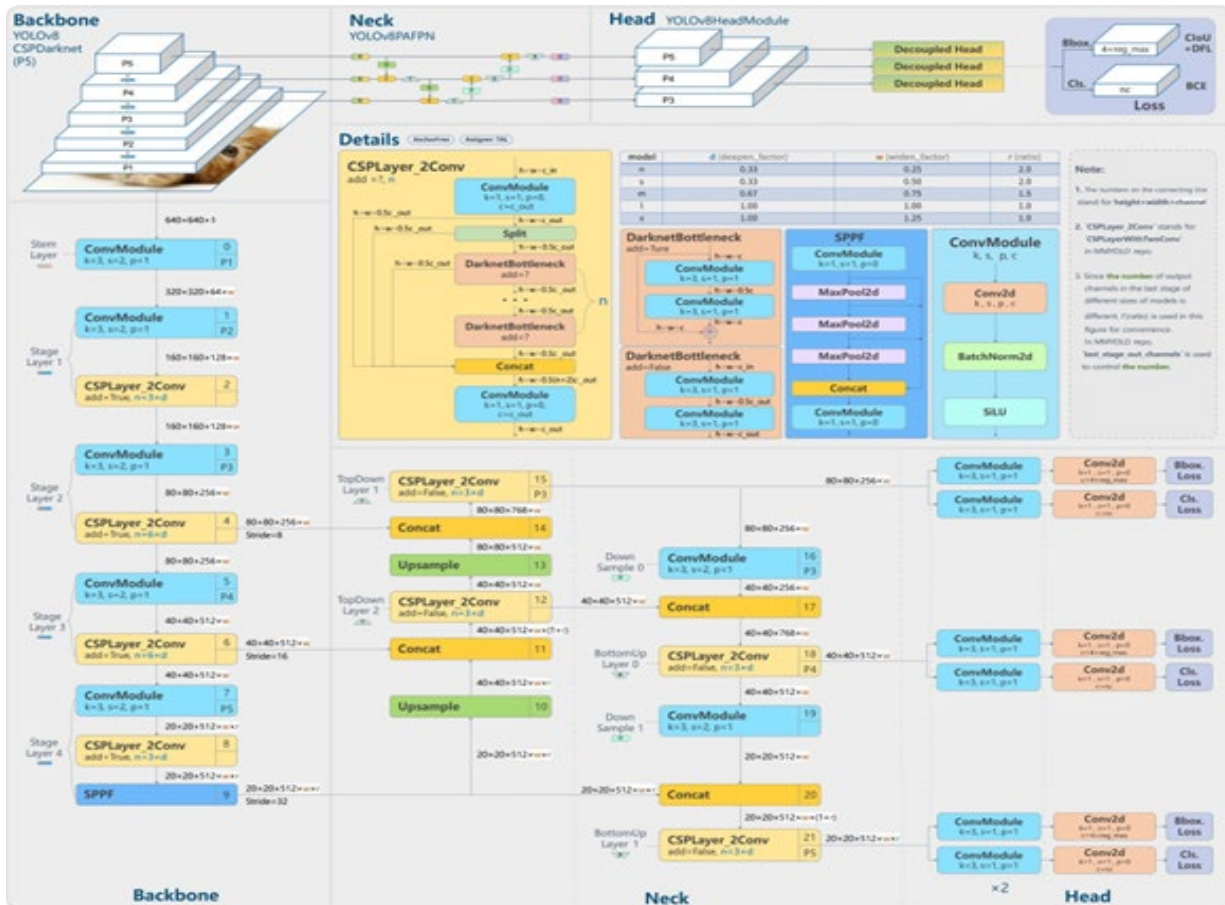
YOLOv5 and YOLOv8 represent significant advancements in the YOLO series, each bringing innovative changes to the architecture to enhance object detection performance. YOLOv5 introduced the CSPDarknet backbone, which utilizes Cross Stage Partial (CSP) connections to reduce computational cost while maintaining high accuracy (Figure 5.5). It also integrated PANet (Path Aggregation Network) in the neck for better feature fusion across different scales and included automated anchor box learning, which adapts to various datasets. Additionally, YOLOv5 leverages advanced data augmentation techniques like Mosaic, which improves the model's robustness and generalization. YOLOv8 moves towards an anchor-free architecture, which simplifies the detection process by eliminating the need for predefined anchor boxes. This anchor-free approach allows YOLOv8 to directly predict object centers and scales, improving its ability to detect small and overlapping objects more accurately and efficiently.

Figure 5.6 YOLOv8 architecture

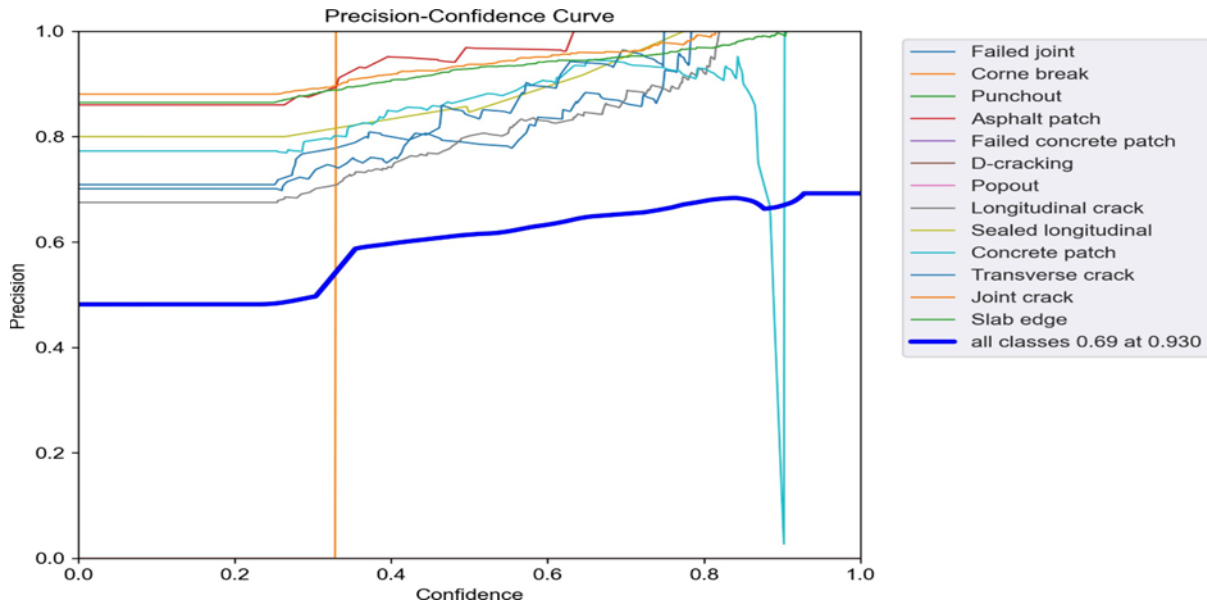
**Figure 5.23 Precision curve for different classes of JCP intensity image dataset**

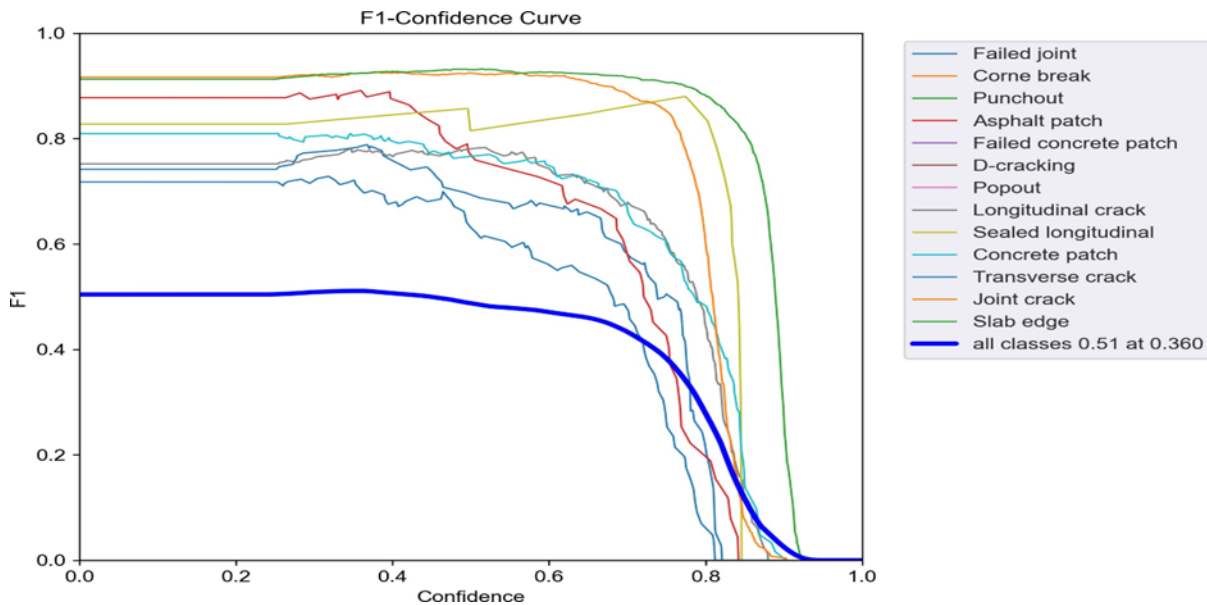
**Figure 5.25 F1 curve for different classes of JCP intensity image dataset**

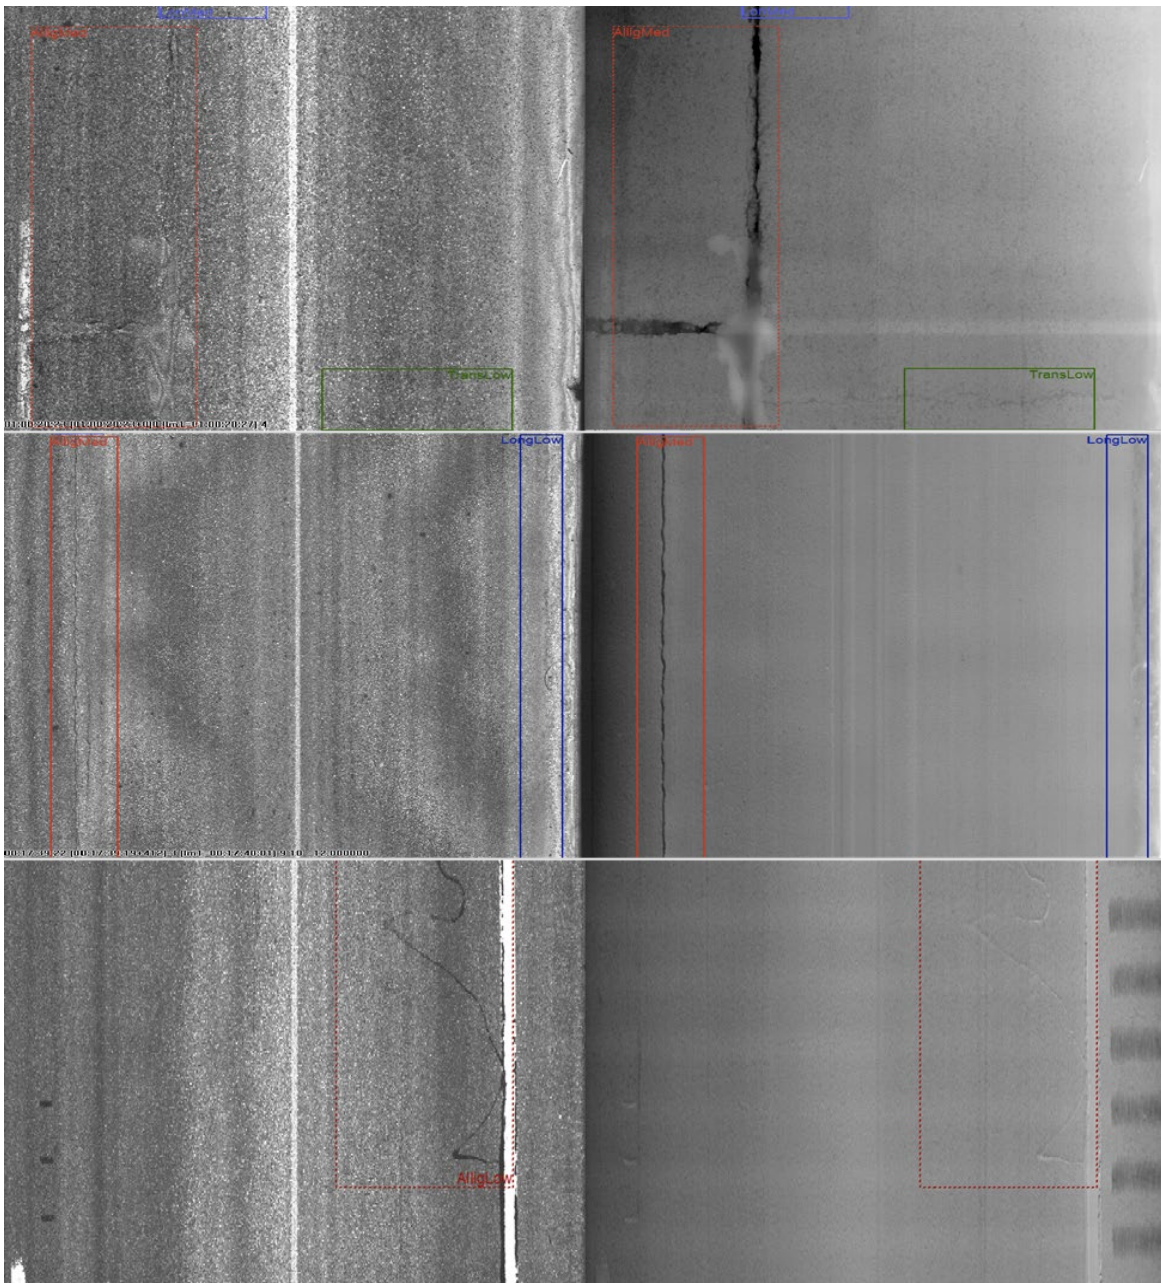
Figure 5.33 Alligator predictions (shown in red bounding boxes) from PathView system

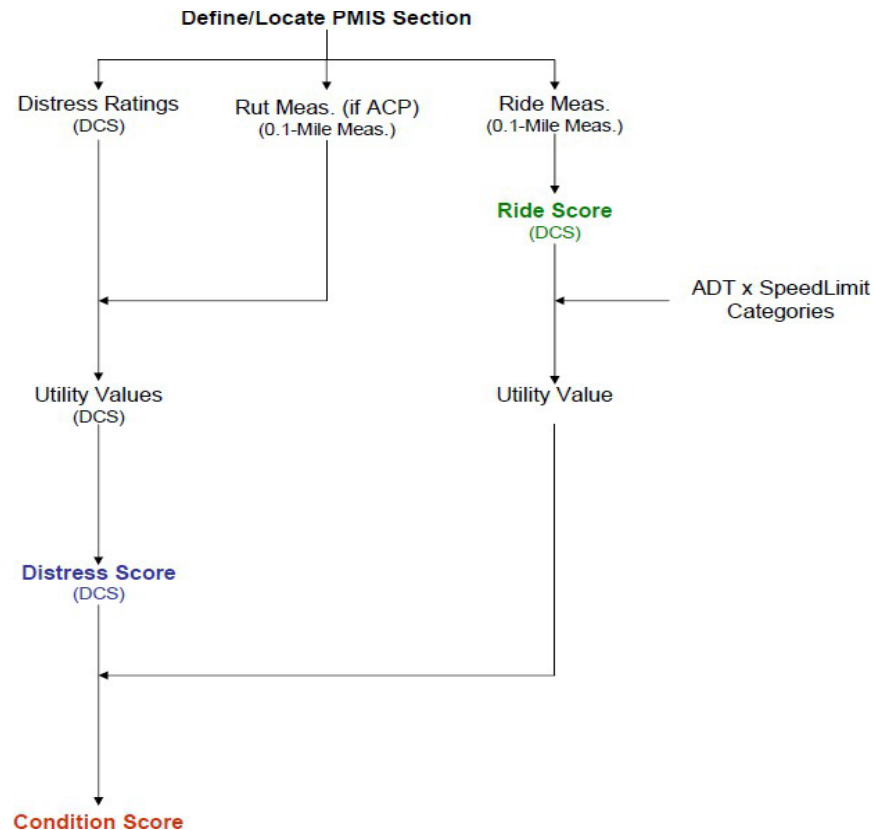
**Figure 6.1 Process used to calculate PMIS condition score**

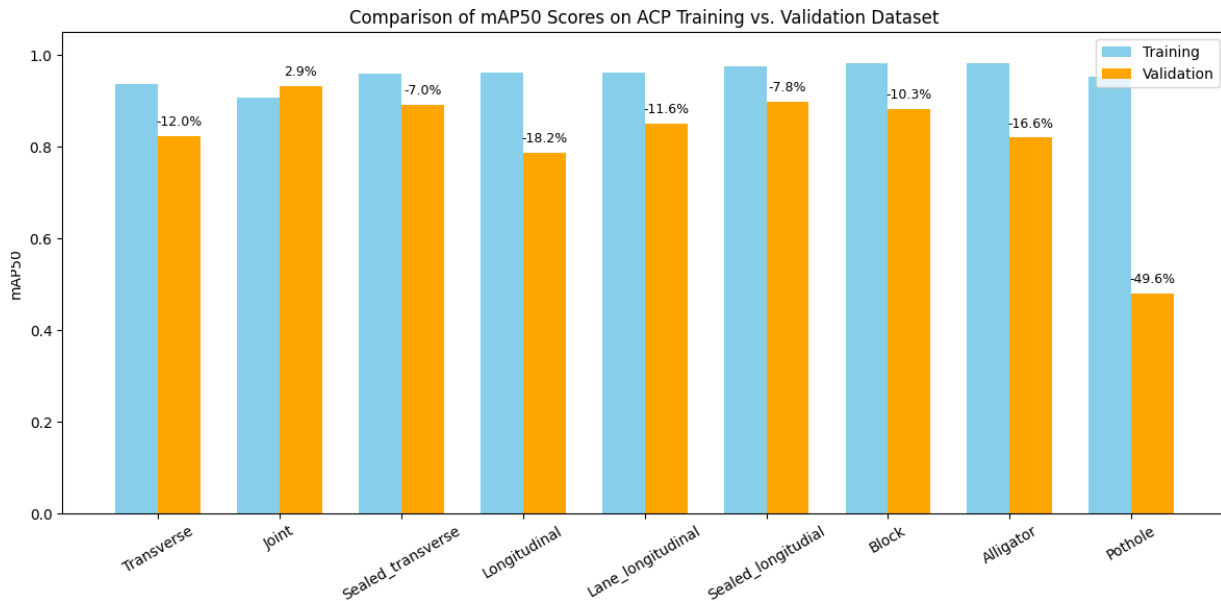
**Figure 7.1 Comparison of mAP50 scores on ACP training and validation datasets**

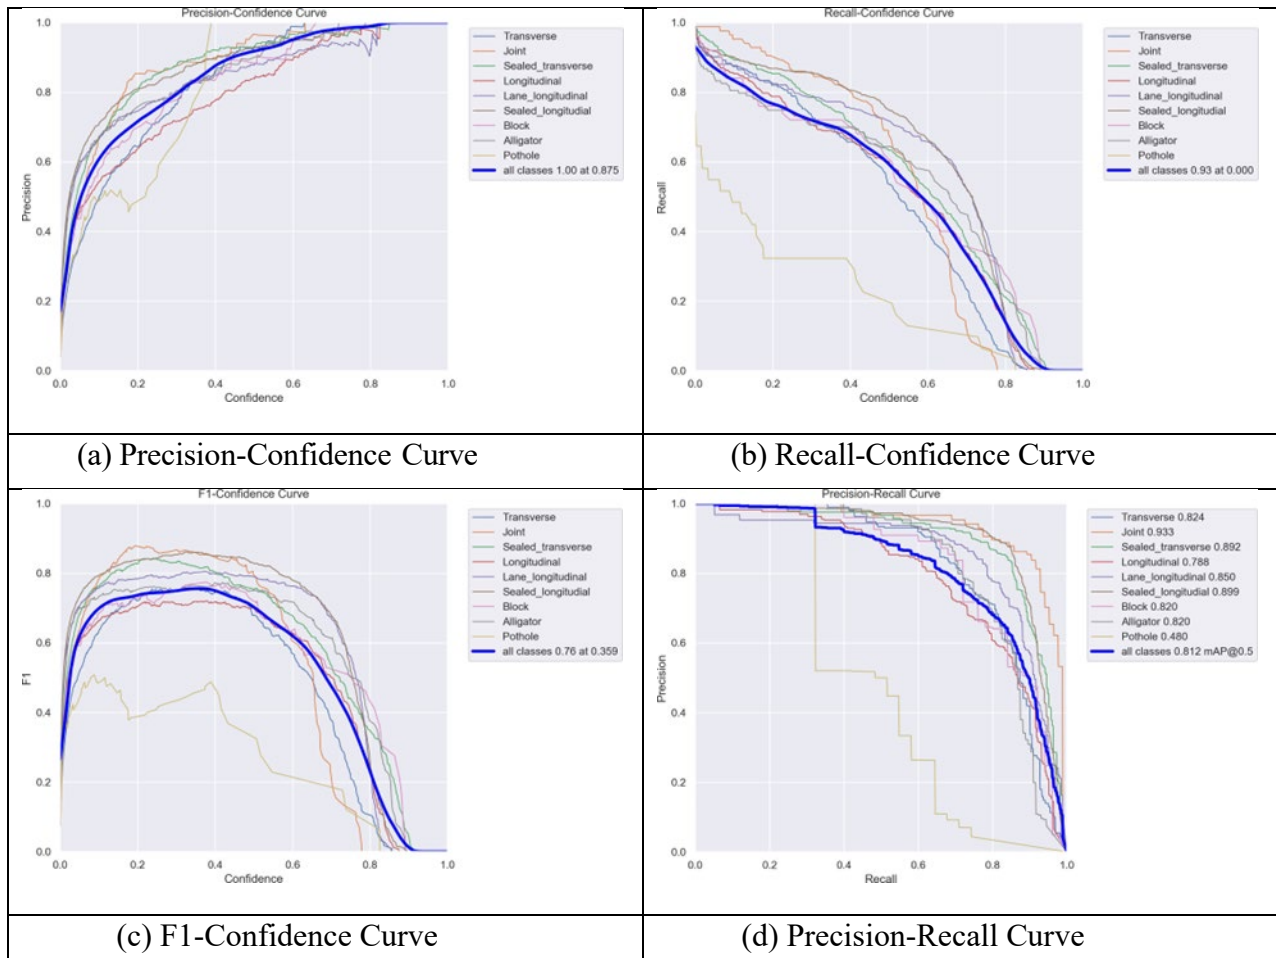
**Figure 7.3 Model evaluation plots for the detection system over the ACP dataset**

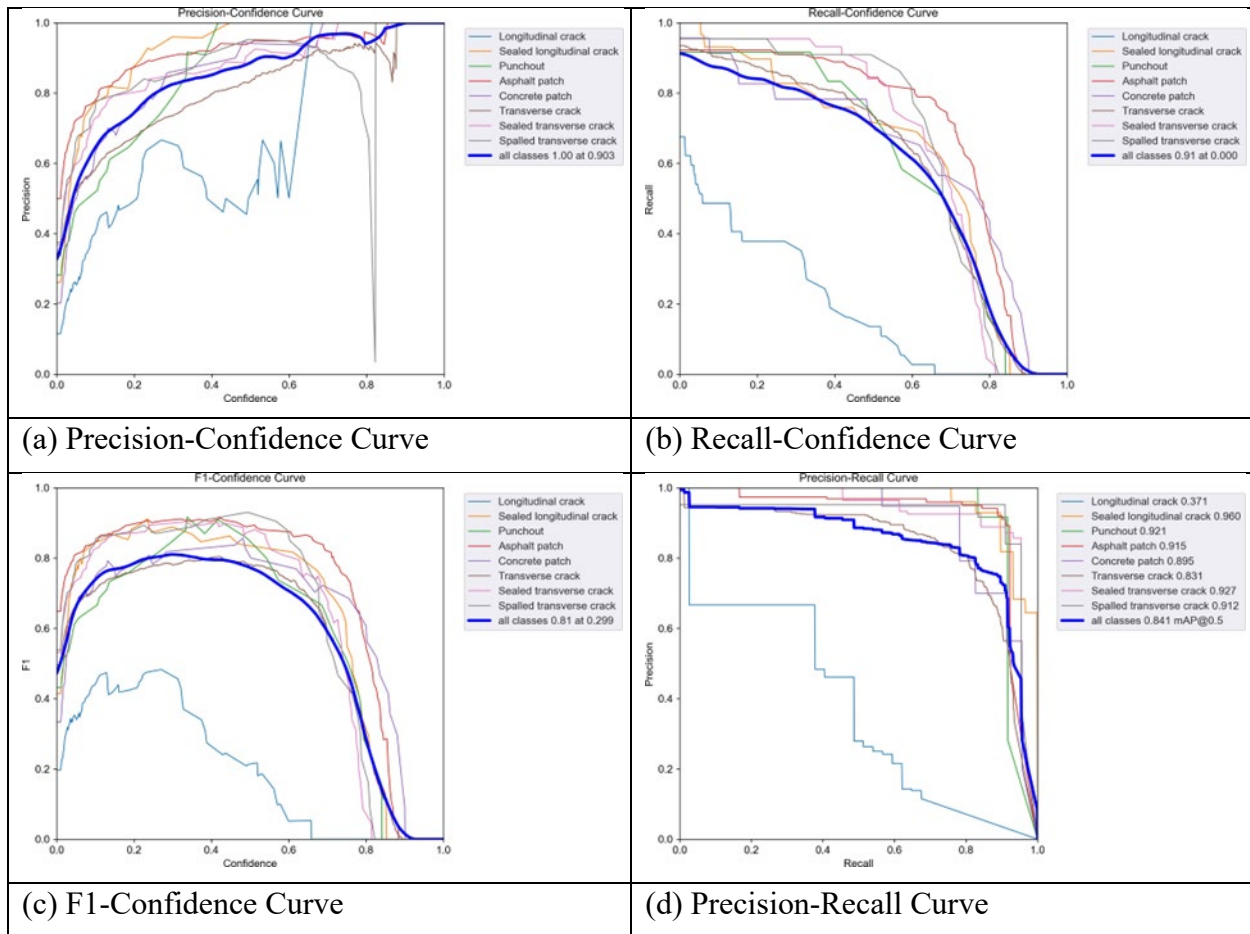
**Figure 7.13 Model evaluation plots for the detection system over the CRCP dataset**

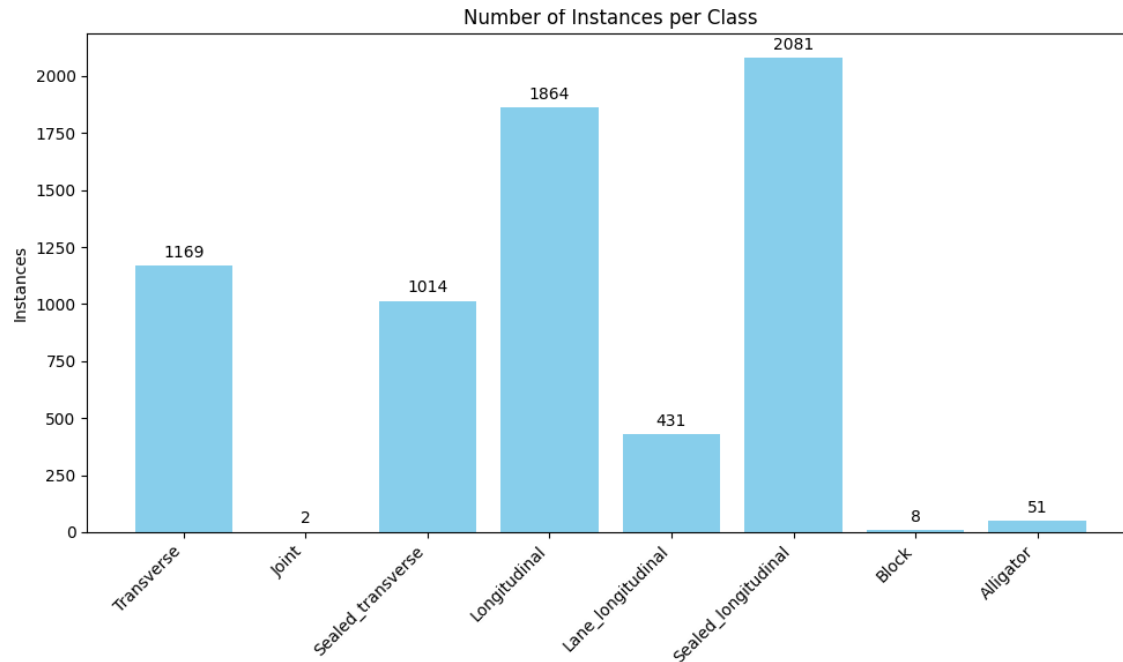
**Figure 7.17 Distribution of the number of individual distress classes of selected ACP sections**

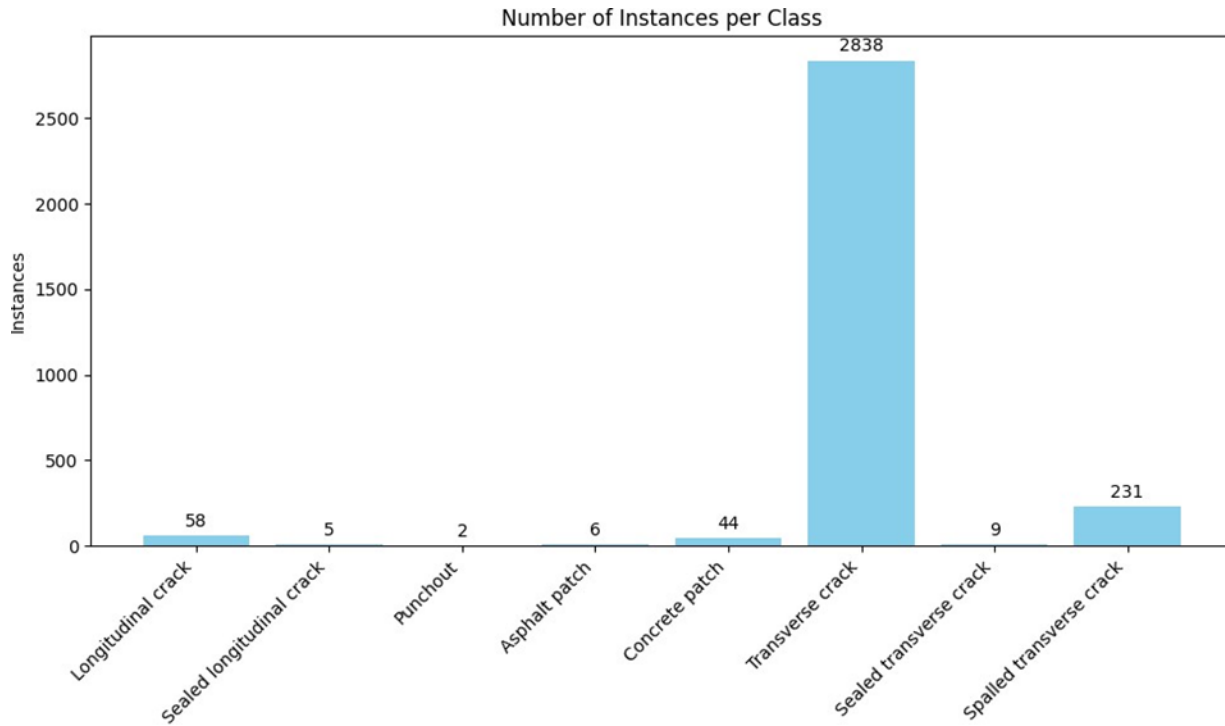
**Figure 7.19 Distribution of the number of individual distress classes of CRCP in Brazoria County**

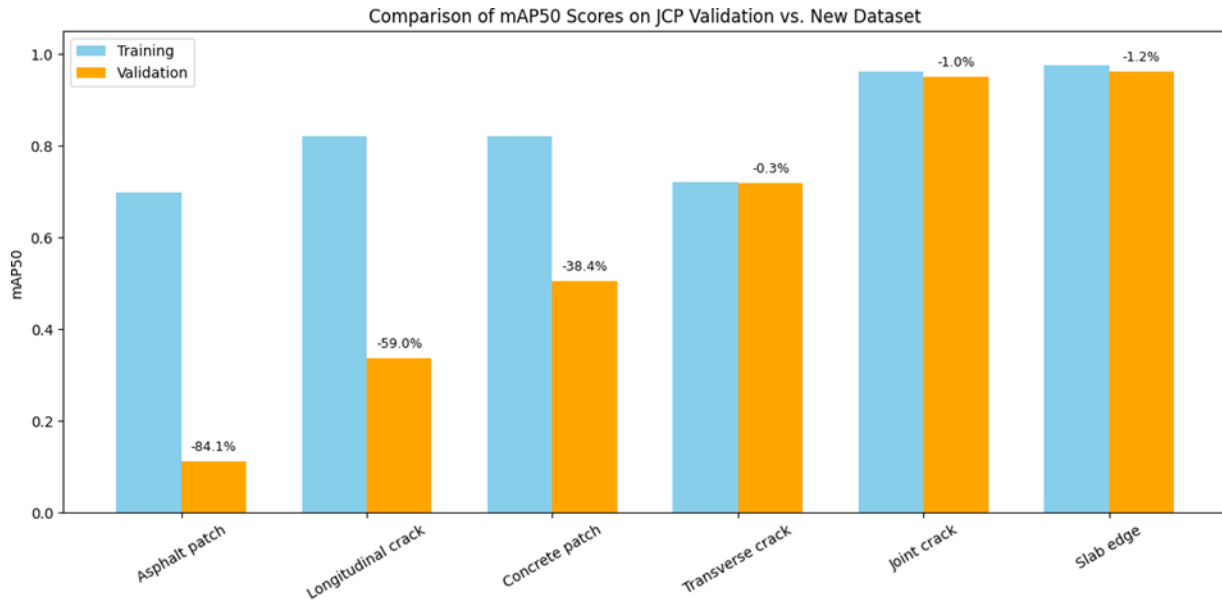
**Figure 7.28 Comparison of mAP50 scores on JCP validation and new datasets**

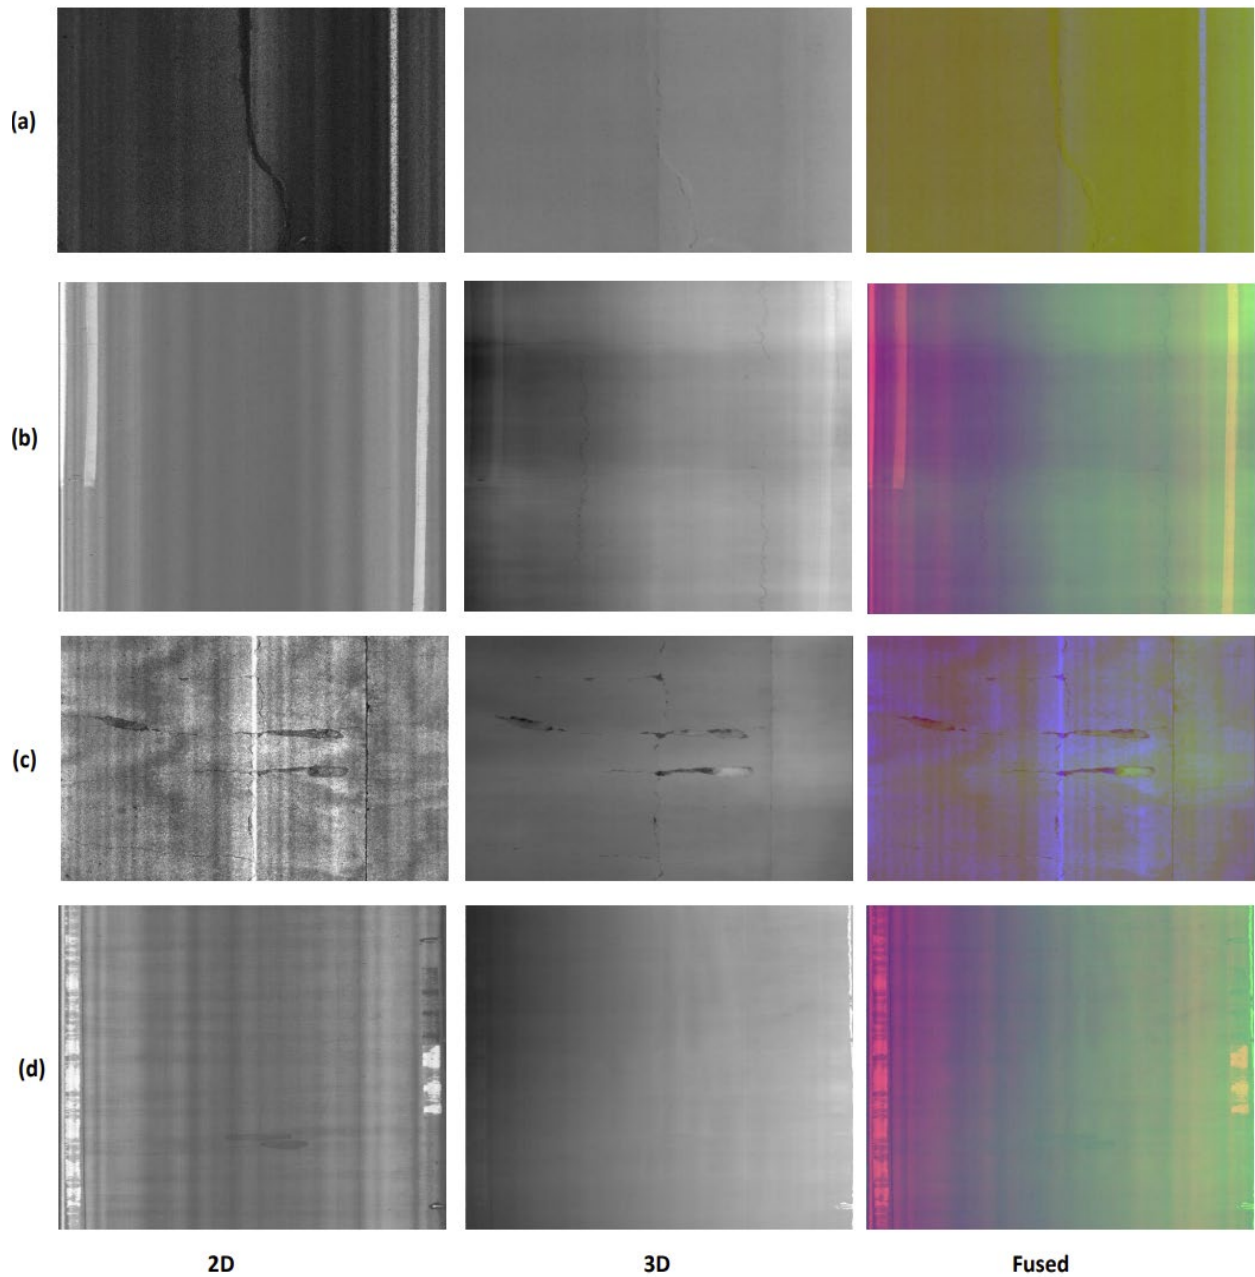
**Figure 7.38 Two different datasets collected in this research. (a) and (c) , (b) and (d) are 2D, 3D, and fused images of ACP and CRCP for Datasets 7150 and NSF, respectively**
